Water Resource Protection Plan For WDID #1B16446CHUM

Ethan Aronson 4220 Browns Road Eureka, California 95501

9-14-2016

Assessment of Standard Conditions for APN 316-063-006 – WDID #1B16446CHUM

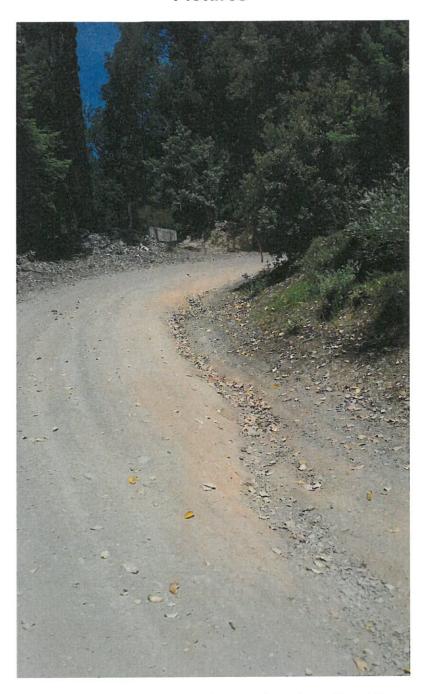
The road that accesses the property is rocked. Road drainage features appeared to be worn down from normal use. The road segment identified as Road Segment 1 on the WRPP Map, appears susceptible to surface erosion and rutting during the winter seasons due to its grade. Shallow rutting had taken place along the road surface during the previous winter. If left unchecked, there is the potential that this road segment would no longer be in compliance with Standard Condition A.(1)(a), above. To prevent future rutting of the road surface, and to remain in compliance with this Standard Condition of the Order, Road Segment 1 should have surface drainage features installed prior to the winter period. Drainage features can include waterbreaks, rolling dips, or drainage push outs.

Picture 1: This is a picture of some of the minor rutting along Road Segment 1 on the WRPP Map, and a good location for a waterbreak to be installed prior to the winter period. Photo date 6/1/2016

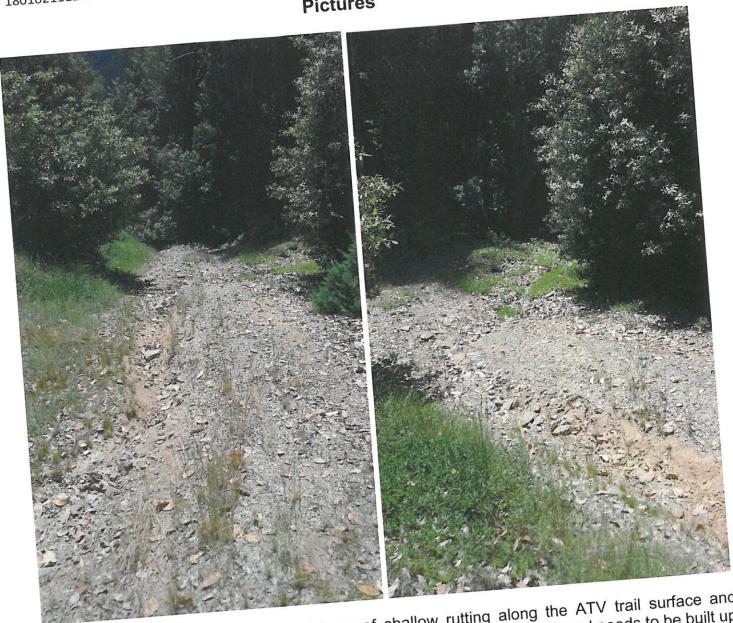
A location was identified where concentrated road surface drainage exits the road at the location of a mapped ATV trail. Map Point 2 is a waterbreak location on this ATV trail that needs to be reconstructed (built up) and maintained to ensure that road drainage is not directed down the ATV trail for a long distance, and to remain in compliance with Standard Condition A.(1)(b). Also, by installing road surface drainage features along Road Segment 1 as directed in (a) above, there will not be as much road surface drainage being directed down the ATV trail in the future.

Pictures 2 and 3: These are pictures of shallow rutting along the ATV trail surface and the waterbreak at Map Point 2. The waterbreak has become worn down and needs to be built up and maintained to ensure that surface flow in the shallow rut does not escape past the waterbreak. Installation of road surface drainage features along Road Segment 1 will result in less concentrated runoff onto this ATV trail. Photo date 6/1/2016

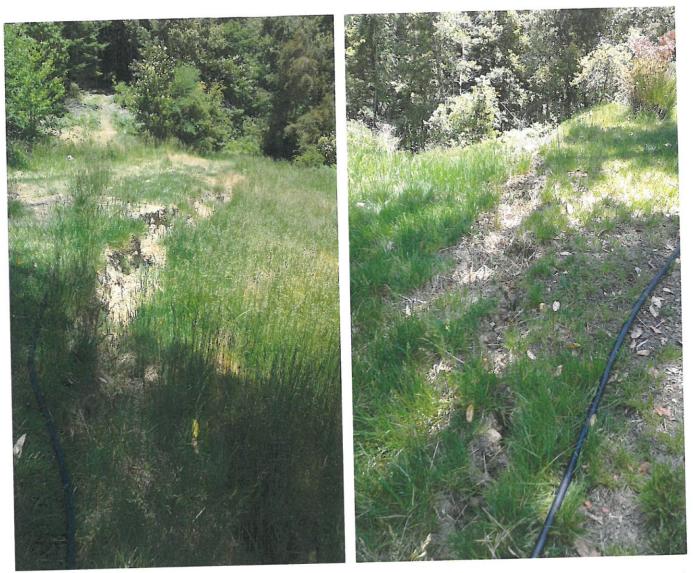
Physical reconnaissance of the property identified one small unstable area per 14CCR 895.1. It appears to have been a road or landing related fill failure. A portion of this property was logged under an approved timber harvest plan, 1-04-077 HUM. The timber harvest plan (THP) was completed on 12/3/07. Its silviculture methods were mostly rehabilitation of understocked areas and seed tree removal areas. It included road construction and reconstruction. According to online records, a significant portion of the THP acreage was not harvested. Development occurred on the property after the timber harvest, between 2008 and 2012. Through review of historic aerial photos, it appears that the unstable area most likely occurred between 2010 and

2012. This was difficult to determine for sure because of quality of the photos. The unstable area is shown to have taken place within a portion of the THP area that, according to on-line records, was not logged. The unstable area is now fully vegetated with grass and shrubs. The 150 to 200 feet that separate the bottom of the unstable area from the large Class II watercourse is timbered and heavily vegetated. The unstable area is not delivering sediment into the Class II watercourse.

Pictures 4 and 5: These are pictures of the unstable area. The picture on the left was taken looking northeasterly along the top edge of the unstable area. The picture on the right was taken looking southerly along the top edge of the unstable area. Photo date 6/1/2016

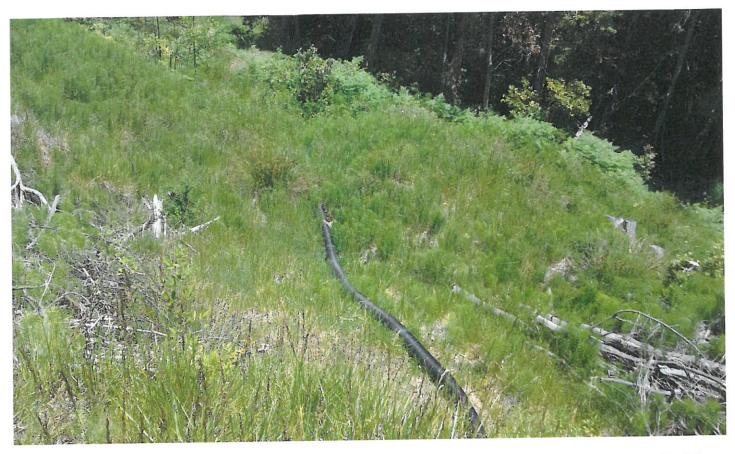
A developed cultivation area is located near the top of the unstable area, at the end of an existing, widened road surface / log landing area. The outside edge of the road / landing immediately beyond the cultivation area is where the unstable area is located. Surface drainage from the cultivation is not being directed towards the unstable area. The road segment containing the cultivation has a level grade. There is a small bank seepage located beyond the end of the cultivation area, above the unstable area. The bank seepage along with road and landing fill placement may have contributed to the unstable area. At some point prior to the assessment date, 6/1/16, a "French drain" was installed in the road surface by the Discharger. It is shown as Map Point 3 on the WRPP Map. The drain is connected to a length of 8 inch diameter flex pipe that extends across the unstable area. The intent was to provide road surface drainage of the seep, while directing surface drainage off of the unstable feature. It appeared to be successful. On the assessment date, the bank seep was still wet and the "French drain" and flex pipe was functioning. To remain in compliance with Standard Condition A.(1)(c), the Discharger should continue to maintain this site to keep the "French drain" functioning and to ensure that in the future, drainage from the cultivation area is not being directed towards the unstable area.

Picture 6: This is a picture of the 8 inch flex pipe that carries bank seep drainage off of the road surface via a "French drain". The flex pipe keeps drainage directed off of the unstable area. Photo date 6/1/2016

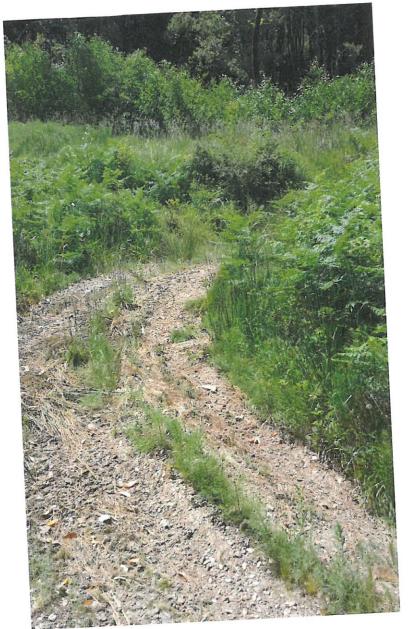
An ATV access trail is located across a portion of the unstable area. It is shown on the WRPP Map. It is used for access to one of the surface diversions (POD) on the property. It is very narrow in width. It is located on the contour of ground and does not contain cuts and fills. It appeared well drained with rolling dips and/or waterbreaks. The Discharger should continue to maintain the existing waterbreaks along this ATV access trail.

Picture 7: This is a picture of the ATV access trail that is located in the unstable area. This photo is taken from the trail surface and looking upslope, northerly. A rolling dip / waterbreak is located just out of view in the picture. Photo date 6/1/2016

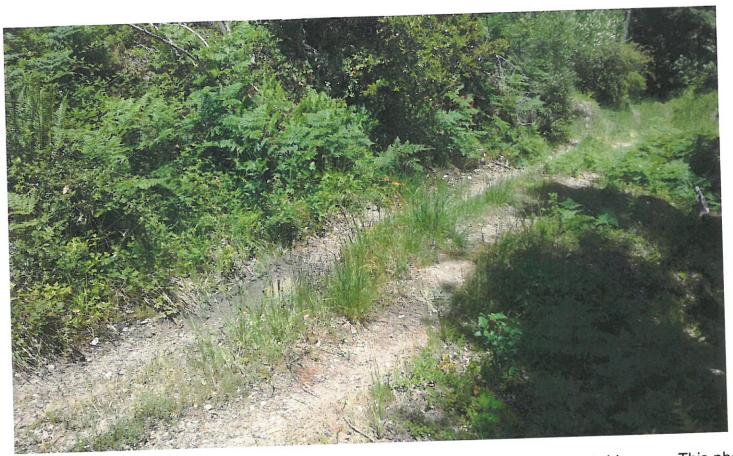
Picture 8: This is a picture of the ATV access trail that is located in the unstable area. This photo shows a rolling dip / waterbreak in the lower half of the ATV trail. This photo is taken from next to the trail surface and looking downslope, northeasterly. Photo date 6/1/2016

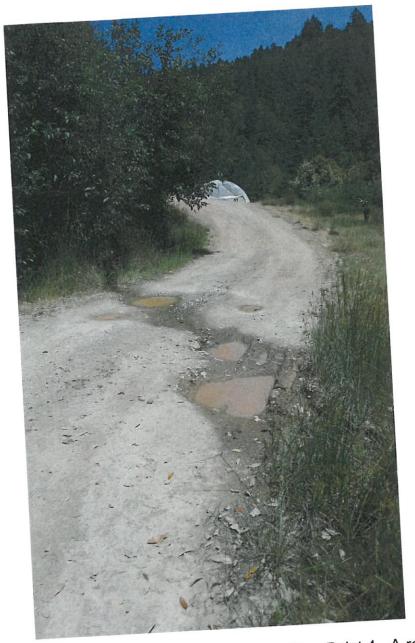
A location was identified where bank seepage crosses the road in a shallow dip. It is shown as Map Point 4 on the WRPP Map. This site is in need of maintenance, but is not a significant erosion site. Currently, this site is not efficiently draining the road surface, as evidenced by several potholes. During heavy precipitation, drainage at this site has potential to escape the shallow dip and extend down the road for a short distance. A rocked rolling dip should be constructed at this site to ensure that the cut bank seep is drained across the road efficiently. Other than this location, roads, clearings, fill prisms, and terraced areas on the property are hydrologically disconnected from surface waters. There are no watercourse crossings on the property.

Picture 9: This is a picture of the road surface at the Map Point 4. A rocked rolling dip should be installed at this location. Photo date 6/1/2016

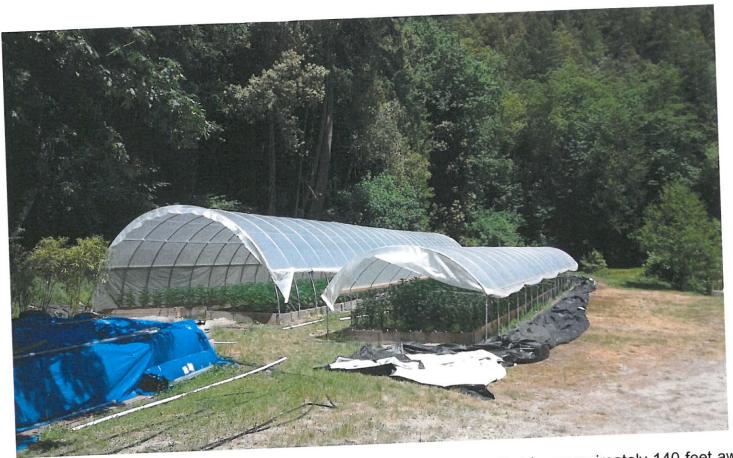
Picture 10: This is a picture of the southerly cultivation area that is approximately 140 feet away from the Class I watercourse. The Class I watercourse is located out of frame to the right. Photo date 6/1/2016

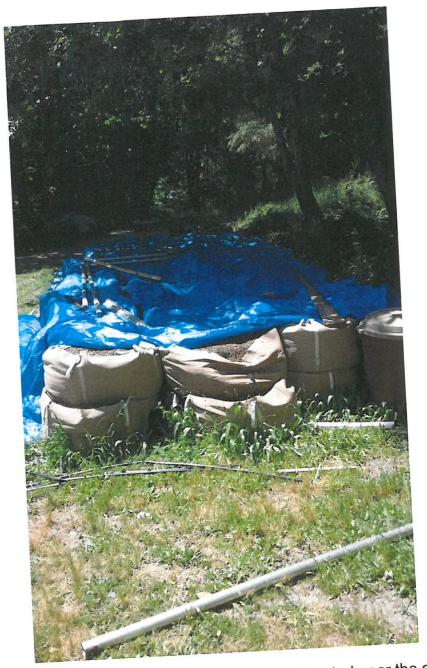
Picture 11: This is a picture of the soil filled grow bags located near the southerly cultivation area. They are approximately 180 feet away from the Class I watercourse and are heavily tarped. The tarp was pulled back slightly for photo purposed. Photo date 6/1/2016

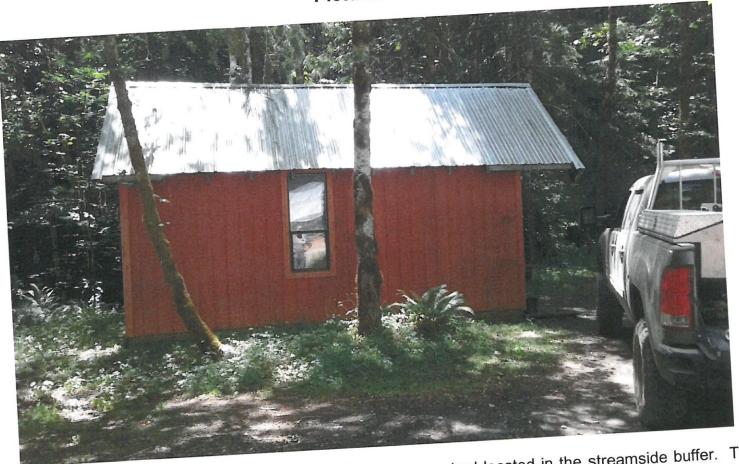
The developed area encompassing the southernmost cultivation area extends into the 100 foot wide streamside buffer. The outer 30 feet (+-) is flat, cleared, useable ground. The inner 70 feet (+-) of this buffer strip is flat, tree covered and heavily shaded. This buffer is made up of natural slopes and is adequate to filter waste. One wooden storage shed, two temporary canvas storage sheds, and a one vehicle wide driveway are located within the wooded portion of the buffer. The wooden storage shed is located within 50 of the watercourse, is well maintained, has a metal roof, wooden floor, and a wooden door that locks. It is used for storage of chemicals such as fertilizers, gas cans, oil containers, and power equipment (chainsaws, string trimmers, etc.). The two portable, canvas storage sheds do not have floors and are used to store things that cannot leach into the ground such as irrigation lines, plastic sheeting, hand tools, etc. These storage sheds are located within approximately 50 feet of the watercourse and did not appear to be a pollution threat to the watercourse. The driveway area is wide enough for one vehicle and is located approximately 60 feet from the watercourse. It is on flat ground and did not appear to be a threat to the watercourse. Within this developed area, the discharger should continue to retain as much tree and vegetation cover as possible within 100 feet of the watercourse while still maintaining the useable portion of the developed area. Refrain from tree removal in this area except for trees that pose a safety hazard. The discharger should monitor runoff coming from storage sheds and / or the driveway during storms to ensure sediment or other pollutants are not reaching the watercourse. modifications to reduce potential pollutants from entering the watercourse should be undertaken by the discharger. These could include things such as covering or removing items with the potential to be carried or leached into the watercourse by surface flow during storms. In the future the discharger should work towards relocating the temporary sheds and to refrain from parking within 100 feet of the watercourse.

Picture 12: This is a picture of the wooden storage shed located in the streamside buffer. The Class I watercourse is located approximately 40 feet beyond the back of this shed. In the future the discharger should work towards relocating the temporary sheds and to refrain from parking within 100 feet of the watercourse. Photo date 6/1/2016

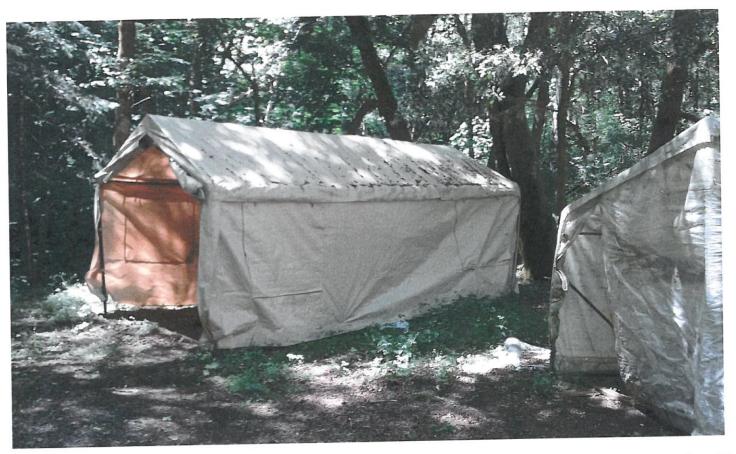
Picture 13: This is a picture of the two canvas storage sheds located in the streamside buffer. The Class I watercourse is located approximately 40 to 50 feet beyond the back of this shed. These are used for storage of materials that cannot be leached into the ground such as irrigation lines, plastic sheeting, hand tool, etc. In the future the discharger should work towards relocating the temporary sheds and to refrain from parking within 100 feet of the watercourse. Photo date 6/1/2016

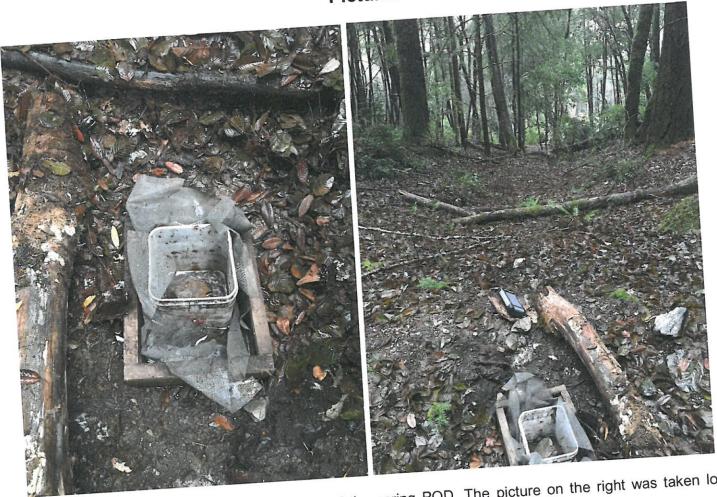
There are two surface water intakes (PODs) in use on the property. They are both used for domestic use and for irrigation. One is located on a very small spring located near the north property line. It consists of a perforated 5 gallon bucket that is set slightly below the grade of the ground and is plumbed with a 1 inch waterline, which gravity feeds into three hard plastic water tanks. Water from these tanks also gravity feeds down to 3 additional water tanks. Water is also pumped up hill to a 2500 gallon water tank that serves the domestic uses as well as some irrigation. Also above the house is a 2500 gallon tank that is kept full and is dedicated solely to emergency fire suppression.

Pictures 14 and 15: These are picutes of the spring POD. The picture on the right was taken looking downslope southeasterly from the spring. Photo date 12/10/2015.

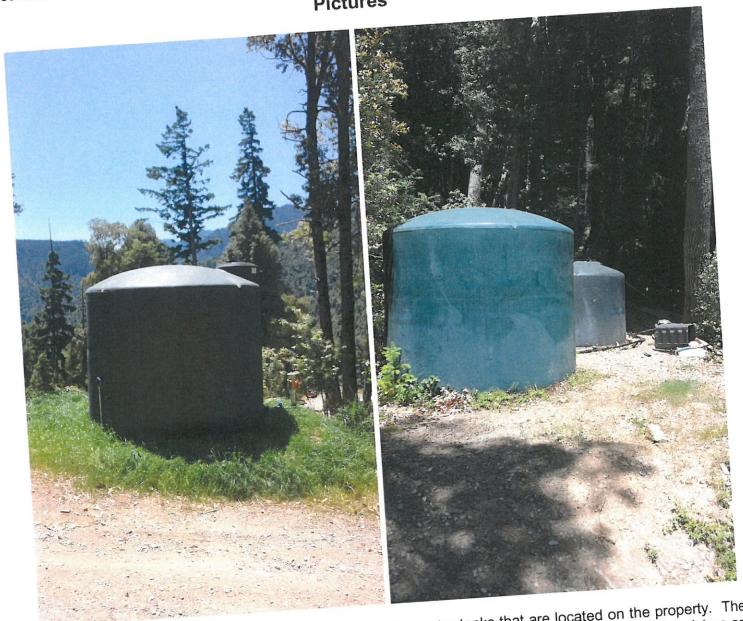
Pictures 17 and 18: These are pictures of some of the water tanks that are located on the property. The picture on the left show the water tank that is reserved for fire suppression purposes only. The picture on the right shows two of the three tanks located southeast of the spring Point of Diversion. All of the water tanks on the property are situated similar to these pictured. Photo date 6/1/2016.

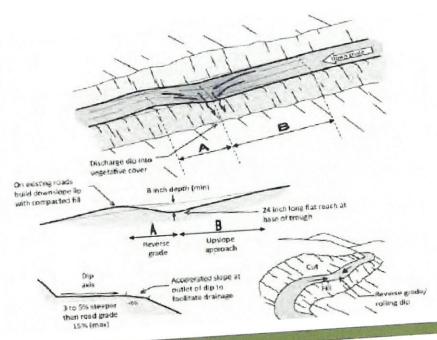
FIGURE 34. A classic Type I rolling dip, where the excavated up-road approach (B) to the rolling dip is several percent steeper than the approaching road and extends for 60 to 80 feet to the dip axis. The lower side of the structure reverses grade (A) over approximately 15 feet or more, and then falls down to rejoin the original road grade. The dip must be deep enough that it is not obliterated by normal grading, but not so deep that it is direcult to negotiate or a hazard to normal traffic. The outward cross-slope of the dip axis should be 3% to 5% greater than the up-road grade (B) so it will drain properly. The dip axis should be outsloped sufficiently to be self-cleaning, without triggering excessive downcutting or sediment deposition in the dip axis (Modified from: Best, 2013).
