HUMBOLDT COUNTY DEPARTMENT OF PUBLIC WORKS  
ROAD EVALUATION REPORT

# Road Evaluation Report for Brannan Mountain Road

PM 0.4 to PM 5.85

Willow Creek, California

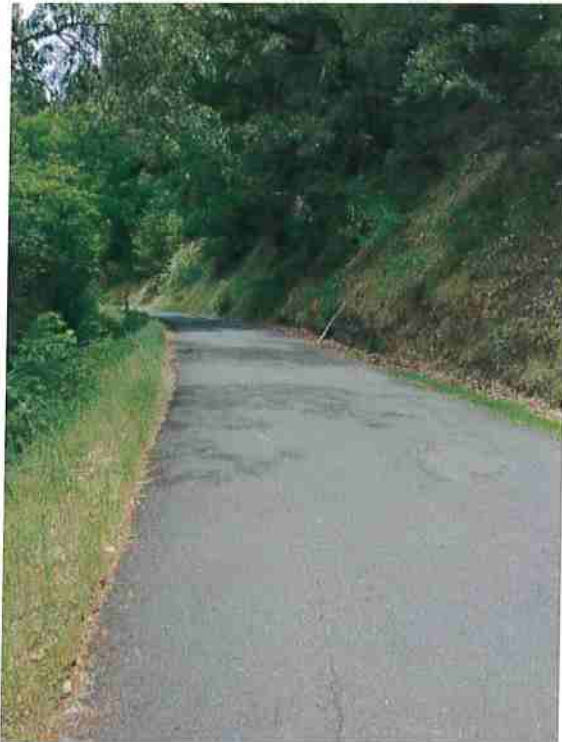
BMR PM 1.0, 15-ft. wide asphalt surface with longitudinal slope of 8% and no shoulder (Photo 9). There are nine (9) pullouts between BMR PM 1.0 and 2.0. Adequate pullouts exist at pinch points, including at PM 1.2, 1.6 and 1.9, for visibility and to allow passing.

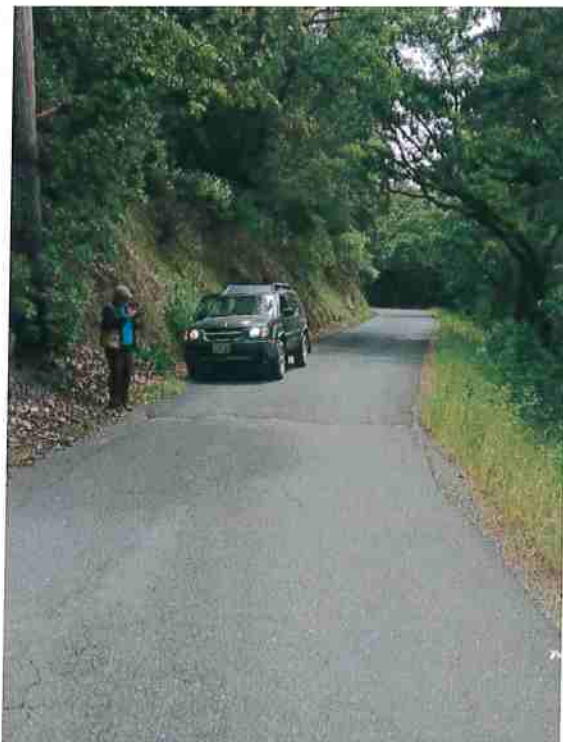
BMR PM 1.17, 15-ft. wide asphalt surface with longitudinal slope of 7 % narrows at utility pole and bedrock on cutbank to 13-ft. wide (Photo 10). A pullout is located to the west of the utility pole.

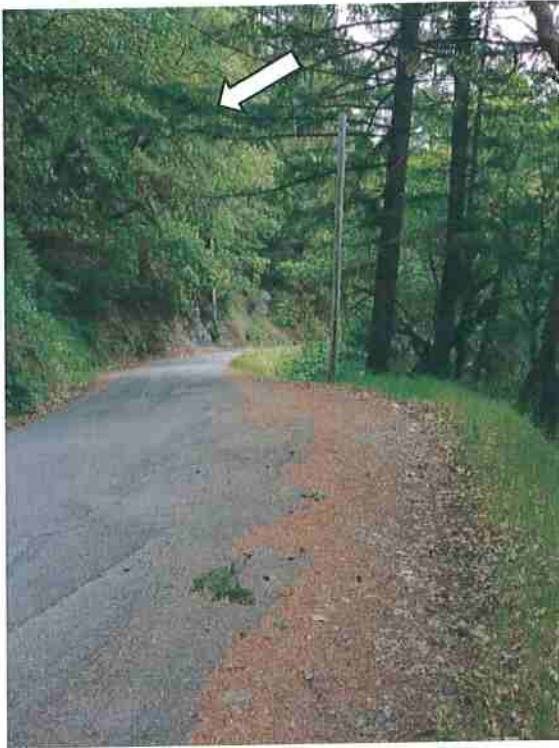
BMR MP 1.2, 15-ft wide asphalt surface with a longitudinal slope of 7%, and 3-ft. wide and 30-ft. long pullout allows for sight distance at utility pole at mile 1.17. Note white arrow showing location of utility pole (Photo 11).

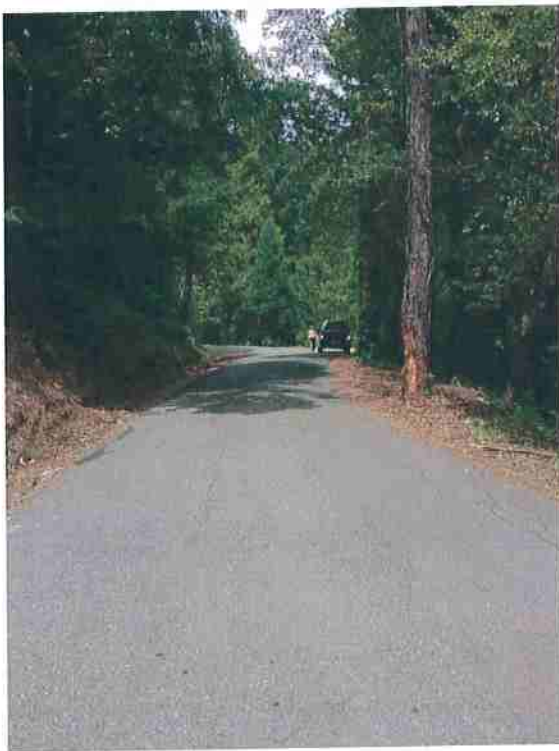
BMR PM 2.8, Brannan Mountain Road characteristics at this location are described on Book 10 of Parcel Maps, page 141 and 142 as Courses 121, 123 and 125. The curve along these courses has a change in horizontal alignment of greater than 135 degrees, so can be classified as a "hairpin curve". The road width of 20 ft. narrows to 12 ft. with a 4 foot shoulder at a tree located at the beginning of the curve (Photo 21). Recent scarring was noted on the trunk of the tree, which appears to be within Humboldt County ROW. There is a change in grade mid-curve.

We recommend that an object marker be located east of the tree in the shoulder at BMR PM 2.8 based on the anecdotal evidence of scarring, or the tree could be removed with the caveat that the adjacent cut slope remains stable and the 4-ft. shoulder is preserved.

Signage could be installed to assist drivers in knowing when the road curves, and when it narrows. A “curve ahead” (W1-1) sign could be placed at PM 2.8, even though the road width through the curve is 20 ft. with a 4-ft. shoulder. A “winding road” sign (W1-5) could be installed at BRM PM 3.38 to alert drivers to conditions for the next mile (approx.). A “pavement ends” sign (W8-3) could be installed prior to the start of the gravel roadway ahead. A Type 2 object marker could be installed on trees encroaching the edge of the traveled way between PM 4.7 and PM 4.8. A Type 4 object marker could be installed at the USFS gate. All warning signs would be required to meet Manual of Uniform Traffic Control Devices (MUTCD Part 5) standards for low-volume roads, and Humboldt County Public Works Standards for local roads.

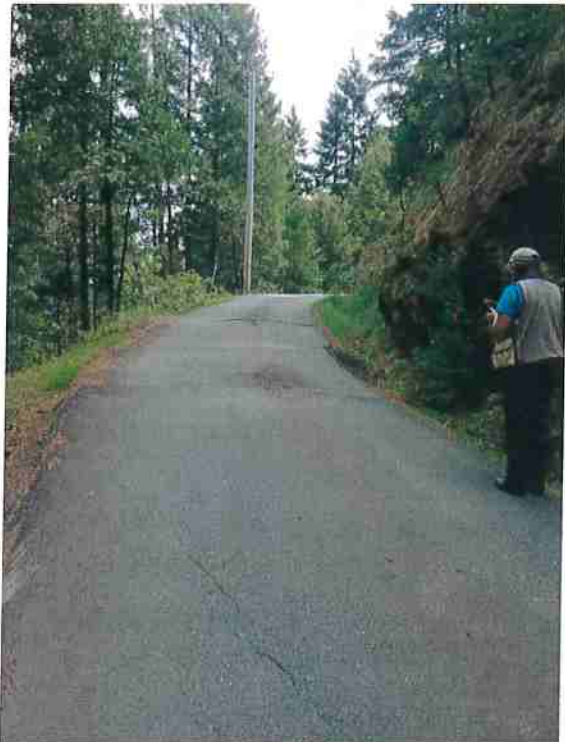
BMR PM 3.63, 18-ft. wide asphalt surface with a longitudinal slope of 11%, narrows to 11-ft. wide with no shoulder at a rock outcropping on the cutbank and proceeds for 250 feet at 15-ft. wide. Visibility is limited to 120 ft. around the curve (Photo 26). Road resumes 18-ft. width past the curve.

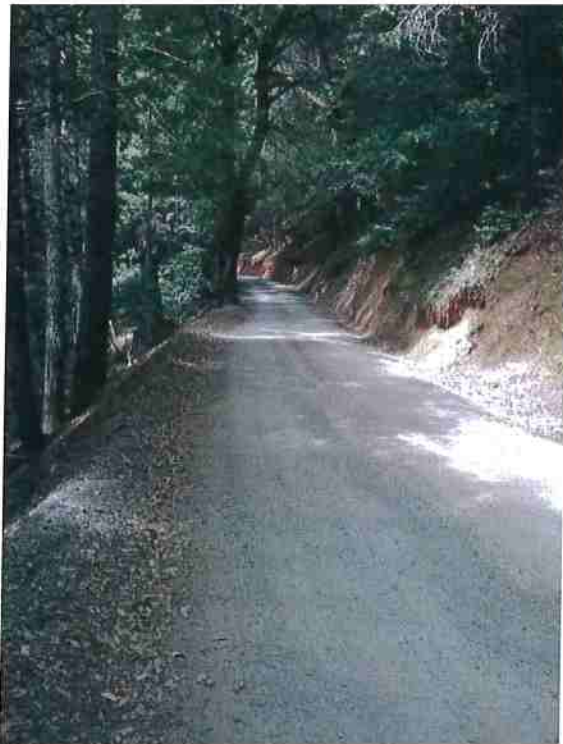
BMR PM 4.7 to PM 4.8, 13-ft. wide gravel surface with a longitudinal slope of 7% at end of asphalt surface. Trees limit visibility (Photo 28).

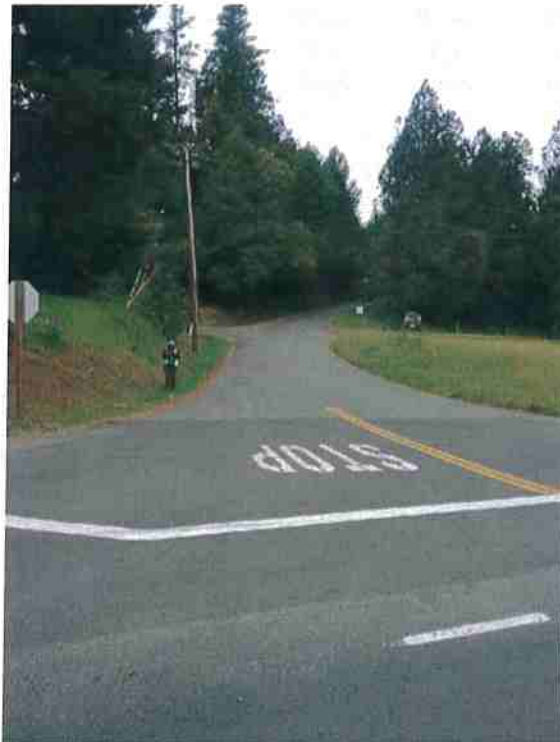
Photo 1. Brannan Mountain Road (BMR) PM 0.0, 36-ft. wide paved surface with a longitudinal slope of less than 5% at the intersection with Highway 96, Willow Creek, CA.

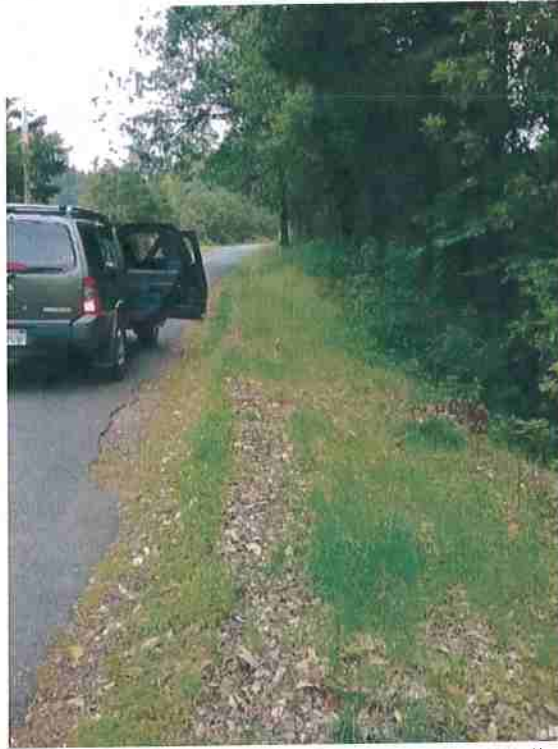
Photo 2. PM 0.1, 20 ft. wide, asphalt surface with a longitudinal slope of 6%, 9-ft. wide shoulder extending approx. 270 ft. west with visible wheel ruts.

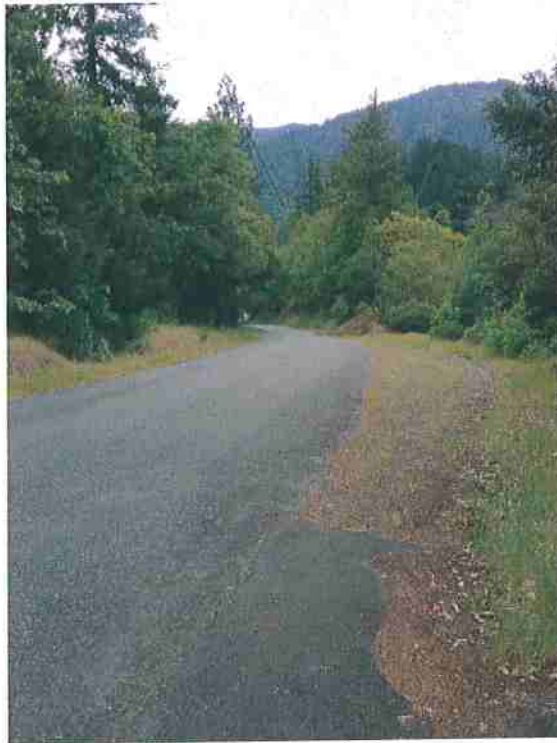
Photo 3. BMR PM 0.2, 21 ft.-wide asphalt surface with a longitudinal slope of 10%, view looking downslope (east) with 10-ft. wide shoulder.

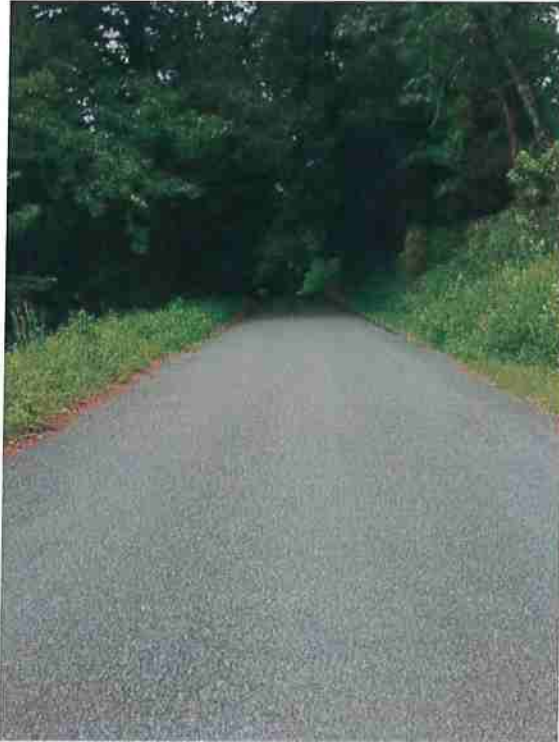
Photo 4. BMR PM 0.5, 20-ft. wide asphalt surface looking west, with a 10% longitudinal slope.

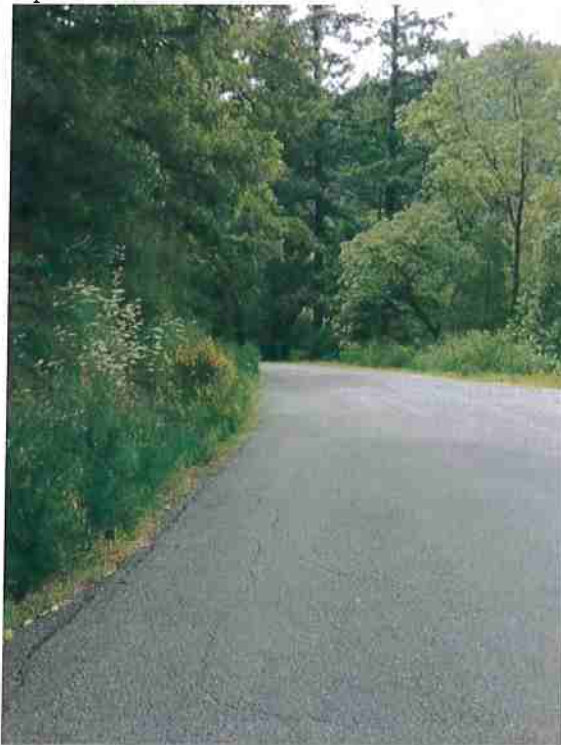
Photo 5. BMR PM 0.65, 20-ft. wide asphalt surface with a longitudinal slope of 10%, looking east with vegetation on the cutbank. Visibility is approx. 150 ft. through the curve.

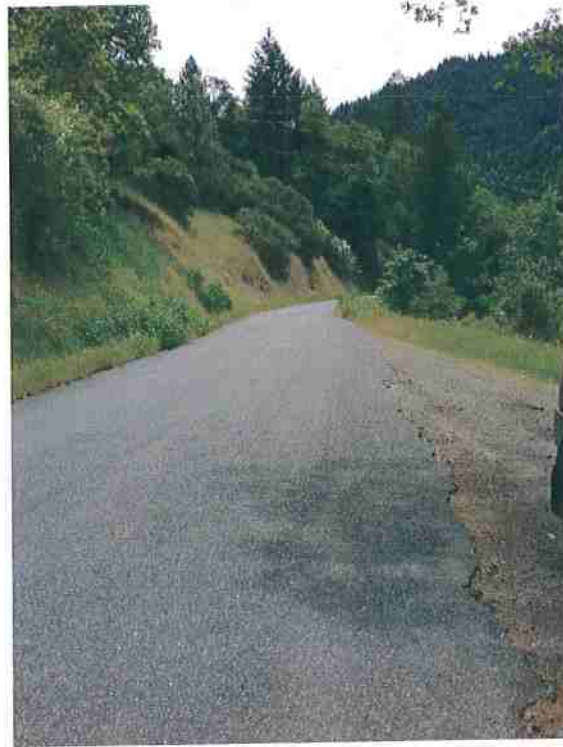
Photo 6. BMR PM 0.75, 20-ft wide asphalt surface with a longitudinal slope of 10%, with 14ft. by 80ft. pullout.

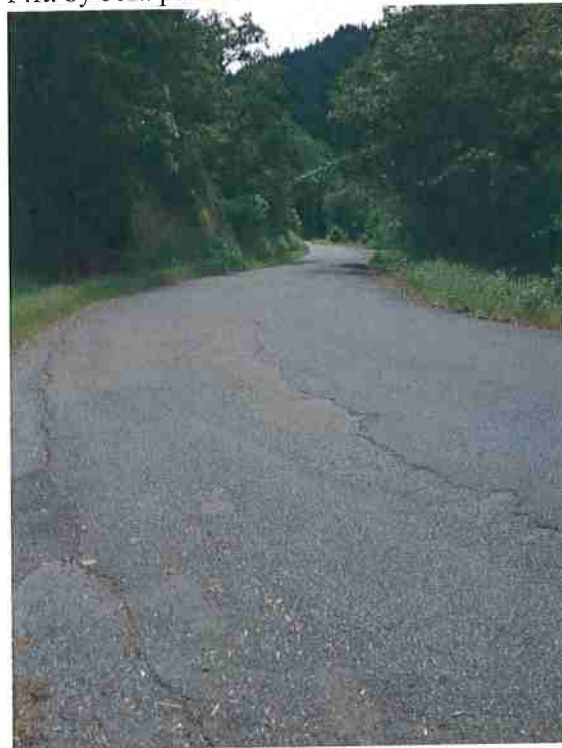
Photo 7. BMR PM 0.8, 30-ft wide asphalt surface with a longitudinal slope of 11% for a distance of 20 ft. and then narrowing to 20 ft. wide.

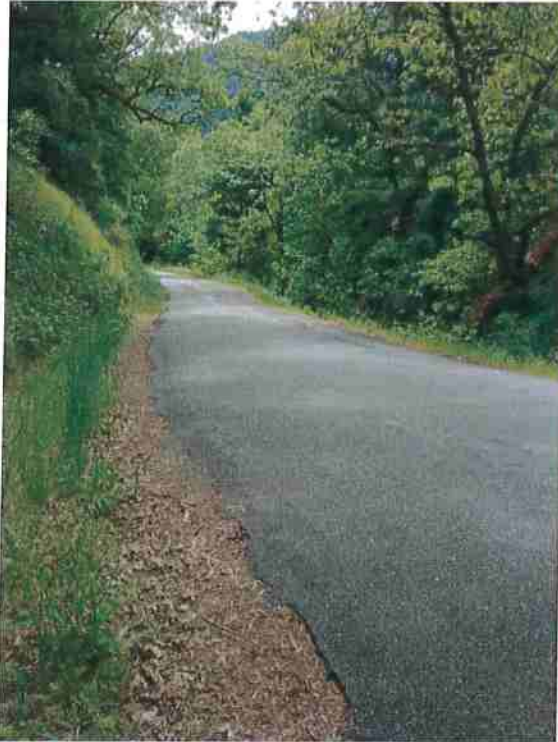
Photo 8. BMR PM 0.9, 20-ft wide asphalt surface with a longitudinal slope of 11%.

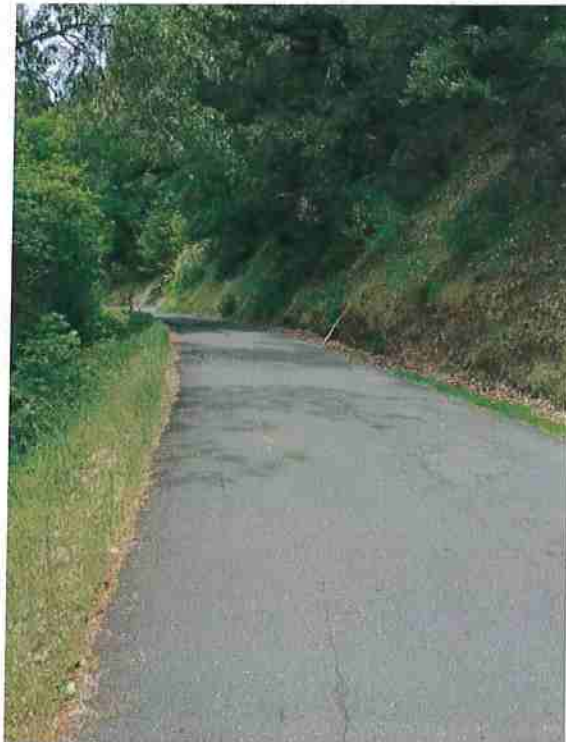
Photo 9. BMR PM 1.0, 15-ft. wide asphalt surface with longitudinal slope of 8% and no shoulder.

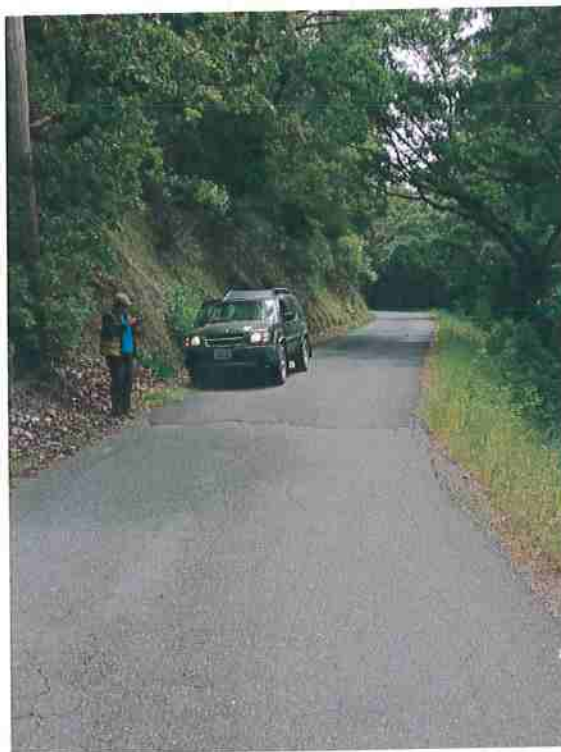
Photo 10. BMR PM 1.17, 15-ft. wide asphalt surface narrows at utility pole and bedrock on cutbank to 13-ft. wide, longitudinal slope of 7%.

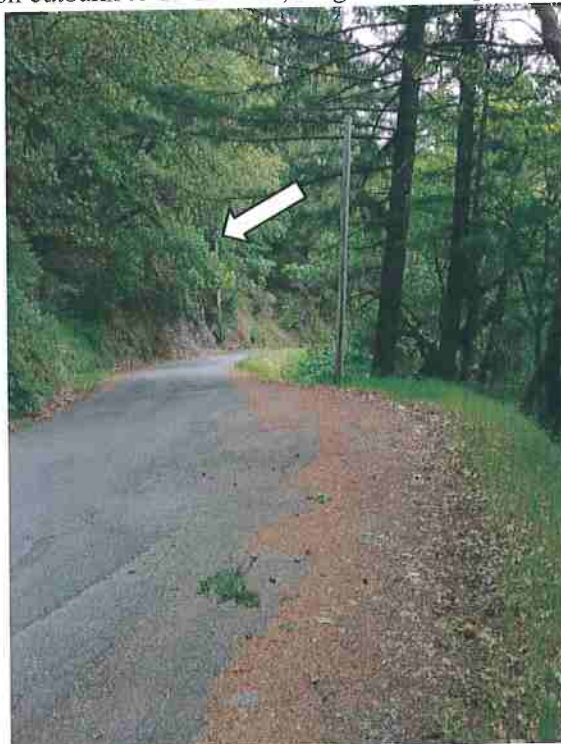
Photo 11. BMR MP 1.2, 15-ft wide asphalt surface with a longitudinal slope of 7%, and 3-ft. wide and 30-ft. long pullout allows for visibility around utility pole at mile 1.17. Note white arrow showing location of far utility pole.

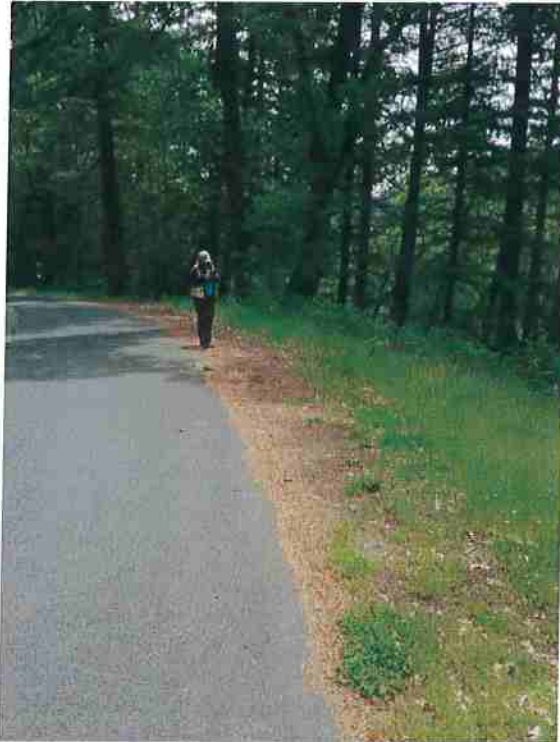
Photo 12. BMR MP 1.3, asphalt surface with a longitudinal slope of 4%, widens to 22-ft wide at 6 ft.-wide by 75 ft.-long pull-out.

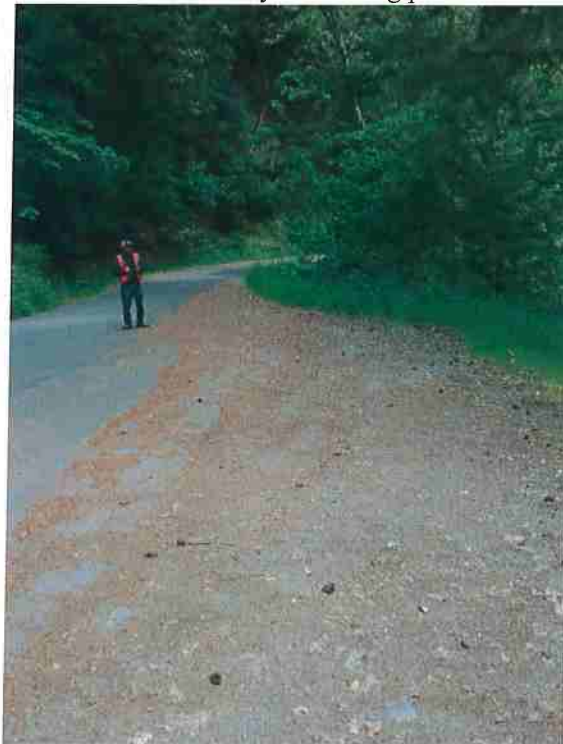
Photo 13. BMR PM 1.4, asphalt surface with a longitudinal slope of 4% narrows to 16 ft. and 14-ft. by 40-ft. pullout on edge of fill slope.

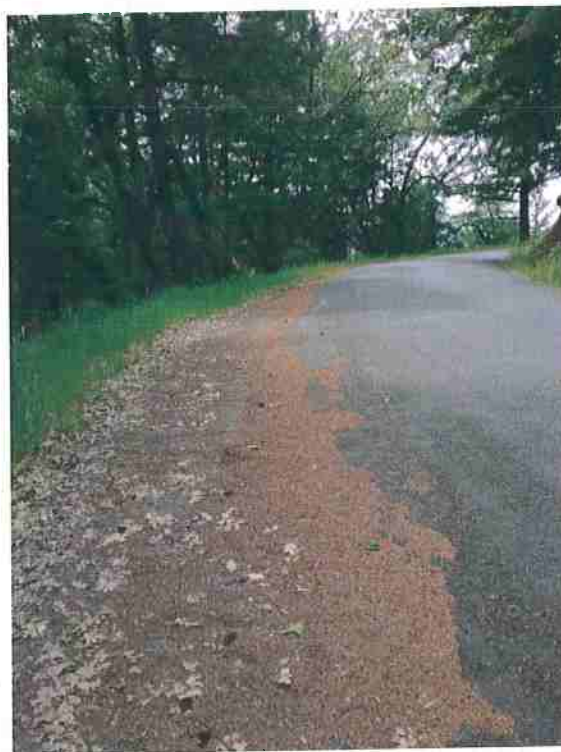
Photo 14. Mile 1.5, 19-ft. wide asphalt surface with a longitudinal slope of 10%, 6 ft. wide and 55 ft. long pullout before a mild curve with a steep rocky cutbank and brush, approx. 120 ft. of visibility.

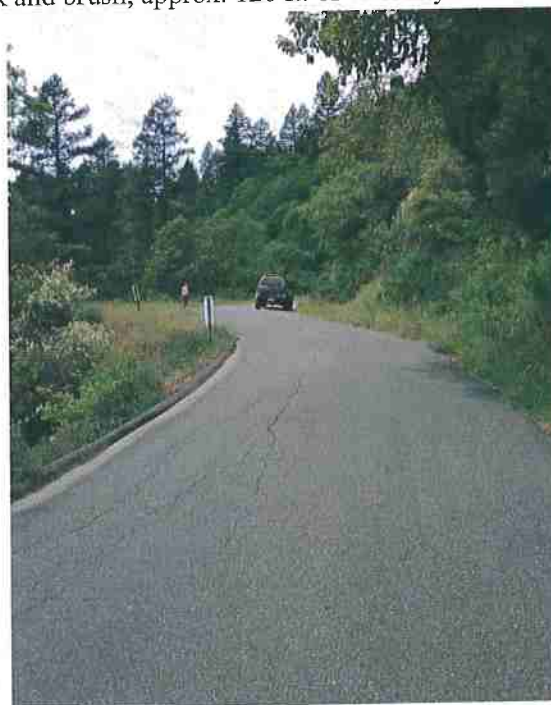
Photo 15. BMR PM 1.55, 14.5-wide cracking asphalt surface, longitudinal slope of 8%, narrowing to. at a fill failure and steep drop off. A culvert was observed near the fill failure. The road continues as 24-ft. wide after the pinch point, including a 15-ft. wide by 83-ft. long pullout to the west.

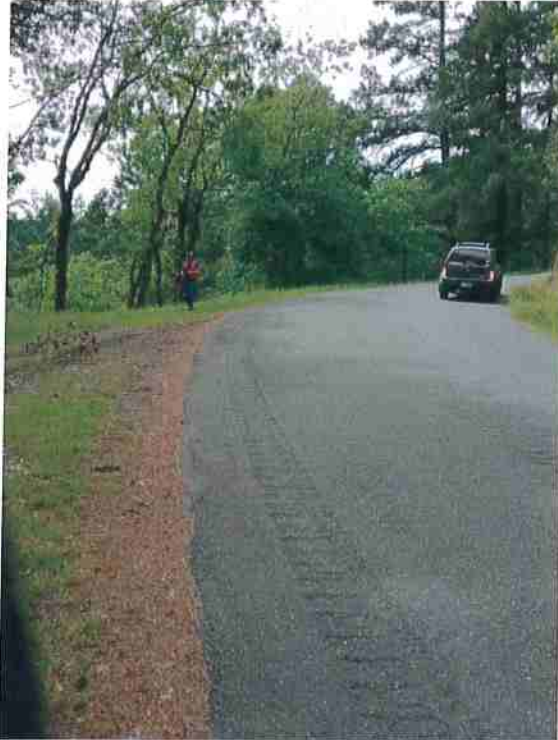
Photo 16. BMR PM 1.8, 33-ft. wide asphalt surface with a longitudinal slope of 14% narrowing to 22 ft. after a wide curve, with 14-ft.-wide and 55-ft.-long pullout with approx. 100 ft. of visibility.

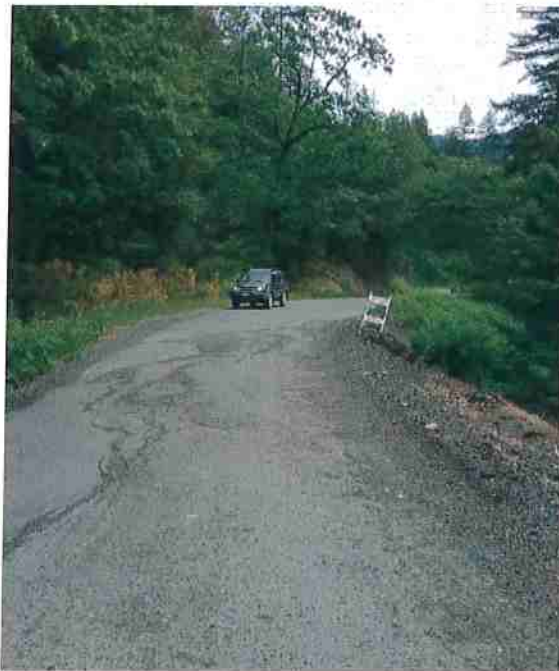
Photo 17. BMR PM 1.93, 20-ft. wide asphalt surface with a longitudinal slope of 9%, narrows to 16 ft. wide at a slope failure, east of the pinch point there is a 6 ft. wide by 30 ft. long pullout along the cutbank, and west, a 7-ft. wide by 35-ft. long pullout to allow passing.

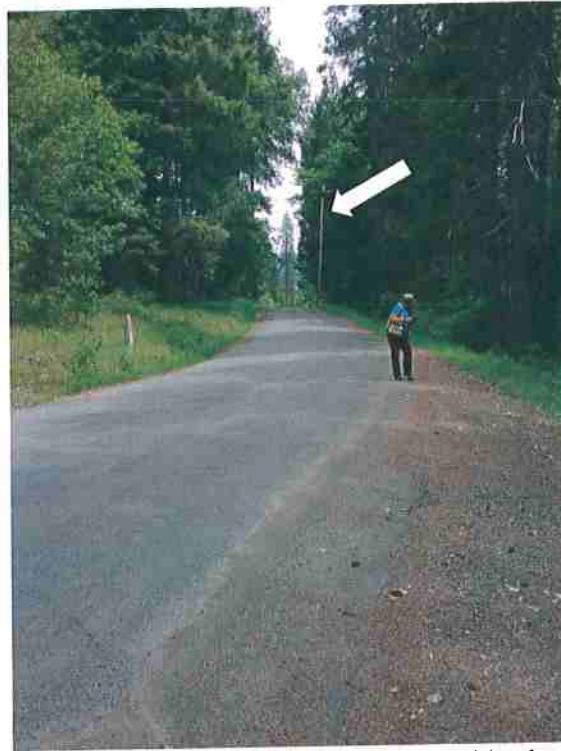
Photo 18. BMR MP 2.1, 20-ft.-wide asphalt surface with a longitudinal slope of 2% narrows to 12 ft. wide at a utility pole. A 13-ft. by 40-ft. pullout is located 150 ft. upslope (west) from the pinch point with 150 ft. of clear visibility for eastbound traffic. Note the white arrow showing the utility pole.

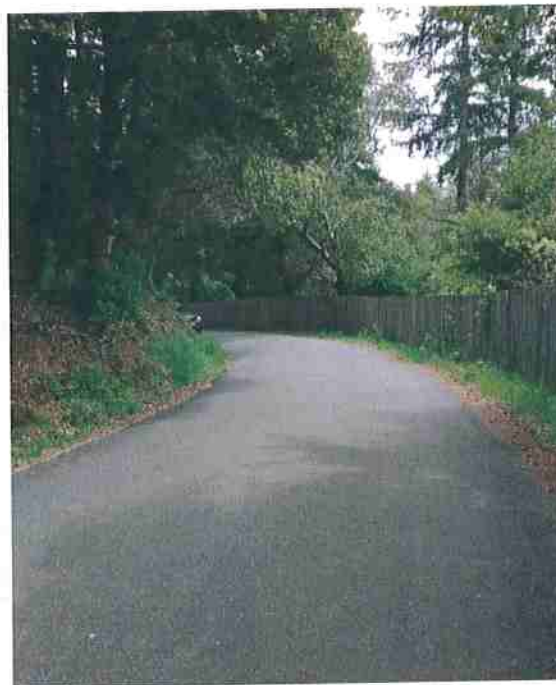
Photo 19. BMR PM 2.4, 20-ft. wide asphalt surface with a longitudinal slope of 10% widens to 30 ft. wide at curve, sight distance is approx. 110 ft. Sparse vegetation on the cutbank slope is a slight impairment to visibility.

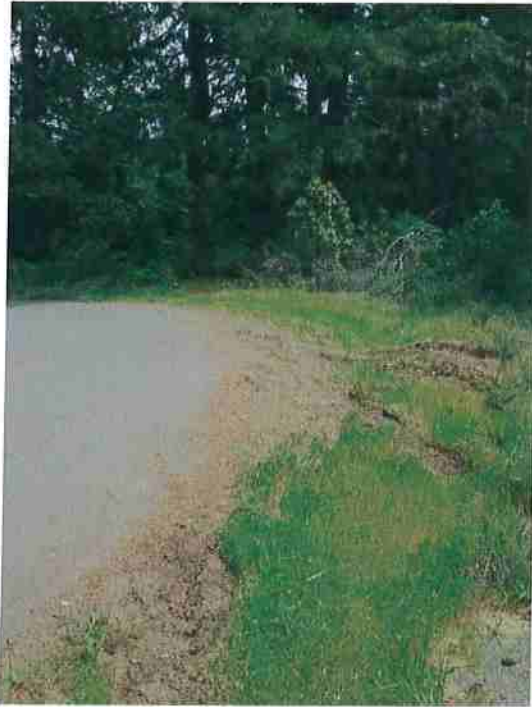
Photo 20. BMR PM 2.75, 30-ft wide asphalt surface with a longitudinal slope of 10% with a 10-ft. by 30-ft. pullout along the fill slope of a tight curve, resuming the 20-ft. width after the curve.

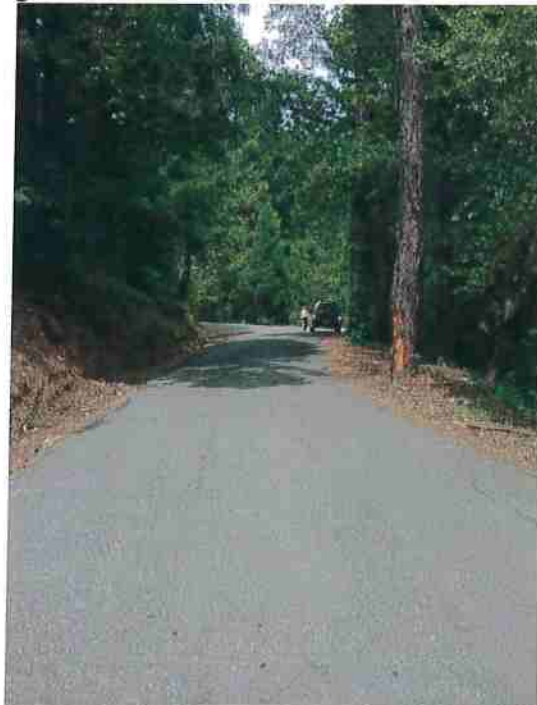
Photo 21. BMR PM 2.8, 20-ft. wide asphalt surface with a longitudinal slope of 7% narrowing to 12 ft. wide with a 4-ft. wide shoulder. The narrowest section of the road is on the approach to a hair pin curve (see Photo 22). Recent scarring was noted on the trunk of the tree. The tree appears to be located within Humboldt County ROW.

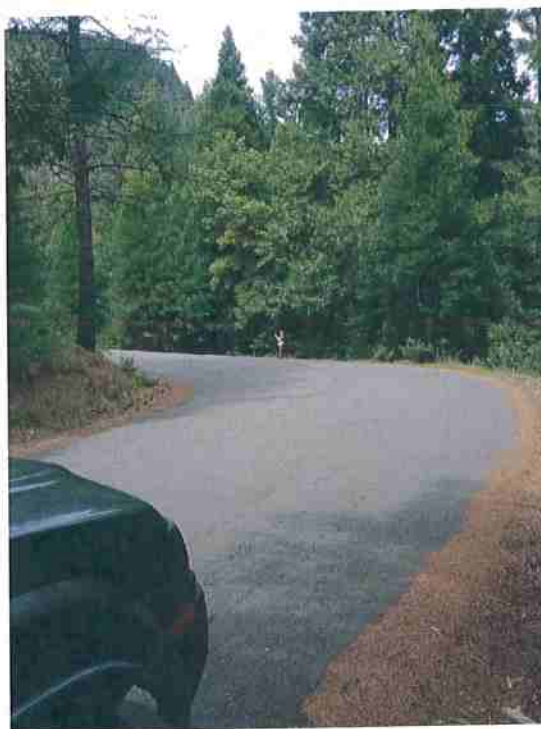
Photo 22. BMR PM 2.87, 20-ft. wide asphalt surface with a longitudinal slope of x%, with 4-ft. shoulder along the edge of the fill slope throughout curve.

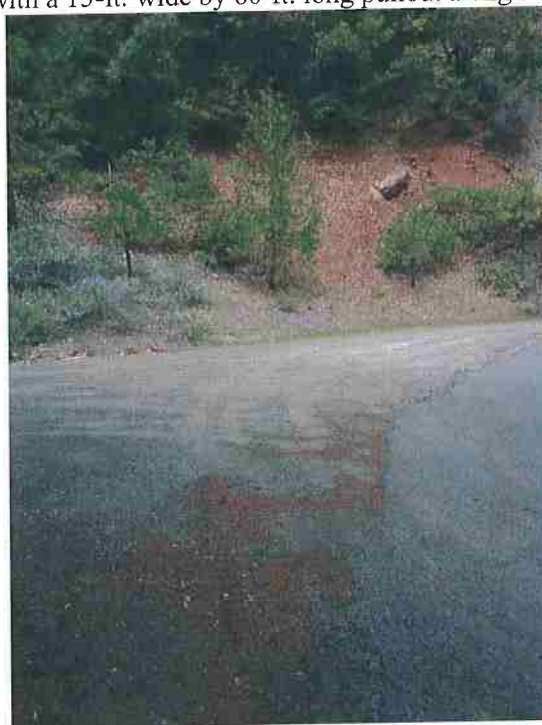
Photo 23. BMR PM 3.37, 15-ft. by 60-ft. pullout east of Brannan Mountain Creek.

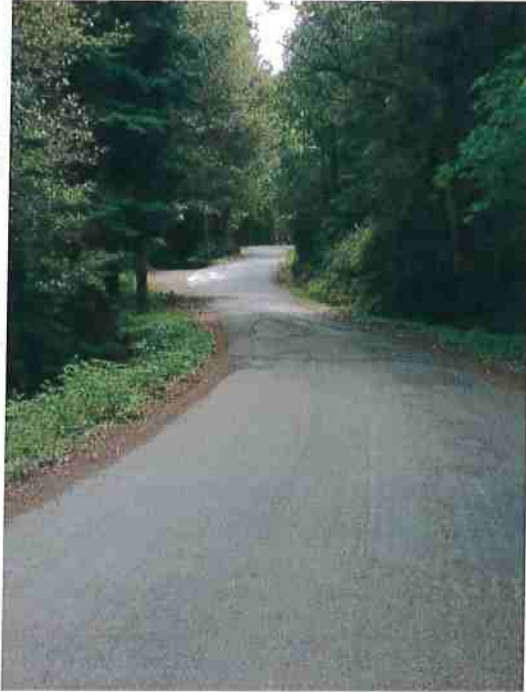
Photo 24. BMR PM 3.37, 20-ft. wide asphalt surface with a longitudinal slope of less than 5%, narrows to 18 ft. at Brannon Creek.

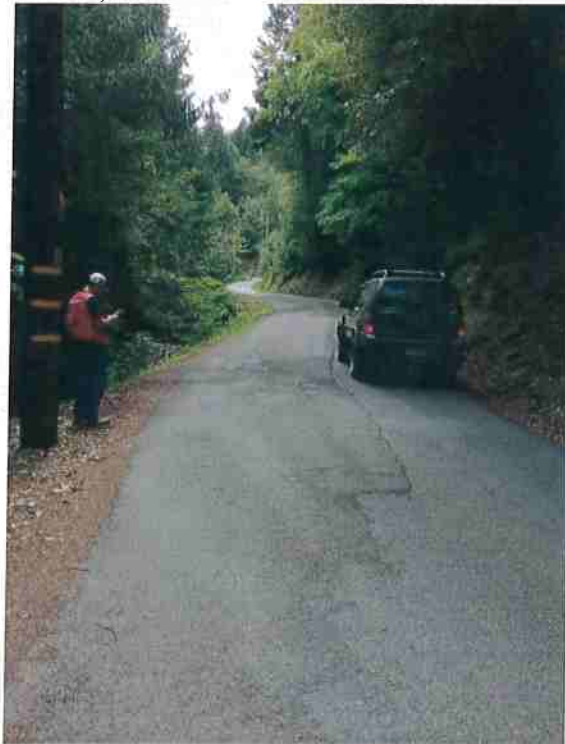
Photo 25. BMR PM 3.4, 18 to 20-ft. wide asphalt surface with a longitudinal slope of less than 5%, 15 ft. asphalt surface and 3-ft. shoulder at utility pole, visibility limited due to mild curve.

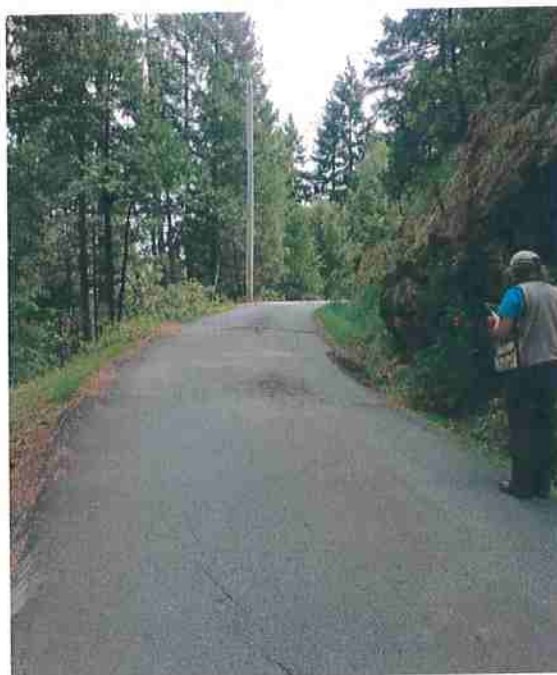
Photo 26. BMR PM 3.63, 18-ft. wide asphalt surface with a longitudinal slope of 11%, narrows to 11-ft. wide at a rock outcropping on the cutbank and proceeds for 250 feet at 15-ft. wide. Visibility is limited to 120 ft. around the curve. Road resumes 18-ft. width past the curve.

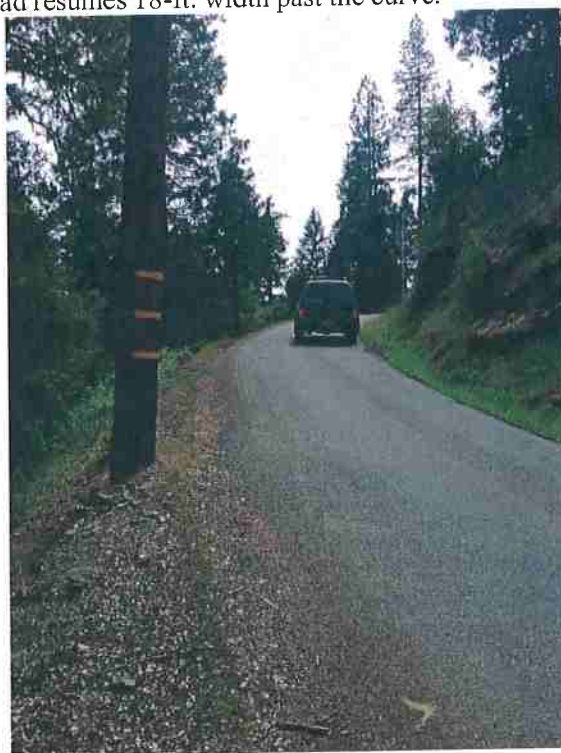
Photo 27. BMR PM 4.0, 18-ft. wide asphalt surface with a longitudinal slope of 12%, narrowing to 13-ft. of asphalt surface and 3 ft. of shoulder at a utility pole.

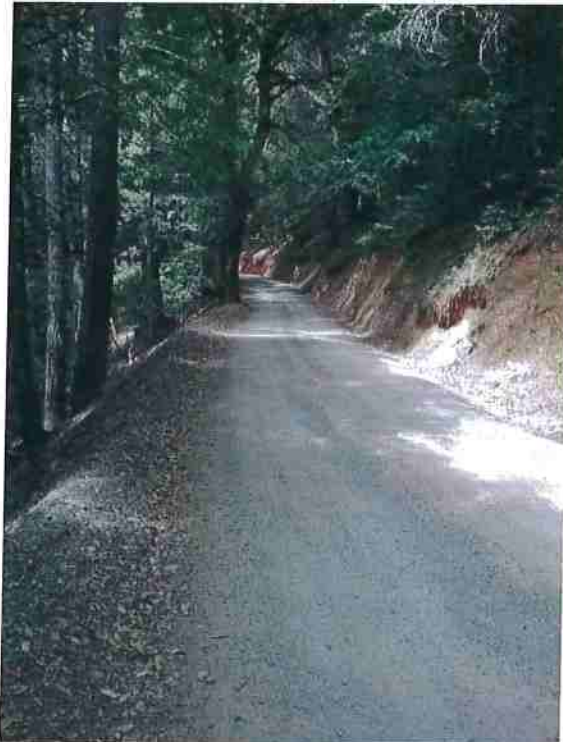
Photo 28. BMR PM 4.7, gravel surface with a longitudinal slope of 7%, 13-ft. wide at end of asphalt surface. Trees limit visibility.

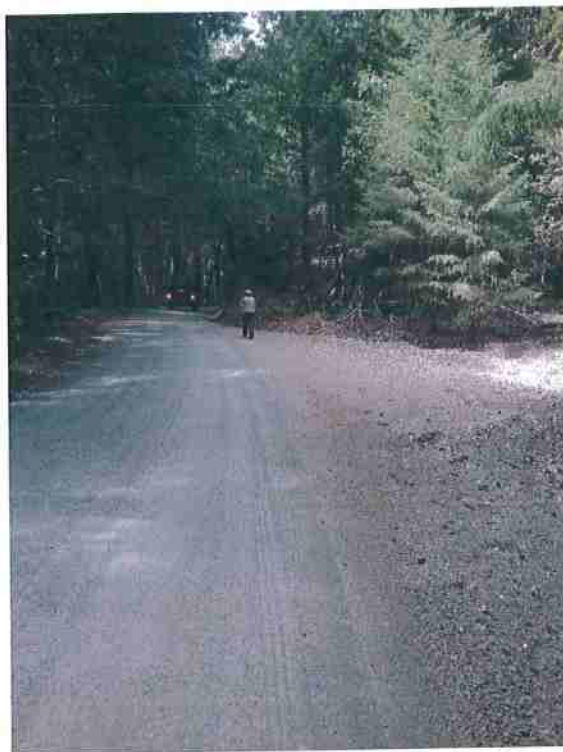
Photo 29. BMR PM 5.34, 18-ft. wide gravel surface with a longitudinal slope of 7% and gravel road features 16 ft. by 50 ft. pullout along north side of road before road narrows to 15 ft. at curve. A 16 ft. wide by 50 ft. long pullout is located east of curve with approx. 80 ft. of visibility through curve. The road resumes an 18-ft. width west of the curve.

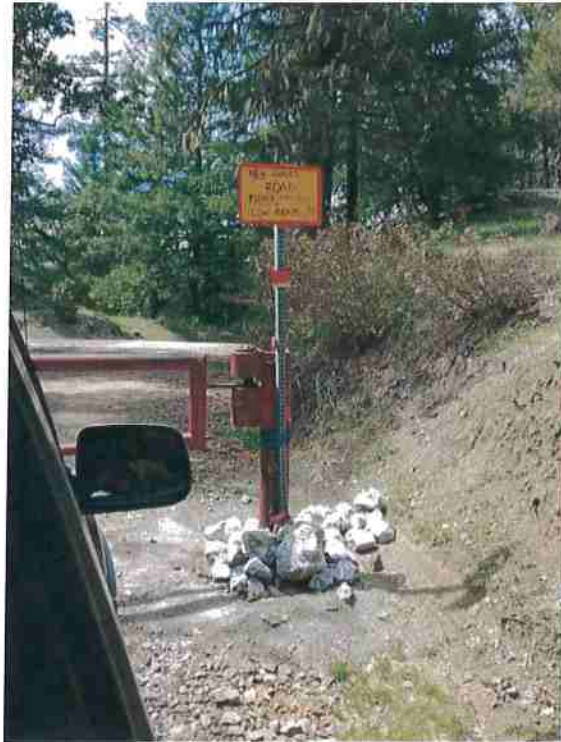
Photo 30. Mile 5.85, 15-ft. wide gravel surface with a longitudinal slope of 6%. Public access ends at a locked United States Forest Service gate.
