HUMBOLDT COUNTY DEPARTMENT OF PUBLIC WORKS ROAD EVALUATION REPORT

Road Evaluation for Stapp Road

Road Evaluation for Showers Pass Road

ROAD EVALUATION REPORT for STAPP & SHOWER'S PASS ROAD BRIDGVILLE, CALIFORNIA APN 317-033-006

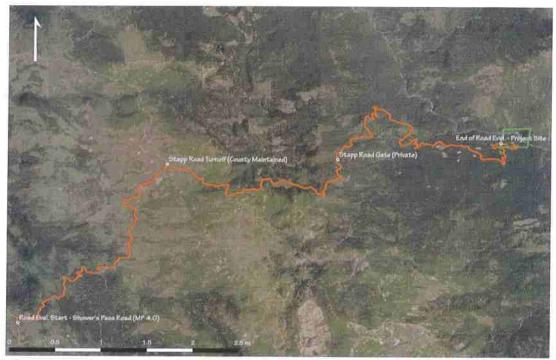
Figure 1: Route Map showing the road network used to access the project site. "4-Mile Post" is the 4-mile marker from the start of Shower's Pass Road.

Shower's Pass Road (County road #6GOW) is a publicly maintained dirt/gravel road that has been evaluated by Humboldt County Public Works and meets the requirements for Road Category 4 Standards for Cannabis Projects from the Kneeland Road turnoff to Shower's Pass mile post (MP) 4.0. Stapp Road (County road #7H010) is a county-maintained road from the intersection of Shower's Pass road to the private gate 3.1 miles past the intersection. The remainder of Stapp road is a gated, private access dirt/gravel road that provides access to many parcels in the areas surrounding the Mad River north of Bridgeville. This report focuses on the un-evaluated 4.4-mile portion of Shower's Pass Road (from MP 4.0 to Stapp Road intersection (MP 8.4)), the 3.1-mile stretch of County maintained Stapp Road and the 5-mile private portion of Stapp Road to the project site, for a total road evaluation length of 12.5 miles. An aerial photo of the road evaluation route can be seen in Figure 1.

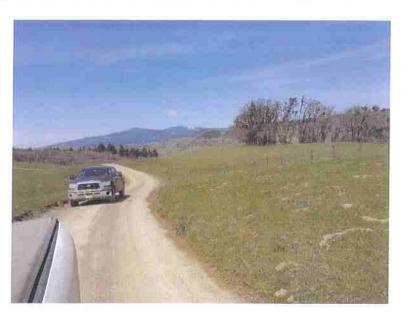
Forward

Mile 4.0 (4-mile Marker on Shower's Pass Road): 0+15+0=15ft wide road prism; Good visibility and sight distance. Recommend a constructing a rocked turnout in this area.

4.0	0.0	15	Start of Road Eval., 4-Mile post on Shower's Pass	Install RH turnout	-
4.0	0.0	.10	Road. Could use rocked turnout in this area	Install RH turnout	Low

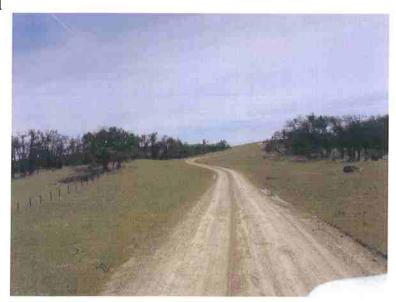
Backward

Mile 4.5 (Shower's Pass Road): 0+18+0=18ft wide road prism; Good visibility and sight distance.

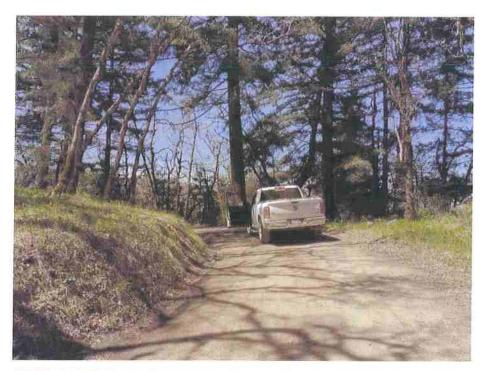
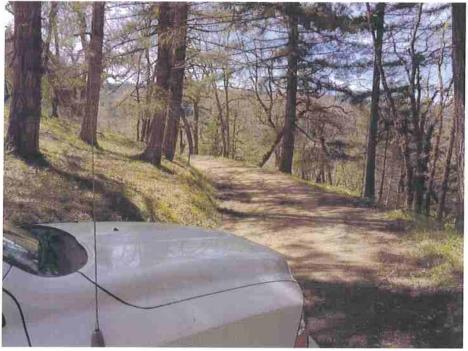
At MP 4.9 on Shower's Pass road, a curve has poor sight distance and has recommended improvements. Otherwise, narrow spots have adequate turnout-options and/or sight distance and meet the intent of Road Category 4 standards. Other minor problem areas are identified in the "Supporting Information" section of the report.

Mile 4.9 (Shower's Pass Road): 0+16+2=18ft wide road prism; curve with inadequate site distance and visibility, recommend "shaving" off rounded corner on left side of top photo for better visibility.

We recommend a turnout be constructed at MP 4.9 on Shower's Pass Road due to inadequate sight distance around the curve. This improvement would be appropriate for a single applicant to be responsible for.

4.2	0.2	625	Turn off to Fort Baker Ranch		
4.3	0.3		Rock query		
4.5	0.5	18	GSD		
4.9	0.9	*	Curve w/ inadequate S.D., shave off curve - Pictures	Remove material from RH cut-bank for better sight distance. Deposit material on roadway & cover with gravel	Med

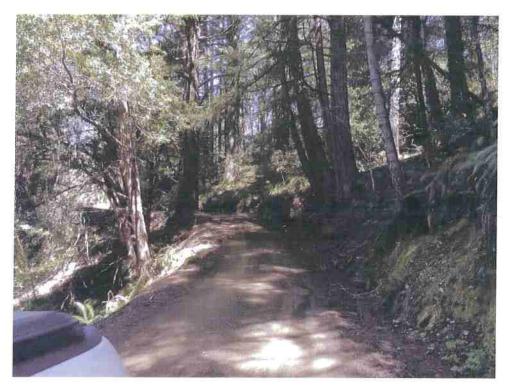
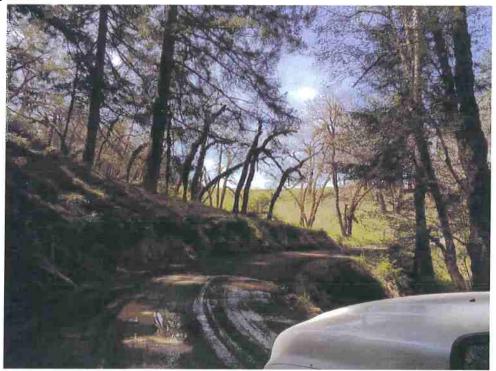
Mile 5.0 (Shower's Pass Road): 0+16+0=16ft wide road prism; Good visibility and sight distance. Forward

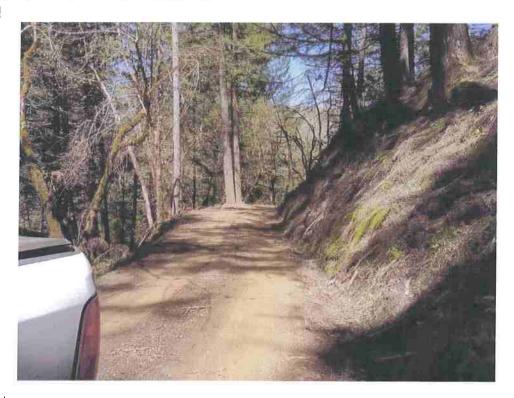
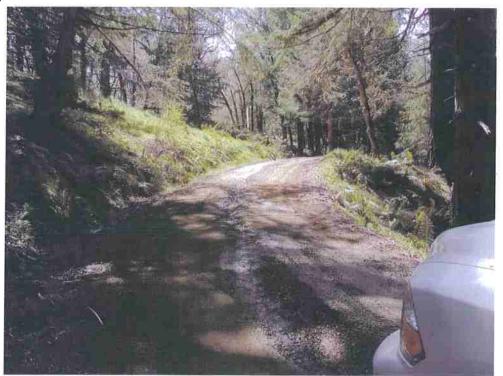
Mile 5.5 (Shower's Pass Road): 2+13+3=18ft wide road prism; Good visibility and sight distance; wet area, consider installing drainage features.

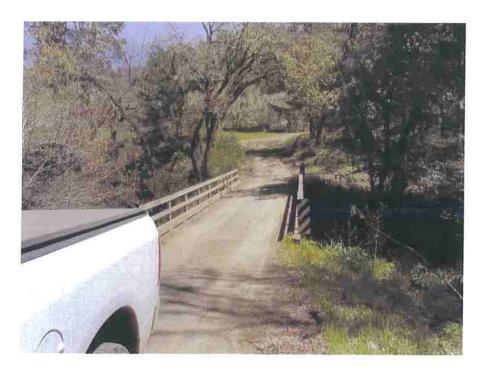
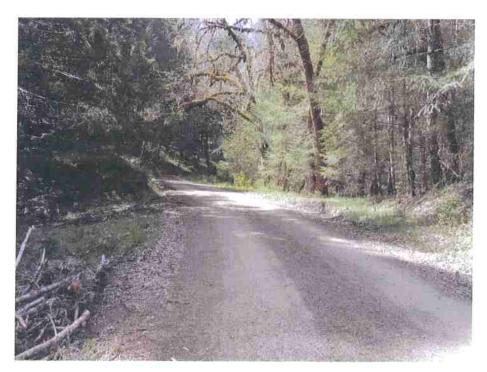
Mile 6.0 (Shower's Pass Road): 5+15+0=20ft wide road prism; Good visibility and sight distance, one lane bridge with turnouts on both sides of the bridge.

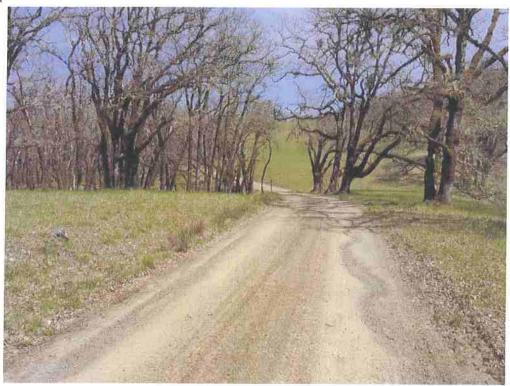
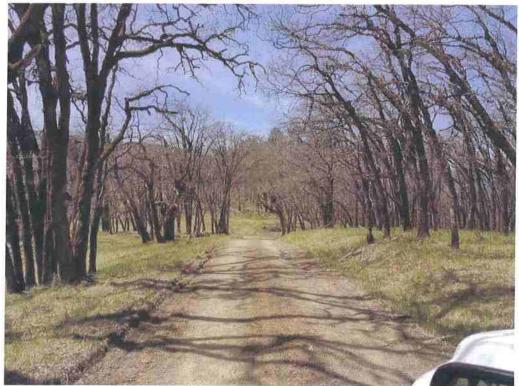
Mile 6.5 (Shower's Pass Road): 2+17+0=19ft wide road prism; Good visibility and sight distance; Turnouts forward and backward.

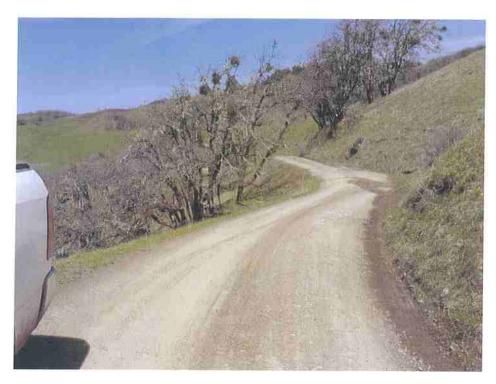
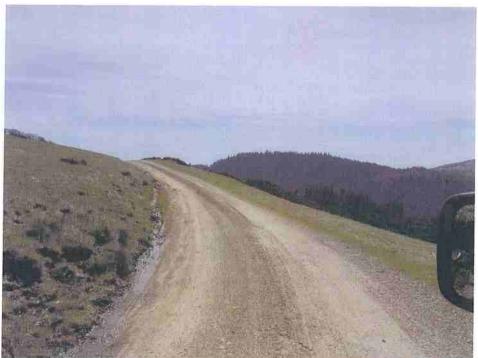
Mile 7.0 (Shower's Pass Road): 0+16+0=16ft wide road prism; Good visibility and sight distance; Turnouts forward and backward.

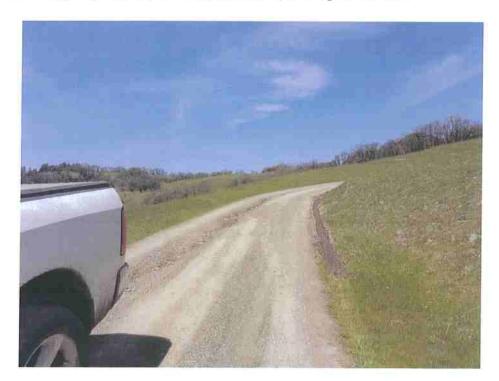
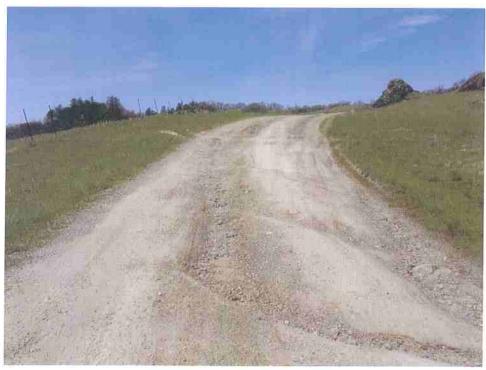
Shower's Pass Road: Severe erosion with steep travel ways was observed from MP 7.5-8.3. See recommendation table for possible improvements.

Mile 7.5 (Shower's Pass Road): 0+16+0=16ft wide road prism; Start of severe roadway erosion, continues until Stapp Road turnoff. Adequate visibility and sight distance.

<u>Shower's Pass Recommendations</u>: The portion of Shower's Pass road from MP 7.5-8.4 is severely eroded through insufficient drainage pathways. In our judgment this portion of Shower's Pass Road is the highest priority for repairs, through drainage grading, rocking & construction of 2-3 turnouts. This would be a large undertaking that should not be shouldered by a single applicant if there are other residents/applicants using this road for access to their parcels.

7.5	3.5	16	GSD, with turnout	Severe erosion from MP 3.5-4.2, recommend regrading lead-off ditches and constructing a RH Turnout	High
7.7	3,7	_	Erosion - pictures	100000000000000000000000000000000000000

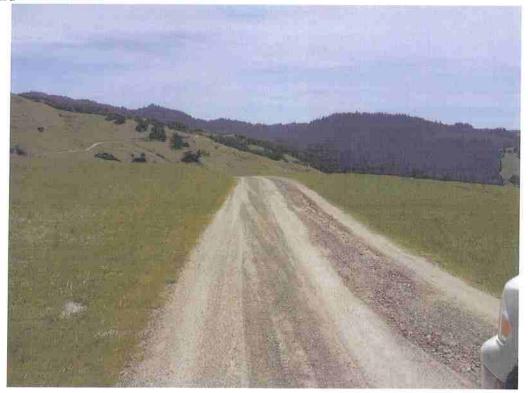
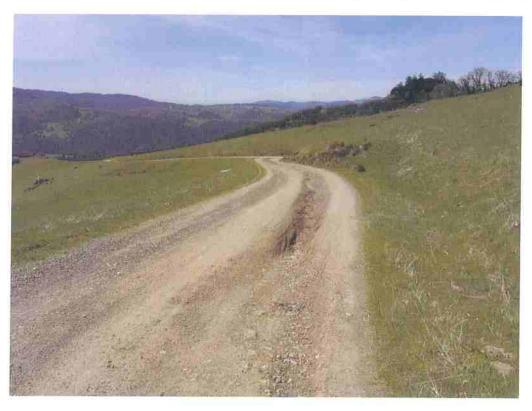
Mile 7.7 (Shower's Pass Road): 0+16+0=16ft wide road prism; Continuation of severe roadway erosion, continues until Stapp Road turnoff. Adequate visibility and sight distance.

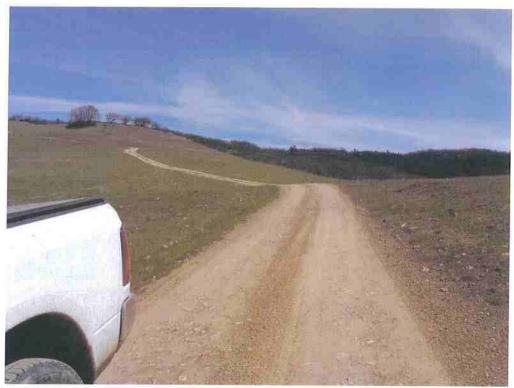
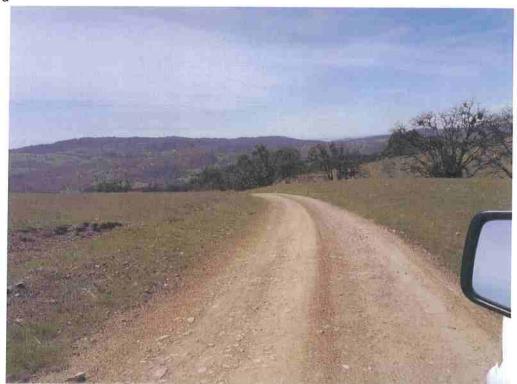
Mile 8.0 (Shower's Pass Road): 1+16+1=18ft wide road prism; Good visibility and sight distance; turnouts backwards and forwards.

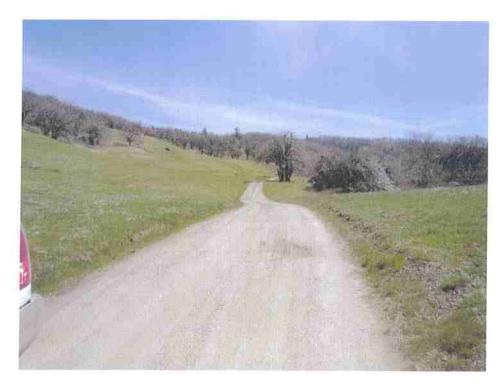
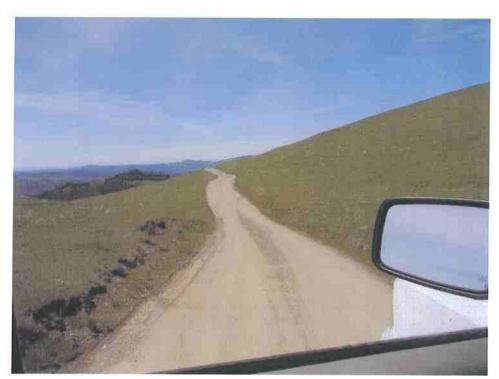
Mile 0.0 (Stapp Road): 0+17+1=17ft wide road prism; Shower's Pass Road Intersection at Shower's Pass MP 8.4; Good visibility and sight distance; 0.1 miles from turnout

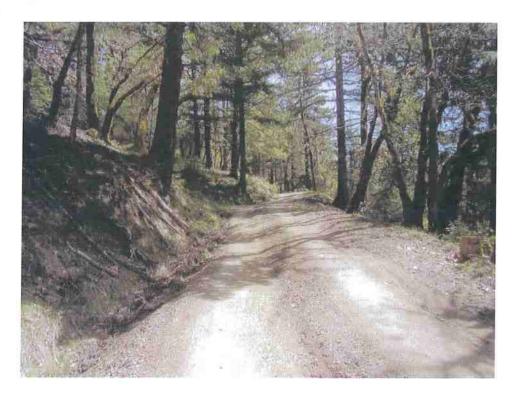
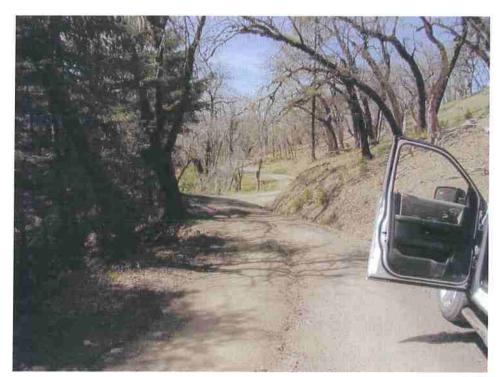
Mile 0.5 (Stapp Road): 3+20+3=26ft wide road prism; Adequate visibility and sight distance; wide enough for two lane traffic

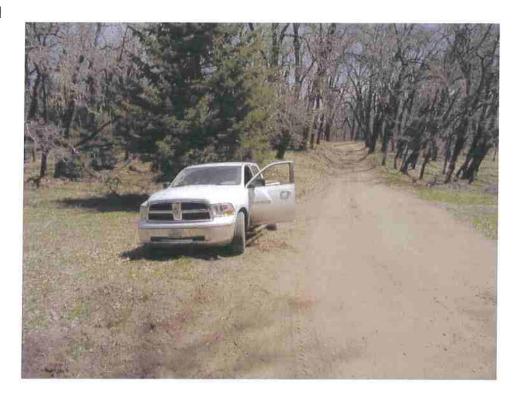
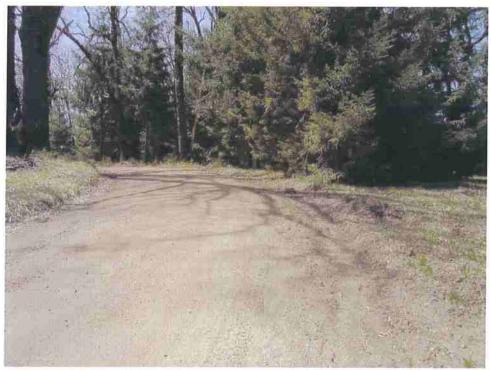
Mile 1.0 (Stapp Road): 3+23+0=26ft wide road prism; Good visibility and site distance; Large turnouts forward and backward.

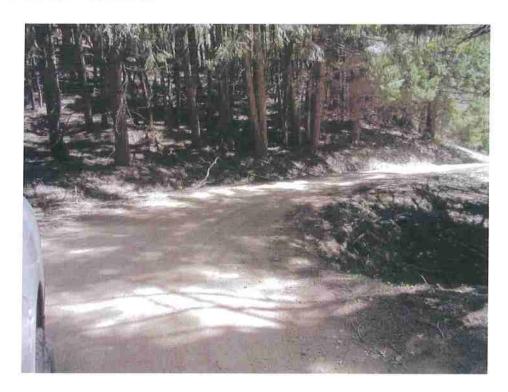
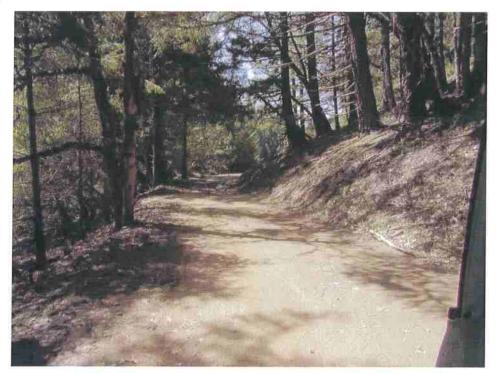
Mile 1.5 (Stapp Road): 0+17+2=19ft wide road prism; Adequate sight distance and visibility; Turnouts forward and backward.

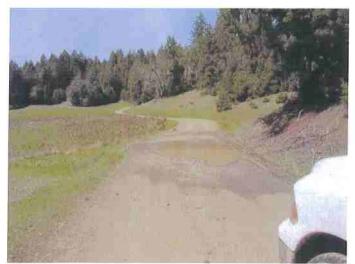
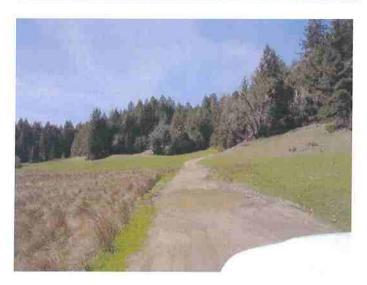
Mile 1.8 (Stapp Road): 2+13+0=15ft wide road prism; Severe ponding in the roadway, propose rocked culvert to alleviate drainage problem. Good visibility and sight distance; Turnouts needed. Backward

<u>Stapp Road – Public Recommendations:</u> Severe ponding in the roadways was observed at MP 1.8 within the county-maintained portion of Stapp road. Ponding alleviation is recommended to avoid any further road degradation. Severe potholes were also observed at MP 2.3 and 2.5.

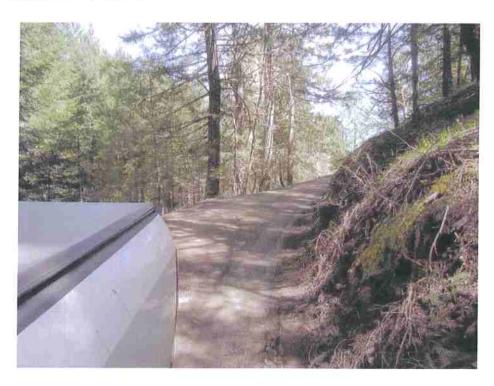
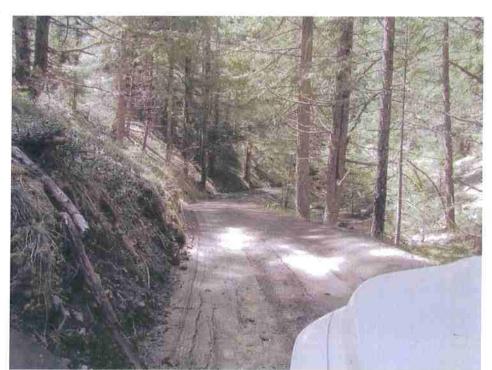
Mile 2.0 (Stapp Road): 2+13+0=15ft wide road prism; Adequate visibility and O.K. sight distance; No turnouts & culvert too short.

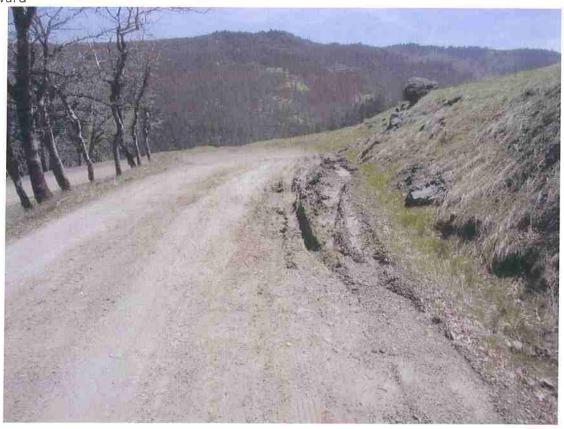
Mile 2.3 (Stapp Road): 0+16+3=19ft wide road prism; Adequate visibility and sight distance; Drainage issues causing severe pot-holes.

2.1	6.5		Culvert too short	estiny aramage manufacture receded 1 mm ramout	IVICA
2.1	6.5		2ft L shoulder		
2,4	6.8		Drainage problems -see pictures, O.K. site distance	County drainage maintinace needed	Med

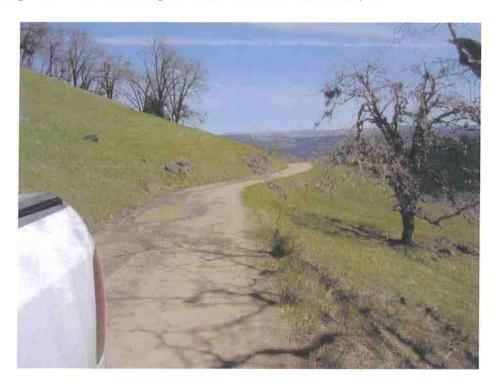
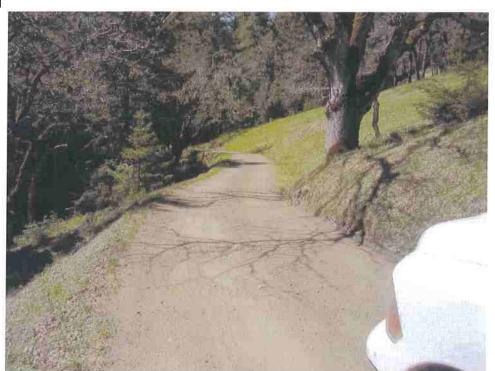
Stapp Road (Public): Drainage issues observed at MP 2.5 and 2.7, possible rolling dip installation needed. Further drainage maintenance by the county is needed at MP 1.8 and 2.3.

Mile 2.5 (Stapp Road): 0+14+0=14ft wide road prism; Good visibility and sight distance; Turnouts needed; Rough road due to drainage issues, needs more cross-slope.

2.6	7.0	14	GSD, Rough due to drainage issues, needs more x- slope & rolling dips	Insall Rolling dip and rocked drainage outlet	Med
2.8	7.2		sever erosion/drainage causing rough road - see pictures	Insall Rolling dlp and rocked drainage outlet	Med

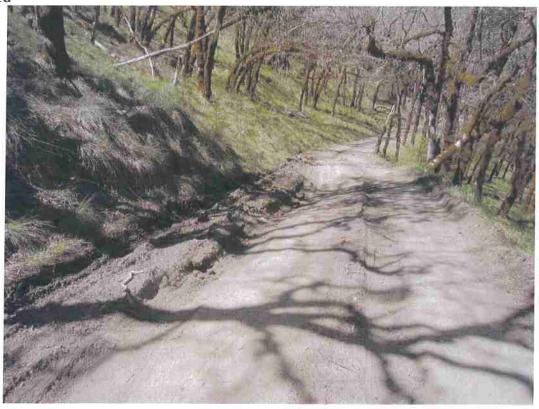
Mile 2.7 (Stapp Road): 0+14+0=14ft wide road prism; Good visibility and sight distance; Turnouts needed; Rough road due to drainage issues, needs more cross-slope.

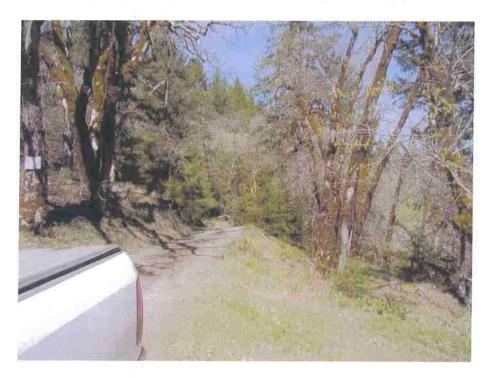
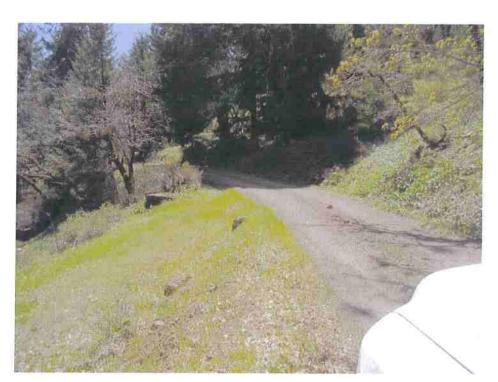
Mile 0.0 (Stapp Road – Private): 0+15+0=15ft wide road prism; Good visibility and sight distance; Turnouts forward and backward; Location of locked private gate on Stapp Road.

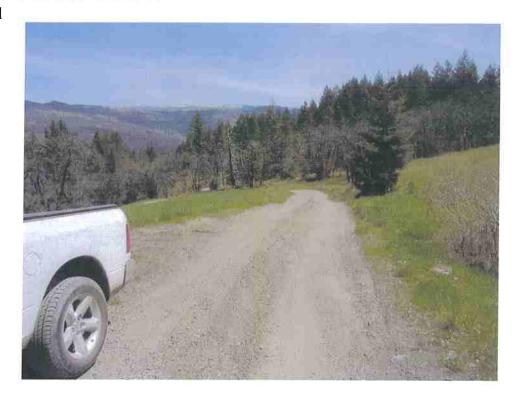
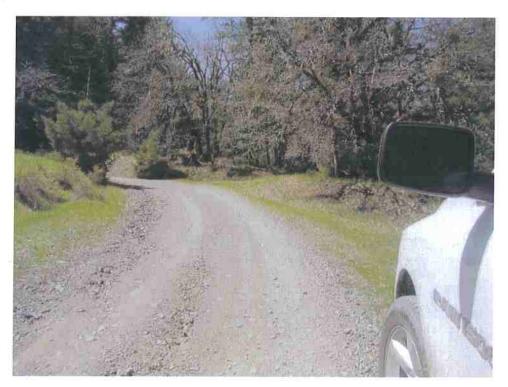
Mile 0.5 (Stapp Road – Private): 3+16+3=22ft wide road prism; Good visibility and sight distance; Turnouts forward and backward.

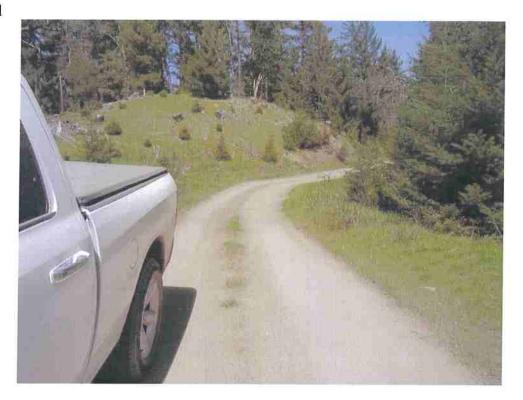
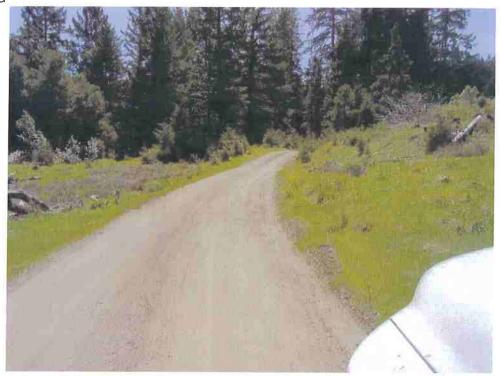
Mile 1.0 (Stapp Road – Private): 0+13+6=19ft wide road prism; Good visibility and sight distance; Turnouts backwards and forwards.

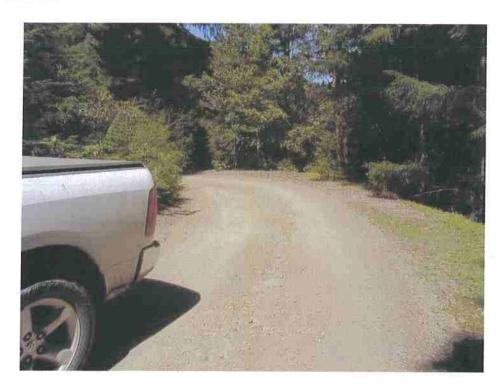
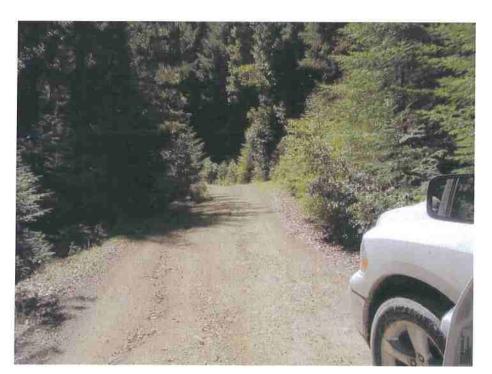
Mile 1.5 (Stapp Road – Private): 0+15+3=18ft wide road prism; Good visibility and sight distance; Turnout forwards.

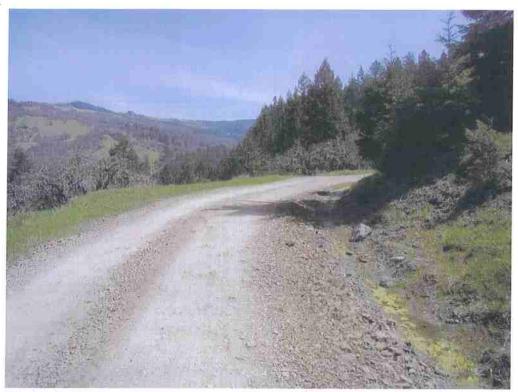
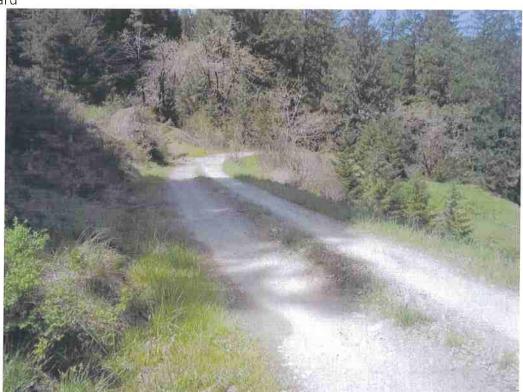
Mile 2.0 (Stapp Road — Private): 0+13+6=19ft wide road prism; Good visibility and sight distance; Turnouts backwards and forwards.

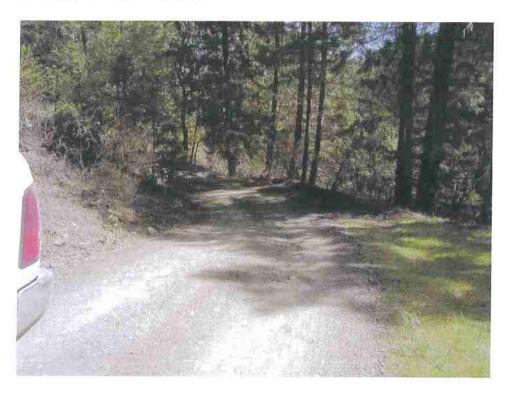
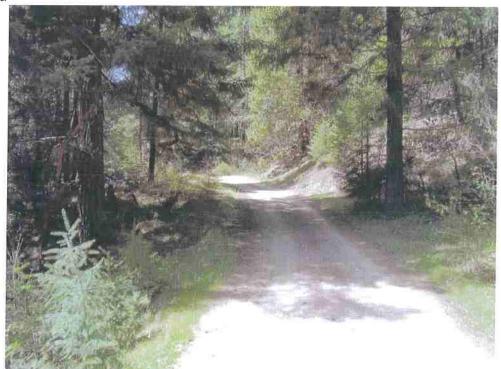
Stapp Road (Private): Drainage issues observed at MP 2.5, see recommendation section for improvements.

Mile 2.5 (Stapp Road – Private): 2+13+2=17ft wide road prism; Adequate visibility and sight distance; Turnout right; Needs rolling dip.

<u>Stapp Road – Private Recommendations:</u> A rolling dip that drains to the right is proposed at MP 2.5 to aid in erosion control. Additionally, the private section of Stapp Road from MP 4.1-4.3 is not suitable for 2-wheel drive passenger vehicles (too steep) without costly realignment requiring new easements. It is recommended that only cultivation and drying is allowed on site to minimize use on this portion of Stapp Road. The road is currently adequate for these purposes.

2.0	9.5		SD		
2.5	10.0	13	Rolling dip + turn out	Install Rolling Dip and RH Turnout	Med
2.8	10.3	- 1	najor creek crossing		
3.1	10.6	19	GSD + Turn out		
3.5	11.0		SSD

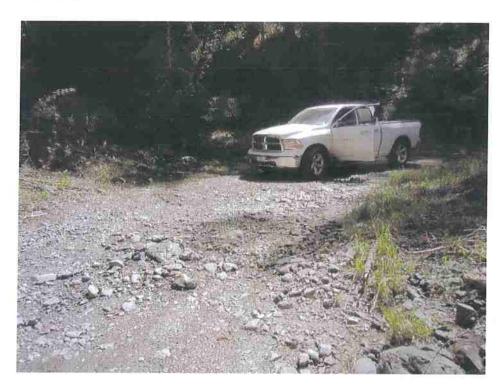
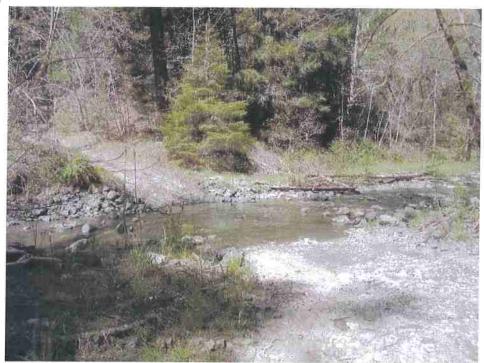
Mile 2.8 (Stapp Road – Private): 0+18+0=18ft wide road prism; Major stream crossing (Showers Creek), adequate site distance. See CDFW LSAA Notification No. 1600-2017-0444-R1 for crossing rights, Issued 03/13/18.

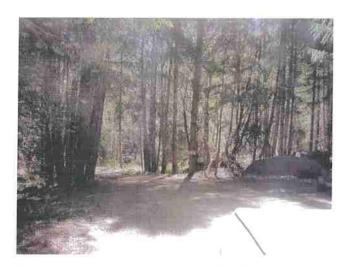
Mile 3.5 (Stapp Road – Private): 0+20+0=20ft wide road prism; Good visibility and sight distance; Large turnout & intersection.

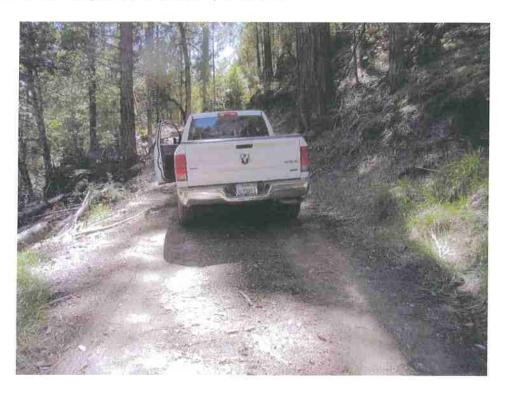
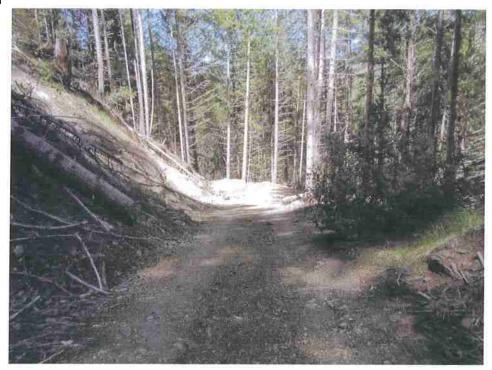
Mile 4.1 (Stapp Road – Private): 0+18+0=18ft wide road prism; Good visibility and sight distance; Steep Grade (8-24% Slope), 4WD necessary at all times.

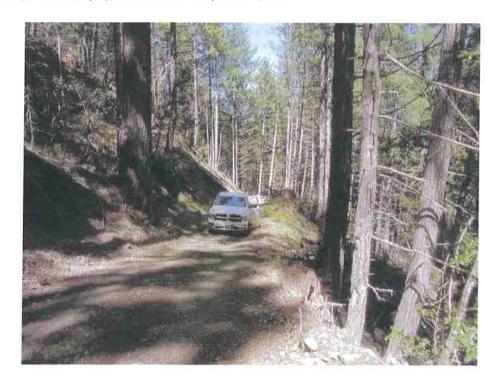
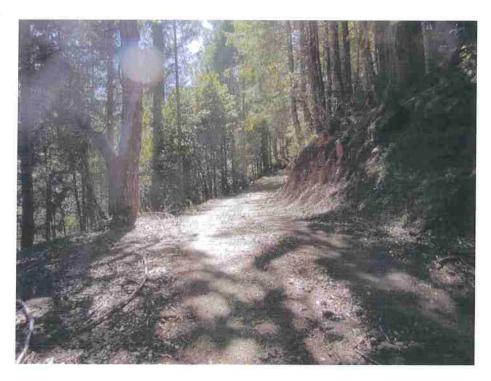
Mile 4.3 (Stapp Road – Private) 0+18+0=18ft wide road prism; Good visibility and sight distance; Steep Grade (8-24% Slope), 4WD necessary at all times

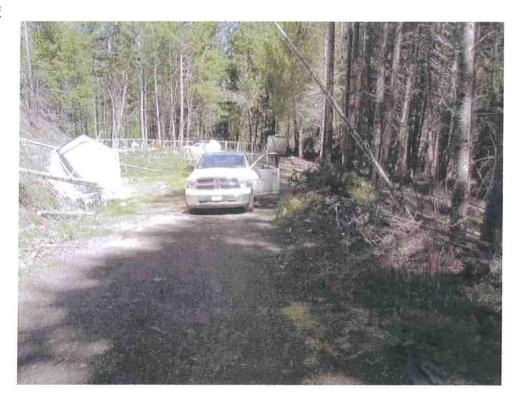
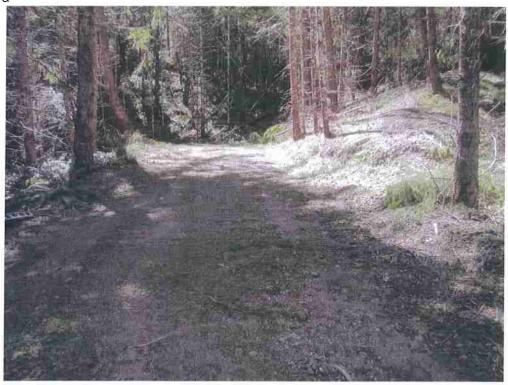
Mile 4.6 (Stapp Road – Private) 1+15+2=18ft wide road prism; Good visibility and sight distance; Turnouts forward and backward.
