# **We Are Up Project**

## **Initial Study & Proposed Mitigated Negative Declaration**

County of Humboldt  
PLN-2022-18047 CUP/SP  
APN 509-181-057

# Aquatic Resources Delineation and Sensitive Habitat Report\_Rev2 We Are Up Housing Project

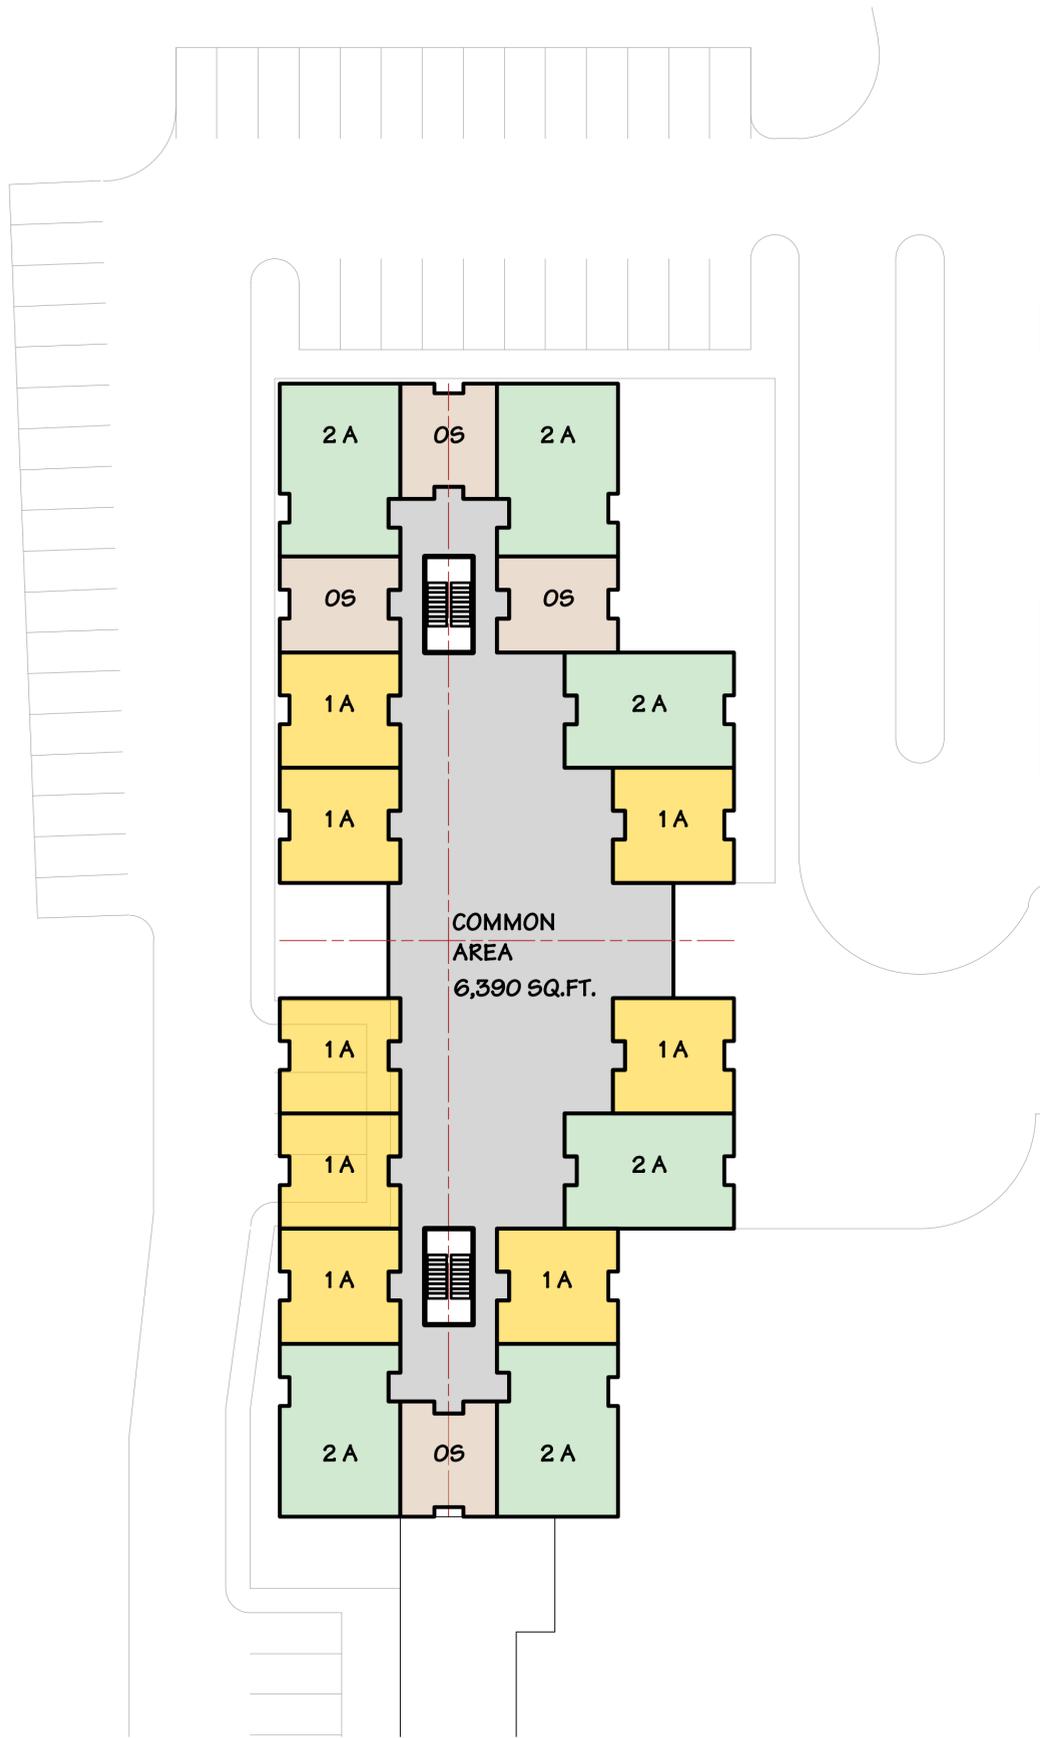
**TOP LEVEL**

**UPPER LEVEL**

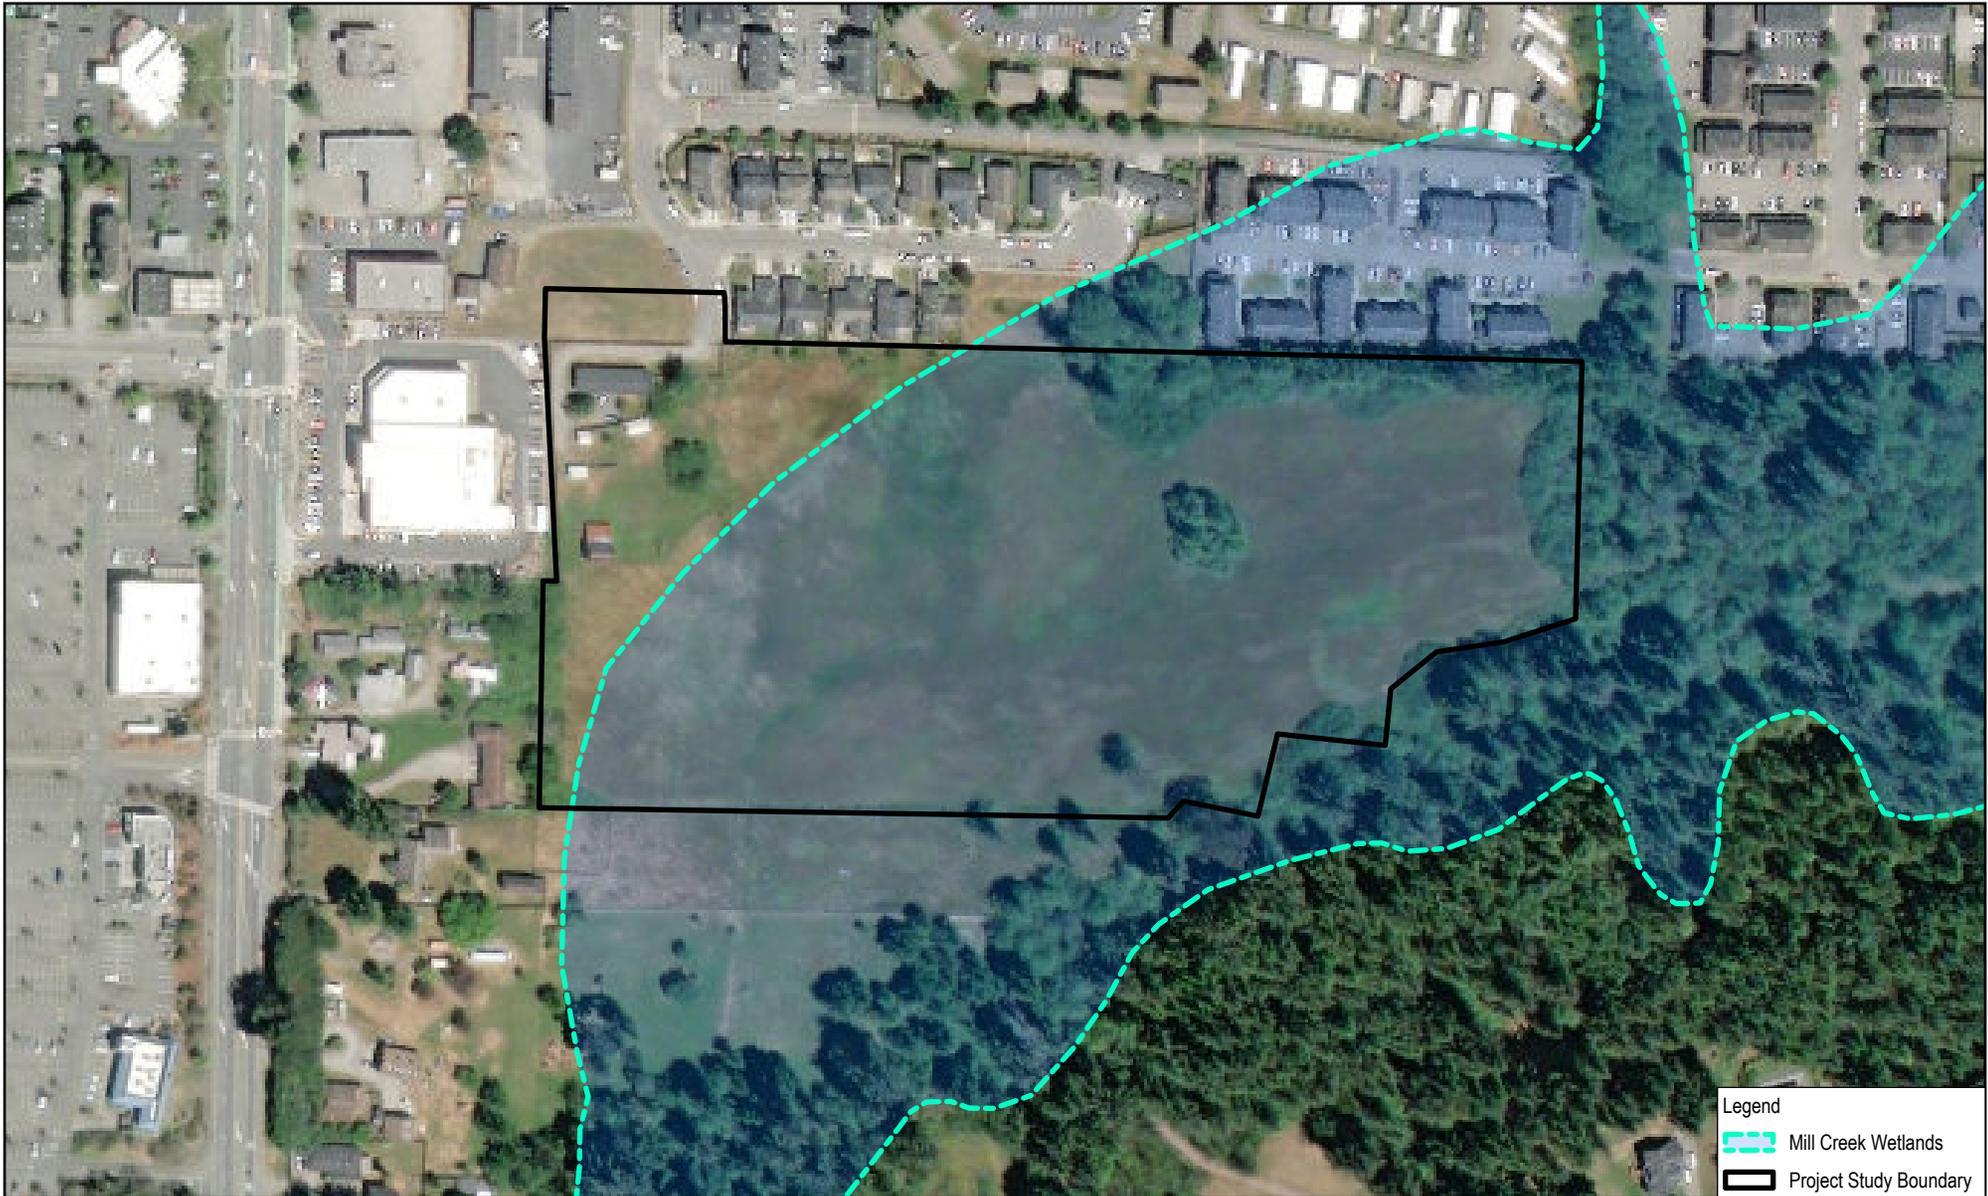
**FIGURE 5**

**Mill Creek Wetland Overlay**

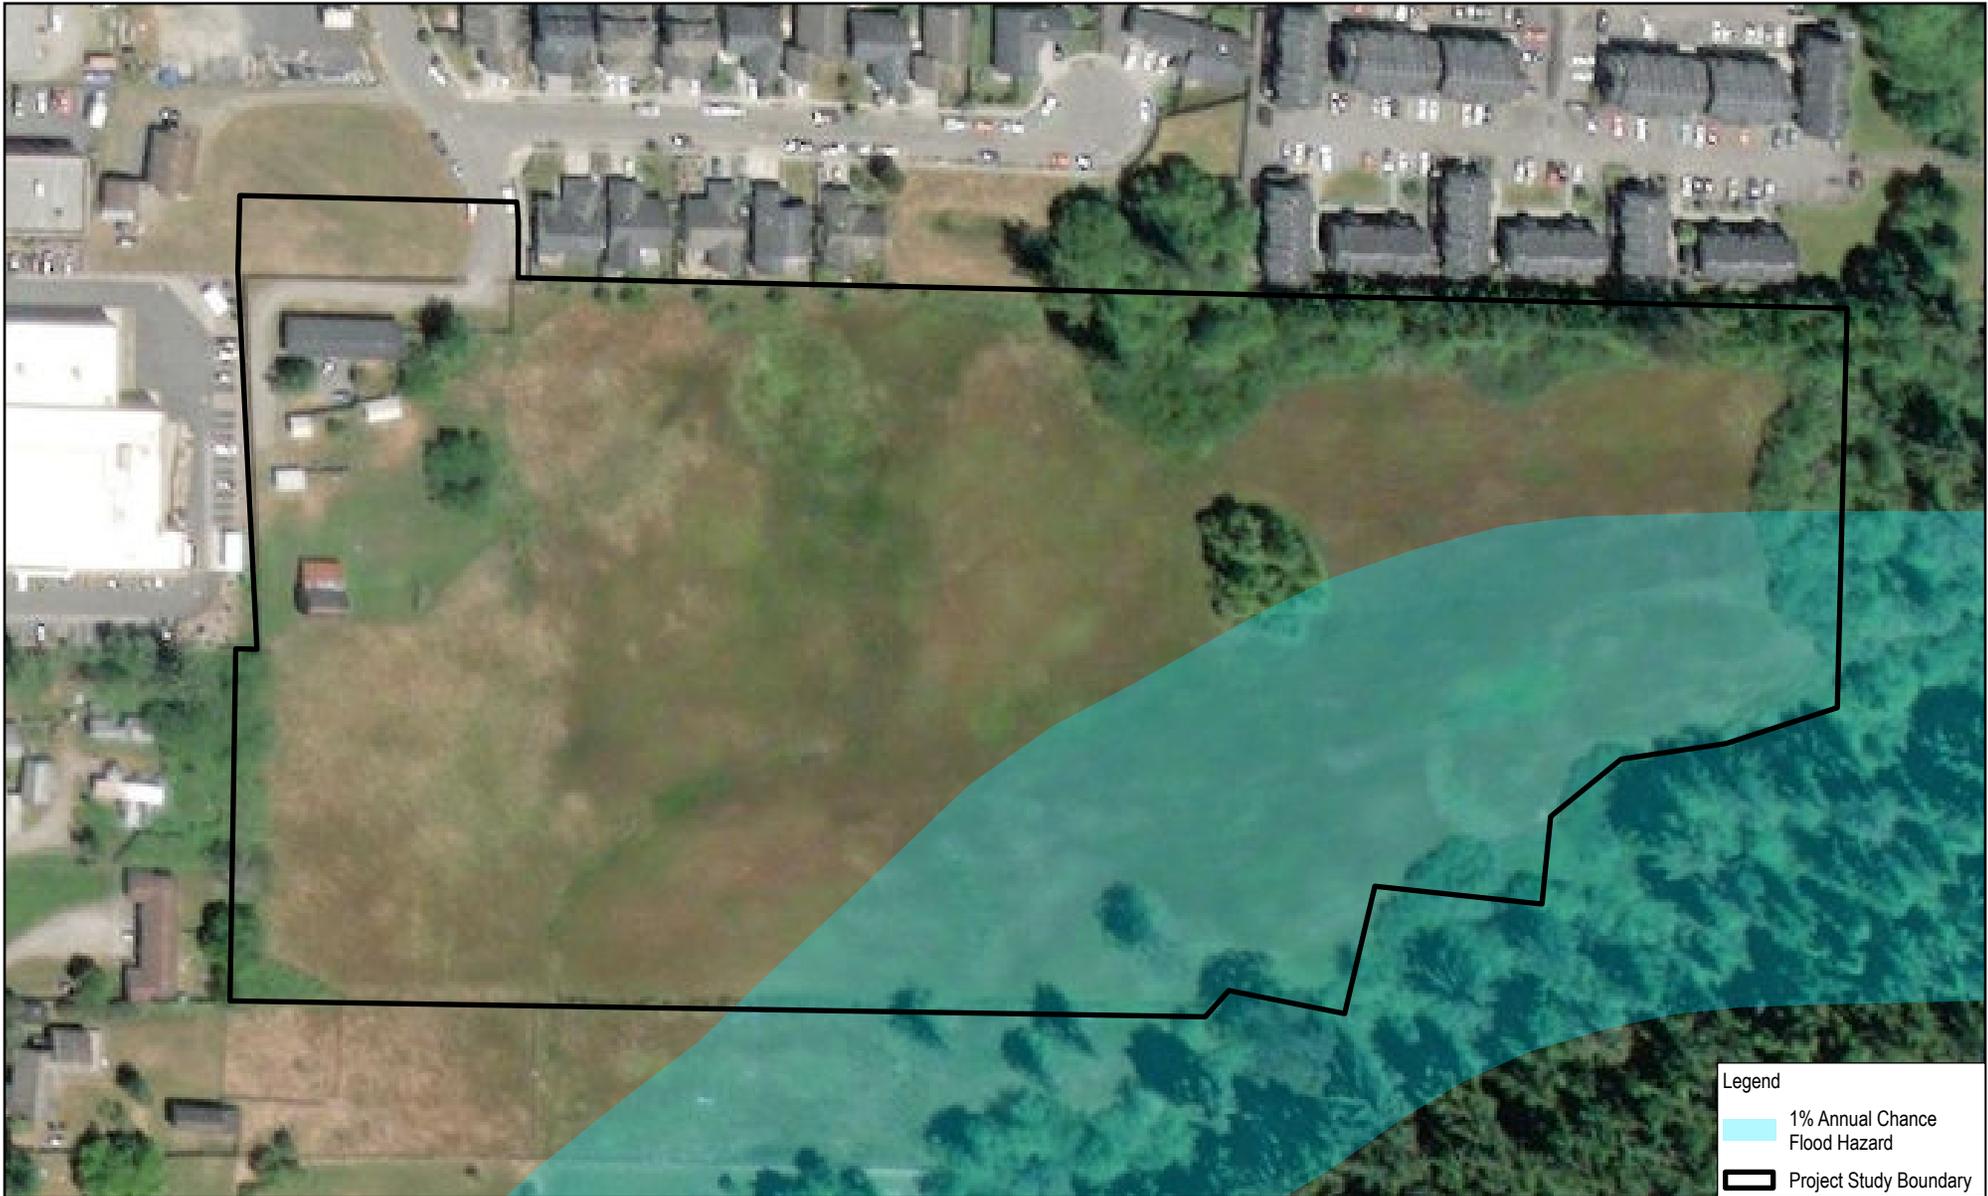
**FIGURE 6**

**FEMA Floodplain**

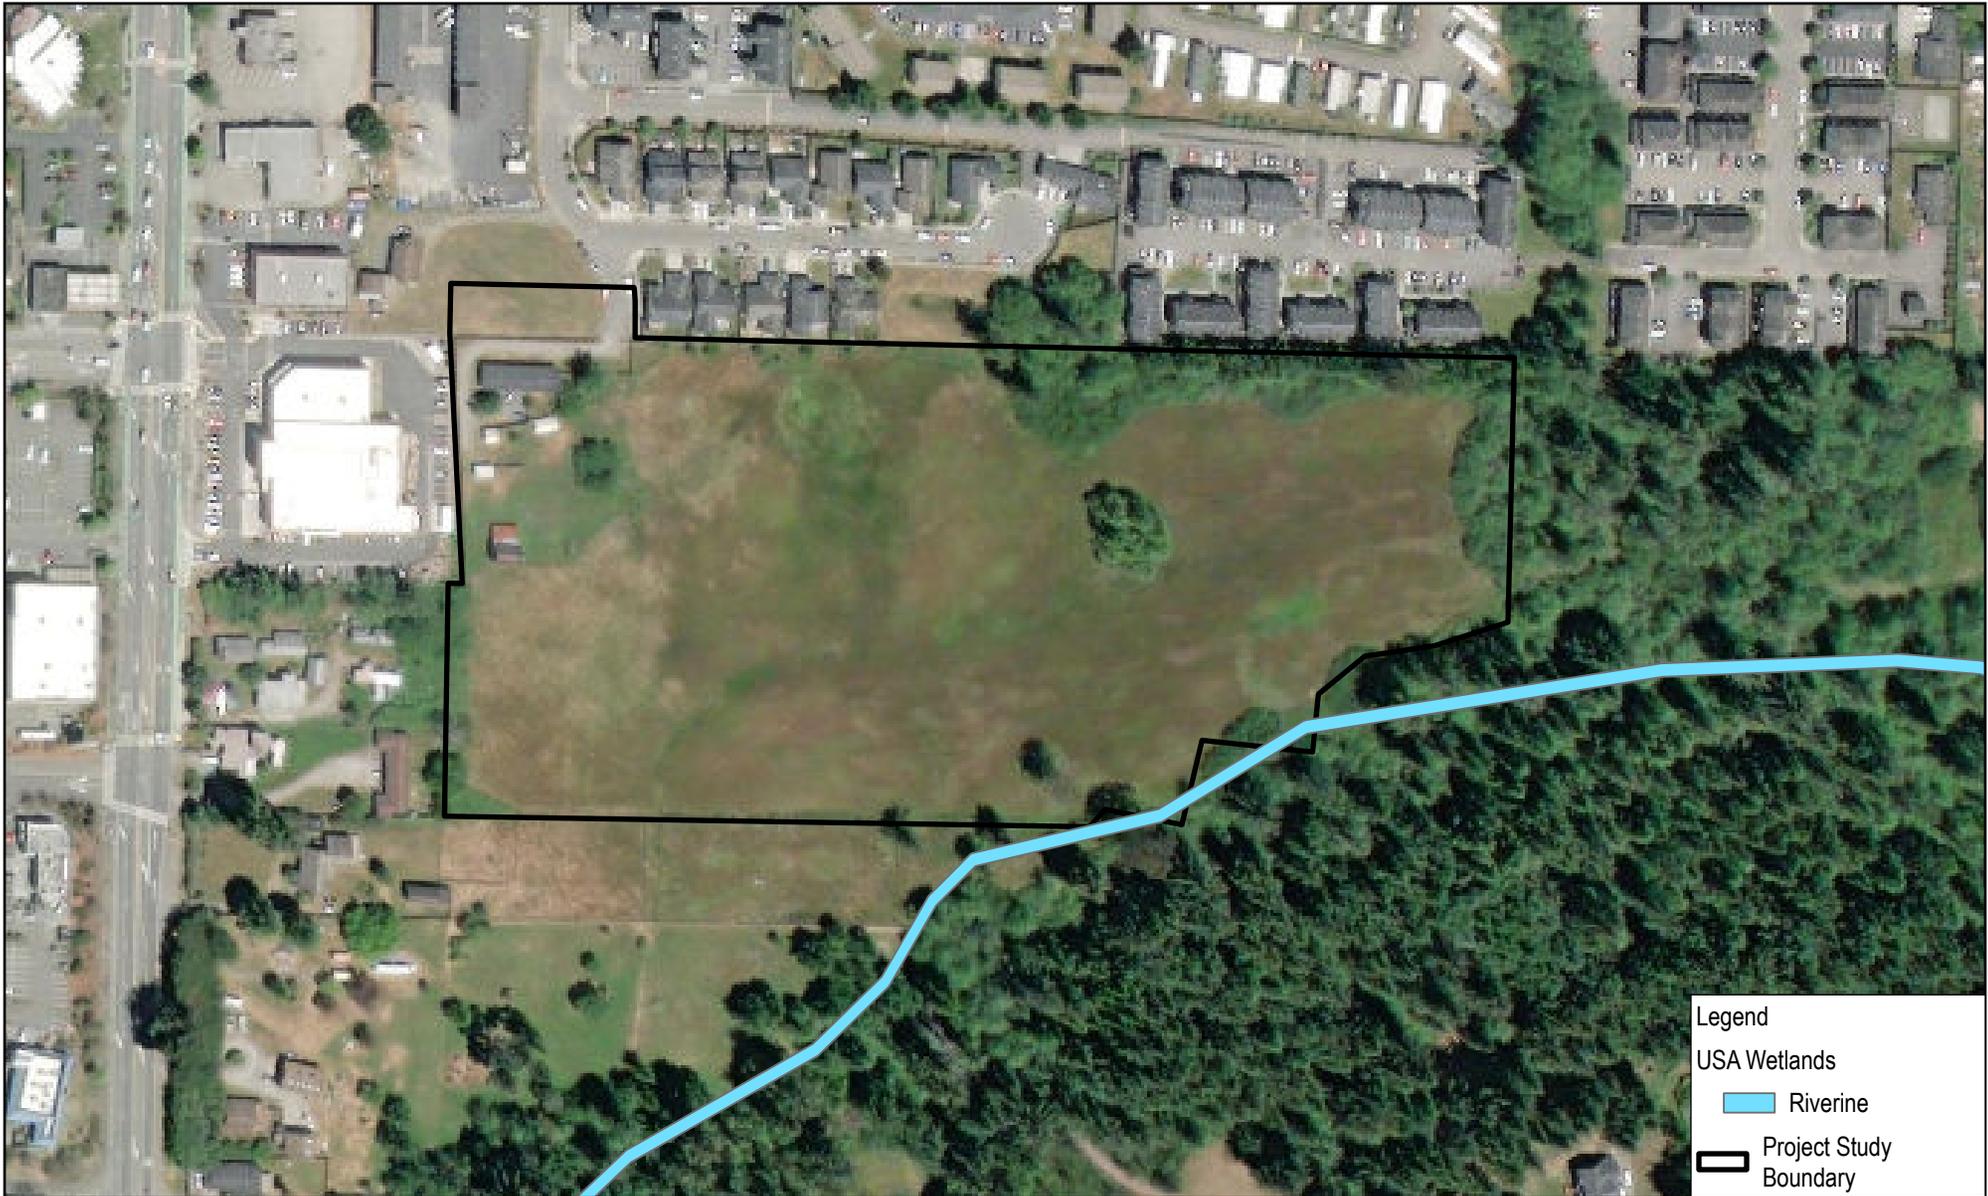
**FIGURE 7**

**National Wetlands Inventory**

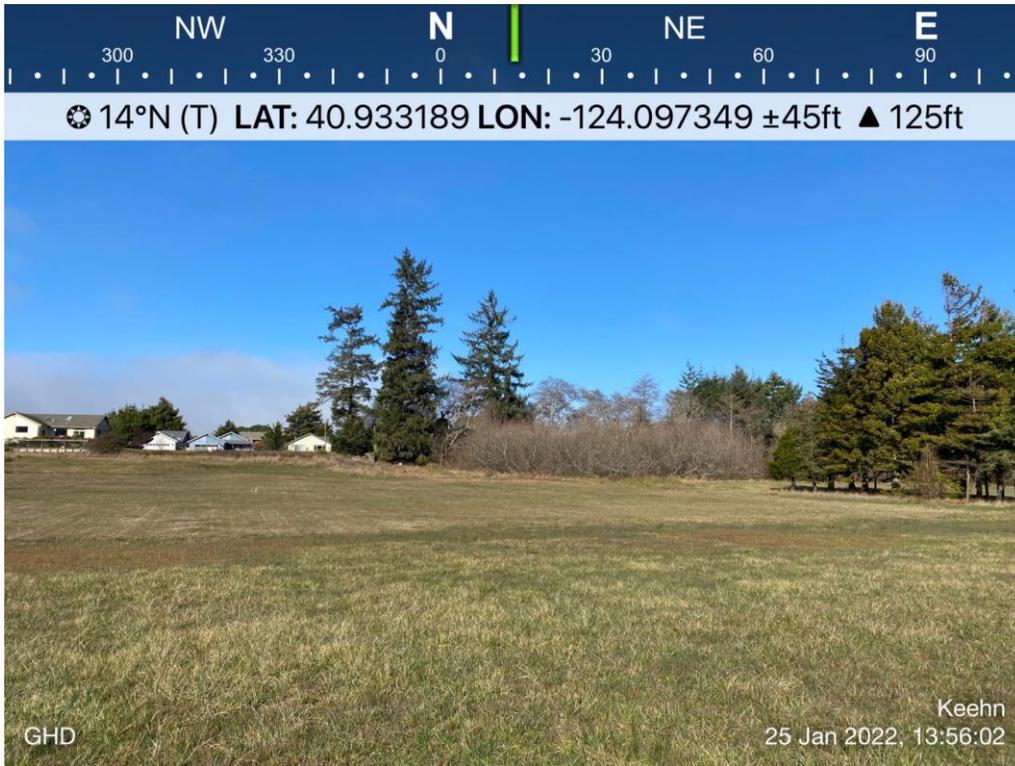
Photo 5. Viewing a swale in the center of the PSB facing North.

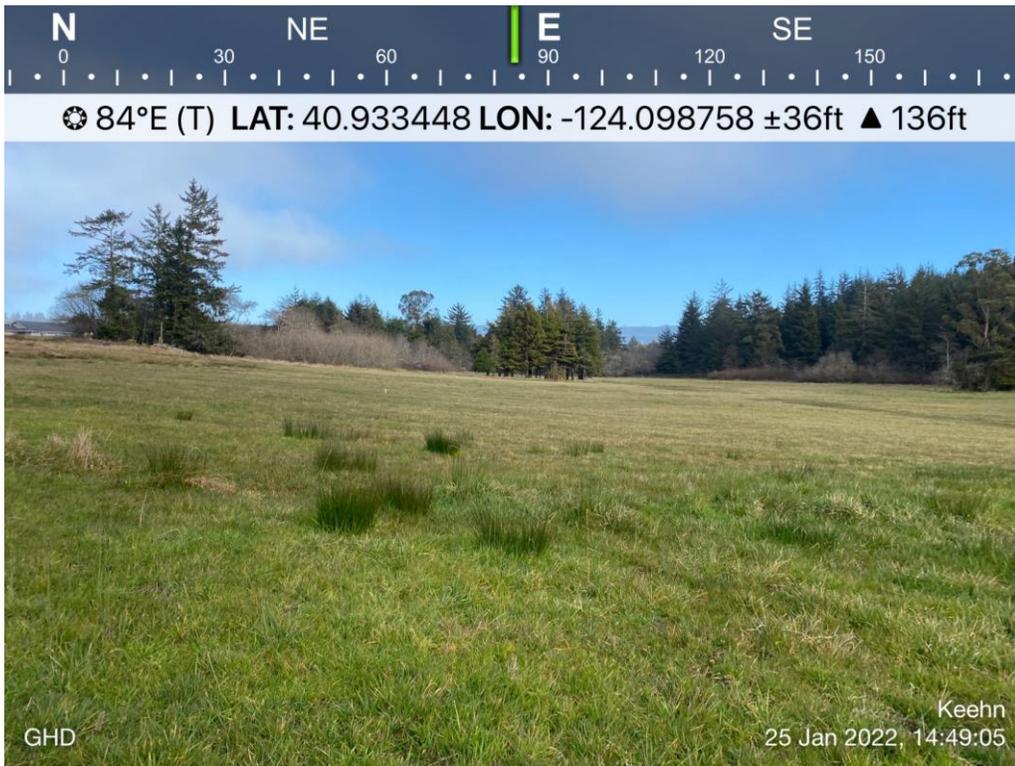
Photo 6. Viewing more hydrophytic vegetation within Wetland 1, present on the upper slope.

Wetland 1 was open and mostly free of rooted woody vegetation and is classified according to the Cowardin system as a Palustrine Emergent wetland (PEM) (FGDC 2013). The vegetation was primarily characterized by redtop (*Agrostis stolonifera*, FAC), reed fescue (*Festuca arundinacea*, FAC), common velvetgrass (*Holcus lanatus*, FAC), Italian rye grass (*Festuca perennis*, FAC), slough sedge (*Carex obnupta*, OBL), and mountain bod sedge (*Scirpus microcarpus*, OBL). Wetland 1 mostly passed the dominance test for hydrophytic vegetation (wetlands plots).

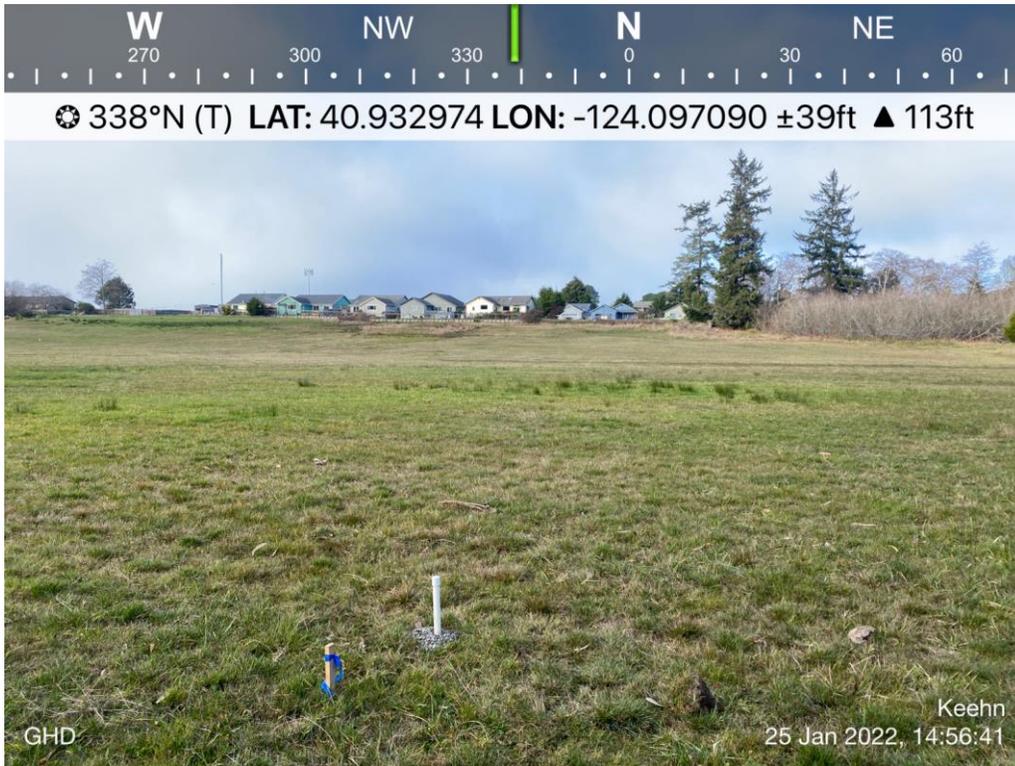
Photo 7. Viewing a swale at the base of the slope within Wetland 1.

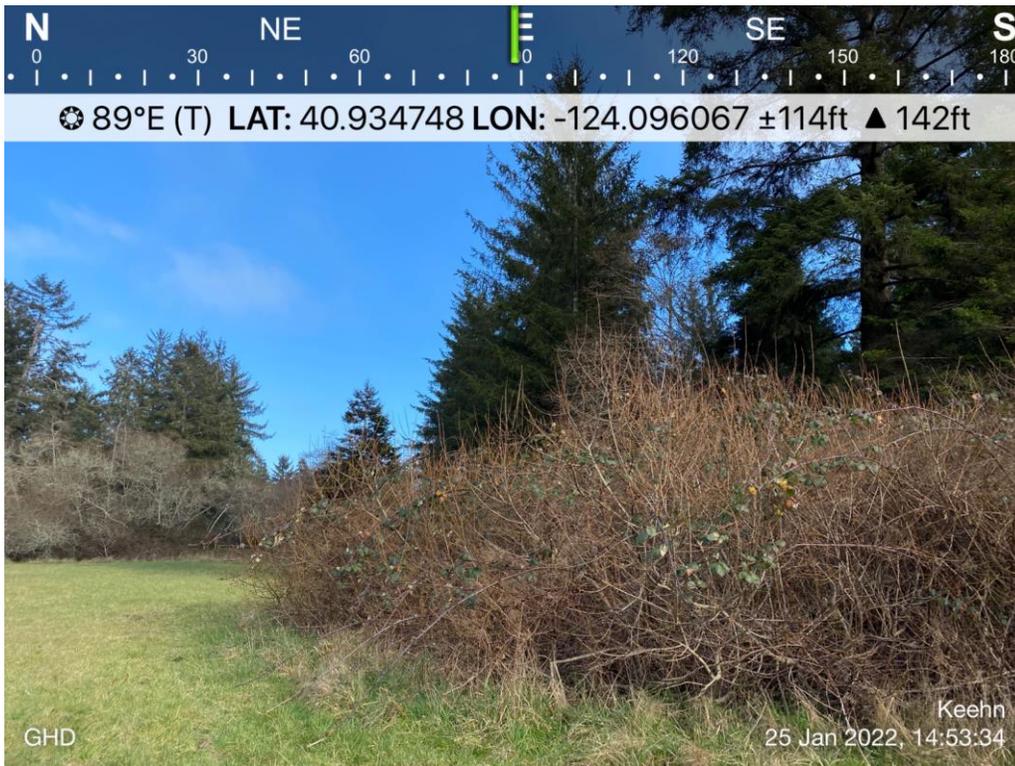
Photo 8. Dormant Coastal Willow Alliance SNC within the riparian corridor of Mill Creek.

The Coastal Willow Alliance corresponds to the Rapid Assessment datasheet WEIR002 in **Appendix D**. The Coastal Willow Alliance was observed in the north, northwest, and southwest edges of the PSB and covers 0.85 acres of the PSB. This SNC contained a tree canopy cover of 2% red alder (*Alnus rubra*), a shrub layer of 85% coastal willow (*Salix hookeriana*), and 20% California blackberry. The Coastal Willow Alliance has a State ranking of S3, therefore qualifying it as an SNC.

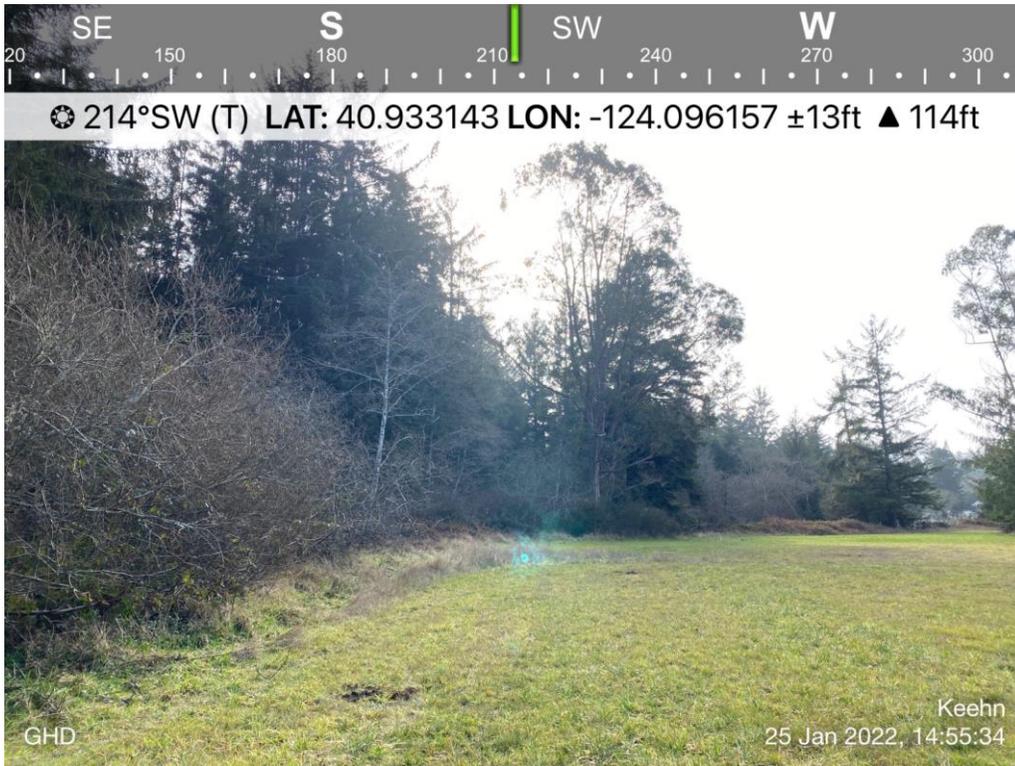
Photo 9. SNCs Coastal Willow Alliance backed by Sitka Spruce Alliance within the riparian corridor of Mill Creek.

The Sitka Spruce Alliance corresponds to the Rapid Assessment datasheet WEIR001 in **Appendix D**. The Sitka Spruce Alliance was observed in the north, northwest, and southwest edges of the PSB and covers 0.75 acres of the PSB. This SNC contained a tree canopy cover of 40% Sitka spruce (*Picea sitchensis*), 35% red alder (*Alnus rubra*), and 20% incense cedar (*Thuja plicata*), and is associated with California blackberry (*Rubus ursinus*). The Sitka Spruce Alliance has a State ranking of S2, therefore qualifying it as an SNC.
