# **HUMBOLDT COUNTY ROADWAY EVALUATION REPORT**

**SITE ACCESS ROAD**

**Private Drive  
Garberville, California**

**April, 2019  
Josh McKnight, P.E.  
Job #1363.01**

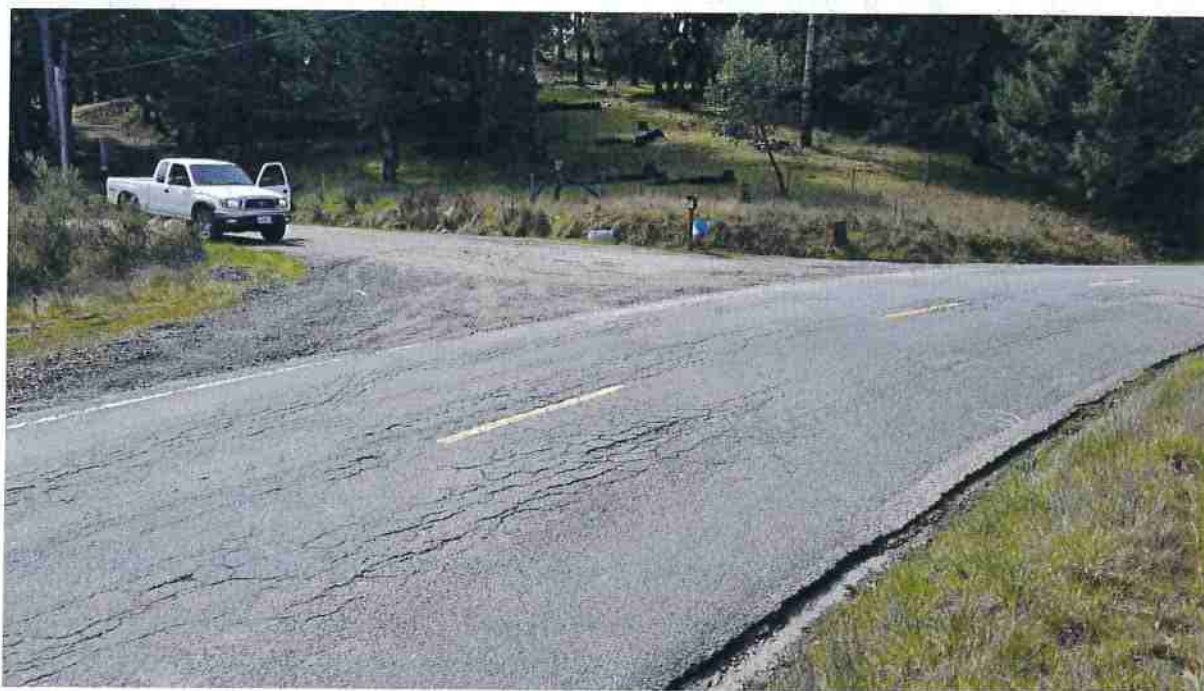
*Figure 1. Photograph showing the start of Little Buck Mountain Road at the intersection of Alderpoint Road. An encroachment permit is being obtained to pave the first 50 feet of Little Buck Mountain Road access.*

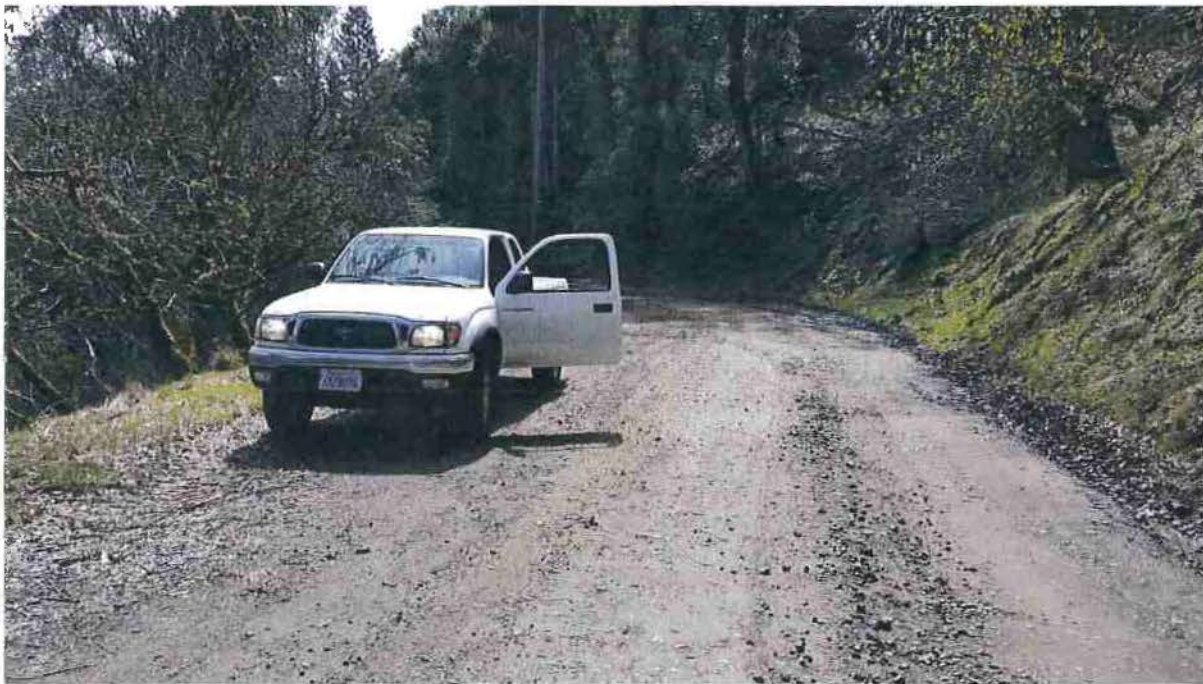
*Figure 2. Photograph showing road point RP1 which is a good turnout.*

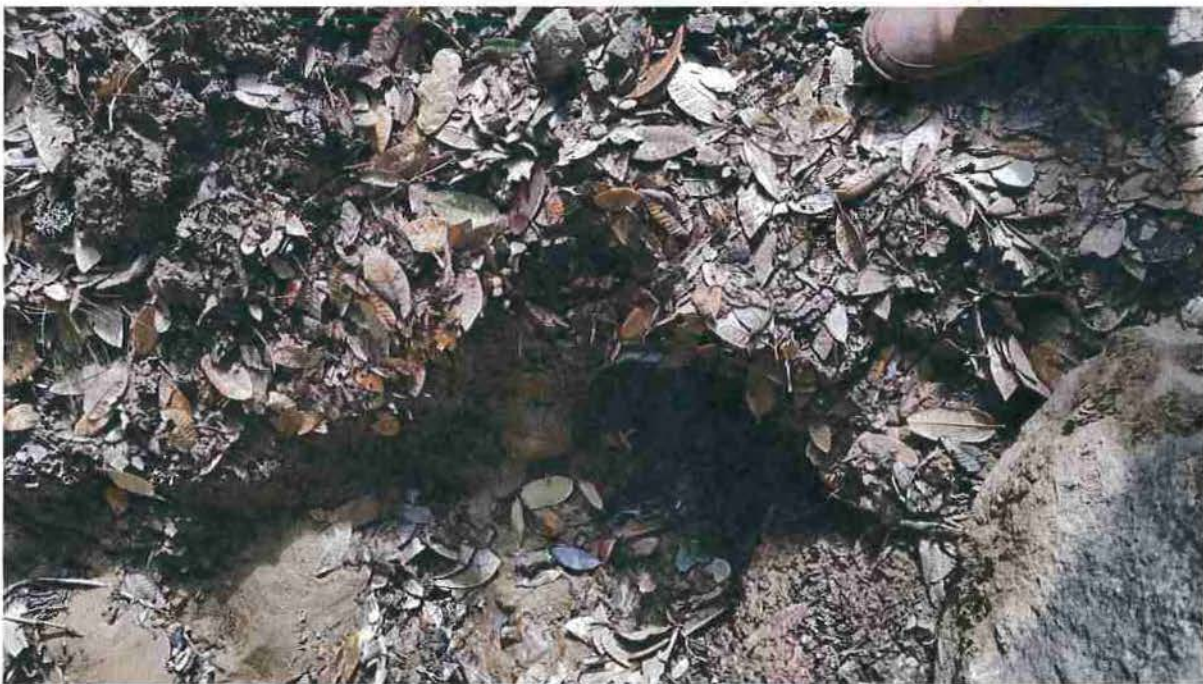
*Figure 3. Photograph showing road point RP2 which is an onstream culvert in good condition. The inside ditch catches the class III stream and diverts it to the culvert.*

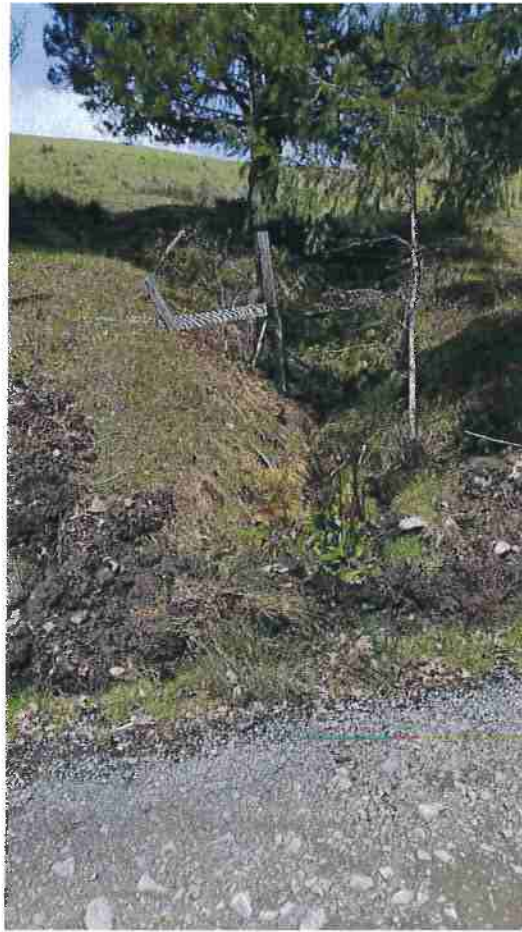
**Figure 4.** Photograph showing the class three stream that is diverted to road point RP2 which is an onstream culvert in good condition. The inside ditch catches the class III stream and diverts it to the culvert. Future work on the culvert will need a CDFW permitting.

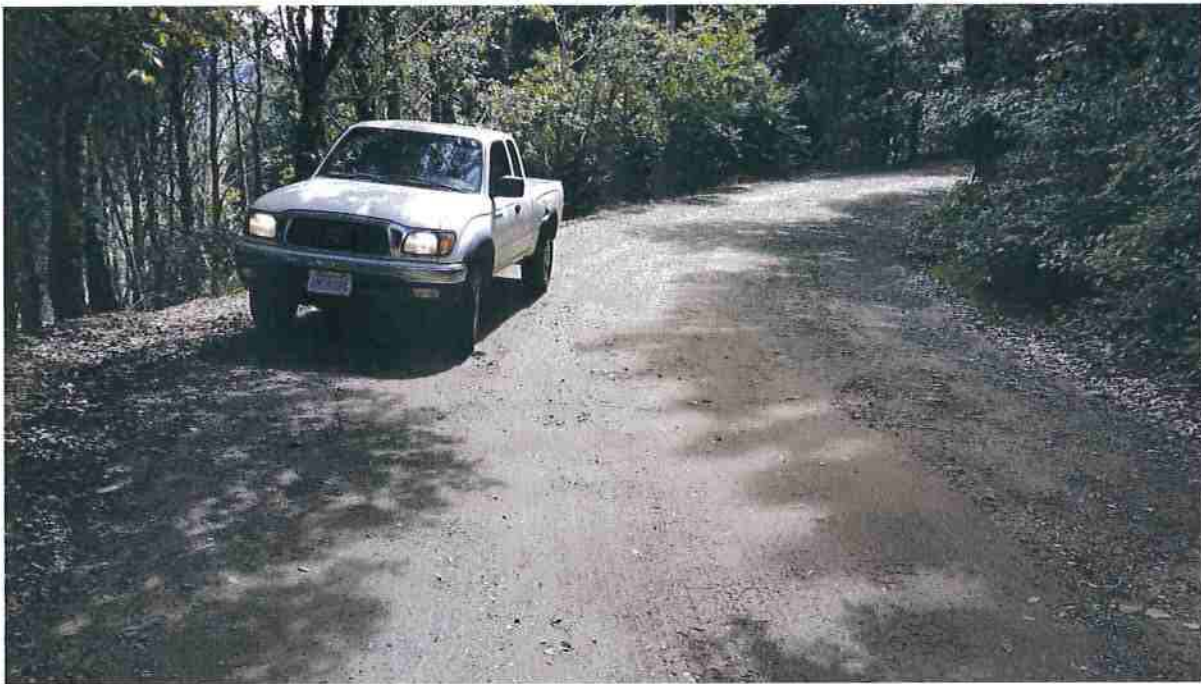
*Figure 5. Photograph showing road point RP3 which is a good turnout.*

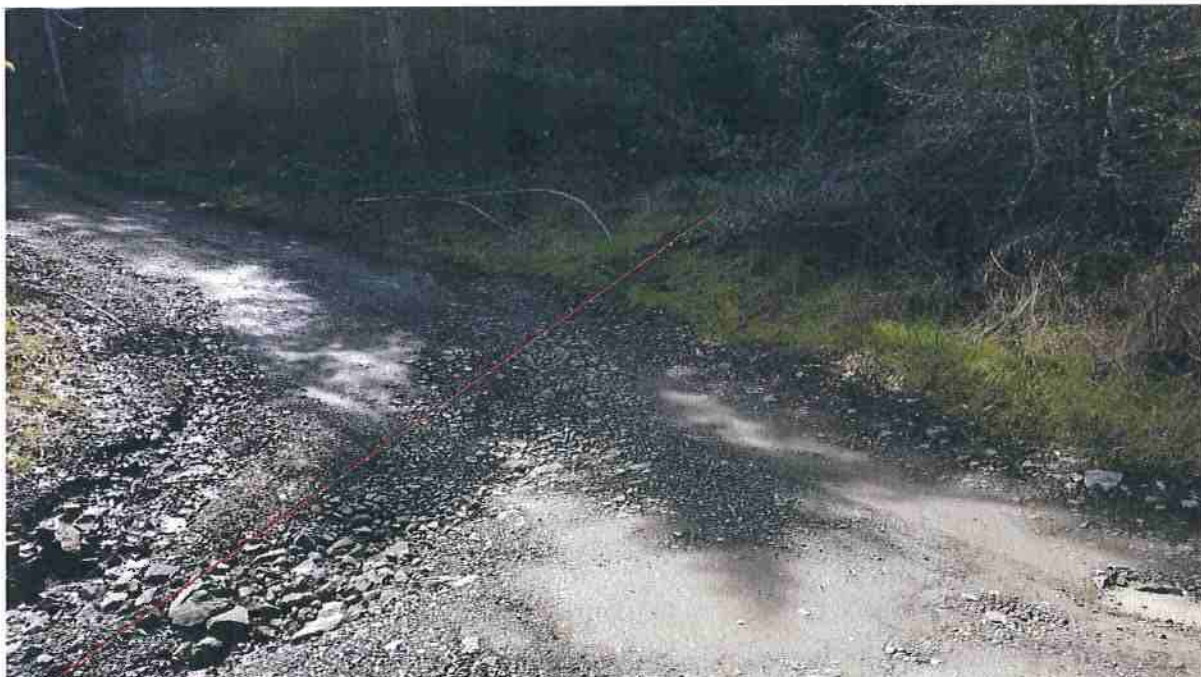
*Figure 6. Photograph showing road point RP4 which is at an intersection to a neighboring roadway. The neighboring access roadway lacks a proper drainage the start of a class three watercourse intersect the roadway at the intersection. A culvert needs to be installed at the start of the class III watercourse*

*crossing both of the access roads and a drainage relief culvert needs to be installed below the intersection to catch the runoff from need to be installed rolling dip installed approximately 50' up the neighboring property. The roadways inside ditch need to be installed from the proposed drainage relief culvert to the inter Photograph showing road point RP5 which is at an intersection to a neighboring roadway. The neighboring access roadway lacks a proper drainage the start of a class three watercourse intersect the roadway at the intersection. A culvert needs to be installed at the start of the class III watercourse crossing both of the access roads and a drainage relief culvert needs to be installed below the intersection to catch the runoff from need to be installed rolling dip installed approximately 50' up the neighboring property. The roadways inside ditch need to be installed from the proposed drainage relief culvert to the intersection..*

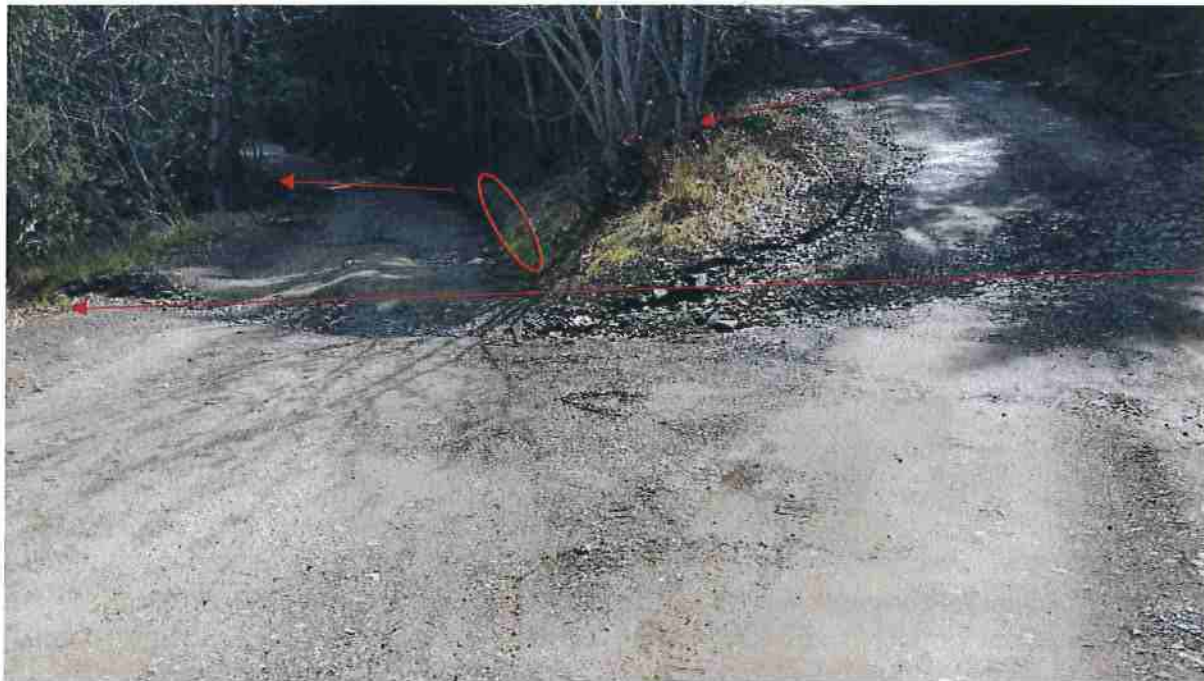
**Figure 7.** Photograph showing road point RP5 which is at an intersection to a neighboring roadway. The neighboring access roadway lacks a proper drainage the start of a class three watercourse intersect the roadway at the intersection. A culvert needs to be installed at the start of the class III watercourse crossing both of the access roads and a drainage relief culvert needs to be installed below the intersection to catch the runoff from need to be installed rolling dip installed approximately 50' up the neighboring property. The roadways inside ditch need to be installed from the proposed drainage relief culvert to the intersection.

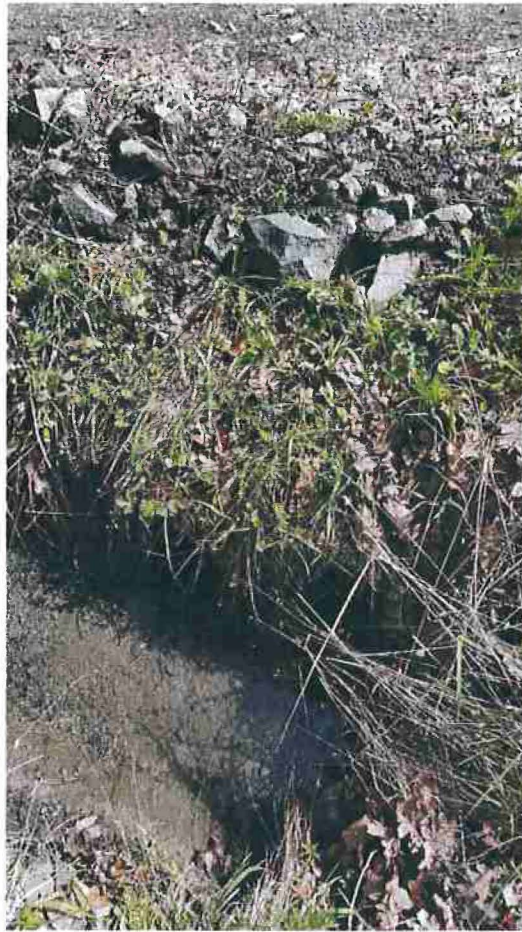
*Figure 8. Photograph showing road point RP6 which is a drainage relief culvert..*

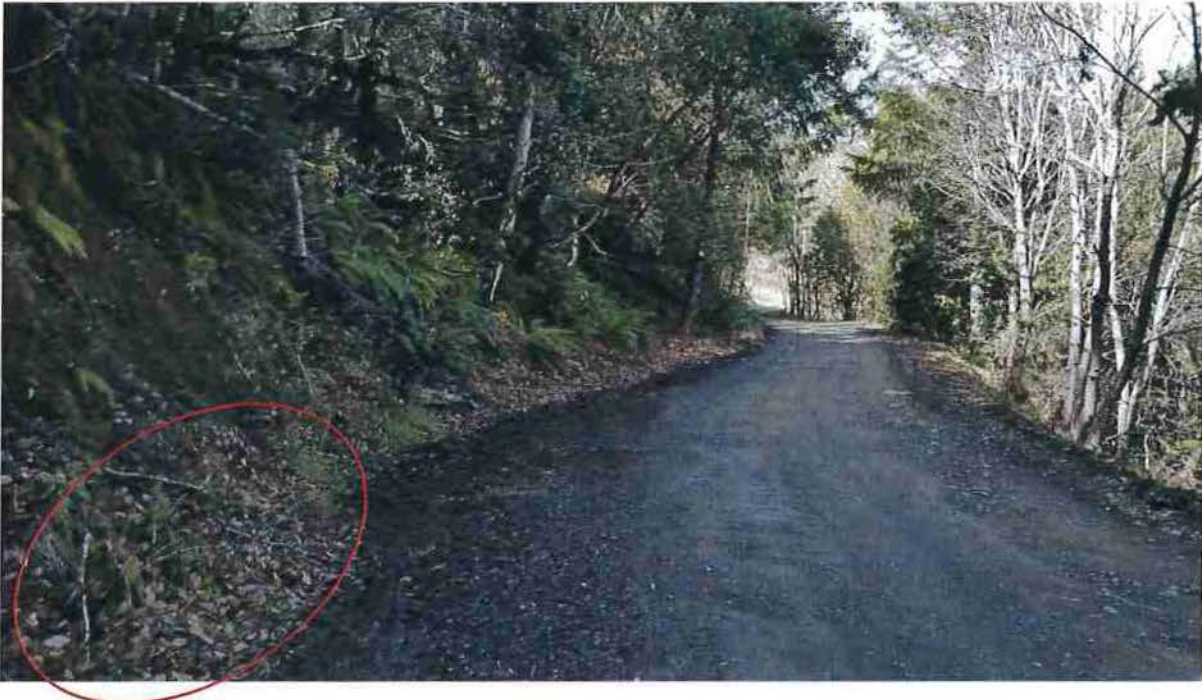
*Figure 9. Photograph showing road point RP7 which is turnout that needs to be regraded.*

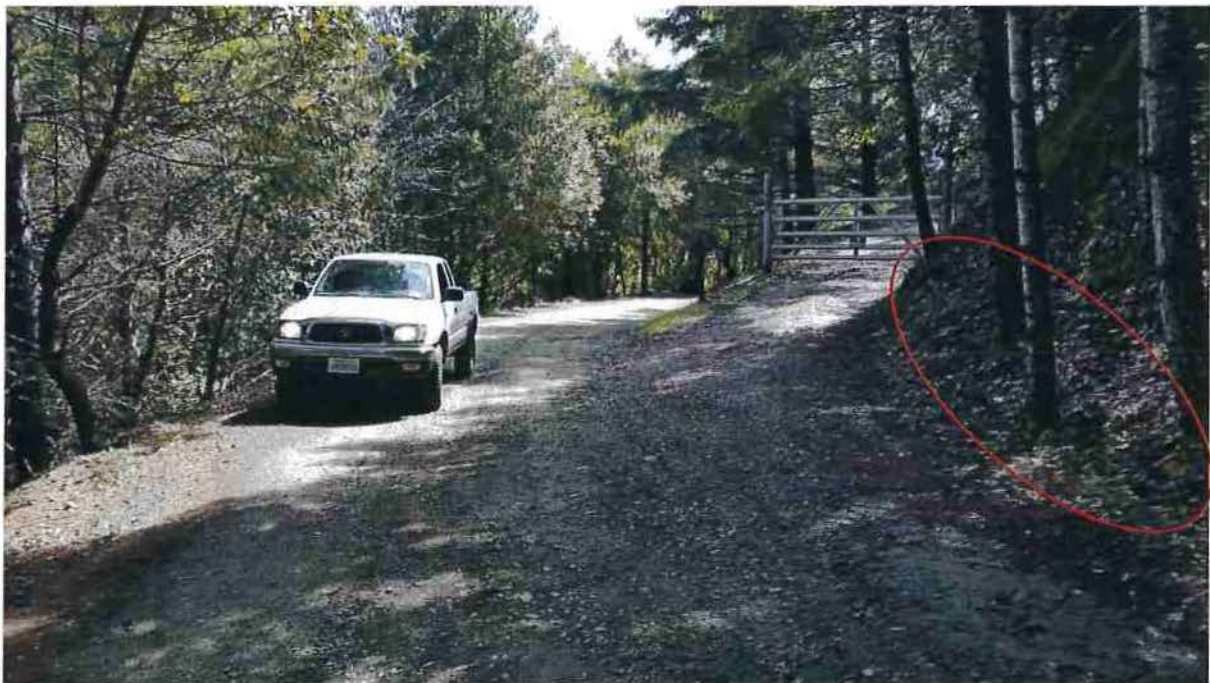
*Figure 10. Photograph showing road point RP8 which is turnout that needs trees to be removed from the inboard ditch and to be regraded.*

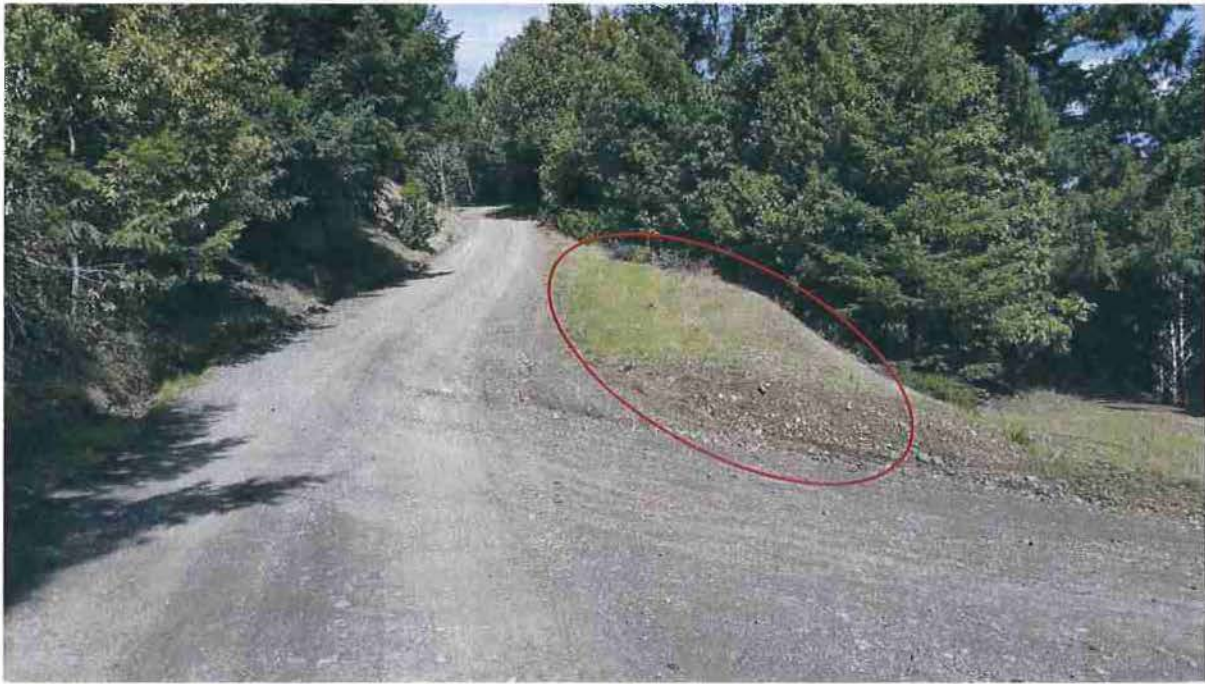
*Figure 11. Photograph showing road point RP9 which is a pullout at an intersection that needs to be regraded to make the transition into the intersection smoother.*

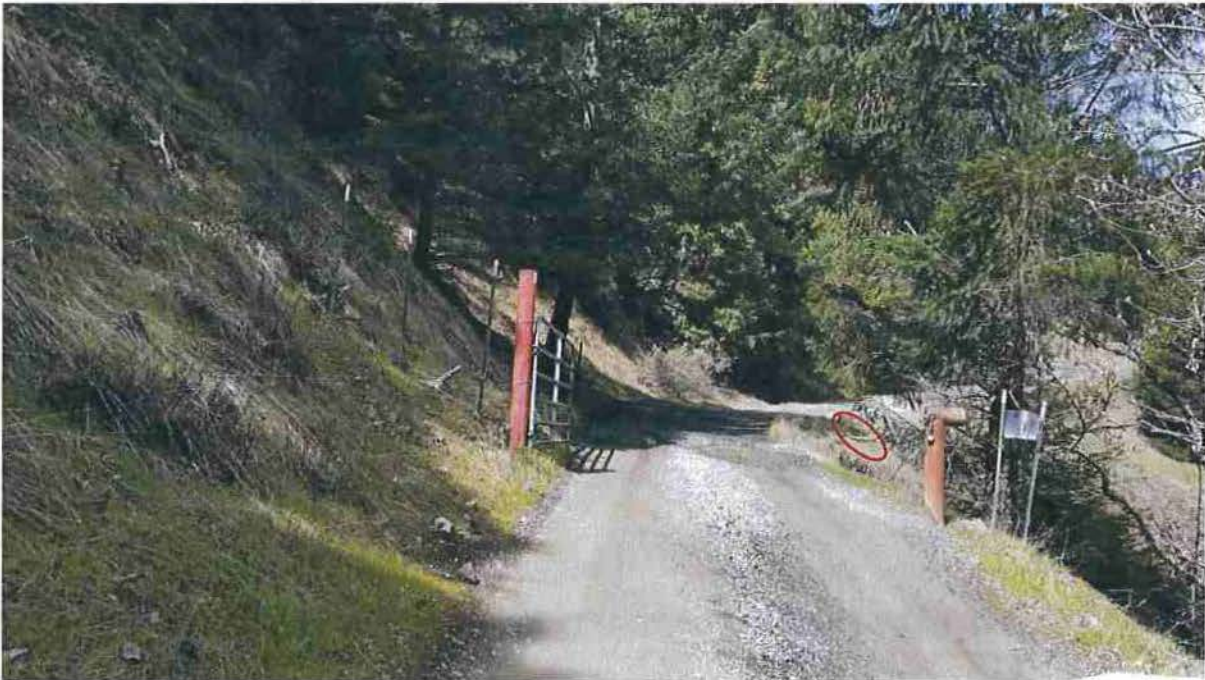
*Figure 12. Photograph showing road point RP11 is a gate with pullout on either side. On the east side of the gate is drainage relief culvert that needs to be extended by approximately 10' (RP10)*

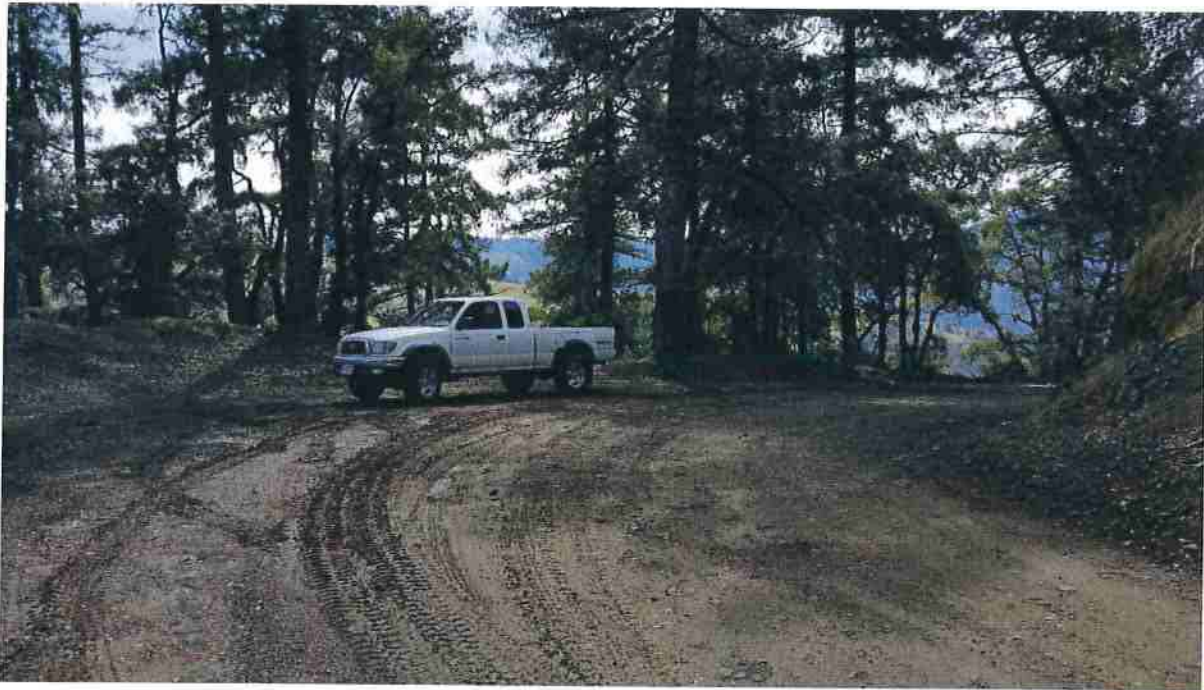
*Figure 13. Photograph showing road point RP12 which is a good pullout.*

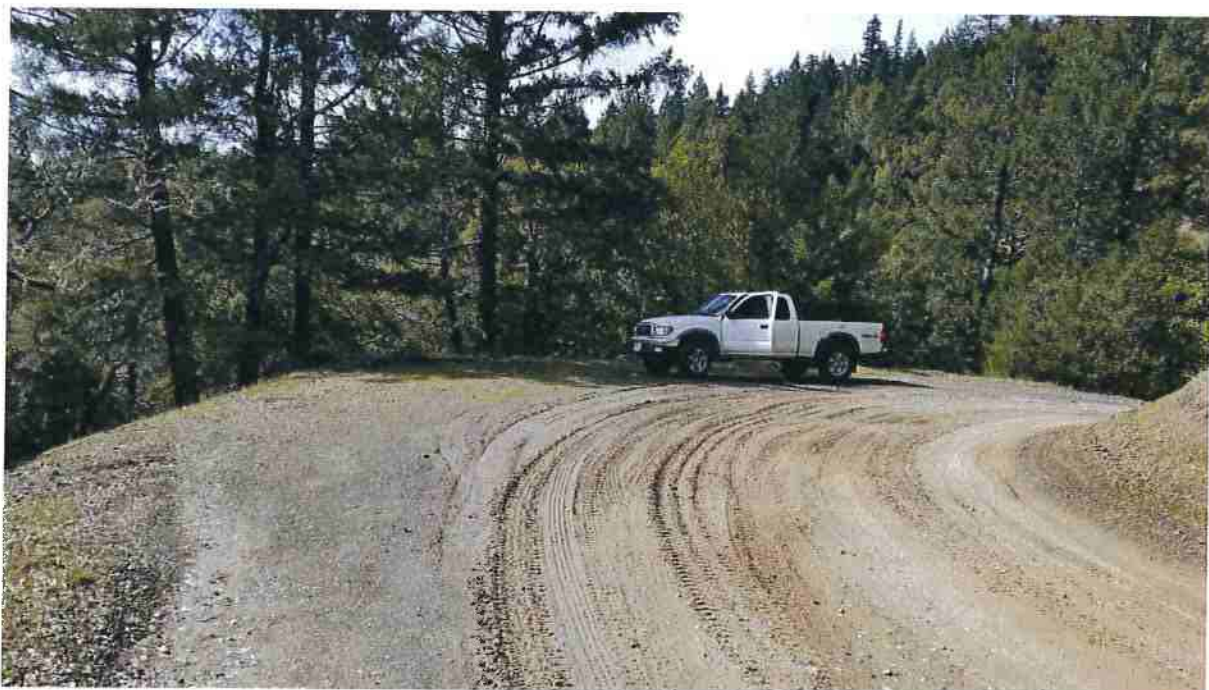
*Figure 14. Photograph showing road point RP13 which is a good pullout.*

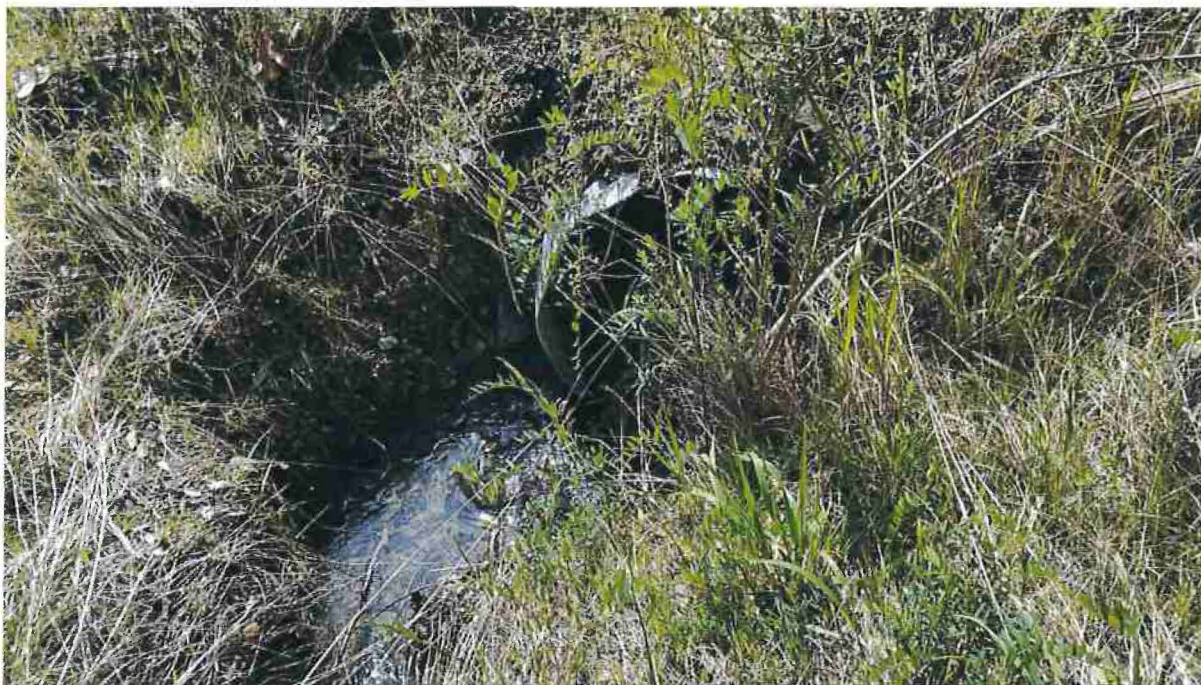
*Figure 17. Photograph showing road point RP16 which is a 24 inch culvert on a class III watercourse that needs debris cleared from the inlet. The culvert is in good condition..*

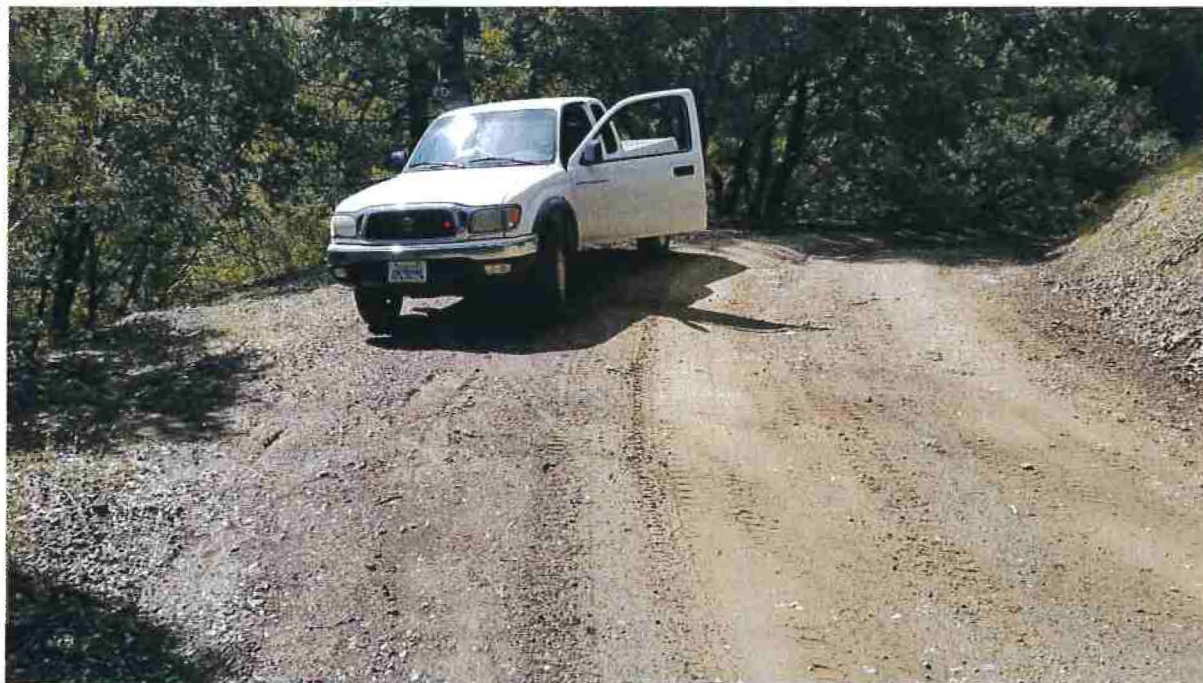
*Figure 18. Photograph showing road point RP17 which is a good pullout.*

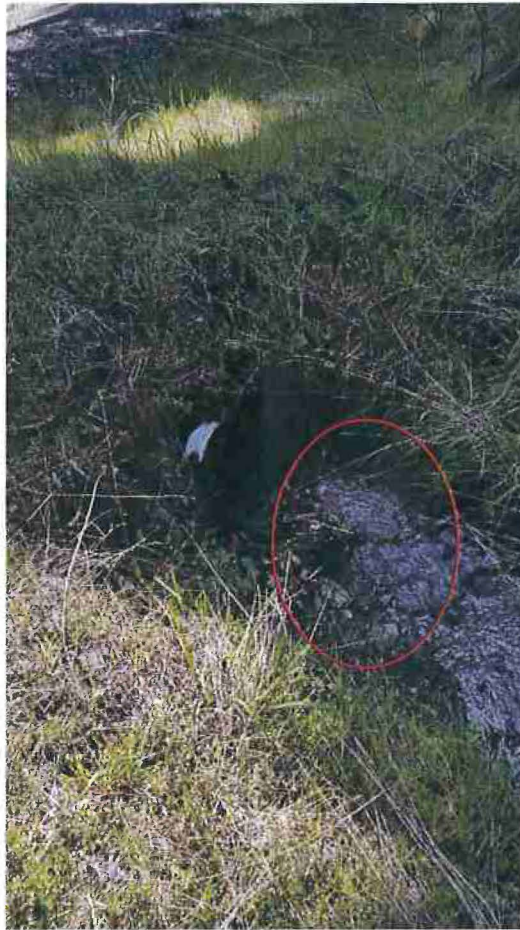
**Figure 19.** Photograph showing road point RP18 which is a 24 inch culvert on a class III watercourse that needs debris cleared from the inlet. The culvert is in good condition.

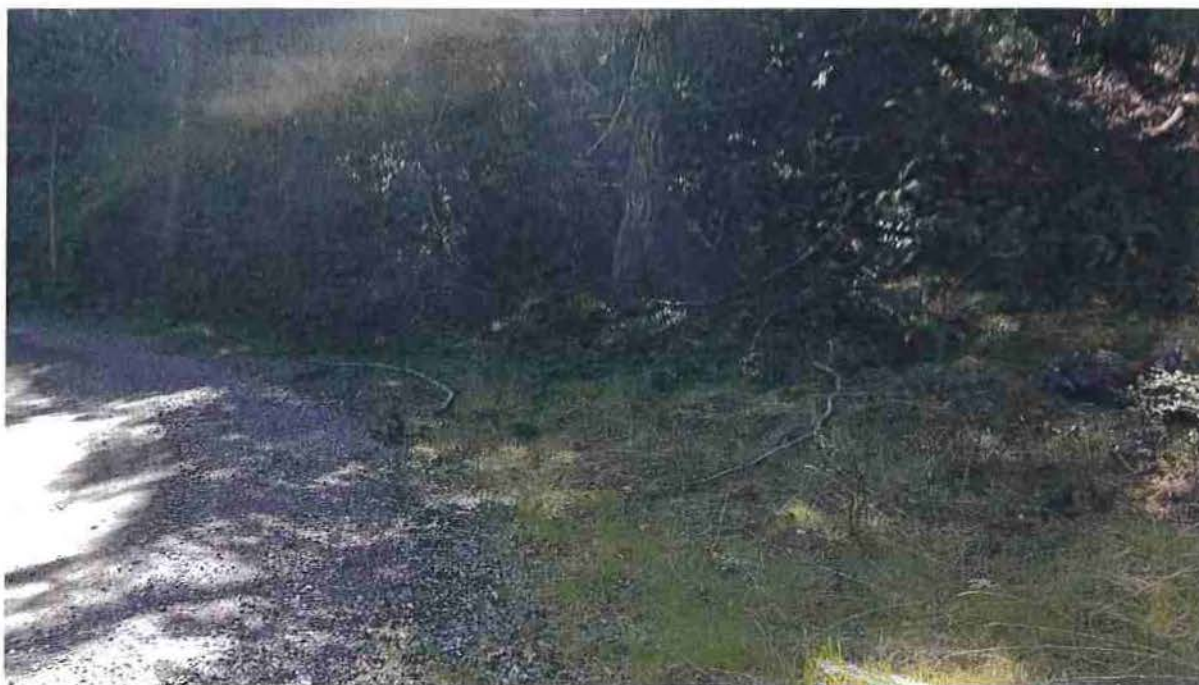
*Figure 20. Photograph showing road point RP19 which a good pullout next to a class III watercourse.*

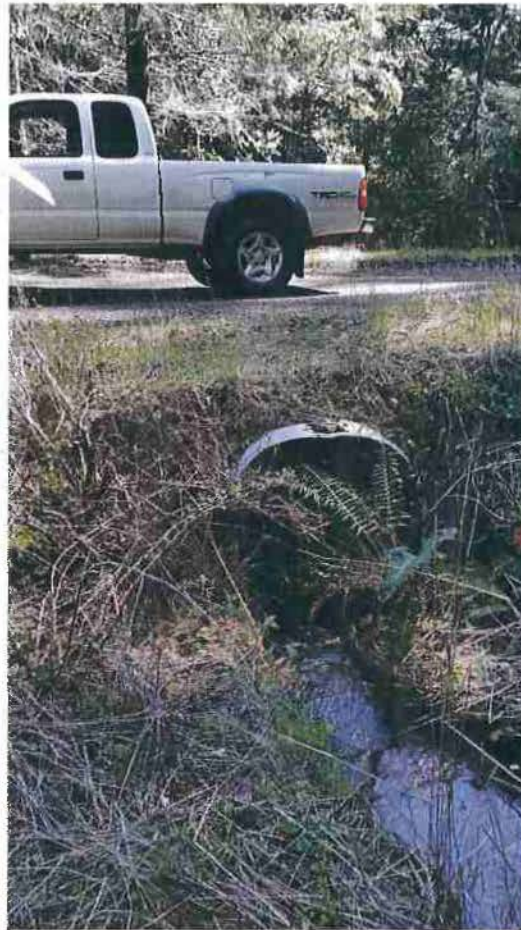
*Figure 22. Photograph showing road point RP21 which is a 48 inch culvert on a class II watercourse in good condition.*

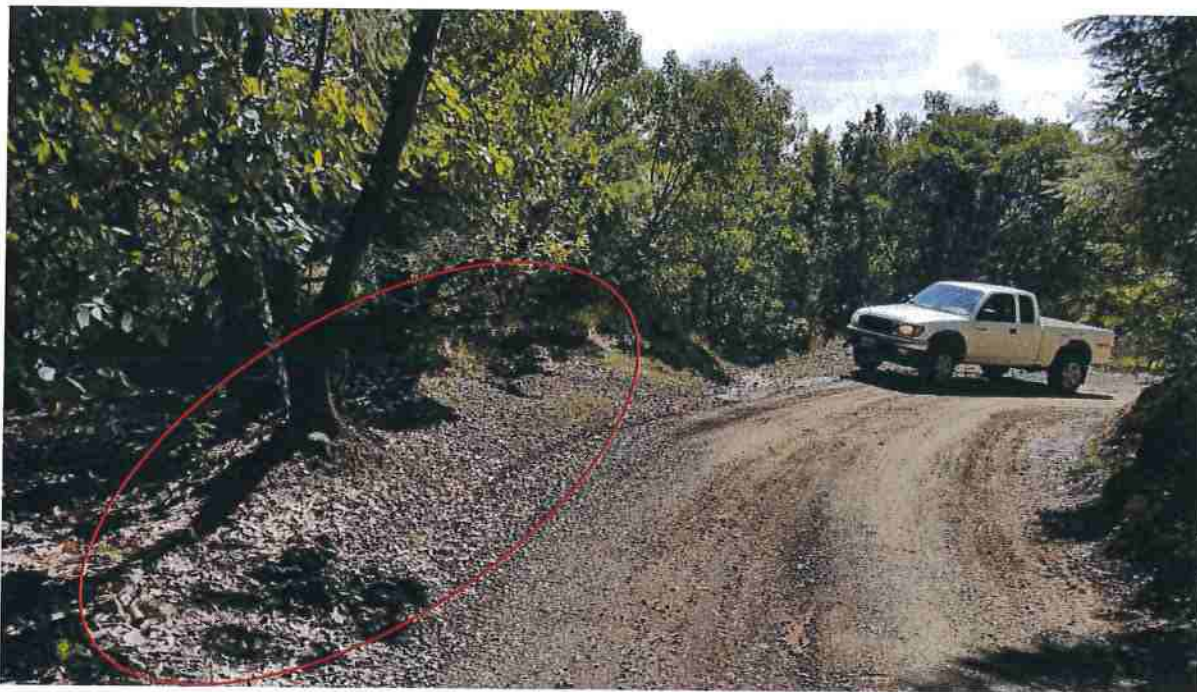
*Figure 23. Photograph showing road point RP22 which is a pullout that needs a two tree to be removed and to be regraded.*

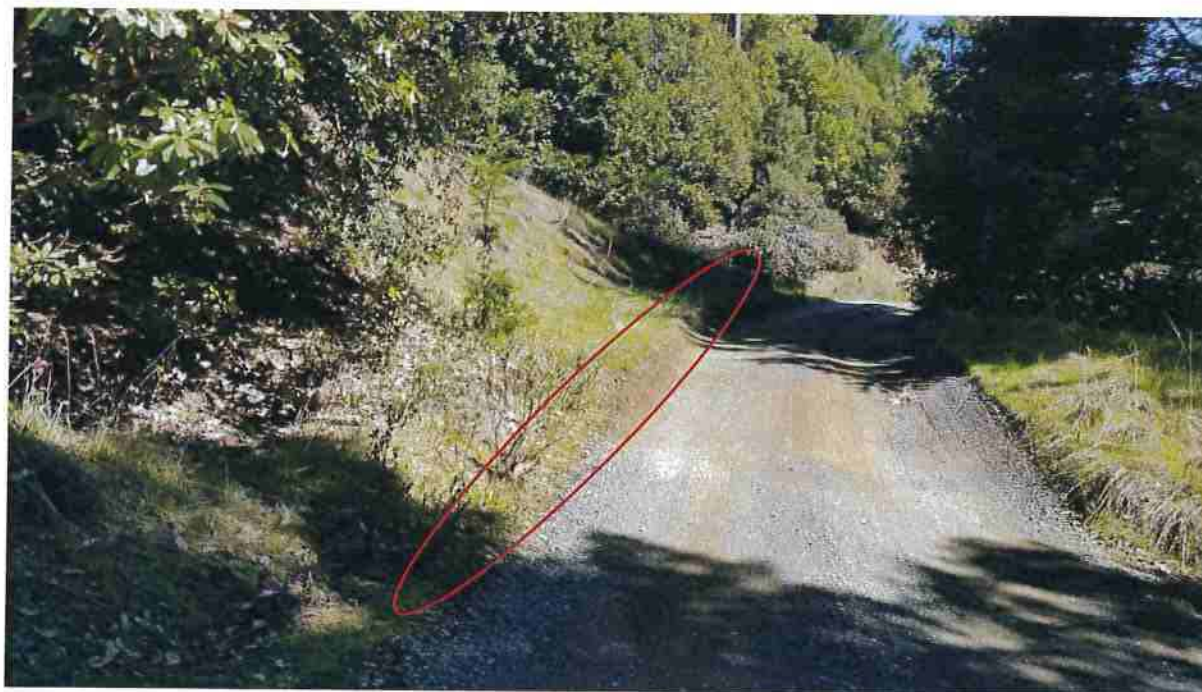
*Figure 24. Photograph showing road point RP23 which is a section of roadway that needs to be regraded. Regrading needs to widen the roadway and re-establish an inside ditch.*

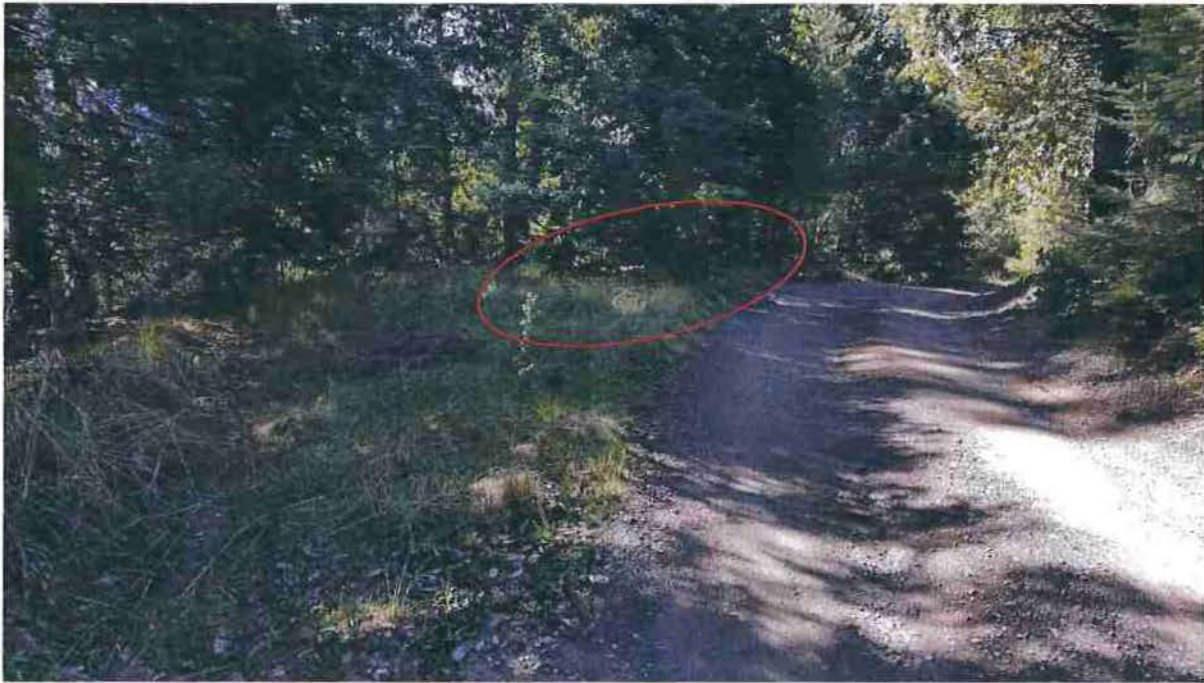
*Figure 25. Photograph showing road point RP24 which is a pullout that needs brush to be cleared and to be regraded.*

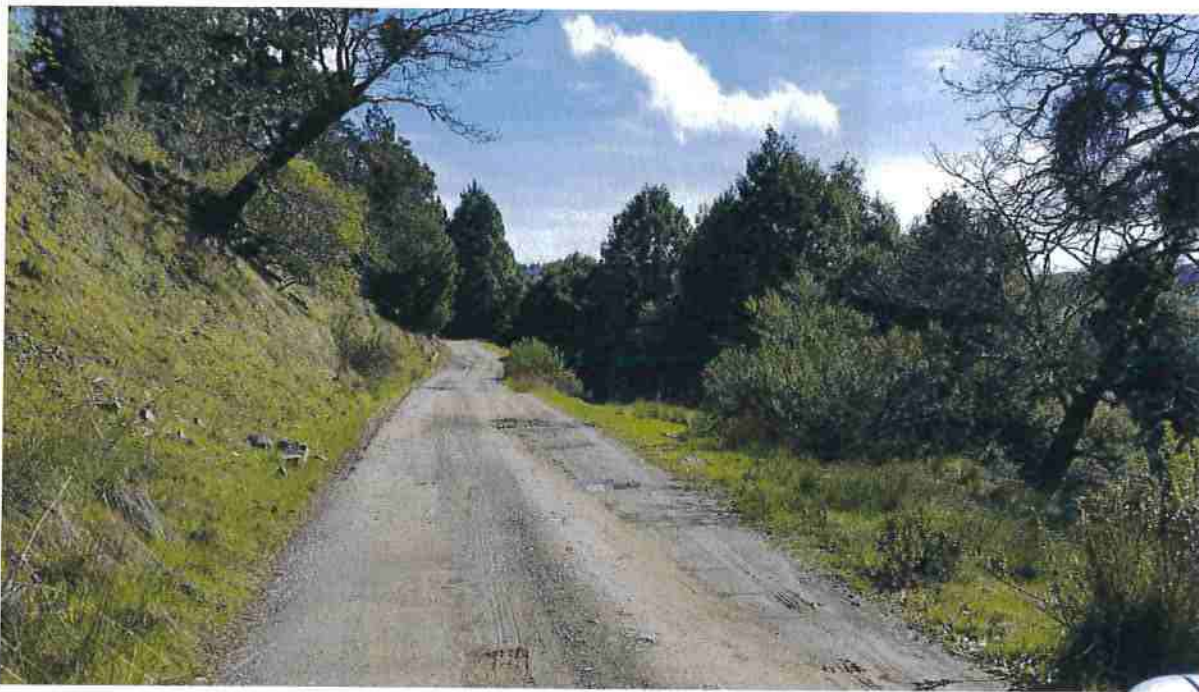
*Figure 27. Photograph showing road point RP25, a good pullout north-east of a narrow section of roadway (RP26).*

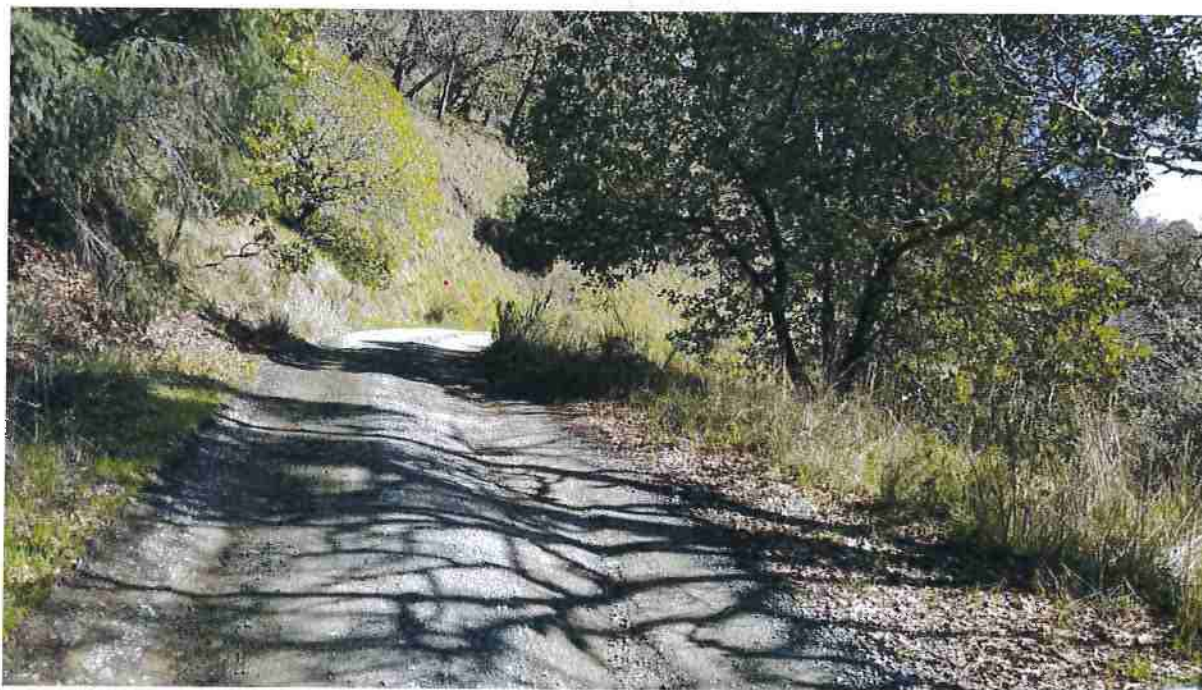
*Figure 28. Photograph showing road point RP26 where the roadway has a narrow section. There is a good pullouts on both sides of the narrow section (RP25 and RP 28, each having good visibility of the roadway leading the narrow point.*

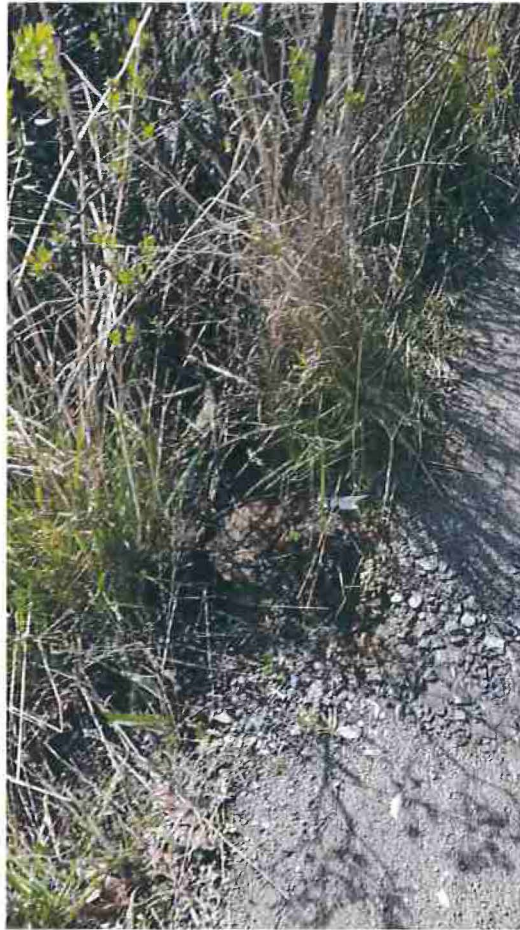
**Figure 29.** Photograph showing road point RP27 which is a failing culvert that drains a class II stream/spring area below a water tank. The culvert needs to be replaced which will require a 1600 and additional permitting.

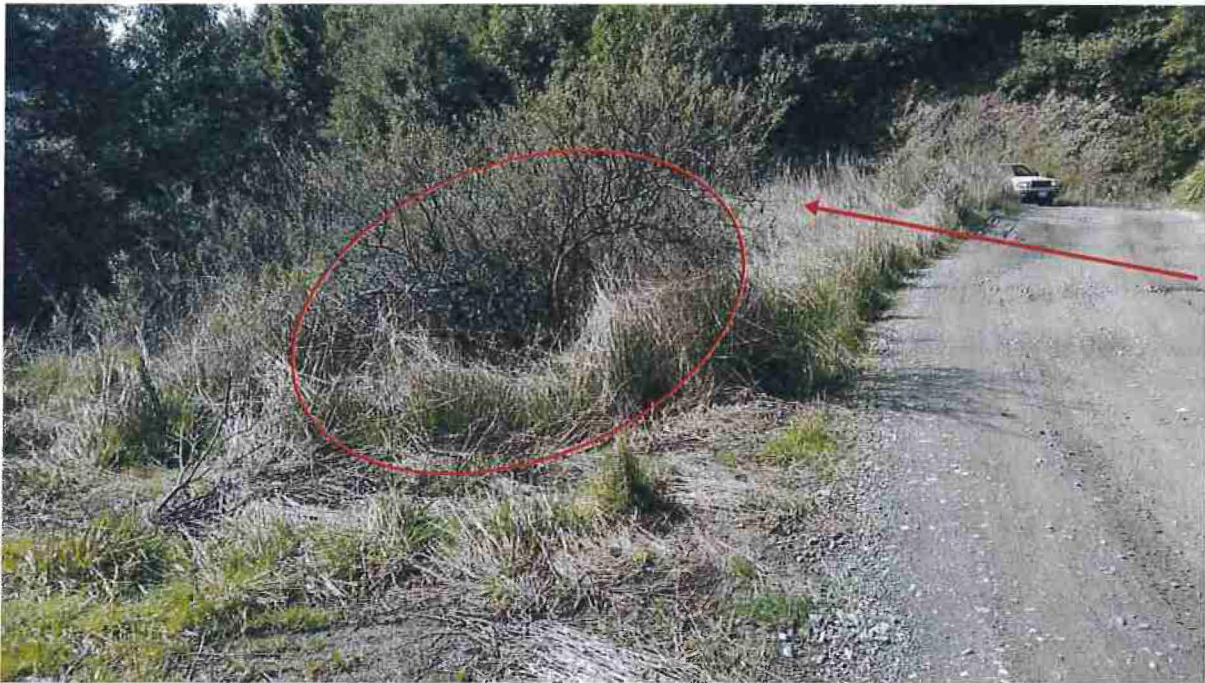
*Figure 30. Photograph showing road point RP31 that is a pullout that needs brush to be cleared and regraded to create a turnout and a rolling dip to disconnect the roadway surface from the watercourse located at RP32.*

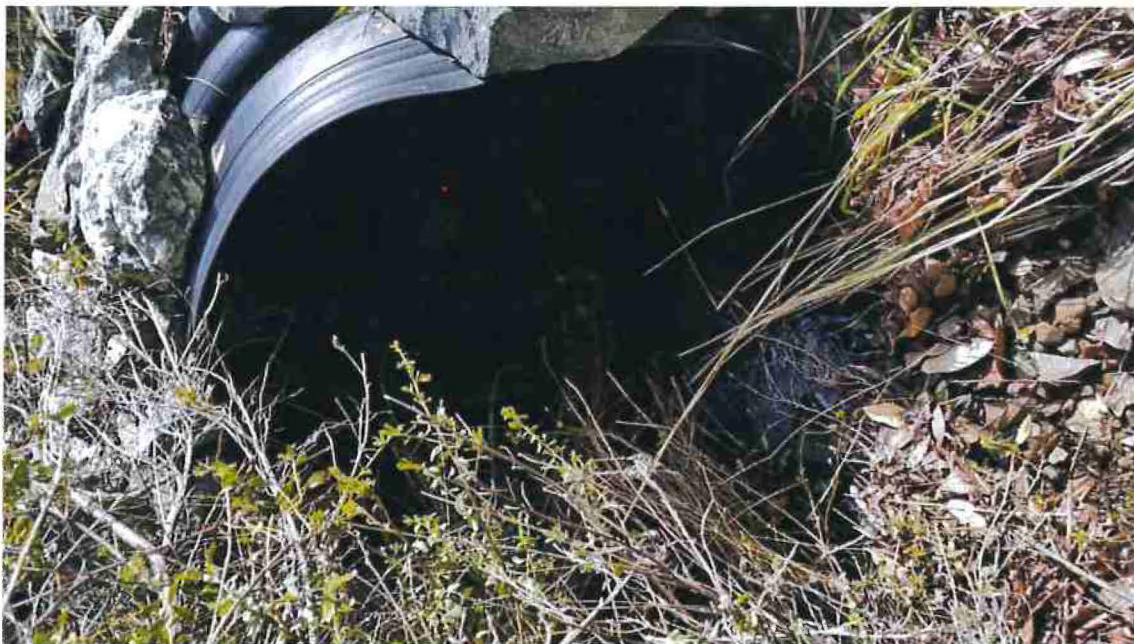
*Figure 31. Photograph showing road point RP32 showing a onstream culvert in good condition on a class II watercourse.*

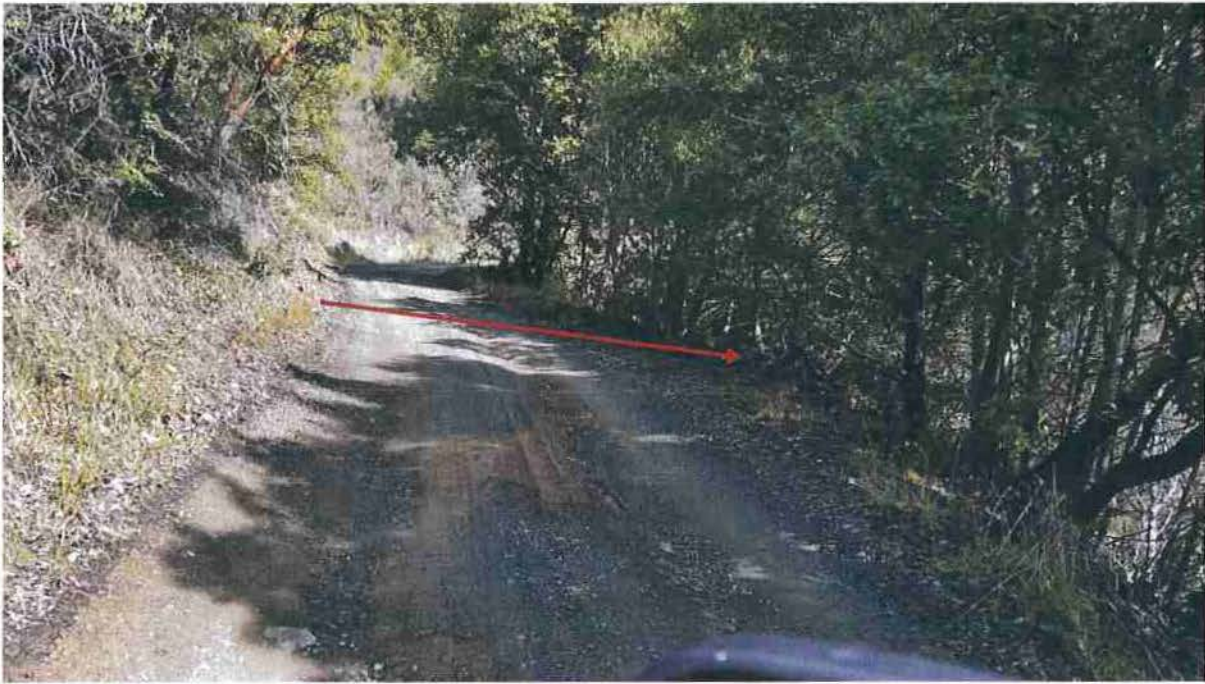
*Figure 32. Photograph showing road point RP34 where water is channelizing on the roadway surface. A rolling dip needs to be created to divert the concentrated roadway runoff off of the roadway surface.*
