# **HUMBOLDT COUNTY ROADWAY EVALUATION REPORT**

**SITE ACCESS ROAD**

**Private Drive  
Garberville, California**

**April, 2019  
Josh McKnight, P.E.  
Job #1363.01**

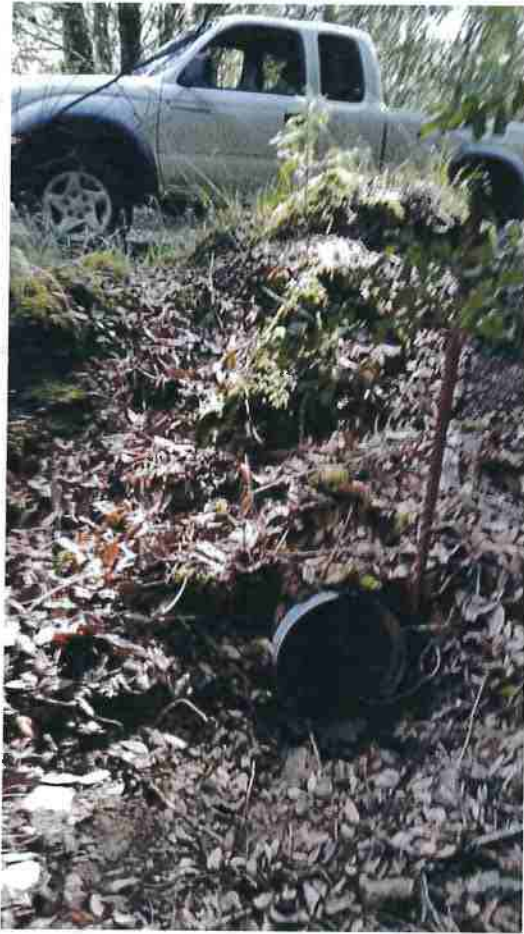
*Figure 33. Photograph showing road point RP35 is a 12" culvert in good condition on a class III watercourse*

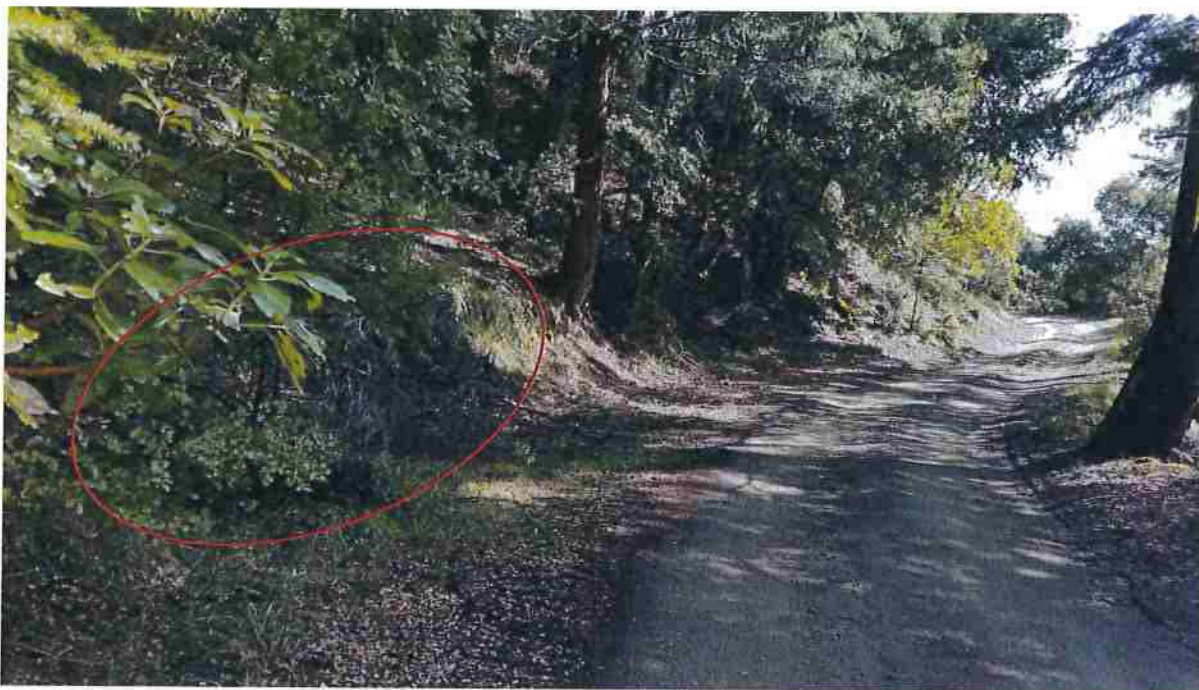
*Figure 36. Photograph showing road point RP38 where a pullout needs brush cleared.*

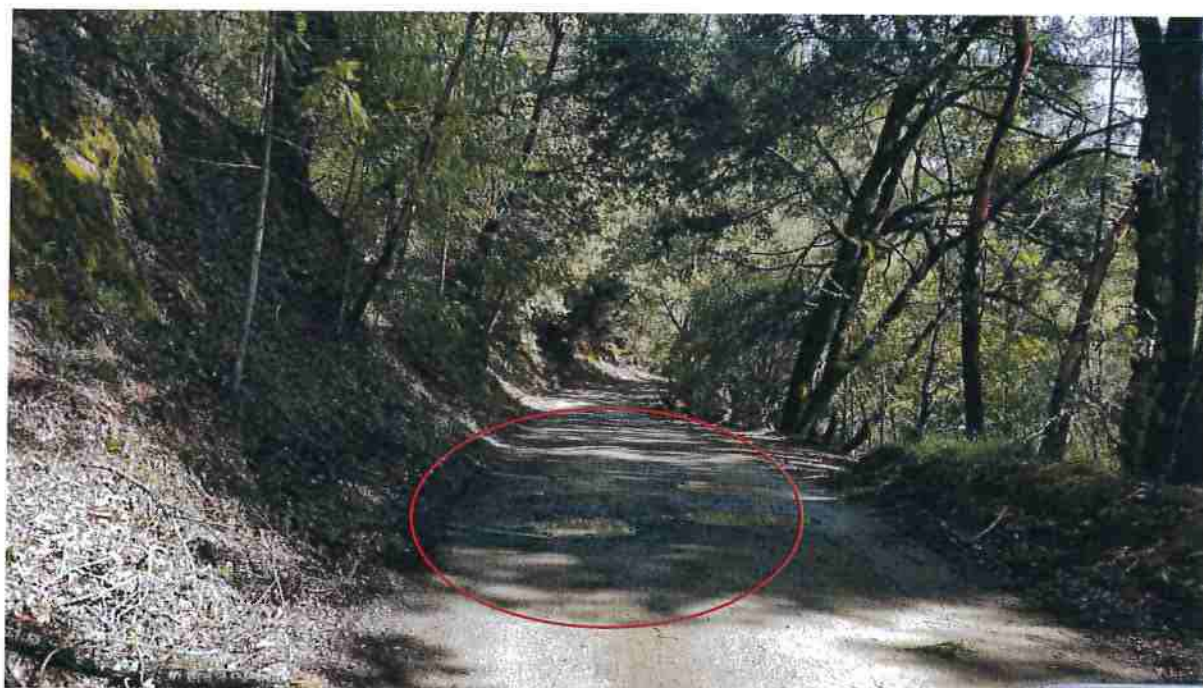
*Figure 37. Photograph showing road point RP39 where the roadway has pot-holes. The roadway surface needs to be regraded in this.*

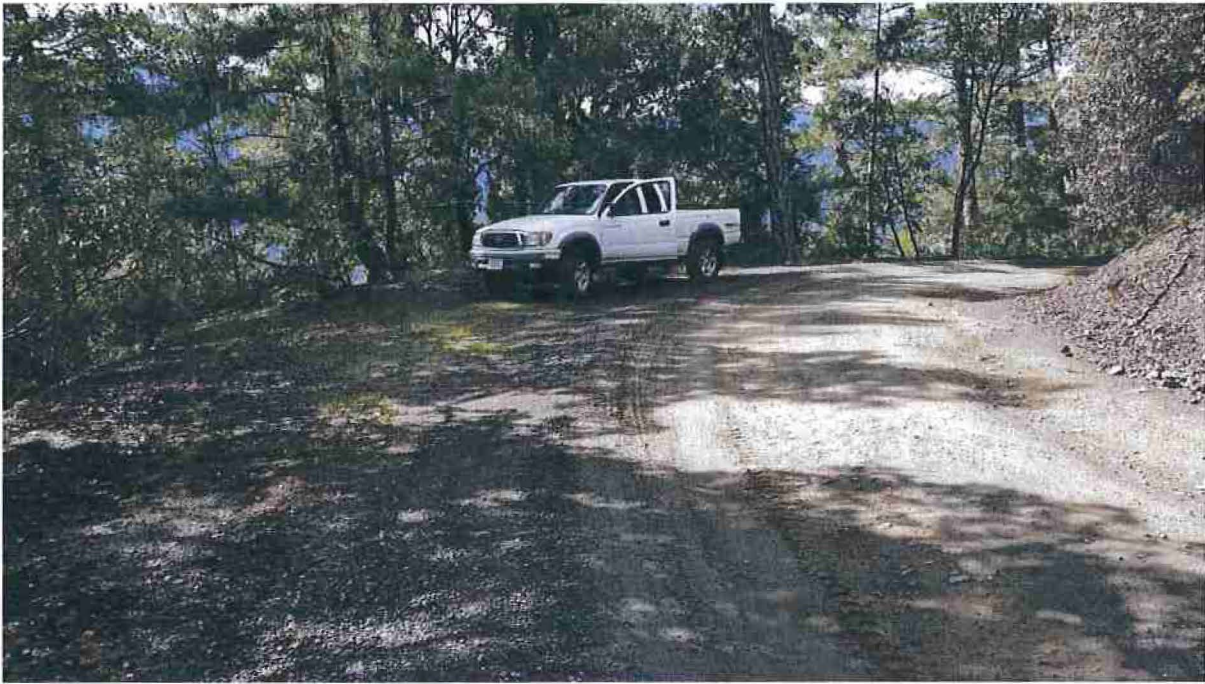
*Figure 38. Photograph showing road point RP40 which is a good pullout.*

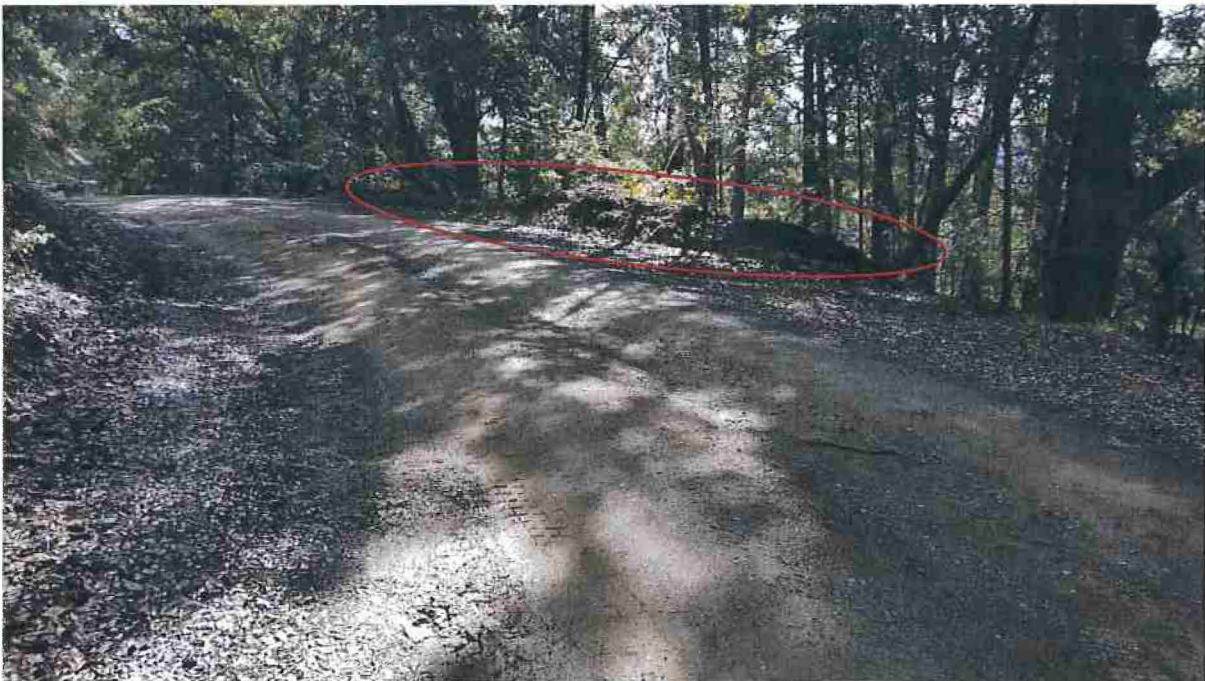
*Figure 39. Photograph showing road point RP41 where a pullout needs to be expanded by grading the outside berm back onto the roadway.*

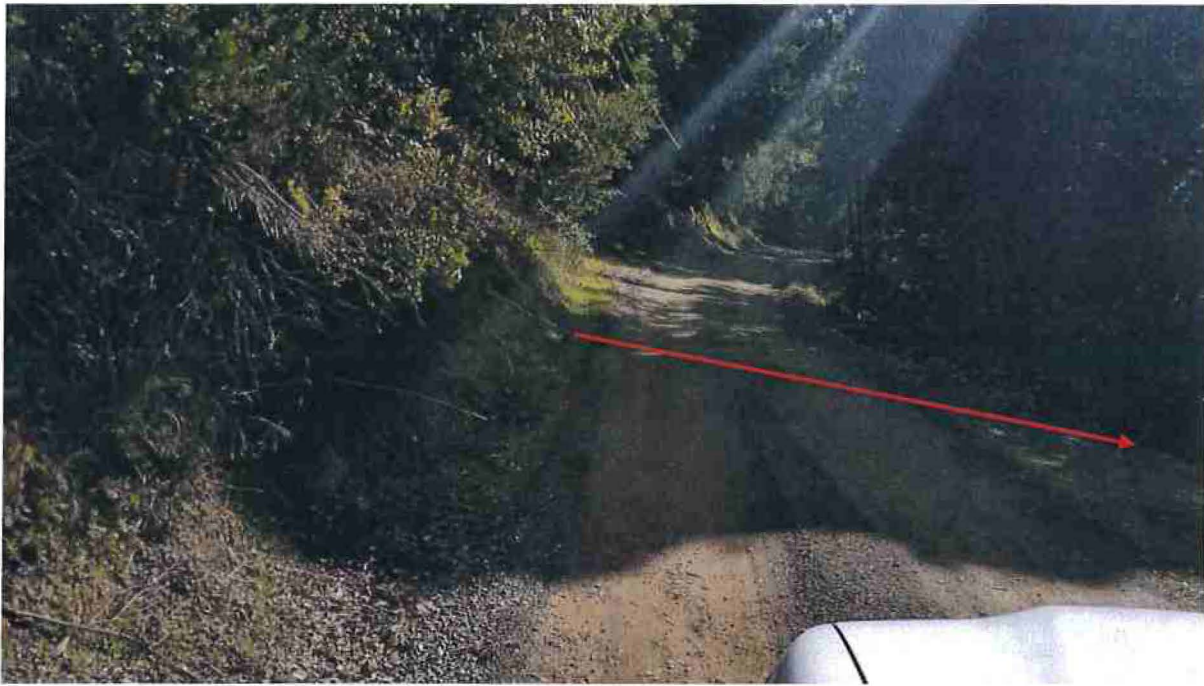
**Figure 40.** Photograph showing road point RP43 where a rolling dip needs to be created to disconnect the roadway surface from the watercourse approximately 100' south-west of RP43.

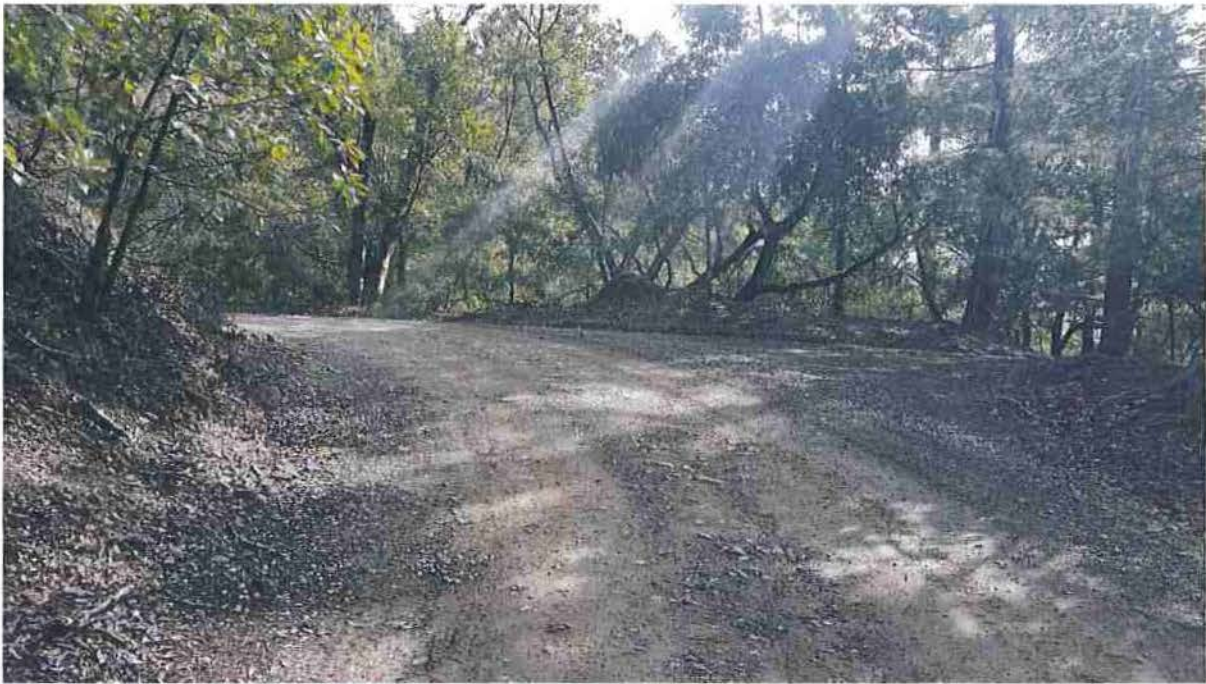
*Figure 42. Photograph showing a good pullout located at road point RP45.*

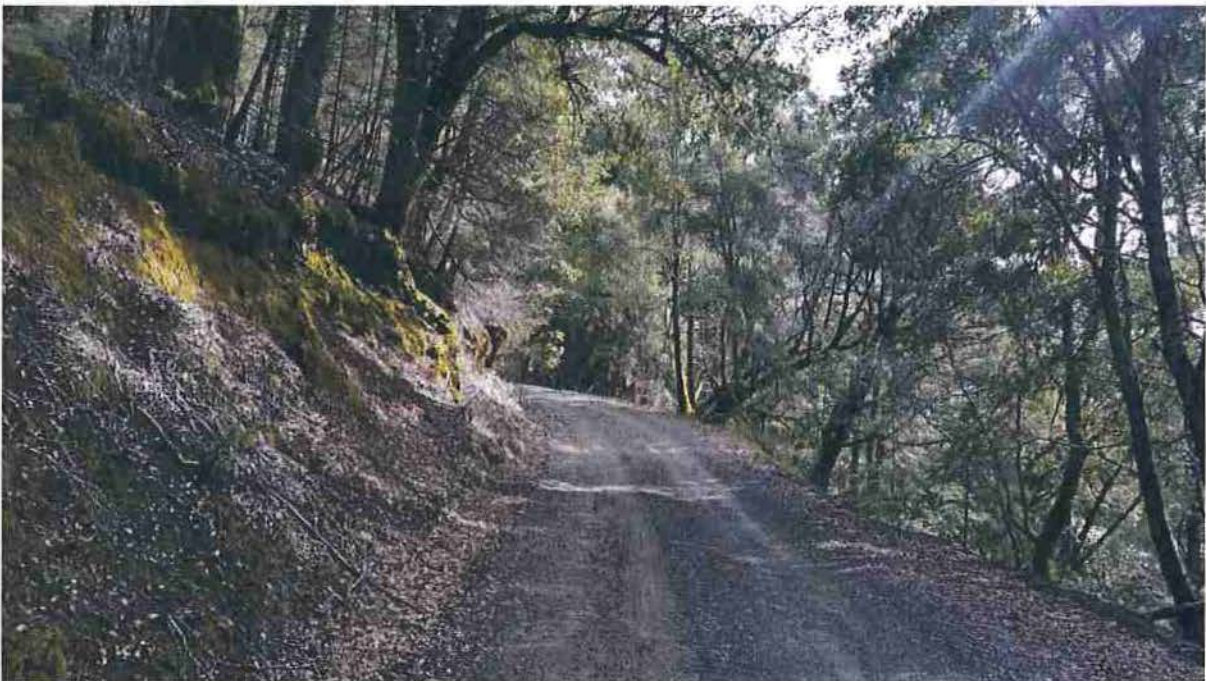
*Figure 43. Photograph showing narrow section of roadway located at RP46.*

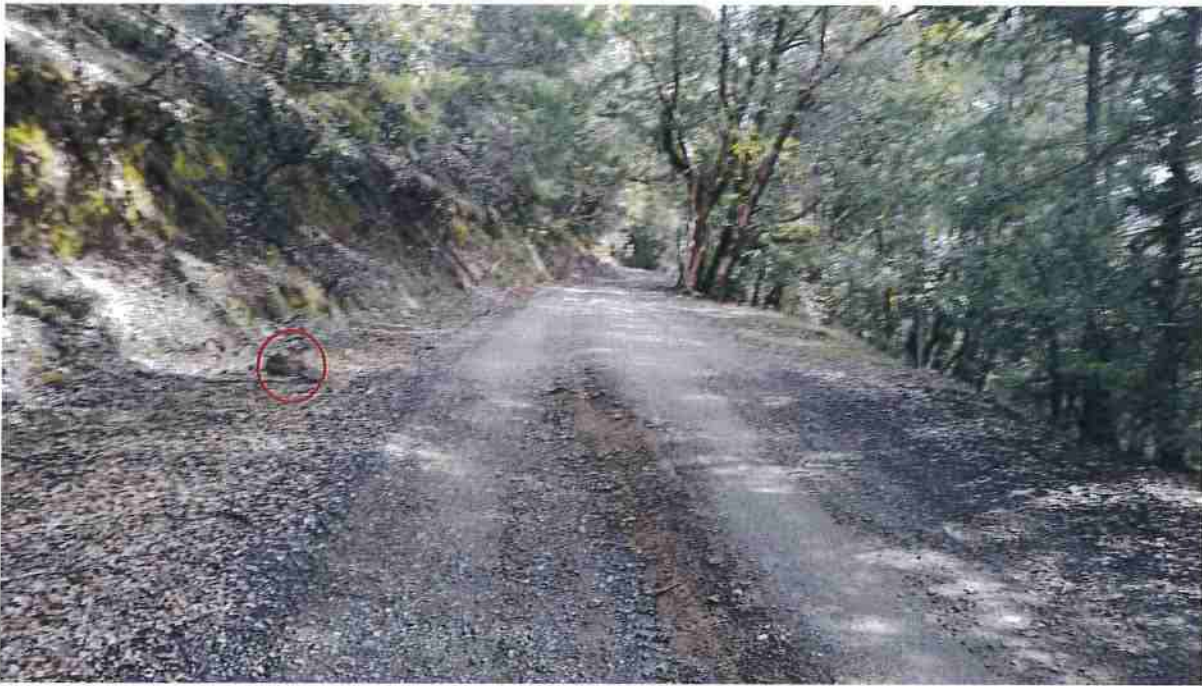
*Figure 44. Photograph showing a pullout located at road points RP47 with a rock that needs to be cleared from the pullout..*

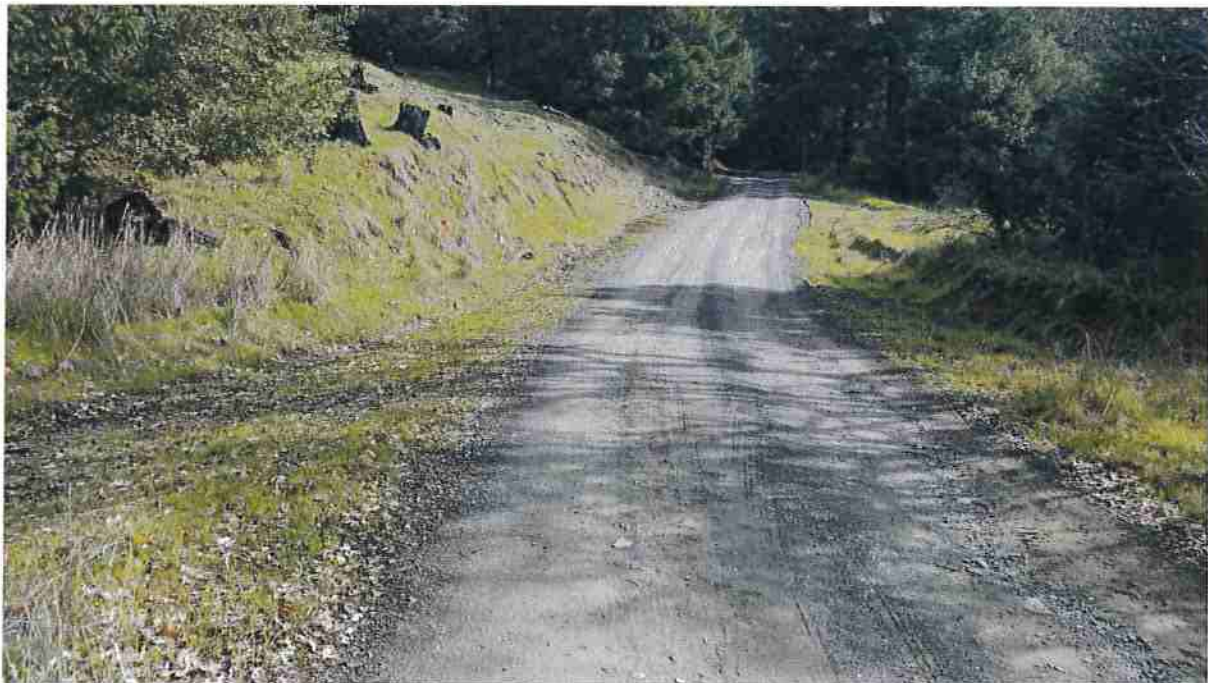
*Figure 45. Photograph showing a pullout and gate located at road points RP50 and RP49.*

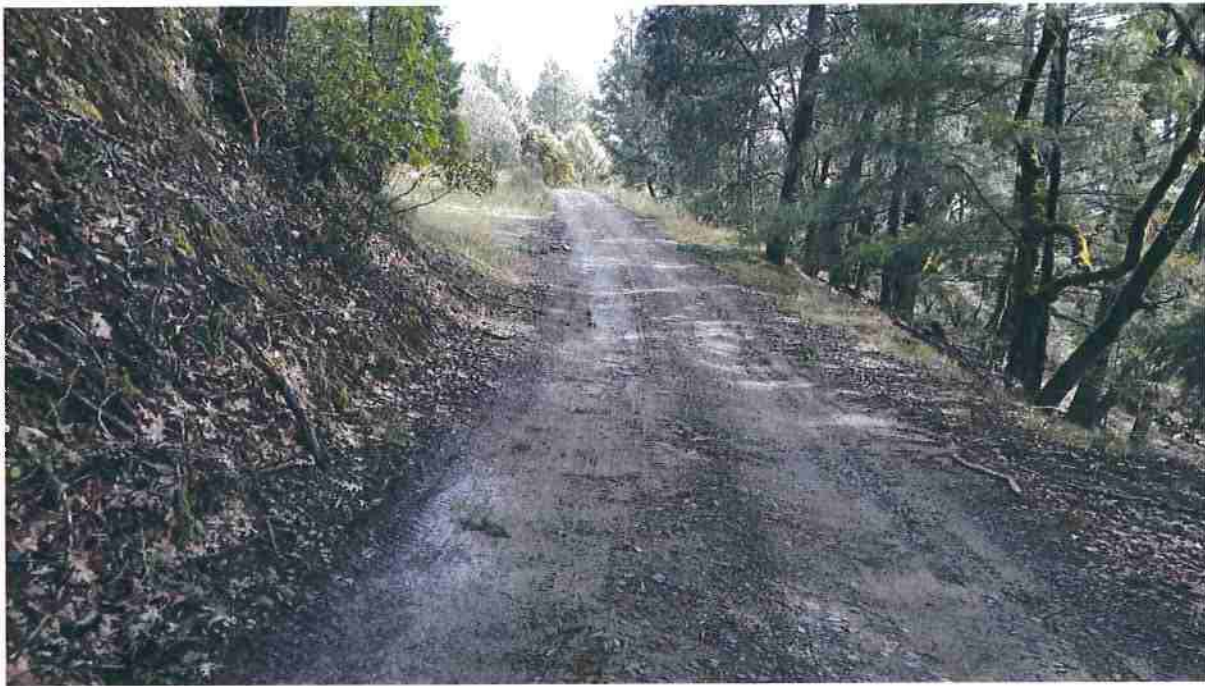
*Figure 46. Photograph showing a steep section of roadway where the road slope is between 16 and 20% Located between RP51 and RP50. The slope is short and there are good pullouts on either side of the steep short steep section. The pullout located at RP51 can be seen on the left just before the steep section.*

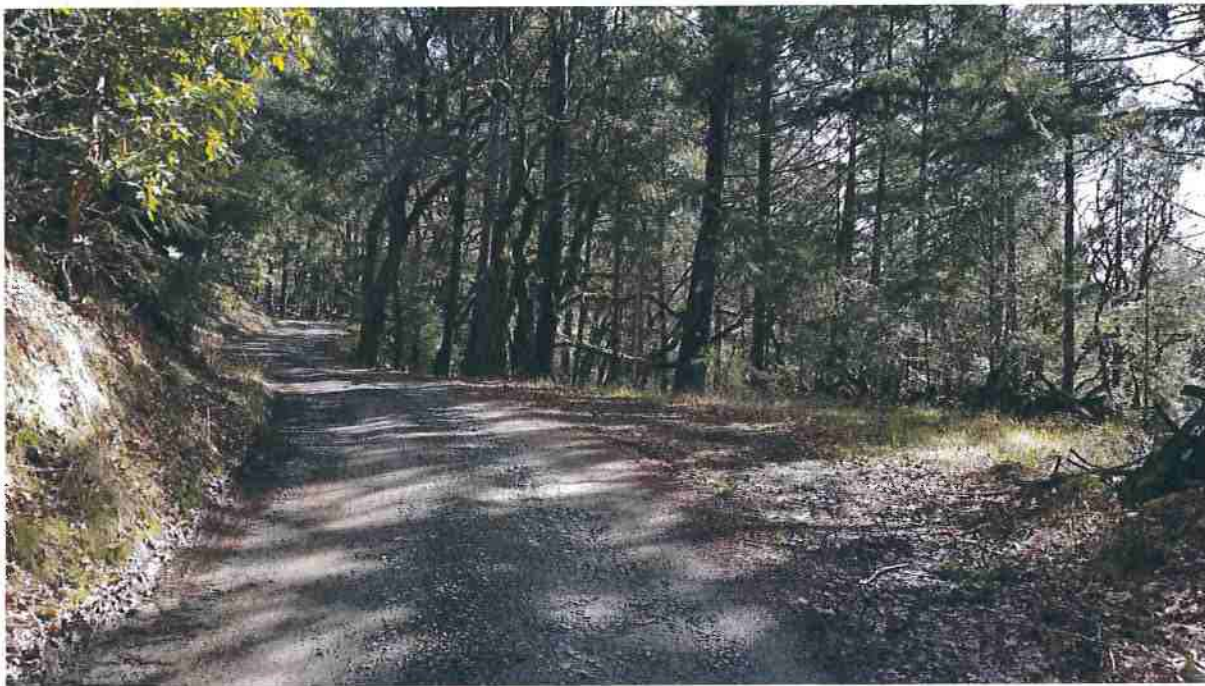
*Figure 47. Photograph showing a pullout located at road point RP52.*

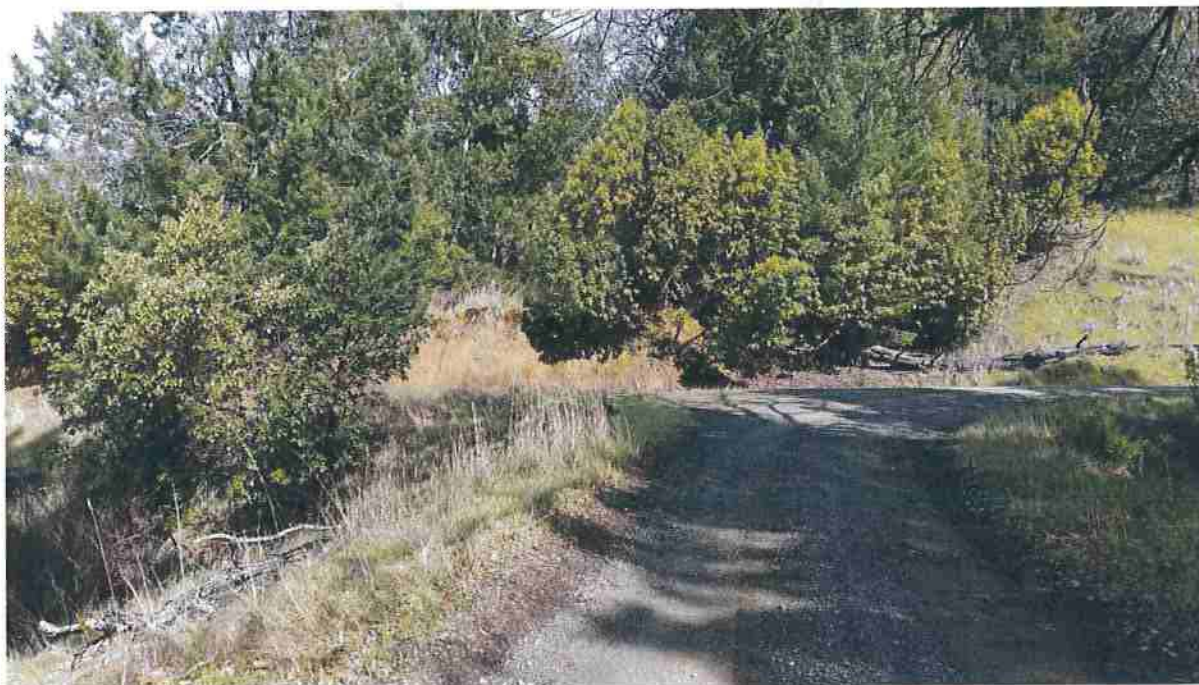
*Figure 49. Photograph showing a pullout above the gate at the intersection of Little Buck Mountain Road and the Private Driveway, located at road point RP54.*

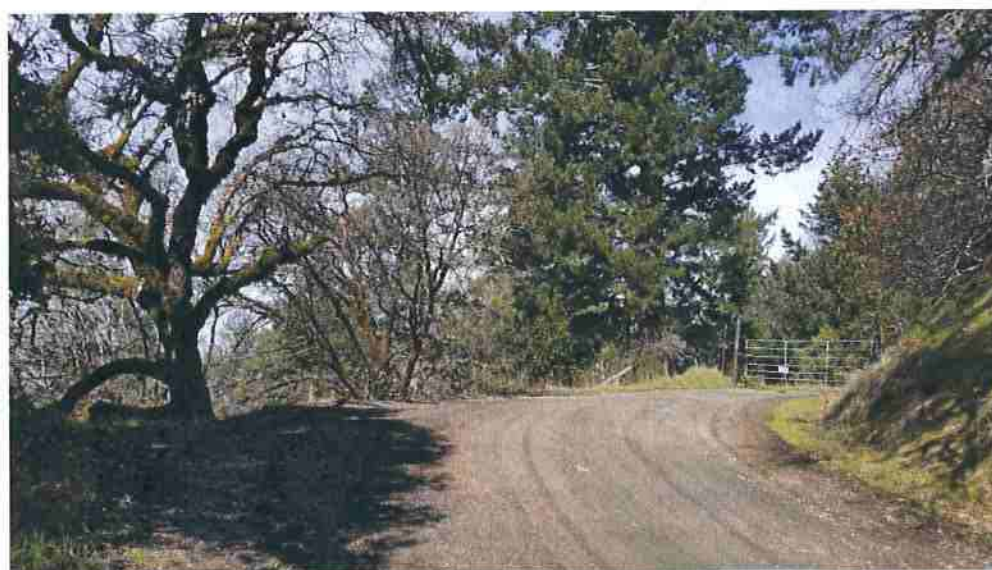
*Figure 50. Photograph showing a pullout below the gate located at road point RP55.*

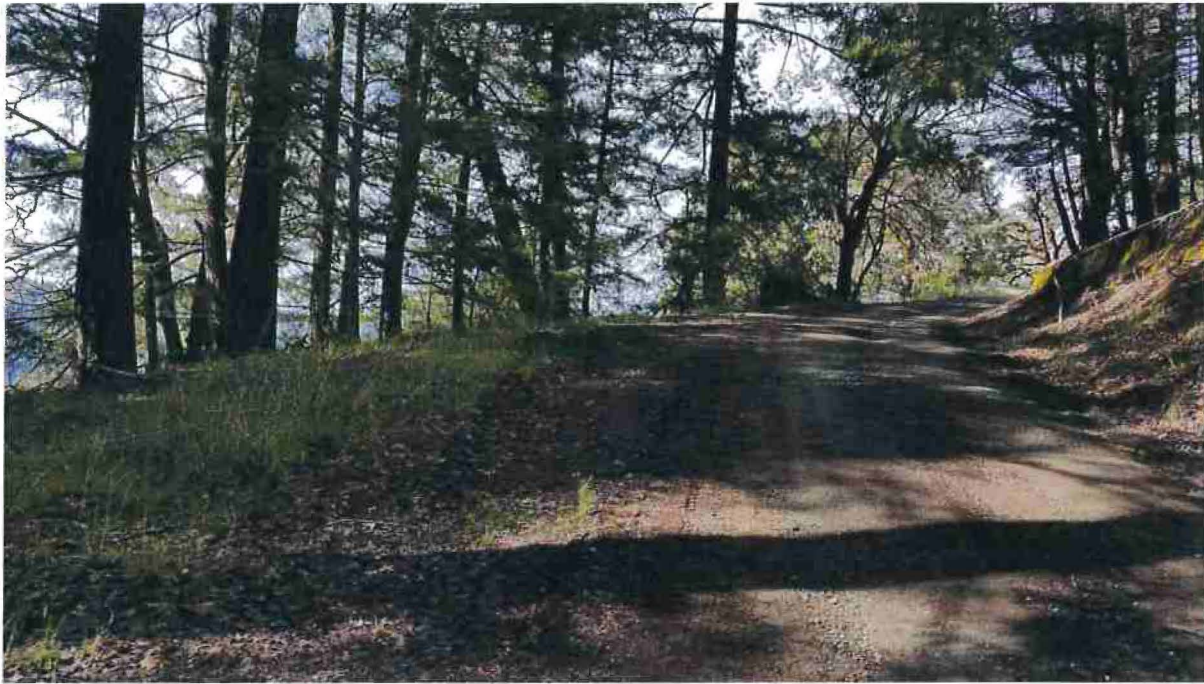
*Figure 51. Photograph showing a pullout at road point RP56.*

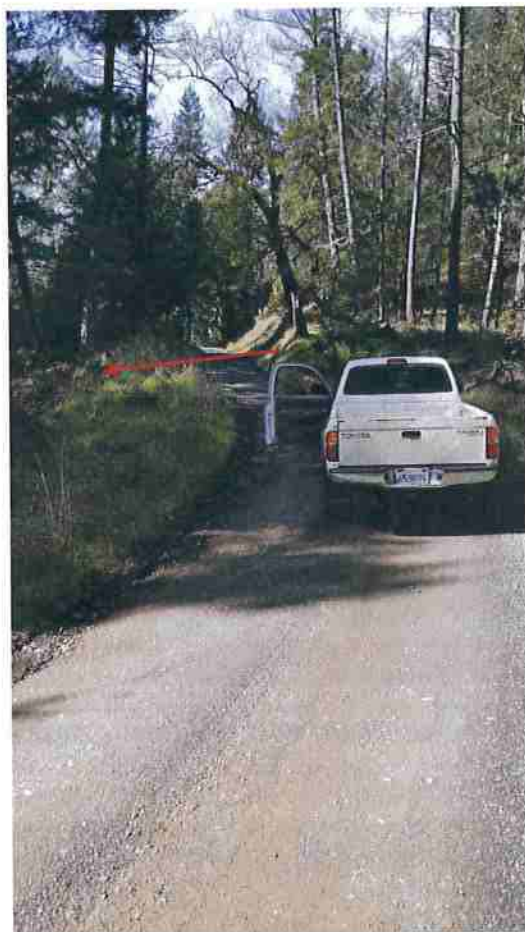
*Figure 53. Photograph showing concentrated flow on the roadway surface at road point RP58. A rolling dip need to be installed to prevent concentrated flow on the roadway surface.*

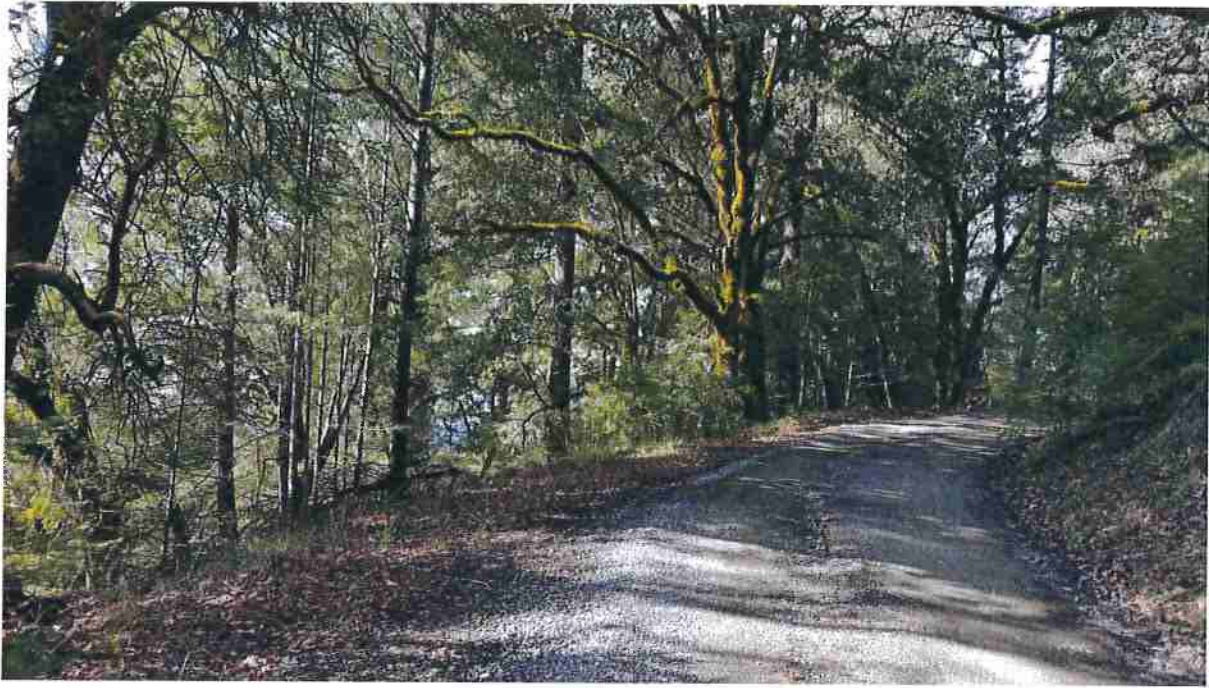
*Figure 54. Photograph showing a pullout at road point RP59.*
