# NILSEN REAL ESTATE APPRAISALS

November 25, 2024

**Re: Vacant Retail Property  
4325 Broadway  
Eureka, CA 95503**

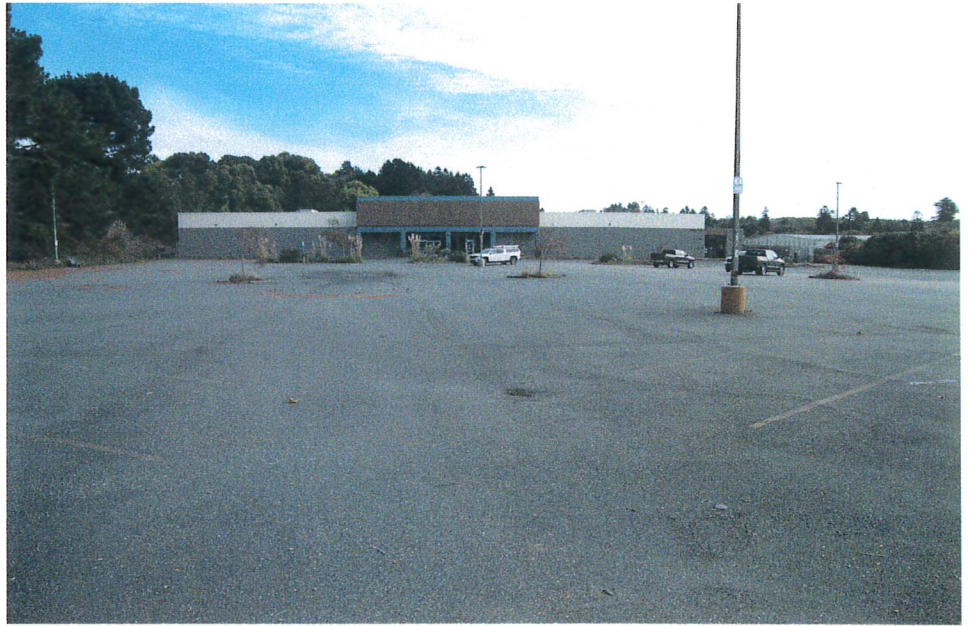
Farther to the north from previous picture along north side of paved off-street parking area. One of the drainage collection inlets is straight ahead. Notice multiple light standards throughout parking lot.

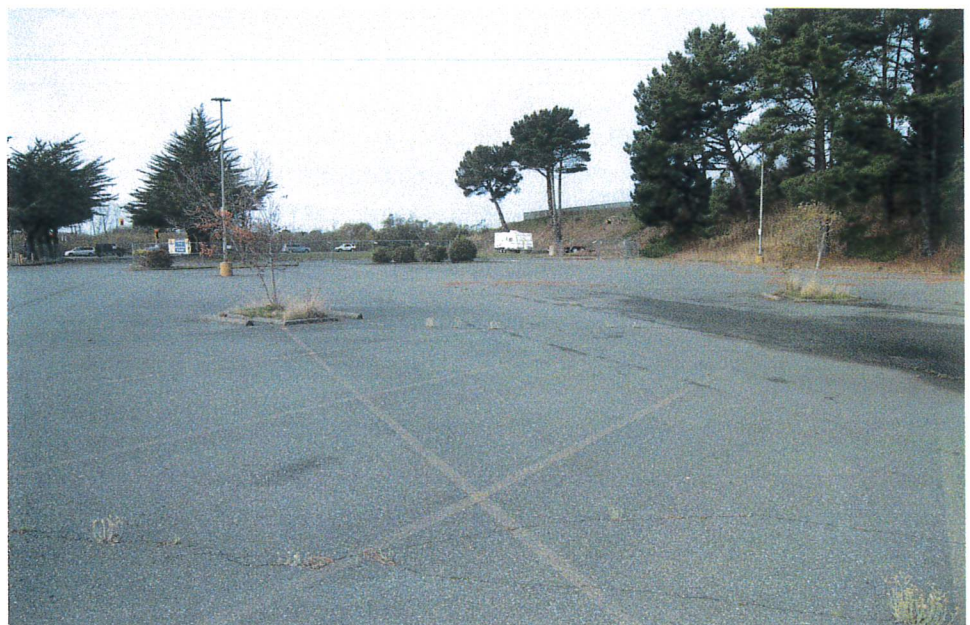
Looking northwest along northern portion of parking lot. Notice overall condition.

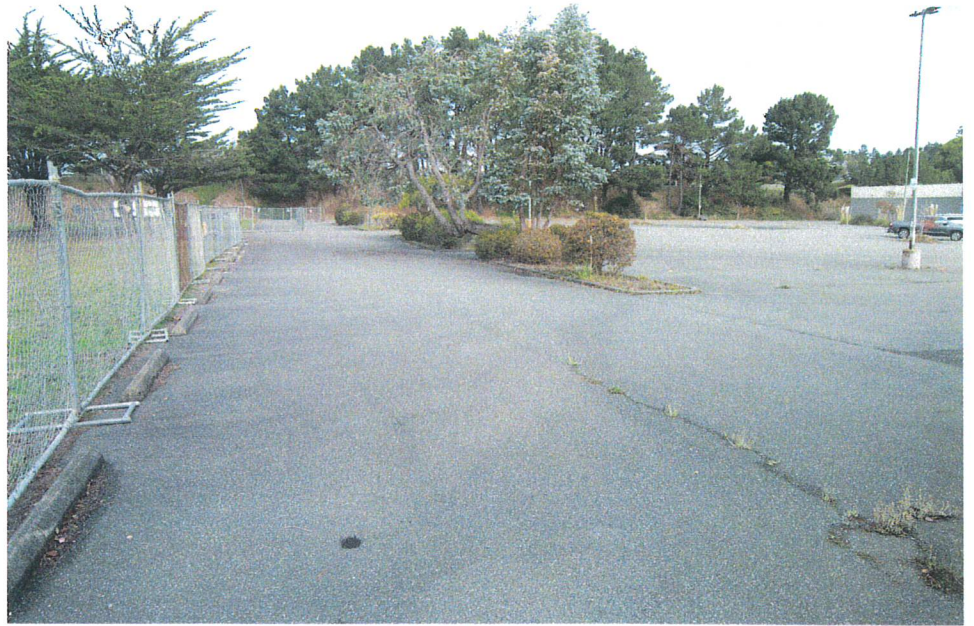
Looking north near southwest corner of overall property. One of the two out parcels is immediately to the left. Notice condition of landscaped islands farther to right.

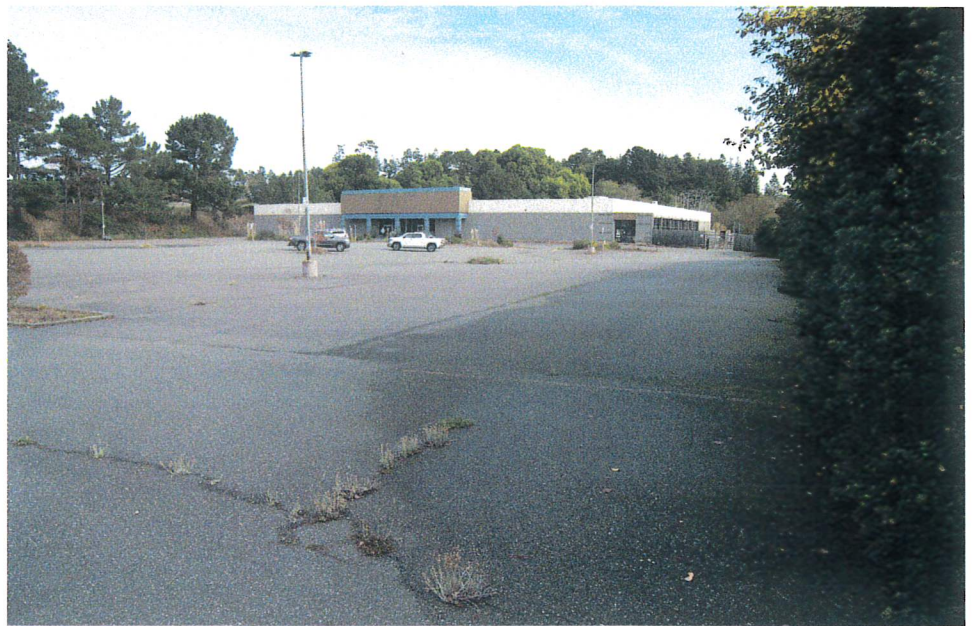
Looking easterly from previous picture with south side of paved driveway and parking lot straight ahead and to the left. Overgrown landscaping is to the right. The south boundary line is approximately 10' farther to right.

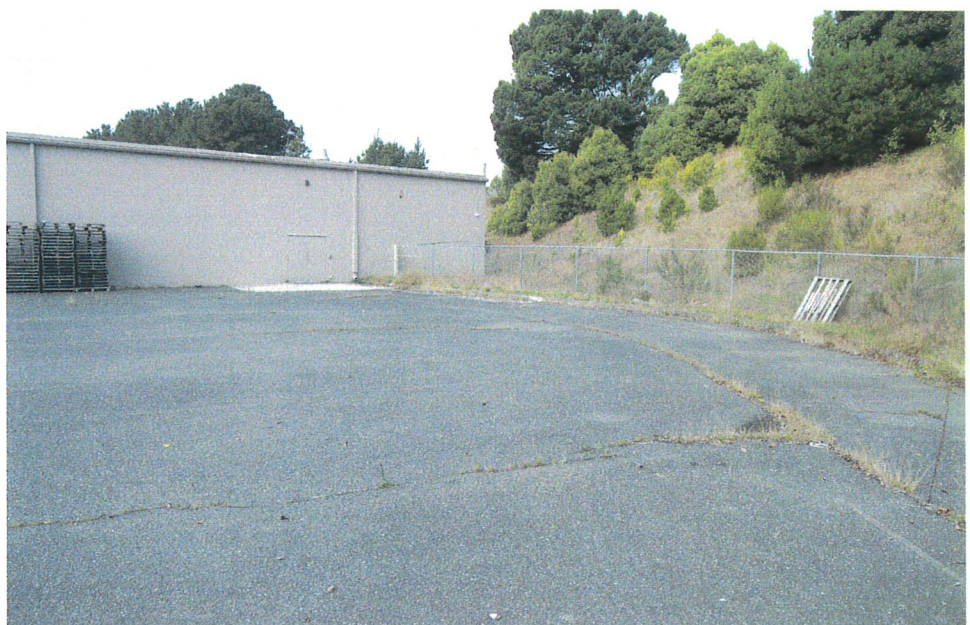
Looking northwest along north side of property. The north boundary line extends to the top of the embankment straight ahead and to the right.

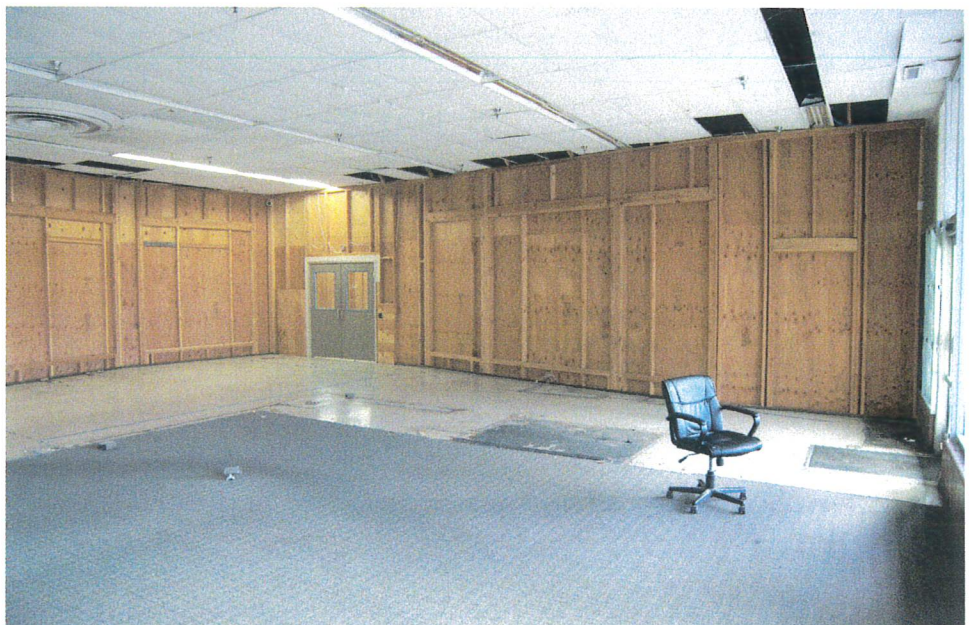
Looking southerly once entering the building. Notice newer installed wood walls at this location. Double wide doors straight ahead allow access to former open retail area.

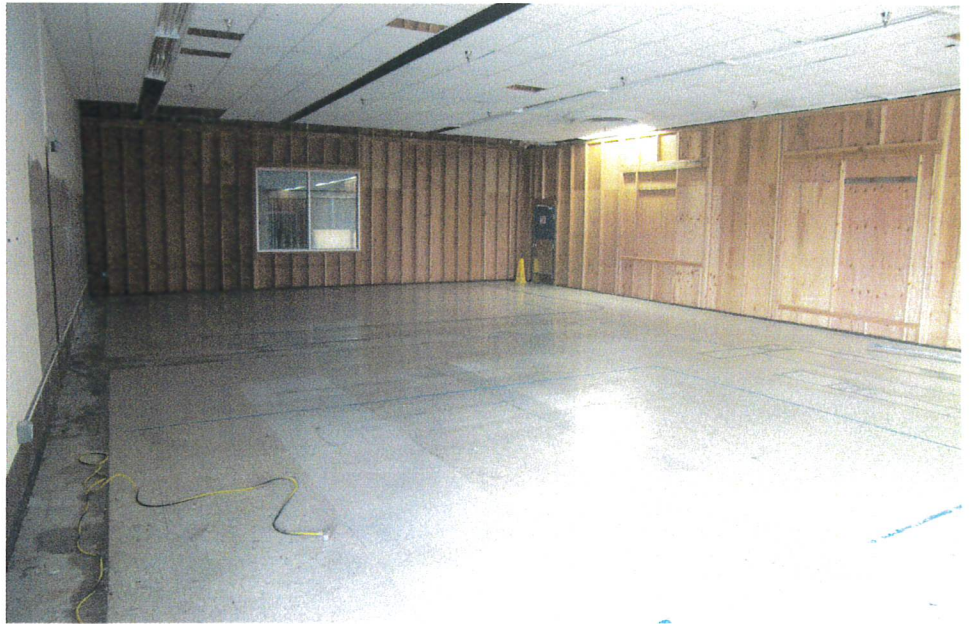
Looking northerly from previous picture along two other newer constructed walls straight ahead and to the right. The west exterior wall extends to the left. Notice condition of floors and ceiling.

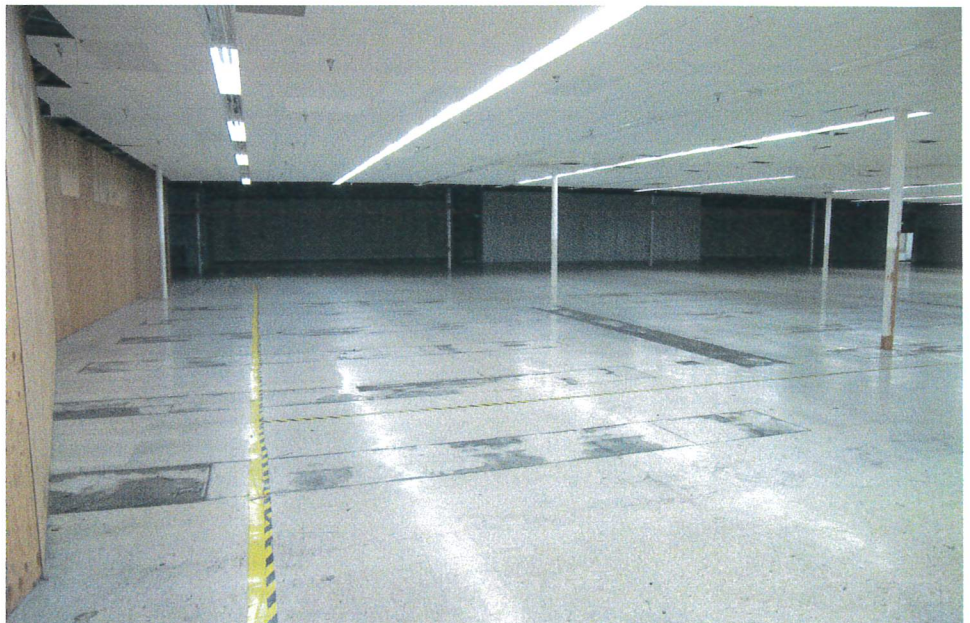
Looking northerly over former open retail sales area. Much of the flooring has not changed for many years.

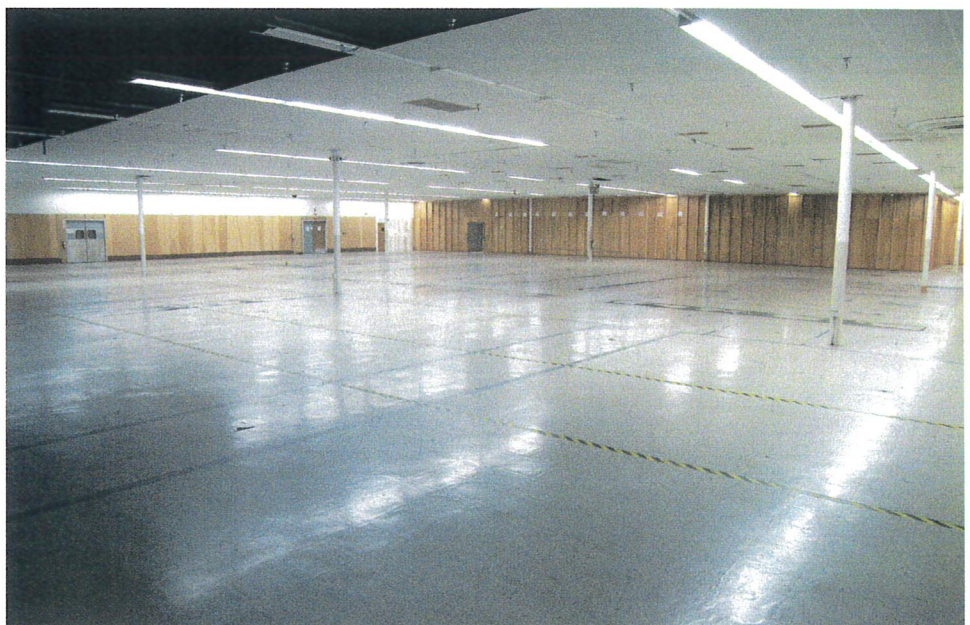
Looking southeast over former retail sales area. Notice removal of drop acoustical ceiling tiles and lighting within this specific area. This extends farther to the left.
