ATTACHMENT 1a
Delaney Full Resubmittal

Mitigation and Remediation Grant Program APPLICATION GUIDELINES

Project Title: Oclaney LSA repair Date of Application: 10/30/22

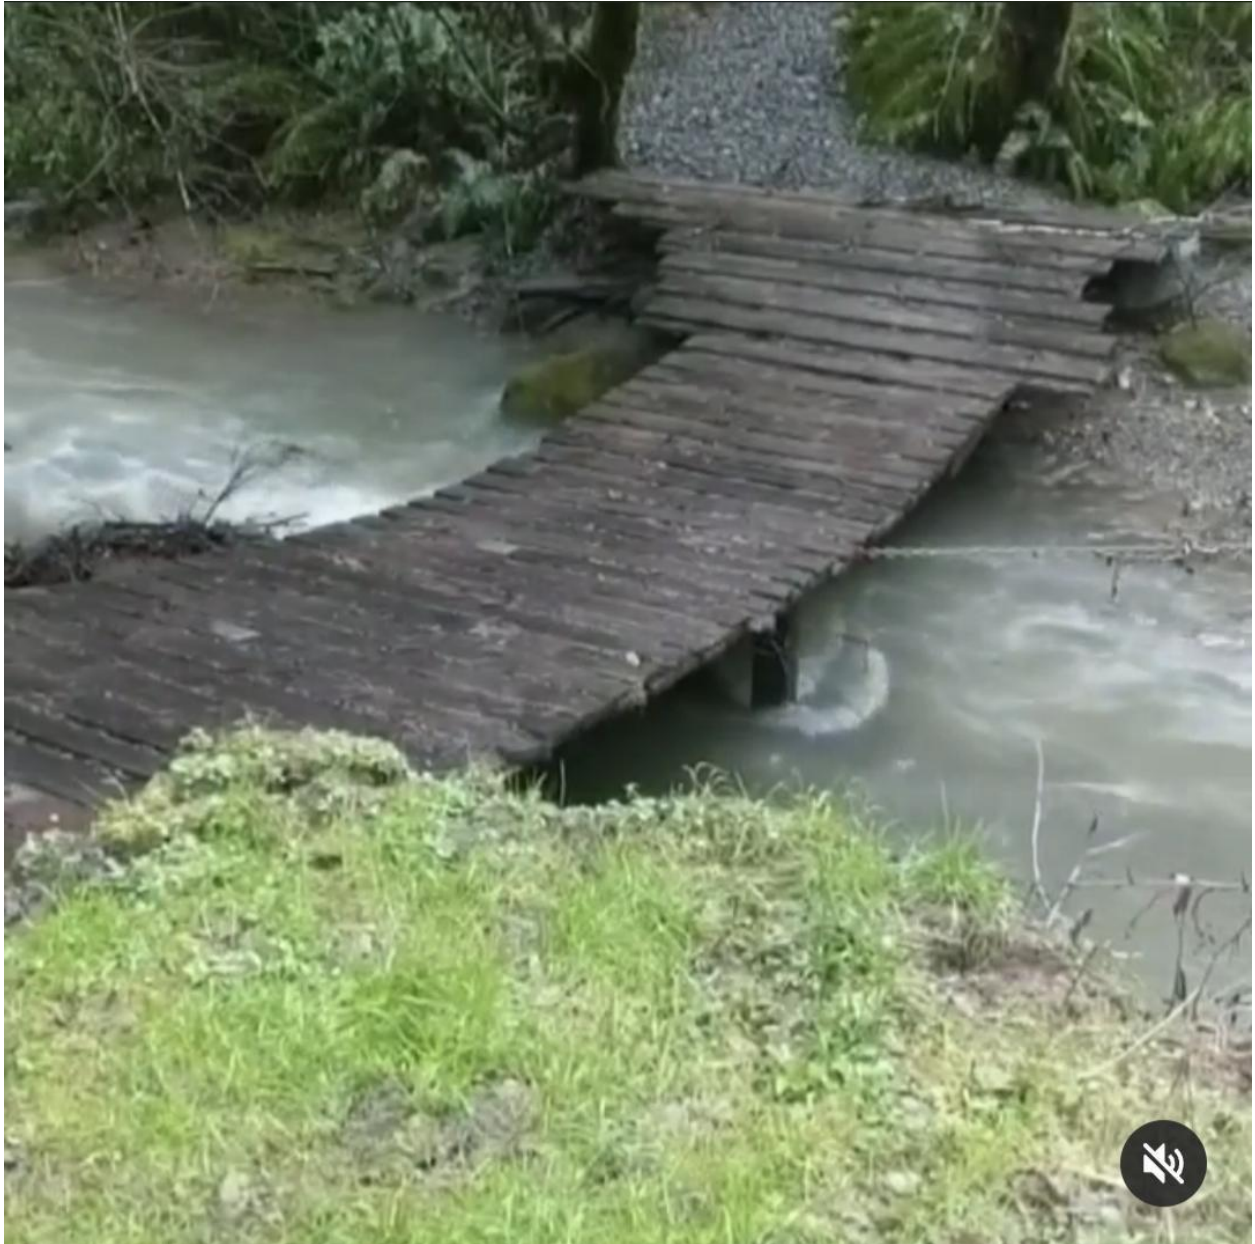
Figure 3. Bridge we are requesting to repair in it's current state, pictured here with the creek at it's highest flow. Fish and game has said that it's current height is not enough to allow down wood to pass through at high tides

The first project is a bridge over Miller Creek that allows us to access the entire back half of the property. At this point in time the bridge sits below current flood levels, which is against Fish and Game regulations. The Fish and Game worker said that it's current configuration is blocking the flow of debris. We have had the bridge wash out before, we have been concerned that this would contribute to erosion. It has also been a growing desire of us and many neighbors on the Blue Slide Creek side of the property that we reinforced the bridge to be used as an escape route in case there is a fire on Blue Slide Creek blocking the outlet. Replacing the crossing to be a permanent crossing above the flood level will maintain the creek's integrity, even in the case of a fire. Because this bridge is located on private property and is not located on the Miller Creek Road sections currently being maintained by the community road association, the burden of repair falls solely on the property owner. This is regardless of the current need for the neighbors to access it in emergency cases and for repairs.

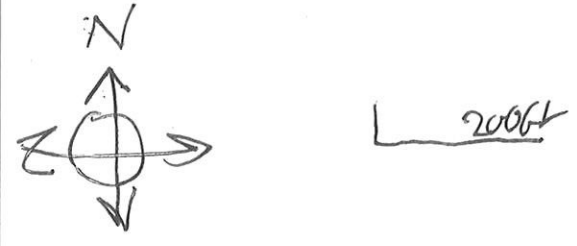
Jennifer Mahaney and
 Sean Delaney
 Plot Plan 10/30/22
 For Aprn 220-282-010
 APN 220-282-019

Utilities
 Sewer: Septic Tank and
 Leach Field
 Water: Spring (X)
 Cannabis irrigation water: Pond
 Electricity: Solar wall and
 propane generator
 Internet: Netlink 101
 All areas not labeled are heavily
 vegetated with trees > 12ft

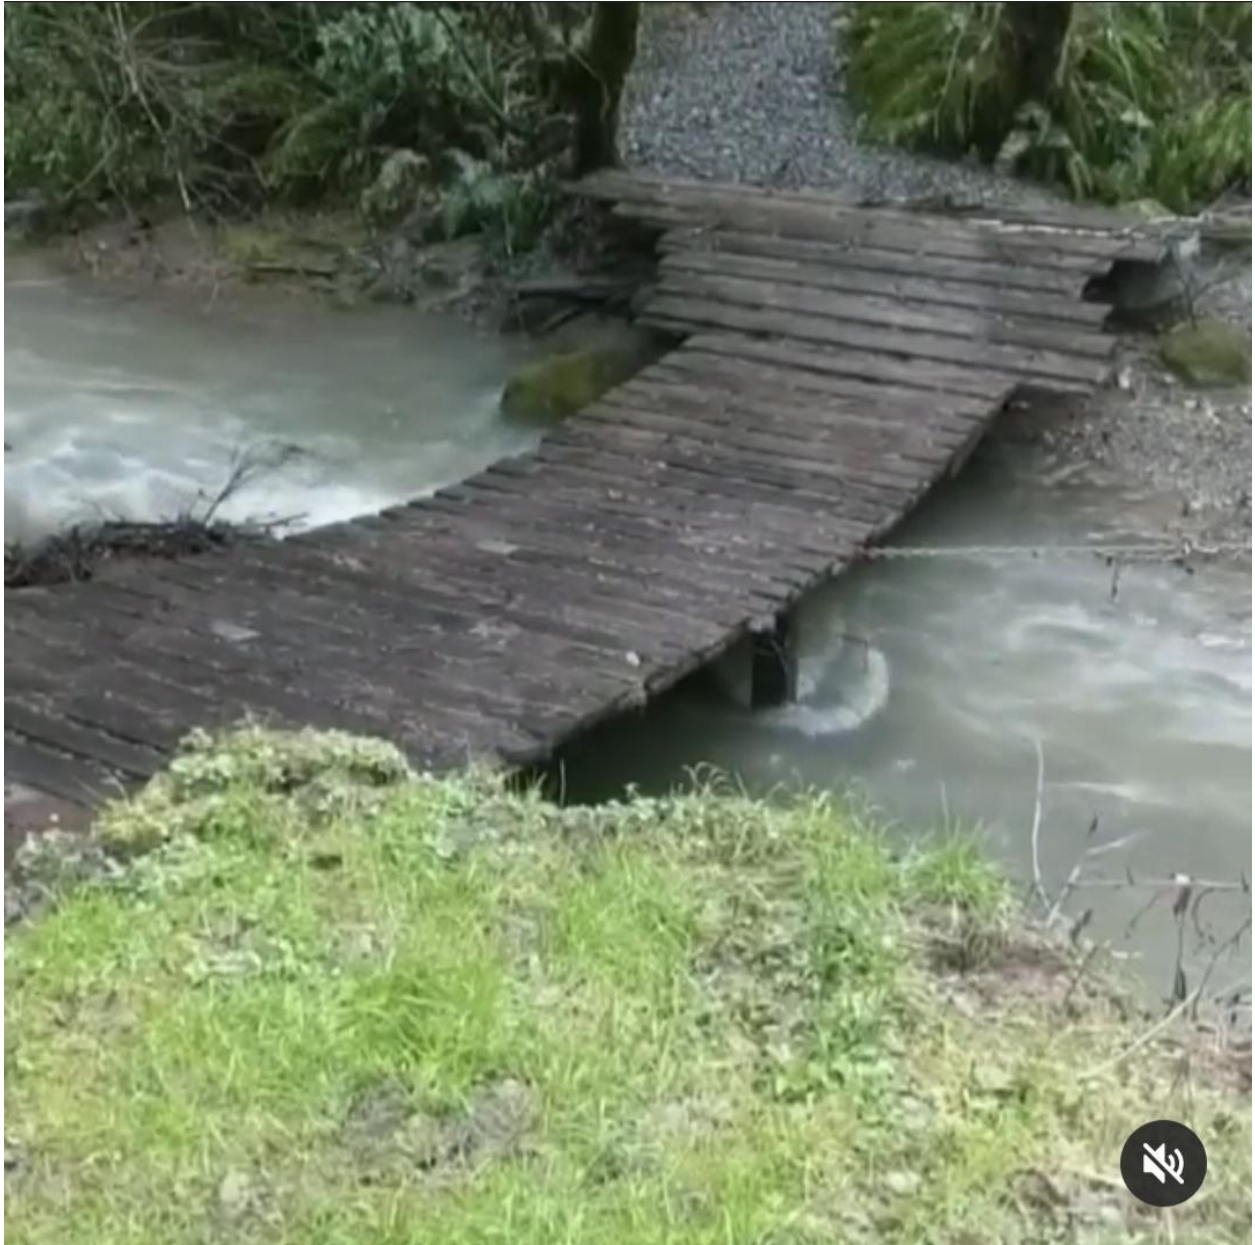
Figure 5. Bridge we are requesting to repair in it's current state, pictured here with the creek at it's highest flow

The third project is a bridge over Miller Creek that allows us to access the entire back half of the property. At this point in time the bridge sits below current flood levels, which is against Fish and Game regulations. The Fish and Game worker said that it's currently configuration is blocking the flow of debris. We have had the bridge wash out before, we have been concerned that this would contribute to erosion. It has also been a growing desire of us and many neighbors on the Blue Slide Creek side of the property that we reinforced the bridge to be used as an escape route in case there is a fire on Blue Slide Creek blocking the outlet. Replacing the crossing to be a permanent crossing above the flood level will maintain the creek's integrity, even in the case of a fire. Because this bridge is located on private property and is not located on the Miller Creek Road sections currently being maintained by the community road association, the burden of repair falls solely on the property owner. This is regardless of the current need for the neighbors to access it in emergency cases.
