COUNTY OF HUMBOLDT, CALIFORNIA

ELECTION DIVISION

ILA COMPLIANCE REPORT (21 MONTH)

2426 TH STREET, EUREKA CA
(COUNTY LEASED FACILITY)

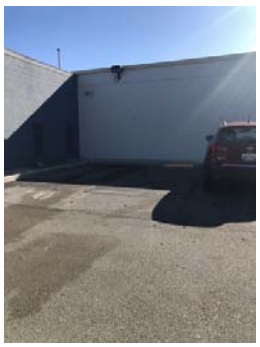
Field Date: 10/29/2019 Report Date: 10/29/2019 Barrier #: 25B

Location: Exterior - Van Accessible Stall 1

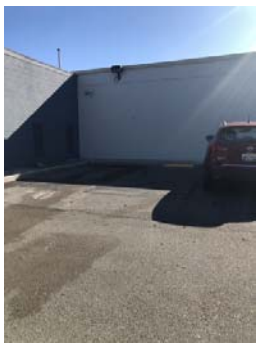
Field Date: 10/29/2019 Report Date: 10/29/2019 Barrier #: 25F

Location: Exterior - Van Accessible Stall 1

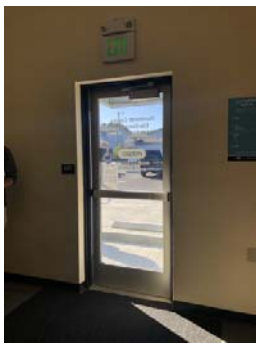
Field Date: 5/4/2018 Report Date: 5/4/2018 Barrier #: 38H

Location: North Entrance
