Waters Investigation Report

Humboldt County APN 104-321-010-000

February 1, 2021

Natural Resources Management Corporation

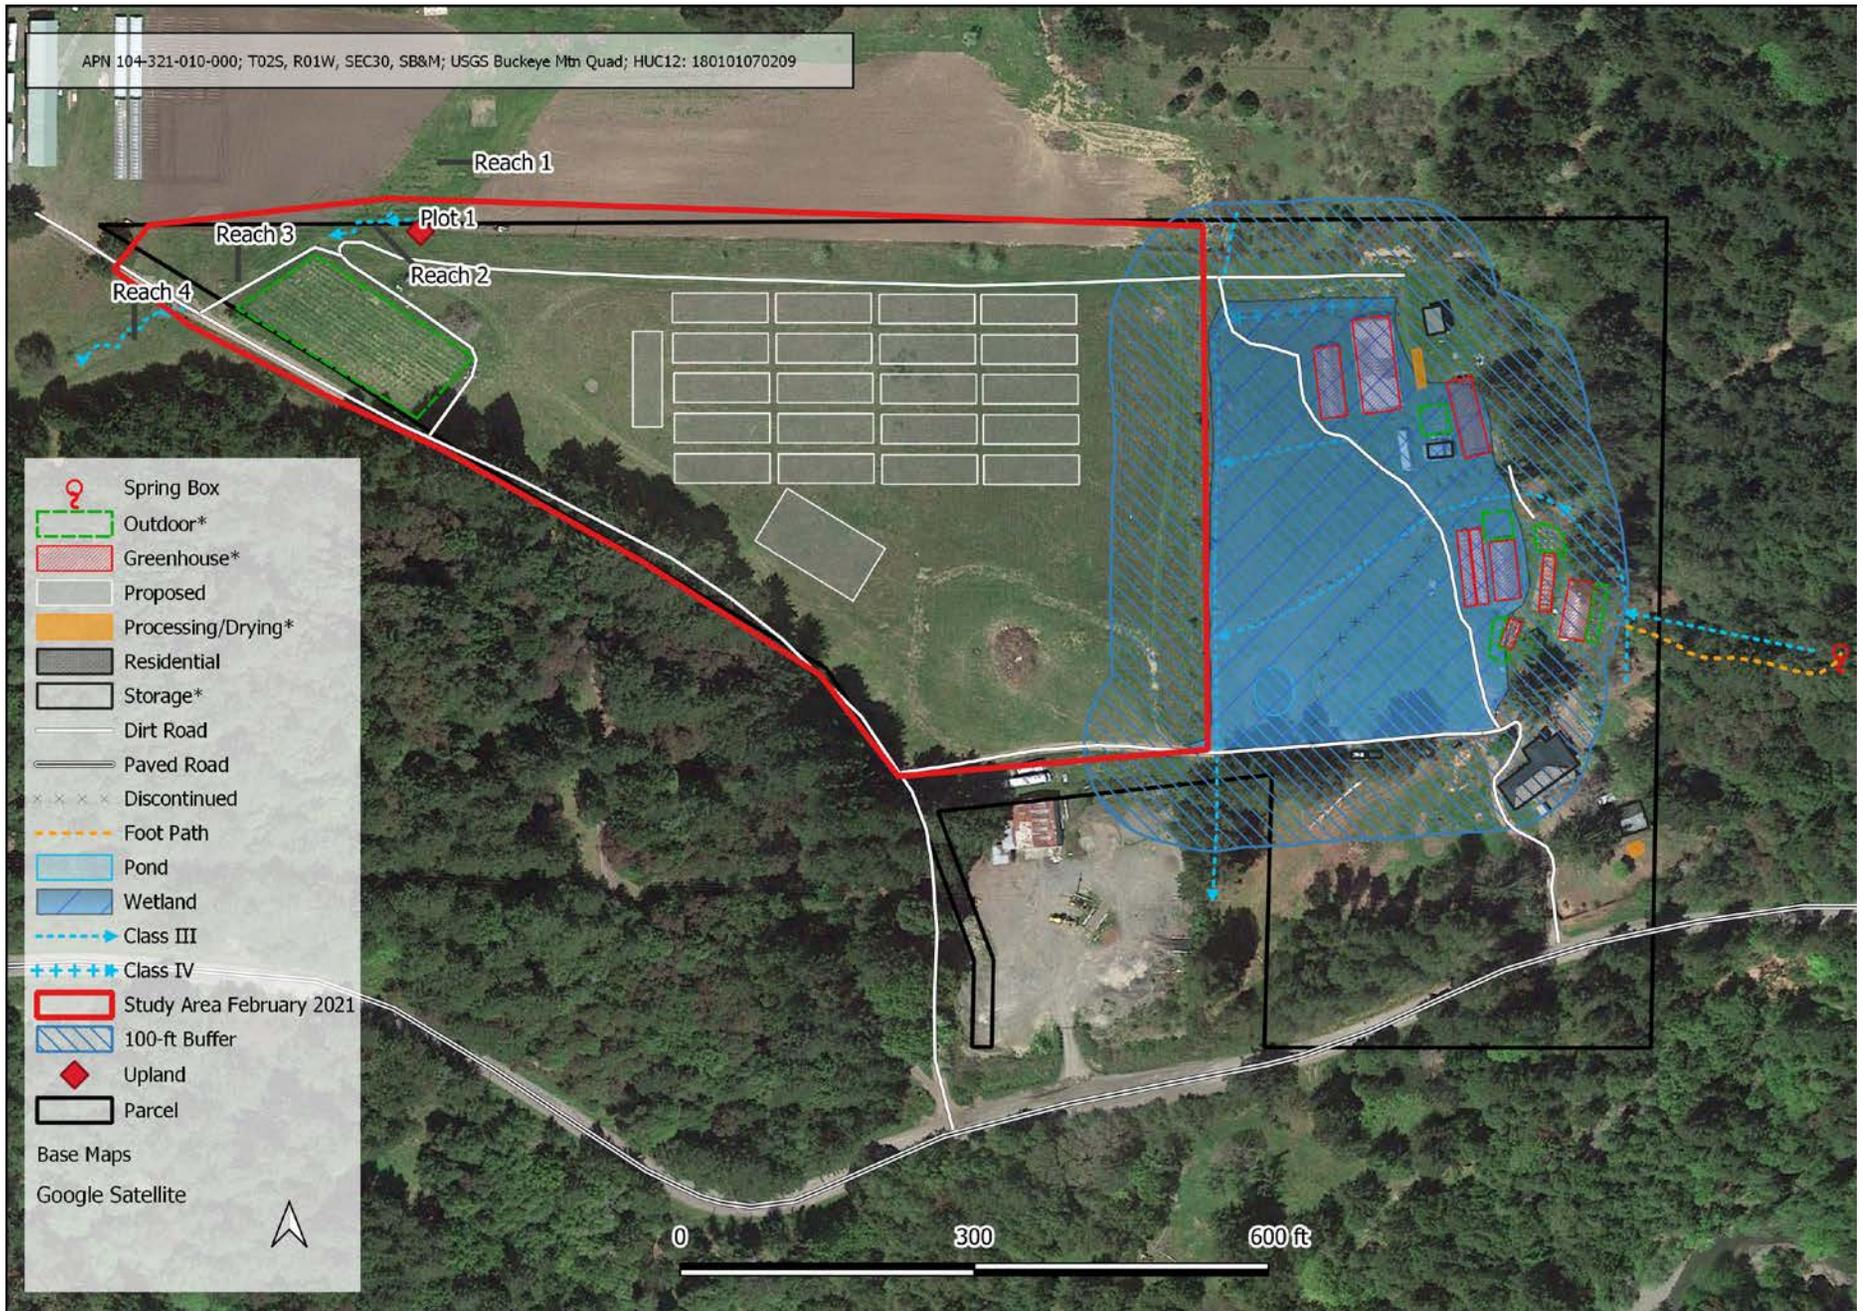
Figure 1. Site Overview, February 1, 2021. * Denotes existing greenhouses, outdoor space, and infrastructure related to existing cannabis cultivation activities which will be removed and relocated to the 'Proposed' growing location at the center of the property.

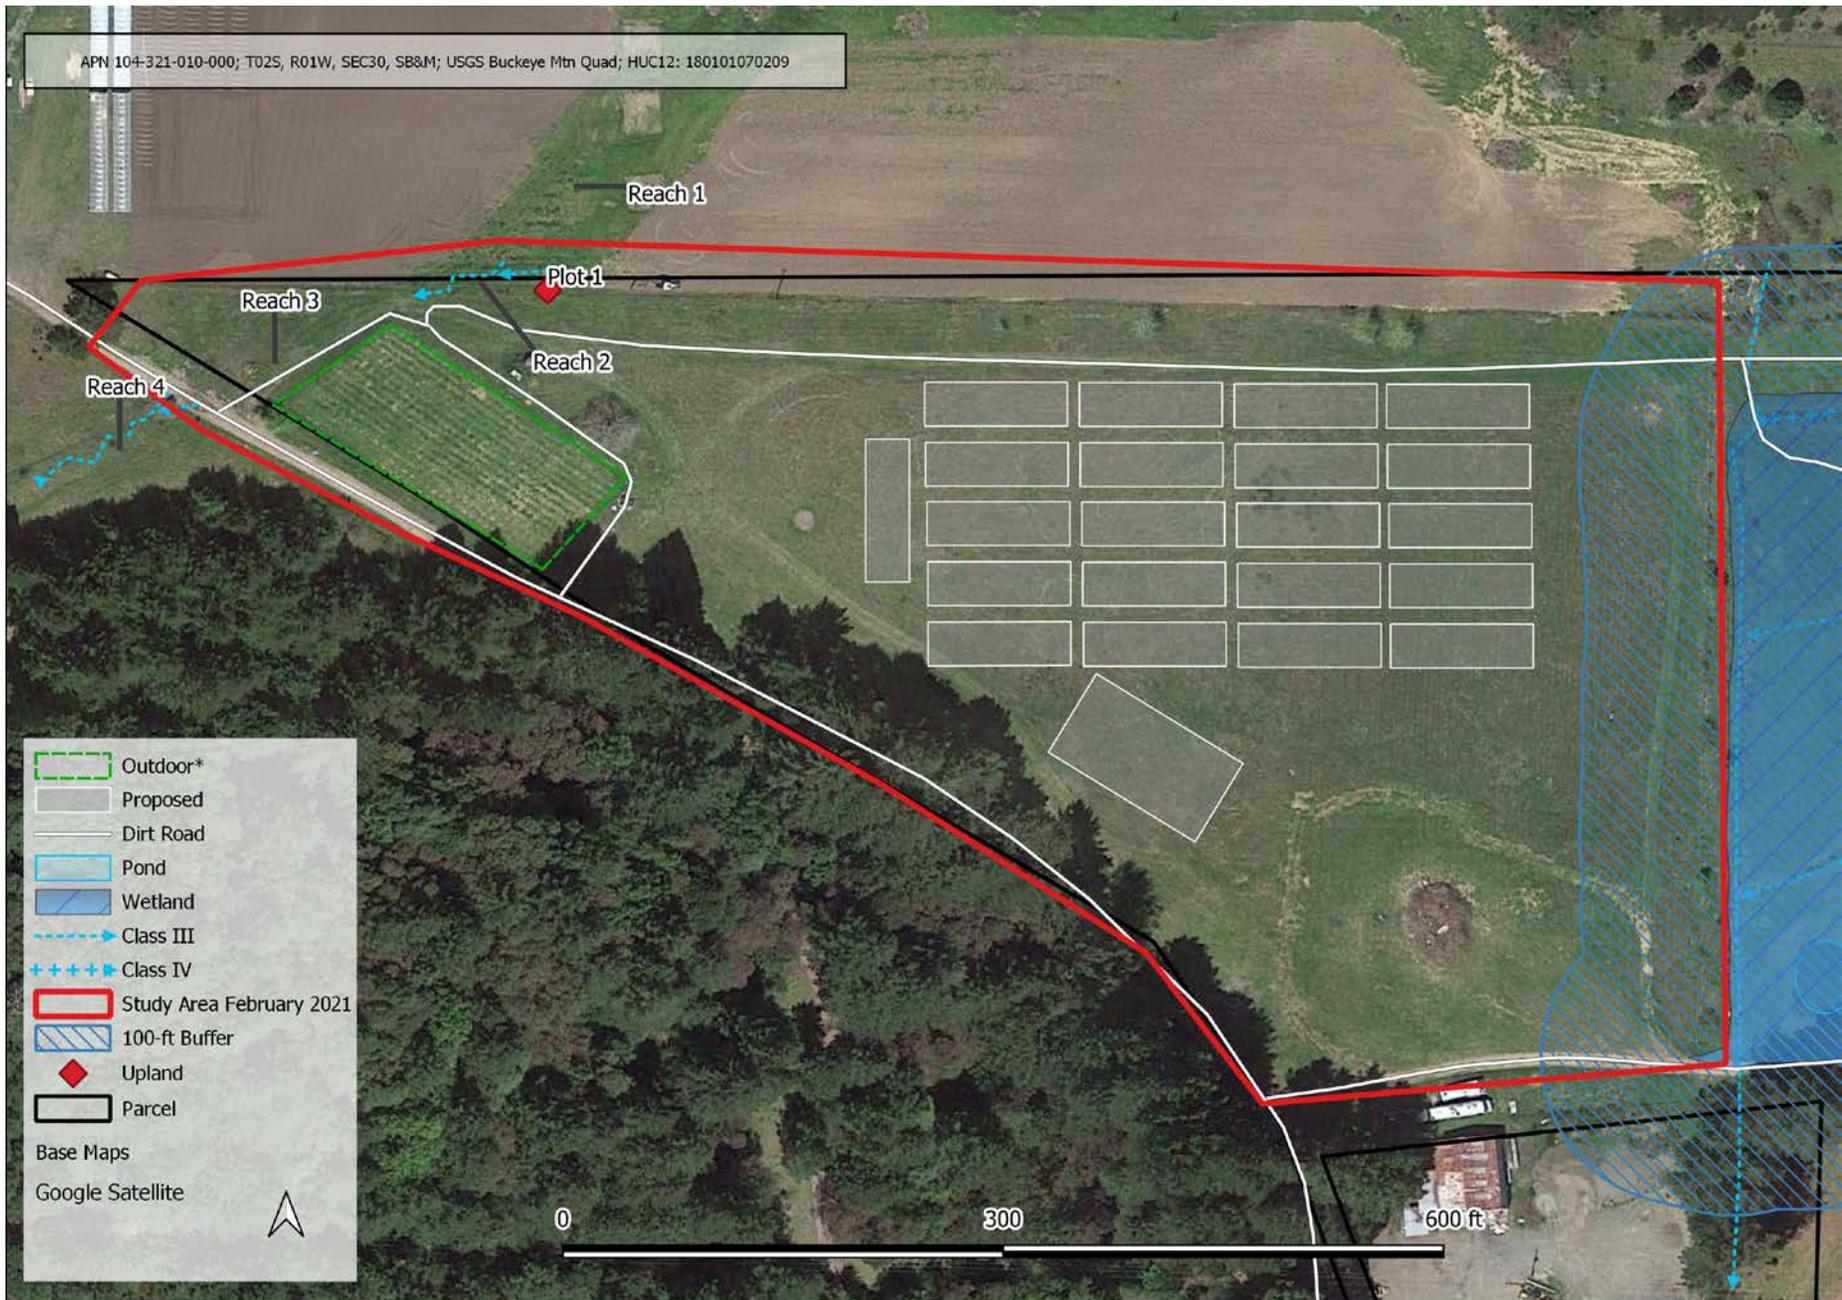
Figure 2. Study Area February 1, 2021. * Denotes existing greenhouses, outdoor space, and infrastructure related to existing cannabis cultivation activities which will be removed and relocated to the 'Proposed' growing location at the center of the property.
