Structural Assessment
Garberville Veterans Building
Garberville, CA

KPFF Consulting Engineers
San Francisco, CA
February 26, 2021

This report presents the findings of the structural assessment of the Garberville Veterans Building located at 483 Conger St, Garberville, CA. The objective of this study was to assess the current condition of the building and to develop recommendations for structural strengthening and repair needed to bring the building up to the California Existing Building Code, 2019 edition.

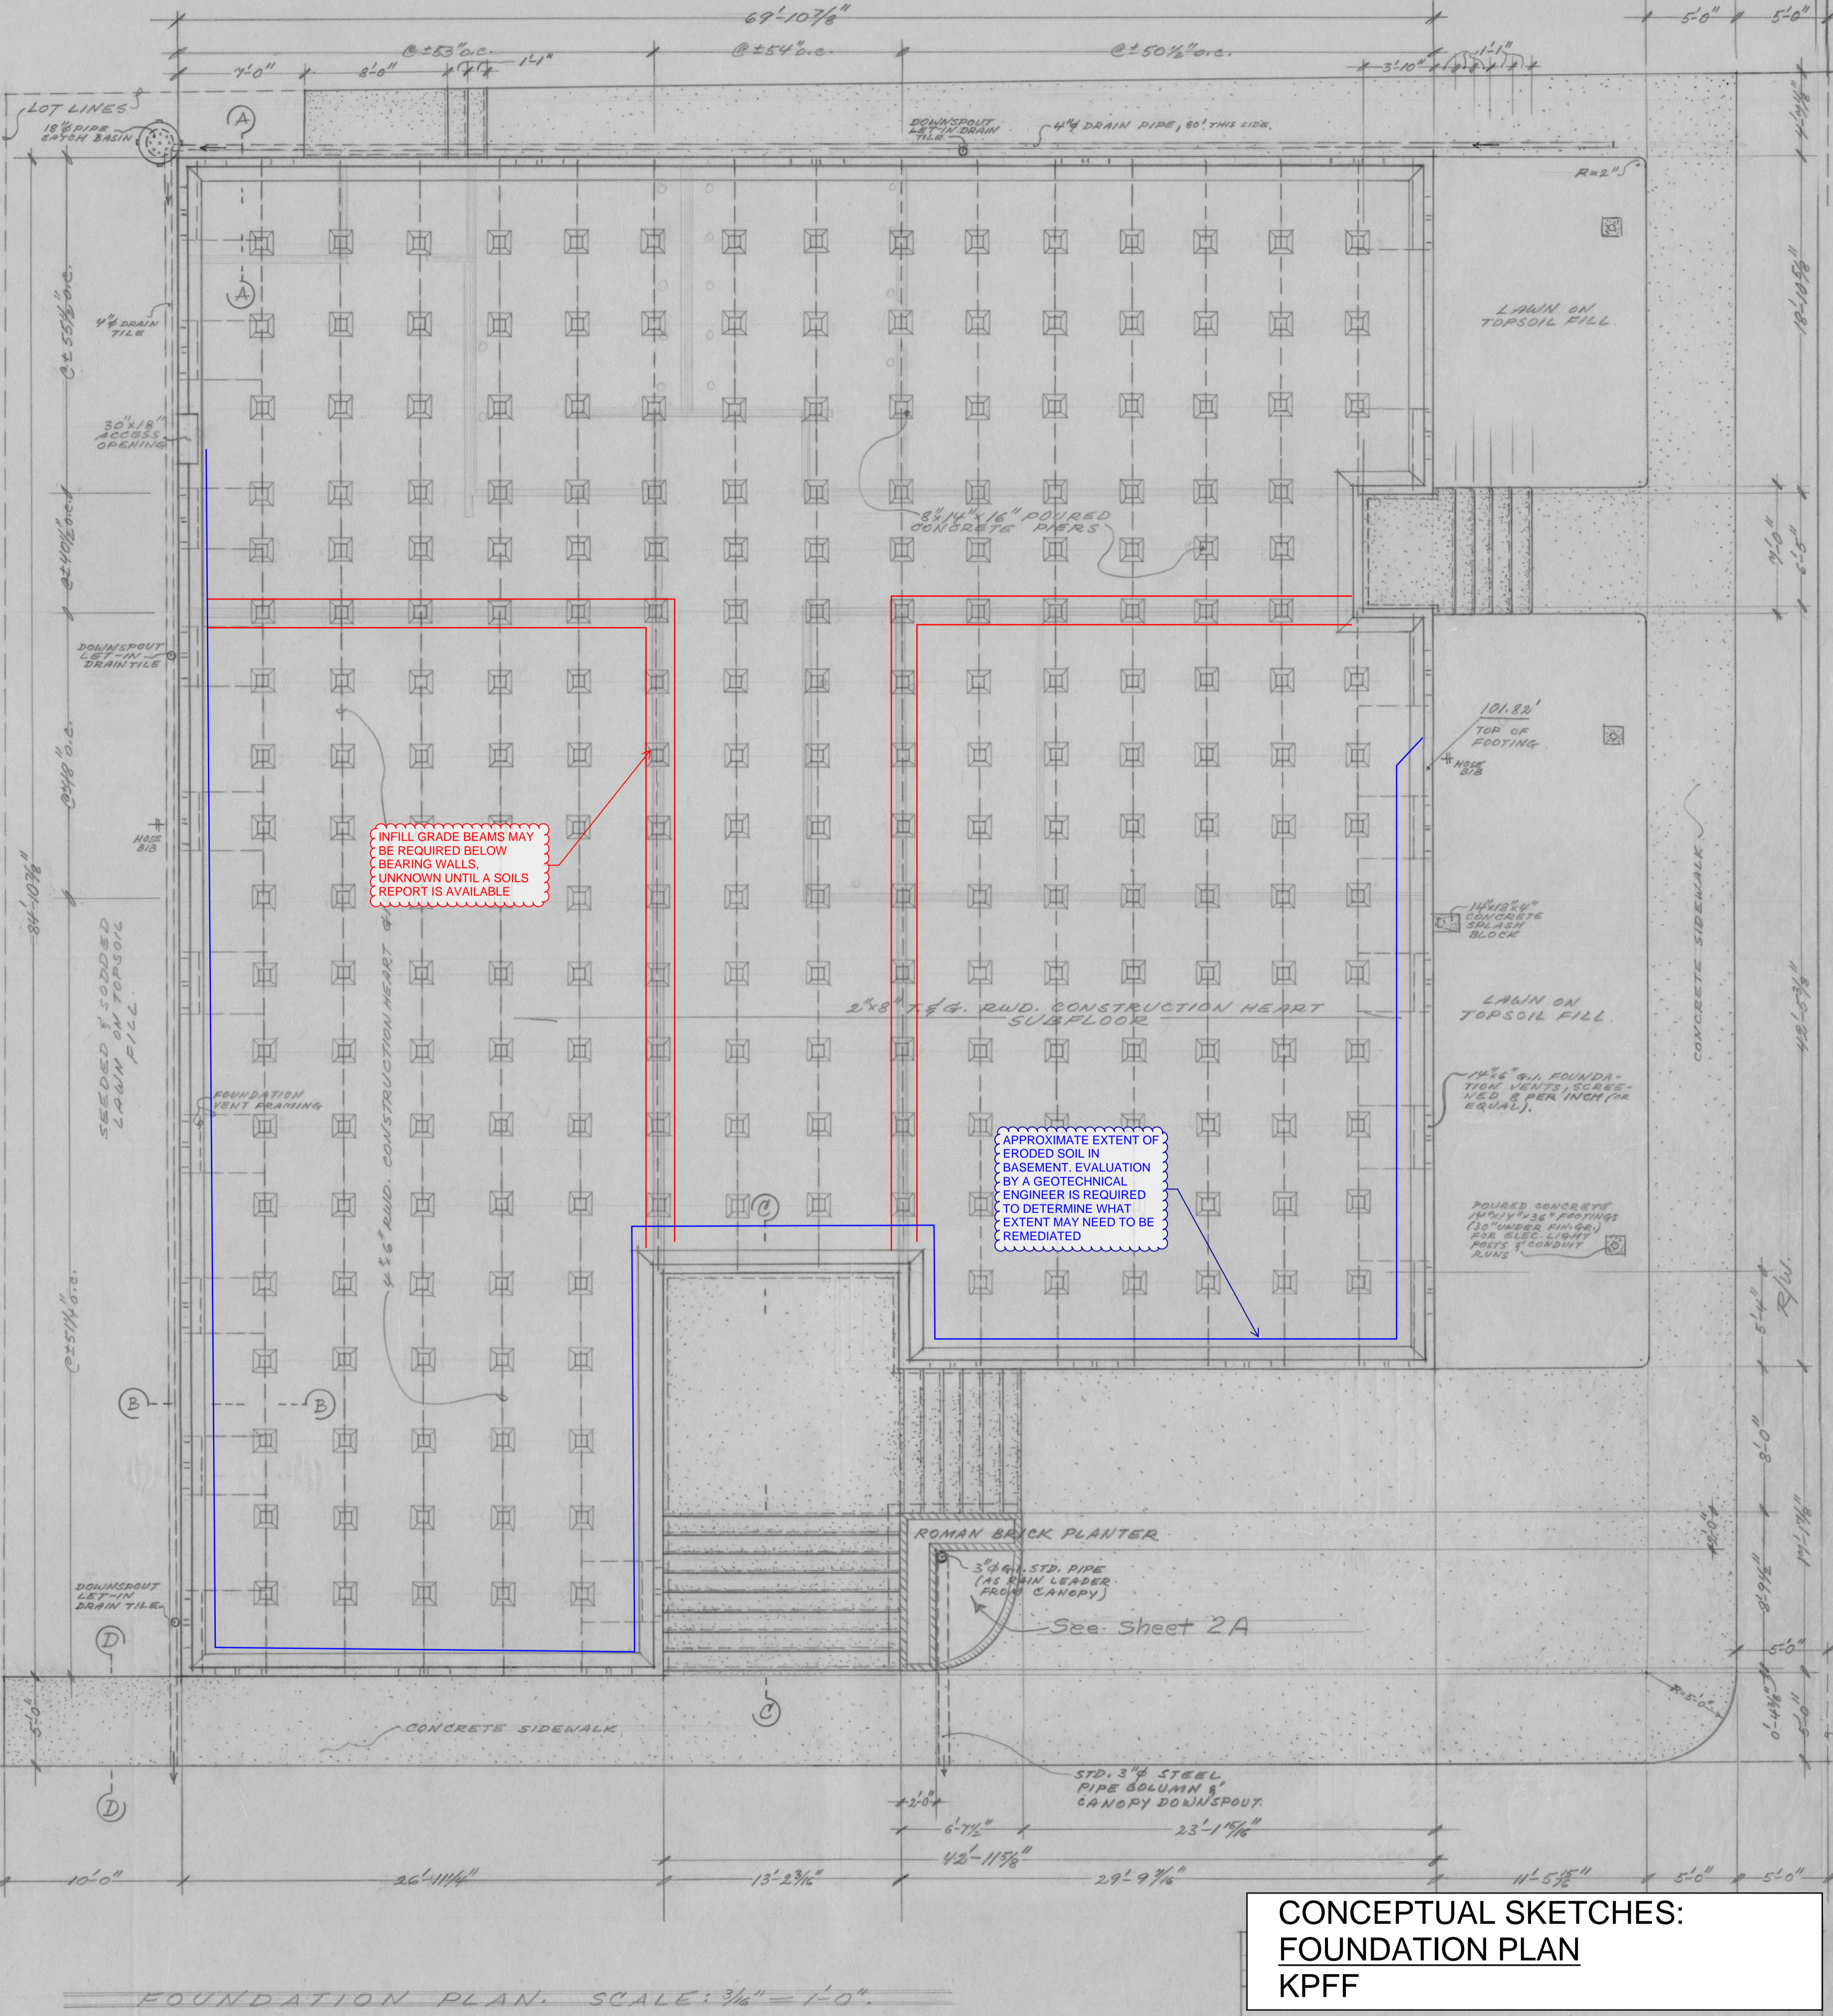
FOUNDATION PLAN SCALE: 3/8" = 1'-0"

INFILL GRADE BEAMS MAY BE REQUIRED BELOW BEARING WALLS. UNKNOWN UNTIL A SOILS REPORT IS AVAILABLE.
