Reference: 018181

June 11, 2019

Subject: Engineering Geologic Evaluation and Soils Reporting for Existing and Proposed Improvements, APN's 216-081-013, 216-135-015, 216-136-004, and 216-135-008; Harris, Humboldt County, California

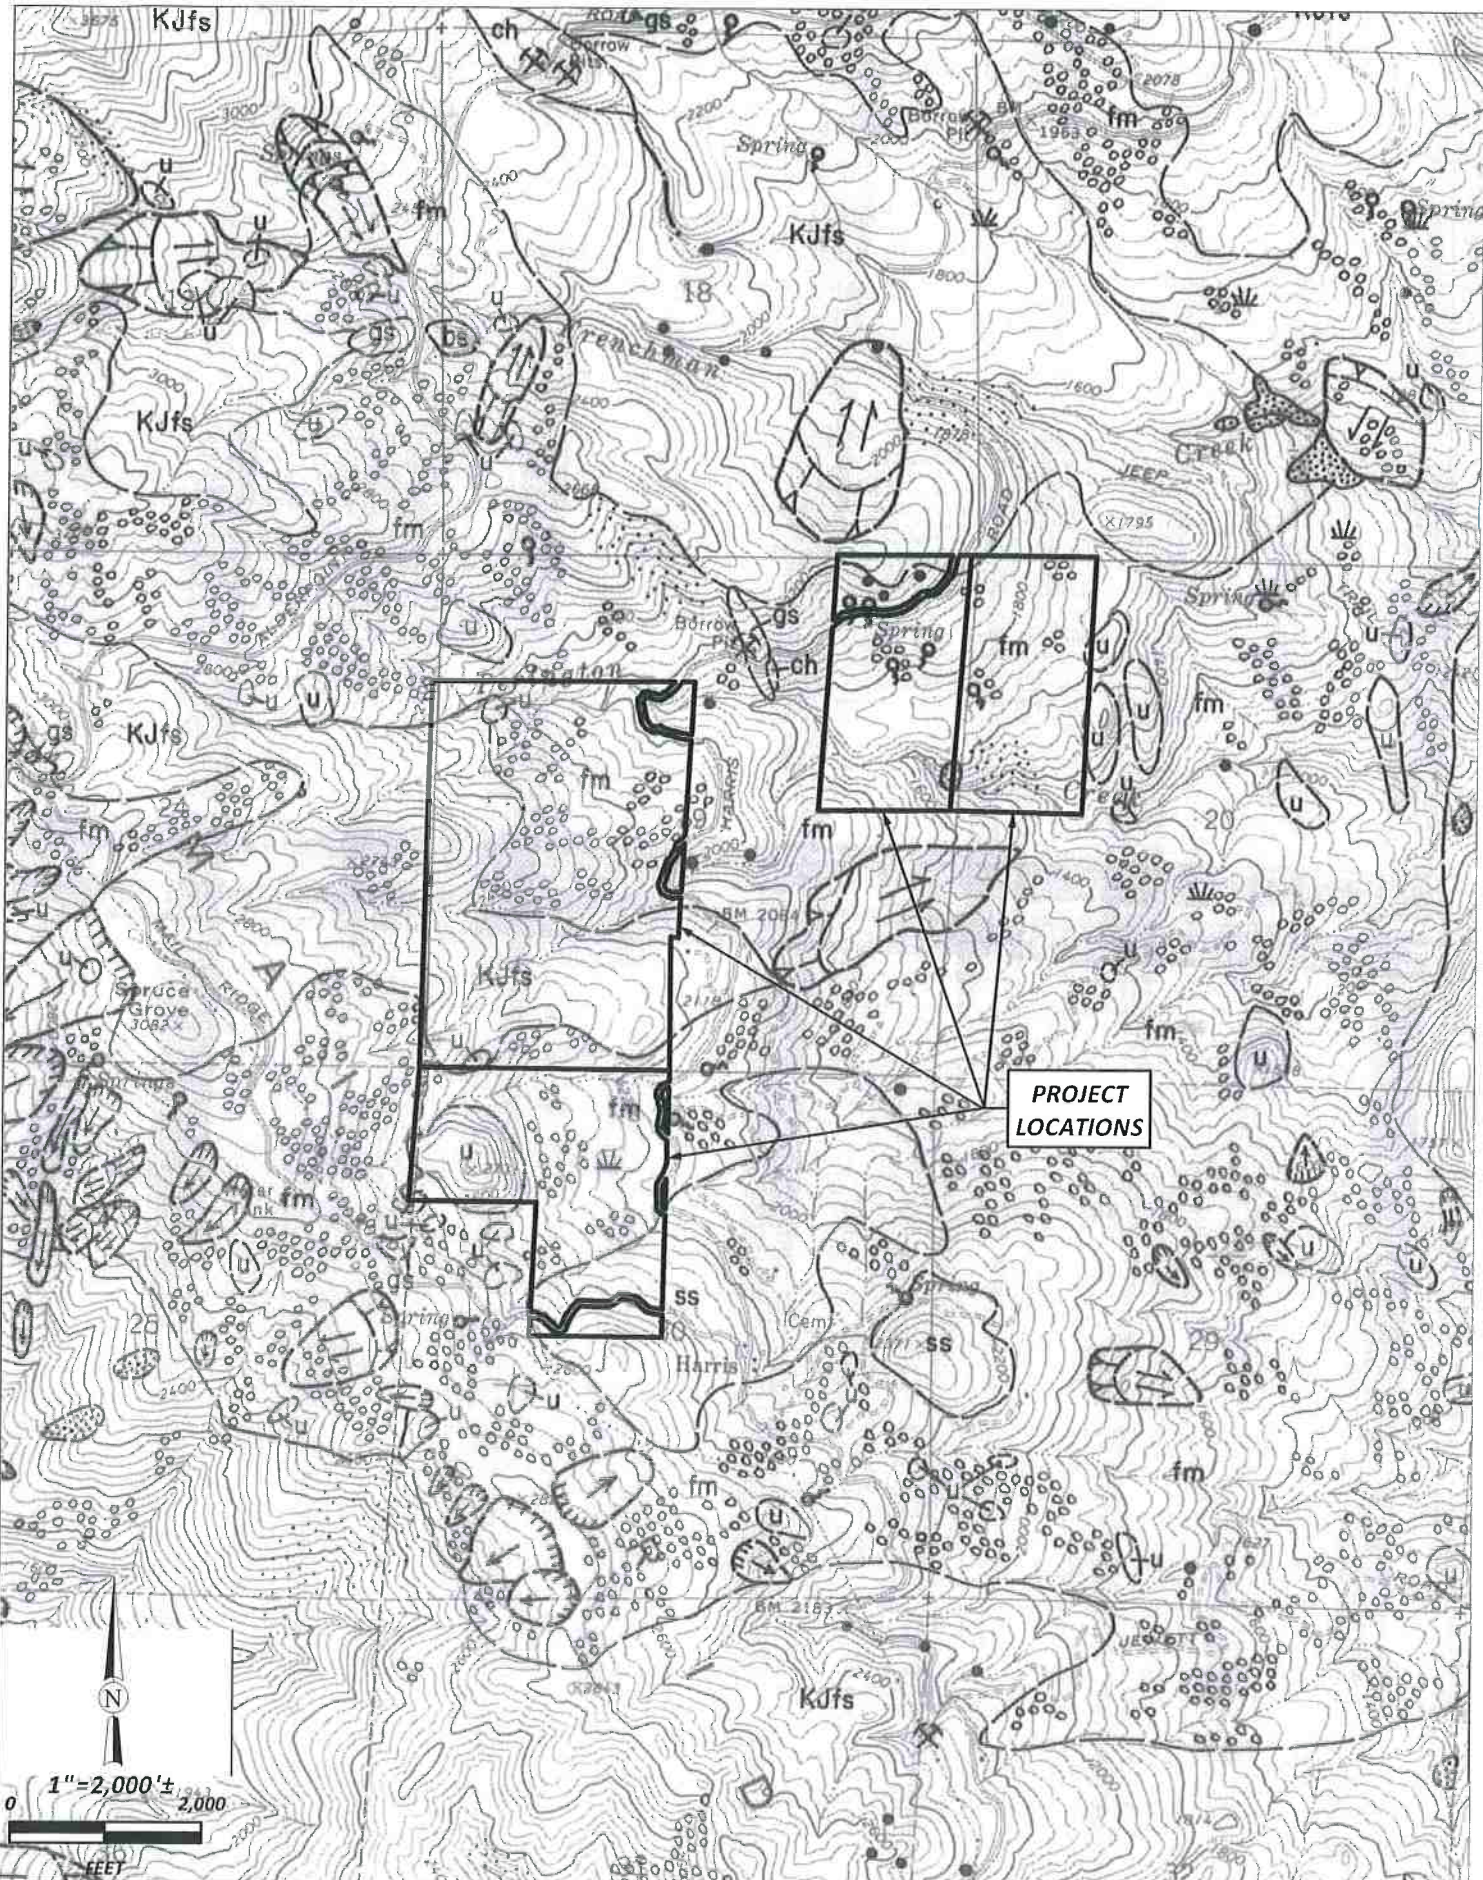
Figure 2

The area is mapped as being underlain by Cretaceous to Jurassic age bedrock of the central belt of the Franciscan Complex (Figure 2). The central belt subunit of the Franciscan Complex is a heterogeneous bedrock unit formed during crustal subduction that contains a wide variety of rock types. The unit is structurally complex with pervasive shearing and a preponderance of *mélange* materials (block-in-matrix texture where hard rock blocks are entrained in a low-strength matrix). Mapping by Spittler (1984) shows the subject parcels as being underlain by *mélange* and various large sandstone blocks.

Landsliding in this terrain is strongly correlative to the underlying earth materials. In areas underlain by competent sandstone bedrock, topography is notably sharp and mass wasting occurs as shallow debris slides and rock topples. Areas underlain by *mélange* are associated with earthflow type mass wasting. Geomorphic mapping by Spittler (1984) shows limited amounts of mass wasting in the four parcels discussed herein, reflecting the geology and general absence of steep terrain (Figure 2). With the exception of a single, small debris slide mapped along Perington Creek on APN 216-135-008 and an adjacent "debris slide slope", areas of inferred mass wasting are shown as "disrupted ground." These areas represent indistinct geomorphic mapping units that are described as "irregular ground" caused by complex landsliding, soil creep, or erosion. They are commonly mapped in prairie areas (where the ground is visible in aerial photographs), where soft soils result in hummocky ground; they are often associated with geomorphic conditions resulting from soil processes unrelated to landsliding.

In general, we observed field conditions consistent with the available published mapping. Substantial areas of resistant bedrock are present on the western parcels (APN's 216-081-013 and 216-135-015) and evidence of mass wasting is very limited. The eastern parcels are predominantly underlain by *mélange*, except for prominent bedrock outcrops along the eastern edge of the eastern parcel, APN 216-136-004. Although areas of significant recent earthflow deformation were not observed in these areas, several soft soil zones were noted and are discussed below.
