Garberville Veterans Hall

Access Compliance Survey Report

January 2021

SSA Project #: 20033.01.00

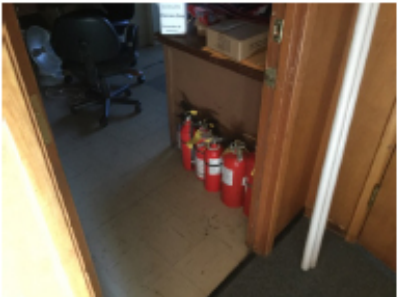
Item no., Rm no. and Name	Existing Architectural Barrier and Proposed Solution	Codes / Mitigation Info	Qty	Unit	Cost	Total
6 Office	<p>Door Clearance</p> <ul style="list-style-type: none"> As-Built Description: Door on accessible route has less than 32" clear and 80" (78" min. to closer if provided) opening width when 90° open. As-Built: 29" wide Proposed Solution: Provide new, larger door and frame with new accessible hardware. Notes: 	PCODE ID01 ADAAG 91 4.13.5 ADA 2010 404.2.3 CBC 2007 1133B.1.1.1.1 CBC 2019 11B-404.2.3 Mitigated: <input type="radio"/> YES <input checked="" type="radio"/> NO	1	JOB	\$7,800	\$7,800

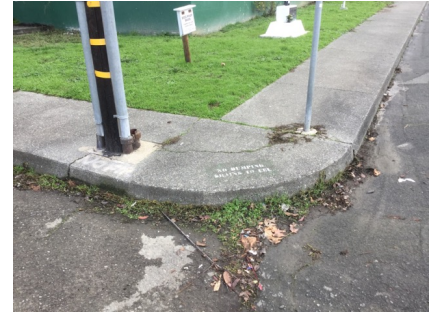
Curb Ramp

- 20
- *As-Built Description:*
No curb ramp available where an accessible route crosses a curb.
 - *Proposed Solution:*
Provide new curb ramp.

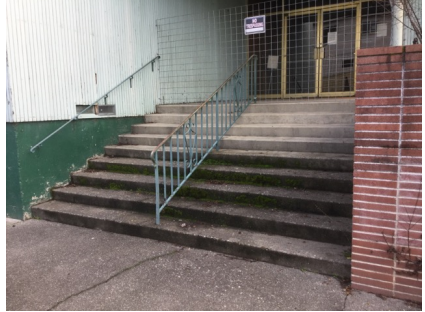
137	<ul style="list-style-type: none"> As-Built Description: No signs at non-accessible entrances directing persons to an accessible entrance of the building. Proposed Solution: Provide directional signage to indicate route to the nearest accessible entrance. 	PCODE SA14 ADAAG 91 4.1.2(7)(e) ADA 2010 216.6 CBC 2007 1127B.3 CBC 2019 11B-504.4.1	1	JOB	\$690	\$690
-----	---------------------------------------------------------------------------------------------------------------------------------------------------------------------------------------------------------------------------------------------------------------------------------------------------------------	--------------------------------------------------------------------------------------------------	---	-----	-------	-------

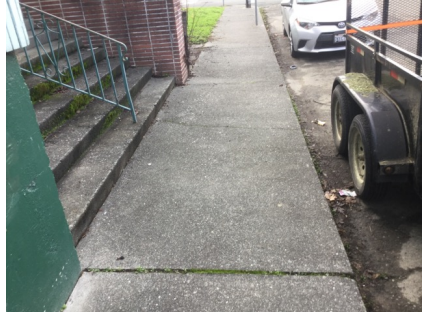
29	<ul style="list-style-type: none"> As-Built Description: Landing at the top or bottom of stairway is not level or not provided. Proposed Solution: Remodel landings to provide a level clear floor space that extends the entire width of the ramp. Notes: Incorporate required landing when improving sidewalk. 	PCODE EC10REF CBC 2019 1009.8	REF			
----	-------------------------------------------------------------------------------------------------------------------------------------------------------------------------------------------------------------------------------------------------------------------------------------------------------------------------------------------------------------------------------------------	----------------------------------	-----	--	--	--

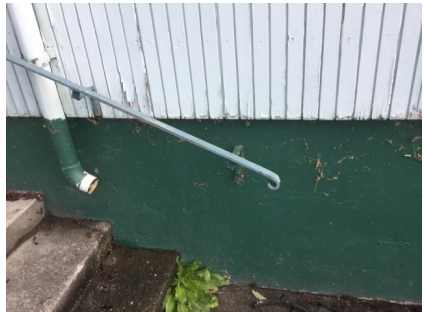
24	<ul style="list-style-type: none"> As-Built Description: Stair handrail does not extend horizontally 12" minimum beyond top nosing, and one tread width sloped, plus 12" minimum horizontally beyond the bottom nosing. As-Built: 0" extensions Proposed Solution: Extend stair handrail at top and bottom. Notes: Includes required extension when installing new handrails. 	PCODE ED06REF ADAAG 91 4.9.4(2) ADA 2010 505.10.2; 505.10.3 CBC 2007 1133B.4.2.2 CBC 2019 11B-505.10.2; 11B-505.10.3	REF			
----	-------------------------------------------------------------------------------------------------------------------------------------------------------------------------------------------------------------------------------------------------------------------------------------------------------------------------------------------------------------------------------------------------------------------------------------------------------------------------------	-------------------------------------------------------------------------------------------------------------------------------------	-----	--	--	--

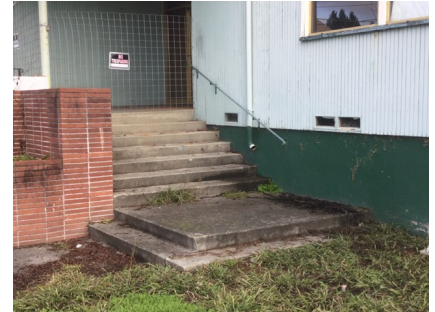
25	<ul style="list-style-type: none"> <i>As-Built Description:</i> The leading 2" of the tread does not have visual contrast of dark-on-light or light-on-dark from the remainder of the tread. <i>Proposed Solution:</i> Provide contrasting color strips at all exterior stair treads. 	<p>PCODE EC02 ADA 2010 504.4 CBC 2007 1133B.4.4 CBC 2019 11B-504.4.1</p> <p>Mitigated: <input type="radio"/> YES <input checked="" type="radio"/> NO</p>	80	LF	\$27	\$2,160
----	-----------------------------------------------------------------------------------------------------------------------------------------------------------------------------------------------------------------------------------------------------------------------------------------------------------------------	---------------------------------------------------------------------------------------------------------------------------------------------------------------------------------------	----	----	------	---------

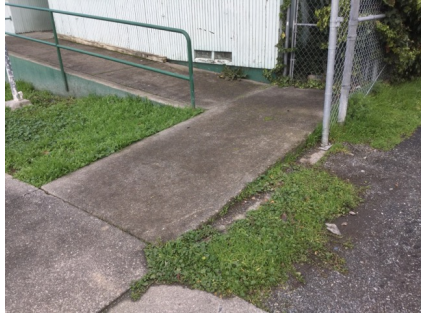
Item no., Rm no. and Name	Existing Architectural Barrier and Proposed Solution	Codes / Mitigation Info	Qty	Unit	Cost	Total
18	<p>Walk</p> <ul style="list-style-type: none"> • <i>As-Built Description:</i> Walk: Slope greater than 1:20 (5.0%), and walk does not comply with requirements for ramps. • <i>As-Built:</i> 5.0%-7.0% • <i>Proposed Solution:</i> Modify walk/sidewalk slope to 1:20 or less. • <i>Notes:</i> Incorporate correction with proposed new ramp. 	<p><i>PCODE</i> EF01REF <i>ADAAG 91</i> 4.3.7 <i>ADA 2010</i> 403.3 <i>CBC 2007</i> 1133B.7.3 <i>CBC 2019</i> 11B-403.3</p>				
		<p>Mitigated:</p> <p><input type="radio"/> YES</p> <p><input checked="" type="radio"/> NO</p>				
		REF

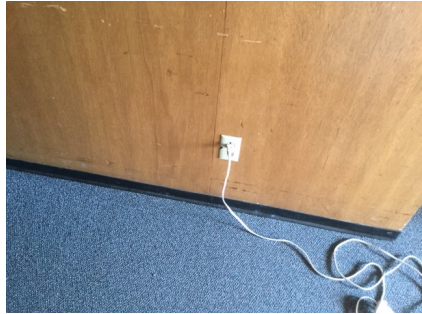
Item no., Rm no. and Name	Existing Architectural Barrier and Proposed Solution	Codes / Mitigation Info	Qty	Unit	Cost	Total
42	<ul style="list-style-type: none"> <i>As-Built Description:</i> Electric switch or control mounted less than 15" measured to the bottom of the outlet box or greater than 48 inches measured to the top of the outlet box. <i>As-Built:</i> 13" o.c. <i>Proposed Solution:</i> Relocate light switches or control to between 15" and 48" height. <i>Notes:</i> Typical issue throughout the building. 	PCODE IC01REF ADAAG 91 4.2.5 & 6 ADA 2010 308.2.1 & 308.2.2 CBC 2007 1117B.6.3 CBC 2019 11B-308.2.1 & 11B-308.2.2 Mitigated: <input type="radio"/> YES <input checked="" type="radio"/> NO				
				REF

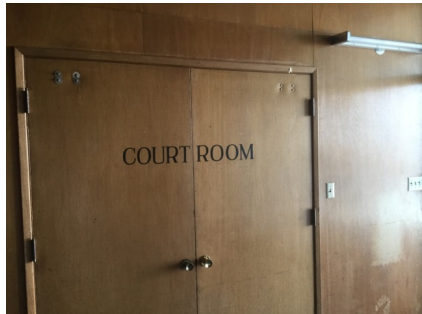
48	<ul style="list-style-type: none"> <i>As-Built Description:</i> Sign not located on latch side of door and/or not located at 48" min. above to baseline of the lowest Braille cells and 60" max. to baseline of the highest line of raised characters. <i>Proposed Solution:</i> Provide compliant signage including tactile characters and Grade II Braille on latch side of door located at compliant height. <i>Notes:</i> Typical issue throughout the building. 	PCODE SA07 ADAAG 91 4.30.6 ADA 2010 703.4.1 CBC 2007 1117B.5.7 CBC 2019 11B-703.4.1 Mitigated: <input type="radio"/> YES <input checked="" type="radio"/> NO			10 JOB	\$150	\$1,500

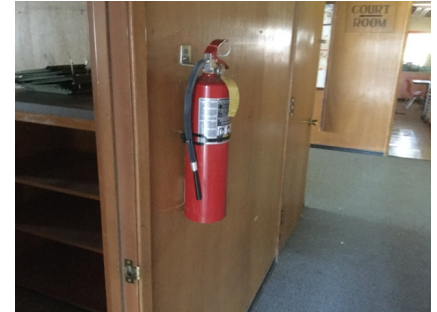
46	<ul style="list-style-type: none"> As-Built Description: Protruding objects more than 4" from wall, when bottom of object more than 27" or less than 80" above finished floor. As-Built: Protruding 5.25" at 38.5" high Proposed Solution: Remove/relocate protruding object. Patch existing surface. Notes: Relocate FE lowest edge at 27" maximum. 	PCODE EG04 ADAAG 91 4.4.1 ADA 2010 307.2 CBC 2007 1133B.8.6.1 CBC 2019 11B-307.2 Mitigated: <input type="radio"/> YES <input checked="" type="radio"/> NO	1	JOB	\$300	\$300
----	--------------------------------------------------------------------------------------------------------------------------------------------------------------------------------------------------------------------------------------------------------------------------------------------------------------------------------------------------------------------------------------------------------------	------------------------------------------------------------------------------------------------------------------------------------------------------------------------------------	---	-----	-------	-------

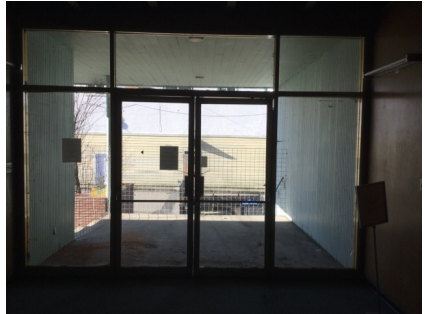
Item no., Rm no. and Name	Existing Architectural Barrier and Proposed Solution	Codes / Mitigation Info	Qty	Unit	Cost	Total
52	<ul style="list-style-type: none"> <i>As-Built Description:</i> At door leading into exit stairway: Where required exit signs are installed, signs to provide exiting information for people with vision impairment are not provided. <i>Proposed Solution:</i> Provide raised letter/Braille "EXIT STAIR UP/DOWN" sign at door. 	PCODE SA10B ADAAG 91 4.1.3(16) ADA 2010 216.4.1 CBC 2007 1011.3 CBC 2019 11B-216.4.1 Mitigated: <input type="radio"/> YES <input checked="" type="radio"/> NO	1	JOB	\$270	\$270

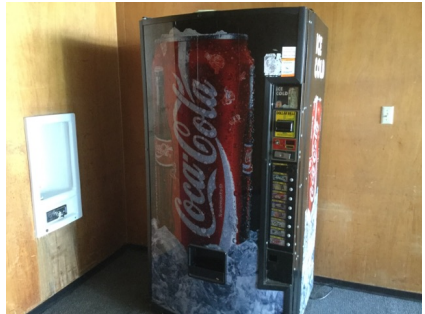
51	<ul style="list-style-type: none"> <i>As-Built Description:</i> Vending machine coin slot or dispensing outlet, for side reach, more than 48" above floor. <i>As-Built:</i> 50.25" to highest operable part <i>Proposed Solution:</i> Advise vendor/leasing company to provide accessible vending machine. 	PCODE IL01REF ADAAG 91 4.2.6 ADA 2010 308.3.1 CBC 2007 1126B CBC 2019 11B-308.3.1 Mitigated: <input type="radio"/> YES <input checked="" type="radio"/> NO	REF

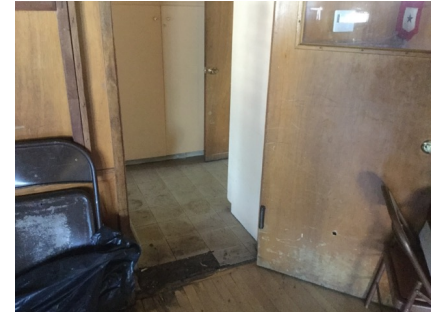
59	<ul style="list-style-type: none"> <i>As-Built Description:</i> Door on accessible route has less than 32" clear and 80" (78" min. to closer if provided) opening width when 90° open. <i>As-Built:</i> 29" wide <i>Proposed Solution:</i> Provide new, larger door and frame with new accessible hardware. 	PCODE ID01 ADAAG 91 4.13.5 ADA 2010 404.2.3 CBC 2007 1133B.1.1.1.1 CBC 2019 11B-404.2.3 Mitigated: <input type="radio"/> YES <input checked="" type="radio"/> NO	1	JOB	\$7,800	\$7,800
----	-------------------------------------------------------------------------------------------------------------------------------------------------------------------------------------------------------------------------------------------------------------------------------------------------------------------------------------------------------------	-------------------------------------------------------------------------------------------------------------------------------------------------------------------------------------------	---	-----	---------	---------

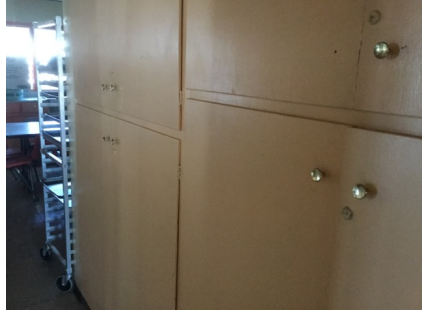
64	<ul style="list-style-type: none"> • <i>As-Built Description:</i> Cabinet or storage door / drawer does not have accessible hardware. • <i>Proposed Solution:</i> Provide accessible pull / latch (touch latches or U-pulls). 	PCODE ID07A ADAAG 91 4.25.4 ADA 2010 309.4 CBC 2007 1125B.4 CBC 2019 11B-309.4 Mitigated: <input type="radio"/> YES <input checked="" type="radio"/> NO	1	JOB	\$300	\$300

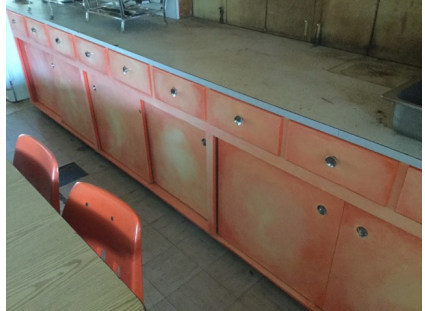
69	<ul style="list-style-type: none"> • <i>As-Built Description:</i> Cabinet or storage door / drawer does not have accessible hardware. • <i>Proposed Solution:</i> Provide accessible pull / latch (touch latches or U-pulls). 	PCODE ID07A ADAAG 91 4.25.4 ADA 2010 309.4 CBC 2007 1125B.4 CBC 2019 11B-309.4 Mitigated: <input type="radio"/> YES <input checked="" type="radio"/> NO	1	JOB	\$300	\$300

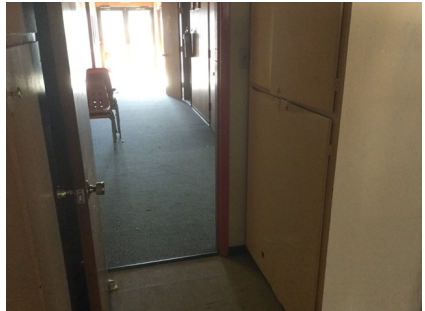
63	<ul style="list-style-type: none"> • <i>As-Built Description:</i> Front approach: At pull side, door does not have clear and level maneuvering space measuring door width plus 18" x 60". (24" x 60" at exterior doors). • <i>As-Built:</i> Door width plus 7" to cabinet • <i>Proposed Solution:</i> Remove or relocate furniture or storage items. 	PCODE ID23A ADAAG 91 Fig. 25(a) ADA 2010 404.2.4 CBC 2007 11B-26A(a) CBC 2019 11B-404.2.4 Mitigated: <input type="radio"/> YES <input checked="" type="radio"/> NO	1	JOB	\$150	\$150

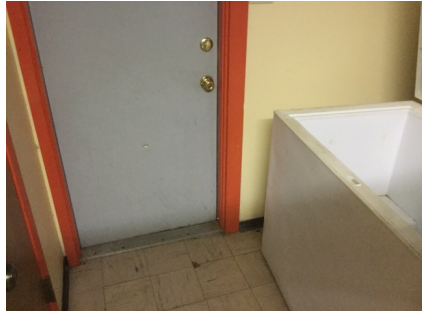
Item no., Rm no. and Name	Existing Architectural Barrier and Proposed Solution	Codes / Mitigation Info	Qty	Unit	Cost	Total
72	<ul style="list-style-type: none"> As-Built Description: Front approach: At push side, door does not have clear and level maneuvering space measuring door width x 48" (door width plus 12" if door has both, latch and closer). Proposed Solution: Remove or relocate furniture or storage items. 	PCODE ID24AREF ADAAG 91 Fig. 25(a) ADA 2010 404.2.4 CBC 2007 11B-26A(a) CBC 2019 11B-404.2.4 Mitigated: <input type="radio"/> YES <input checked="" type="radio"/> NO				REF

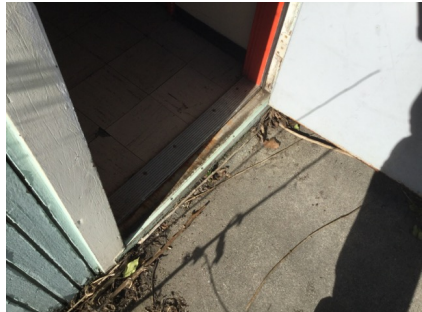
74	<ul style="list-style-type: none"> As-Built Description: Door inaccessible due to threshold or step at door exceeding 1/2"." As-Built: 3" high Proposed Solution: Modify threshold to be no more than 1/2" by removing existing paving at door and providing landing with edge ramping (slope 1:20 max). Notes: Verify if required fire exit. 	PCODE ID02AREF ADAAG 91 4.13.8 ADA 2010 404.2.5 CBC 2007 1133B.2.4.1 CBC 2019 11B-404.2.5 Mitigated: <input type="radio"/> YES <input checked="" type="radio"/> NO				REF

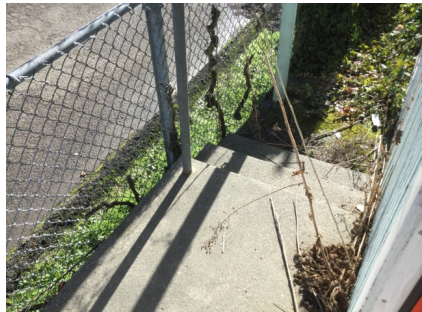
73	<ul style="list-style-type: none"> As-Built Description: Handrail not provided at stairs or ramp, required on both sides (not required at curb ramps or adjacent to seating areas). Proposed Solution: Provide new handrail for each side including extensions. Notes: Verify if required fire exit. 	PCODE ED01REF ADAAG 91 4.8.5 & 4.9.4 ADA 2010 505.2 CBC 2007 1133B.4.1.1 CBC 2019 & .5.5 11B-505.2 Mitigated: <input type="radio"/> YES <input checked="" type="radio"/> NO				REF

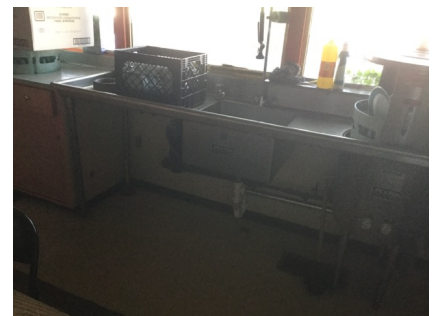
- *As-Built Description:*
 Sink does not have knee space min. 27" high x 19" deep x 30" wide.
- *As-Built:* **Knee space: 24" high**
- *Proposed Solution:*
 Remodel sink cabinet.

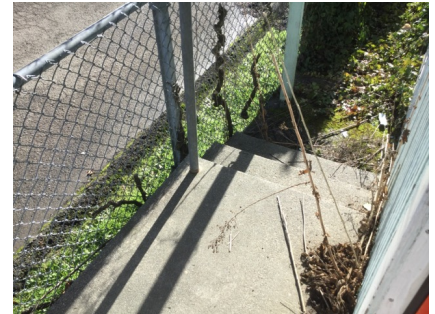
Tread Surface

140 • *As-Built Description:*
 Contrasting color strip not provided at all stair nosings.
 • *Proposed Solution:*
 Provide contrasting color strips at all exterior stair treads when altering area.
 • **Notes:**
Verify if required fire exit.

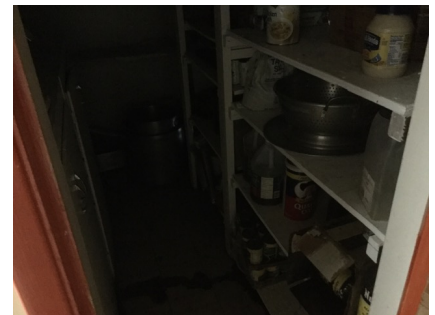
Turning Space

70 • *As-Built Description:*
 The area does not provide a minimum 60" diameter turning space within to allow maneuvering through the space.
 • *Proposed Solution:*
 Modify area to provide sufficient maneuvering space.

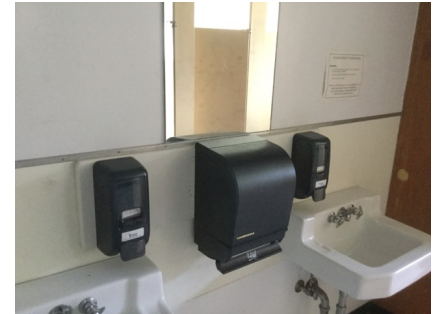
4 Women Restroom

- 83
- *As-Built Description:*
Bottom of mirror located above lavatories or countertops more than 40" above floor.
 - *As-Built:* **50" high**
 - *Proposed Solution:*
Relocate or provide new accessible mirror.

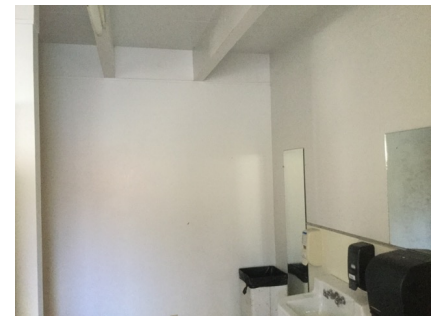
Alarm Signal

- 87
- *As-Built Description:*
At facility with a fire alarm system, visual signal (strobe) not provided at required type of common use area.
 - *Proposed Solution:*
Provide combination visual / audible signal device connected to existing fire alarm system.

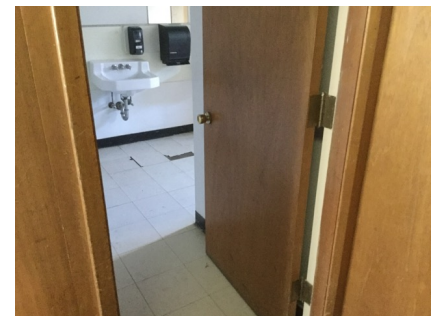
Door Pair

- 78
- *As-Built Description:*
Pair of doors on accessible route has less than 32" clear opening width with one leaf open 90°.
 - *As-Built:* **29.25" wide**
 - *Proposed Solution:*
Provide new, wider door pair and frame with new accessible hardware.

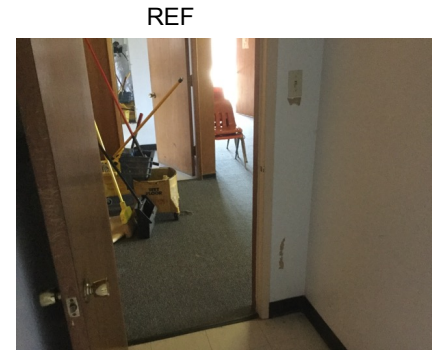
Door Swing

79 • *As-Built Description:*
 Front approach: At pull side, door does not have clear and level maneuvering space measuring door width plus 18" x 60". (24" x 60" at exterior doors).
 • *As-Built:* **Door width plus 11" to wall**
 • *Proposed Solution:*
 Provide relocated new door and frame; remodel walls as needed.

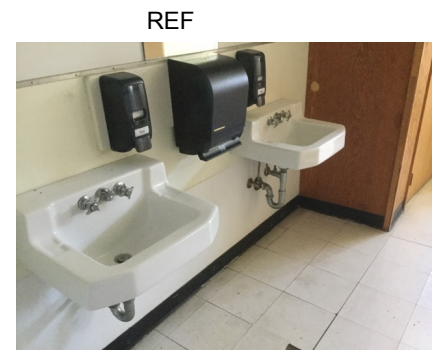
Lavatory

80 • *As-Built Description:*
 Knee clearance 27" min. high starting 8" back from the front edge of the lavatory towards the wall is not provided.
 • *As-Built:* **Knee space: 25" high**
 • *Proposed Solution:*
 Provide new accessible lavatory. Remodel restroom as needed.

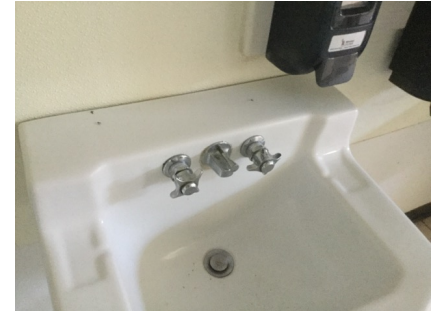
Item no., Rm no. and Name	Existing Architectural Barrier and Proposed Solution	Codes / Mitigation Info	Qty	Unit	Cost	Total
82	<ul style="list-style-type: none"> <i>As-Built Description:</i> Lavatory: Accessible faucet (lever-operated, push-type or electronically controlled) not provided at otherwise accessible lavatory. <i>Proposed Solution:</i> Provide accessible faucet at accessible lavatory. 	PCODE WD06REF ADAAG 91 4.19.5 ADA 2010 606.4 CBC 2007 1115B.4.3 CBC 2019 11B-606.4 Mitigated: <input type="radio"/> YES <input checked="" type="radio"/> NO				REF
<input type="radio"/> Staff Only

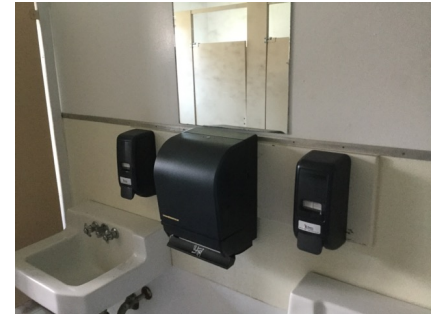
5 Men Restroom

- 91 • *As-Built Description:*
 Bottom of mirror located above lavatories or countertops more than 40" above floor.
- *As-Built:* **50" high**
- *Proposed Solution:*
 Relocate or provide new accessible mirror.

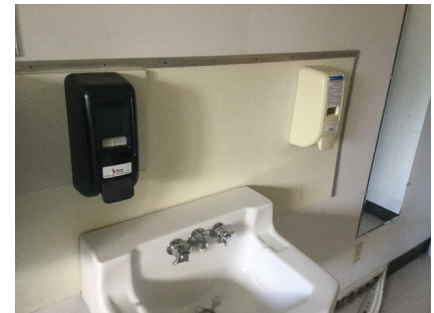
- 94 • *As-Built Description:*
 Dispensers in sanitary facilities, such as for towels, soap, sanitary napkins, seat covers, etc., and waste receptacles more than 48" (CA only: 40") from floor to highest operating slot or control.
- *As-Built:* **SD: 41" high**
- *Proposed Solution:*
 Relocate existing restroom accessories.

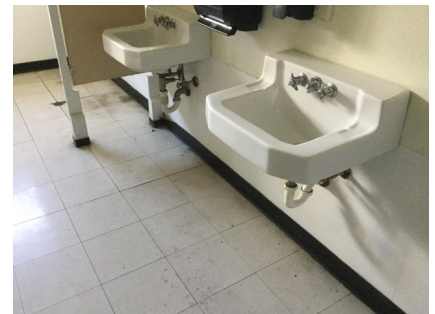
- 93
- *As-Built Description:*
 Hot or sharp-surfaced water/drain pipe not insulated or covered.
 - *Proposed Solution:*
 Insulate or cover water/drain pipe.

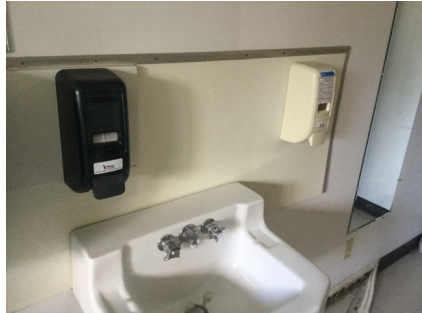
Item no., Rm no. and Name	Existing Architectural Barrier and Proposed Solution	Codes / Mitigation Info	Qty	Unit	Cost	Total
139	<ul style="list-style-type: none"> As-Built Description: Lavatory: Accessible faucet (lever-operated, push-type or electronically controlled) not provided at otherwise accessible lavatory. Proposed Solution: Provide accessible faucet at accessible lavatory. 	PCODE WD06REF ADAAG 91 4.19.5 ADA 2010 606.4 CBC 2007 1115B.4.3 CBC 2019 11B-606.4 Mitigated: <input type="radio"/> YES <input checked="" type="radio"/> NO				
						REF

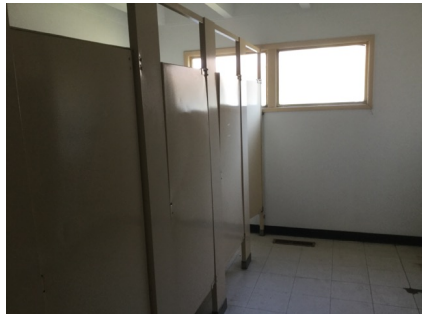
Semi-Ambulant Stall

98	<ul style="list-style-type: none"> As-Built Description: Semi-Ambulant stall with 36" width, parallel grab bars, and out-swinging door not provided (one required where 6 or more exist). Proposed Solution: Provide 36" wide stall with out-swinging door and two side grab bars. Remodel restroom as needed. Notes: 5 stalls and 2 urinals. 	PCODE WB06AREF ADAAG 91 4.22.4 ADA 2010 213.3.1 & 604.8.2 CBC 2007 1115B.3.1.5 CBC 2019 11B-213.3.1 & 11B-604.8.2 Mitigated: <input type="radio"/> YES <input checked="" type="radio"/> NO				
						REF

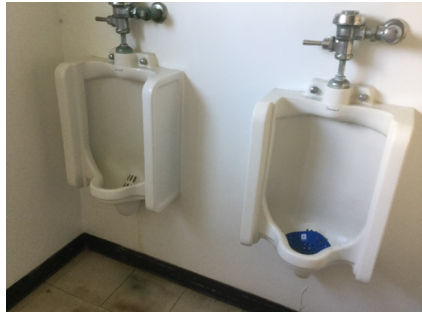
Item no., Rm no. and Name	Existing Architectural Barrier and Proposed Solution	Codes / Mitigation Info	Qty	Unit	Cost	Total
96	<ul style="list-style-type: none"> As-Built Description: CA only: Front of rim projects less than 13.5" from wall. As-Built: 12" deep Proposed Solution: Provide accessible urinal. Remodel restroom as needed. 	<p>PCODE WE01REF ADA 2010 605.2 CBC 2007 1115B.4.2.1 CBC 2019 11B-605.2</p> <p>Mitigated: <input type="radio"/> YES <input checked="" type="radio"/> NO</p>		REF

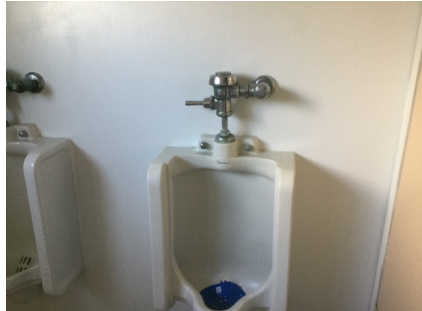
<input type="radio"/> Staff Only			
97	<ul style="list-style-type: none"> As-Built Description: Urinal flush control lever more than 48" above floor. (CA Only: 44" max.) As-Built: 49" high Proposed Solution: Provide accessible urinal flush control. 	<p>PCODE WE03REF ADAAG 91 4.18.4 ADA 2010 605.4 CBC 2007 1115B.4.2.2 CBC 2019 11B-605.4</p> <p>Mitigated: <input type="radio"/> YES <input checked="" type="radio"/> NO</p>		REF

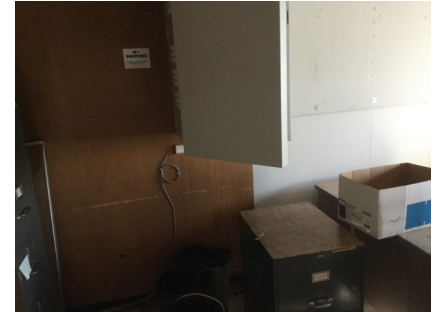
Protrusion Limits

108	<ul style="list-style-type: none"> As-Built Description: Protruding objects more than 4" from wall, when bottom of object more than 27" or less than 80" above finished floor. As-Built: Protruding 24" at 46" high Proposed Solution: Provide cane-detectable railing to mark area of low clearance. 	PCODE EG04A ADAAG 91 4.4.1 ADA 2010 307.2 CBC 2007 1133B.8.6.1 CBC 2019 11B-307.2 Mitigated: <input type="radio"/> YES <input checked="" type="radio"/> NO	4	LF	\$300	\$1,200
-----	-----------------------------------------------------------------------------------------------------------------------------------------------------------------------------------------------------------------------------------------------------------------------------------------------------------------------------------------------	-------------------------------------------------------------------------------------------------------------------------------------------------------------------------------------	---	----	-------	---------

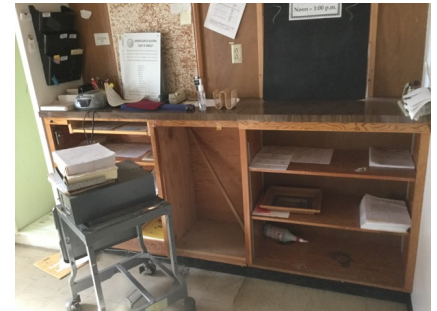
Public Counter

109	<ul style="list-style-type: none"> As-Built Description: Service counter (stand-up): Accessible section min. 36" length and 36" max. height (in CA: 28" to 34" high) not provided. As-Built: 42" high Proposed Solution: Retrofit existing counter to provide accessible section. Interim solution: Provide auxiliary counter, table, or clipboard. Notes: At staff side of service counter. 	PCODE IN03 ADAAG 91 7.2(2) ADA 2010 904.4 CBC 2007 1122B.4 CBC 2019 11B-904.4 Mitigated: <input type="radio"/> YES <input checked="" type="radio"/> NO	1	JOB	\$6,000	\$6,000
-----	------------------------------------------------------------------------------------------------------------------------------------------------------------------------------------------------------------------------------------------------------------------------------------------------------------------------------------------------------------------------------------------------------------------------------------------------------	---------------------------------------------------------------------------------------------------------------------------------------------------------------------------------	---	-----	---------	---------

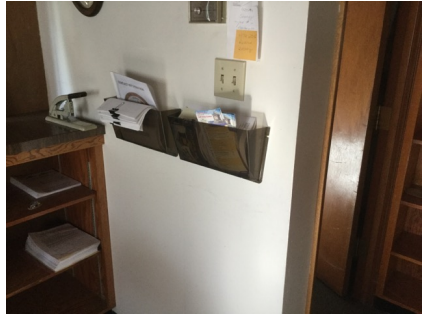
Item no., Rm no. and Name	Existing Architectural Barrier and Proposed Solution	Codes / Mitigation Info	Qty	Unit	Cost	Total
111	<ul style="list-style-type: none"> As-Built Description: Reach height to control or access point, exceeds 48" or is less than 15". As-Built: 49" high Proposed Solution: Modify equipment or mounting. 	PCODE IE01 ADAAG 91 4.2.5 ADA 2010 308.2.1 CBC 2007 1118B.5 CBC 2019 11B-308.2.1 Mitigated: <input type="radio"/> YES <input checked="" type="radio"/> NO	1	JOB	\$300	\$300

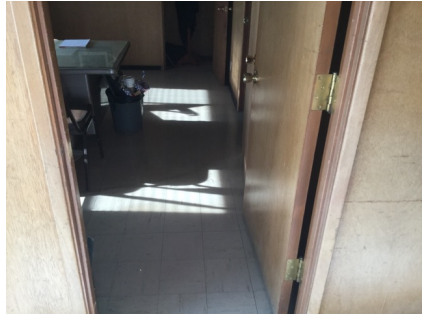
Door Clearance

<p>113</p> <ul style="list-style-type: none"> • <i>As-Built Description:</i> Door on accessible route has less than 32" clear and 80" (78" min. to closer if provided) opening width when 90° open. • <i>As-Built:</i> 29" wide • <i>Proposed Solution:</i> Provide new, larger door and frame with new accessible hardware. 	<p>PCODE ID01 ADAAG 91 4.13.5 ADA 2010 404.2.3 CBC 2007 1133B.1.1.1.1 CBC 2019 11B-404.2.3</p> <p>Mitigated: <input type="radio"/> YES <input checked="" type="radio"/> NO</p>	<p>1 JOB \$7,800 \$7,800</p>

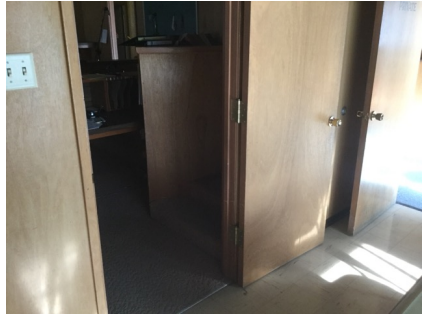
<p>115</p> <ul style="list-style-type: none"> • <i>As-Built Description:</i> Door on accessible route has less than 32" clear and 80" (78" min. to closer if provided) opening width when 90° open. • <i>As-Built:</i> 31.5" wide • <i>Proposed Solution:</i> Provide new, larger door and frame with new accessible hardware. 	<p>PCODE ID01 ADAAG 91 4.13.5 ADA 2010 404.2.3 CBC 2007 1133B.1.1.1.1 CBC 2019 11B-404.2.3</p> <p>Mitigated: <input type="radio"/> YES <input checked="" type="radio"/> NO</p>	<p>1 JOB \$7,800 \$7,800</p>

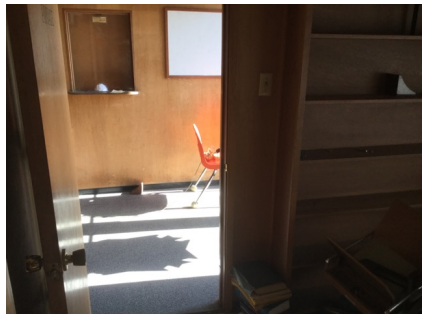
Door Swing

<p>114</p> <ul style="list-style-type: none"> • <i>As-Built Description:</i> Front approach: At pull side, door does not have clear and level maneuvering space measuring door width plus 18" x 60". (24" x 60" at exterior doors). • <i>As-Built:</i> Door width plus 11.5" to cabinet • <i>Proposed Solution:</i> Remove or relocate furniture or storage items. 	<p>PCODE ID23A ADAAG 91 Fig. 25(a) ADA 2010 404.2.4 CBC 2007 11B-26A(a) CBC 2019 11B-404.2.4</p> <p>Mitigated: <input type="radio"/> YES <input checked="" type="radio"/> NO</p>	<p>1 JOB \$150 \$150</p>

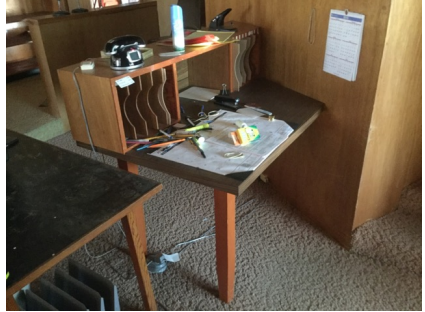
Clerk's Station

131	<ul style="list-style-type: none"> As-Built Description: Court clerk's station/floor space does not have accessible seating space. Proposed Solution: Modify station/floor space to provide accessible wheelchair space. Notes: Redesign judge, witness and jury areas as a whole. 	PCODE JA06 ADAAG 91 11.2.1(4) ADA 2010 808.4 CBC 2007 1105B.3.5 CBC 2019 11B-808.4	1	JOB	\$1,800	\$1,800
-----	-------------------------------------------------------------------------------------------------------------------------------------------------------------------------------------------------------------------------------------------------------------------------------------------------------------------------------------------------------------	------------------------------------------------------------------------------------------------	---	-----	---------	---------

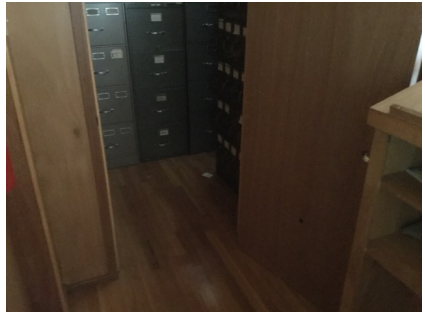
Door Clearance

125	<ul style="list-style-type: none"> As-Built Description: Door on accessible route has less than 32" clear and 80" (78" min. to closer if provided) opening width when 90° open. As-Built: 27.5" wide Proposed Solution: Provide new, larger door and frame with new accessible hardware. 	PCODE ID01 ADAAG 91 4.13.5 ADA 2010 404.2.3 CBC 2007 1133B.1.1.1.1 CBC 2019 11B-404.2.3	1	JOB	\$7,800	\$7,800
-----	---------------------------------------------------------------------------------------------------------------------------------------------------------------------------------------------------------------------------------------------------------------------------------------------------------------------------------------------------------------	-----------------------------------------------------------------------------------------------------	---	-----	---------	---------

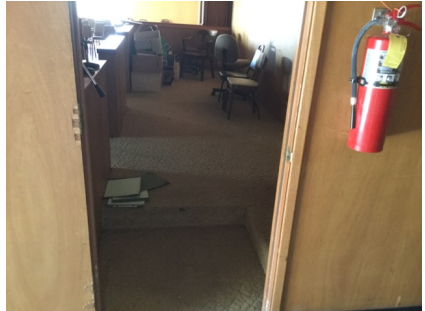
129	<ul style="list-style-type: none"> As-Built Description: Door on accessible route has less than 32" clear and 80" (78" min. to closer if provided) opening width when 90° open. As-Built: 31.5" wide Proposed Solution: Provide new, larger door and frame with new accessible hardware. 	PCODE ID01 ADAAG 91 4.13.5 ADA 2010 404.2.3 CBC 2007 1133B.1.1.1.1 CBC 2019 11B-404.2.3	1	JOB	\$7,800	\$7,800
-----	---------------------------------------------------------------------------------------------------------------------------------------------------------------------------------------------------------------------------------------------------------------------------------------------------------------------------------------------------------------	-----------------------------------------------------------------------------------------------------	---	-----	---------	---------

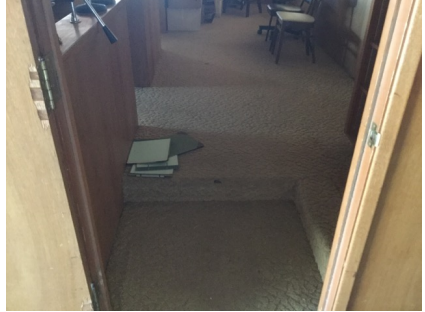
Jury Box

130	<ul style="list-style-type: none"> <i>As-Built Description:</i> Accessible route to jury box not provided. <i>Proposed Solution:</i> Provide ramp to jury box level. Notes: Redesign judge, witness and jury areas as a whole. 	PCODE JA02A ADAAG 91 11.2.1 ADA 2010 402.2 CBC 2007 1105B.3.5 CBC 2019 11B-402.2 Mitigated: <input type="radio"/> YES <input checked="" type="radio"/> NO	20	LF	\$300	\$6,000
-----	-------------------------------------------------------------------------------------------------------------------------------------------------------------------------------------------------------------------------------------------------------------------------------------------	-------------------------------------------------------------------------------------------------------------------------------------------------------------------------------------------	----	----	-------	---------

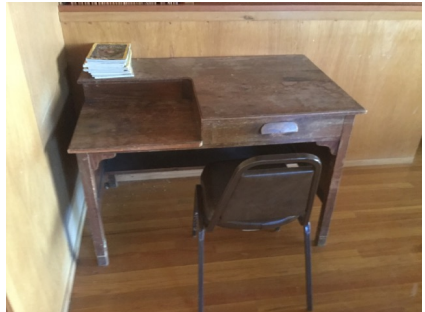
Non-Fixed Desk

122	<ul style="list-style-type: none"> <i>As-Built Description:</i> Accessible non-fixed table or desk (top 28" to 34" high; knee space at least 27" high x 19" deep x 30" wide) not provided. <i>As-Built:</i> Knee space: 25" high <i>Proposed Solution:</i> Provide table or desk with accessible dimensions when purchasing new furniture. 	PCODE IN02A ADAAG 91 4.32.3 & 4 ADA 2010 306.1 CBC 2007 1122B.3 & 4 CBC 2019 11B-306.1 & 11B-902.3 Mitigated: <input type="radio"/> YES <input checked="" type="radio"/> NO	1	JOB	\$4,800	\$4,800
-----	--------------------------------------------------------------------------------------------------------------------------------------------------------------------------------------------------------------------------------------------------------------------------------------------------------------------------------------------------------------------------------------------	-------------------------------------------------------------------------------------------------------------------------------------------------------------------------------------------------------------	---	-----	---------	---------

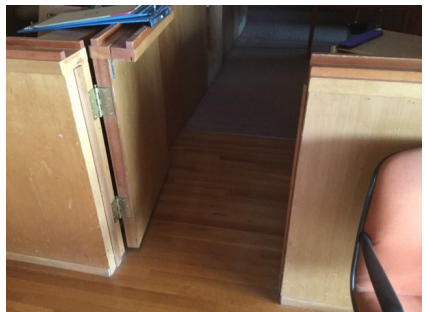
Path of Travel

121	<ul style="list-style-type: none"> <i>As-Built Description:</i> Interior gate not accessible (same requirements as for doors). <i>As-Built:</i> 27" wide <i>Proposed Solution:</i> Remodel gate for accessibility. 	PCODE JA01 ADAAG 91 11.2.1(1) ADA 2010 404.2.3 CBC 2007 1105B.3.5 CBC 2019 11B-404.2.3 Mitigated: <input type="radio"/> YES <input checked="" type="radio"/> NO	1	JOB	\$1,050	\$1,050
-----	--------------------------------------------------------------------------------------------------------------------------------------------------------------------------------------------------------------------------------------------------------------------	-------------------------------------------------------------------------------------------------------------------------------------------------------------------------------------------------	---	-----	---------	---------

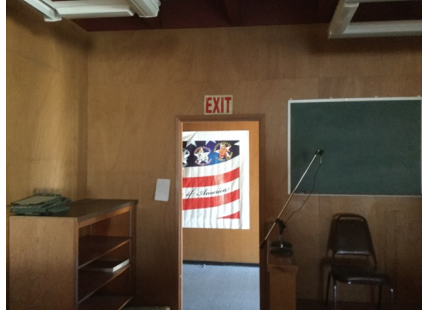
Signage

116	<ul style="list-style-type: none"> As-Built Description: At door leading into exit corridor: Where required exit signs are installed, signs to provide exiting information for people with vision impairment are not provided. Proposed Solution: Provide raised letter/Braille "EXIT ROUTE" sign at door. 	<p>PCODE SA10D ADAAG 91 4.1.3(16) ADA 2010 216.4.1 CBC 2007 1011.3 CBC 2019 11B-216.4.1</p> <p>Mitigated: <input type="radio"/> YES <input checked="" type="radio"/> NO</p>	1	JOB	\$270	\$270
-----	----------------------------------------------------------------------------------------------------------------------------------------------------------------------------------------------------------------------------------------------------------------------------------------------------------------------------------------------------------	--------------------------------------------------------------------------------------------------------------------------------------------------------------------------------------------------------------------------------------------------------------------------------------------------	---	-----	-------	-------

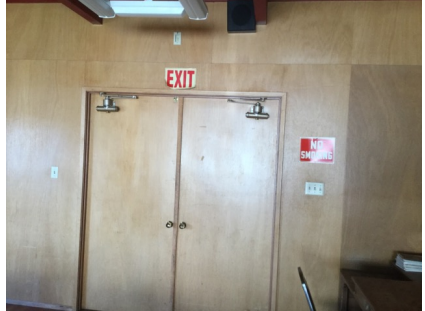
119	<ul style="list-style-type: none"> As-Built Description: At door leading into exit corridor: Where required exit signs are installed, signs to provide exiting information for people with vision impairment are not provided. Proposed Solution: Provide raised letter/Braille "EXIT ROUTE" sign at door. 	<p>PCODE SA10D ADAAG 91 4.1.3(16) ADA 2010 216.4.1 CBC 2007 1011.3 CBC 2019 11B-216.4.1</p> <p>Mitigated: <input type="radio"/> YES <input checked="" type="radio"/> NO</p>	1	JOB	\$270	\$270
-----	----------------------------------------------------------------------------------------------------------------------------------------------------------------------------------------------------------------------------------------------------------------------------------------------------------------------------------------------------------	--------------------------------------------------------------------------------------------------------------------------------------------------------------------------------------------------------------------------------------------------------------------------------------------------	---	-----	-------	-------

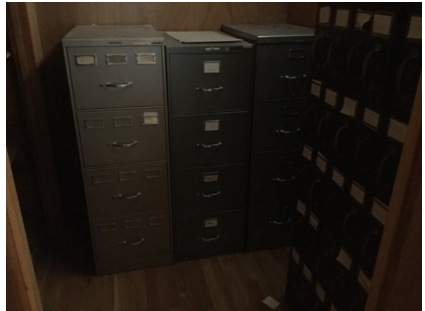
Turning Space

127	<ul style="list-style-type: none"> As-Built Description: The area does not provide a minimum 60" diameter turning space within to allow maneuvering through the space. Proposed Solution: Modify area to provide sufficient maneuvering space. Notes: Rearrange existing cabinets. 	<p>PCODE IH05 ADA 2010 304.3 CBC 2019 11B-304.3</p> <p>Mitigated: <input type="radio"/> YES <input checked="" type="radio"/> NO</p>	1	JOB	\$1,500	\$1,500
-----	------------------------------------------------------------------------------------------------------------------------------------------------------------------------------------------------------------------------------------------------------------------------------------------------------------------------------------------------------	--------------------------------------------------------------------------------------------------------------------------------------------------------------------------------------------------------	---	-----	---------	---------

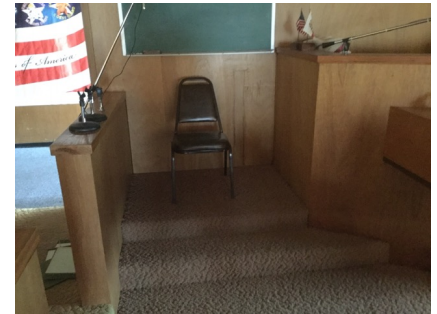
Witness Stand

- 134
- *As-Built Description:*
Accessible route to witness stand not provided.
 - *Proposed Solution:*
Provide ramp to witness stand level.
 - *Notes:*
Redesign judge, witness and jury areas as a whole.

PCODE JA03A
 ADAAG 91 11.2.1
 ADA 2010 402.2
 CBC 2007 1105B.3.5
 CBC 2019 11B-402.2
