ROADWAY ASSESSMENT REPORT

SITE ACCESS ROAD(S)

**French Road
Miranda, California
APN: 214-234-006
and
APN: 214-234-007**

**September, 2018
Josh McKnight, P.E.
Job #756.05**

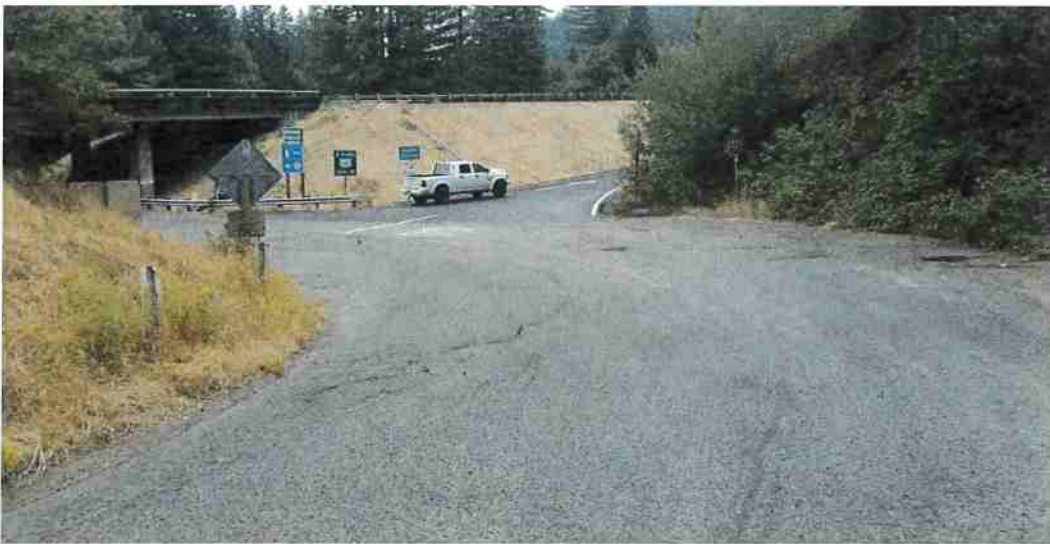
Figure 1. Photograph showing the start of Gibney Drive from the highway 101 on-ramp.

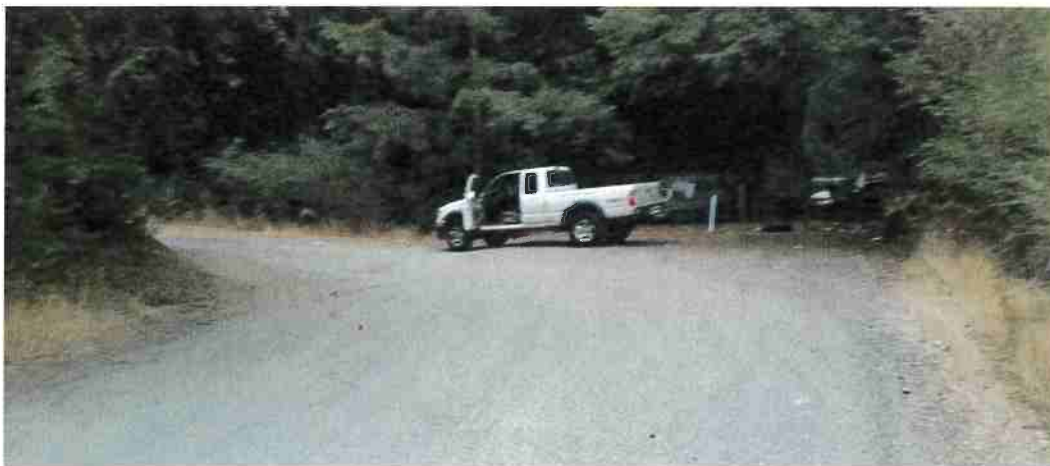
Figure 2. Photograph showing the end of Gibney Drive and the start of French road.

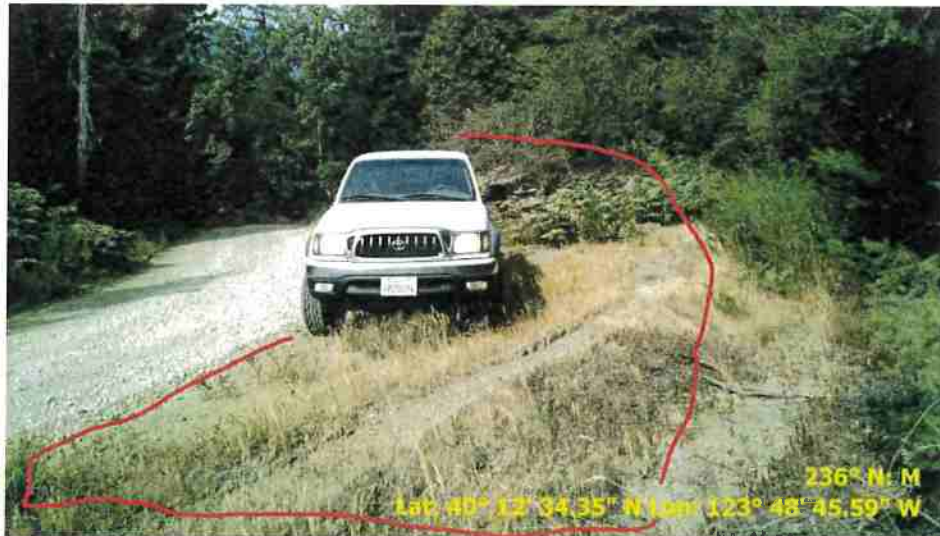
Figure 13. Photograph showing Road Point 64 which is a pullout that needs to be regraded to make room for larger vehicles.

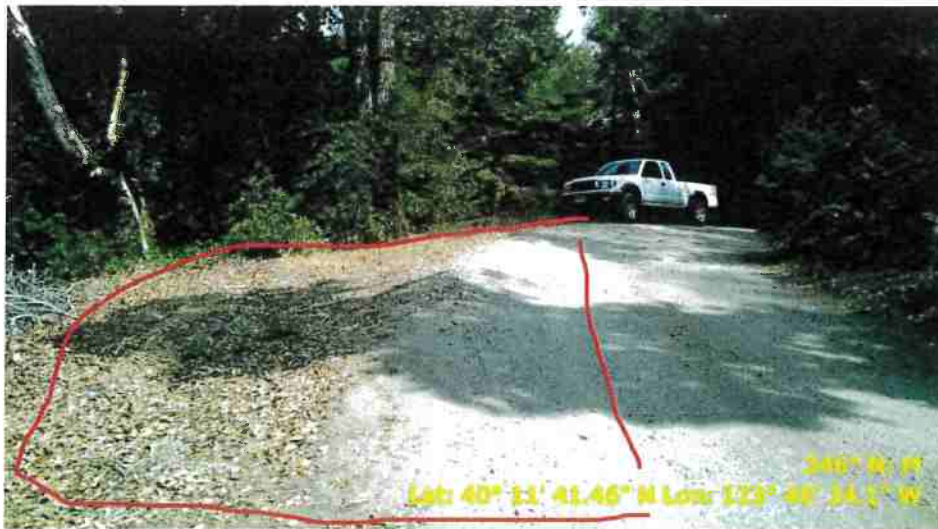
Figure 30. Photo of Road Point 103 showing a pullout that needs to be regraded.

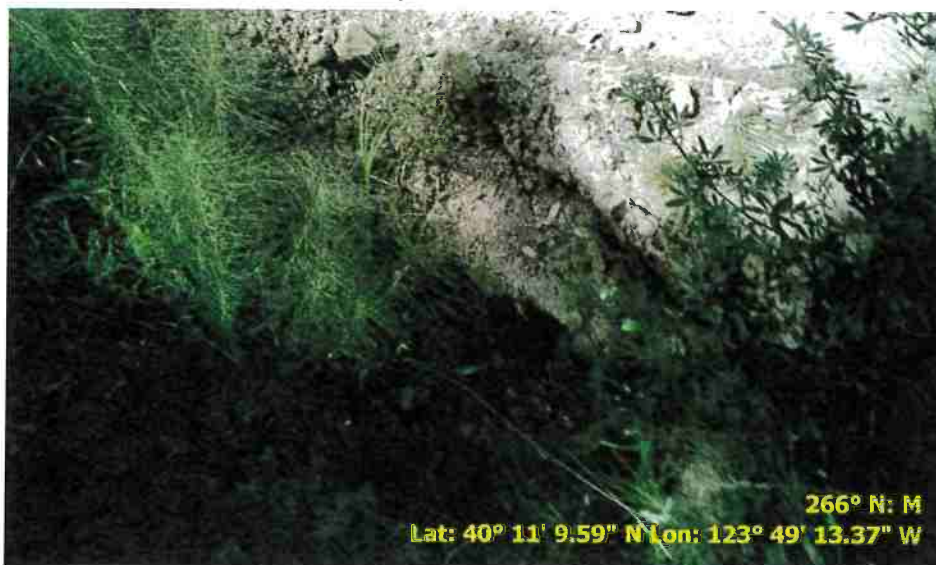
Point ID	Comments	Latitude	Longitude
1	Needs cleaning at outlet 18" CPP	40.2169964	-123.8196498
15	18" CMP with exposed opening at road, needs a plate bolted or replacement.	40.21481	-123.818
42	Clear inlet 18" CPP	40.2102757	-123.8176974
82	Clear inlet 18" CMP	40.2016473	-123.8069977
109	Clear inlet 18" CMP	40.1923786	-123.8084436
132	Clear inlet 18" CPP	40.1880211	-123.8181688
148	Clear and rock inlet of 18" concrete culvert	40.1859977	-123.8203488

Figure 46. Photo of Road Point 148 showing the inlet of an 18" onstream culvert that needs the inlet cleared and the inlet needs rock slope protection above and around the inlet.

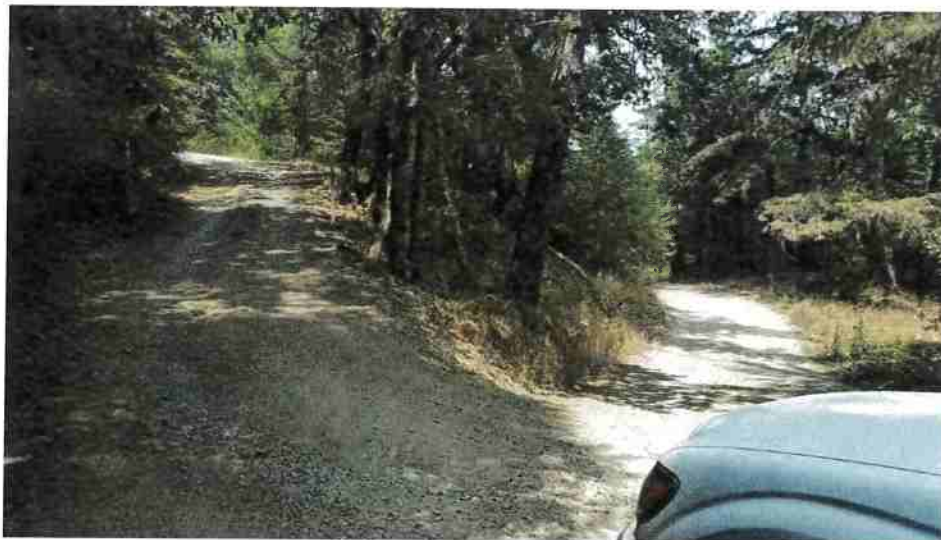
Figure 50. Road Point 202 Shows the gate at intersection of access Road 4 and the off property driveway that leads to Project 2. The start of the driveway has a slope that is approximately 18%.
