**LIMITED ASBESTOS
SURVEY & PAINT SAMPLING
FOR ADA RENOVATIONS AT THE
HUMBOLDT COUNTY MENTAL
HEALTH FACILITY
720 WOOD STREET
EUREKA, CALIFORNIA**

December 24, 2018

Project #1800321

Prepared for:
County of Humboldt
County Administrative Office
ADA Compliance Team
Attn: Mr. Travis I. Smith
825 5th Street, Room 112
Eureka, CA 95501
(707) 476-2388

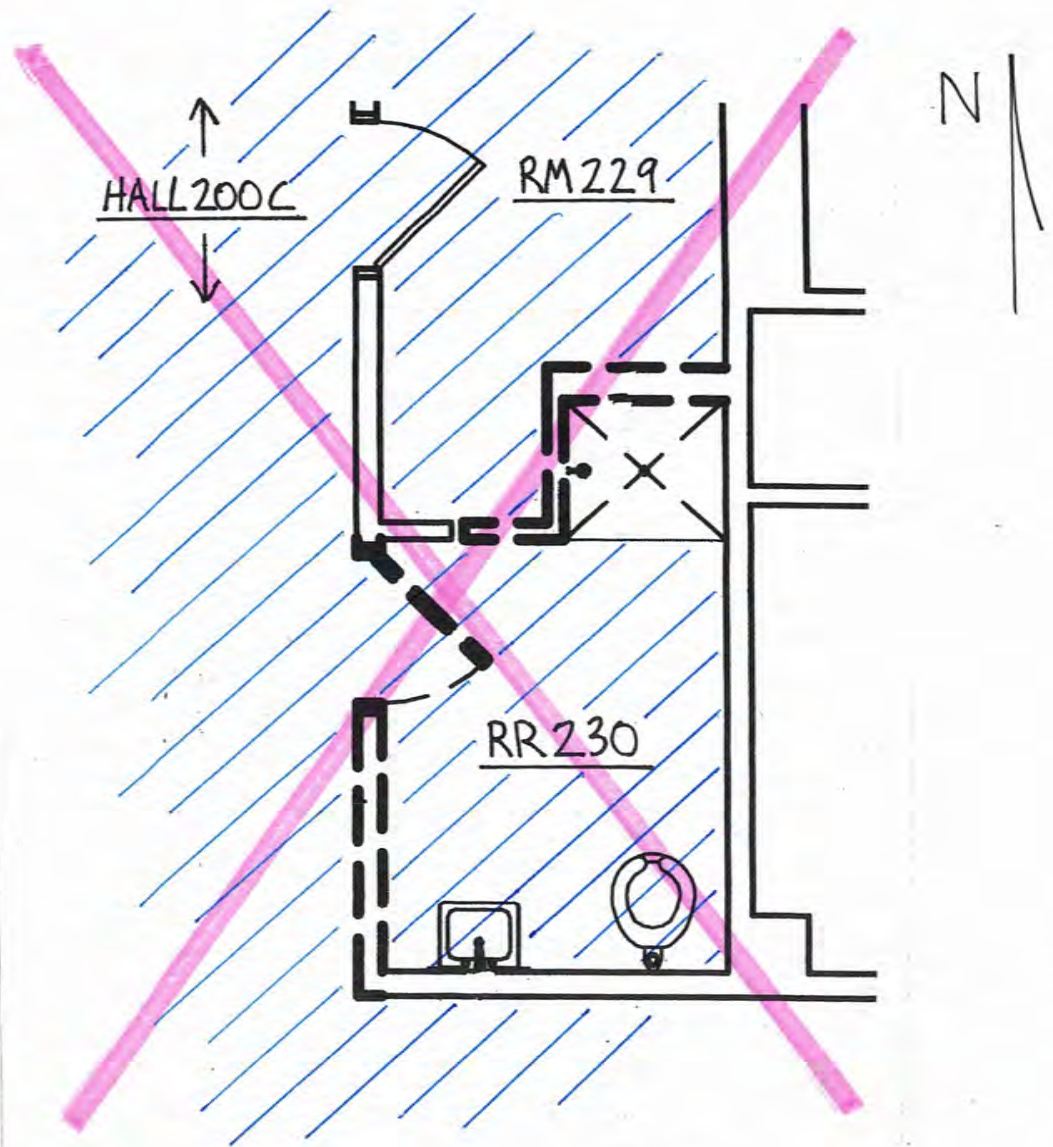
- ACCM Plaster; top coat/rough coat, all wall & ceiling plaster on the 2nd floor (see previous survey, Appendix. C)
- ACM Pipe insulation elbows & tees, white compound, found on pipes above ceilings & potentially in walls
- ACM Spray-on fireproofing, above ceiling, on ceilings, walls, around wall penetrations, and overspray on equipment and ducting
- ▣ ACM Vinyl floor tile, gray with splotches & associated ACM Black mastic
- ACCM Baseboard mastic, dark brown, potentially present as remnant baseboard mastic on all walls behind newer baseboard

Note: See Table 2 for asbestos material location details

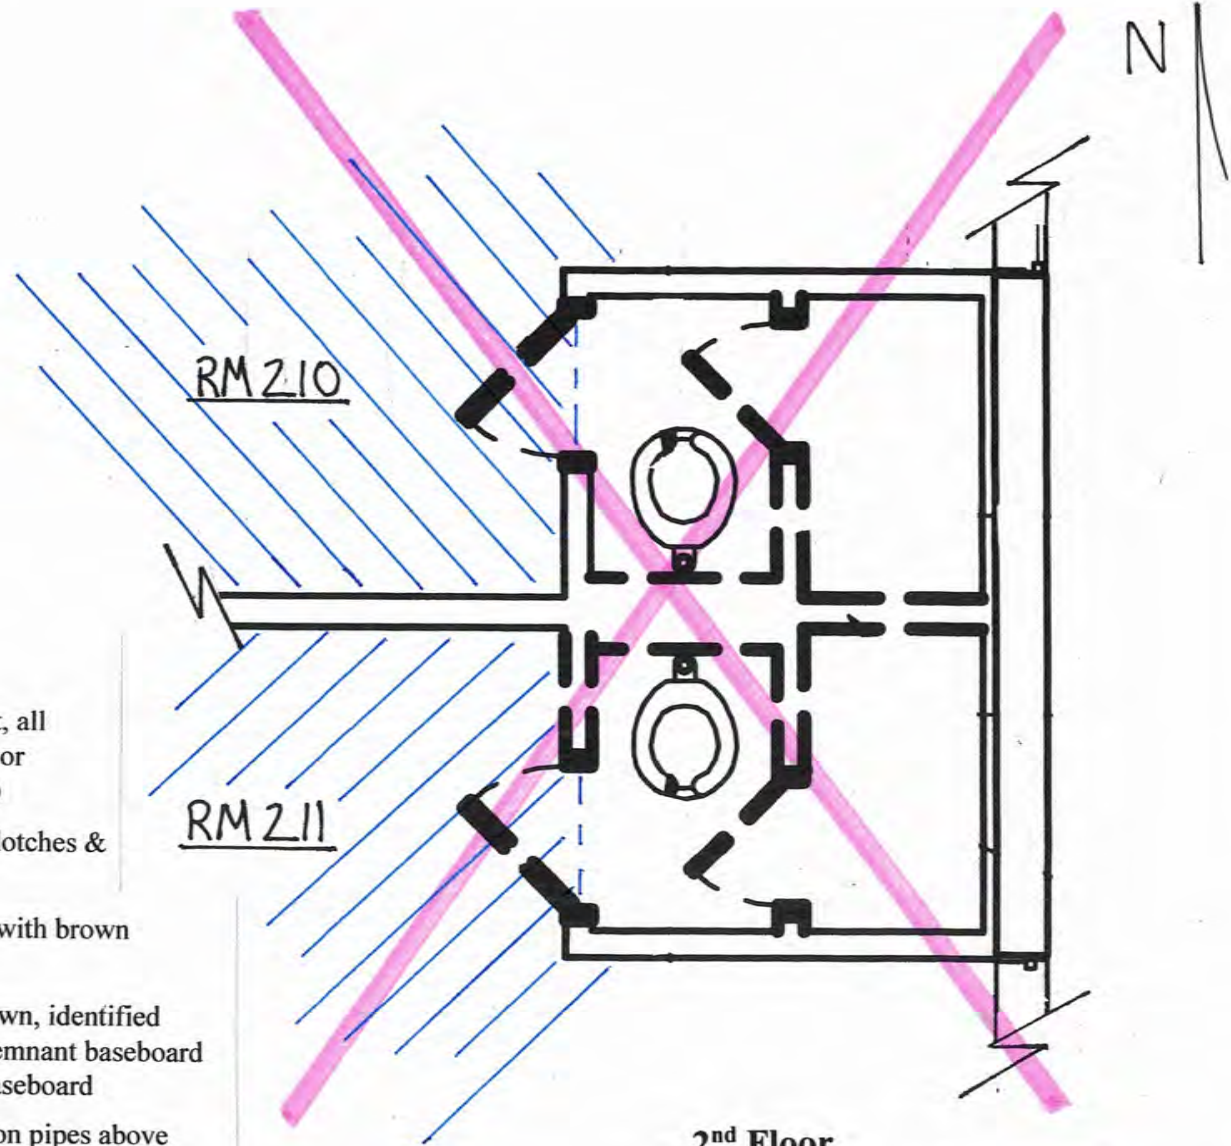
Note: potential for ACM Spray-on fireproofing above hard ceilings: on ceilings, walls, around wall penetrations, and overspray on equipment and ducting

Note: See Table 2 for asbestos material location details

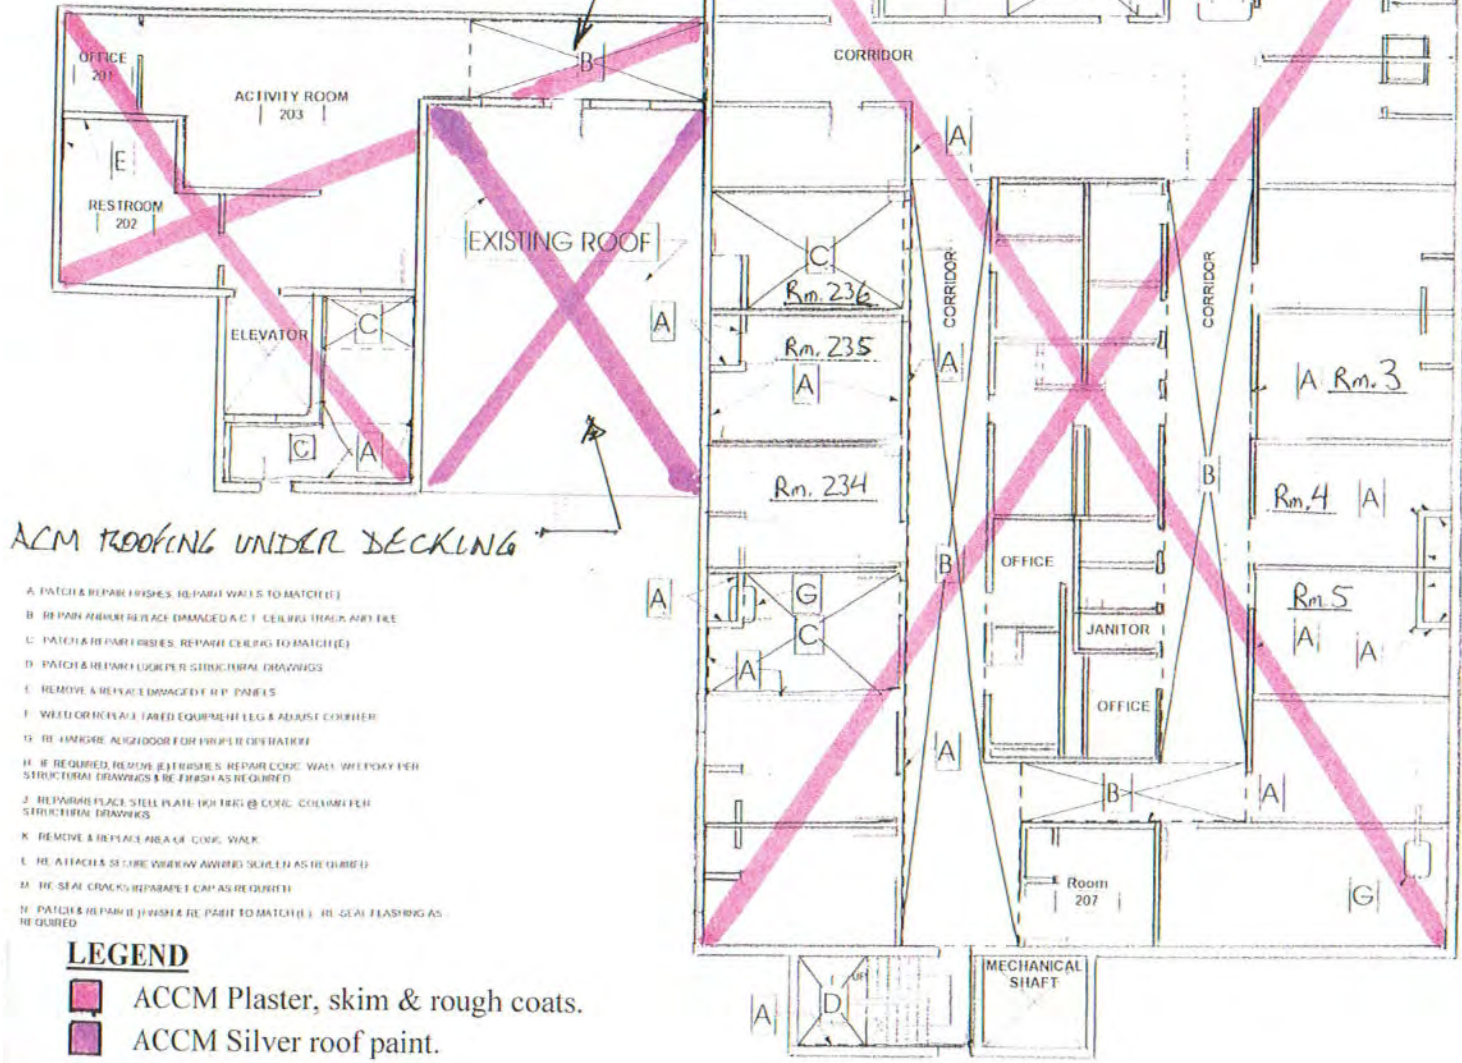
FIG 4

Piping with ACM TSI
 NOTED ABOVE DROP CEILING

ACM ROOFING UNDER DECKING

See ACM TSI notation on this Fig.
 See ACCM roofing on Figs. 5 & 6.
 See ACM VFT on Fig. 8

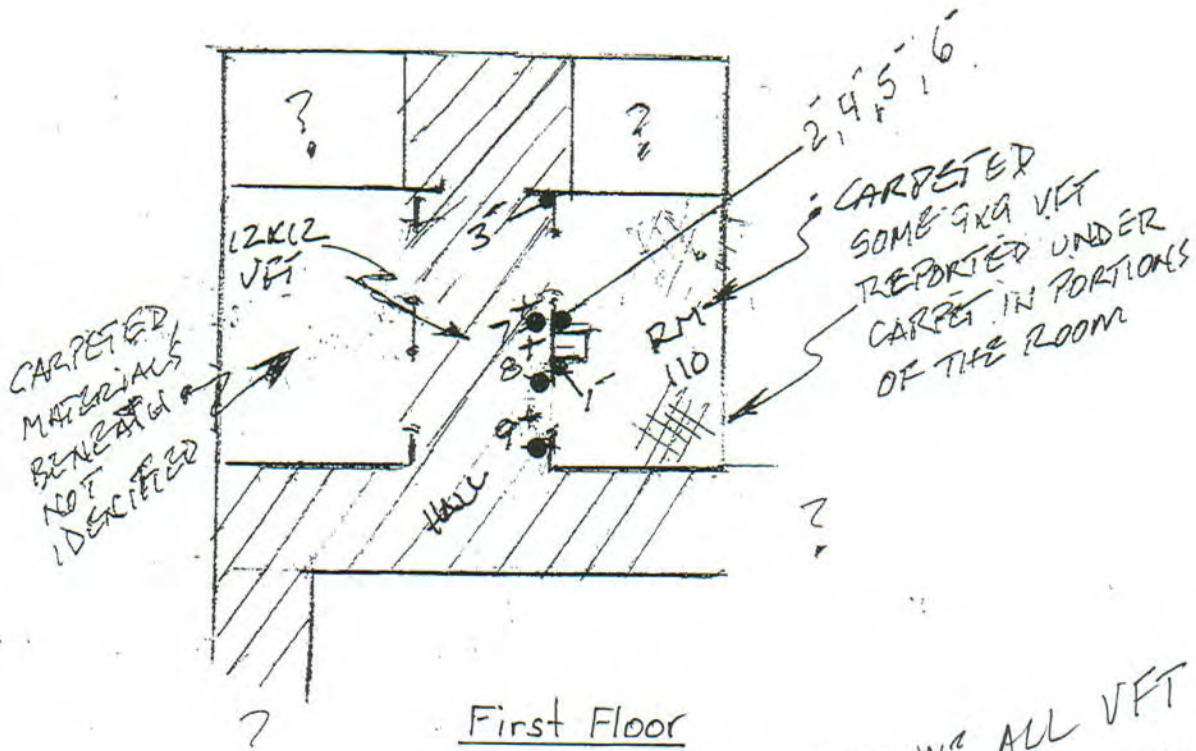
PRESUME ALL VFT ON 1ST FLOOR IS ACM

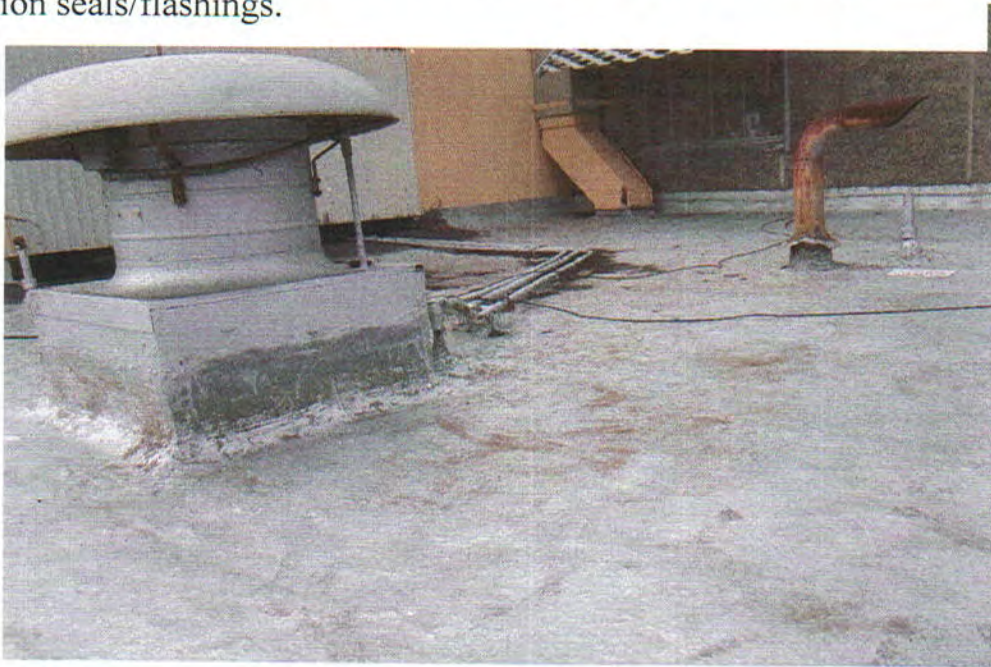
Top—Over-spray of ACM insulation above drop ceiling, 1st floor, east side of west corridor.1

Bottom—1st level roof over SE corner of Coroners offices, note silver ACM reflective paint on membrane, piping and all penetration seals/flashings.
