Jennifer Farley  
JAG Architects  
428 1st Street  
Eureka, CA 95501

At your request we have provided our professional opinion, based on one site inspection, for the historical integrity of those building structures at 281 Table Bluff Rd., Loleta CA. There are five building on site, named for the purpose of this survey as: (1) Single Family Residence, (2) Stable, (3) Garage, (4) Animal Pen and (5) Barn. (See attached annotated image, Figure 1.2)

## **Introduction**

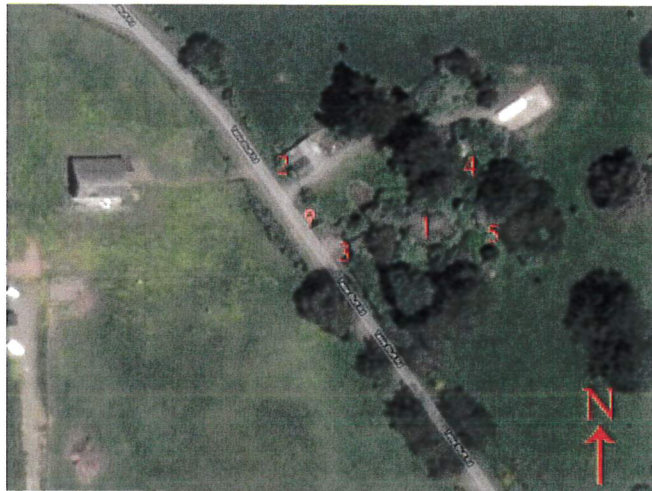
Figure 1.2 Site Plan B

The property occupies approximately one acre of land and is accessed by a private drive off the North east side of Table Bluff Road. It is considered part of the unincorporated Humboldt County. There are five buildings on the property: (1) Single Family Residence, (2) Stable, (3) Garage, (4) Animal Pen, and (5) Barn..
