# HUMBOLDT COUNTY MOTOR POOL EQUIPMENT MAINTENANCE

Location: 3130 Jacobs Avenue, Eureka, CA 95501

Use: Motor Pool & Equipment Maintenance

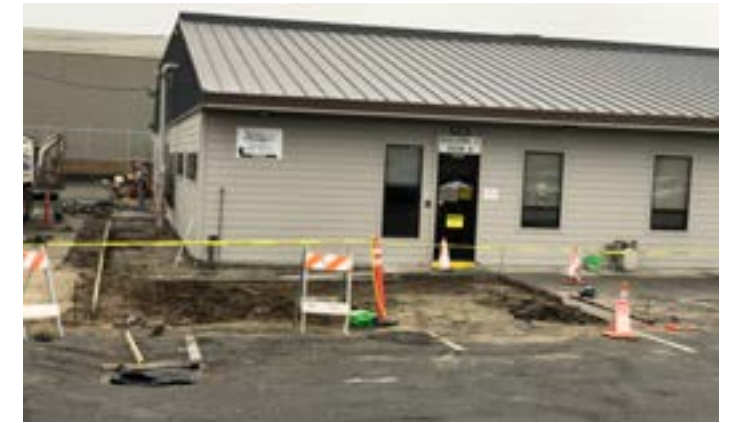
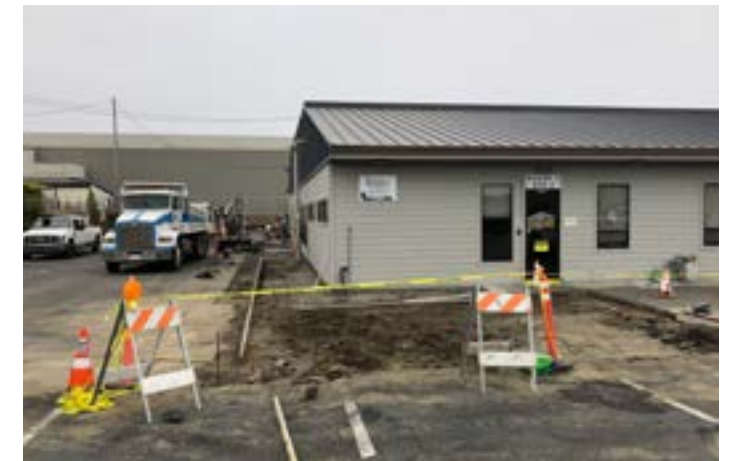
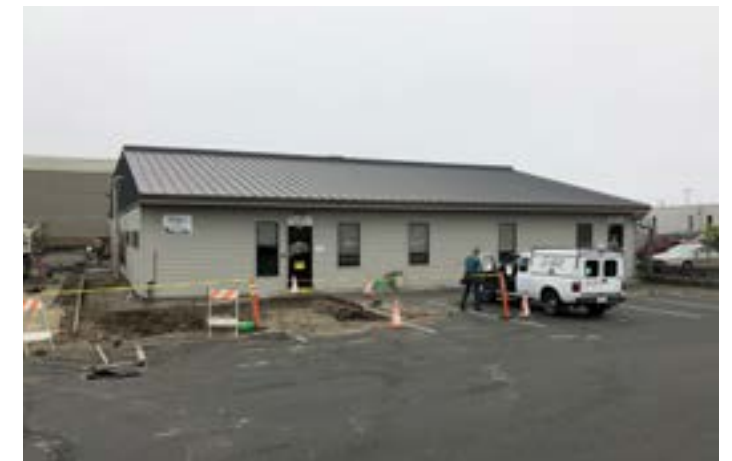
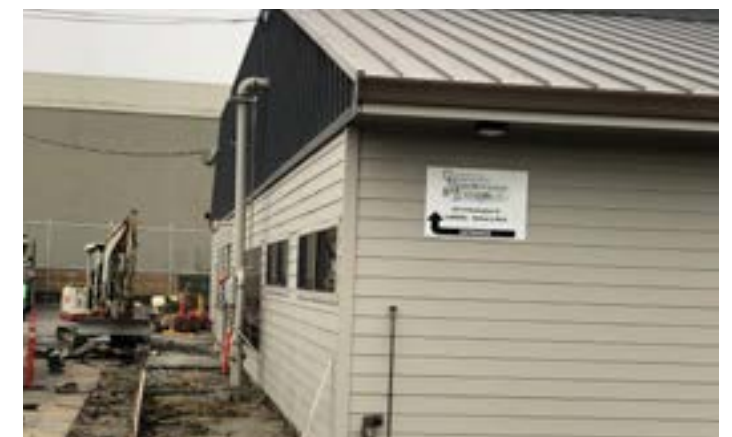
**Site:** Fences around Building B have rusted through in several places exposing jagged edges. Paint is peeling from wooden handrails. Parking striping and paint on curbs is very faded especially around Building A. Weeds are growing between cracks in sidewalk, curbing and pavement. Ground cover is dying and peppered with weeds especially around Buildings D and A. Bench bases outside Building D are quite rusted.

**Exterior Envelope:** Exterior doors throughout the complex are rusting especially around the hinges and handles. Single pane windows throughout the complex are inefficient. Metal siding on Building F is dented and showing some corrosion at the ground connection. Exterior light fixtures are showing above average signs of wear and tear.

**Roof:** No issues reported, roof appears to be in acceptable condition aside from some rusting gutter attachments.

**Structure:** Concrete structures appear to be in good condition.

**MEP:** Most systems were replaced eight years ago and continue to function as intended other than the electrical system which is undersized.

**Site:** Replace deteriorated Fences and handrails around Building B and repaint wooden handrails. Restripe parking areas and repaint faded curbs. Restore and maintain ground cover, update landscaping to drought resistant plants optional. Mediate weeds growing in paved areas. Replace rusted bench base connections.

**Exterior Envelope:** Replace corroded door hardware throughout the complex. Replacement of single pane windows with efficient counterparts is optional. Replacement of dented metal siding is optional. Replacement of exterior light fixtures is optional.

**Roof:** Replace corroded elements of gutter and downspout systems.

**Structure:** Further inspect foundations of portable structures for rot and other deterioration.

**Interior Elements:** Adjust and potentially replace compromised ceiling tiles.

**MEP:** Assess electrical needs of facilities and update/replace electrical system if necessary.

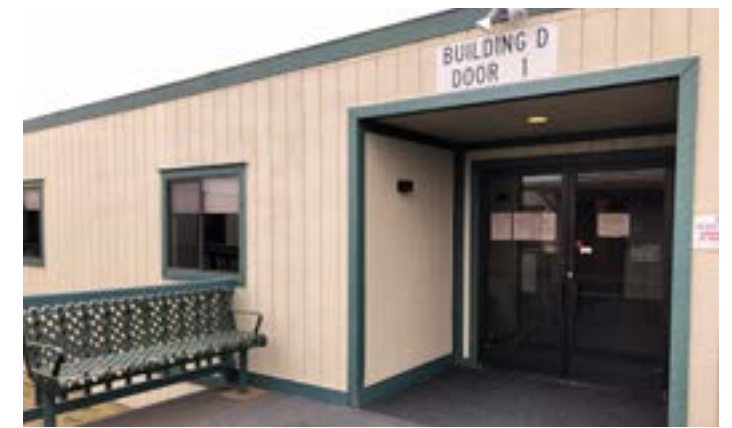
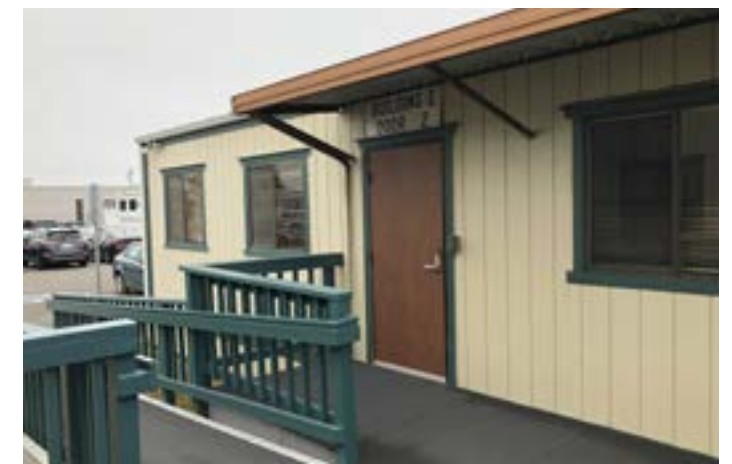
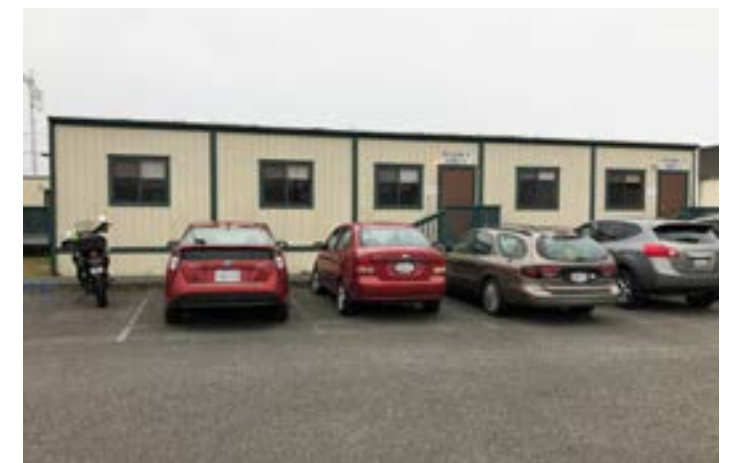
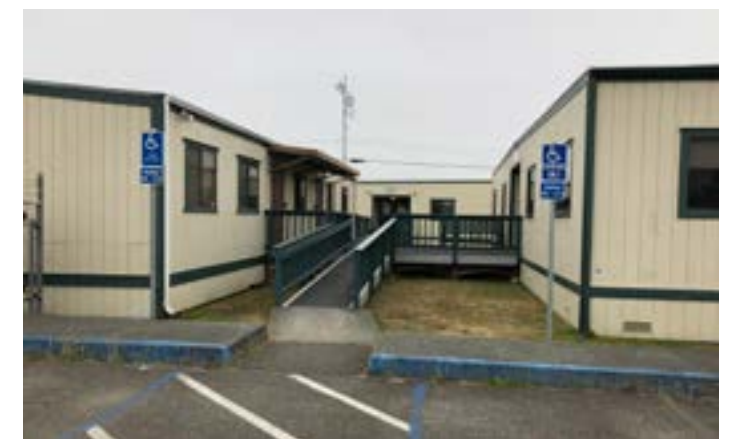
**Site:** Fences around Building B have rusted through in several places exposing jagged edges. Paint is peeling from wooden handrails. Parking striping and paint on curbs is very faded especially around Building A. Weeds are growing between cracks in sidewalk, curbing and pavement. Ground cover is dying and peppered with weeds especially around Buildings D and A. Bench bases outside Building D are quite rusted.

**Exterior Envelope:** Exterior doors throughout the complex are rusting especially around the hinges and handles. Single pane windows throughout the complex are inefficient. Metal siding on Building F is dented and showing some corrosion at the ground connection. Exterior light fixtures are showing above average signs of wear and tear.

**Roof:** No issues reported, roof appears to be in acceptable condition aside from some rusting gutter attachments.

**Structure:** Concrete structures appear to be in good condition.

**MEP:** Most systems were replaced eight years ago and continue to function as intended other than the electrical system which is undersized.

**Site:** Replace deteriorated Fences and handrails around Building B and repaint wooden handrails. Restripe parking areas and repaint faded curbs. Restore and maintain ground cover, update landscaping to drought resistant plants optional. Mediate weeds growing in paved areas. Replace rusted bench base connections.

**Exterior Envelope:** Replace corroded door hardware throughout the complex. Replacement of single pane windows with efficient counterparts is optional. Replacement of dented metal siding is optional. Replacement of exterior light fixtures is optional.

**Roof:** Replace corroded elements of gutter and downspout systems.

**Structure:** Further inspect foundations of portable structures for rot and other deterioration.

**Interior Elements:** Adjust and potentially replace compromised ceiling tiles.

**MEP:** Assess electrical needs of facilities and update/replace electrical system if necessary.

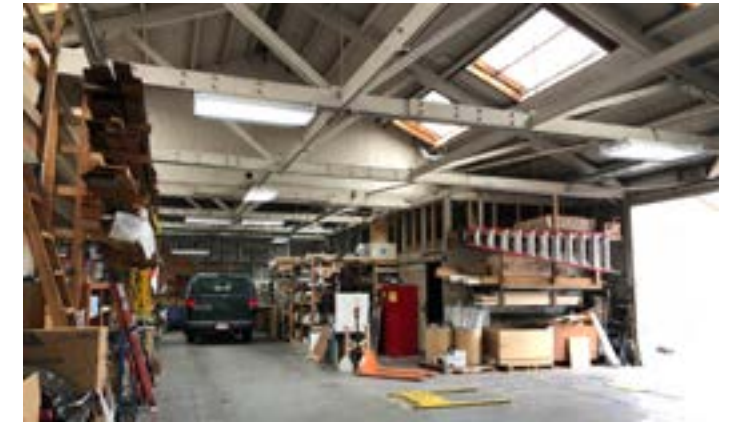
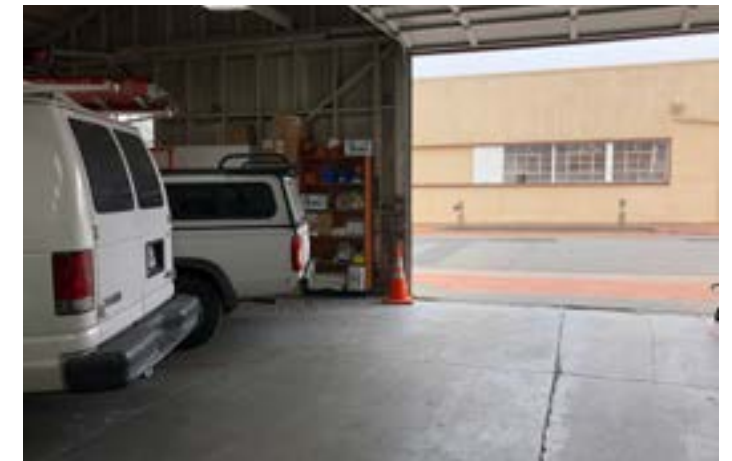
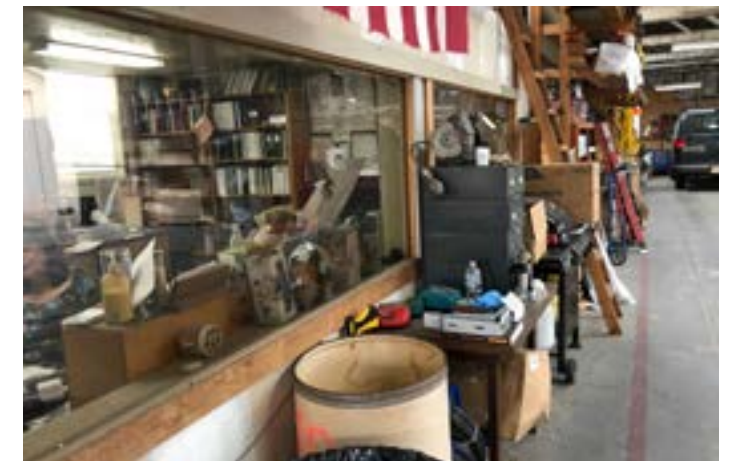
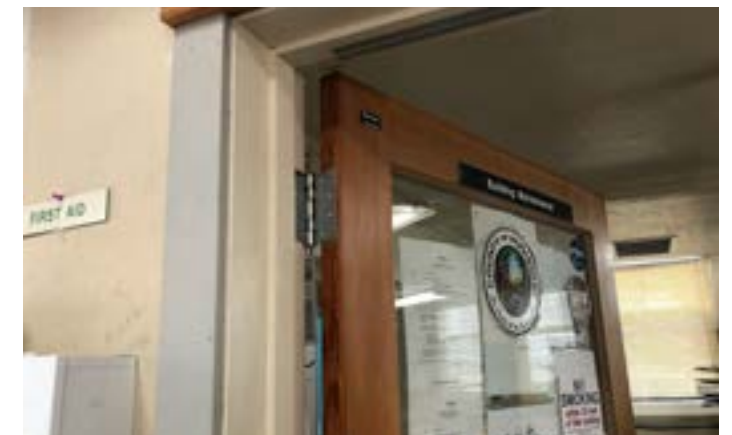
**Exterior Envelope:** The metal building is dirty with accumulated grime and some panels are warped. Some windows are replaced but most appear to be single pane original to the building construction.

**Roof:** The building's roof is in poor condition. Gutters and downspouts are clogged in areas. Skylights appear to be in good condition but wood rot is apparent at skylight framing.

**Interior Elements:** The interior is generally arranged as a shop with tools and storage throughout. Offices on the west side of the building provide space for operations and department workers. Concrete shop flooring is in fair condition as are interior doors and walls. Paint is peeling in some areas of the shop interior.

**MEP:** Lighting tubes have been recently upgraded to LED. Roll-up door allowing vehicle entry into shop appears to be in good condition. Some conduit requires painting.

**Exterior Envelope:** Power wash entire structure. Replace original windows with better insulating double pane units.

**Roof:** Re-roof structure and clean gutters and downspouts. Replace rotten wood and improve waterproofing at skylights.

**Interior Elements:** Maintenance Department may benefit from some interior reorganization. Paint building interior.

**MEP:** Maintain interior lighting levels or increase levels with additional LED fixtures if desired. Maintain roll-up door accordingly and paint conduit.

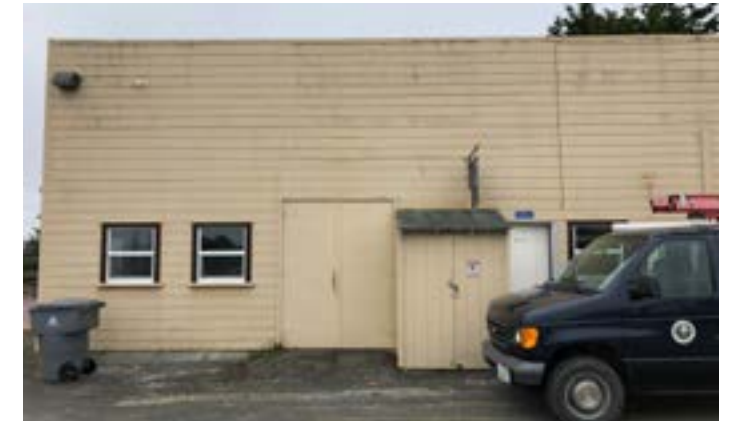
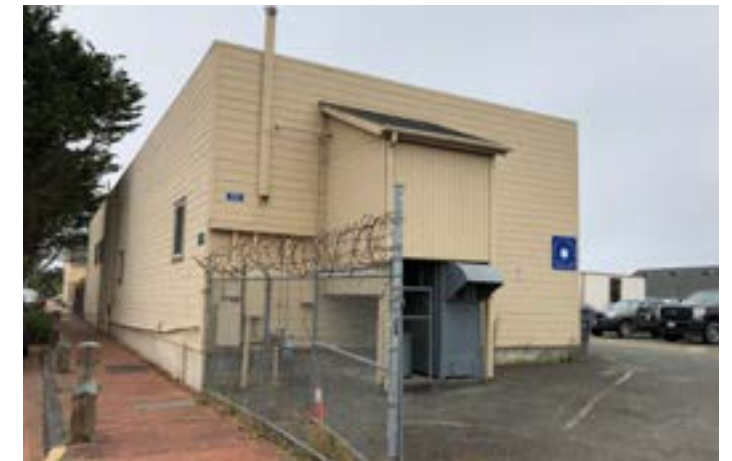
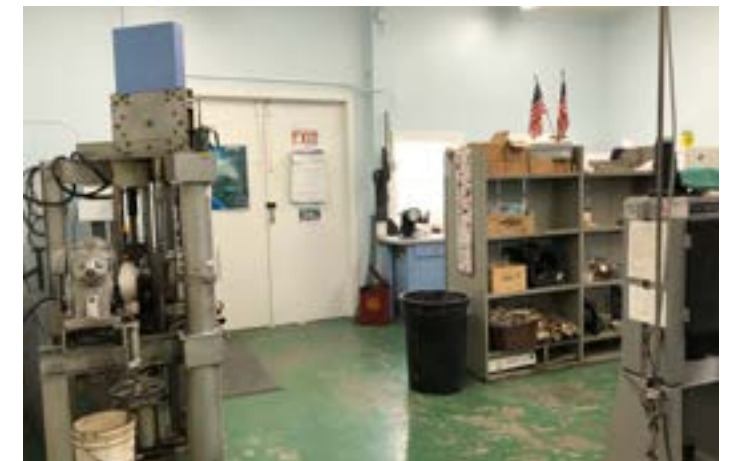
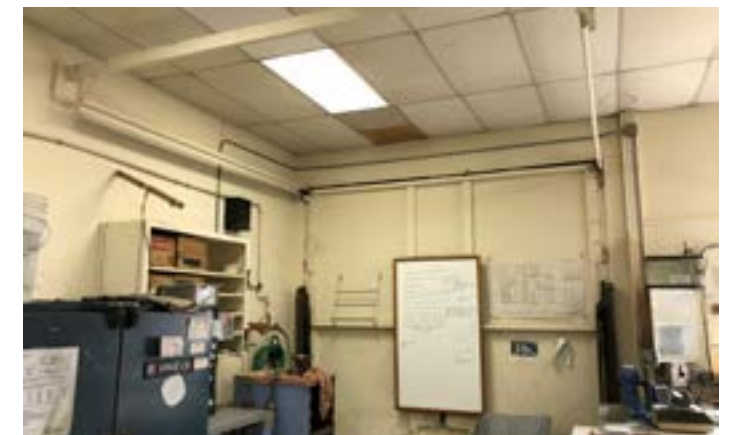
**Site:** Fences and gates are deteriorated with rust and are not appealing with barbed wire chain link. Wood bollards are past their useful service life. Masonry landscaping walls are in fair shape but should be reconditioned. Cobblestones on sidewalks are extremely dirty, curbs are deteriorated, asphalt pavement has multiple cracks and the parking lot needs to be restriped. Dry and sparse grass surrounds the site.

**Exterior Envelope:** Windowsills and frames are deteriorated. Windows in approximately one third of the shop area are only single pane. Exterior siding is faded and rotting at the base in areas. Downspouts are rusted.

**Structure:** Interior studs are being used to incorrectly support other structures as visible in part of the building interior. This is likely to be a structural and safety hazard.

**Interior Elements:** Multiple moisture stains were observed on acoustical ceiling tiles and drywall areas, indicating a water leakage problem. Paint of concrete floor is peeling off and is cracked in areas with signs of more than normal wear and tear. Interior furniture lacks appropriate support. Gypsum board is missing in some partitions or has inadequate installation. Toilet stalls require a step to access.

**Site:** Replace fences, gates and wood bollards. Clean sidewalks and recondition landscaping walls. Provide new grass or other landscaping. Repair site walls, curbs and asphalt pavement. Restripe parking lot.

**Exterior Envelope:** Paint window sills and replace deteriorated window elements. Replace single pane windows with double pane windows. Replace deteriorated siding elements and downspouts.

**Structure:** Remove additional structures supported by wood studs and further investigate structural systems for deficiencies.

**Interior Elements:** Replace damaged acoustical tiles. Repair concrete floors. Replace shelving system. Repair damaged gypsum board partitions. Increase waterproofing measures.

**MEP:** Provide a fire suppression system, fire alarm system and lighted exit signs.

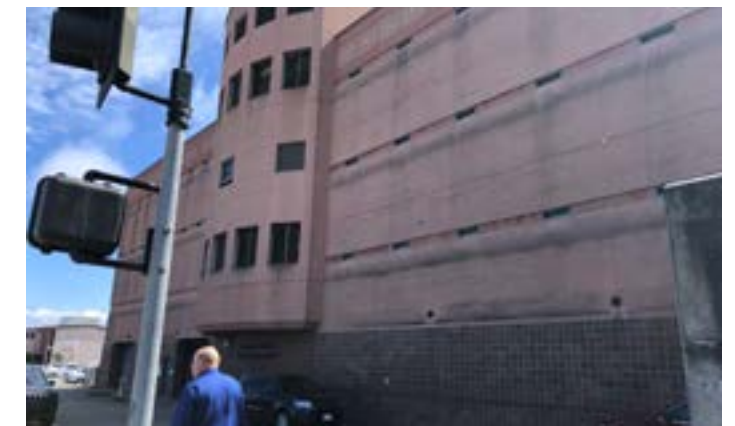
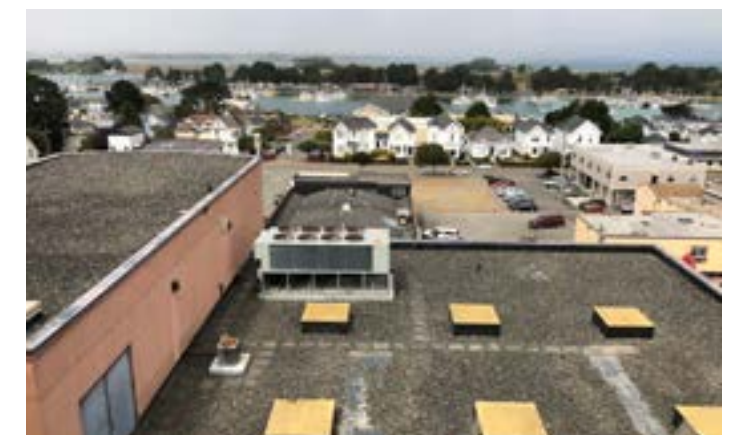
**MEP:** Discoloration at various places on ductwork and piping suggest leaks in basement mechanical room. Mechanical spaces may contain hazardous materials on duct work insulation and other areas. Ducts in exterior areas have panels that have completely rusted through. Coils on Carrier Air handler are deteriorated. Fire protection/water room has malodorous air and ponding water on the floor. Condenser drainage leaks. Elevator shaft bearings and other items are in poor condition. Water heater was installed in 2010. Piping insulation requires abatement. MetaSys is due for an upgrade. Economizers require replacement. Lots of butterfly valves exist in the plumbing systems and cause problems for maintenance.

**Interior Elements:** Clean and repaint interior elements throughout the facility. Refinish discolored concrete flooring throughout if desired. Provide new modern lighting fixtures with LED lighting. Remove rust and refinish or replace rusting cell doors with new. Repaint metal mesh for recreation yards.

**MEP:** Remove rusted duct components and replace with weather-resistant components. Replace rotten Air handler coils with new ones. Investigate leak sources in rooftop mechanical rooms and mediate. A full investigation of mechanical equipment and remaining service life of units should be performed. Remove abandoned torpedoes from old boiler system. Provide maintenance to elevator shaft bearings and other modernizations. Abate piping insulation where required. Upgrade MetaSys. Replace economizers. Replace butterfly valves with ball valves.

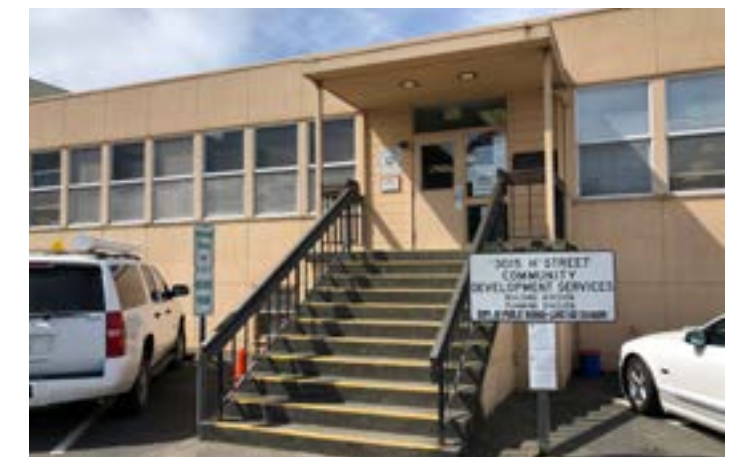
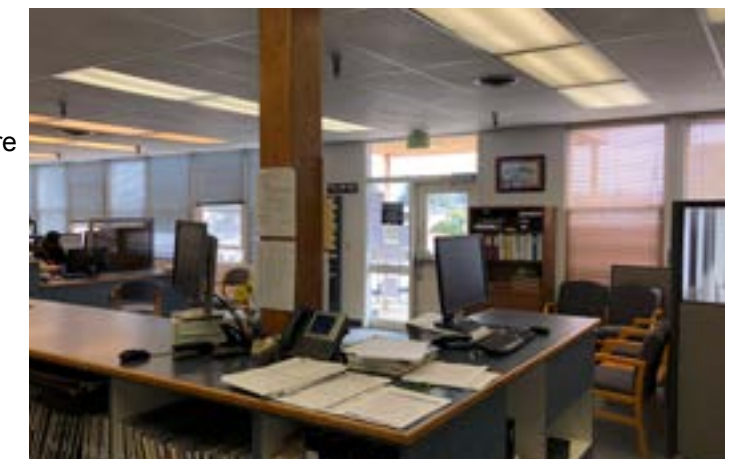
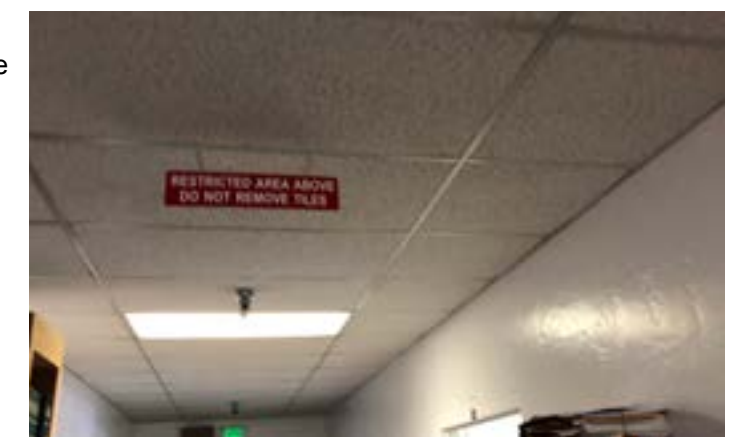
in this building are primarily used for storage but are reaching capacity, with some areas no longer accessible due to overflowing stored items. Toilet facilities are in poor condition with deteriorated flooring, stall hardware that is out-of-plumb, dangerous floor heaters and are generally outdated. There is an endless hot water heater installed which serves hot water needs well. Toilet paper is stored on top of the toilet which is unsanitary.

**MEP:** Some systems throughout the building are outdated and fixtures in the mechanical room have exposed wiring and cracking seals at their ductwork.

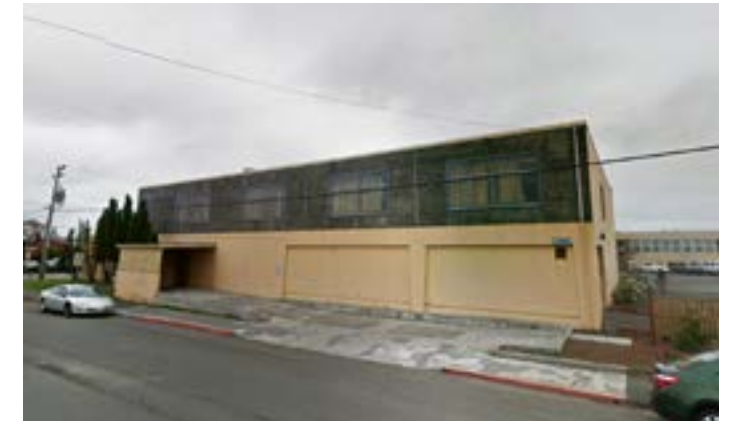
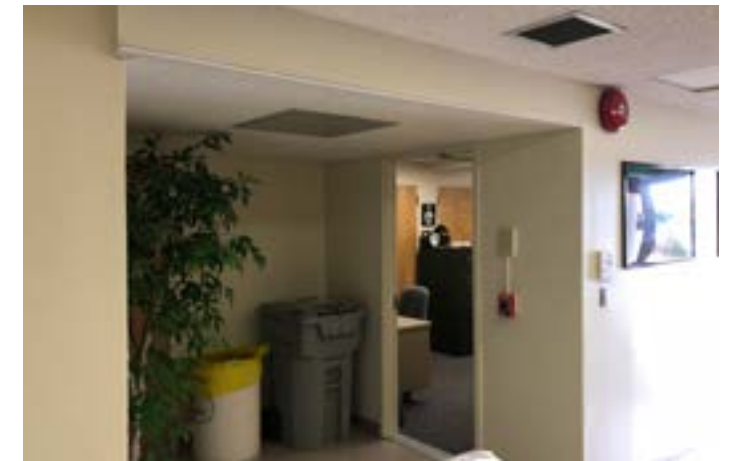
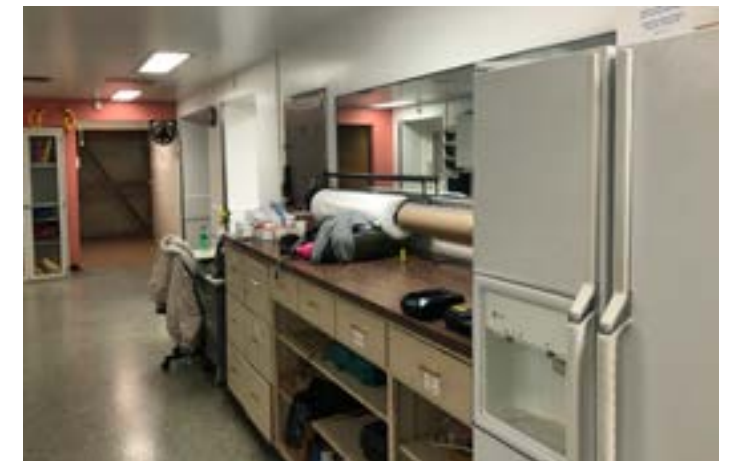
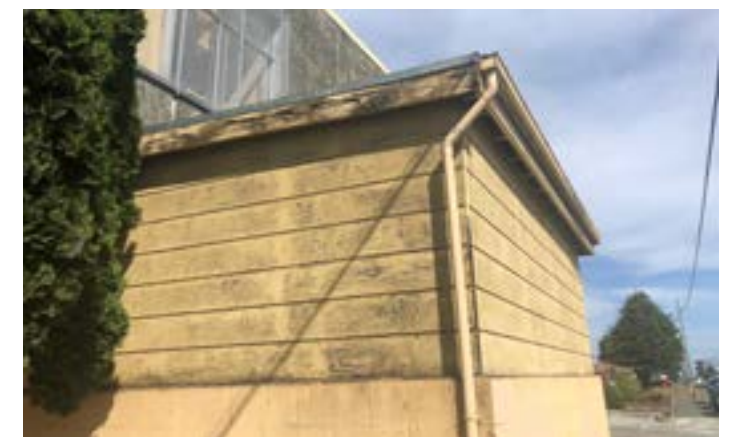
**Site:** Ground cover is sparse with many weeds growing in mulch areas and at curbing and pathway seams. Some cracking and discoloration is apparent in concrete paving. Exterior ramp covering of sally port is aged, discolored and beginning to deteriorate.

**Exterior Envelope:** Exterior wall finishes are showing signs of above average wear and tear with accumulated mildew, discolored patches and chipping/scraped paint at wall to ground connections. Roof eaves at the I Street entrance have excessive accumulated grime and signs of deterioration via discoloration patches. Vent on the northwest corner of the building appears corroded. Asbestos materials are in use on the roof, some of which is showing bubbling. Accessible roof areas do not have safety railings in place.

**Roof:** Some sealant around rooftop equipment is cracking. Faculty reports roof leakage.

**Interior Elements:** Although largely straight and intact, some ceiling tiles are stained. Toilet fixtures have broken tiles and mildew accumulation around their mounting hardware. Other restrooms and fixtures are not ADA compliant and cloth towel underneath orange restroom sink implies leakage. Wall finishes throughout the facility have some marks and dents but are largely intact. Storage space is reaching full capacity and some stored items are infringing on accessible paths and work surfaces throughout.

**MEP:** Various MEP equipment below the Coroner's Office is reaching the end of its useful service life. Supporting structure for air unit on roof is very rusty. Inefficient fluorescent light fixtures throughout. No fire suppression system is installed in the Coroner's Office.

**Site:** Remediate weed accumulation around the site. Grind sidewalk cracking to level or replace when cracks become a tripping hazard.

**Exterior Envelope:** Clean exterior walls and eaves, repair material degradation. Replace corroded wall vent. Paint exterior including sally port.

**Roof:** Remove cracked equipment sealant, properly install new seal material. Investigate roof leakage extent and proceed with fixes per updated findings.

**Interior Elements:** Remove and investigate cause of discolored ceiling tiles and consider replacement. Clean and repair material surrounding toilet fixtures. Implement changes to one restroom to meet ADA standards. Reorganize storage and work flow layouts to clear accessible pathways.

**MEP:** Replace structure underneath rooftop air system. Light fixture updates are optional. Install fire suppression system in this portion of the building.

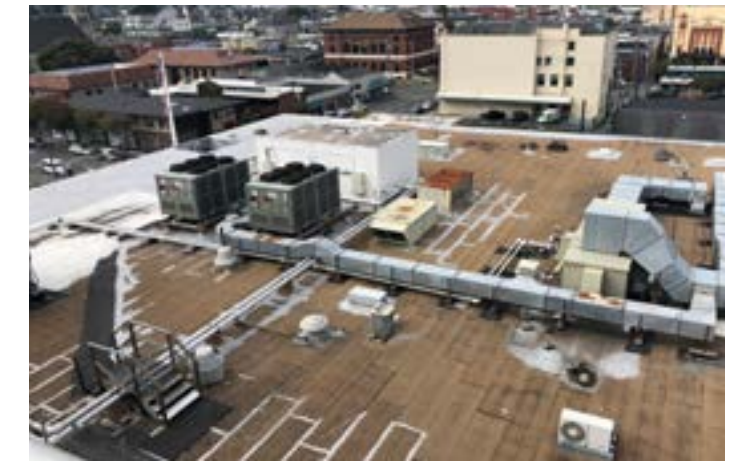
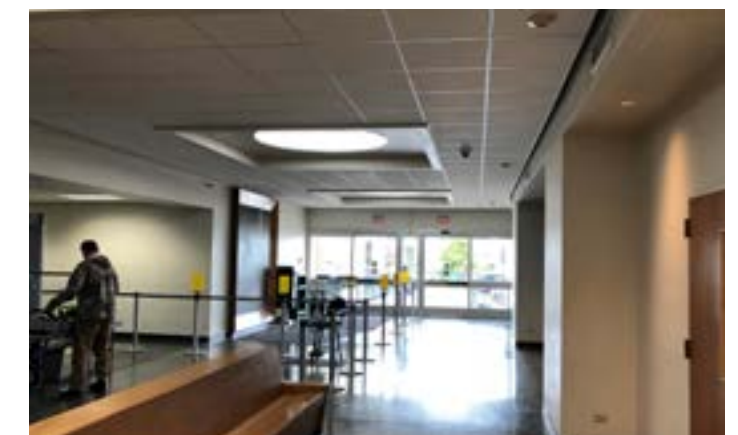
**Site:** Landscaping at corner of Southbound 101 and I Street has been compromised by excessive travel through grass. Some unwanted plant growth at base of building near main entrance and in mulched areas. Sidewalks are cracking especially near roadside curbs.

**Exterior Envelope:** Inefficient single ply glazing has been used in most windows throughout the building. Rusty louvers at vents into the mechanical room are detaching from their housing but some have been rigged to allow airflow. Some broken windows exist.

**Roof:** Roof drainage is rusty with lips on drain overflow being too high as evidenced by ponding water discoloration. Hydro-stop applied in many places throughout roof implying patched leakage. MEP systems housed on the roof rusted in many places. Rooftop equipment curbing is cracked and rusted. Pigeons nesting under roof eaves which are also rusting. Safety railing missing from accessible roof areas. Domed section is in severe need of replacement.

**Interior Elements:** Vinyl flooring is warping and dented in some areas, especially where heavy items have been stored on top of floor and in some high traffic areas. Carpeting is loose especially in the District Attorney's office. Drywall is cracking in stairwell areas. Insulation is exposed and torn in mechanical rooms. Discoloration of some ceiling tiles was observed in family court. Ineffective sound

**MEP:** Electrical transformers and distribution panel replacements are planned and funded. Ducting in mechanical areas is rusted through in several areas, especially at corners and areas directly exposed to the outside. Plumbing pipes exposed in the third floor mechanical room are not laterally braced. Catch pans and deflectors are in place to catch moisture from sweaty pipes. Mechanical systems housed on the roof all have some level of rusted components, ductwork, and/or mounting hardware. Elevator machinery reportedly is broken down often.

**Site:** Mulch new path or replace grass that has been worn down. Pull weeds at base of building and other plant-free areas. Observe sidewalks crack and repair when cracks become a tripping hazard.

**Exterior Envelope:** Install energy efficient windows to replace single ply windows where necessary. Remove compromised louvers and replace with alternative weather-resistant venting. Repair broken windows including those in library.

**Roof:** Remove patched materials, reseal and replace with proper coverings. Clear out older/cracked sealing, replace with new seals, consider protective enclosure over rooftop equipment. Clear out nesting pigeons from roof eaves and install anti-bird hardware. Install safety railing at accessible roof ledges. Install safety railings to roof areas able to be occupied adjacent to hazardous edge conditions. Replace domed section of roof. Roof may require extensive renovations.

**Interior Elements:** Remove compromised flooring elements, replace backing and floor finish material before tripping hazards are created. Add sound insulation and sound deadening materials where necessary. Replace torn

and exposed insulation over ducting in mechanical room. Clean and repaint doors and frames where possible and replace with new materials where needed.

**MEP:** Investigate leaks and seal or replace compromised components. Remove rusted components where possible, replace units and ductwork where necessary. Install new elevator machinery if alternative ADA access not available. Continue with plan to replace transformers and distribution panels with new. Repair insulation in mechanical rooms.

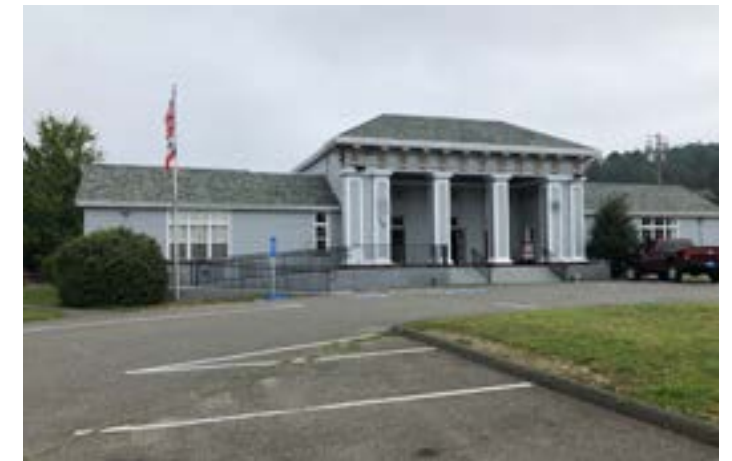
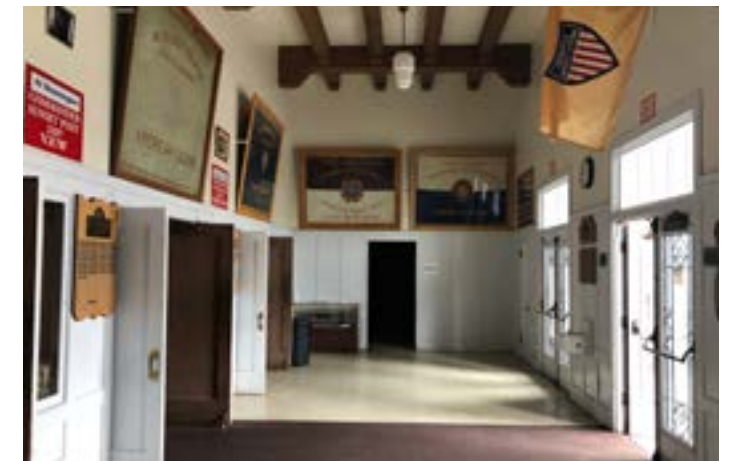
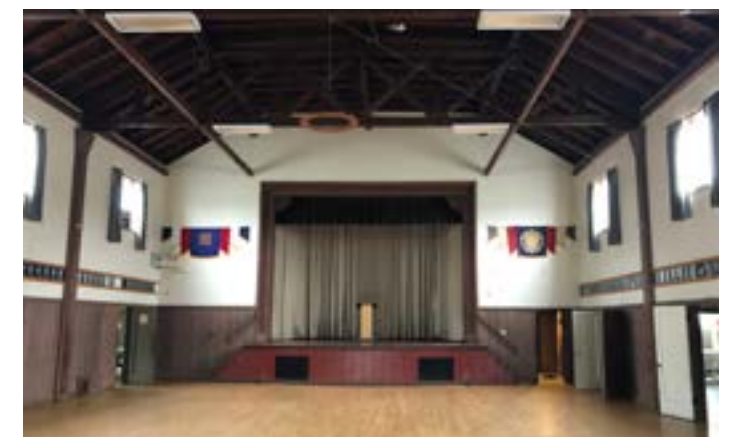
Restroom floors and toilet partitions are in poor condition. Toilet paper dispensers do not meet ADA height requirements. Vinyl floors show signs of more than normal wear and tear. Kitchen service counter does not meet ADA height requirement. Some walls are not painted in the kitchen. Stairs to access stage are missing one handrail and existing handrail does not meet ADA extension requirements. In some areas of the ceiling, gypsum board is missing. The wood floors and other finishes in the small meeting room have been removed.

**MEP:** Light fixtures at kitchen ceiling are very old, bent and dirty. There are no lighted exit signs.
