App# 12030-CUP16

Timberland Conversion Evaluation Report

Legal Description of Ownership: **PARCEL 43 TIMBERLINE RANCH EST RS BK 26 PG 135**
Address: **River Rd. off County Line Creek Rd. (USFS 1N15)**

APN(s): **208-221-006**
Section 28; T2N; R5E; HB&M; Humboldt County
Parcel Size: **Approximately 40 acres**
Acres Converted: **2.99 acres**

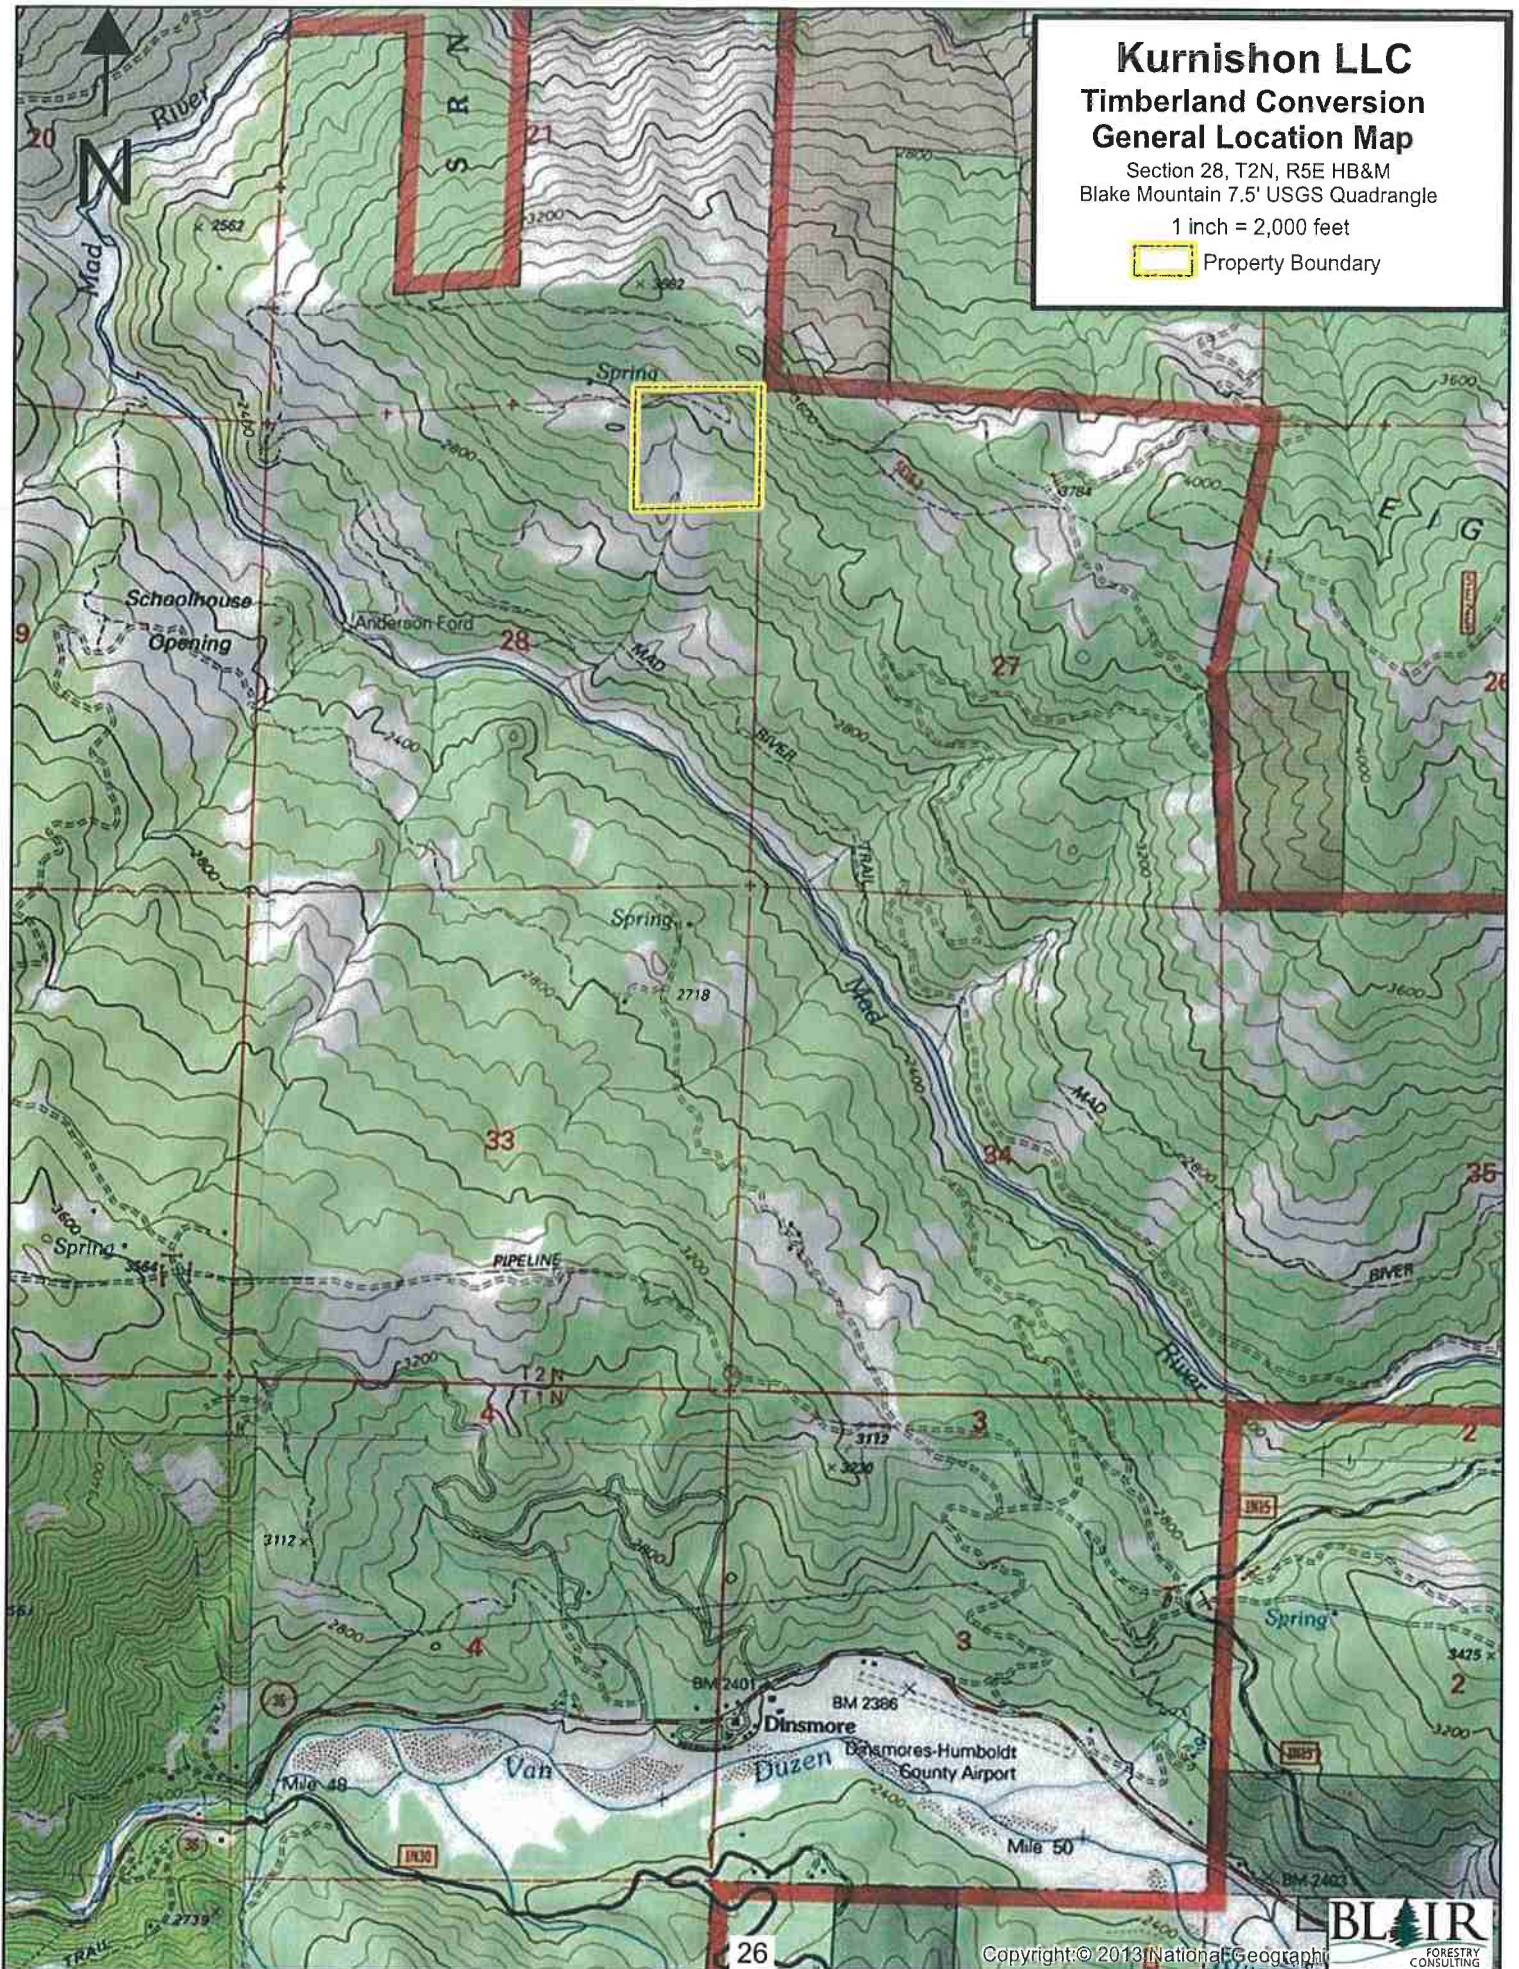
Kurnishon LLC Timberland Conversion Evaluation Map

The conversion sites and the surrounding timber stand were walked and assessed for debris resulting from timberland conversion activities. There were notable sites at all 3 Conversion Areas where debris, presumably resulting from nearby conversion activities, was stacked or accumulated. At Conversion Area #1 there is stacked debris along the side of the road (Observation Point 1(a)). At Conversion Area #2, a log deck resulting from timber operations was observed at Observation Point 2(a). At Conversion Area #3 there is a log deck stacked at Observation Point 3(b) there is a stacked log deck likely resulting from activities at Conversion Area #4.

Recommendations: Cut sawlogs at Observation Sites 1(a), 2(a) and 3(b) to a minimum of 2 feet in length as per 14 CCR 1104.1(a)(2)(D)(1).

- 1. Roads, Soil Stabilization and Erosion Control**
 - Address items in **Table 2** above and shown on the Conversion Evaluation Map at the end of this report.
- 2. Watercourse and Water Resources**
 - Address items in **Table 3** above and shown on the Conversion Evaluation Map at the end of this report.
- 3. Hazard Reduction**

- Address log decks at Observation Points 1(a), 2(a) and 3(b) as described in the Hazard Reduction section above.
