DEPARTMENT OF FISH AND WILDLIFE
Northern Region, Eureka Field Office
619 2nd Street
Eureka, CA 95501

Field Note: Stream Setback Measurements and Coho Salmon Detections in Noisy Creek, Tributary to the Mad River, Humboldt County, California.

Prepared by: CDFW Environmental Scientists Katie Rian and Jonathan Hollis

Survey Date: January 30, 2025

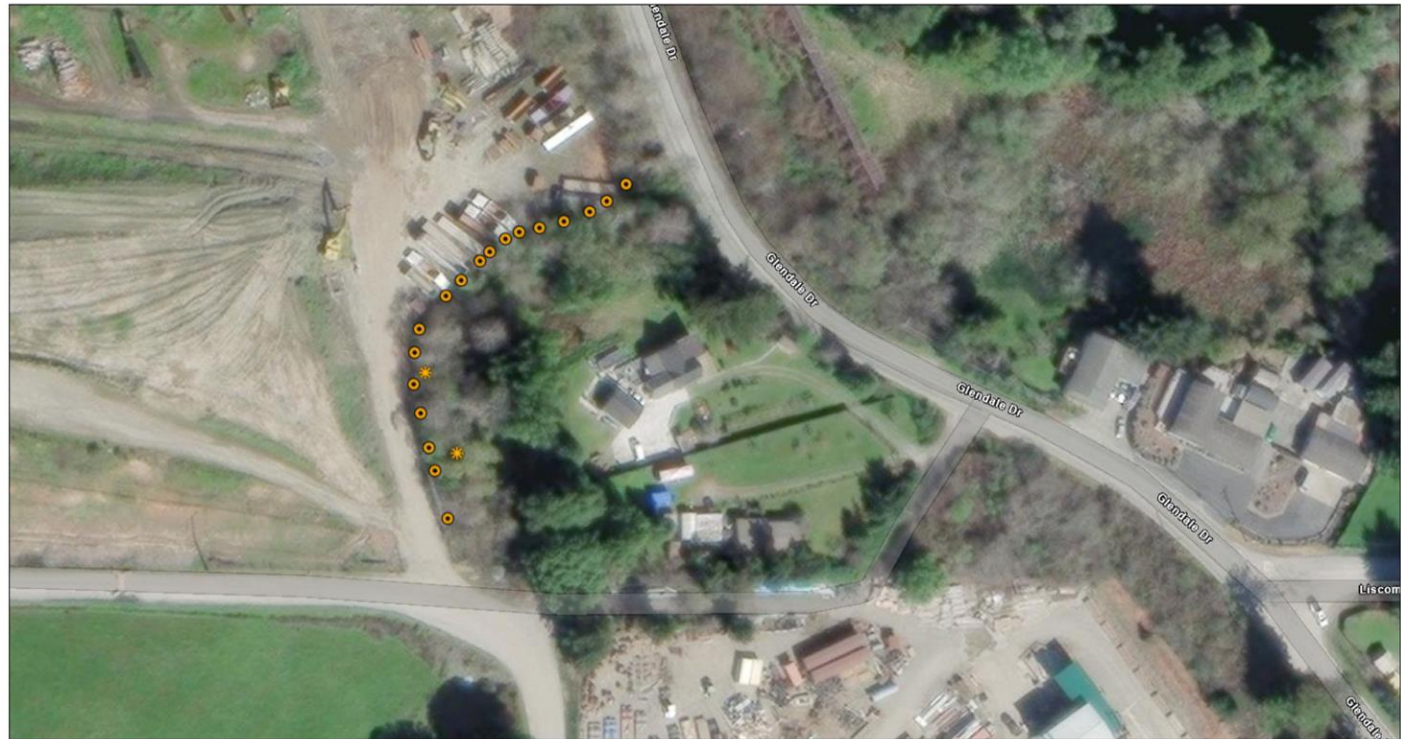
To characterize the width of the stream setback, we made 18 measurements along the western bank of the stream, working in a downstream fashion from Glendale drive to the 12-foot CMP culvert (Figure 1). Measurements were spaced approximately 15 to 25 feet apart, depending on our ability to safely access the stream. We collected spatial data at each survey point along the berm using an EOS Arrow 100 @ Submeter GNSS Receiver. Additional spatial data were collected at corresponding points along the

Figure 1. Map depicting the location of the California Department of Fish & Wildlife site visit conducted on January 30, 2025. Yellow dots denote survey points collected along the streamside edge of the recently constructed berm with an EOS Arrow 100® Submeter GNSS Receiver; distance measurement of the riparian buffer were made at each of these locations (Table 1). Yellow asterisks represent the approximate locations where coho salmon carcasses were observed by CDFW Scientists.

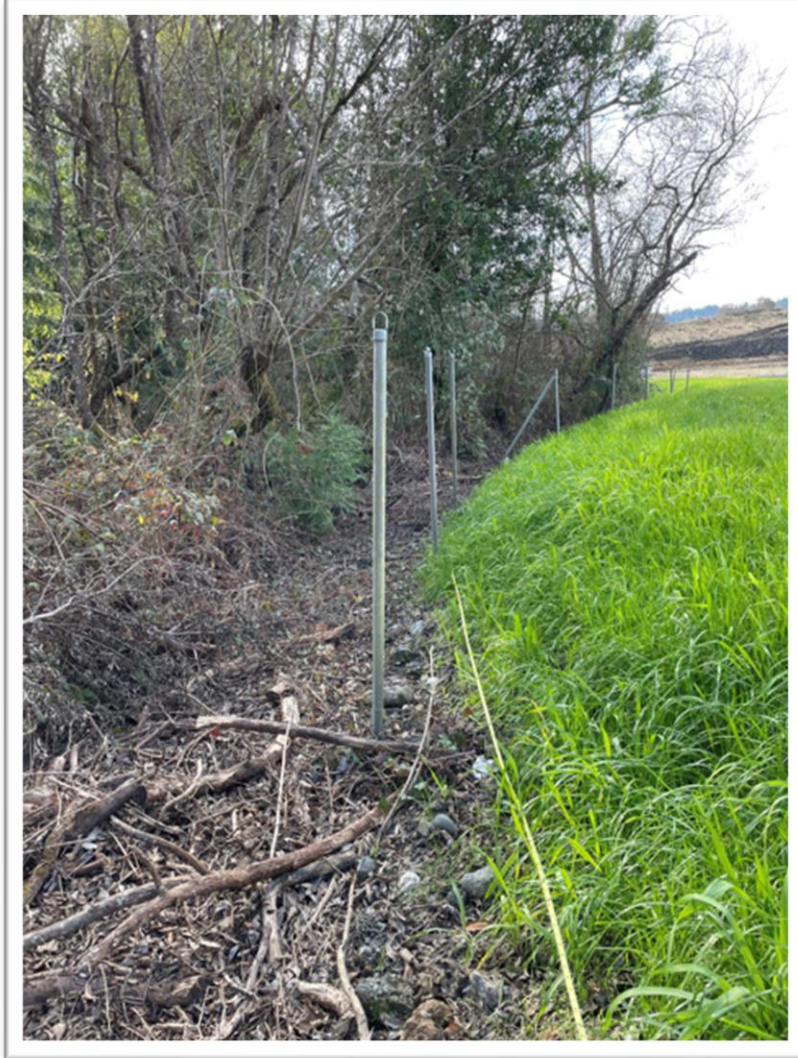
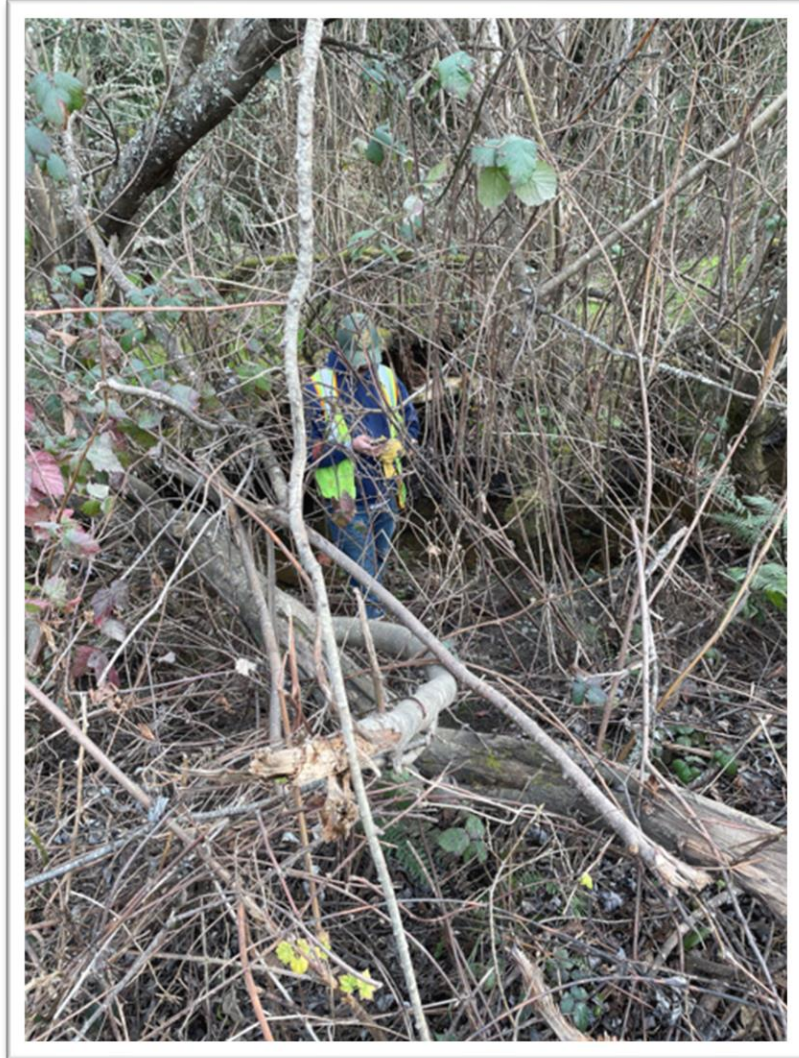
Figure 2. Characteristic riparian vegetation along the western bank of Noisy Creek. Red alder and willow dominate the overstory layer (left), with an understory primarily composed of Himalayan blackberry (right).

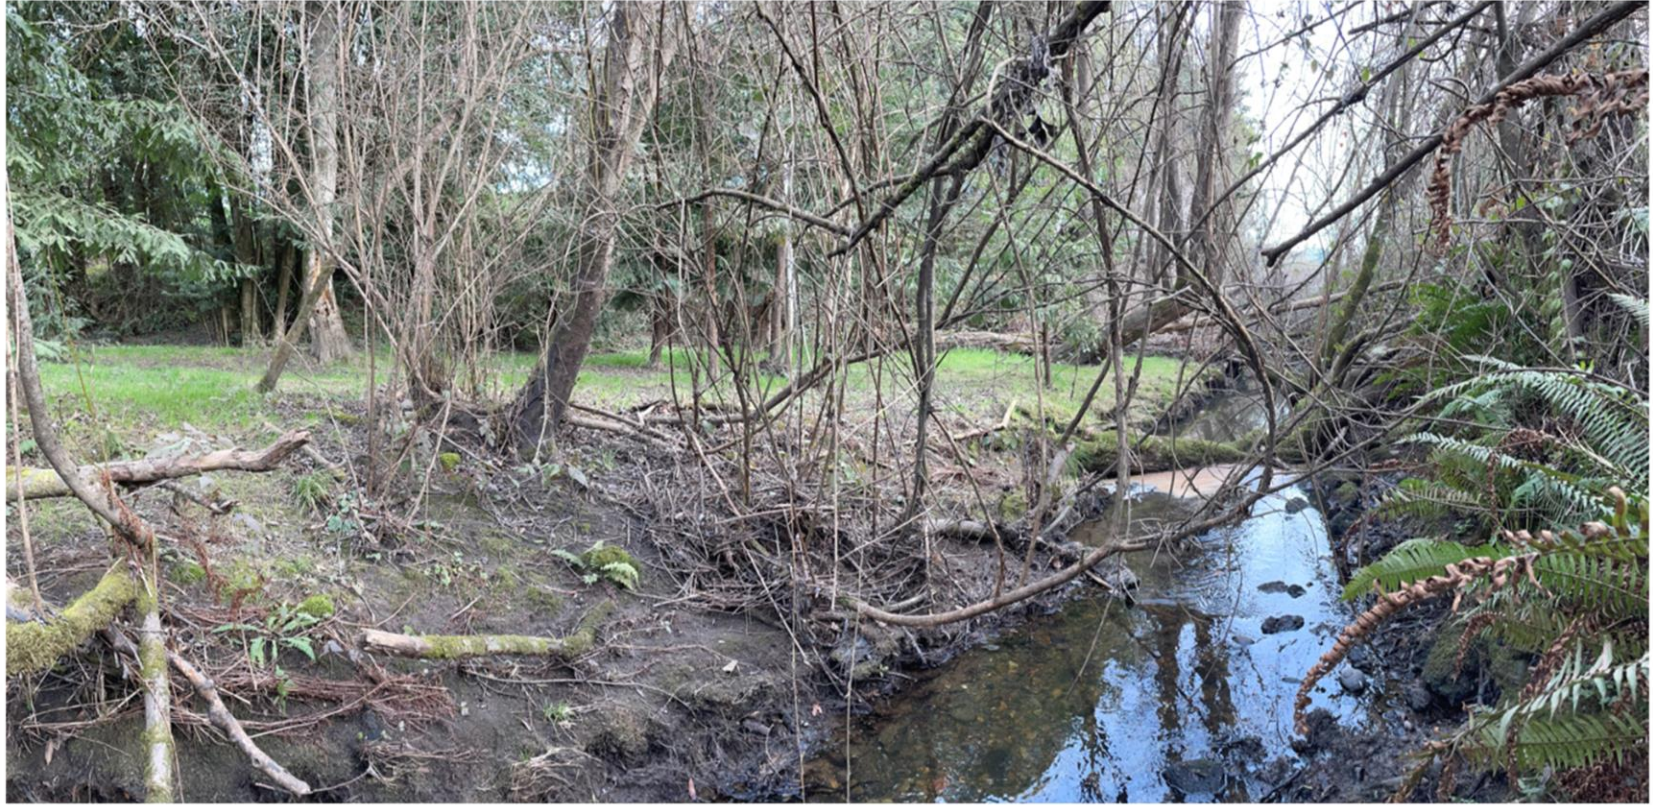
Figure 3. Floodplain terrace along the left bank (eastern side of Noisy Creek, with an overstory of red alder and willow. The understory shrub and herbaceous layers were sparse compared to the western bank (right).
