# Timberland Conversion Evaluation Report

December 27, 2018

Legal Description of Ownership: PARCEL 62 TIMBERLINE RANCH EST RS BK 26 PG 135  
Address: Bear Creek Road  
Dinsmore, CA 32219

APN(s): 208-201-017  
Section 30; T2N; R5E; HB&M; Humboldt County  
Parcel Size: Approximately 40 acres  
Acres Converted: > 0.10 acres

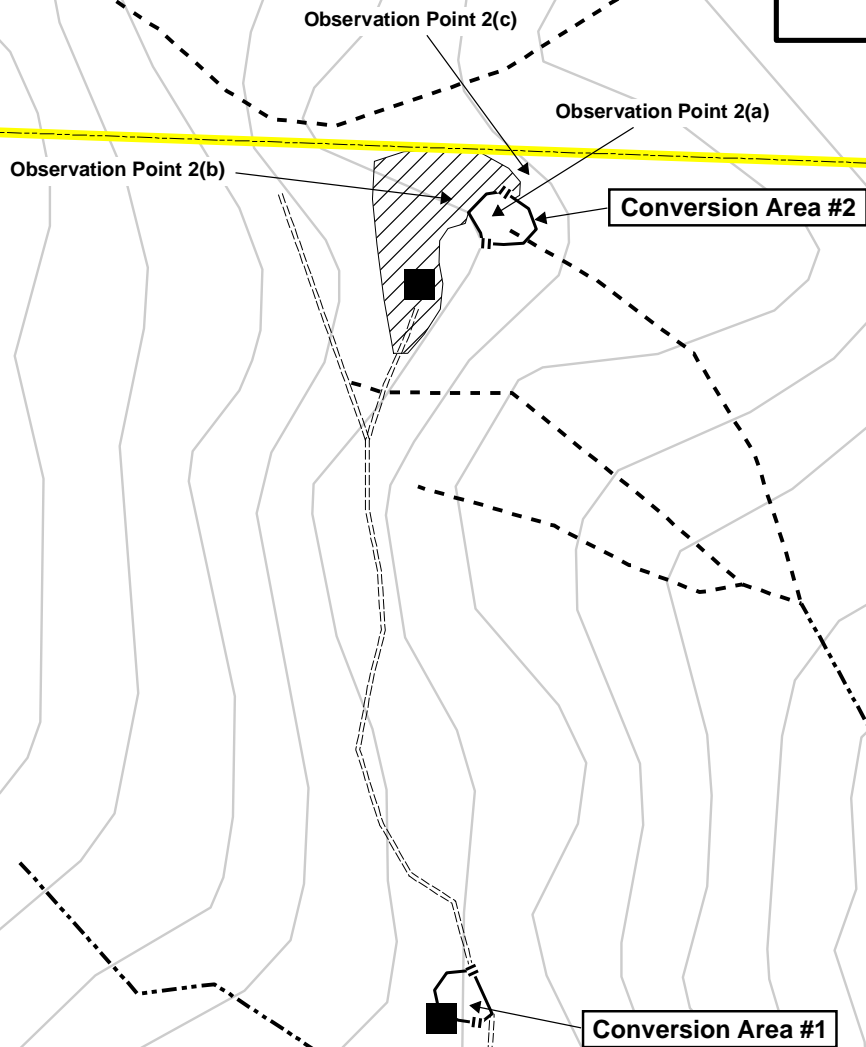
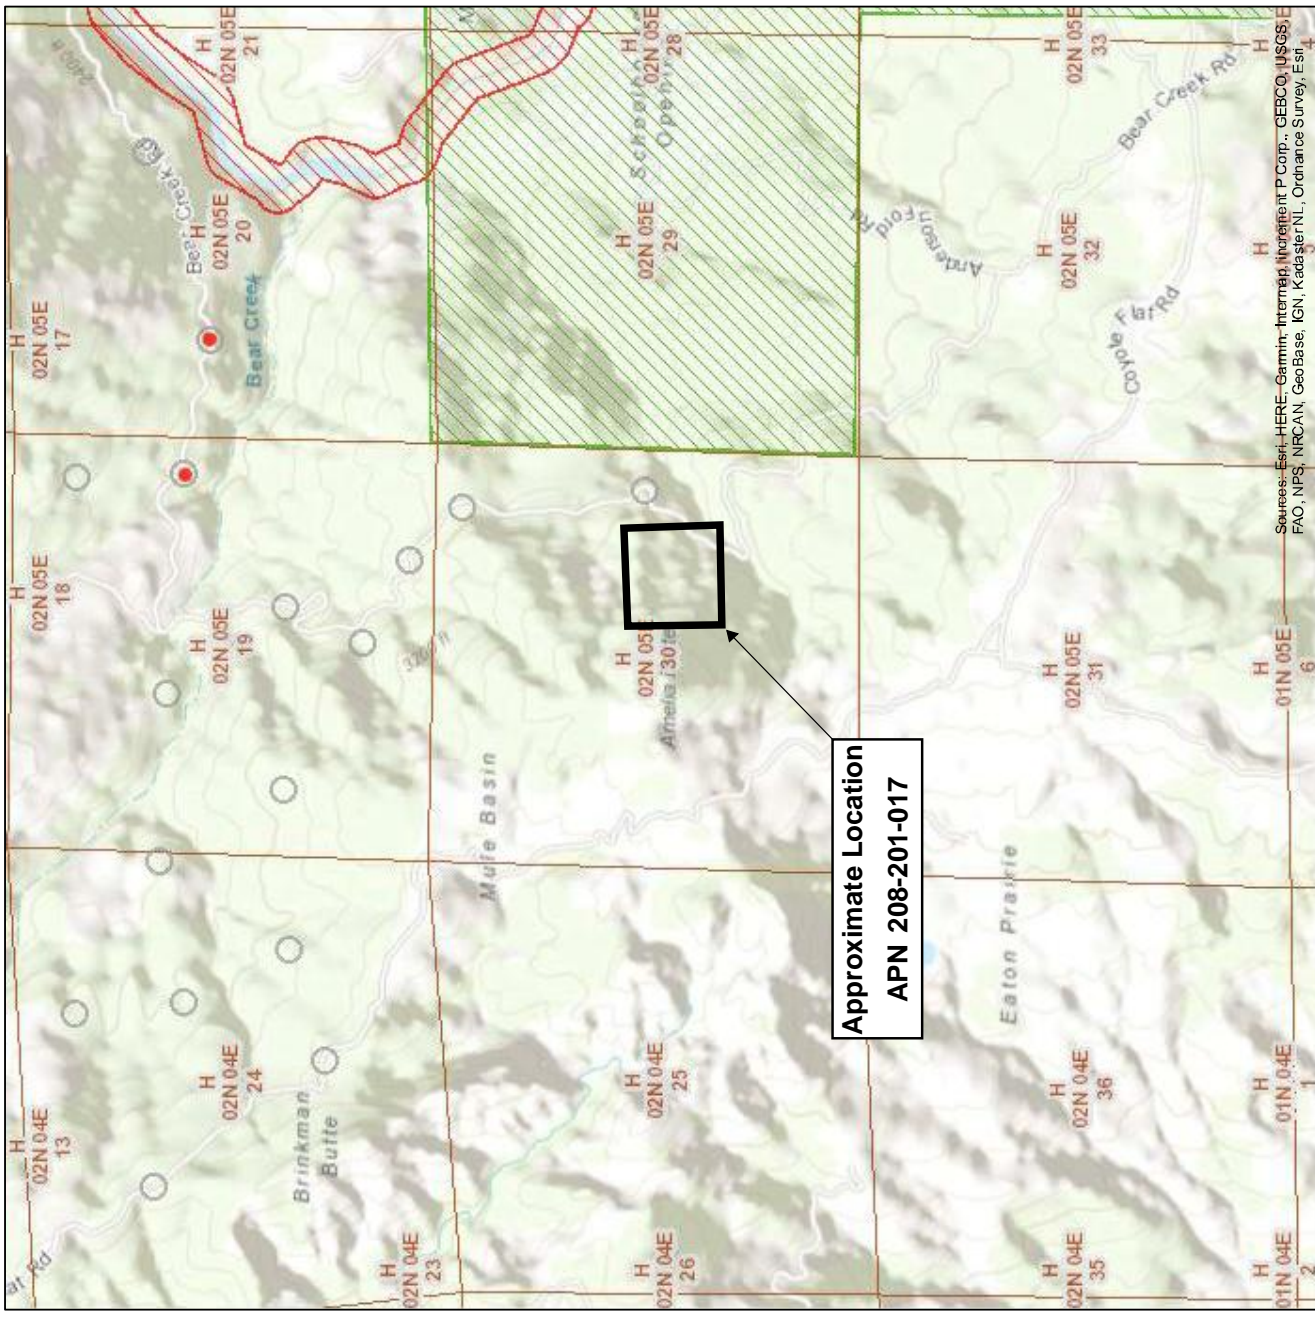
# Cherry Tree, LLC CNDDB

A query of the California Natural Diversity Database (CNDDDB) on December 27, 2018 showed no observations of sensitive, rare, threatened, or endangered species or species of special concern within the conversion area. Additionally, none of these species were observed during the field assessment of the property. A copy of the CNDDDB map generated by this query is included in this report.

The conversion area appears to comply with 14 CCR 1104.1 (2)(H). No recommendation is suggested regarding biological resources.
