PACIFIC WATERSHED ASSOCIATES INC.

Re: Characterization of existing structures within SMA, APN # 218-151-005

Photos of the two buildings constructed within the SMA APN: 218-151-005

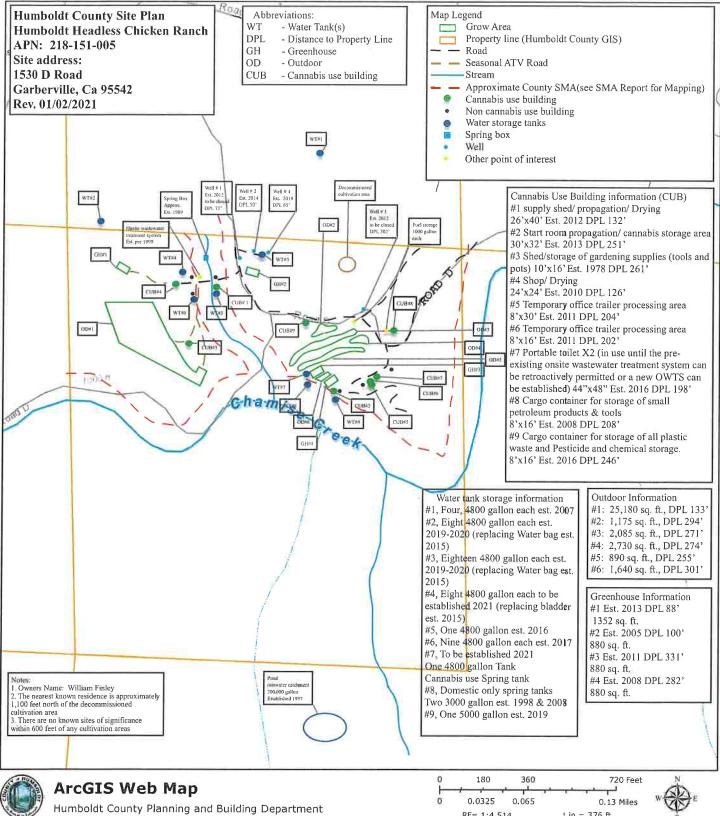
The southern building is located at the top of the left bank of Chamise Creek at the southernmost segment of the cannabis operations. The building is labeled "CUB#2" on the attached map. Currently the building is being used for plant propagation/drying/storage for the operations. Materials commonly observed within this building include small amounts of potting soil, plant containers, watering infrastructure, and other nursery related infrastructure. Additionally, the building will contain drying plant material during the latter half of the growing season. The operations are conducted such that no materials within the building are capable of migrating outside the building footprint. The building is well constructed as a metal shed on a slab and appears to conform to Humboldt County building permit requirements. The roof is metal and is fully functioning to keep the interior of the building dry and protected. The SW corner of the footprint of the building is located approximately 85' from the left bank highwater edge of Chamise Creek, a steelhead bearing stream.

The past runoff from the building roof was discharged onto the hillside below the building. Recent observations indicate there were no established surface water flow paths between the building and Chamise Creek and that the roof runoff dispersed and infiltrated the native undisturbed ground within 30' of being discharged off the roof. Regardless, the landowner installed gutters and a rainwater capture system for the building to assure enhanced environmental protection in the form of eliminating all runoff from the building footprint.

Photo of building #2 looking north-northeast. Note the grass, native rock, and duff on the margins of the building. Also note the rainwater capture infrastructure attached to the building.

- (1) Although the buildings have been constructed in the SMA, it is my opinion that they pose minimal short or long term threats to the environment and that the landowner should be able to continue use of the structures until more suitable locations can be agreed upon.
- (2) Upon negotiations with the County, an SMA variance should be granted for these structures as the environmental degradation from decommissioning these buildings and relocating them will likely be more significant that leaving them in place.
