ATTACHMENT 1b  
Sprowl Creek Full Resubmittal

# ETA Humboldt, LLC

**Photographs Correlating to Site Management Plan Map**

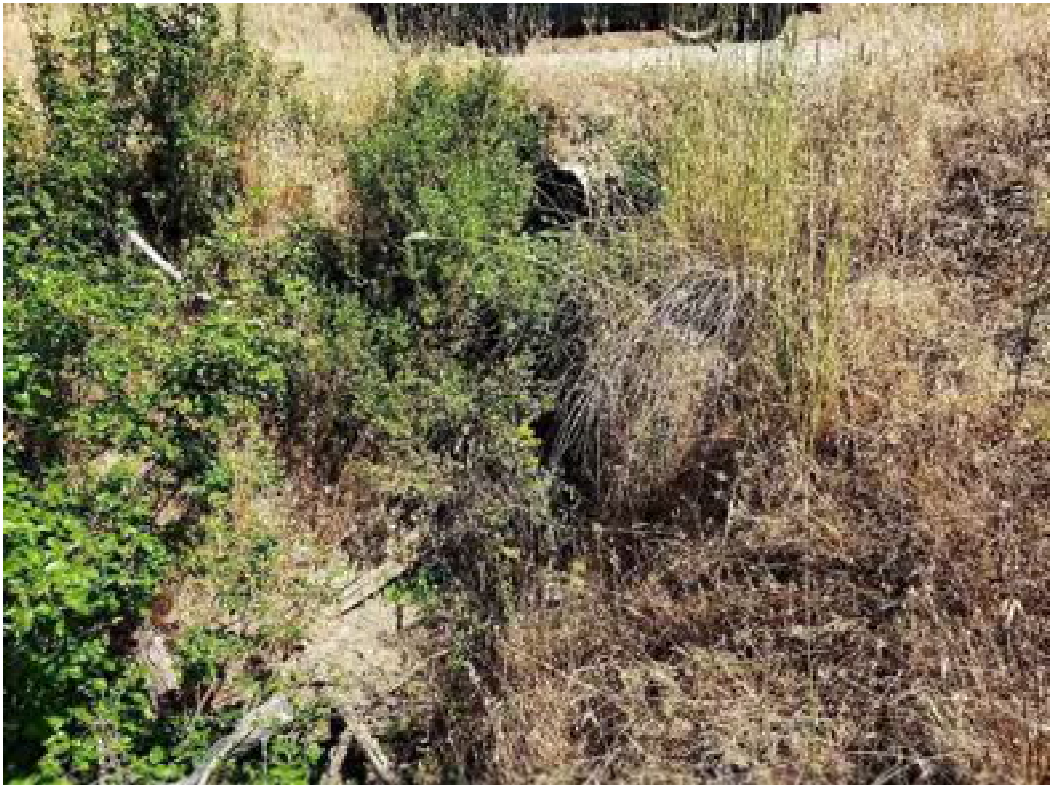
Site 03. Looking at the outlet.

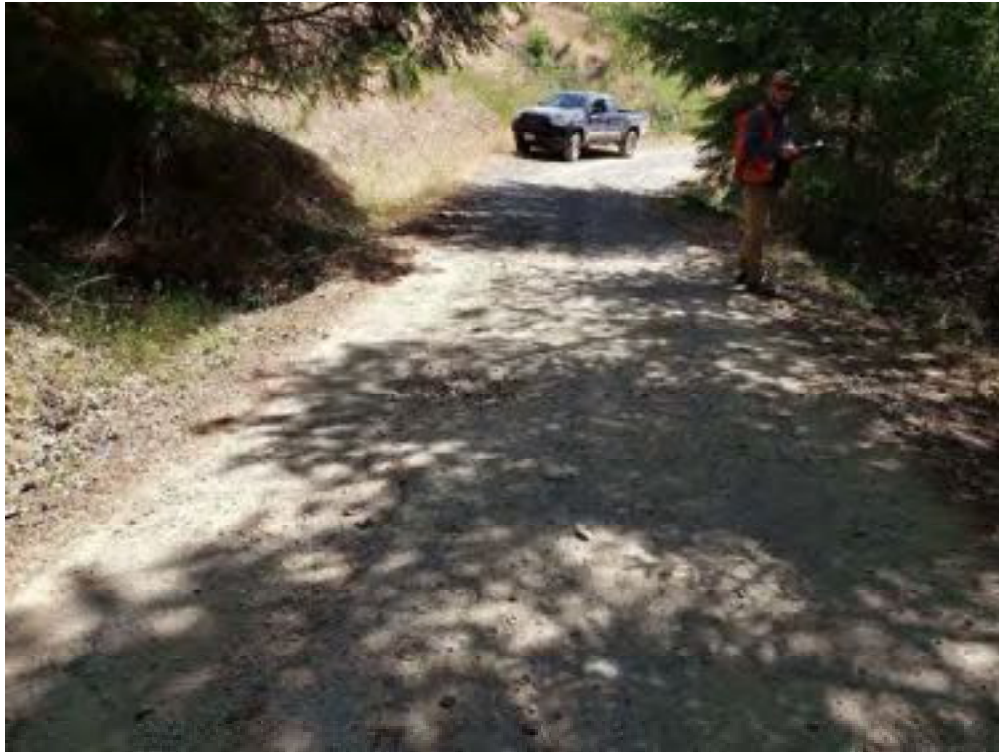
Site 05. Looking up grade to the east towards Site 04..

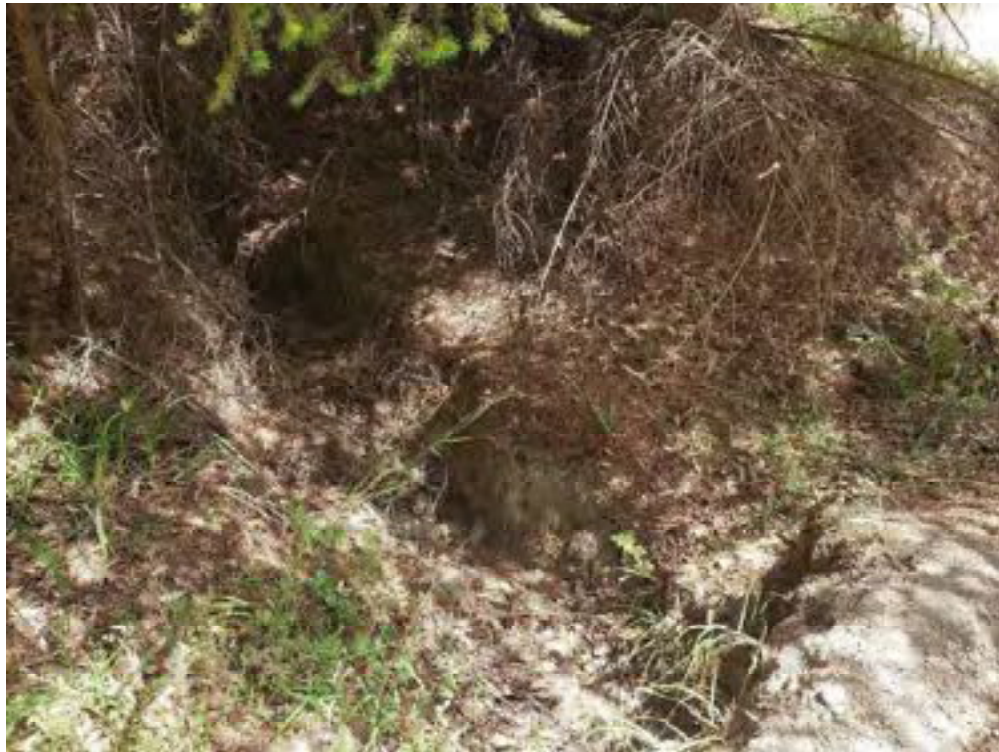
Site 05. Looking at the inlet to the lower right and up channel to the upper left.

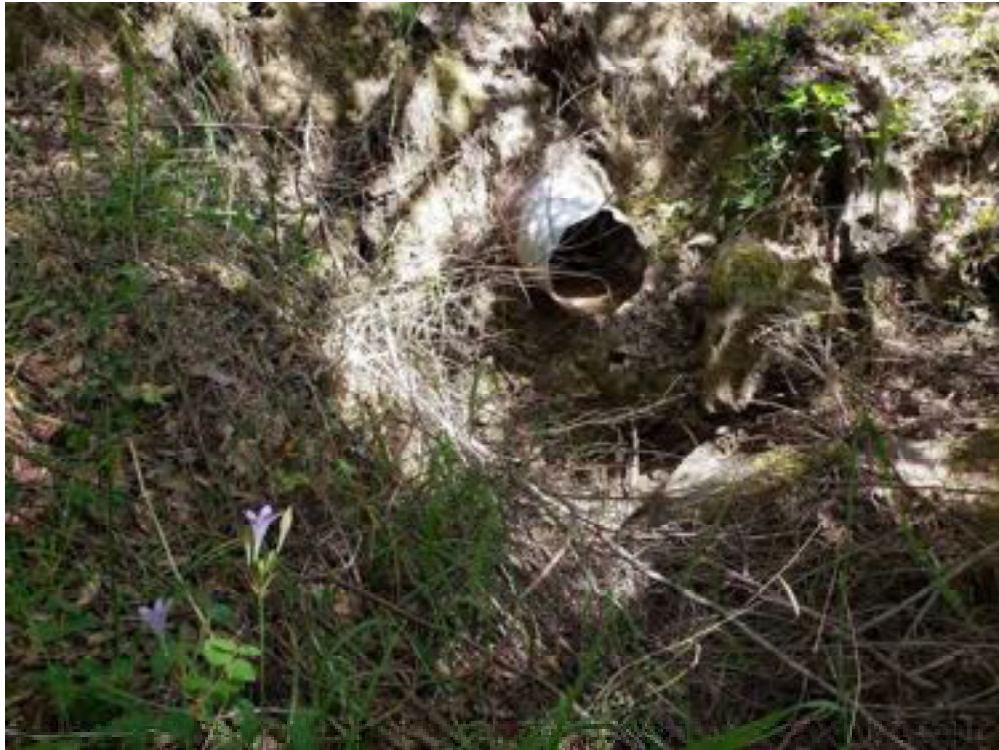
*Site 05. Looking at the outlet.*

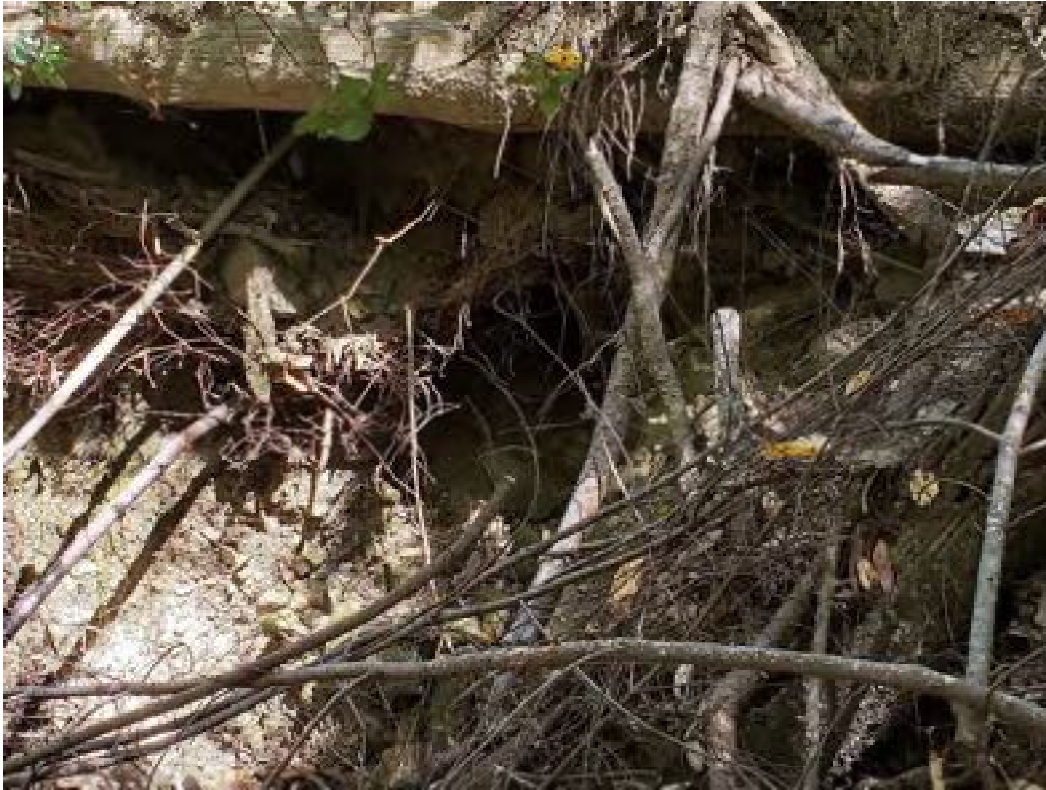
Site 06. Looking at the outlet.

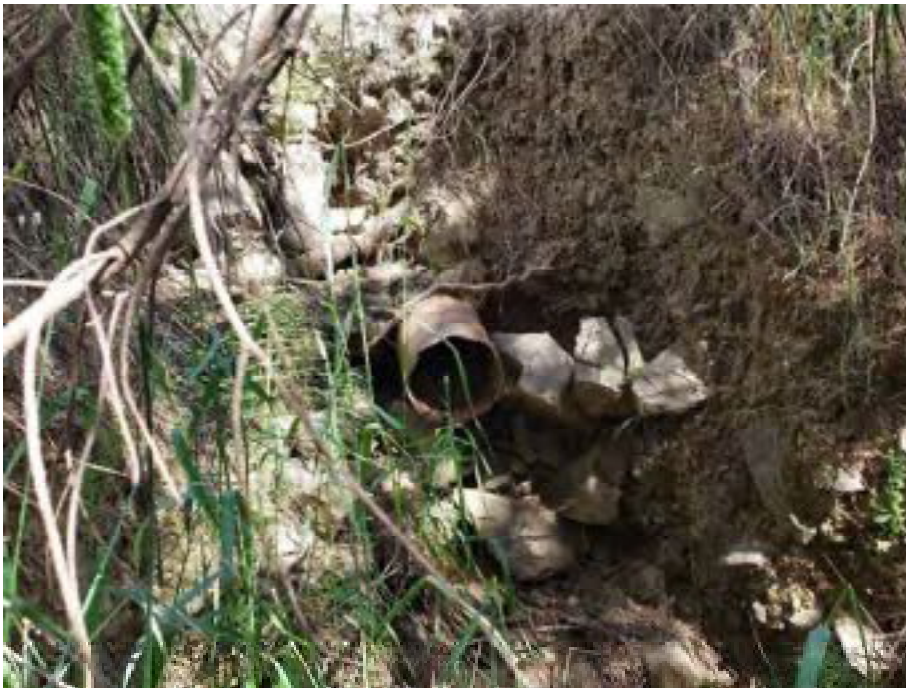
*Site 07. Looking at the outlet.*

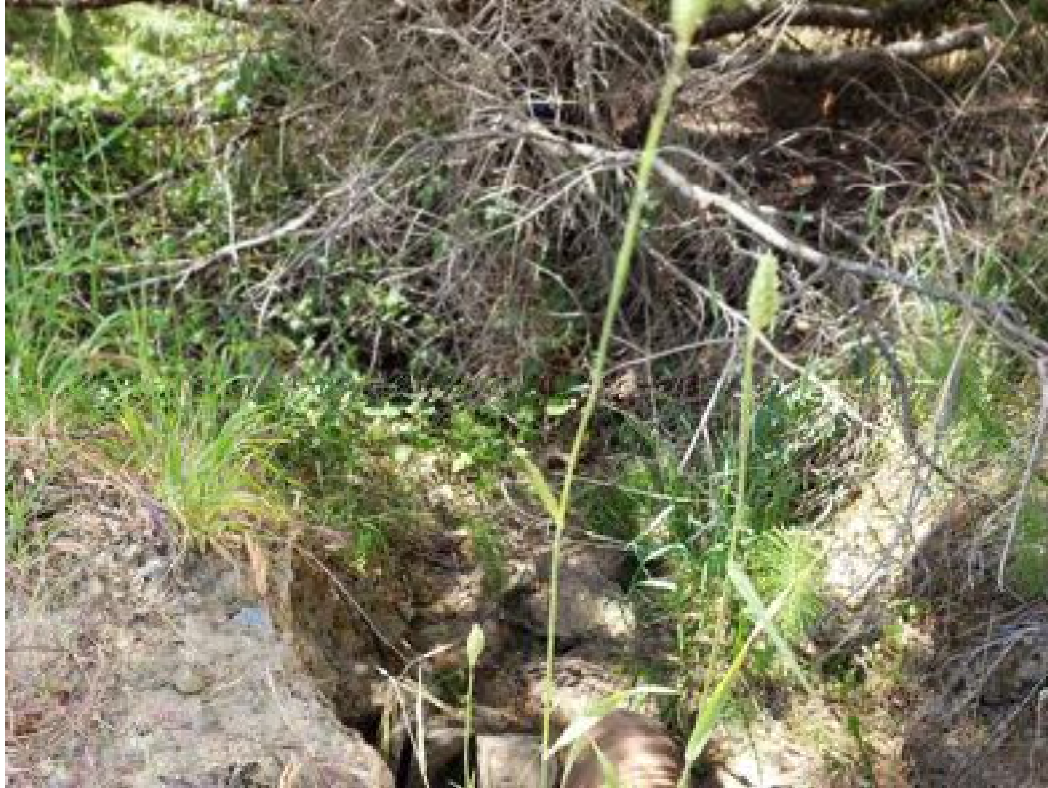
*Site 07. Looking down channel from the outlet. The upgraded culvert will outlet approximately in the brush to the upper center of the photo.*

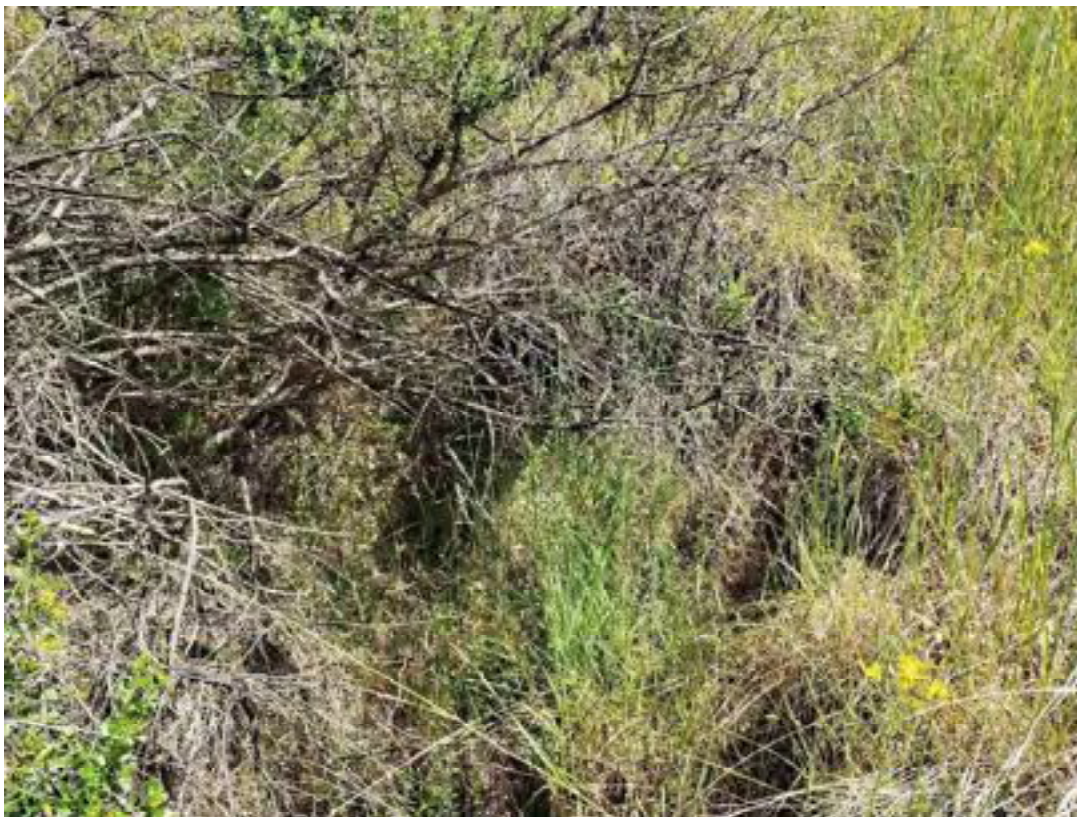
*Site 08. Looking at the outlet of the culvert.*

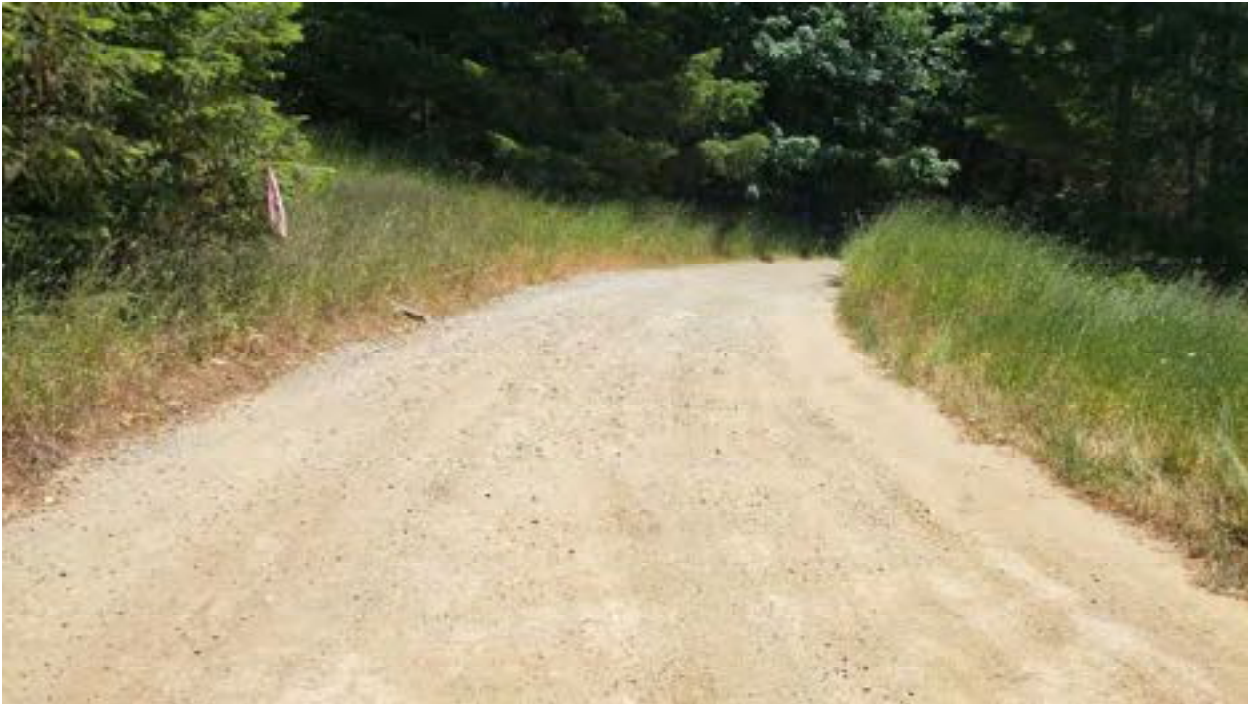
*Site 12. Hydrologic disconnect for Sites 13, 14, and 23.*

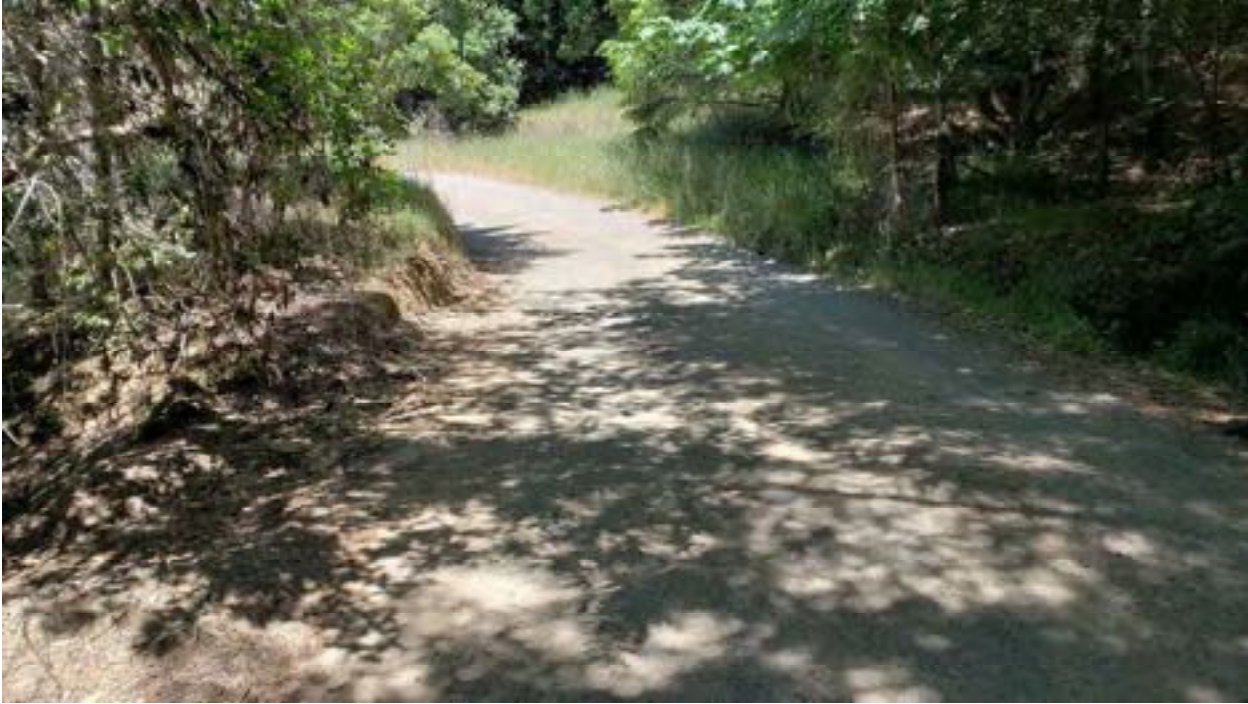
Site 13. Looking up grade at Site 13. A Class III watercourse is diverted down the inside ditch to the right. Re-alignment of this watercourse will consist of a culvert installed diagonally across the road from the grass patch in the upper center right to the lower left of the photo.

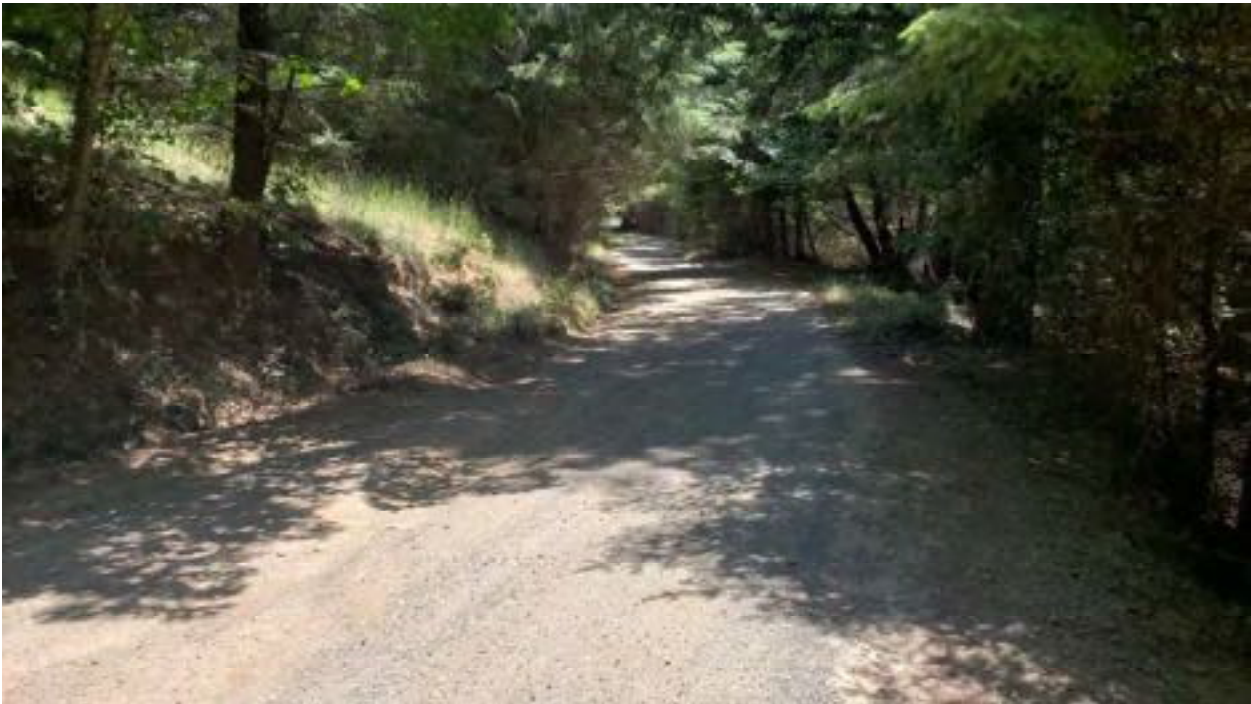
Site 14. Looking down grade at Site 14 with Site 15 further down grade a short distance.

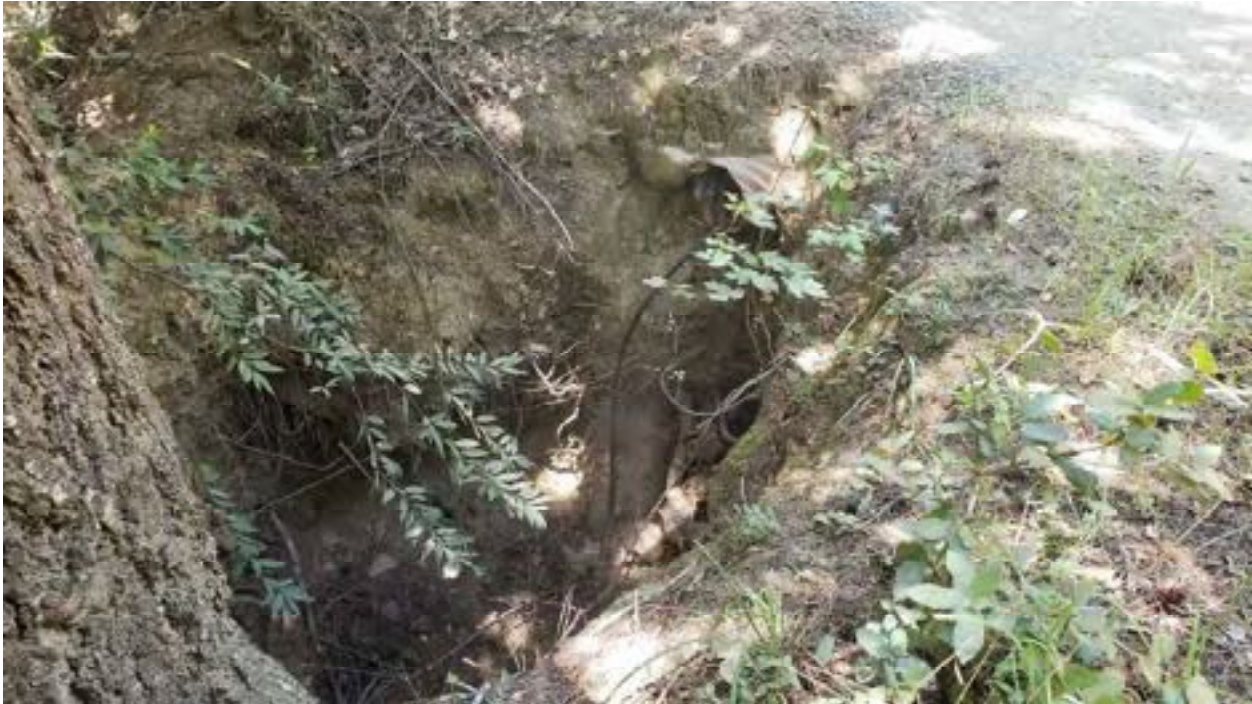
Site 14. Looking at the outlet of the ditch relief culvert.

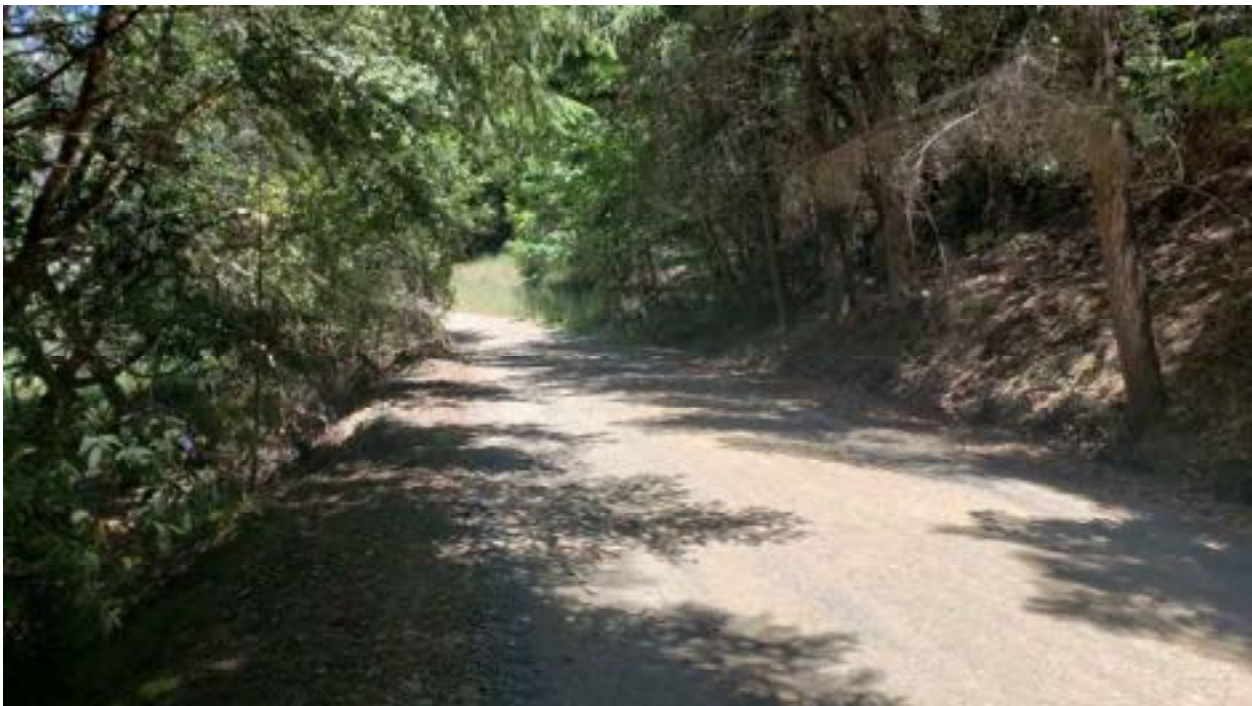
Site 14. Looking up grade towards Site 13.

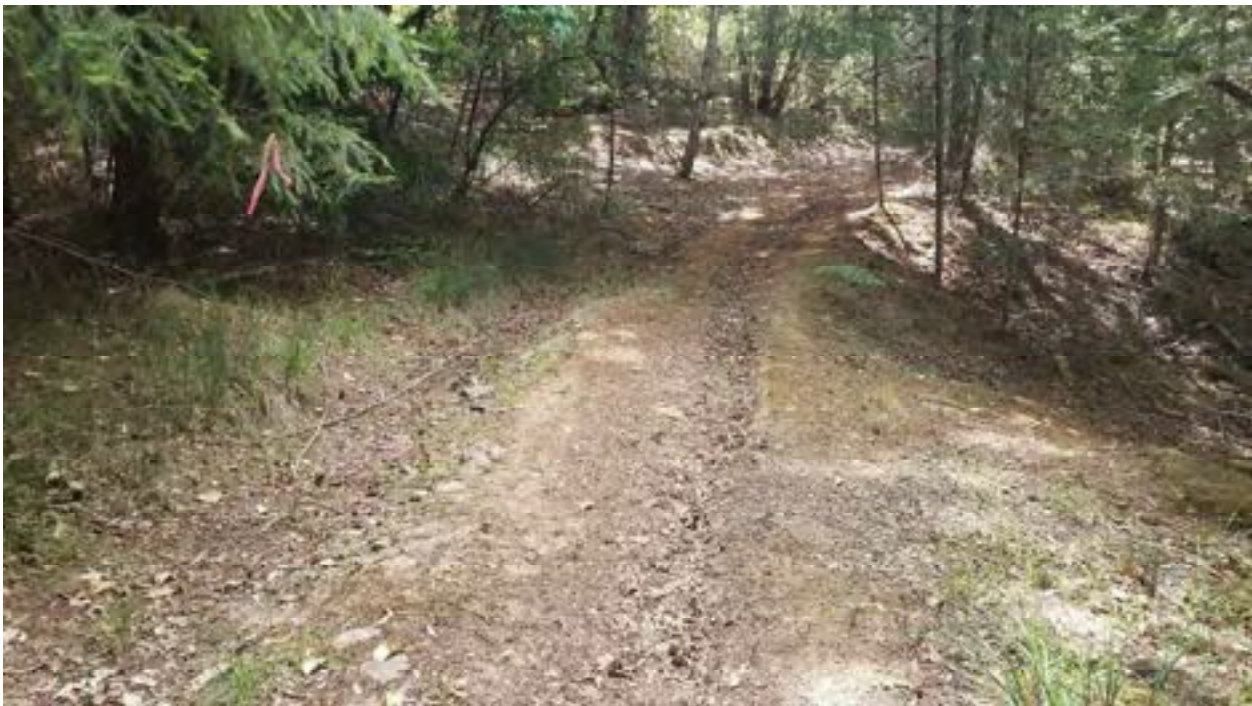
*Photo looking up grade at Site 16.*

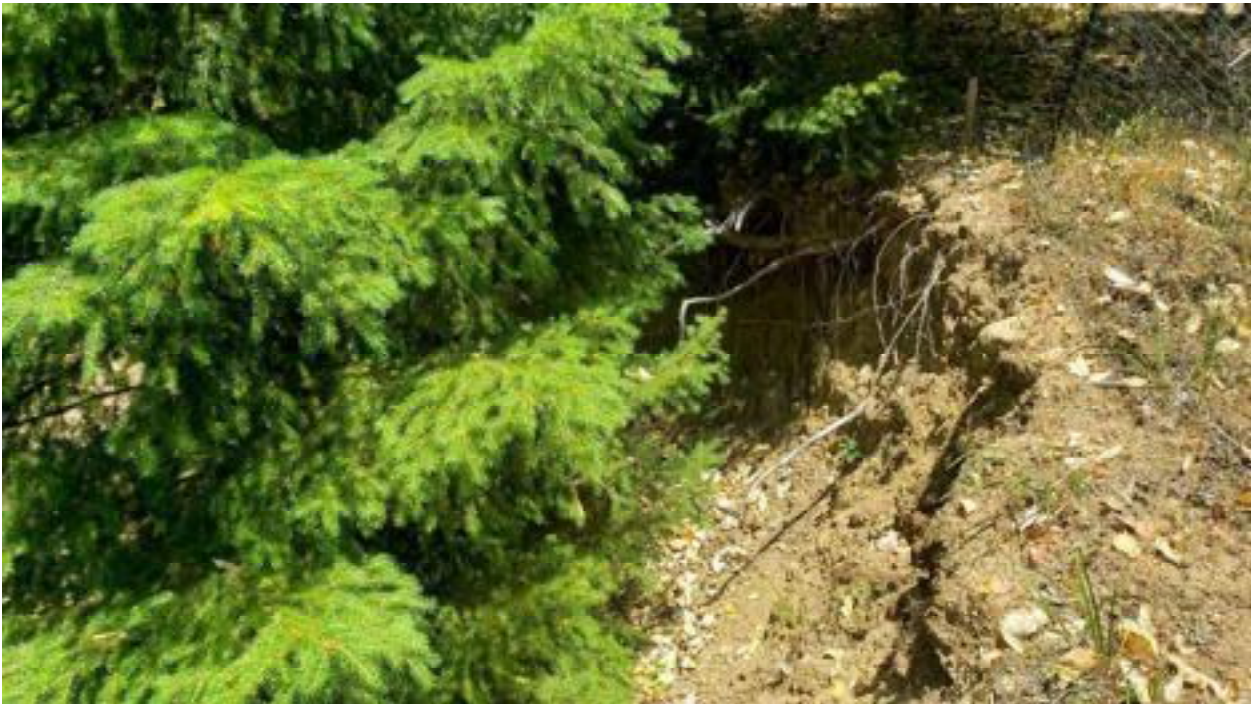
*Looking at the lower extent of Site 21.*

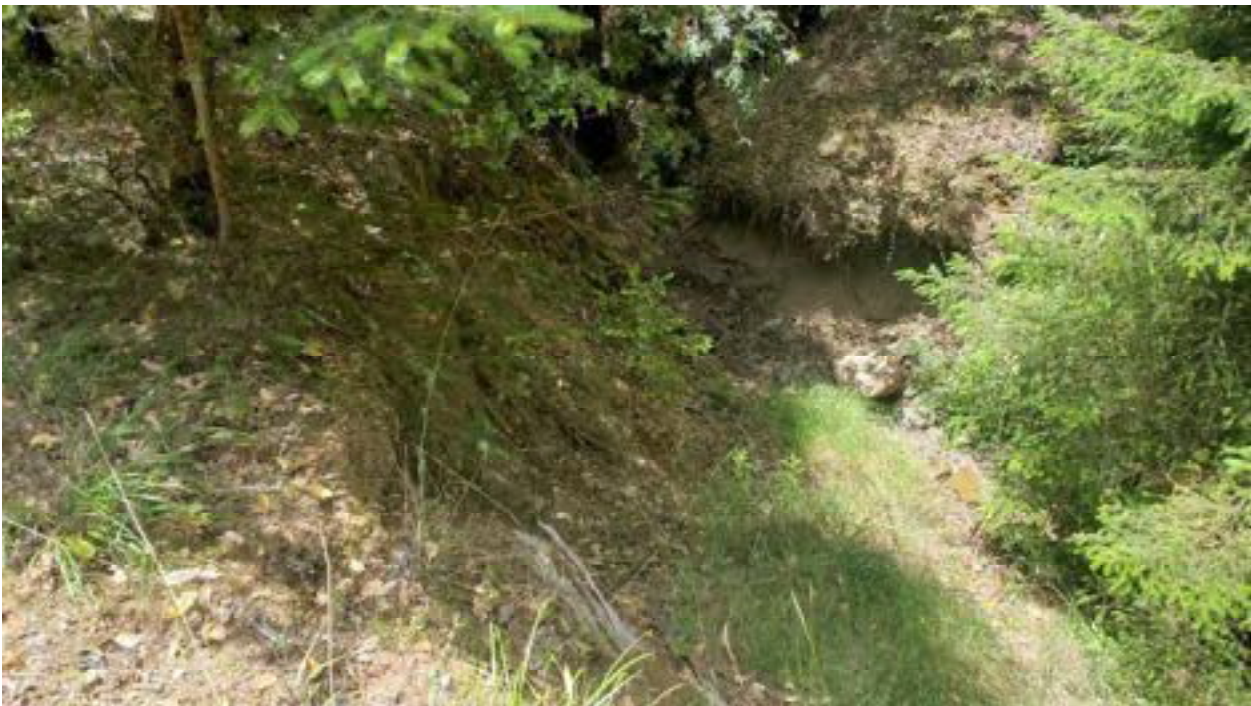
Site 22

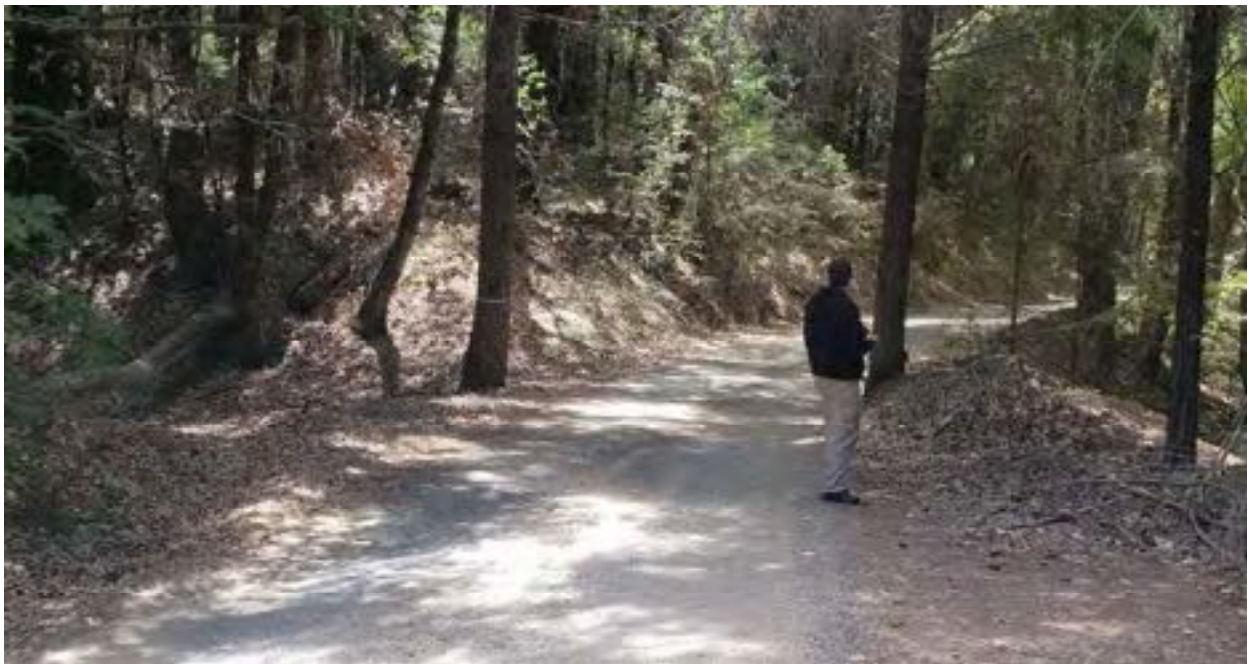
Site 23. The outlet is to the right center, inlet is to the left center out of frame.

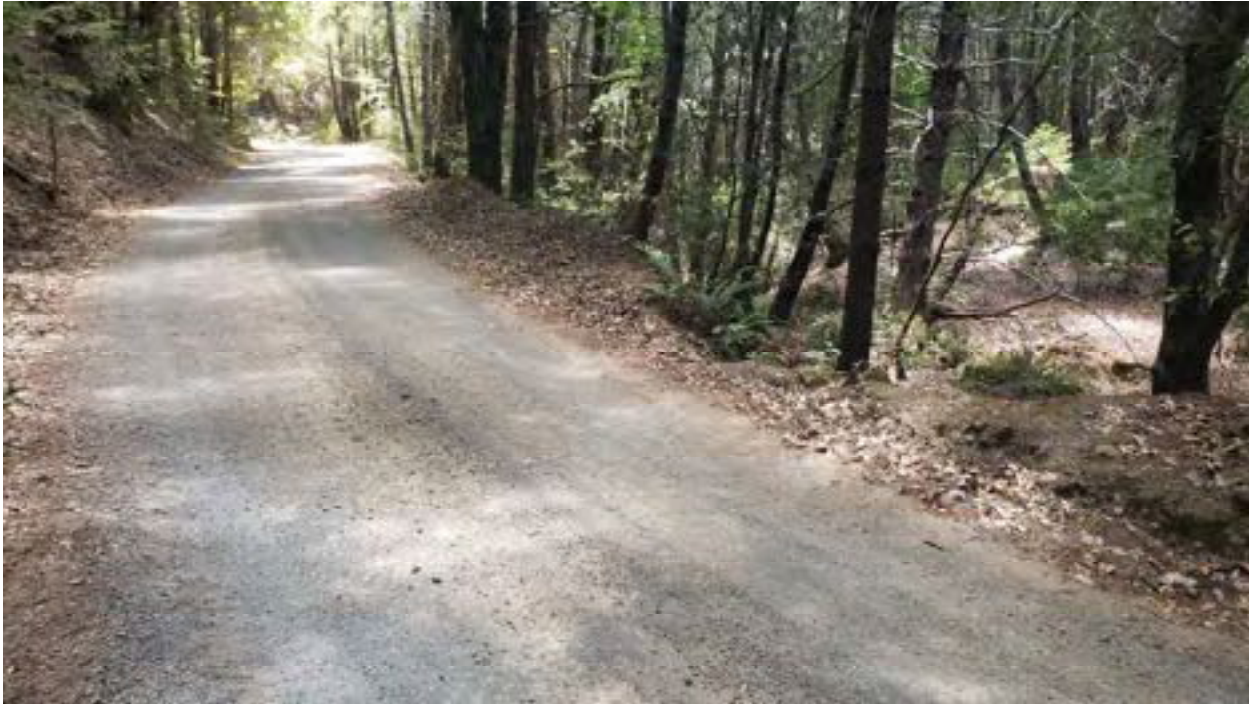
Outlet of watercourse crossing at Site 23. Blue flag represents proposed outlet of culvert upgrade.

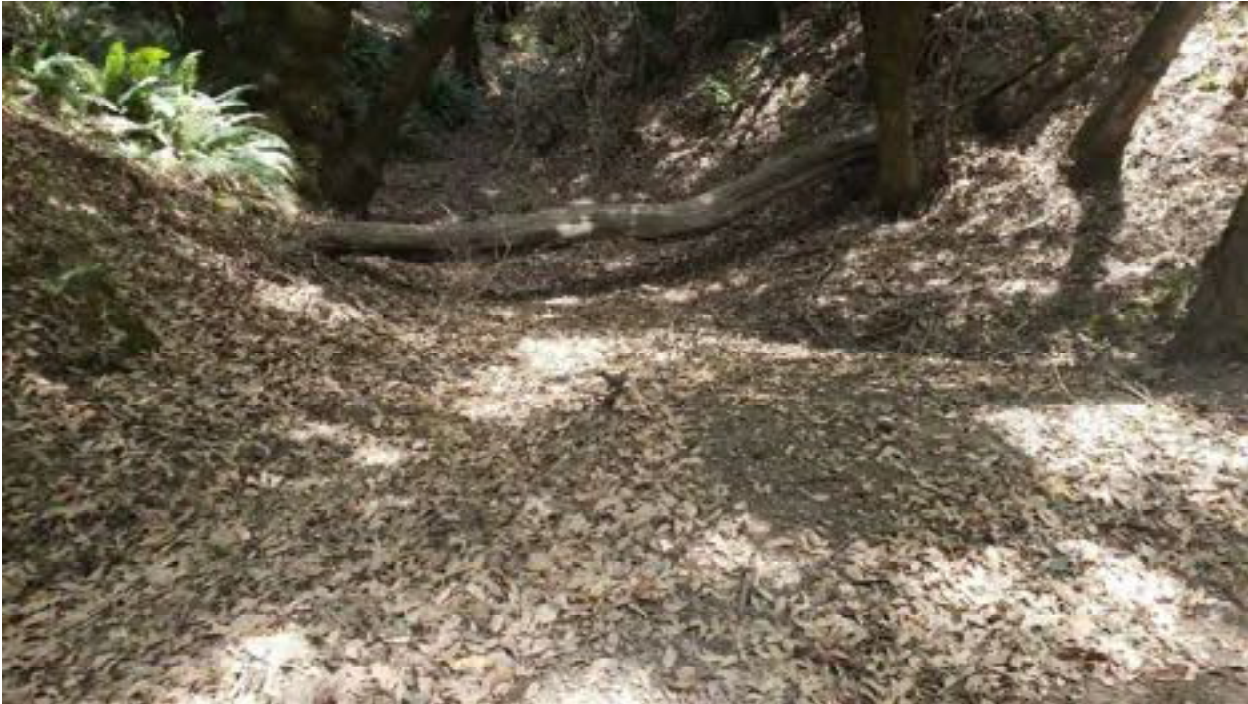
Site 23. Looking down channel from the outlet. The upgraded culvert will outlet approximately where the blue flag is being hanged.

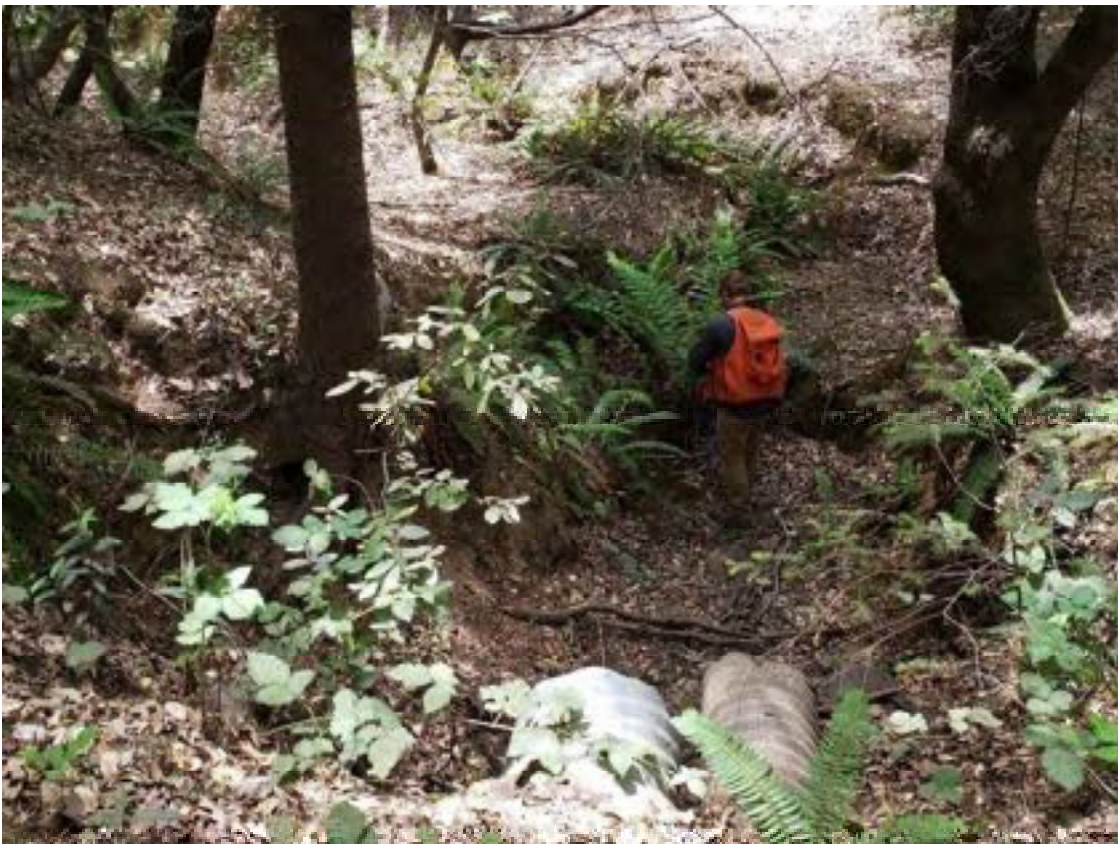
*Looking up grade from Site 23 towards Site 14 and 15.*

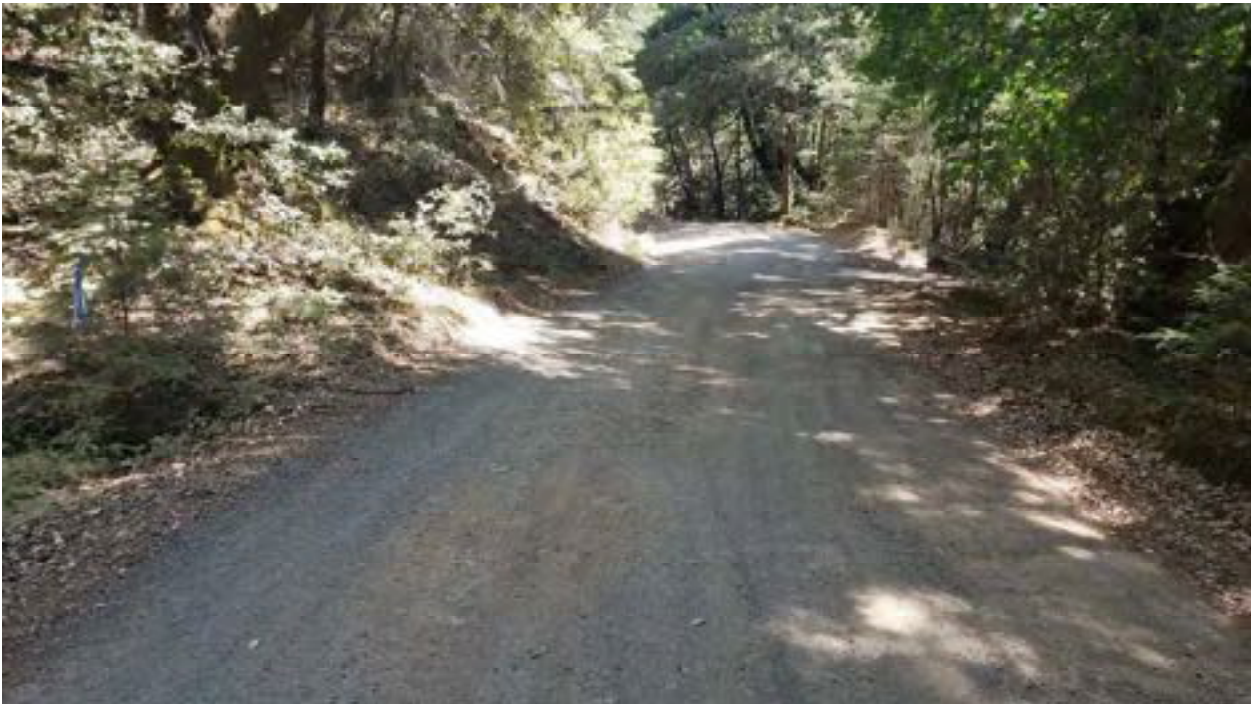
Site 24. Inlet of the watercourse crossing.

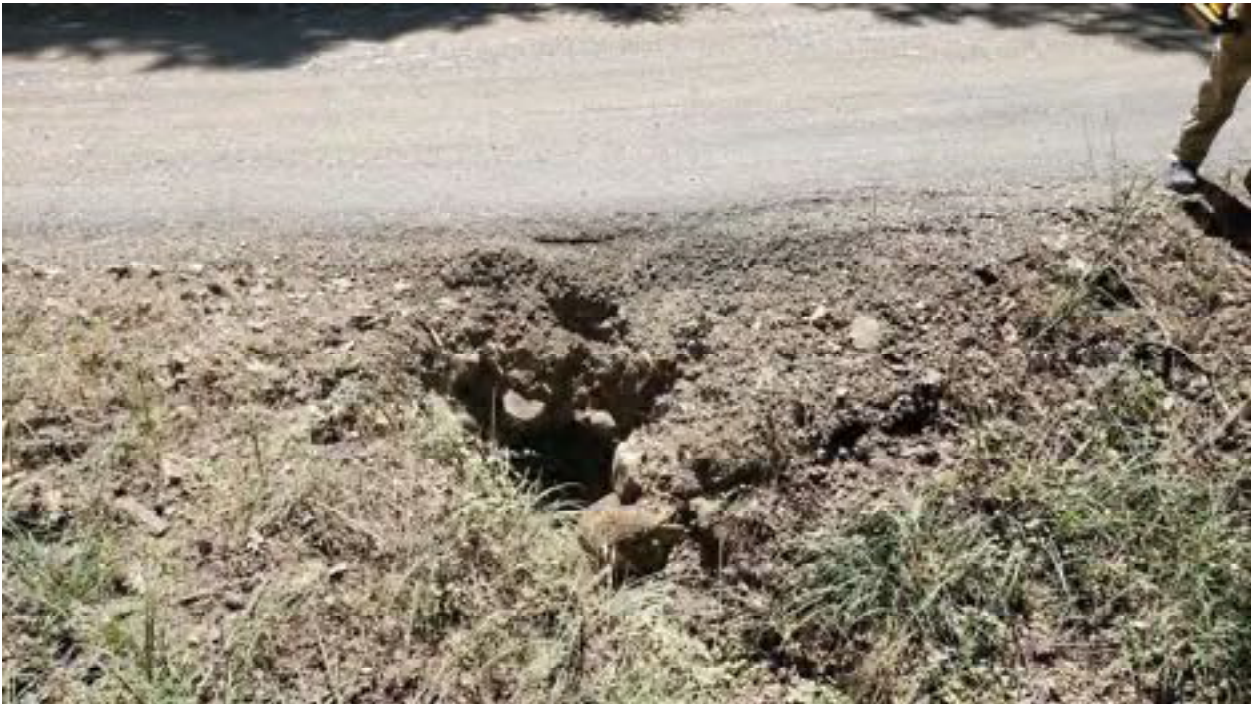
*Site 26. Inlet of the watercourse crossing.*

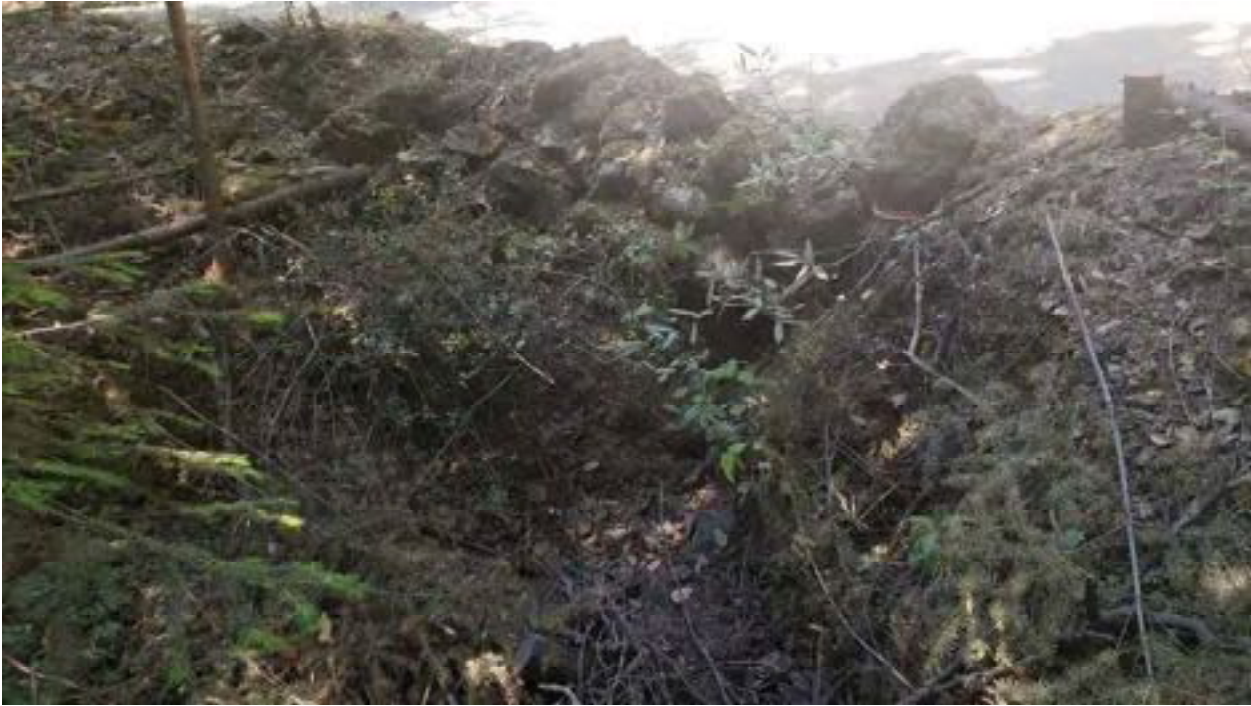
Site 26. Outlet of the watercourse crossing.

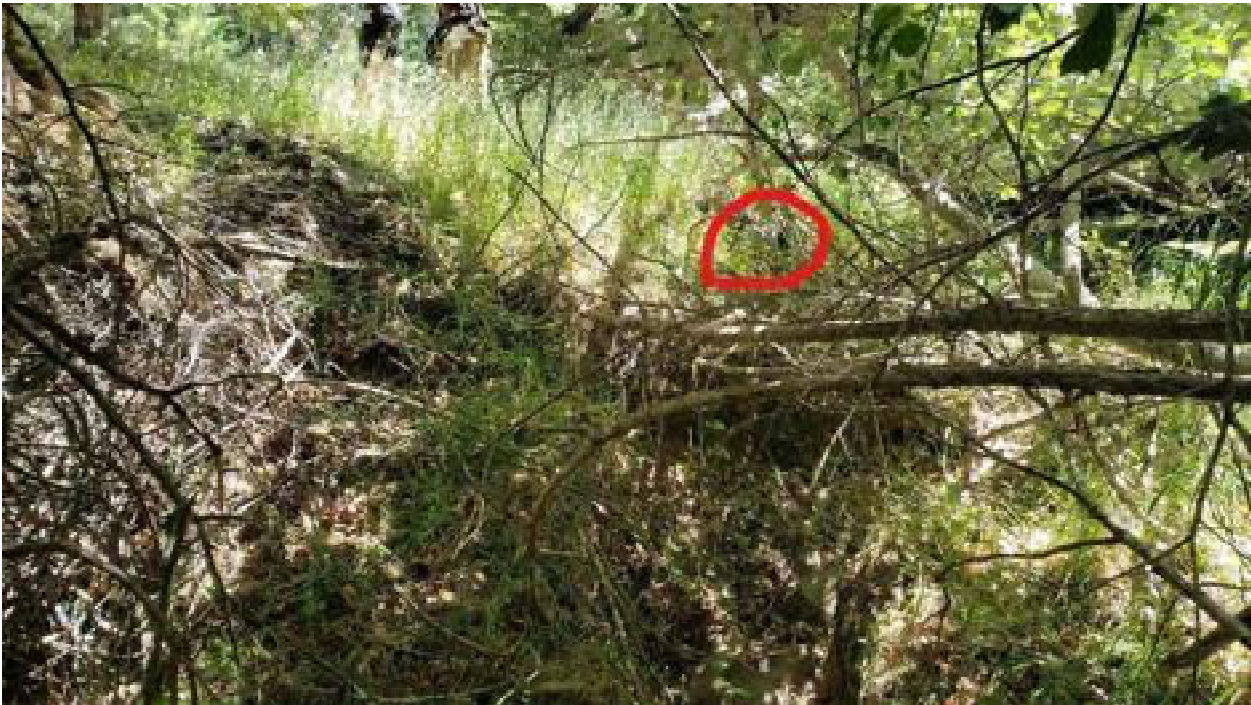
Site 35. Looking at the outlet(circled). The culvert upgrade will re-align the watercourse to its original channel, which will require the outlet to be placed in the lower left of the photo.

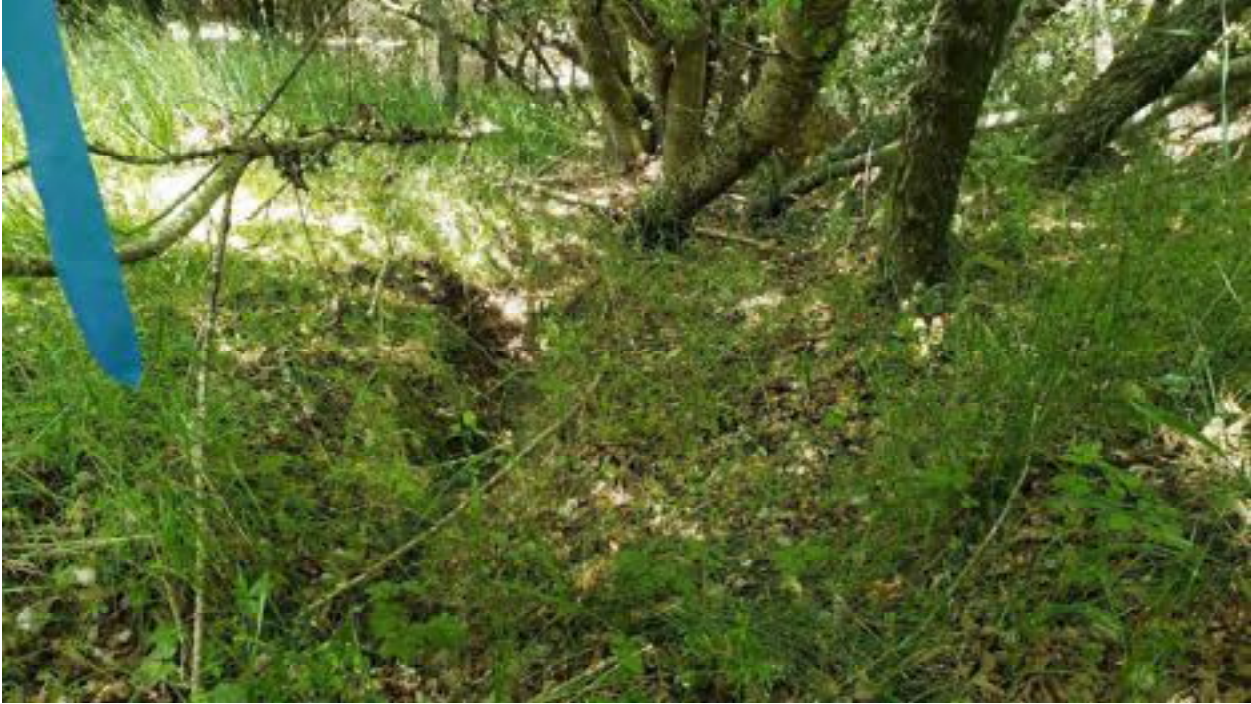
Site 35. Looking at the down channel and where the culvert outlet will approximately be located.

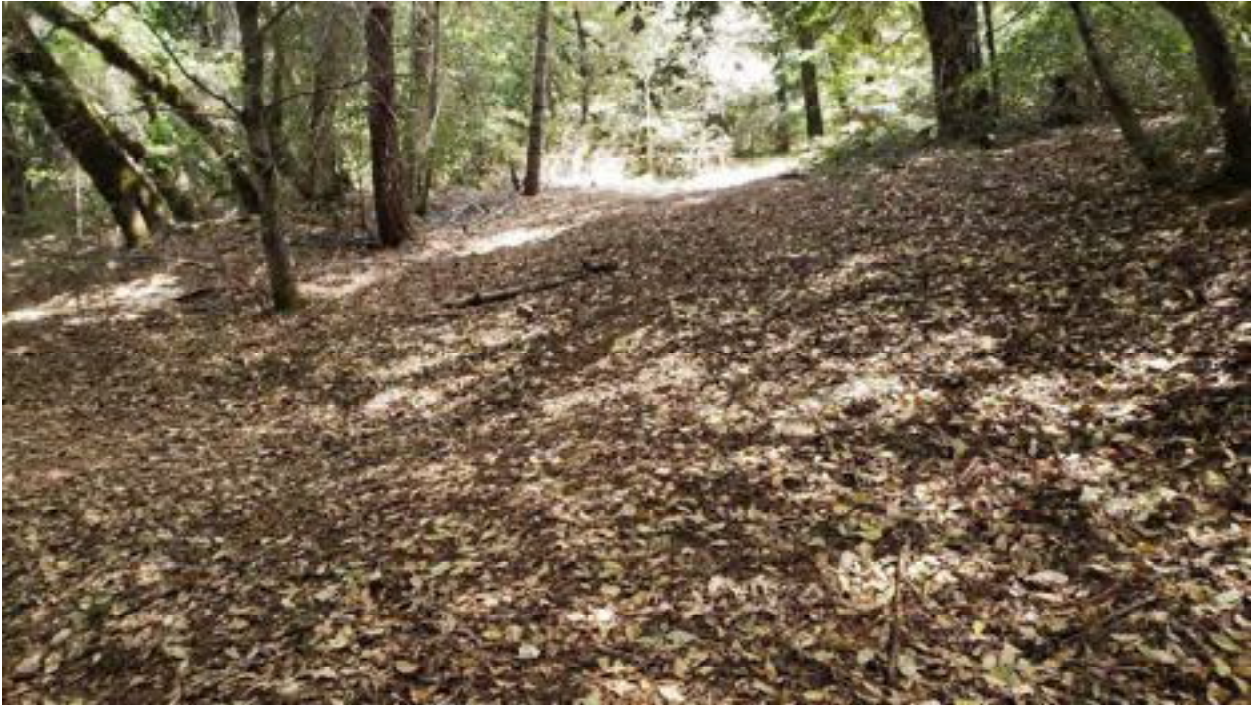
*Photo looking up grade at the road down to G1, G2, G3, and G4 from approximately where the photos on page 19 of the 2015 Inspection Report were taken.*
