ATTACHMENT 1b  
Sprowl Creek Full Resubmittal

# ETA Humboldt, LLC

**Photographs Correlating to Site Management Plan Map**

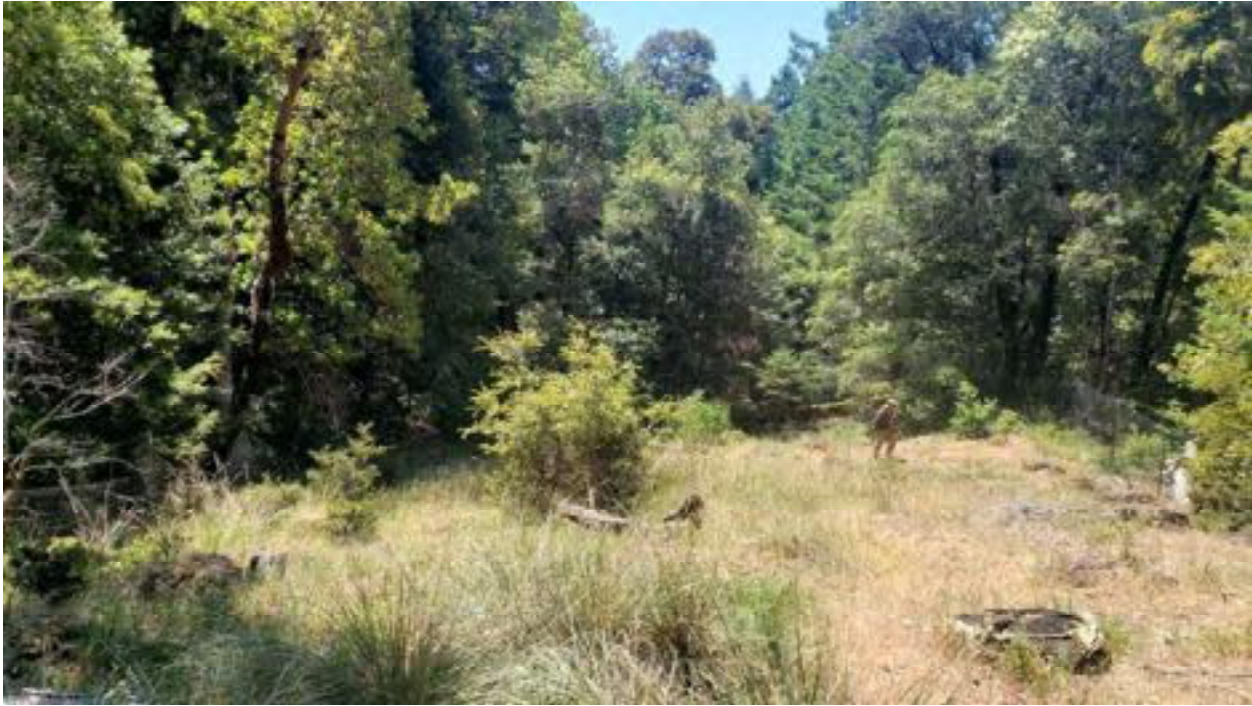
*Looking down grade at OG1.*

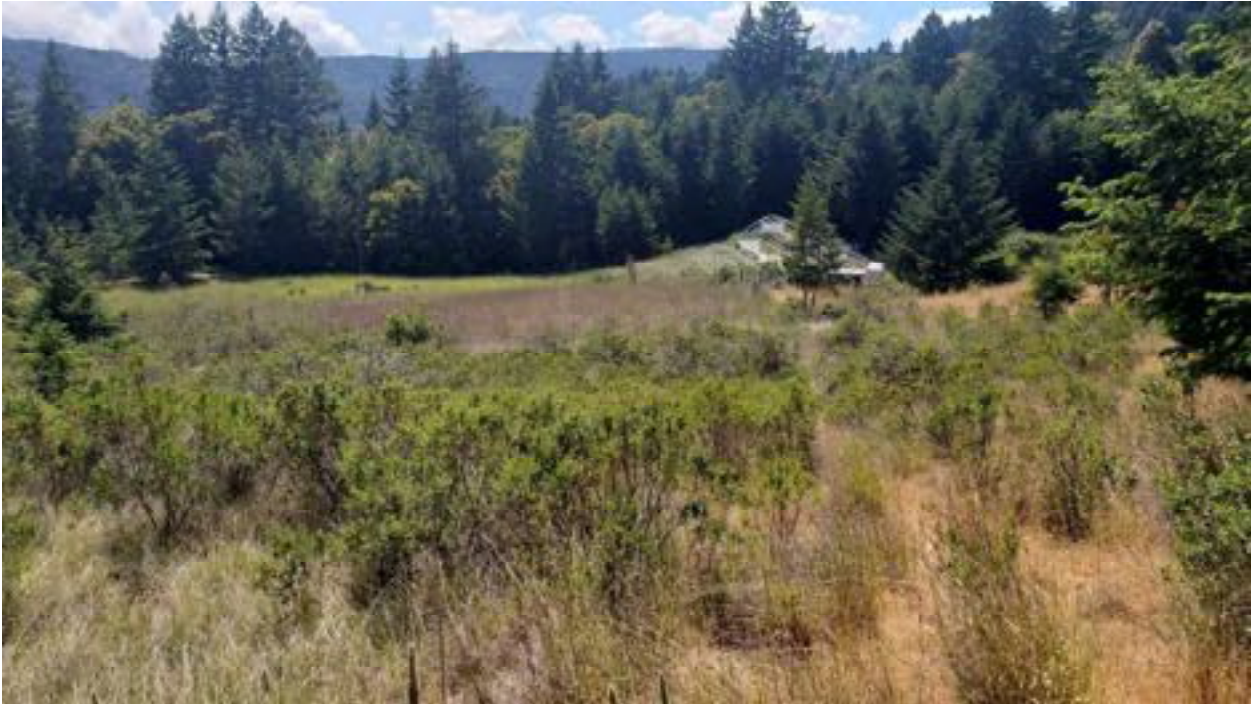
*Photo looking at the Past Cultivation Area located adjacent to Site 31 and P27.*

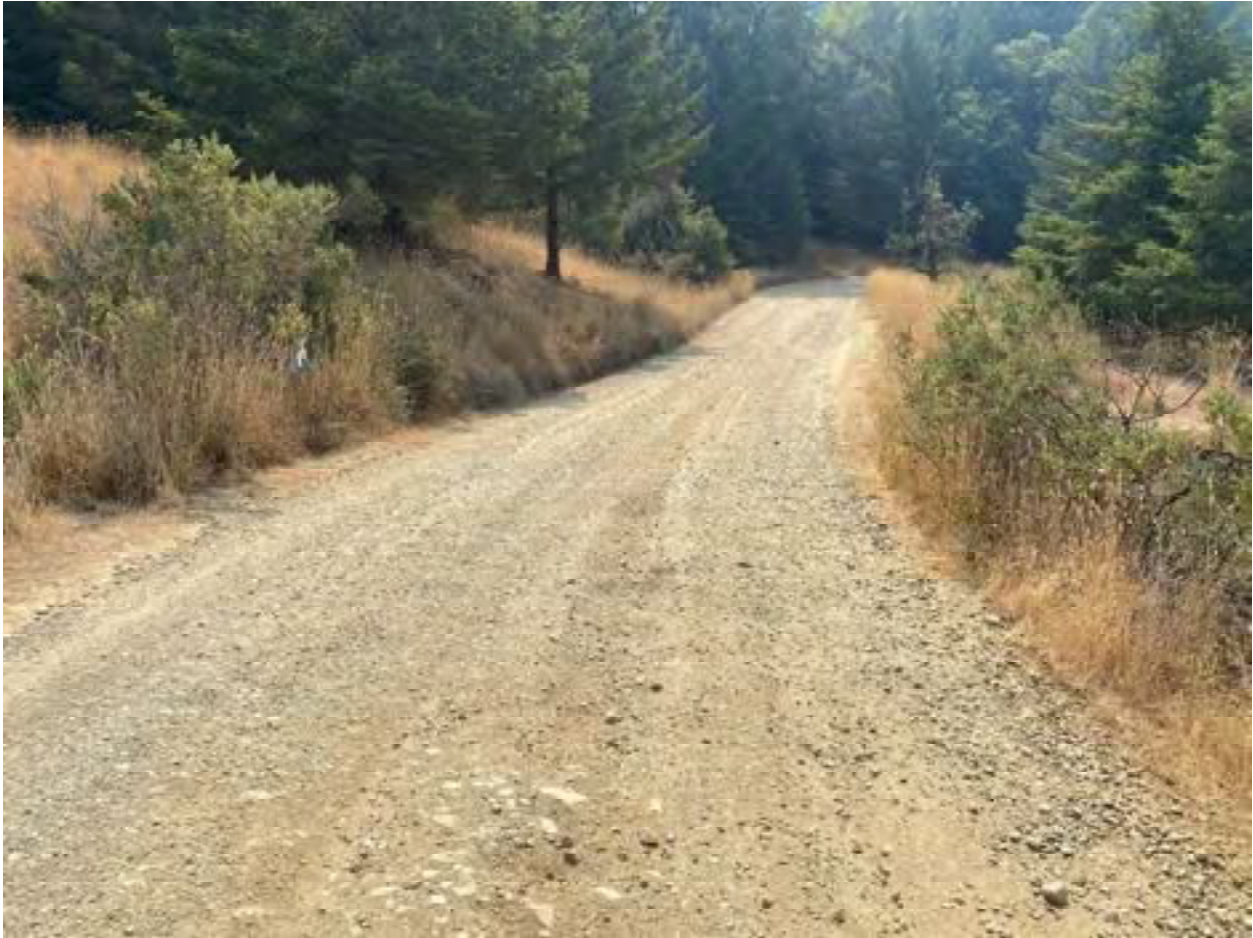
**Photo 37:** Stream Crossing 11. The roadside approach to stream crossing 11 facing Northwest. Photo date 9-1-2021.

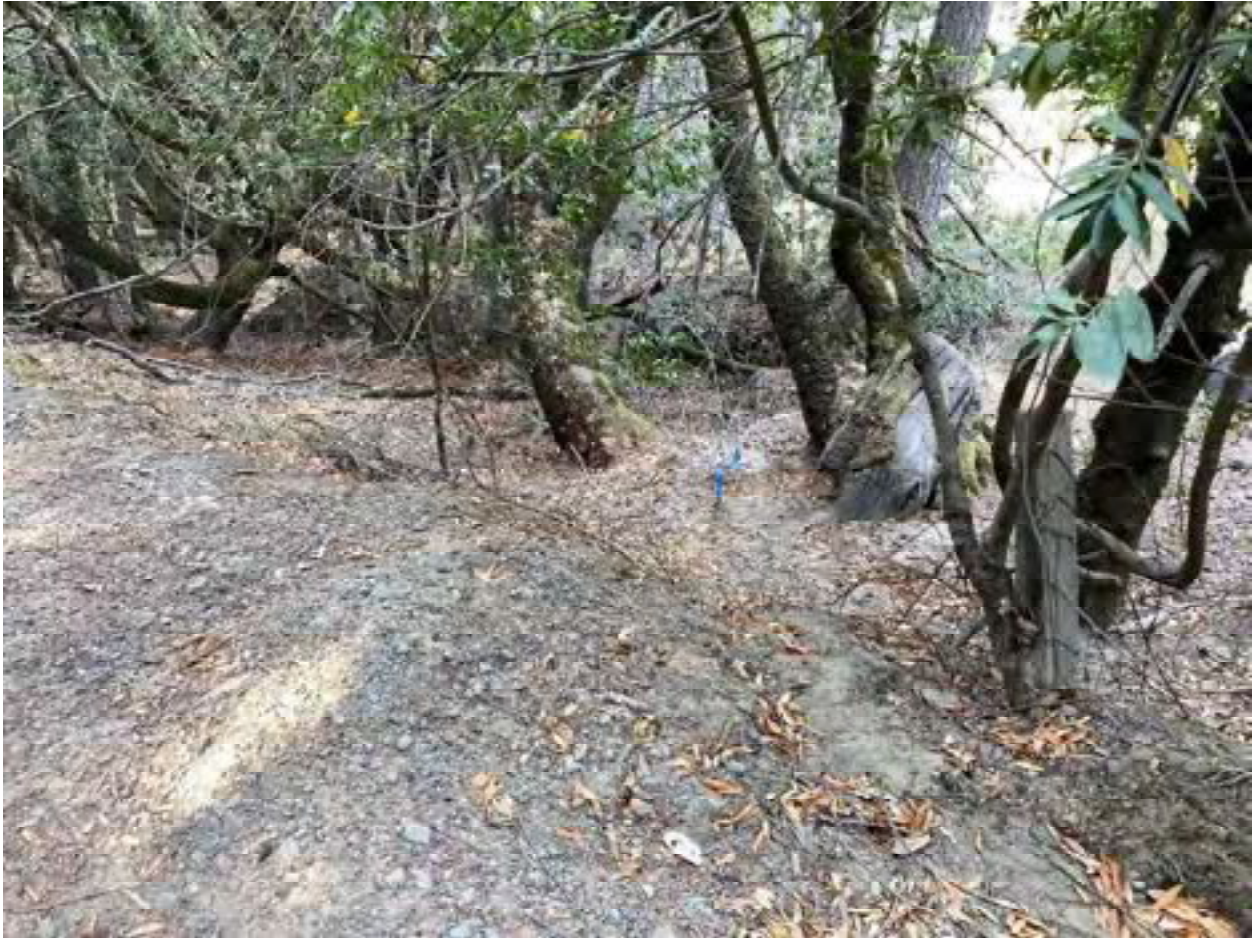
**Photo 41:** Stream Crossing 13. Looking downstream from the road where the outlet of stream crossing 13 is proposed. Photo date 9-1-2021.

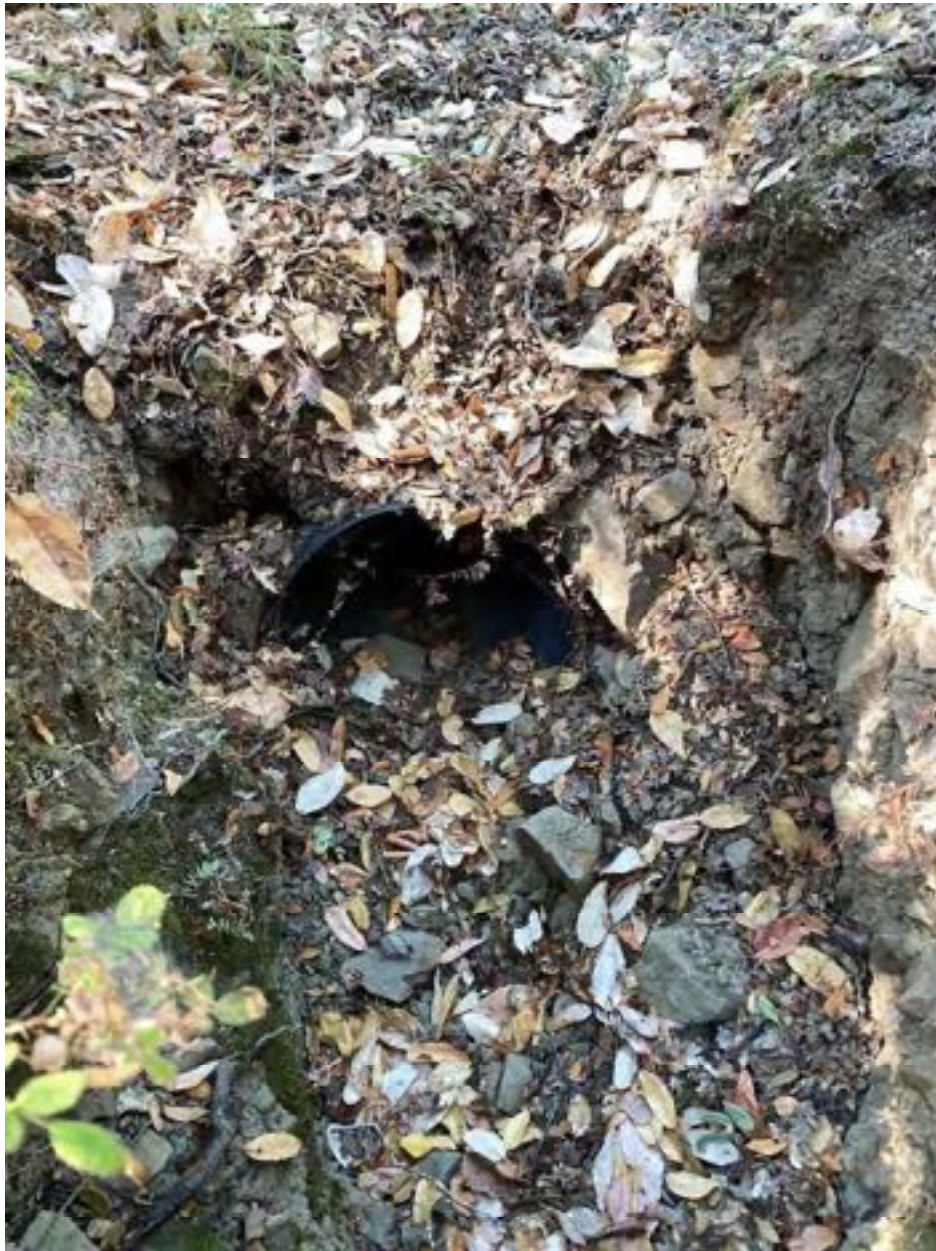
**Photo 47:** Stream Crossing 17. Looking downstream towards the inlet of the 18-inch diameter culvert at stream crossing 17 that is proposed for removal. Photo date 9-1-2021.

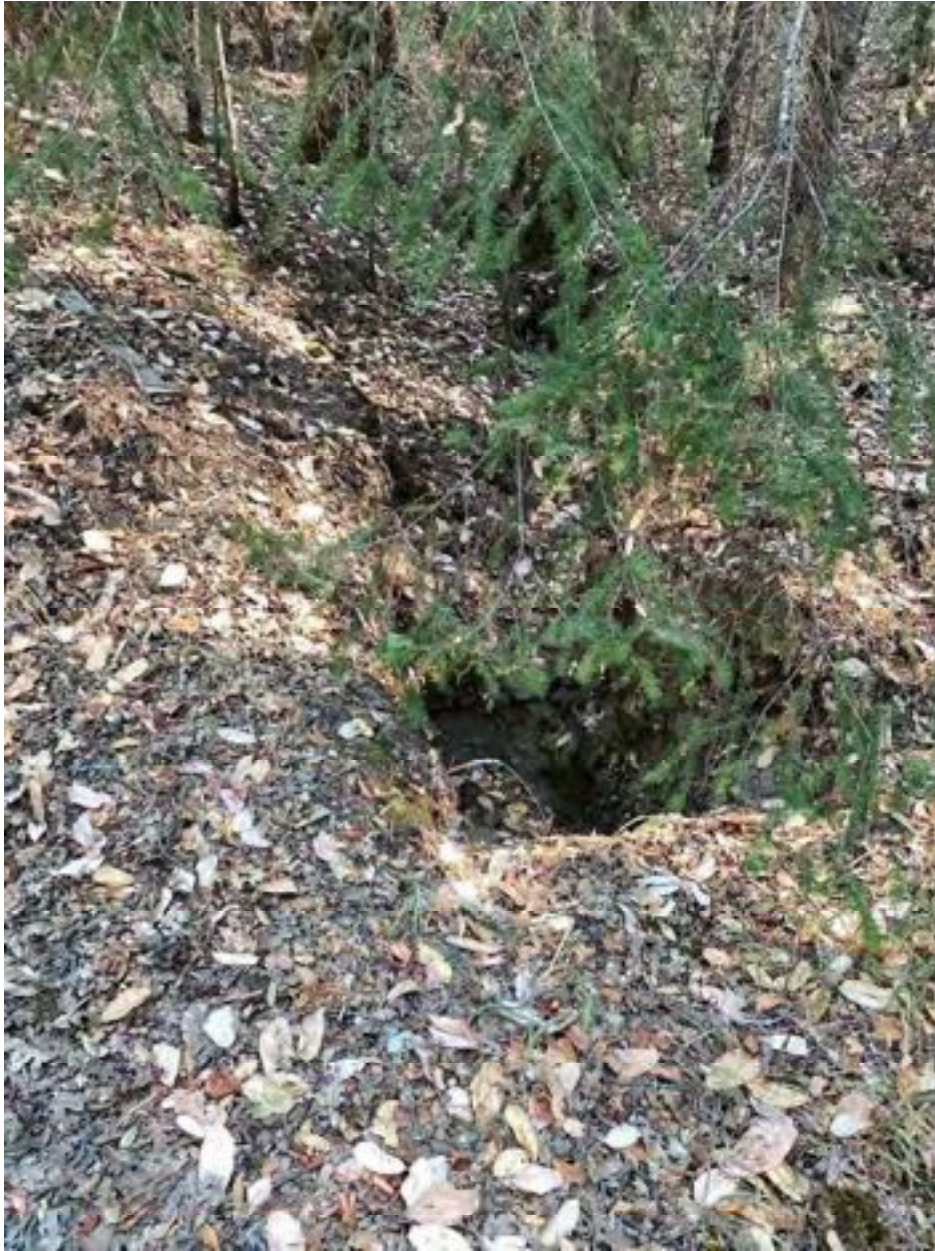
**Photo 51:** Stream Crossing 17. Looking downstream from the outlet of the 18-inch diameter culvert at stream crossing 17 that is proposed for removal. Photo date 9-1-2021.

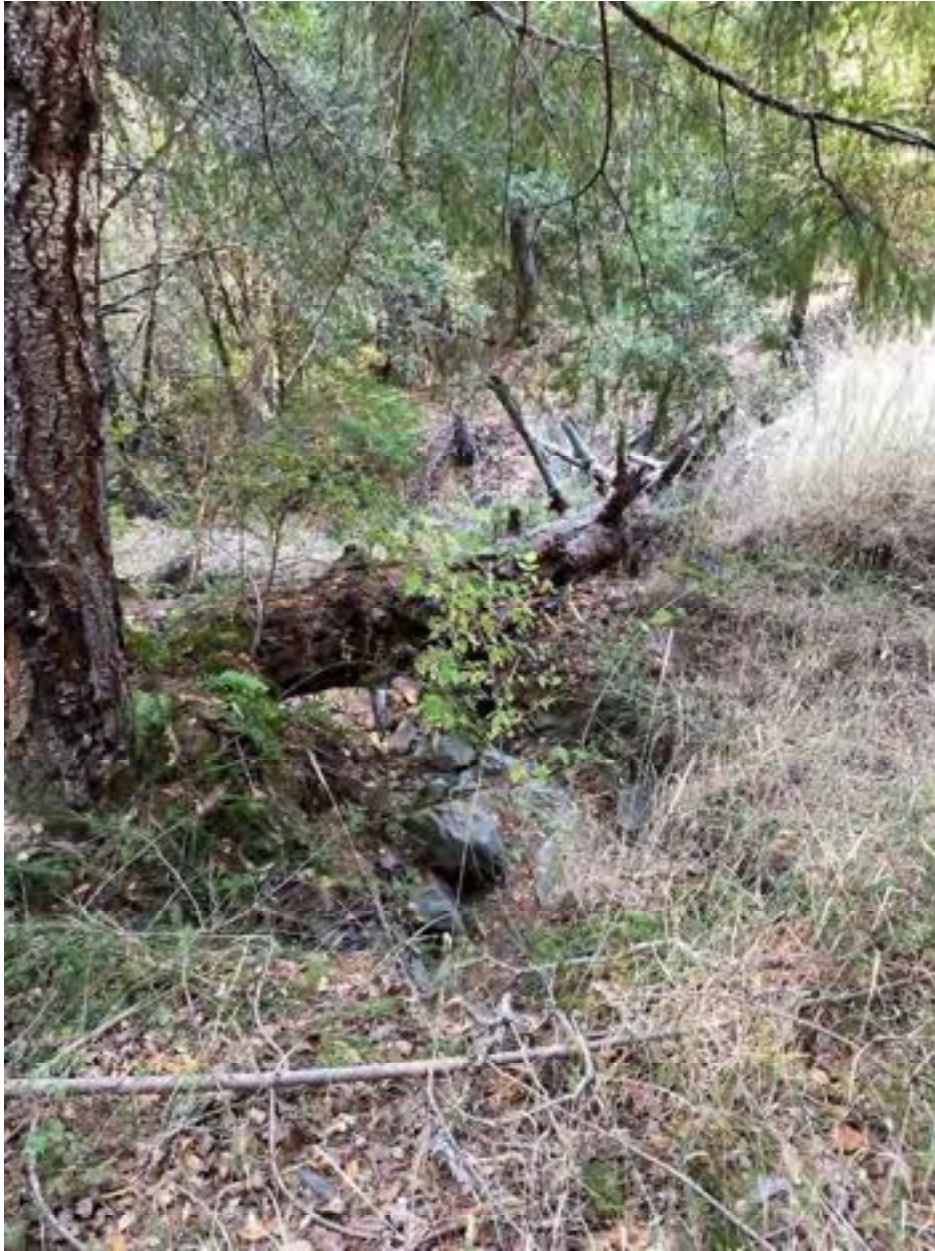
**Photo 56:** Stream Crossing 19. Looking downstream from the outlet of the 18-inch diameter culvert at stream crossing 19. Photo date 9-1-2021.

| Project Site Identification | Estimated Completion Date |
|---|--|
| SC-19 | An existing, misaligned, and failing 18-inch culvert on an abandoned road shall be removed and the road decommissioned. The crossing shall be realigned to match with the native channel. This is a site of remediation. The proposed work shall be completed by no later than October 31, 2023. |

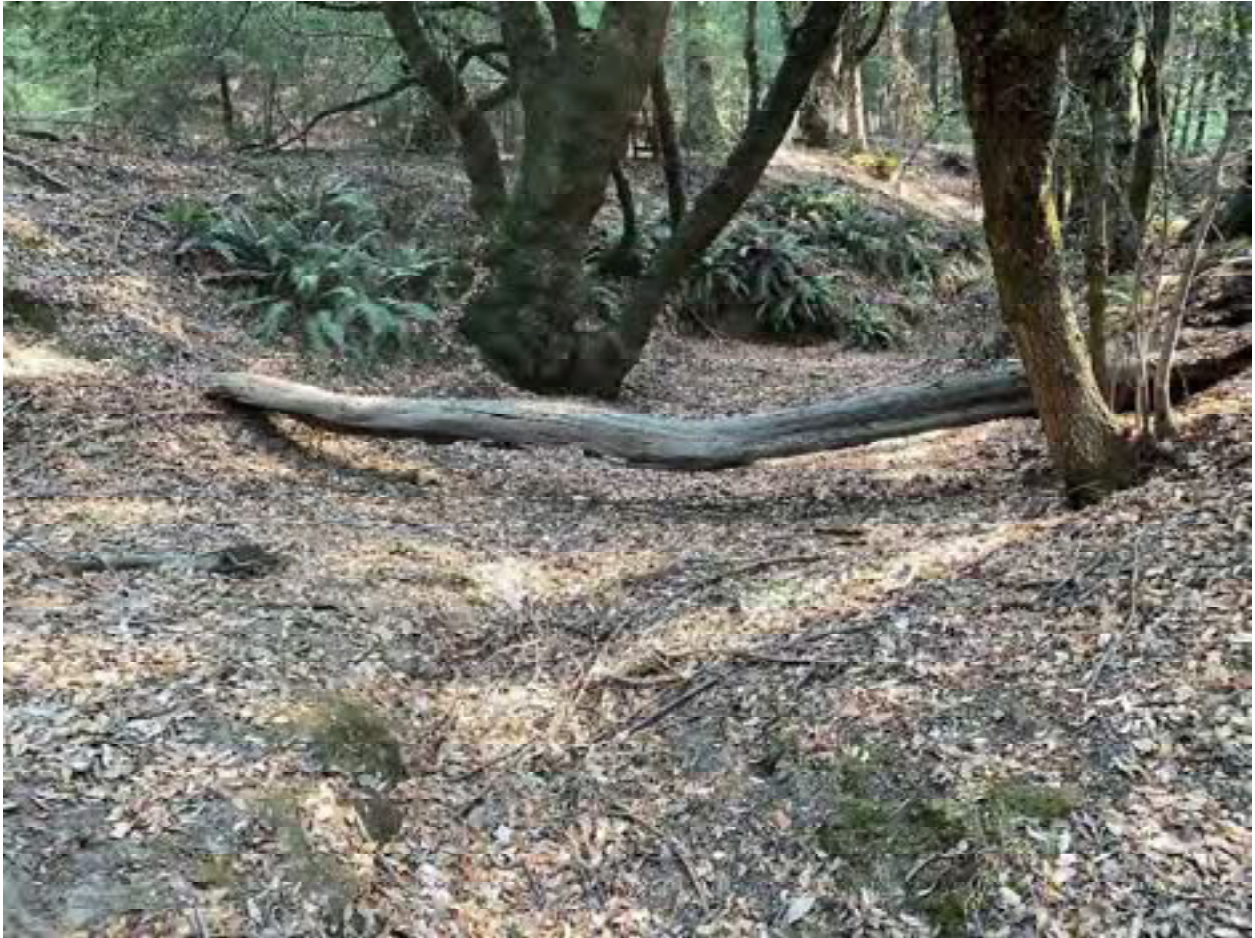
**Photo 59:** Stream Crossing 23. Looking upstream from the inlet of stream crossing 23. Photo date 9-1-2021.

| Project Site Identification | Estimated Completion Date |
|---|--|
| SC-23 | Replace an existing double barrel 18-inch diameter culvert(s) shall be removed and upgraded to a minimum 30-inch diameter culvert. The proposed work shall be completed by no later than October 31, 2024. |

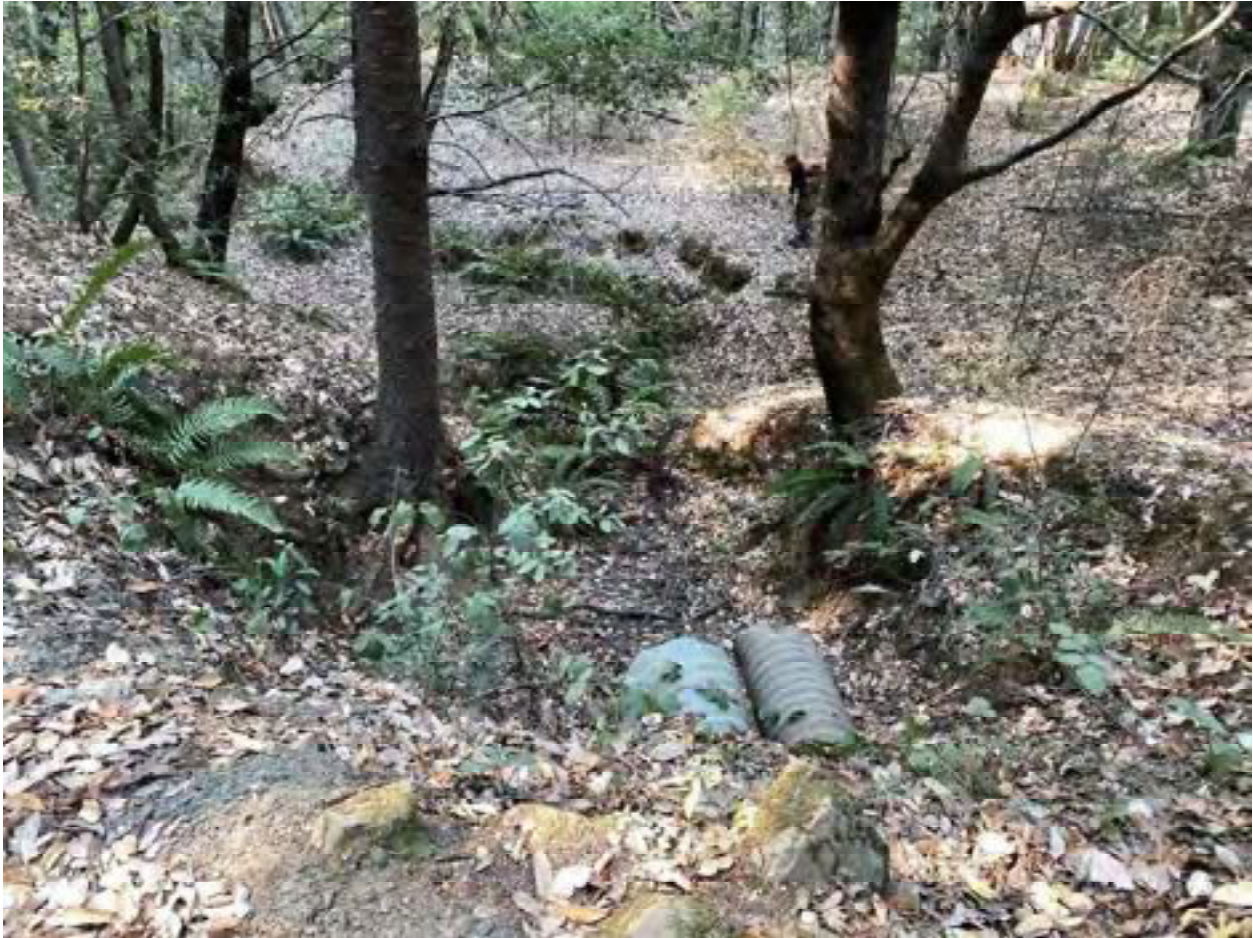
**Photo 62:** Stream Crossing 23. Looking downstream from the outlet of stream crossing 23. Photo date 9-1-2021.

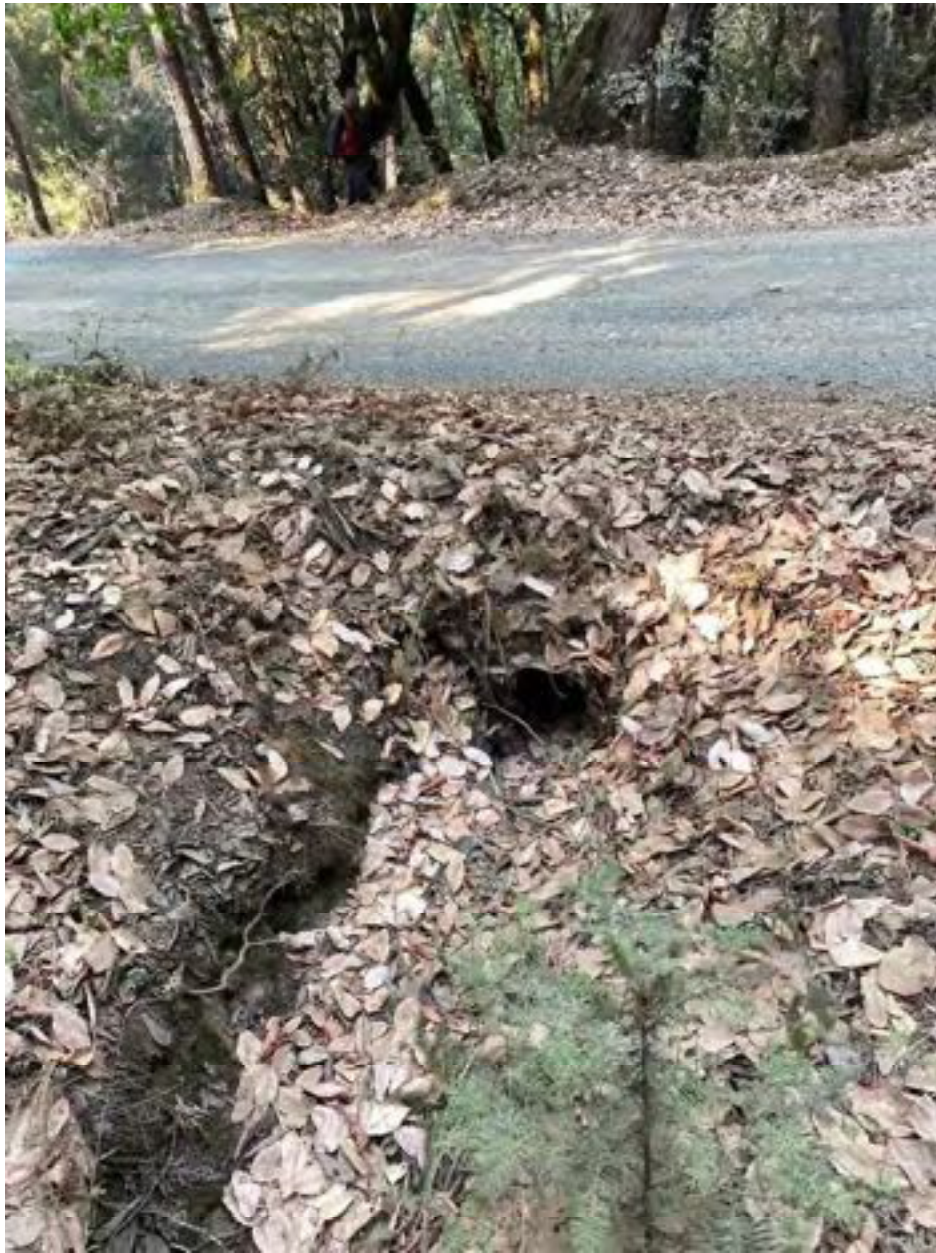
**Photo 63:** Stream Crossing 24. Looking downstream towards the inlet of the 18-inch diameter culvert at stream crossing 24. Photo date 9-1-2021.

| Project Site Identification | Estimated Completion Date |
|---|--|
| SC-24 | Replace an existing 18-inch diameter culvert with a minimum 36-inch diameter culvert set to grade. Rock armor the inlet and outlet as necessary to minimize potential erosion. The proposed work shall be completed by no later than October 31, 2024. |

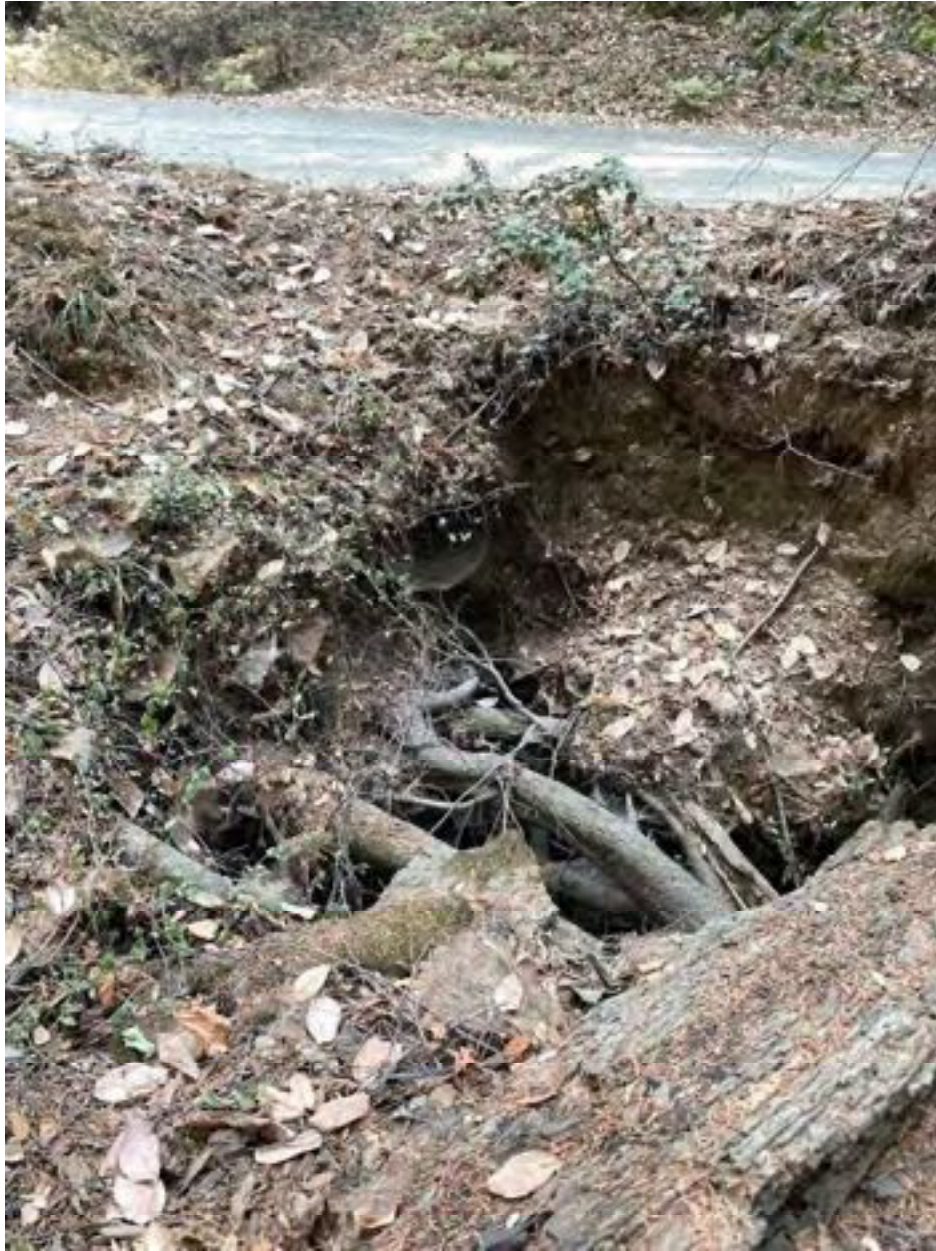
**Photo 66:** Stream Crossing 24. Looking upstream towards the outlet of the 18-inch diameter culvert at stream crossing 24. Photo date 9-1-2021.

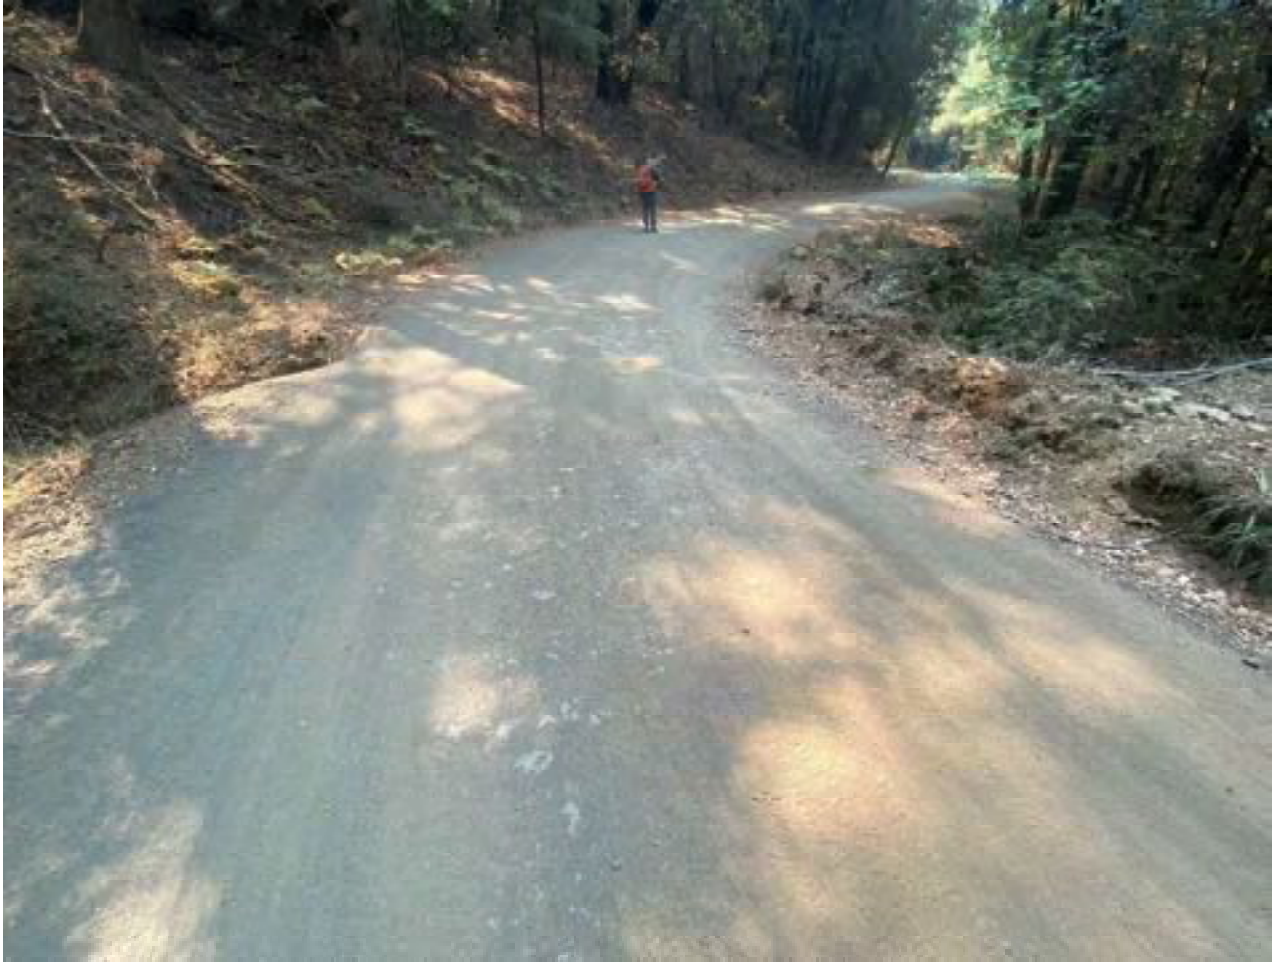
**Photo 70:** Stream Crossing 26. The roadside approach to stream crossing 26 facing South. Photo date 9-1-2021.

| Project Site Identification | Estimated Completion Date |
|---|--|
| SC-26 | Replace an existing 18-inch diameter with a minimum 30-inch diameter culvert set to grade. Rock armor the inlet and outlet as necessary to minimize potential erosion. The proposed work shall be completed by no later than October 31, 2025. |

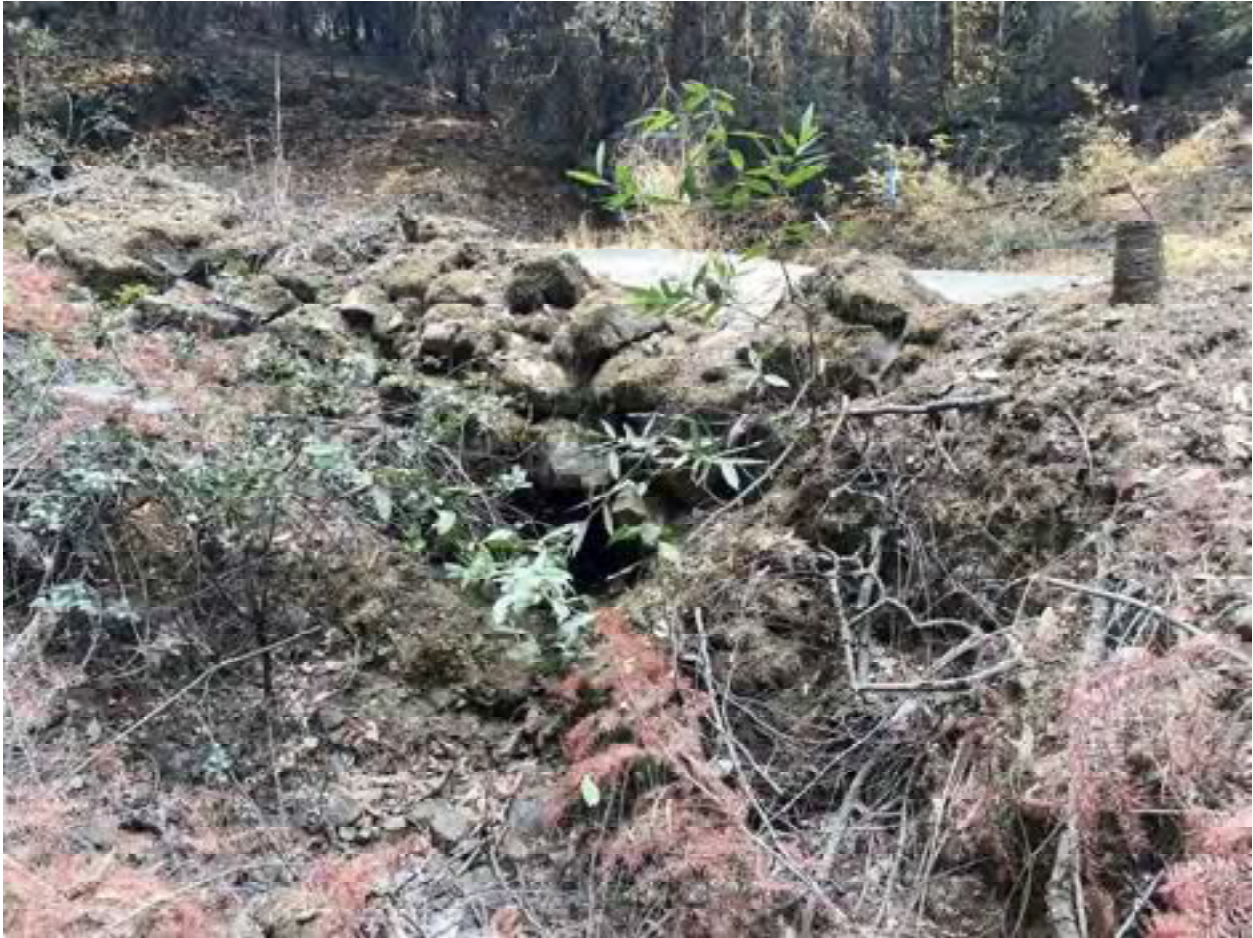
**Photo 71:** Stream Crossing 26. Looking upstream towards the outlet of the 18-inch diameter culvert at stream crossing 26. Photo date 9-1-2021.

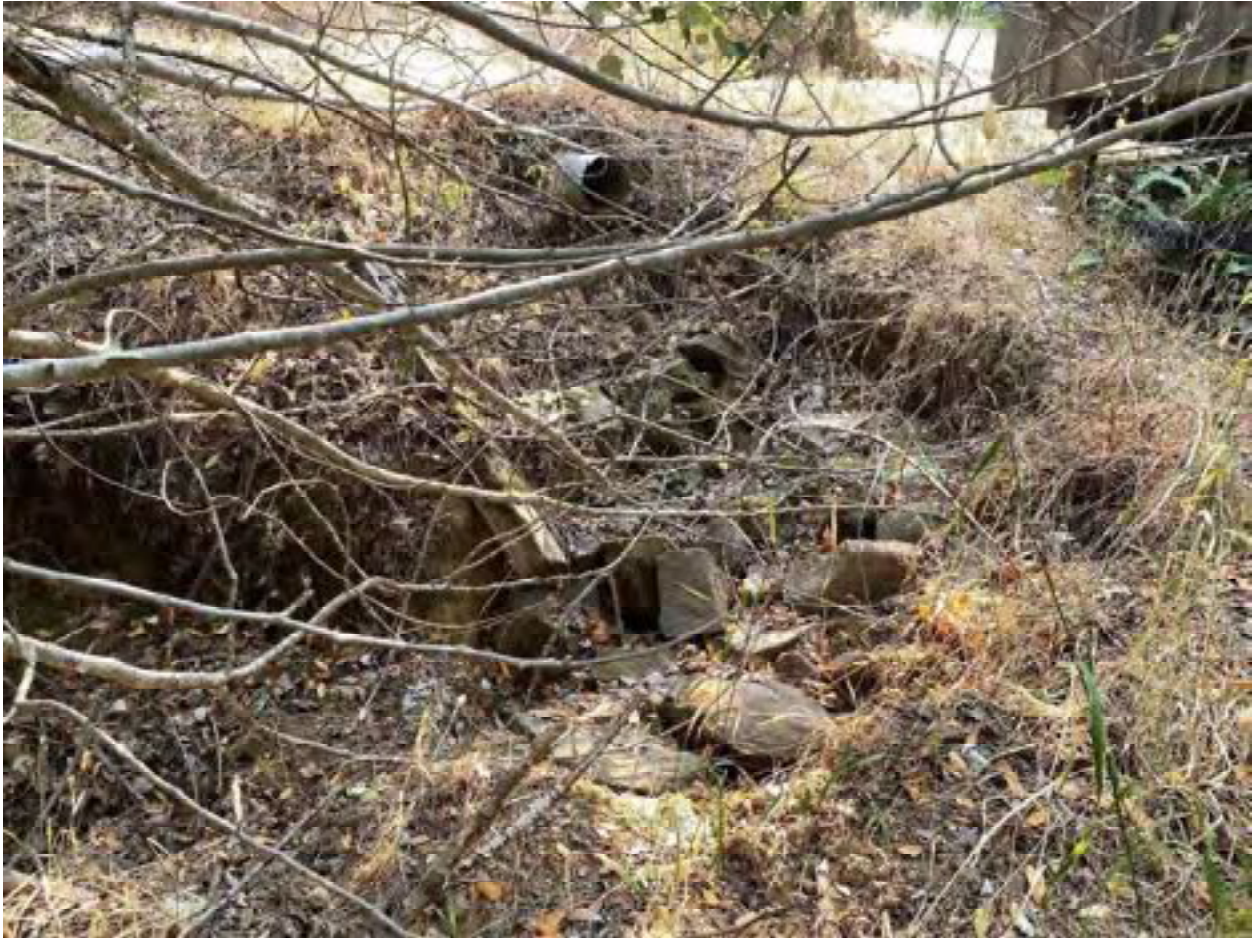
**Photo 76:** Stream Crossing 35. Looking upstream towards the outlet of the 8-inch diameter culvert at stream crossing 35. Photo date 9-1-2021.

| Project Site Identification | Estimated Completion Date |
|---|--|
| SC-35 | Replace an existing undersized 8-inch diameter culvert with a minimum 18-inch diameter culvert set to grade. Rock armor as necessary to minimize potential erosion. The proposed work shall be completed by no later than October 31, 2024. |
