Lost Coast Elixirs LLC 569 Eubanks Rd, Garberville CA 95542 Permit Application 11247

Water Resource Protection Plan

Assessment of Standard Conditions for APN 220-081-016 – WDID #1B16459CHUM

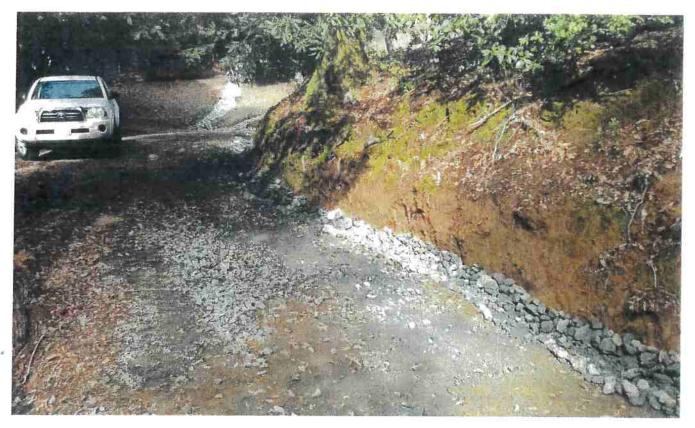
Pictures 4 and 5: These pictures show the bottom of the newly rock lined drainage channels and where they intersect with the newly rock lined inside ditch along Map Point 2. Photo date 12/2/2016

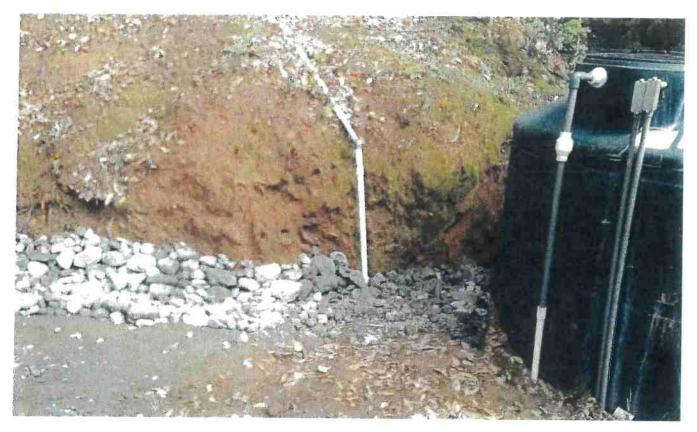
Picture 6: This is a picture along Map Point 2 showing the bottom half of the newly rock lined inside ditch taken from near the location of picture 2 above. Photo date 12/2/2016

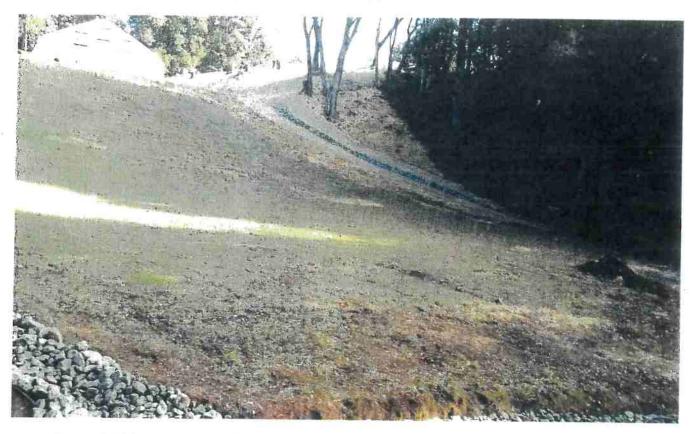
Pictures 8 and 9: The picture on the left shows recently widened and rock lined ditch. In it, the rock lined ditch shall be extended over the end of the road, towards the Class III watercourse. A rolling dip shall be installed just prior to the end of the road, to drain the road surface towards the right so that it no longer can drain over the fill slope straight off of the end of the road. The picture on the right shows the grassed over jute netting placed on the fills beyond the end of the road. Rock armor shall be placed along the bottom edge of the jute netting and in the small erosion gully in the foreground of the photo. Photo date 2/13/2017

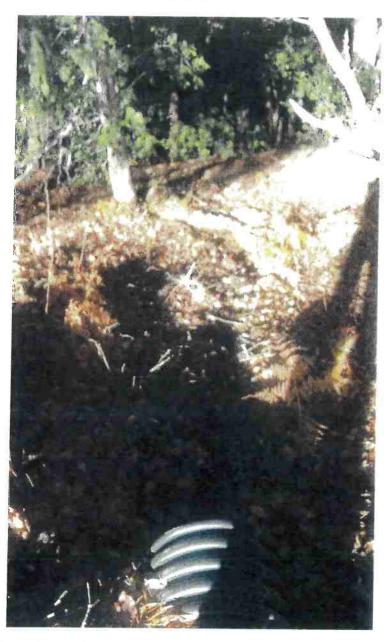
Map Point 2.5: Map Point 2.5 is a recently rock lined drainage channel that extends from the outlet of a "French Drain" that exists under the developed cultivation area. The rock lined drainage extends downslope for approximately 100 feet and ends just above the head of a Class III watercourse. The areas adjacent to the rock lined channel has been lined with "jute" netting and covered with straw. The application of rock to the drainage ditch and the adjacent erosion control had just recently been installed prior to the site visit on 12/2/16. No erosion was observed at the site, but it had not yet experienced prolonged, heavy precipitation. The site is mapped and was designated as Map Point 2.5 on the WRPP Map. Future monitoring of the site shall take place following periods of prolonged precipitation to determine if erosion is occurring to the area, especially between the bottom of the rock lined drainage and the top of the Class III watercourse. If erosion begins to take place, the Discharger shall contact Timberland Resource Consultants to determine future erosion control measures to be taken.

Picture 10: This is a picture of the newly rock lined drainage ditch that drains a "French drain" outlet that collects from the surface of the developed cultivation area. It ends above a swale that contains the top of a Class III watercourse. Photo date 12/2/2016

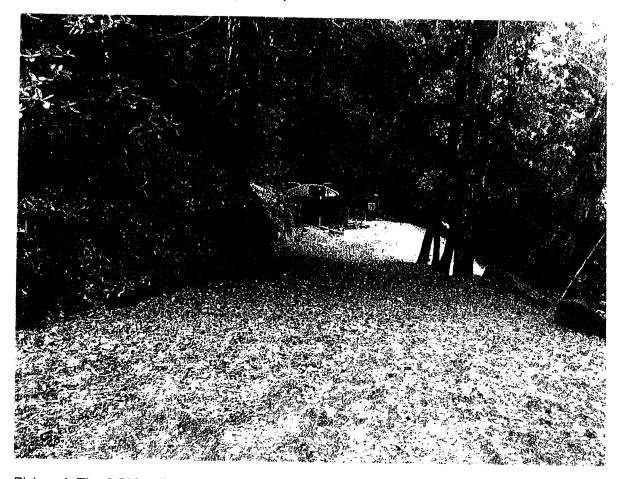
Picture 4: The 2,500 gallon plastic tank pictured above is located directly below the 1,200 gallon tank in Picture 3. The inside ditch of this road is hydrologically connected to the watercourse in the distance. This ditch shall be disconnected from the watercourse via a series of drainage structures, which have yet to be specifically determined at this point but will be further addressed in the Water Resource Protection Plan upon re-visiting the site this winter. Photo date 8-25-2016.

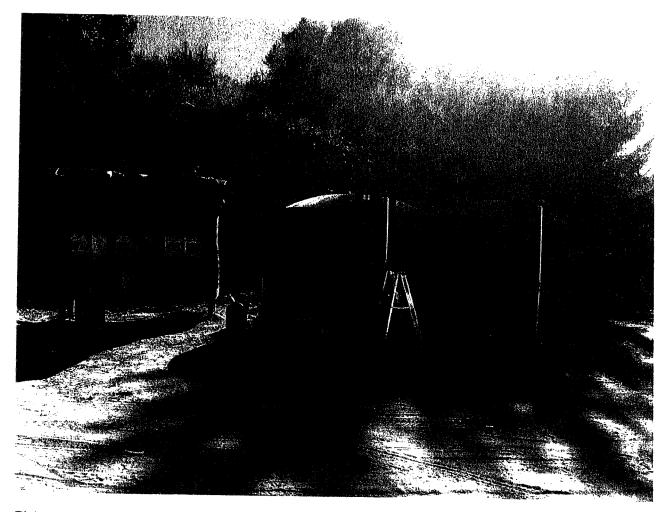
Picture 7: Southern-most well and two 2,500 gallon hard plastic tanks to right. Photo date 8-25-2016.

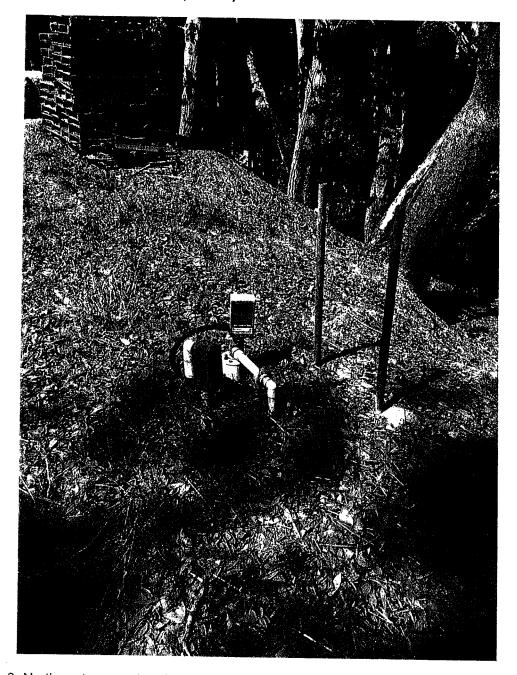
Picture 9: Northwestern-most well. Photo date 8-25-2016.

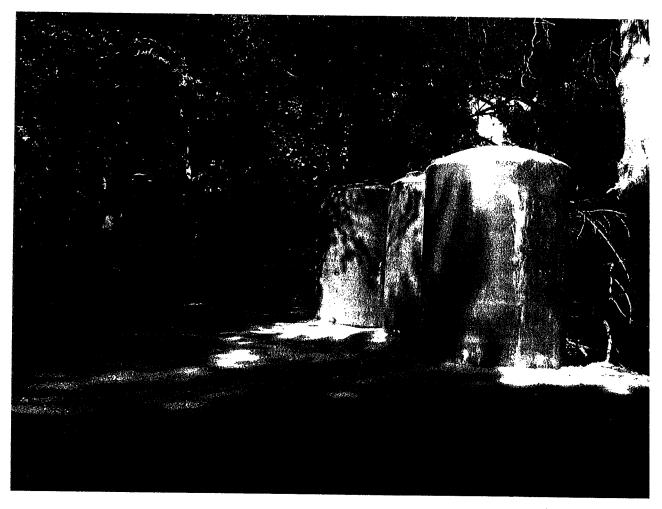
Picture 11: Tank farm located north of 50,000 gallon pioneer tank consisting of five 5,000-gallon hard plastic tanks. Photo date 8-25-2016.

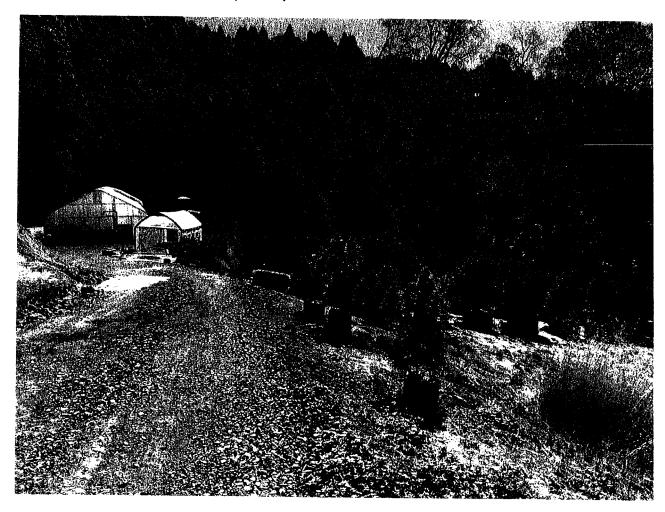
Picture 17: 30-foot by 90-foot mixed light greenhouse located at bottom of the property. Photo date 8-25-2016

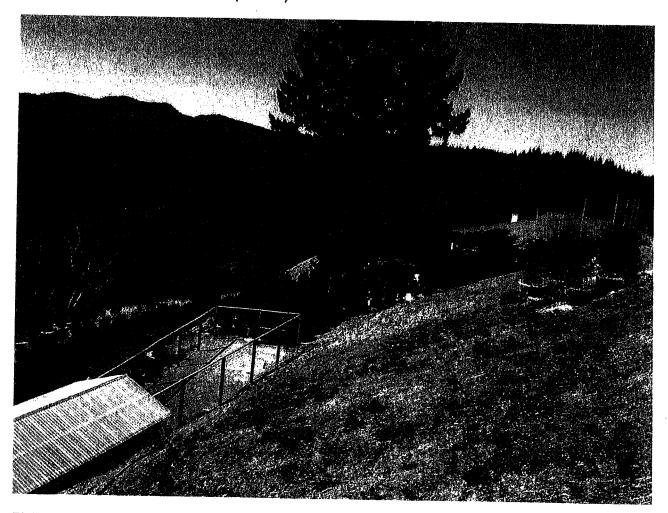
Picture 19: Hillside cultivation area located east-southeast of house. Chicken coop in left hand corner and house in distance to the right. Photo date 8-25-2016.

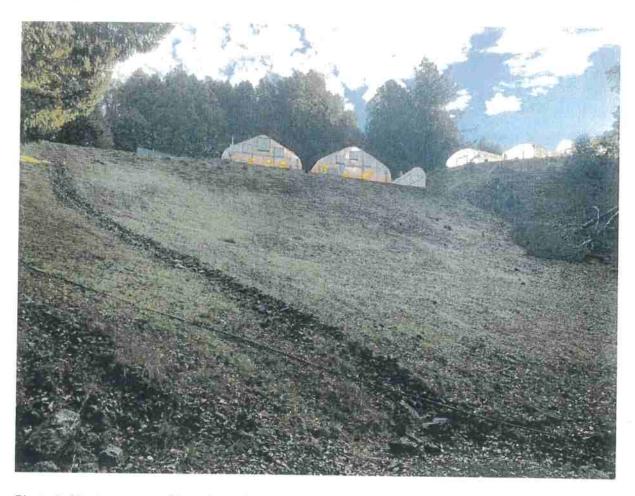
Photo 3: Site B center and Site A distant left. Note rocked V-ditch constructed to accommodate storm-water runoff from the graded flat. Photo date 1-17-2022.

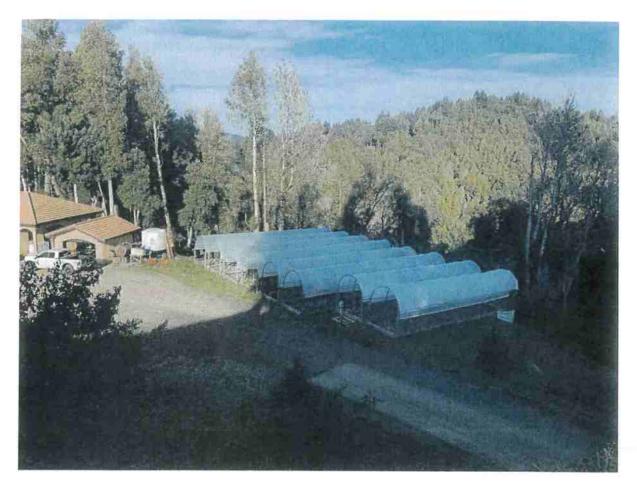
Photo 6: Site F. Note dying tanoak trees infected with SOD behind greenhouses. Photo date 1-17-2022.

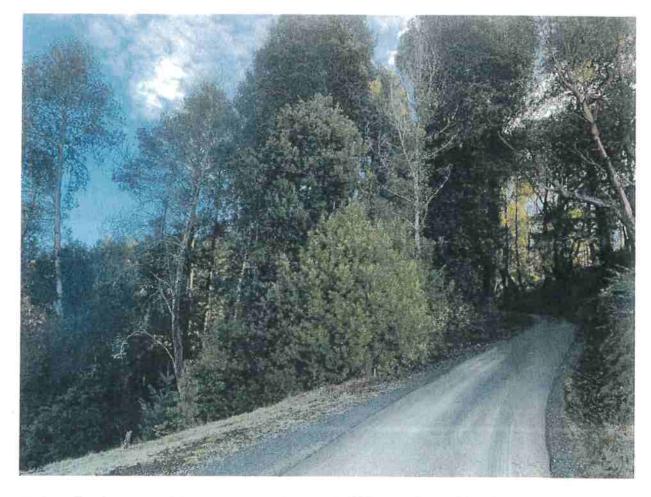
Photo 9: Dead, dying, and diseased tanoak infected with SOD located east of Site F along the permanent paved road. Photo date 1-17-2022.

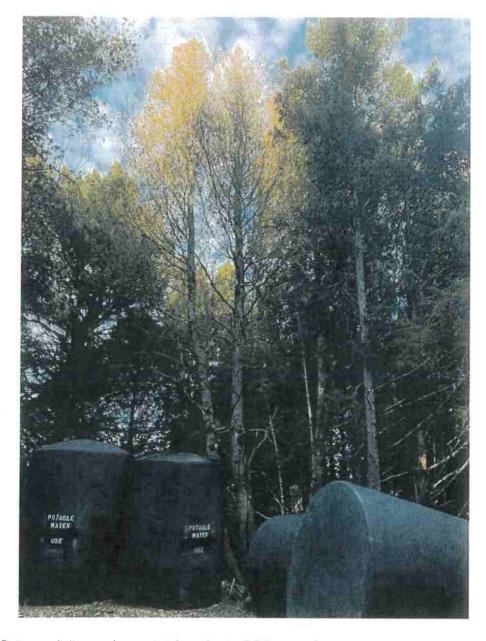
Photo 9: Dying and diseased tanoak infected with SOD located along the periphery of the Water Tank Farm. Photo date 1-17-2022.

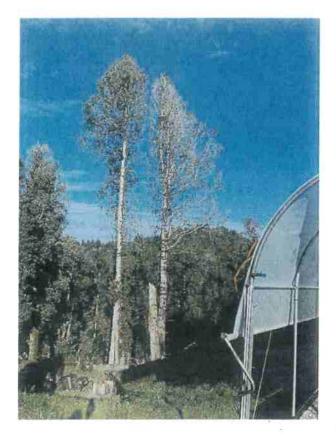
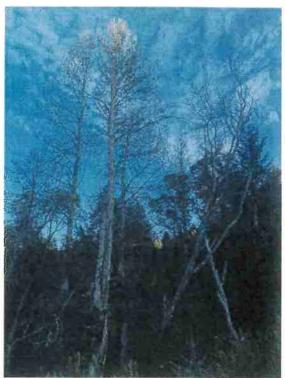
Photo 10: Dying and diseased tanoak infected with SOD located behind Site F. Photo date 1-17-2022.

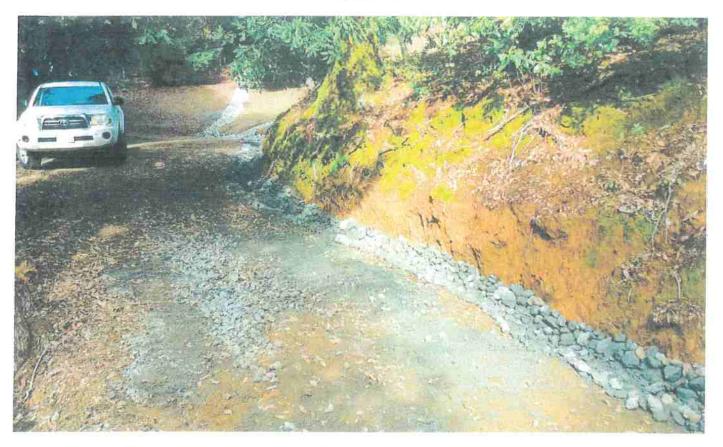
Picture 6: This is a picture along Map Point 2 showing the bottom half of the newly rock lined inside ditch taken from near the location of picture 2 above. Photo date 12/2/2016

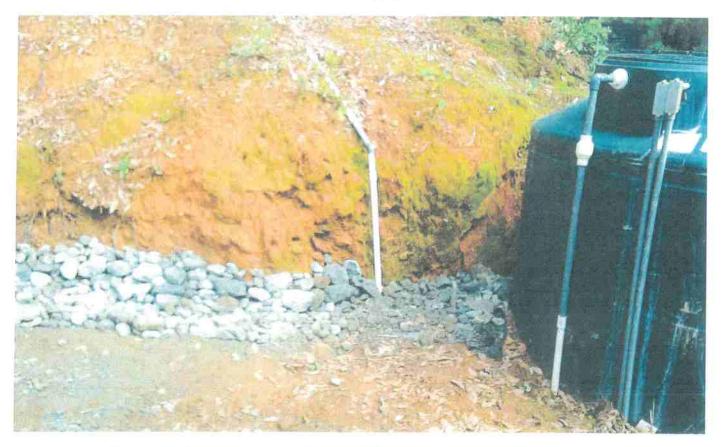
Picture 7: This is a picture at the end of the road where the rock lining of the ditch ends at the south end of Map Point 2. Photo date 12/2/2016

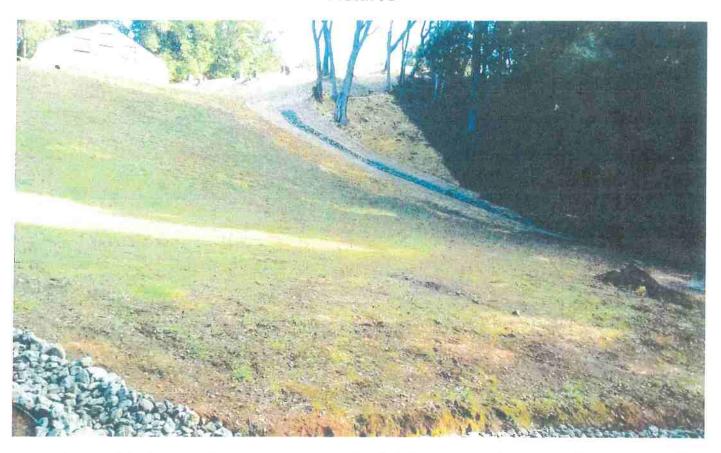
Picture 10: This is a picture of the newly rock lined drainage ditch (Map Point 2.5) that drains a "French drain" outlet that collects from the surface of the developed cultivation area. It ends above a swale that contains the top of a Class III watercourse and a Class II spring and POD. Photo date 12/2/2016

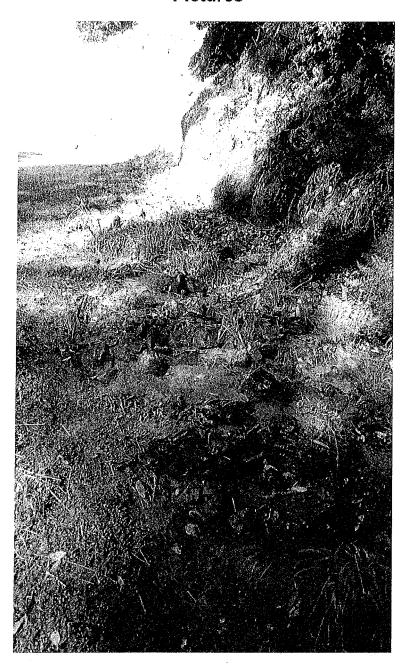
Picture 11: This is a picture of some of the leftover rock armoring along the connected inside ditch drainage that is shown as Map Point 6. Mitigation for this connected inside ditch segment is stated in detail in the assessment above. It involves dispersal of surface flows and rain catchment off of buildings to reduce runoff, and piping remaining ditch flows away from the watercourse to disperse on the forest floor. Photo date 11/3/2016

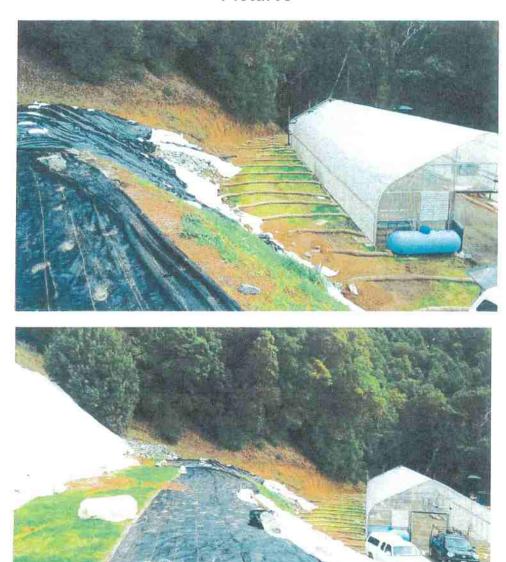
Pictures 14 and 15: These are pictures of the area of Map Point 6 on the WRPP Map. The straw wattles were recently installed to trap sediment from reaching the watercourse beyond the end of the greenhouse in the picture. The terraced area in the left half of the picture is slumping slightly and will be re-configured as stated in the report. Photo date 2/13/2017

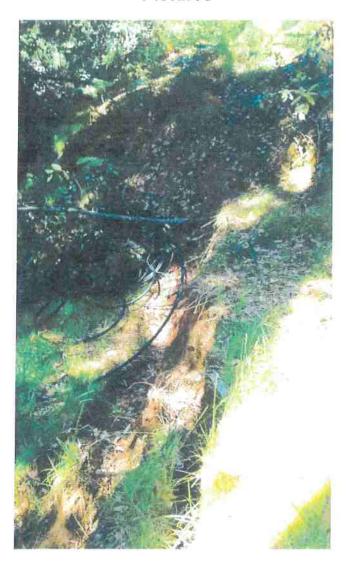
Picture 16: These are pictures of the recently slumped fill material shown as Map Point 6.5 on the WRPP Map. Slopes shall be recontoured as close as possible to the natural grade and aspect. Photo date 6/13/2017

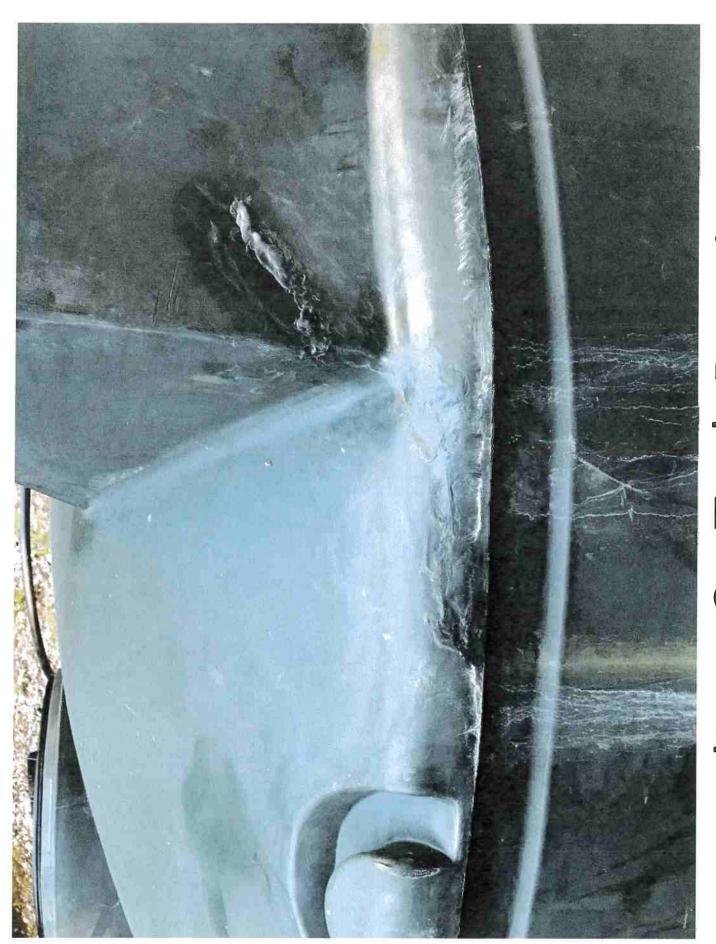
Item 2: Float Valve

Department staff observed (1) no flow meter installed on either diversion, (2) no float valve installed on and a crack with water leaking from the storage tank receiving water from the diversions, (3) inadequate screen attached to the spring box outlet, (4) failure to complete POD3 removal by agreed deadline, (5) failure to record and report the quantity of water used from the diversions, (6) failure to submit a water management plan, (7) failure to submit project inspection report, (8) silt and nutrient laden runoff entry into a stream and placement of potting soil and cannabis stems where they may enter a stream, (9) failure to notify for a stream crossing encroachment prior to conducting work, and (10) firewood rounds from upslope clearing abandoned in a stream. Because of these observations, the project violates the requirement in Fish and Game Code section 1602 that a project be conducted in accordance with an approved Agreement.

Based on the above, you will need to correct these violations by (1) installing a flow meter on each water diversion to comply with Measure 2.6, (2) installing a float valve and repair or replace water tank to comply with Measure 2.12, (3), installing a screen to comply with Measure 2.9, (4) removing POD3 and all trash in the stream or with the potential to enter the stream, (5) recording and reporting the quantity of water used from each water diversion, (6) submitting a water management plan to comply with Measure 2.7, (7) submitting a project inspection report to comply with Measure 2.20, (8) remove potting soil from current location and install adequate road drainage structure to comply with measures 2.16-2.18, (9) submitting a major amendment to your Agreement and pay the applicable fee, and (10) remove firewood rounds abandoned in the stream. The Department requests that items 1-4, 8, and 10 be corrected within 15 days and that items 5-7 and 9 be corrected within 45 days from the date of this letter.
