Brunelle & Clark Consulting, LLC

December 26, 2018

1800320

Re: Limited Asbestos Survey & Representative Paint Sampling for ADA Renovations, Humboldt County Coroner's Office, 720 Wood Street, Eureka, CA.

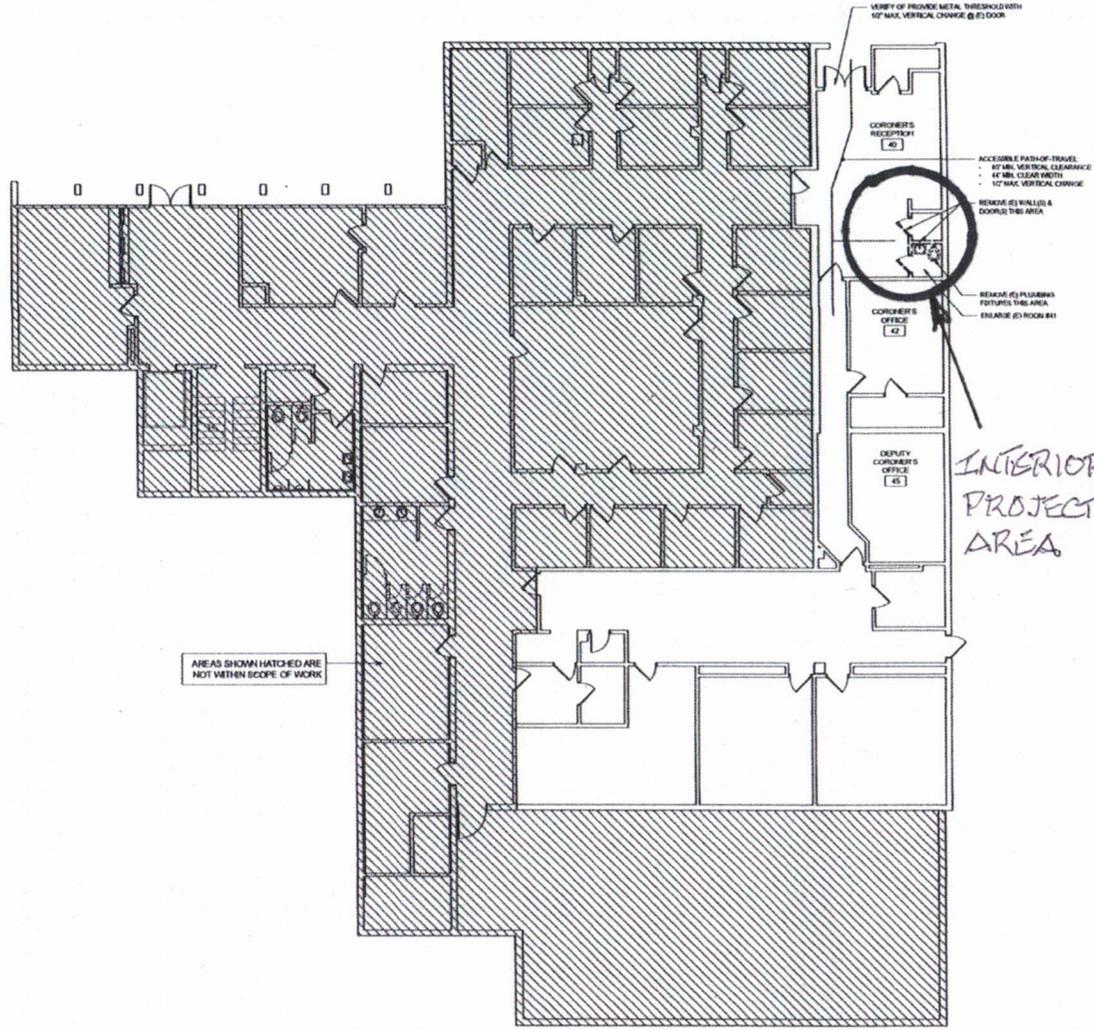
FIG. 1

1 OVERALL FIRST FLOOR PLAN - EXISTING / DEMO
1/8" = 1'-0"

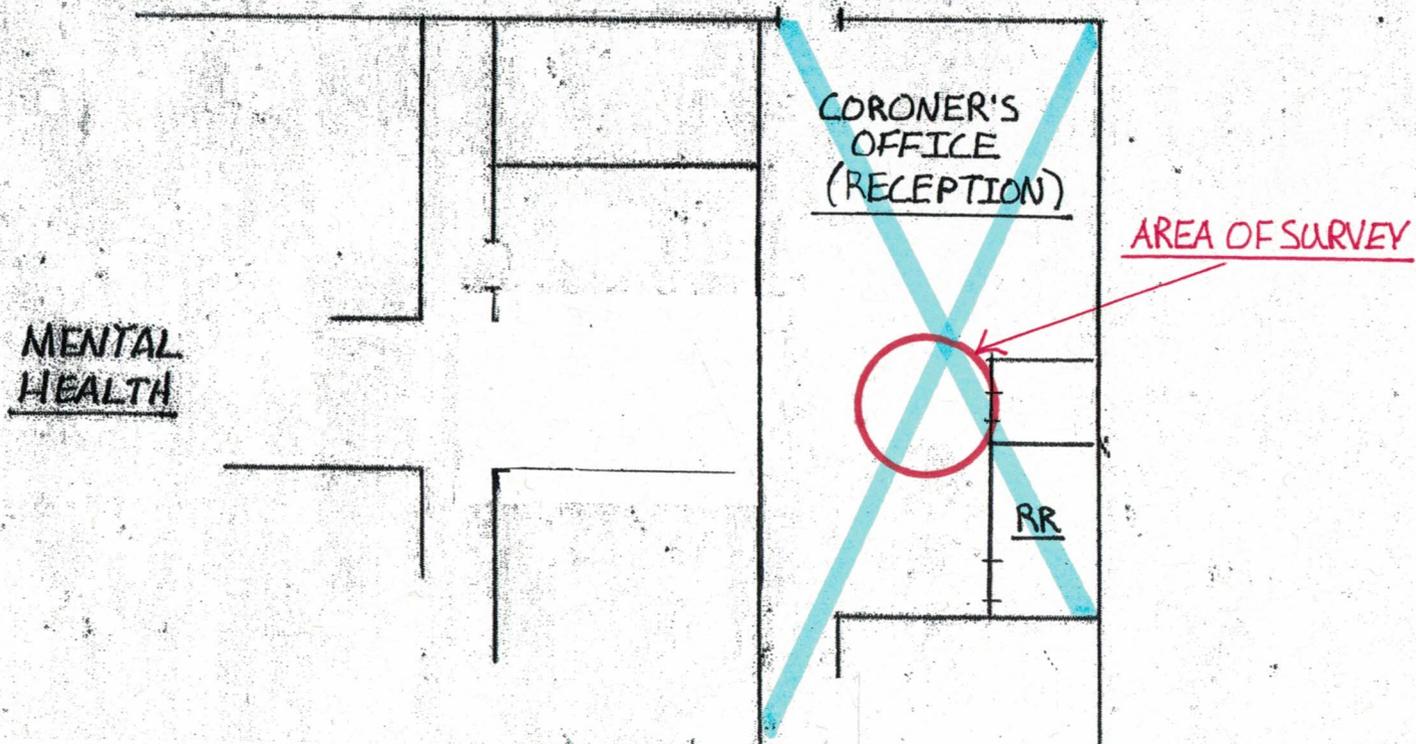
FIG. 1

The samples were submitted to an accredited laboratory for the initial analysis of asbestos content by Polarized Light Microscopy (PLM). The sample Chain of Custody and Laboratory Report are attached. The sample locations are indicated on attached Figure 1, and a summary of the analytic data is included in the attached Table 2.
