NOVEMBER 2018

Water Resource Protection Plan & Site Management Plan for Humboldt County APN ARSTINE

222-071-017

Stillwater Sciences 850 G Street, Suite K Arcata, CA 95521

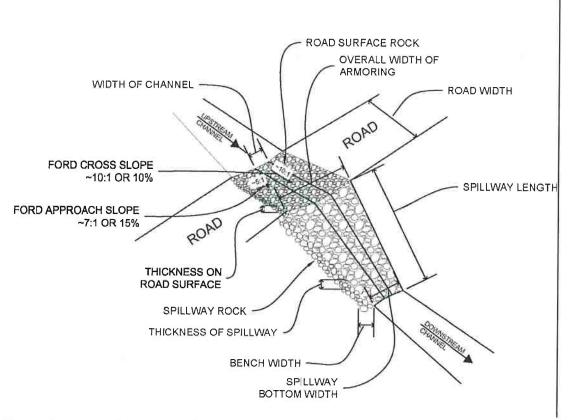
Figure 6. Armored ford schematic.

- Within the portion of the ford where the spillway meets the road surface rock, contractor
  shall exercise special care to compact the underlying material and use a variety of rock
  sizes ranging from small gravel to cobble; this portion of the structure is especially
  susceptible to failure in the first few winters, especially at sites where culverts are being
  removed.

Typical armored ford construction is depicted on Figure 6. Additionally, the following specifications should be followed when constructing the armored fords:

- Firmly compact road surface armoring.
