LSAA Restoration Plan for APN 211-362-015

Subject: Notice of Violation of Fish and Game Code Sections 1602, 5650, and 5652 in
Conjunction with Cannabis Cultivation

CDFW LSA Notification
Sharp Ridge
APN: 211-362-015 (HUM)

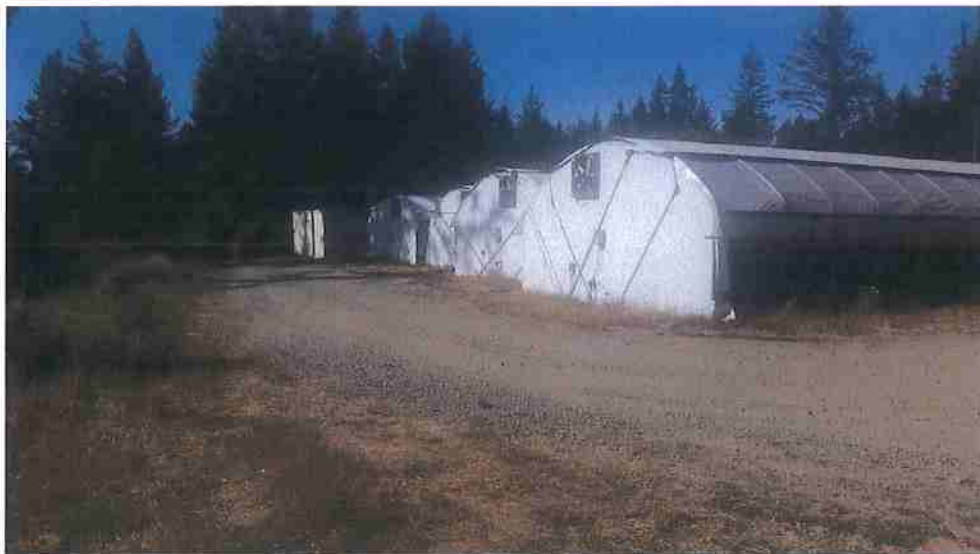
Figure 5. Photograph taken at Site 2 looking toward the north-west showing four of eight 2,400 square foot greenhouses along with a shipping container (see Site Map, Container 8) with dimensions of 20 feet by 8 feet. The shipping container is used to store batteries for the solar power system which supplies power to fans within the greenhouses. All 8 greenhouses are used for mixed light cultivation of cannabis.

The greenhouses are located on a graded flat that was created between 2010 and 2011. The flat is situated on a ridge where the slopes are mild at between 2 and 5%. The average slopes to the south and south-east of the flat are approximately 35%. A watercourse is also located approximately 200 feet east of the flat. The existing impermeable area located at Site 2 is approximately 21,500 square feet (0.494 acres).

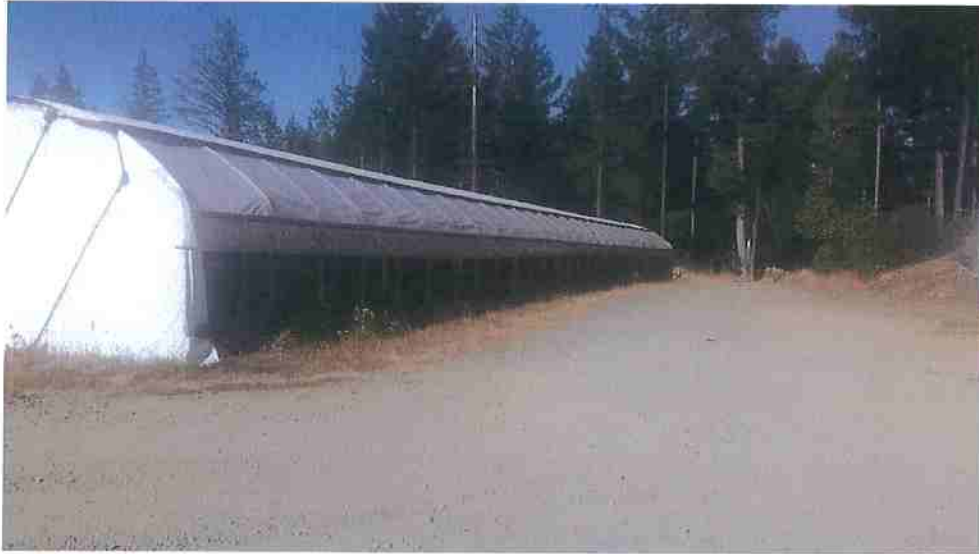
Figure 6. Photograph taken at Site 2 looking toward the west along greenhouse # C (see Site Map). The hillslope beyond the graded flat is approximately 55%. There are two watercourses located north of the flat with one starting approximately 175 feet from the extents of grading for the flat. The start of the other stream is located approximately 75 feet west of the extents of the graded area.

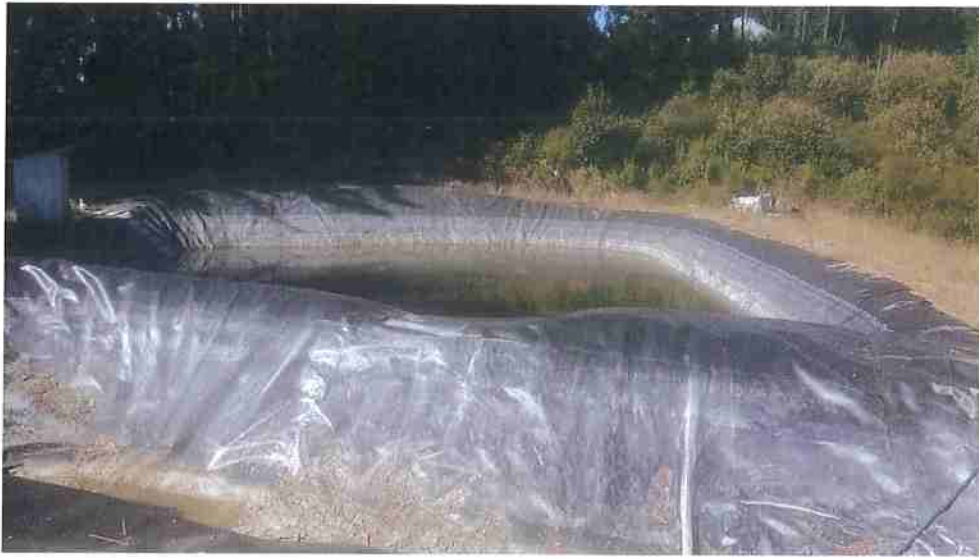
Figure 11. Photograph taken looking toward the south-west showing the rainwater impoundment structure and pump house. The settling pond can be viewed in the foreground and a greenhouse at Site 1 can be viewed in the background. The rain water impoundment structure collects rainwater and runoff from the structures located at Site 1 until the water used for agricultural purposes.

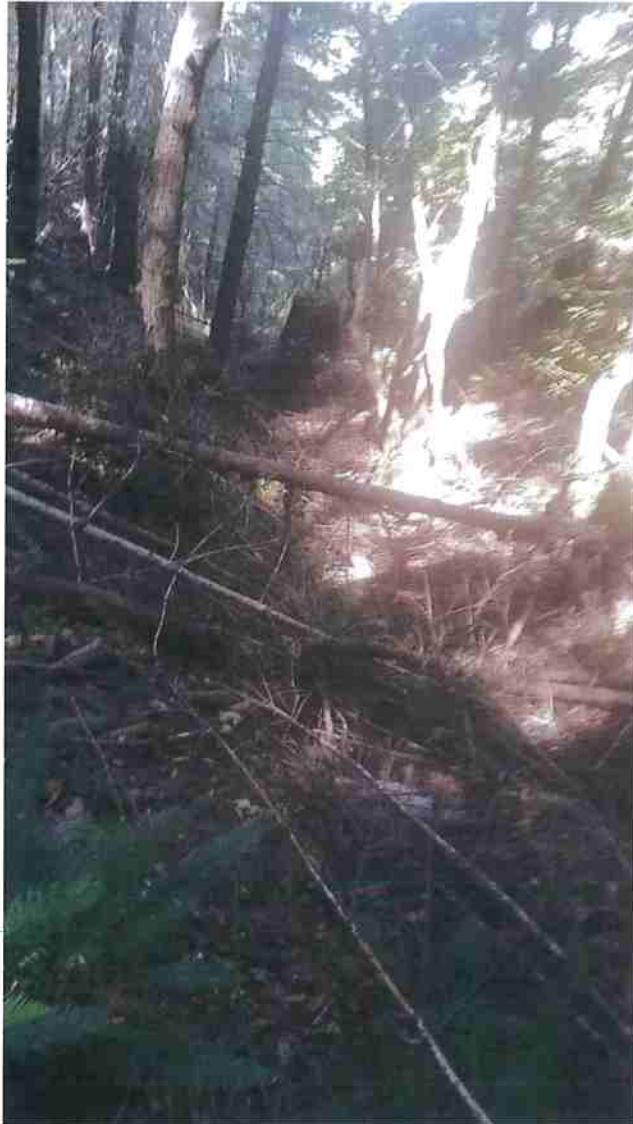
Figure 34. Photograph showing the drainage flowline below the old logging road looking north west looking down stream. Pictured is the intersection point of the flowlines of Drainage 1 and Drainage 2.

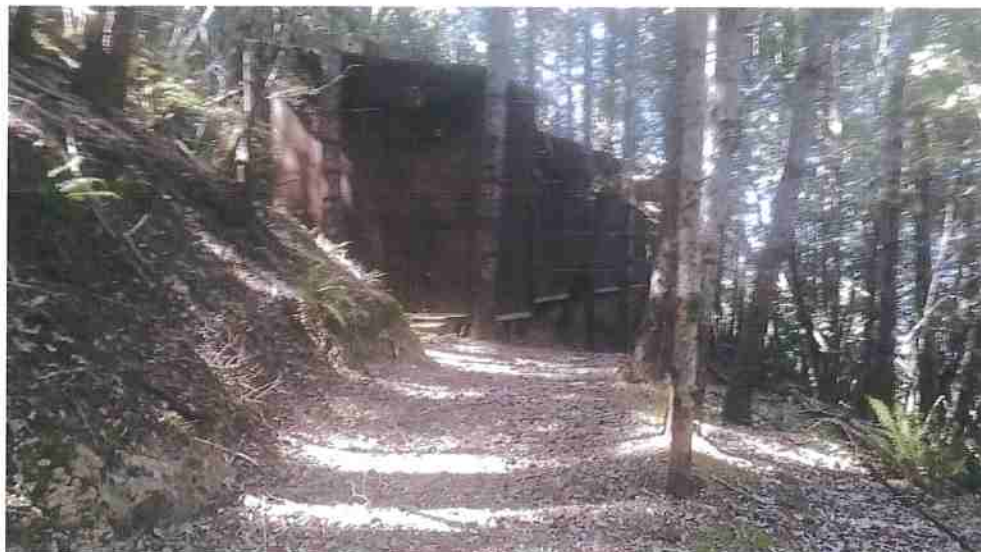
Figure 36. Photograph showing Building 1 which is located approximately 100 feet east of western drainage of SC 1. Building 1 is not being used for cannabis.

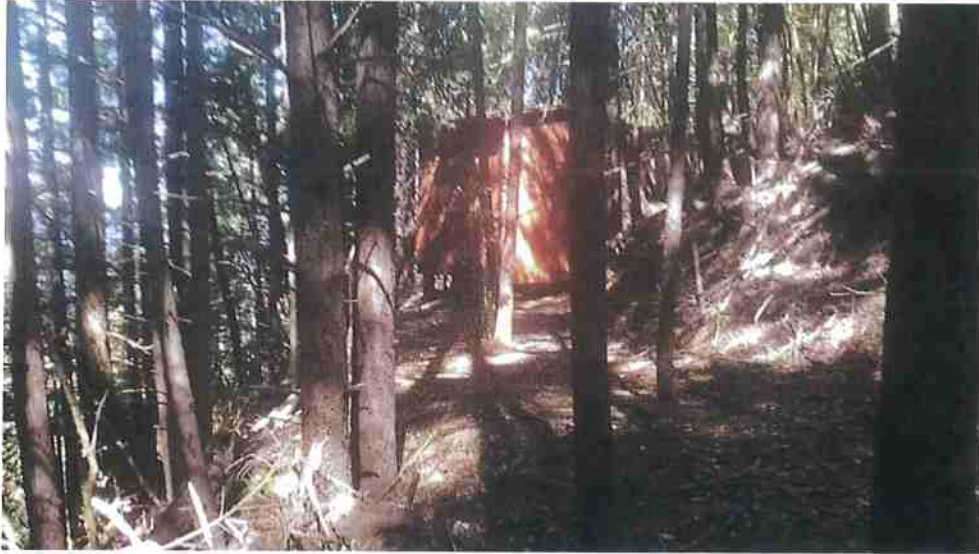
Figure 37. Photograph showing Building 4 which is located approximately 80 feet north of Drainage 2 of stream crossing SC 1. Building 4 is not used for cannabis.

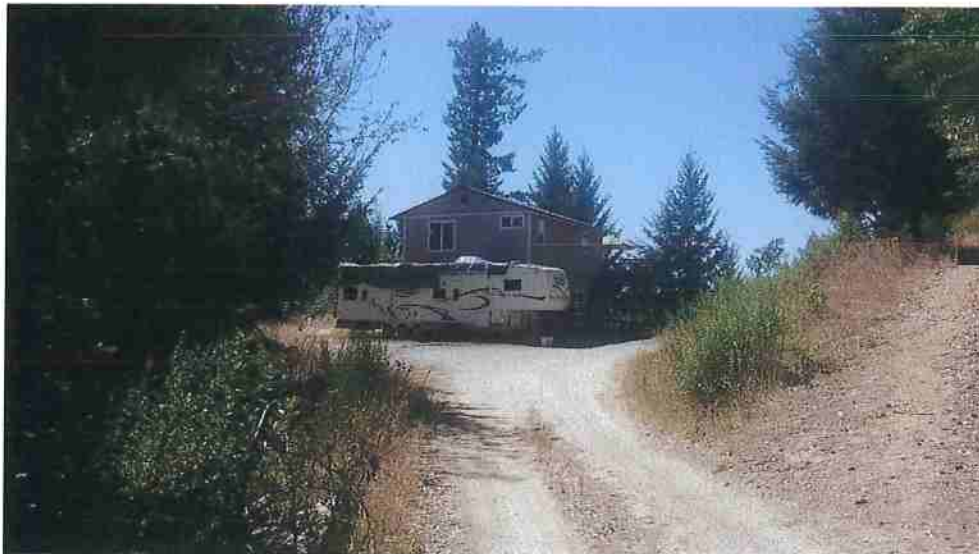
Figure 38. Photograph showing Building 5 which is located in the south-east corner of the property. The building is not used for cannabis.

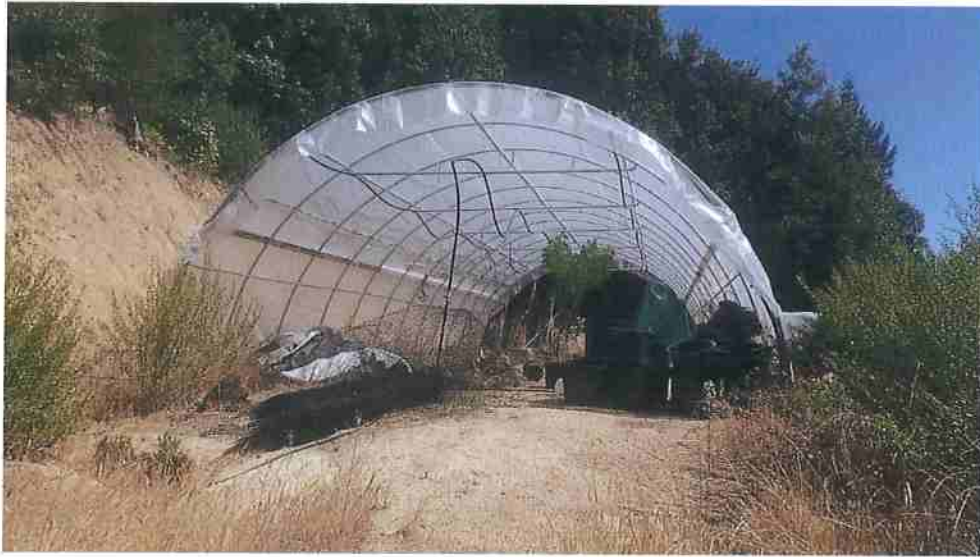
Figure 39. Photograph showing Site 4 which consists of Greenhouse K which is 900 square feet. The slopes of the graded flat are gradual sloping 5% toward the south. The slopes are approximately 40% above the cultivation area and are 30% below the cultivation area. The closest watercourse is situated approximately 250 feet to the east of Site 4 (see Site Plan).

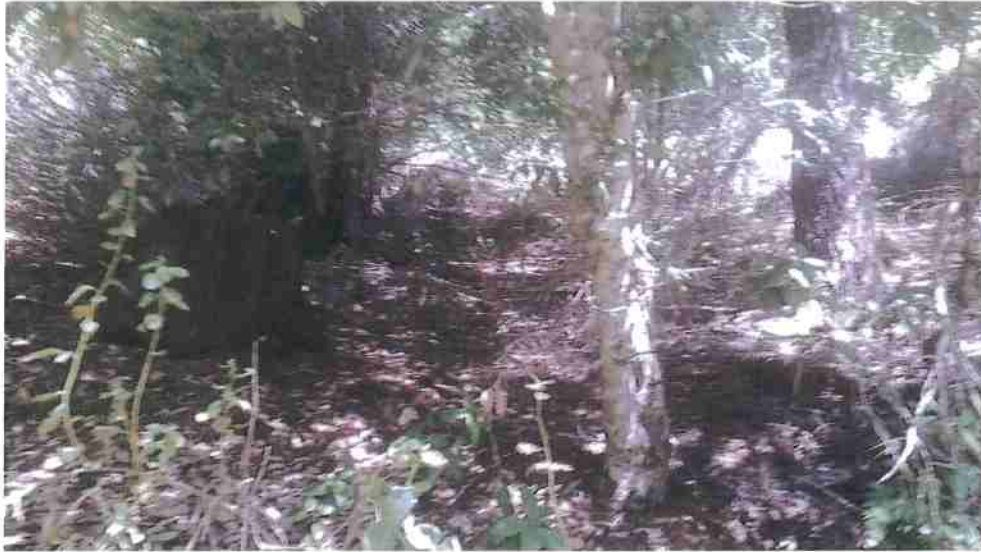
Figure 41. Photograph of the area above the rolling dip above stream crossing CS2. No channel is present above the road.

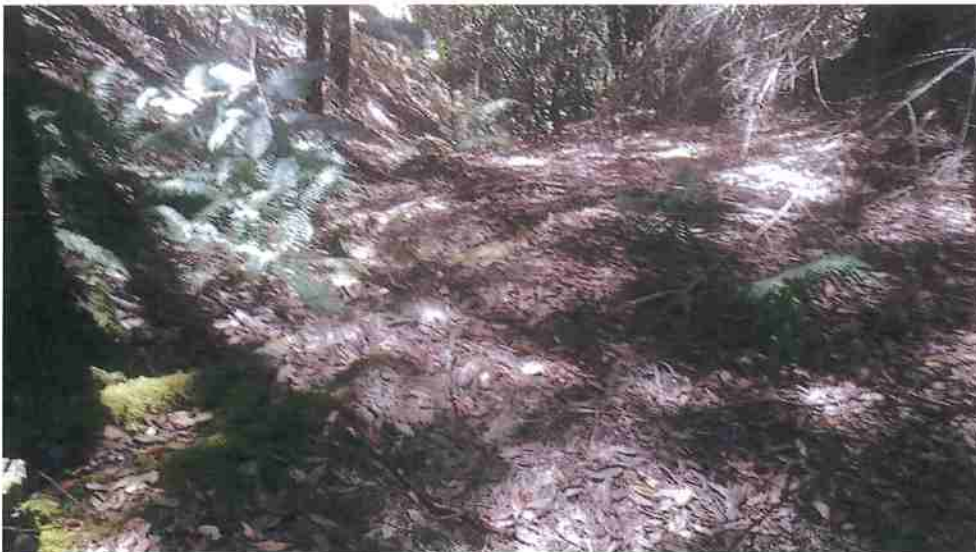
Figure 42. Photograph of the area above the rolling dip above stream crossing CS2. No channel is present above the road.
