Water Resource Protection Plan

WDID# - 1B16468CHUM

APN 523-026-003

Timberland Resource Consultants

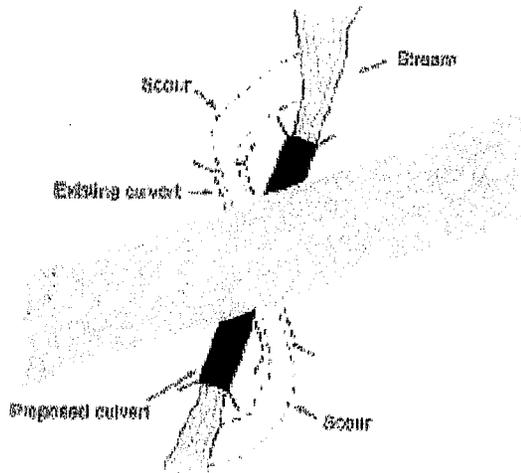
FIGURE 97. Culvert alignment should be in relation to the stream and not the road. It is important that the stream enter and leave the culvert in a relatively straight horizontal alignment so streamflow does not have to turn to enter the inlet or discharge into a bank as it exits. This figure shows a redesigned culvert installation that replaces the bending alignment that previously existed. Channel turns at the inlet increase plugging potential because wood going through the turn will not align with the inlet. Similarly, channel turns at the inlet and outlet are often accompanied by scour against the channel banks (Wisconsin Transportation Information Center, 2004).

- Align culverts with the natural stream channel orientation to ensure proper function, prevent bank erosion, and minimize debris plugging. See Figure 97 below.

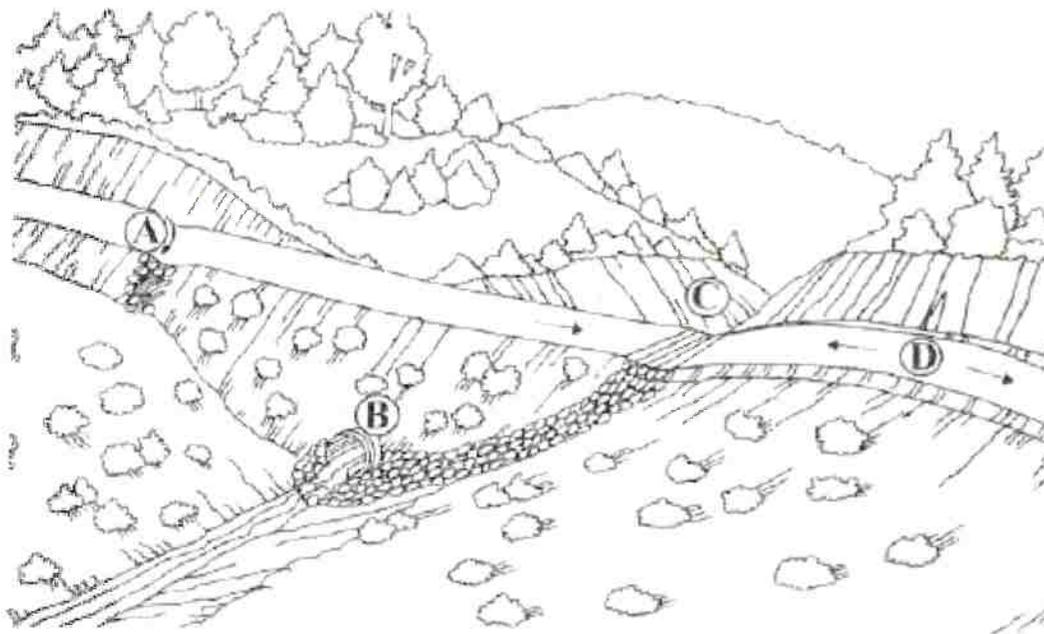
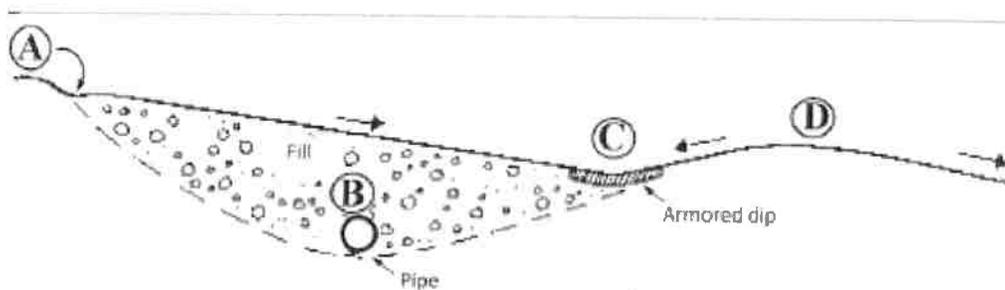
FIGURE 84. Critical dips or dipped crossing fills should be centered near a stream crossing's down-road hinge line, not over the centerline of the crossing where overtopping could cause washout or severe erosion of the fill. If the stream crossing culvert (B) plugs, water will pond behind the fill until reaching the critical dip or low point in the crossing (C) and flowing back down into the natural stream channel. The down-road ditch must be plugged to prevent streamflow from diverting down the ditch line. For extra protection in this sketch, diprap armor has been placed at the critical dip outlet and extending downslope to the stream channel. This is only required or suggested on stream crossings where the culvert is highly likely to plug and the crossing fill overtopped. The dip at the hinge line is usually sufficient to limit erosional damage during an overtopping event. Road surface and ditch runoff is disconnected from the stream crossing by installing a rolling dip and ditch relief culvert just up-road from the crossing (A) (Keller and Sherer, 2003).

- Critical dips shall be installed on culvert crossings to eliminate diversion potential. Refer to Figure 84 below.
- Road approaches to crossings shall be treated out to the first drainage structure (i.e. waterbar, rolling dip, or hydrologic divide) to prevent transport of sediment.

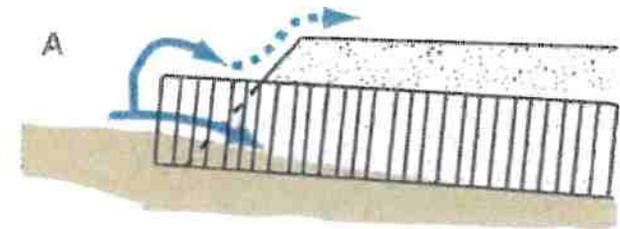
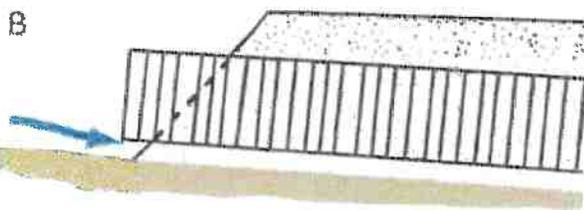
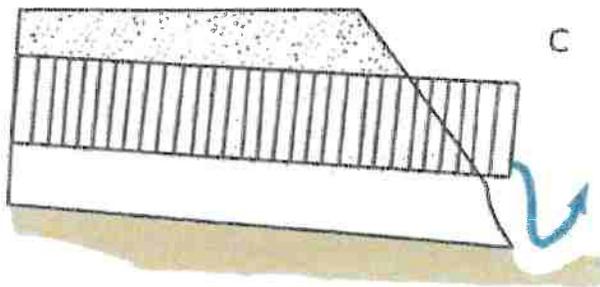
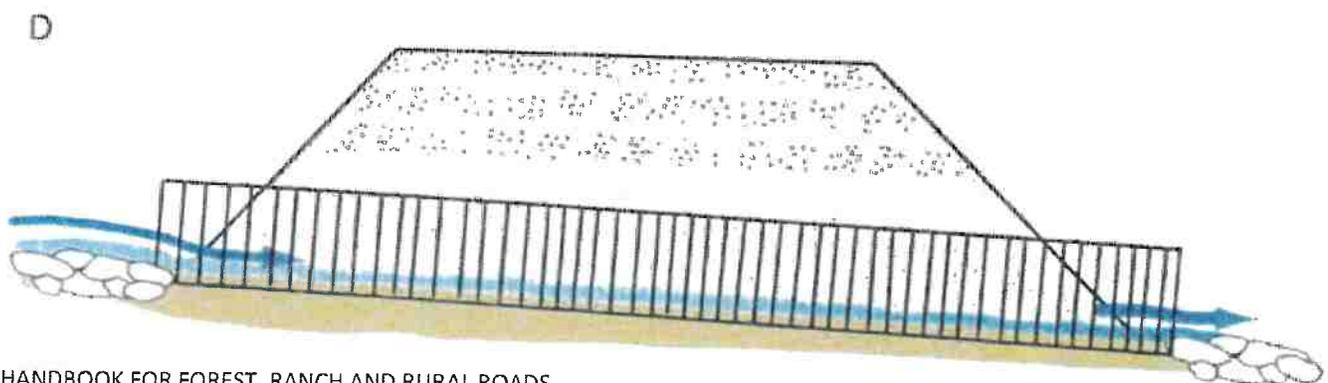
FIGURE 155. Proper culvert installation involves correct culvert orientation, setting the pipe slightly below the bed of the original stream, and backfilling and compacting the fill as it is placed over the culvert. Installing the inlet too low in the stream (A) can lead to culvert plugging, yet if set too high (B) flow can undercut the inlet. If the culvert is placed too high in the fill (C), flow at the outfall will erode the fill. Placed correctly (D), the culvert is set slightly below the original stream grade and protected with armor at the inlet and outlet. Culverts installed in fish-bearing stream channels must be inset into the streambed sufficiently (>25% embedded) to have a natural gravel bottom throughout the culvert (Modified from: MDSL, 1991).

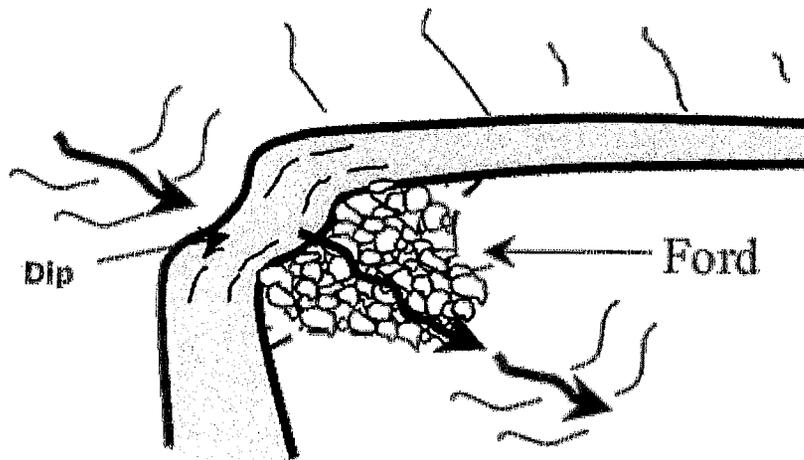
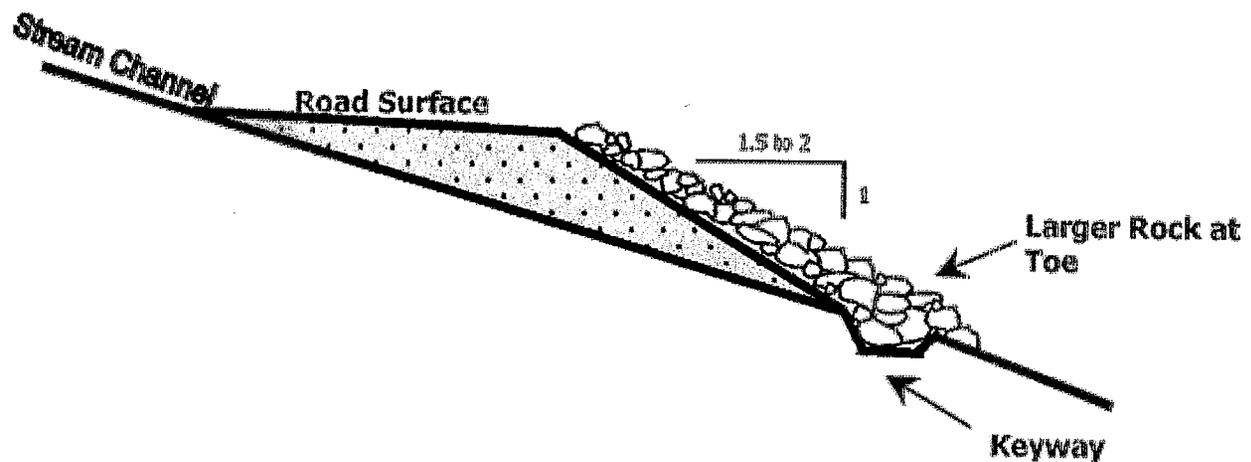
FORD: A large dip is graded into the road at the axis of the stream channel. The outside fill face is dished out to form a spillway with large rock. On large watercourses, rock is keyed several feet into firm native soils. The road surface is rocked with 6" of minus rock.

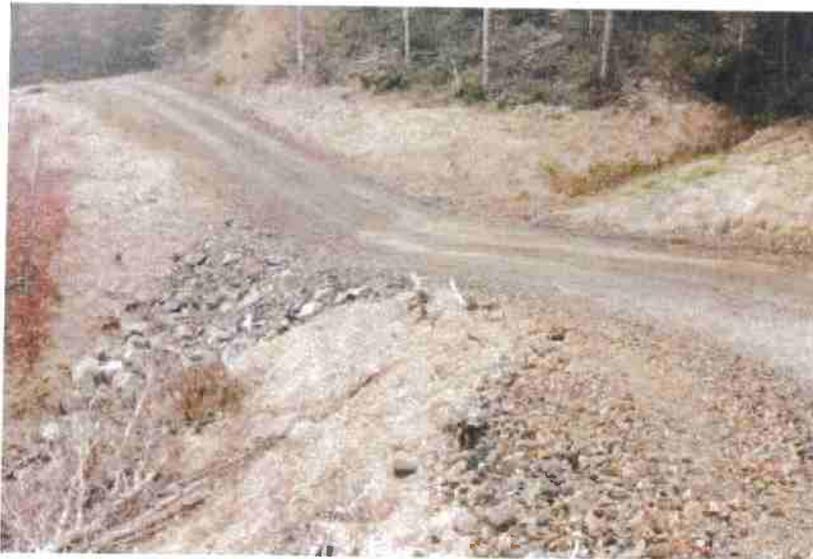
FIGURE 120. This armored fill crossing of a steep, ephemeral stream was constructed to provide a low maintenance crossing. The crossing has been deeply dipped to reduce the volume of road fill and to eliminate the potential for stream diversion. The fill slope has been heavily armored through the axis of the crossing to contain flood flows and prevent downcutting. Armored fills cannot be used on fish bearing streams.

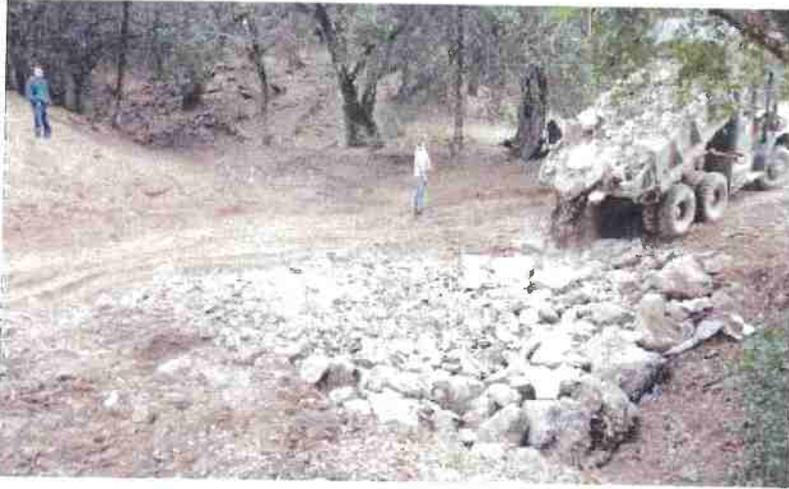
FIGURE 121D. Well graded rock armor is then backfilled into the structure and spread across the breadth of the U-shaped stream crossing, and about one-third the way up the roadbed, so that streamflow will only flow over or come in contact with resistant armor material. The armor must be spread and compacted across the design width of the expected flood flow channel width so peak flows will not flank the armored structure.

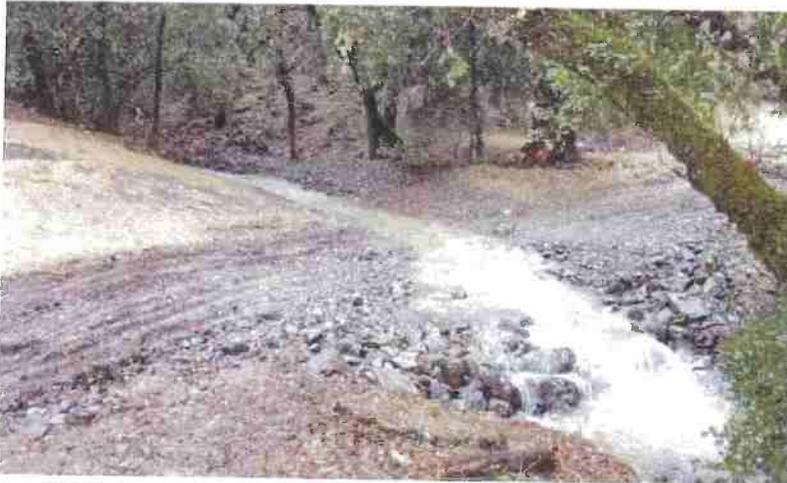
FIGURE 121E. Two weeks after this armored fill was constructed, a storm flow event occurred and the structure maintained its function and integrity. The road approaches had not yet been compacted or surfaced with road rock.

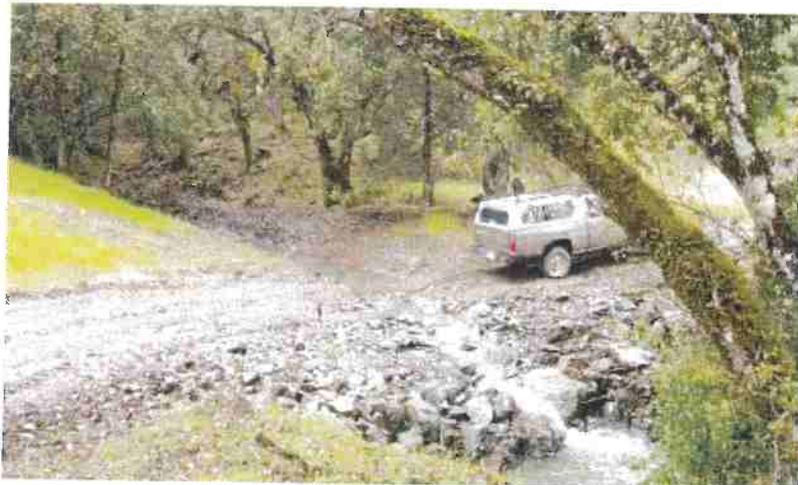
FIGURE 121F. The same armored fill as it appeared after the first winter flood flows. No maintenance was required to reopen the road. It is also clear that no stream diversion is possible at this stream crossing site, and the volume of fill within the crossing has been restored to the minimum amount needed to maintain a relatively smooth driving surface on this low volume road.

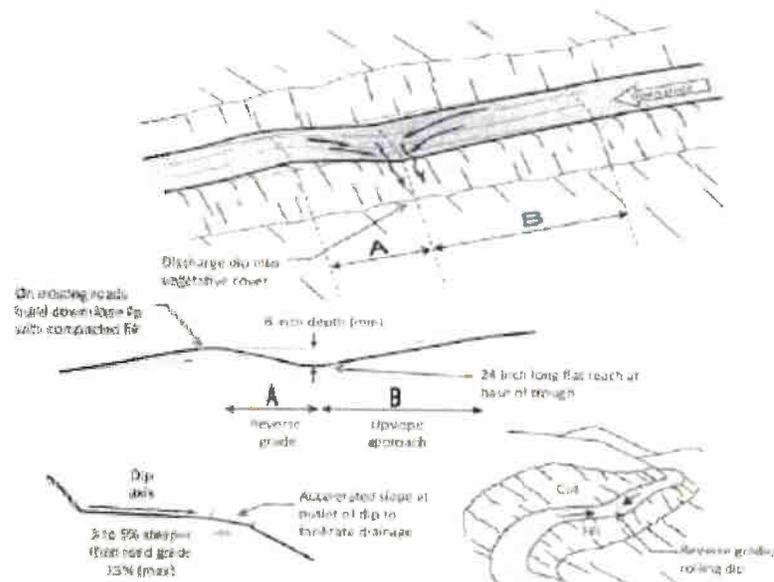
FIGURE 34. A classic Type I rolling dip, where the excavated up-road approach (B) to the rolling dip is several percent steeper than the approaching road and extends for 60 to 80 feet to the dip axis. The lower side of the structure reverses grade (A) over approximately 15 feet or more, and then falls down to rejoin the original road grade. The dip must be deep enough that it is not obviated by normal grading, but not so deep that it is difficult to negotiate or a hazard to normal traffic. The outward cross-slope of the dip axis should be 3% to 5% greater than the up-road grade (B) so it will drain properly. The dip axis should be out-sloped sufficiently to be self-cleaning, without triggering excessive downcutting or sediment deposition in the dip axis (Modified from: Best, 2013).

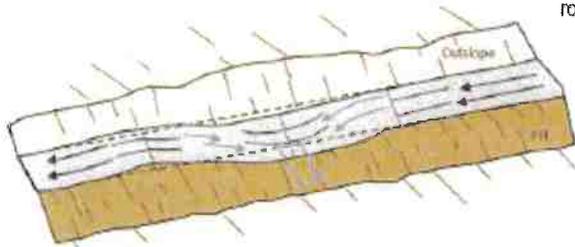
Type 1 Rolling Dip
(Standard)

Type 1 rolling dips are used where road grades are less than about 12-14% and road runoff is not confined by a large through cut or berm. The axis of the dip should be perpendicular to the road alignment and sloped at 3-4% across the road tread. Steep roads will have longer and more abrupt dip dimensions to develop reverse grade through the dip axis. The road tread and/or the dip outlet can be rocked to protect against erosion, if needed.

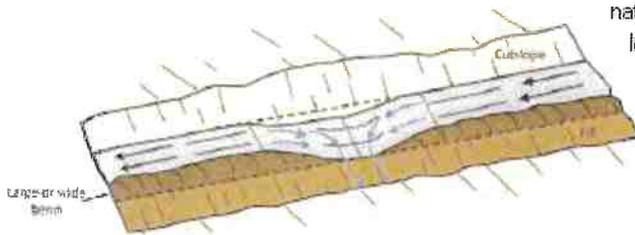
Type 2 Rolling Dip
(Through-cut or thick berm road reaches)

Type 2 rolling dips are constructed on roads up to 12-14% grade where there is a through cut up to 3 feet tall, or a wide or tall berm that otherwise blocks road drainage. The berm or native through cut material should be removed for the length of the dip, or at least through the axis of the dip, to the extent needed to provide for uninterrupted drainage onto the adjacent slope. The berm and slope material can be excavated and endhauled, or the material can be sidecast onto native slopes up to 45%, provided it will not enter a stream.

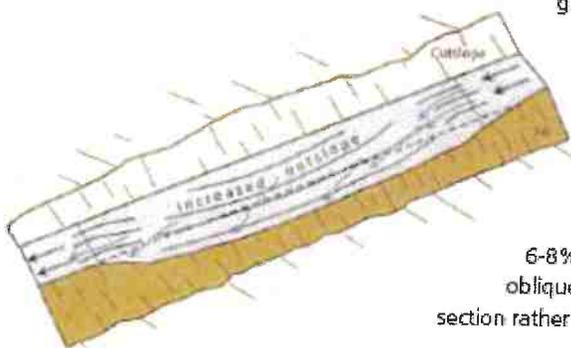
Type 3 Rolling Dip
(Steep road grade)

Type 3 rolling dips are utilized where road grades are steeper than about 12% and it is not feasible to develop a reverse grade that will also allow passage of the design vehicle (steep road grades require more abrupt grade reversals that some vehicles may not be able to traverse without bottoming out).

Instead of relying on the dip's grade reversal to turn runoff off the roadbed, the road is built with an exaggerated outslope of 6-8% across the dip axis. Road runoff is deflected obliquely across the dip axis and is shed off the outsloped section rather than continuing down the steep road grade.

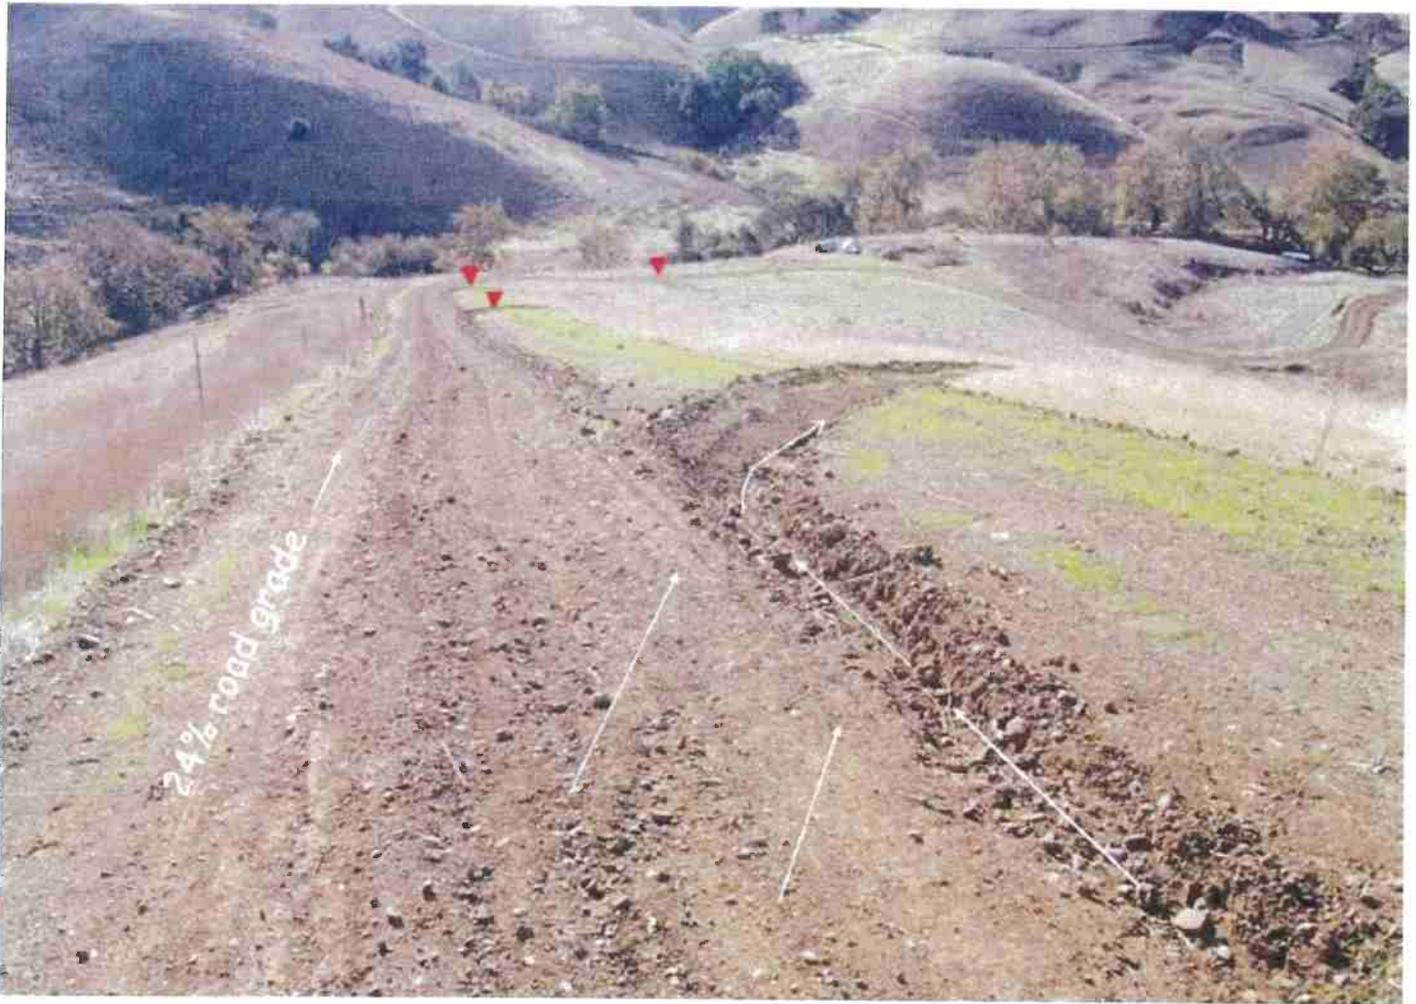
FIGURE 55. Steep roads that go straight up or down a hillside are very difficult to drain. This steep, fall line road developed a through cut cross section that was drained using lead out ditches to direct runoff off the road and onto the adjacent, vegetated hillside. The road was “outsloped” to drain runoff to the right side, and the lead out ditch was built slightly steeper than the road grade, to be self-cleaning. Four lead out ditches have been constructed at 100-foot intervals to the bottom of the hillside.

- Steep road drainage structures are used on permanent roads where water bars would obstruct access and where roads are too steep (<14%).
- Structures consist of an outsloped section of road leading to a “push-out” ditch that carries water away from the road. The outslope of the road may be either continuous or intermittent at the location of an individual push-out.
- To avoid push-outs requiring regular maintenance, a push-out ditch should have a grade that is greater than or equal to the grade of road draining to it to prevent sediment from settling out and filling in the push-out ditch.

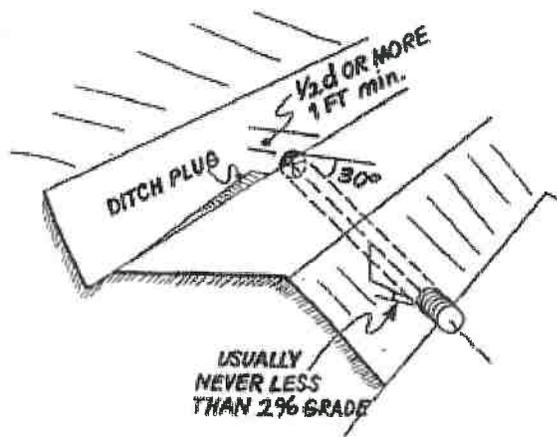
FIGURE 48. The elements of a properly installed ditch relief culvert. The culvert is angled at about 30 degrees to the road alignment to help capture flow and prevent culvert plugging or erosion of the inlet area. It is set at the base of the fill (ideally) or with a grade slightly steeper than the grade of the contributing ditch (but never with a grade less than 2 percent) (USDA-SCS, 1983). At a minimum, the grade of the ditch relief culvert should be sufficient to prevent sediment accumulation at the inlet or deposition within the culvert itself (it should be self-cleaning) (USDA-SCS, 1983).

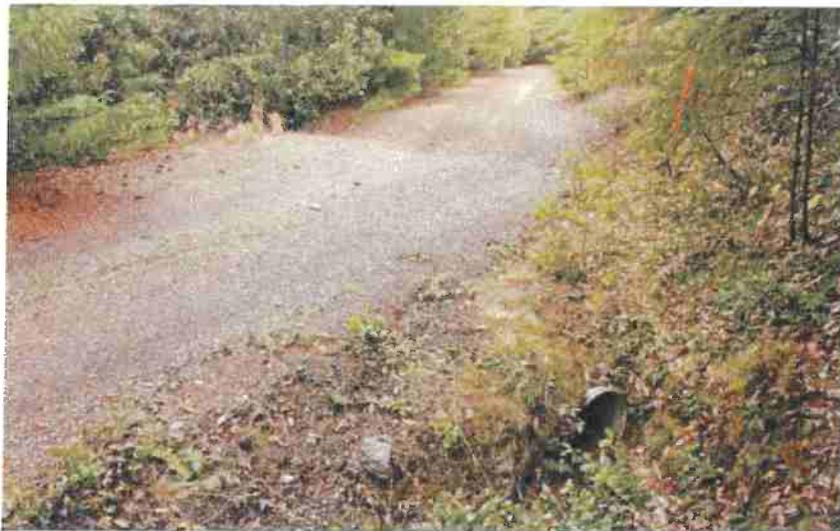
FIGURE 39.

Waterbars are often used to drain surface runoff from seasonal, unsurfaced roads. Because they are easily broken down by vehicles, waterbars are only used on unsurfaced roads where there is little or no wet weather traffic. In this photo, a waterbar and ditch relief culvert are used to drain all road surface and ditch runoff from the insloped road prism.

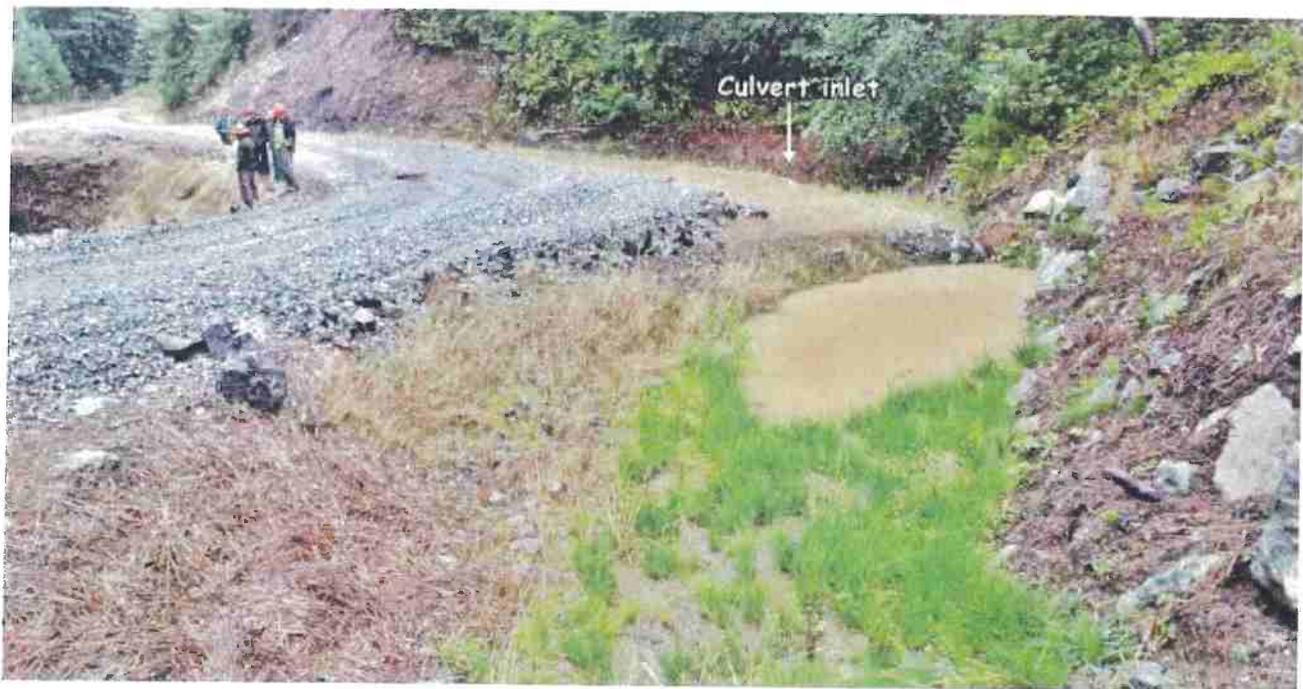
FIGURE 238. Traffic and surface runoff from graveled roads often produces surface erosion, turbid runoff and fine sediment transport that can be delivered to streams. Where ditches can't be eliminated, sediment traps and roadside settling basins can be installed to capture and remove most of the eroded sediment. This settling basin has been constructed along the inside ditch just before a stream crossing culvert inlet (see arrow). Eroded sediment from the road and ditch are deposited in the basin before flow is released to the stream. Fine sediments have filled about 1/3 of this basin and vegetation is now growing. Sediment basins require periodic maintenance to maintain their storage capacity.

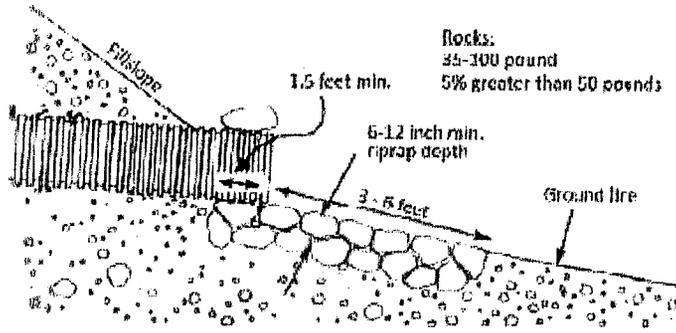
FIGURE 107A. Riprap armor at culvert outlet (Modified from: Keller et al., 2011).

- Inlets may require construction of an inlet basin.
- Slopes at the outlet should be shaped to a 2:1 or natural slope prior to placing rock armor.
- Rock used at culvert inlets and outlets should be a matrix of various sized rocks and rip-rap that range from a 3" dia. to a 2' dia.

- The largest rocks should be placed at the base of the culvert or fill. Incrementally smaller rocks shall be placed over the larger rocks at the armoring extend up the slope. Voids and spaces shall be back filled with smaller gravels and rocks.

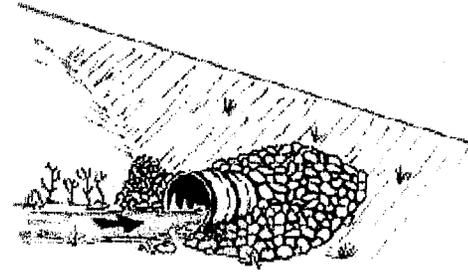
FIGURE 107B. Riprap armor at culvert inlet (Keller and Sherax, 2003).
