# Geotechnical Investigation Report

Washington Terrace Subdivision

McKinleyville, California

**Subject: Geotechnical Investigation Report, Washington Terrace Subdivision, APN 508-242-044, McKinleyville, California**

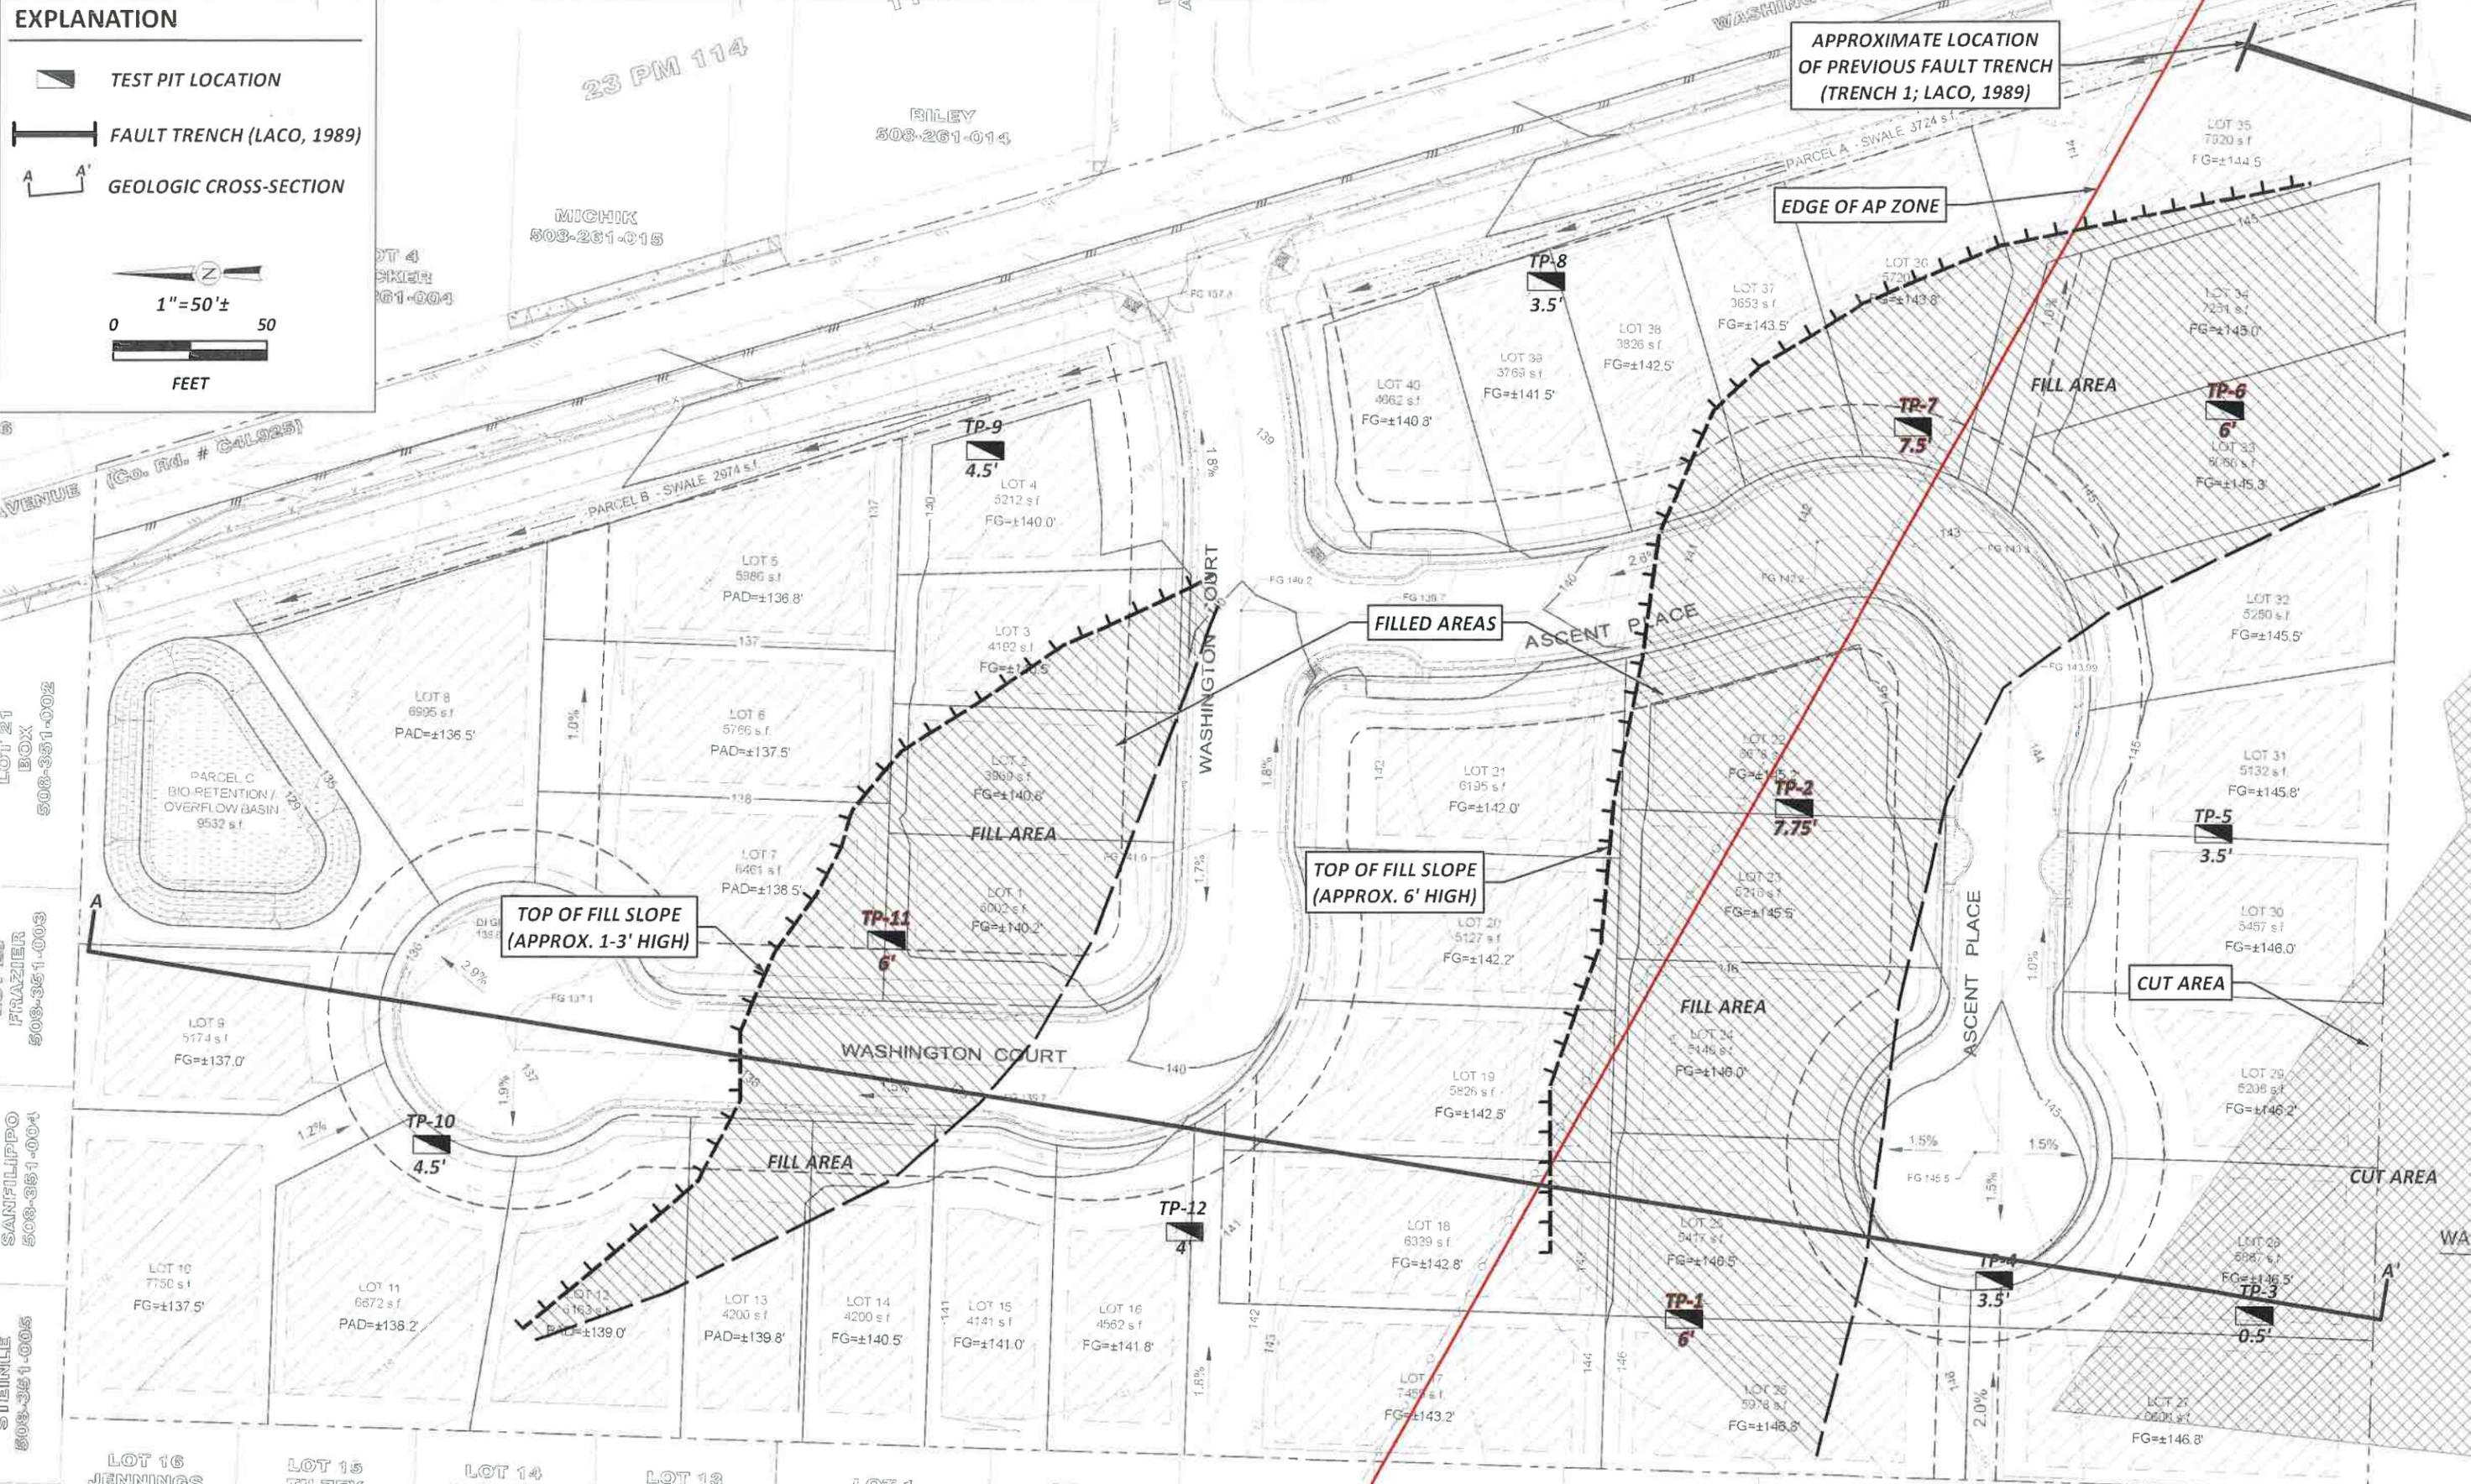
Site Plan Map Showing Test Pit Locations and Fill Areas  
 SHN 020060  
 Figure2\_SitePlanMap1  
 Figure 2

**TOP OF FILL SLOPE (APPROX. 1.3' HIGH)**

**TOP OF FILL SLOPE (APPROX. 6' HIGH)**

We understand the project will consist of the development of 40 single-family residential lots (Figure 2). We understand the proposed residences will be one- or two-story wood-frame structures with slab-on-grade driveways and garage floors, and the residences will have raised floors with crawlspaces beneath the living spaces. Two roads, named Washington Court and Ascent Place (Figure 2), will be developed to provide access to the residential lots.

On April 17, 2020, a project geologist from SHN logged and sampled 12 shallow backhoe test pits at the project site. The test pits (Figure 2) were excavated to a maximum depth of 10 feet below (existing) ground surface (BGS). Test pits were intentionally located outside the building footprints in order to avoid disturbance of the footing soils. Approximate locations of the test pits are shown on Figure 2.

the lower surface is marked by a 1- to 3-foot-high slope that descends to the northeast. The lower surface is in the northern portion of the parcel at an approximate elevation of 135 feet. See Figure 2 for site features.

to 7.75 feet BGS. Test pits TP-1 through TP-7 were excavated on the upper surface, test pits TP-8 through TP-10 were excavated on the lower surface, and test pits TP-11 and TP-12 were excavated on the intermediate surface (Figure 2). Soil conditions encountered on the three surfaces are summarized below and shown on the cross-section in Figure 3.

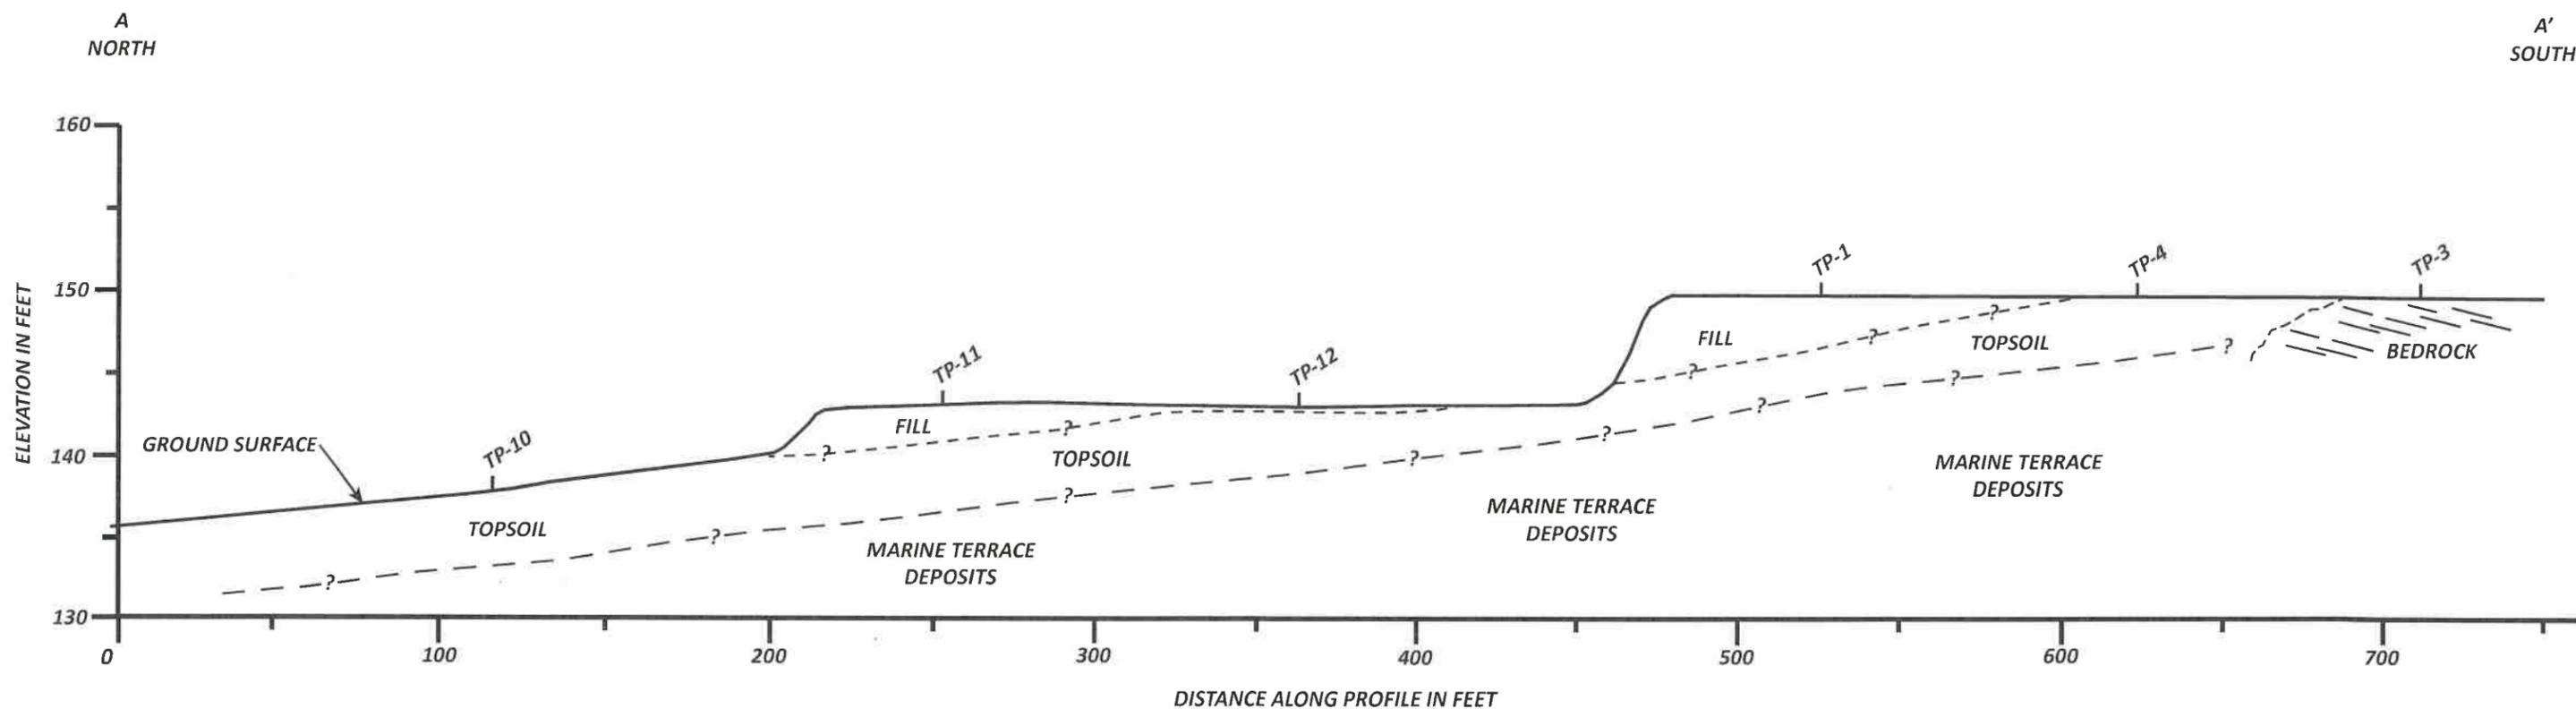
Figure 3

WASHINGTON TERRACE SUBDIVISION  
STATIGRAPHIC CROSS-SECTION

SCALE:  
 VERTICAL: 1" = 10'  
 HORIZONTAL: 1" = 50'  
 V.E. = 5x  
 FEATURES ARE APPROXIMATE

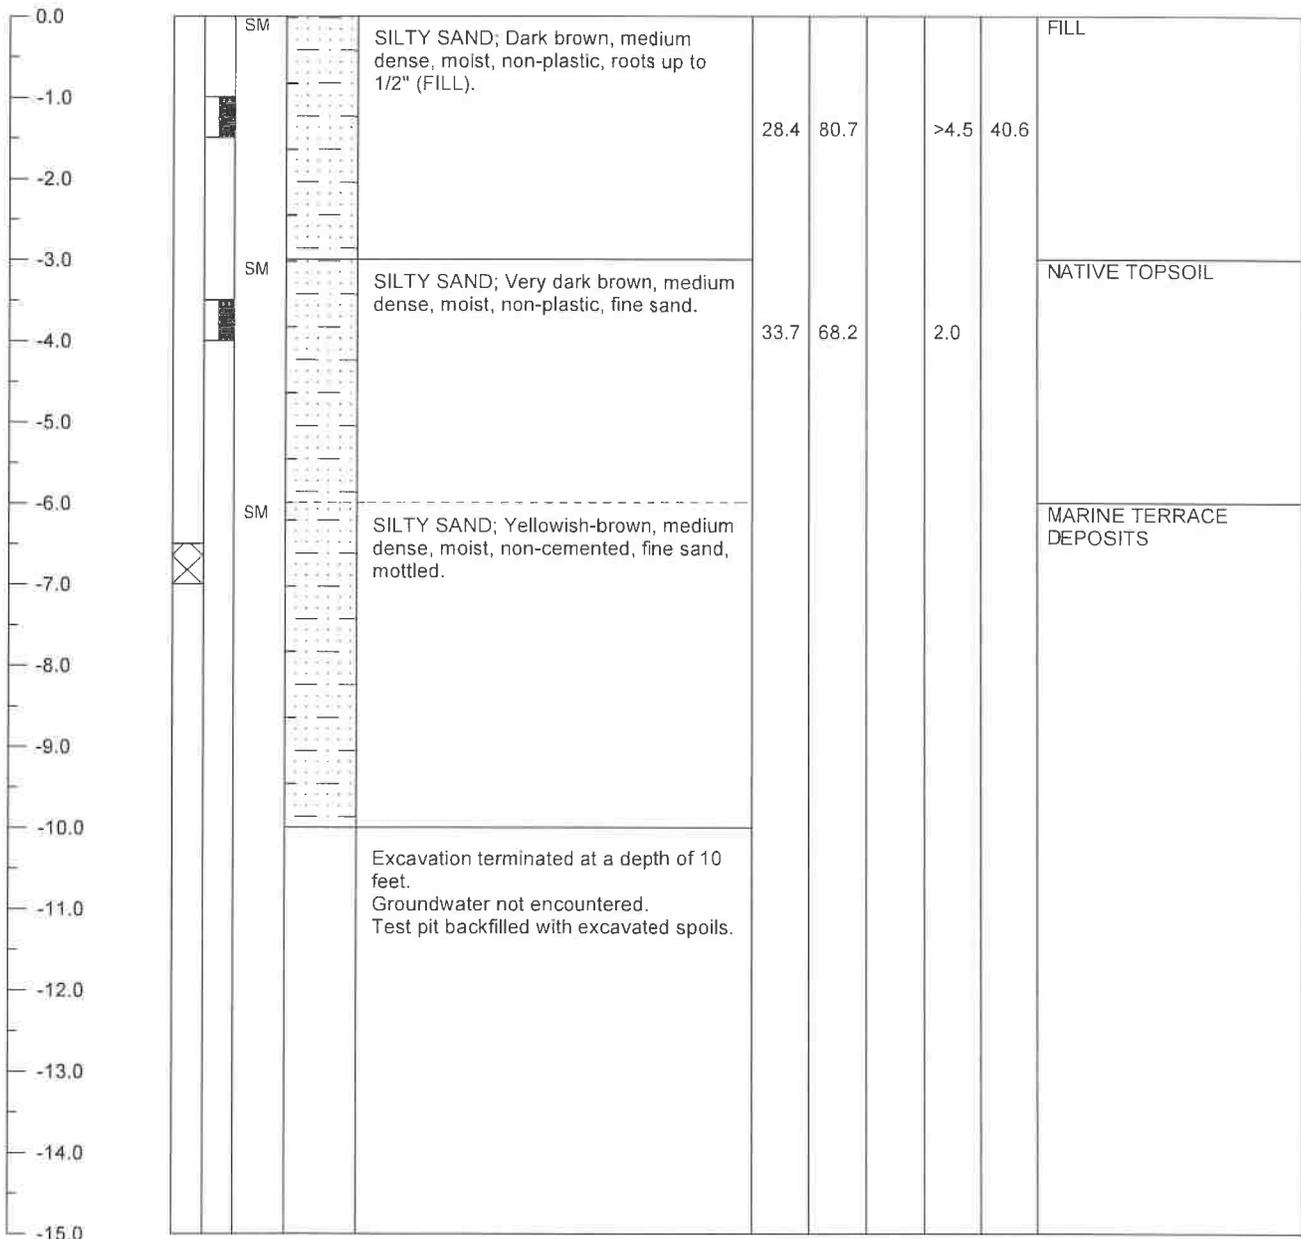
**TEST PIT  
NUMBER  
TP-1**

**PROJECT:** Washington Terrace Subdivision  
**LOCATION:** Washington Terrace Lot 25/26  
**GROUND SURFACE ELEVATION:** 149 Feet  
**EXCAVATION METHOD:** Backhoe  
**LOGGED BY:** P. Sundberg

DEPTH (FT)	BULK SAMPLES	TUBE SAMPLES	USCS	PROFILE	DESCRIPTION	% Moisture	Dry Density (pcf)	Unc. Cor. (psf)	U.C. (tsf) by P.P.	% Passing 200	REMARKS
------------	--------------	--------------	------	---------	-------------	------------	-------------------	-----------------	--------------------	---------------	---------

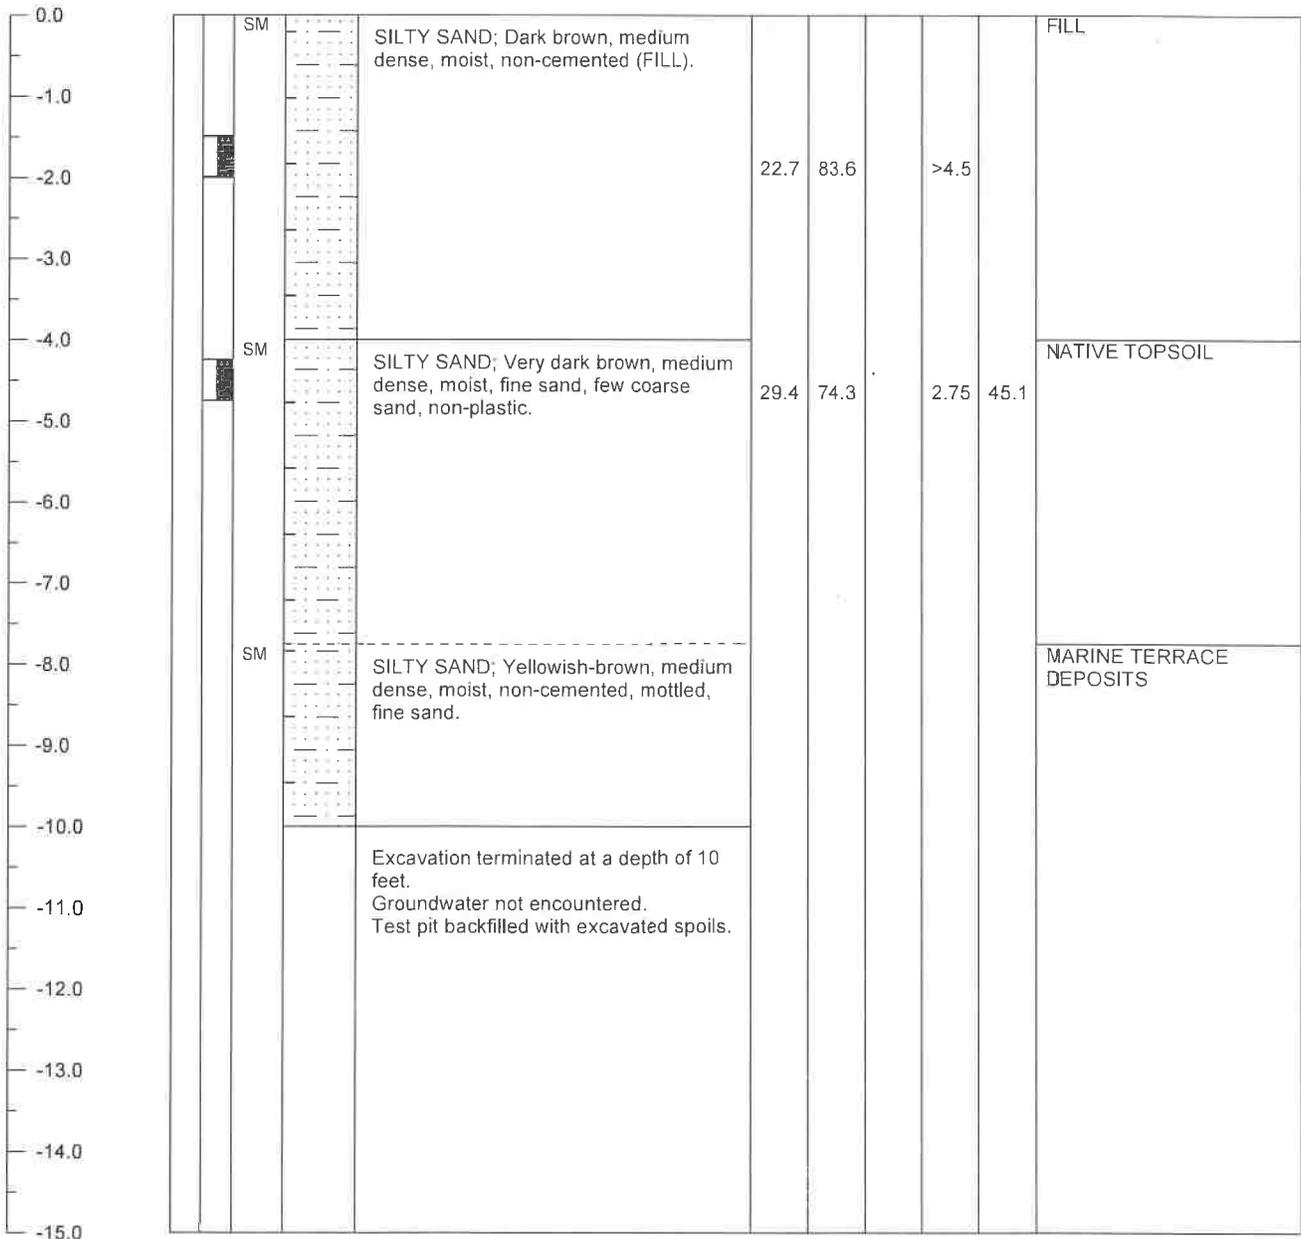
TEST PIT  
 NUMBER  
**TP-2**

PROJECT: Washington Terrace Subdivision  
 LOCATION: Washington Terrace Lot 22/23  
 GROUND SURFACE ELEVATION: 149 Feet  
 EXCAVATION METHOD: Backhoe  
 LOGGED BY: P. Sundberg

DEPTH (FT)	BULK SAMPLES TUBE SAMPLES	USCS	PROFILE	DESCRIPTION	% Moisture	Dry Density (pcf)	Unc. Com. (pcf)	U.C. (tsf) by P.P.	% Passing 200	REMARKS
------------	------------------------------	------	---------	-------------	------------	-------------------	-----------------	--------------------	---------------	---------

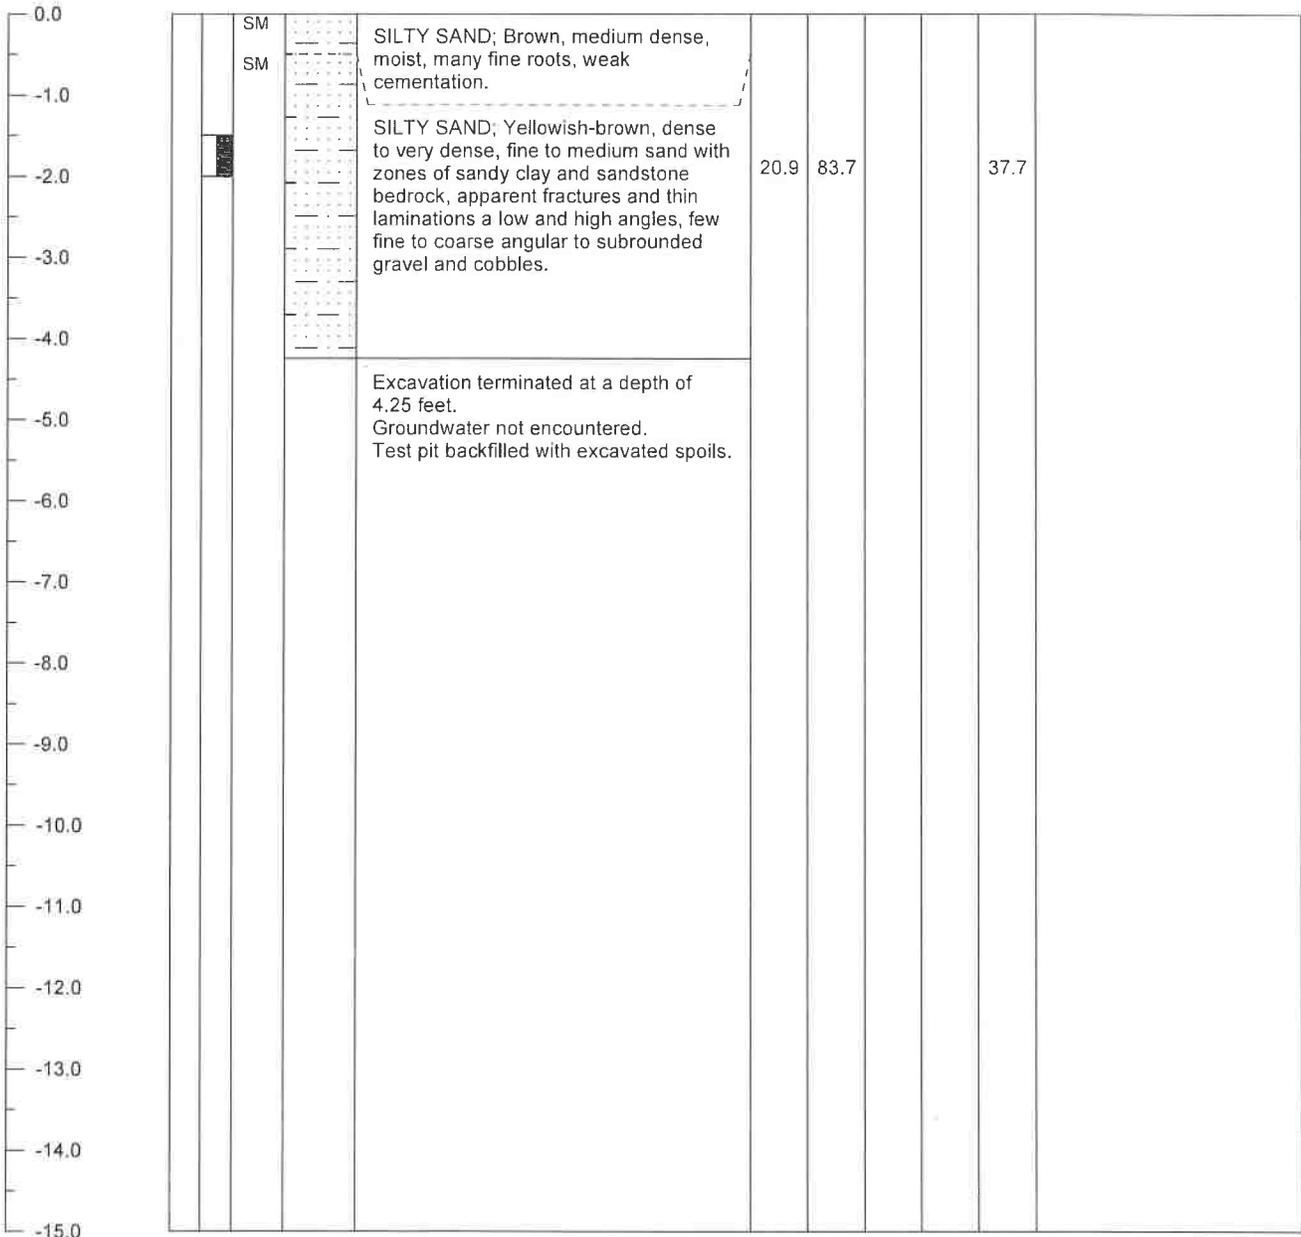
TEST PIT  
 NUMBER  
**TP-3**

PROJECT: Washington Terrace Subdivision  
 LOCATION: Washington Terrace Lot 27/28  
 GROUND SURFACE ELEVATION: 150 Feet  
 EXCAVATION METHOD: Backhoe  
 LOGGED BY: P. Sundberg

DEPTH (FT)	BULK SAMPLES TUBE SAMPLES	USCS	PROFILE	DESCRIPTION	% Moisture	Dry Density (pcf)	Unc. Com. (psf)	U.C. (tsf) by P.P.	% Passing 200	REMARKS
------------	------------------------------	------	---------	-------------	------------	-------------------	-----------------	--------------------	---------------	---------

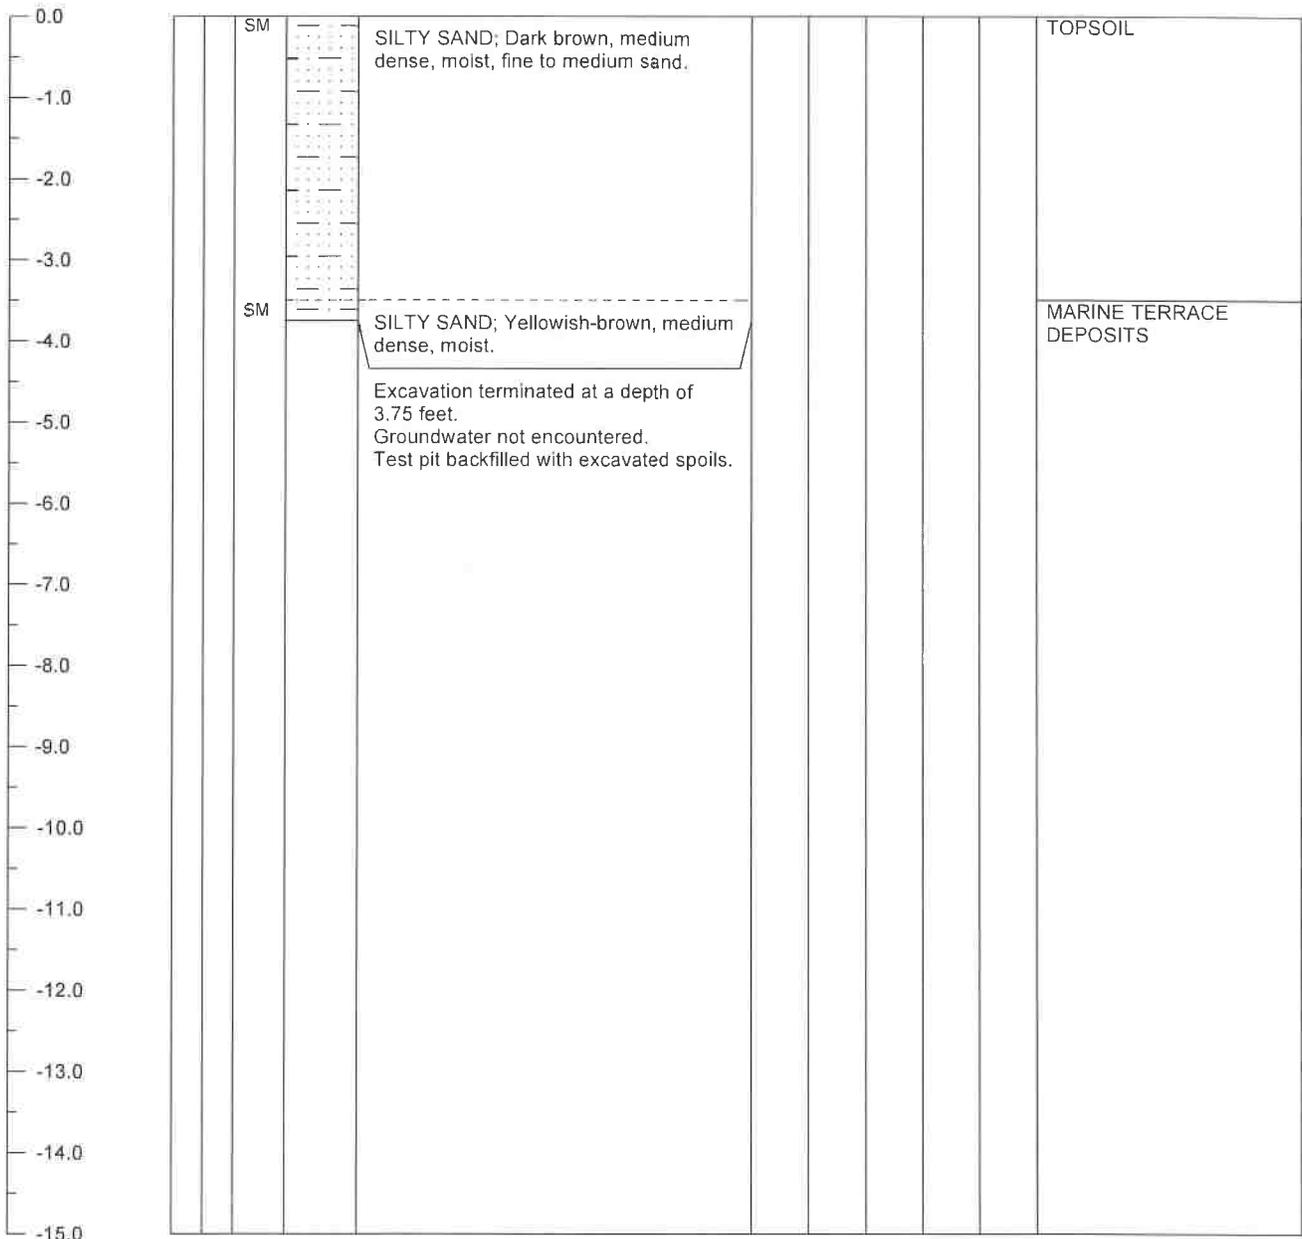
**TEST PIT  
NUMBER  
TP-4**

**PROJECT:** Washington Terrace Subdivision  
**LOCATION:** Washington Terrace Lot 26/27/28  
**GROUND SURFACE ELEVATION:** 150 Feet  
**EXCAVATION METHOD:** Backhoe  
**LOGGED BY:** P. Sundberg

DEPTH (FT)	BULK SAMPLES	TUBE SAMPLES	USCS	PROFILE	DESCRIPTION	% Moisture	Dry Density (pcf)	Unc. Com. (psf)	U.C. (Isf) by P.P.	% Passing 200	REMARKS
------------	--------------	--------------	------	---------	-------------	------------	-------------------	-----------------	--------------------	---------------	---------

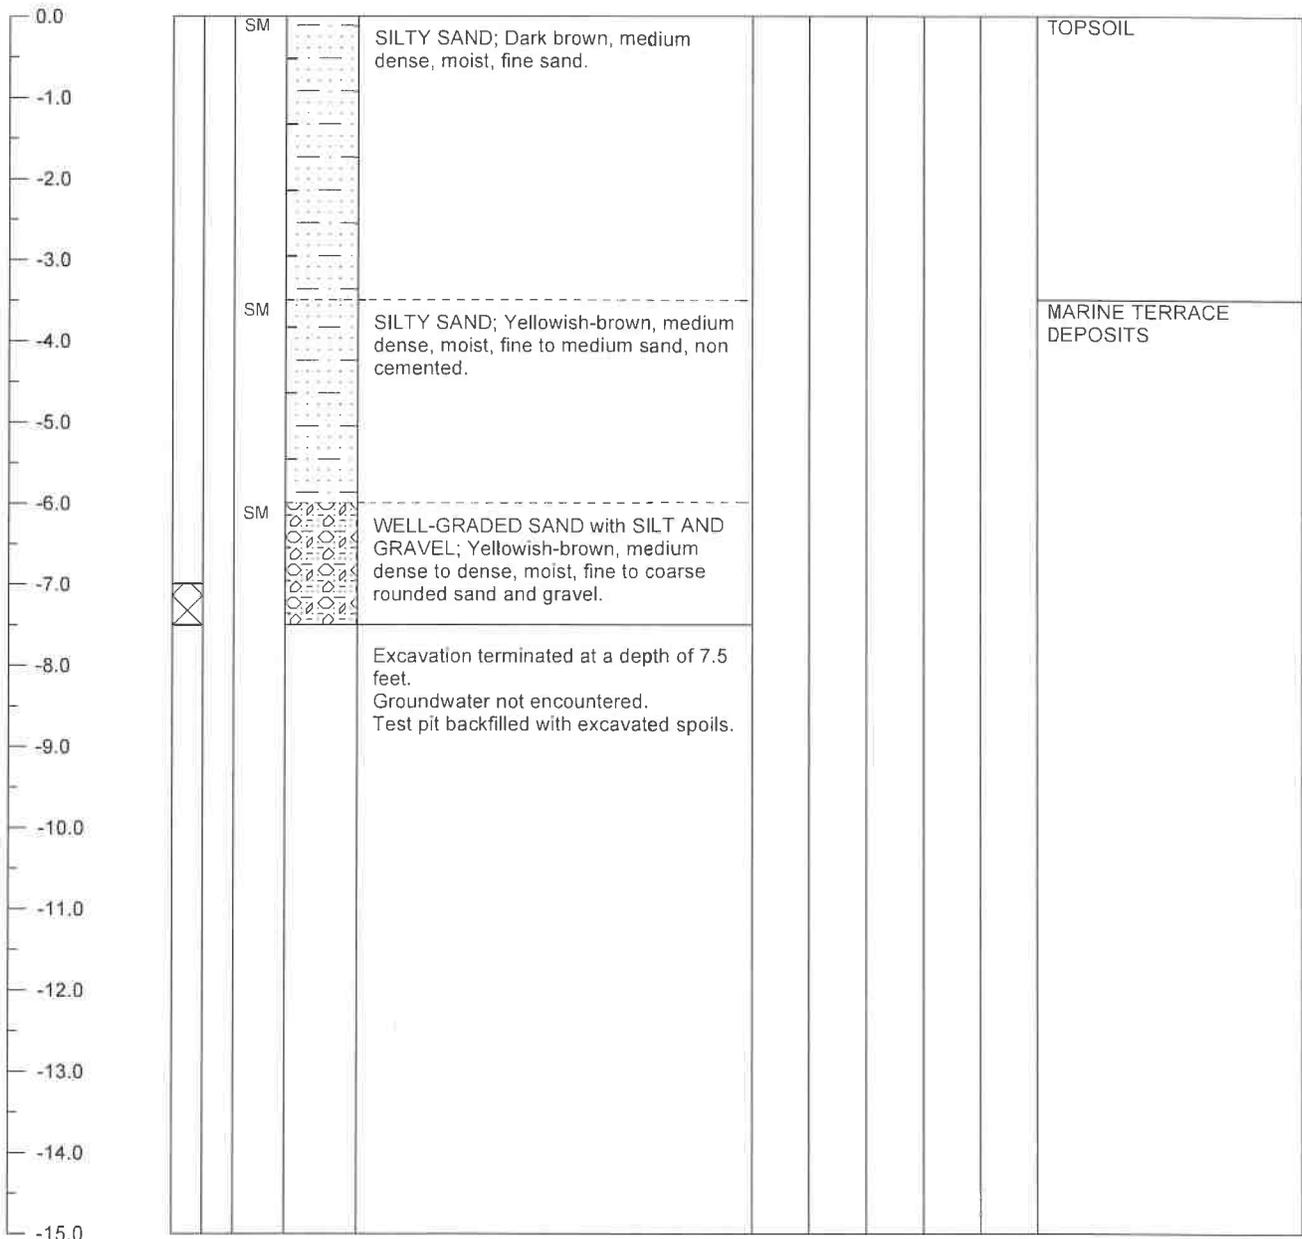
**TEST PIT  
 NUMBER  
 TP-5**

**PROJECT:** Washington Terrace Subdivision  
**LOCATION:** Washington Terrace Lot 30/31  
**GROUND SURFACE ELEVATION:** 150 Feet  
**EXCAVATION METHOD:** Backhoe  
**LOGGED BY:** P. Sundberg

DEPTH (FT)	BULK SAMPLES	TUBE SAMPLES	USCS	PROFILE	DESCRIPTION	% Moisture	Dry Density (pcf)	Unc. Com. (psf)	U.C. (1st) by P.P.	% Passing 200	REMARKS
------------	--------------	--------------	------	---------	-------------	------------	-------------------	-----------------	--------------------	---------------	---------

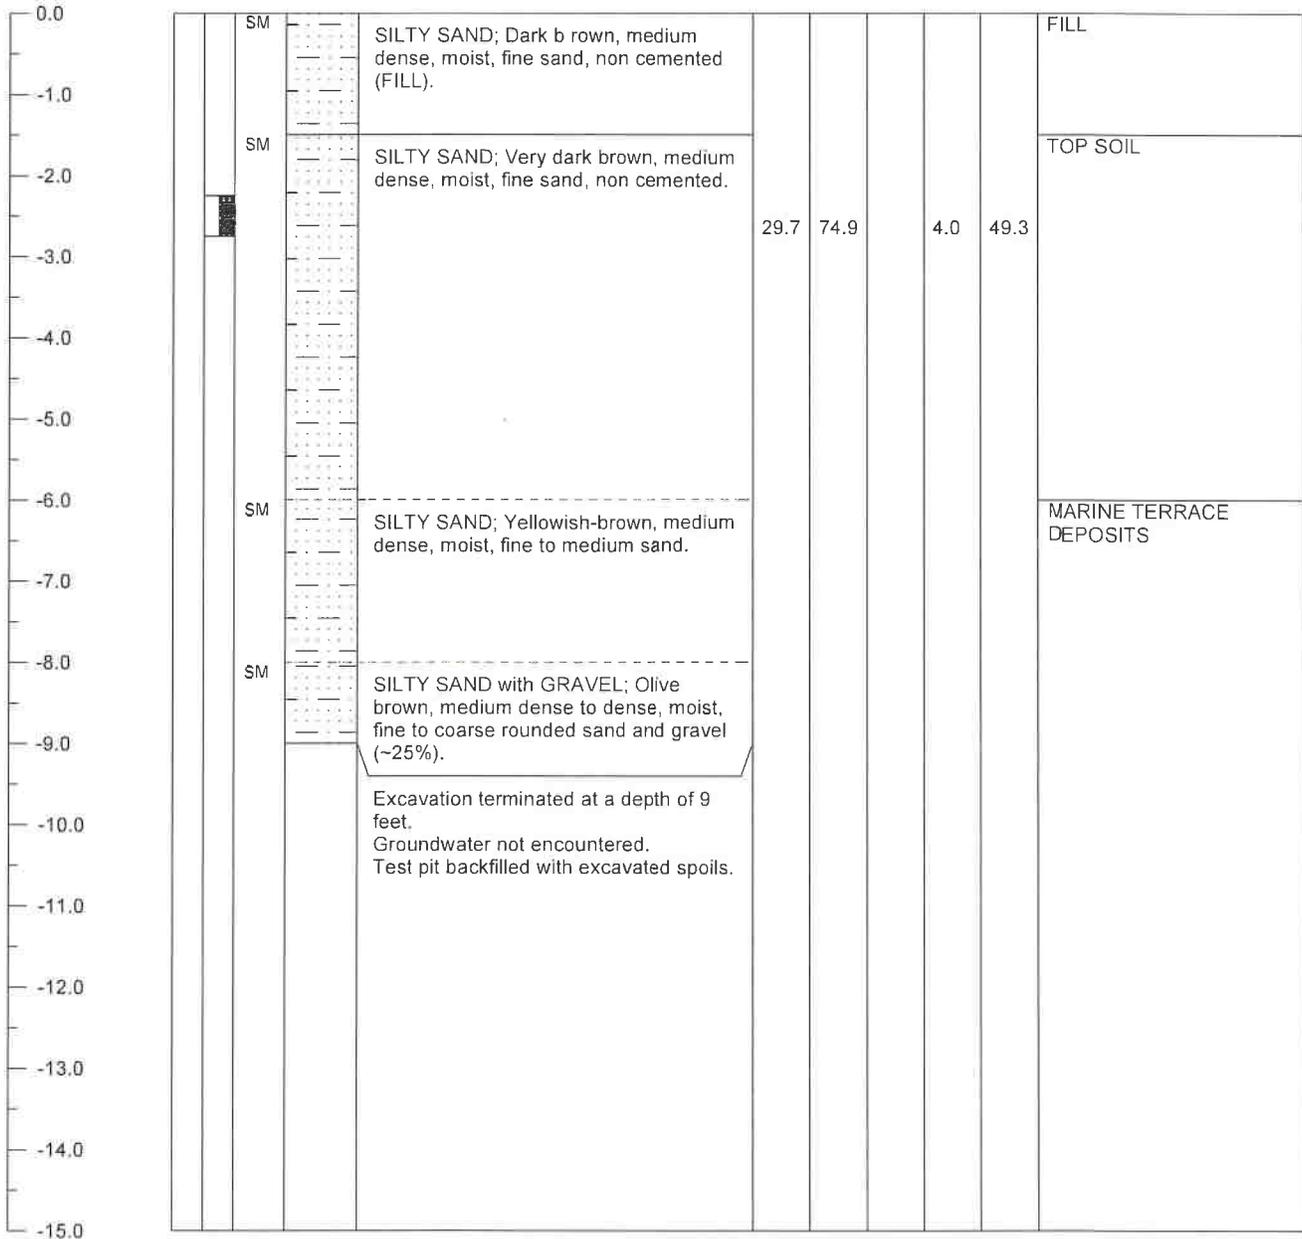
TEST PIT  
 NUMBER  
**TP-6**

PROJECT: Washington Terrace Subdivision  
 LOCATION: Washington Terrace Lot 33/34  
 GROUND SURFACE ELEVATION: 150 Feet  
 EXCAVATION METHOD: Backhoe  
 LOGGED BY: P. Sundberg

DEPTH (FT)	BULK SAMPLES TUBE SAMPLES	USCS	PROFILE	DESCRIPTION	% Moisture	Dry Density (pcf)	Unc. Cor. (psf)	U.C. (tsf) by P.P.	% Passing 200	REMARKS
------------	------------------------------	------	---------	-------------	------------	-------------------	-----------------	--------------------	---------------	---------

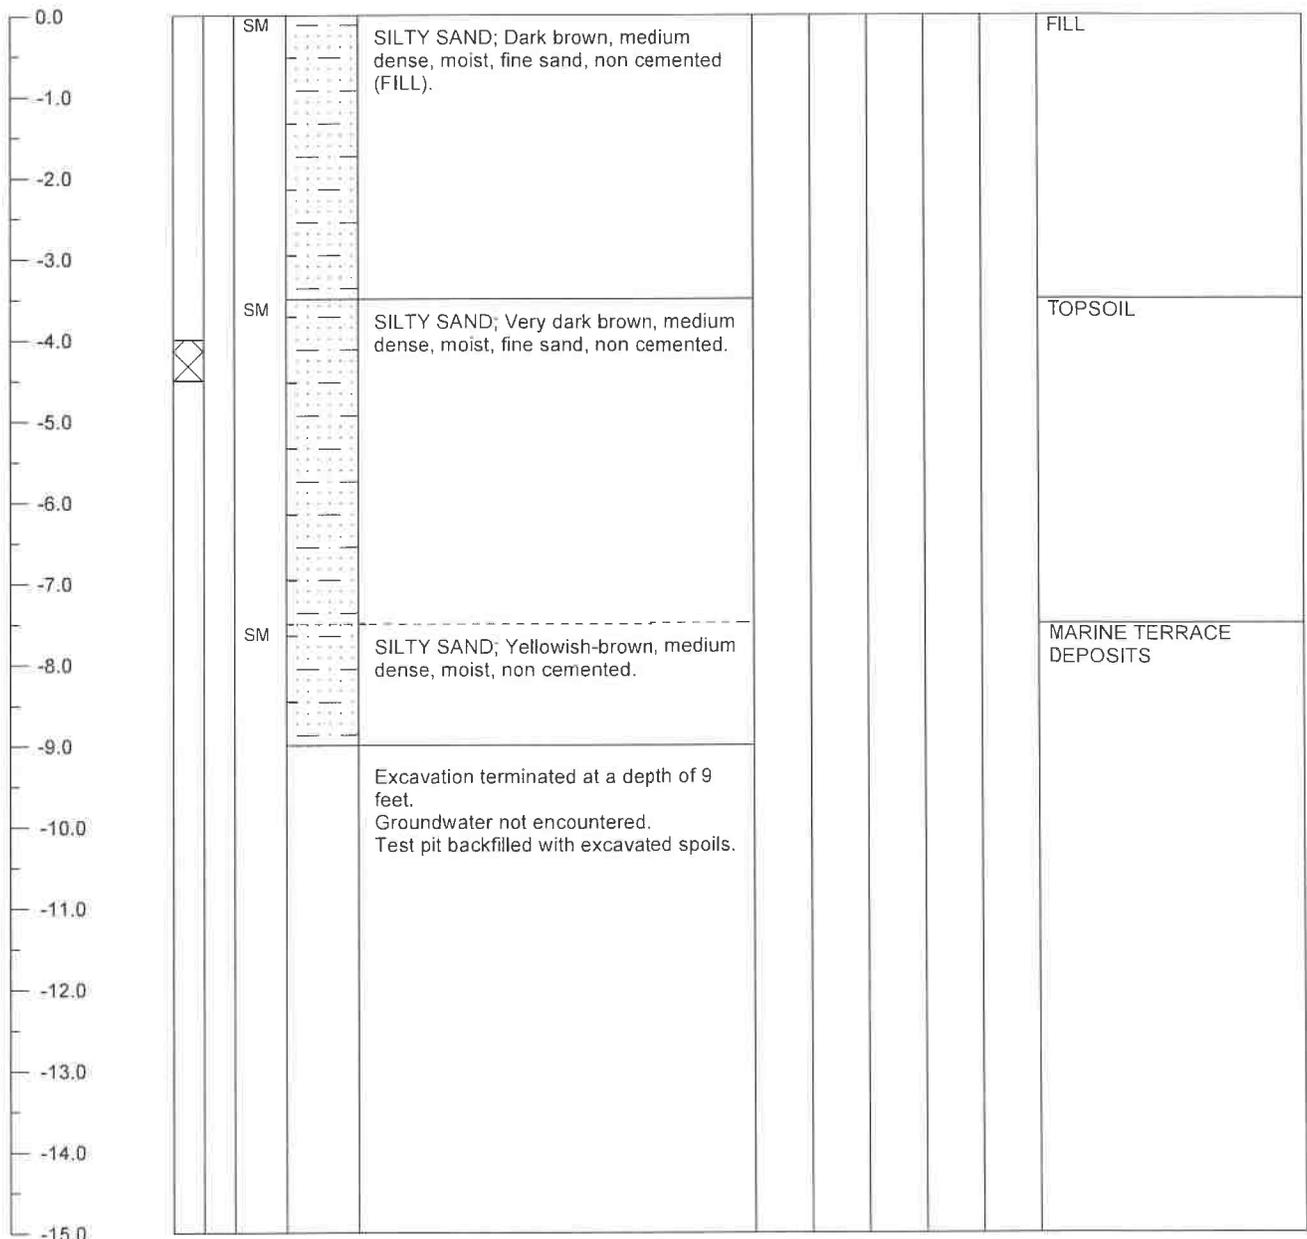
**TEST PIT  
NUMBER  
TP-7**

**PROJECT:** Washington Terrace Subdivision  
**LOCATION:** Washington Terrace Lot 36/37  
**GROUND SURFACE ELEVATION:** 150 Feet  
**EXCAVATION METHOD:** Backhoe  
**LOGGED BY:** P. Sundberg

DEPTH (FT)	BULK SAMPLES	TUBE SAMPLES	USCS	PROFILE	DESCRIPTION	% Moisture	Dry Density (pcf)	Unc. Com. (psf)	U.C. (tsf) by P.P.	% Passing #200	REMARKS
------------	--------------	--------------	------	---------	-------------	------------	-------------------	-----------------	--------------------	----------------	---------

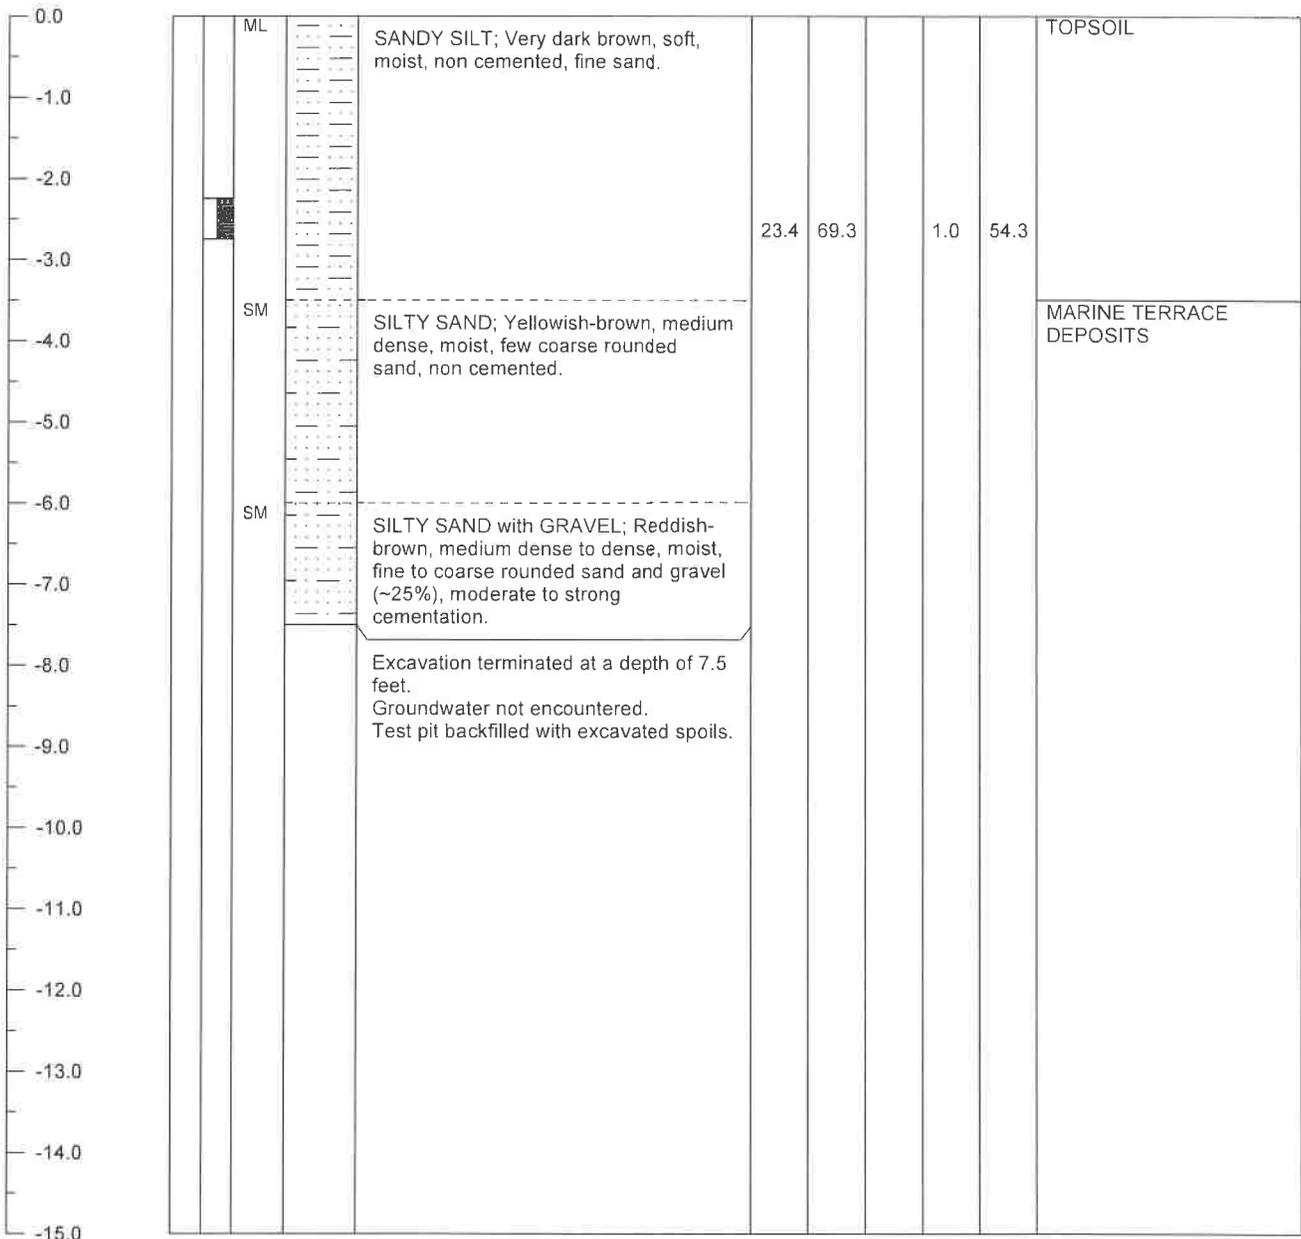
TEST PIT  
 NUMBER  
**TP-8**

PROJECT: Washington Terrace Subdivision  
 LOCATION: Washington Terrace Lot 38/39  
 GROUND SURFACE ELEVATION: 141 Feet  
 EXCAVATION METHOD: Backhoe  
 LOGGED BY: P. Sundberg

DEPTH (FT)	BULK SAMPLES TUBE SAMPLES	USCS	PROFILE	DESCRIPTION	% Moisture	Dry Density (pcf)	Unc. Com. (pcf)	U.C. (tsf) by P.P.	% Passing 200	REMARKS
------------	------------------------------	------	---------	-------------	------------	-------------------	-----------------	--------------------	---------------	---------

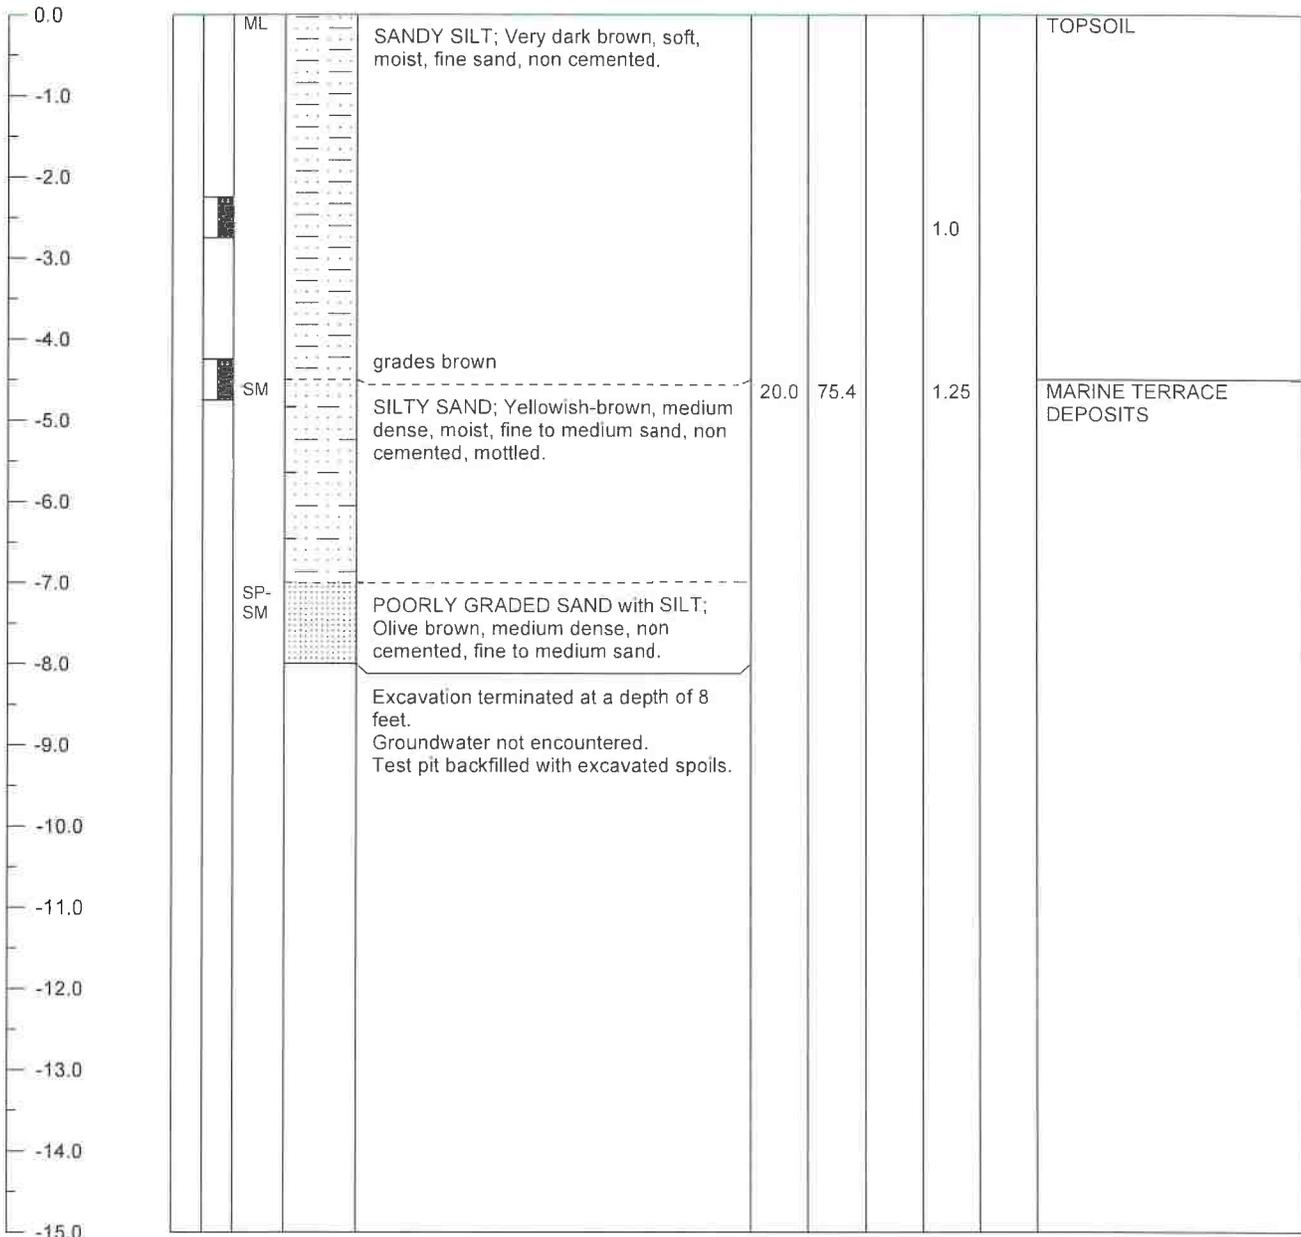
TEST PIT  
 NUMBER  
**TP-9**

PROJECT: Washington Terrace Subdivision  
 LOCATION: Washington Terrace Lot 4  
 GROUND SURFACE ELEVATION: 141 Feet  
 EXCAVATION METHOD: Backhoe  
 LOGGED BY: P. Sundberg

DEPTH (FT)	BULK SAMPLES TUBE SAMPLES	USCS	PROFILE	DESCRIPTION	% Moisture	Dry Density (pcf)	Unc. Com. (psf)	U.C. (tsf) by P.P.	% Passing 200	REMARKS
------------	------------------------------	------	---------	-------------	------------	-------------------	-----------------	--------------------	---------------	---------
