# Geotechnical Investigation Report

Washington Terrace Subdivision

McKinleyville, California

**Subject: Geotechnical Investigation Report, Washington Terrace Subdivision, APN 508-242-044, McKinleyville, California**

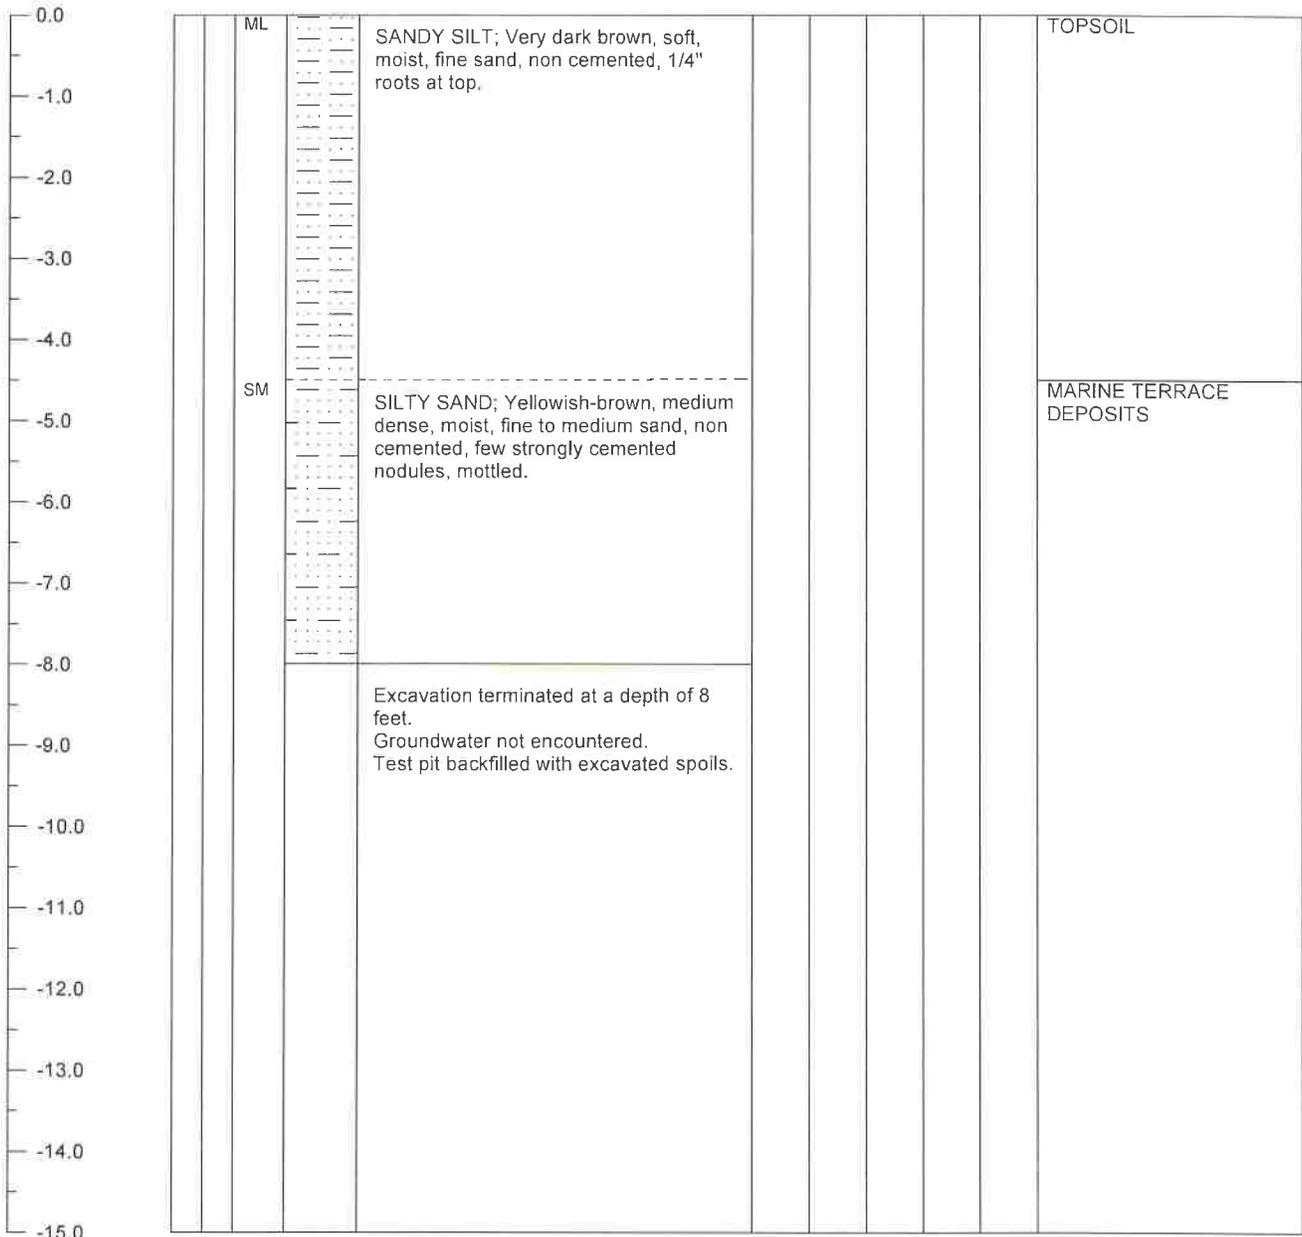
TEST PIT  
 NUMBER  
**TP-10**

PROJECT: Washington Terrace Subdivision  
 LOCATION: Washington Terrace Lot 11  
 GROUND SURFACE ELEVATION: 139 Feet  
 EXCAVATION METHOD: Backhoe  
 LOGGED BY: P. Sundberg

DEPTH (FT)	BULK SAMPLES TUBE SAMPLES	USCS	PROFILE	DESCRIPTION	% Moisture	Dry Density (pcf)	Unc. Com. (psf)	U.C. (tsf) by P.P.	% Passing 200	REMARKS
------------	------------------------------	------	---------	-------------	------------	-------------------	-----------------	--------------------	---------------	---------

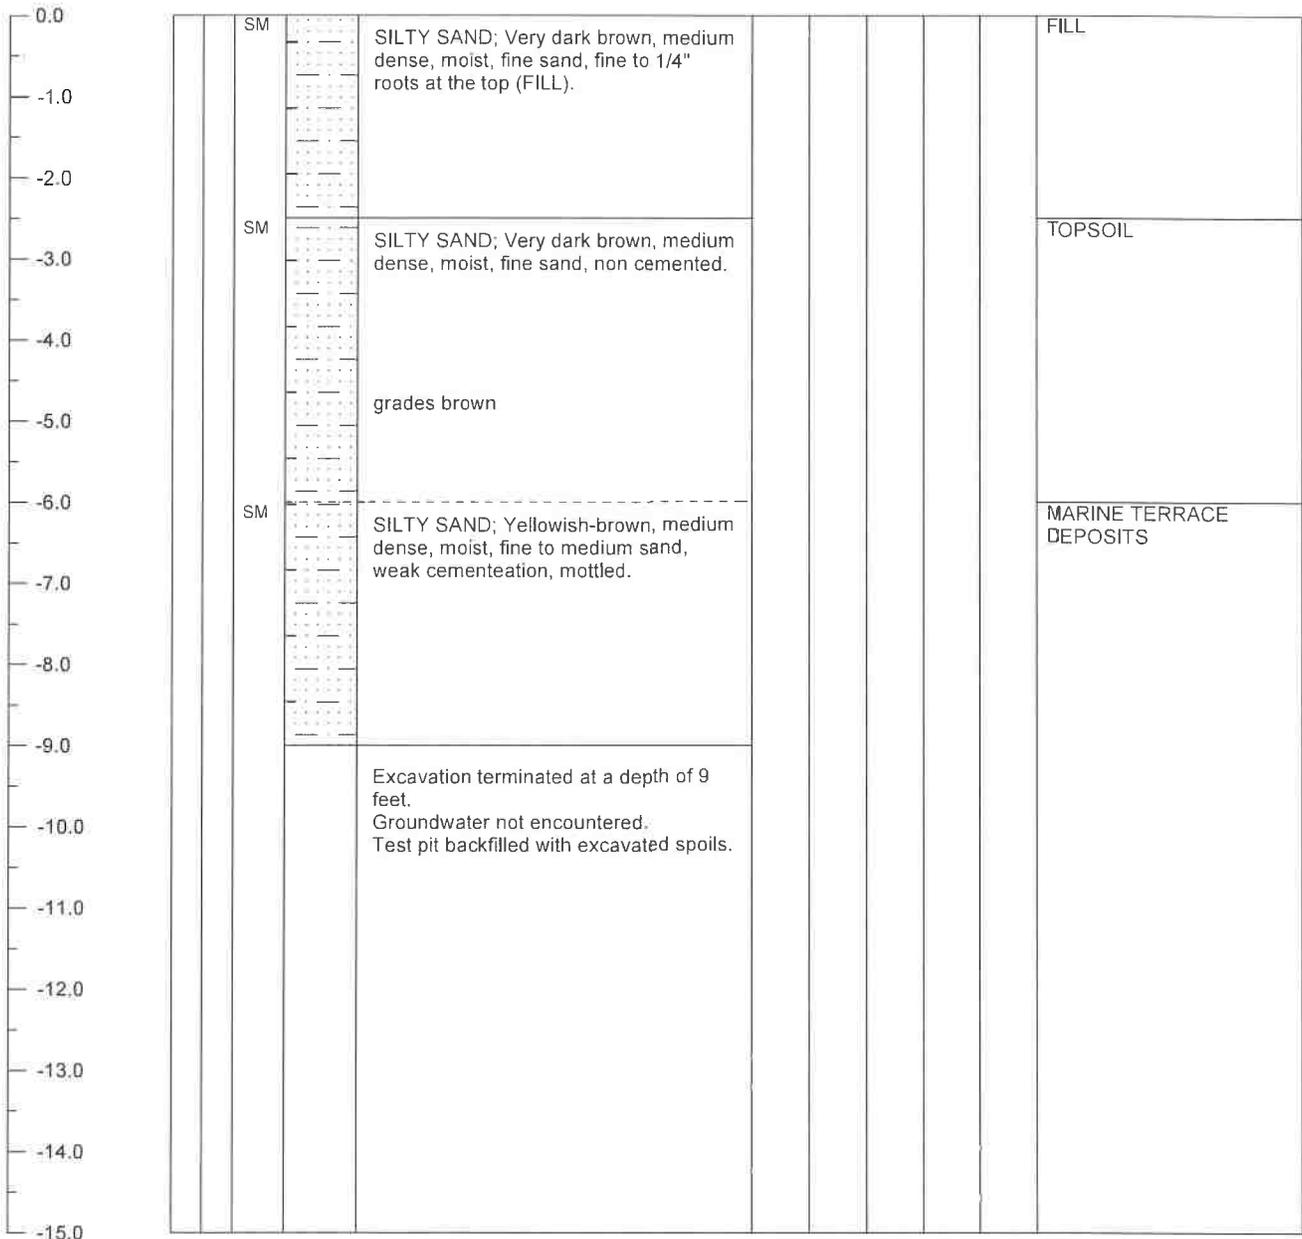
**TEST PIT  
 NUMBER  
 TP-11**

**PROJECT:** Washington Terrace Subdivision  
**LOCATION:** Washington Terrace Lot 1/7  
**GROUND SURFACE ELEVATION:** 143 Feet  
**EXCAVATION METHOD:** Backhoe  
**LOGGED BY:** P. Sundberg

DEPTH (FT)	BULK SAMPLES	TUBE SAMPLES	USCS	PROFILE	DESCRIPTION	% Moisture	Dry Density (pcf)	Unc. Cor. (psf)	U.C. (tsf) by P.P.	% Passing 200	REMARKS
------------	--------------	--------------	------	---------	-------------	------------	-------------------	-----------------	--------------------	---------------	---------

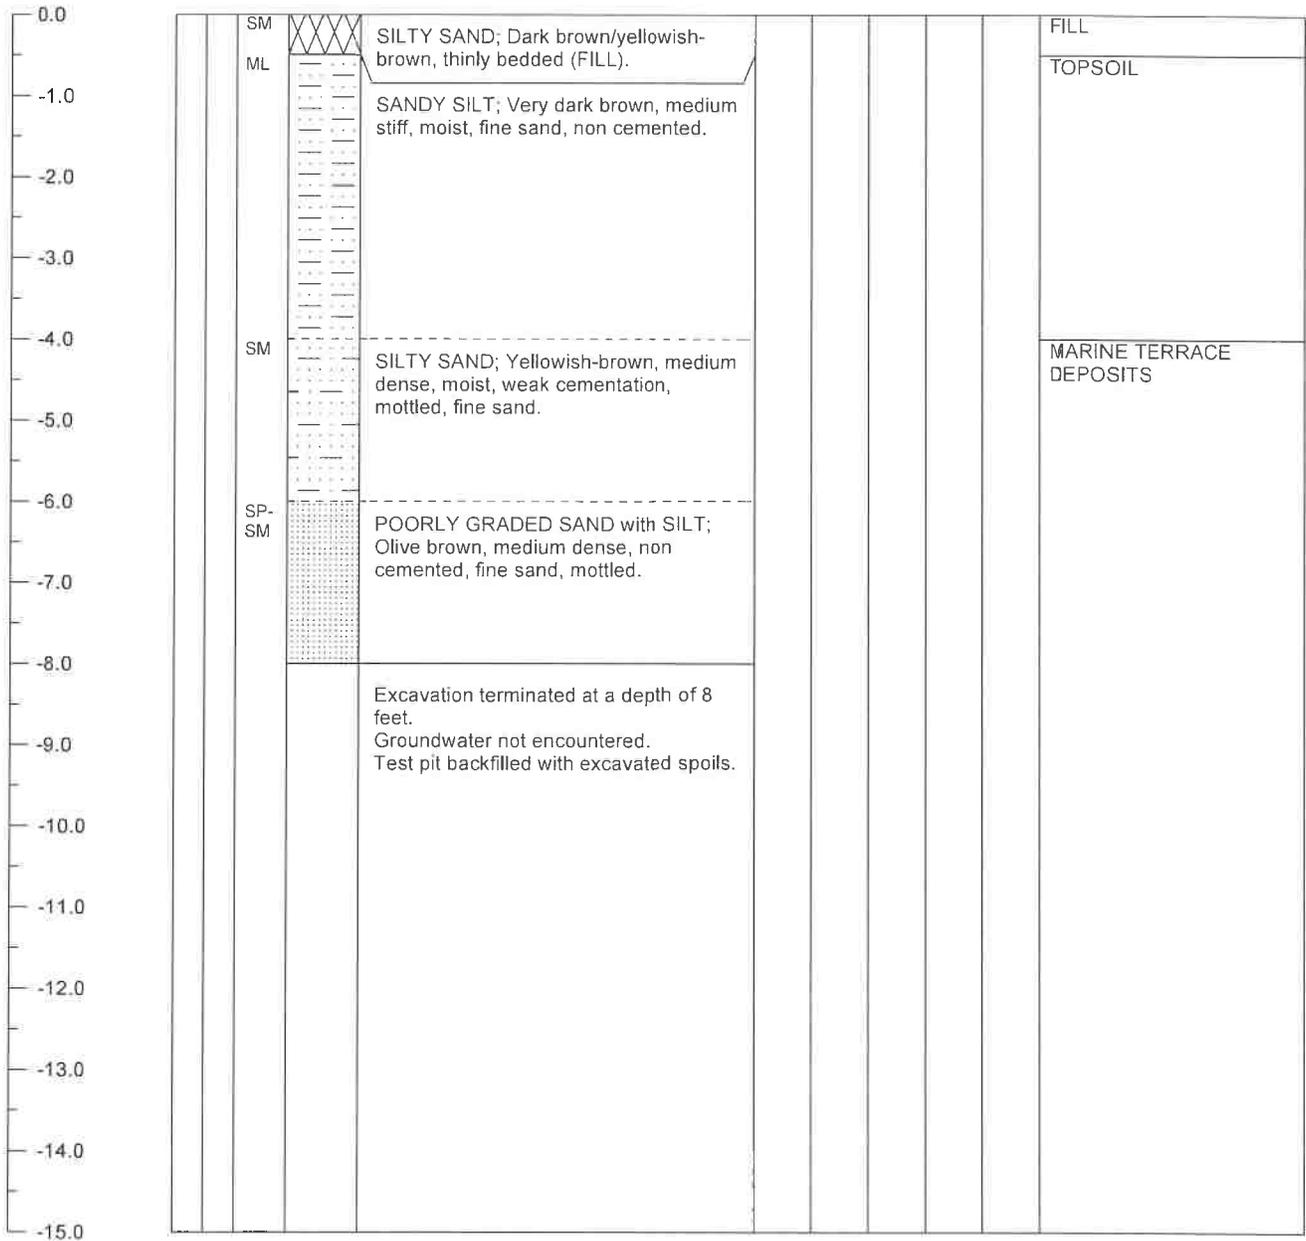
**TEST PIT  
 NUMBER  
 TP-12**

PROJECT: Washington Terrace Subdivision  
 LOCATION: Washington Terrace Lot 16/18  
 GROUND SURFACE ELEVATION: 142 Feet  
 EXCAVATION METHOD: Backhoe  
 LOGGED BY: P. Sundberg

DEPTH (FT)	BULK SAMPLES	TUBE SAMPLES	USCS	PROFILE	DESCRIPTION	% Moisture	Dry Density (pcf)	Unc. Cor. (pcf)	U.C. (tsf) by P.P.	% Passing 200	REMARKS
------------	--------------	--------------	------	---------	-------------	------------	-------------------	-----------------	--------------------	---------------	---------
