ENGINEERING GEOLOGIC SOILS REPORT

GEOLOGIC HAZARDS AND DEVELOPMENT CLASS R2

Aurel Coza
APN: 110-251-037 & 110-251-038
Block 199, Lots 31 & 32
Shelter Cove, CA
Humboldt County

Job# 23-6059

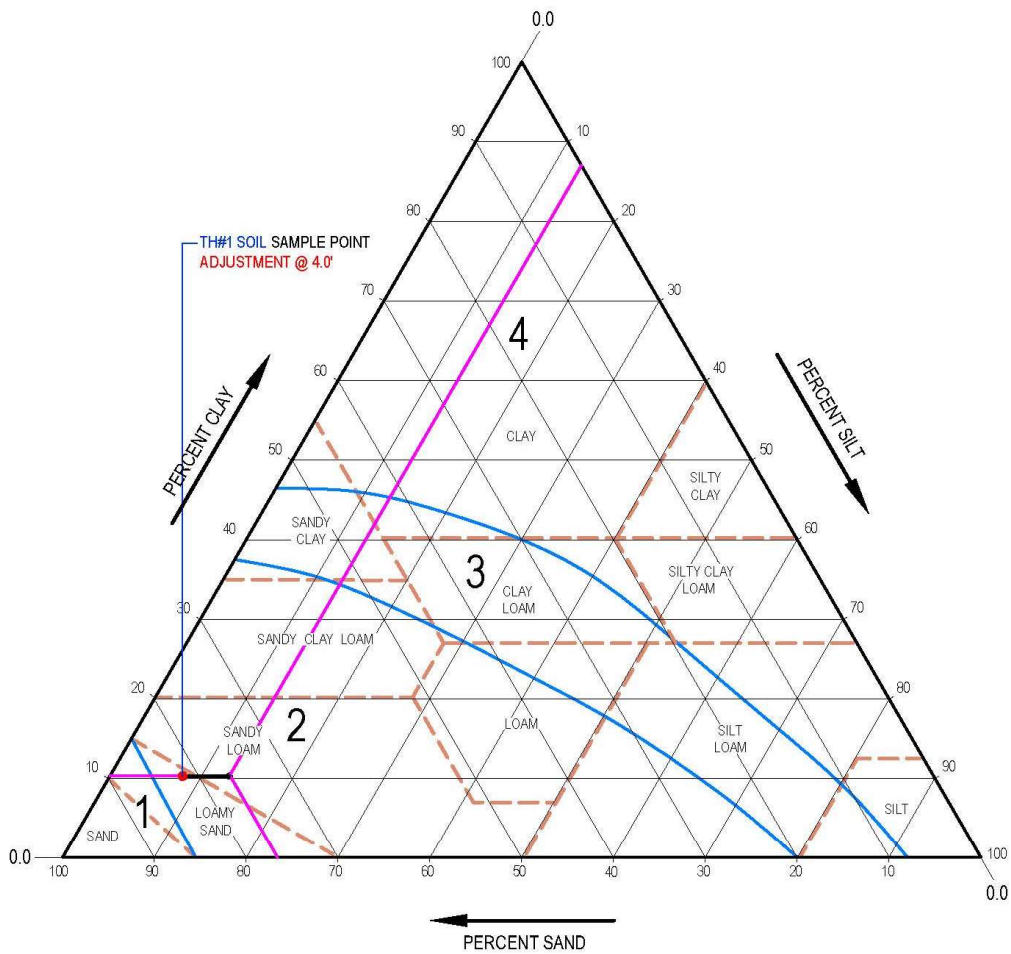
PROJECT NAME:	COZA	DATE OF EXCAVATION:	03/30/2023
PROJECT #:	23-6059	EXCAVATION METHOD:	EXCAVATOR / HAND
SITE APN:	110-251-037 & 038	WEATHER SEASON:	WET
TEST HOLE #:	1	LOGGED BY:	CPL

COARSE ADJUSTMENT: TH#1 @ 4.0' = 5.1%

In the last soil horizon, the soil is single-grain, Zone 2 light yellowish brown sandy loam (Munsell color 10 YR 6/4) from approximately 4.25 feet in depth to the bottom of the test pit with a coarse content of approximately 45% consisting of gravel and small angular rock. The soil is very friable when moist and slightly sticky when wet with slight plasticity. No soil mottling or oxidation was observed in the test hole. The soil profile, textural analysis and soil chart are appended.
