Water Resource Protection Plan

WDID# - 1B161035CHUM

**APN 216-025-009, 216-025-002,
216-025-011, 216-025-016**

Timberland Resource Consultants

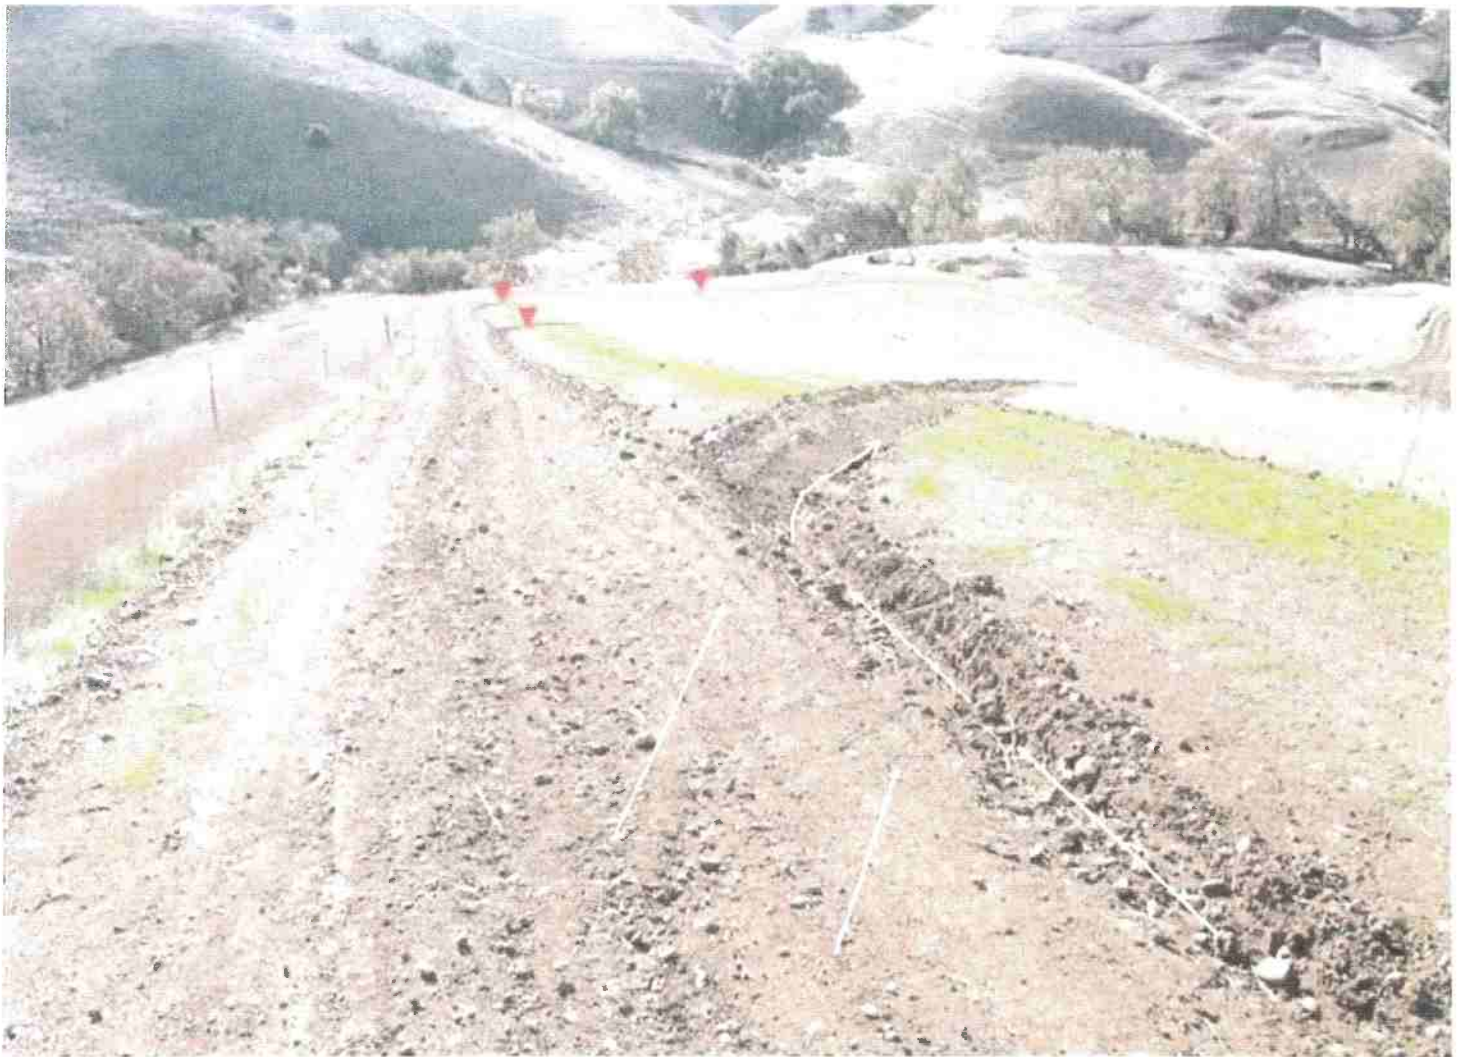
FIGURE 55. Steep roads that go straight up or down a hillside are very difficult to drain. This steep, fall line road developed a through cut cross section that was drained using lead out ditches to direct runoff off the road and onto the adjacent, vegetated hillside. The road was "outsloped" to drain runoff to the right side, and the lead out ditch was built slightly steeper than the road grade, to be self-cleaning. Four lead out ditches have been constructed at 100-foot intervals to the bottom of the hillside.

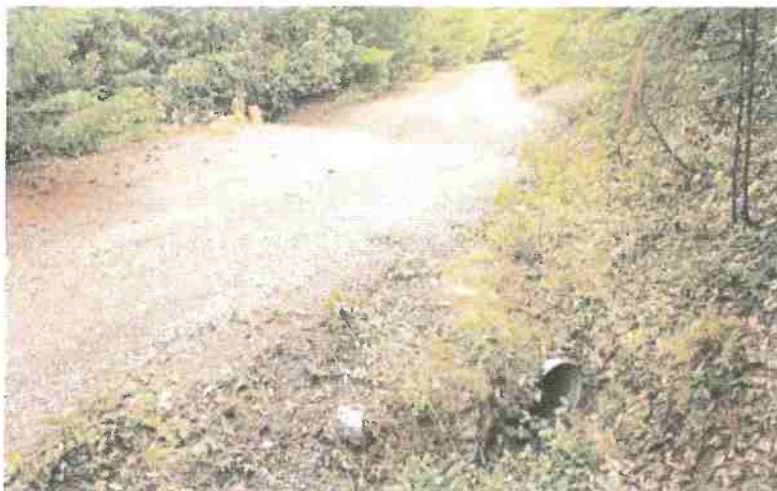
FIGURE 39

Waterbars are often used to drain surface runoff from seasonal unsurfaced roads. Because they are easily broken down by vehicles, waterbars are only used on unsurfaced roads where there is little or no wet weather traffic. In this photo, a waterbar and ditch relief culvert are used to drain all road surface and ditch runoff from the insloped road prism.

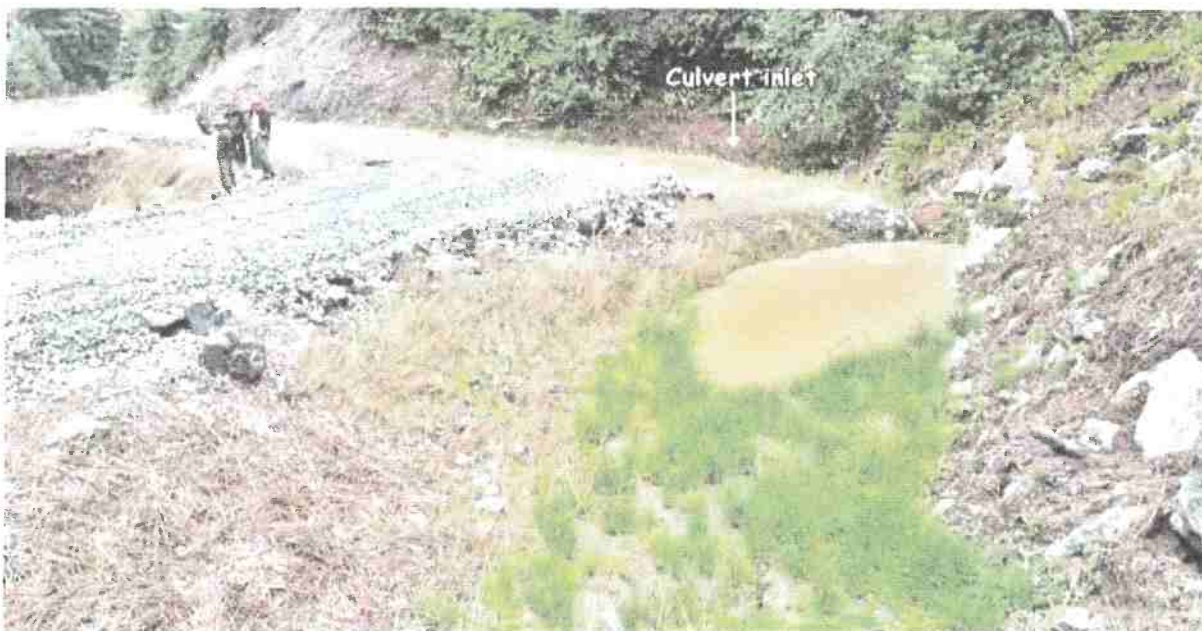
FIGURE 238. Traffic and surface runoff from graveled roads often produces surface erosion, turbid runoff and fine sediment transport that can be delivered to streams. Where ditches can't be eliminated, sediment traps and roadside settling basins can be installed to capture and remove most of the eroded sediment. This settling basin has been constructed along the inside ditch just before a stream crossing culvert inlet (see arrow). Eroded sediment from the road and ditch are deposited in the basin before flow is released to the stream. Fine sediments have filled about 1/3 of this basin and vegetation is now growing. Sediment basins require periodic maintenance to maintain their storage capacity.

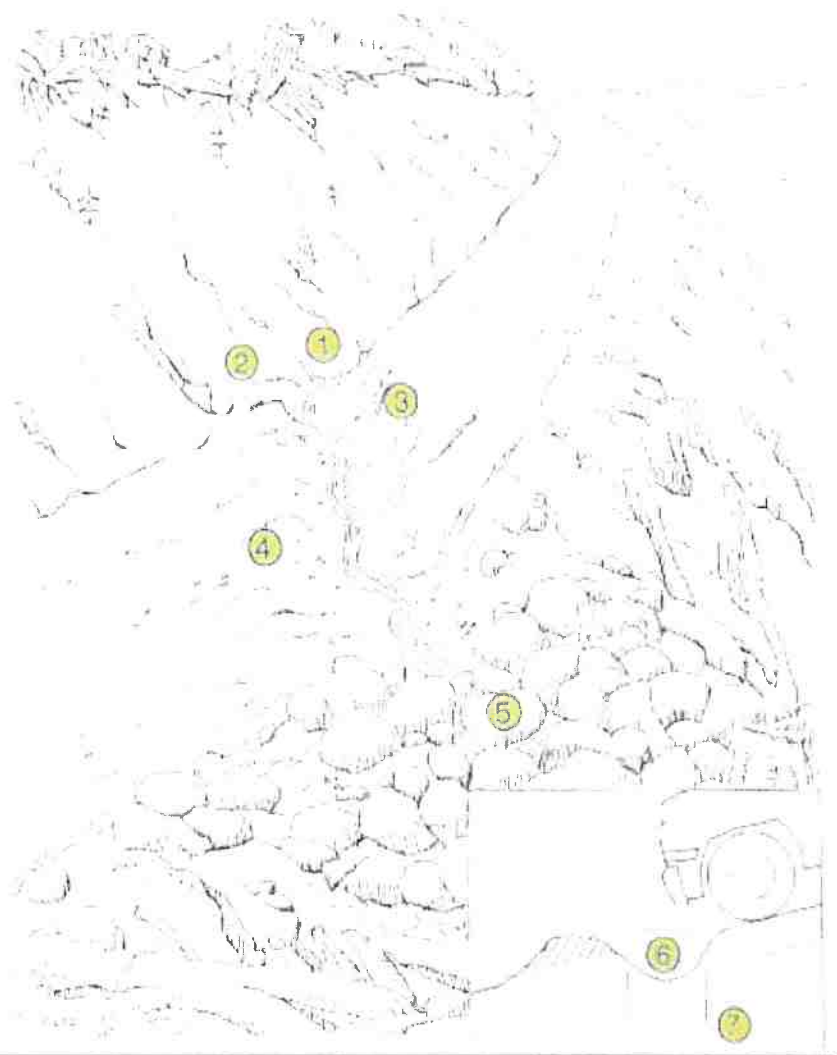
FIGURE 40. Waterbars are constructed on unsurfaced forest and ranch roads that will have little or no traffic during the wet season. The waterbar should be extended to the cutbank to intercept all ditch flow (1) and extend beyond the shoulder of the road. A berm (2) must block and prevent ditch flow from continuing down the road during flood flows. The excavated waterbar (3) should be constructed to be self-cleaning, typically with a 30° skew to the road alignment with the excavated material bermed on the downhill grade of the road (4). Water should always be discharged onto the downhill side on a stable slope protected by vegetation. Rock (shown in the figure) should not be necessary if waterbars are spaced close enough to prevent serious erosion. (5) The cross ditch depth (6) and width (7) must allow vehicle cross-over without destroying the function of the drain. Several alternate types of waterbars are possible, including one that drains only the road surface (not the ditch), and one that drains the road surface into the inside ditch (BCME, 1991).
