LINDBERG GEOLOGIC CONSULTING

0257.01

Subject: Clarification and Amendment; Engineering-Geologic R-2 Soils Exploration Report
Existing Pond Expansion Assessment on Assessor's Parcel 222-071-030, at
161 Oak Rock Road, near Garberville, Humboldt County, California

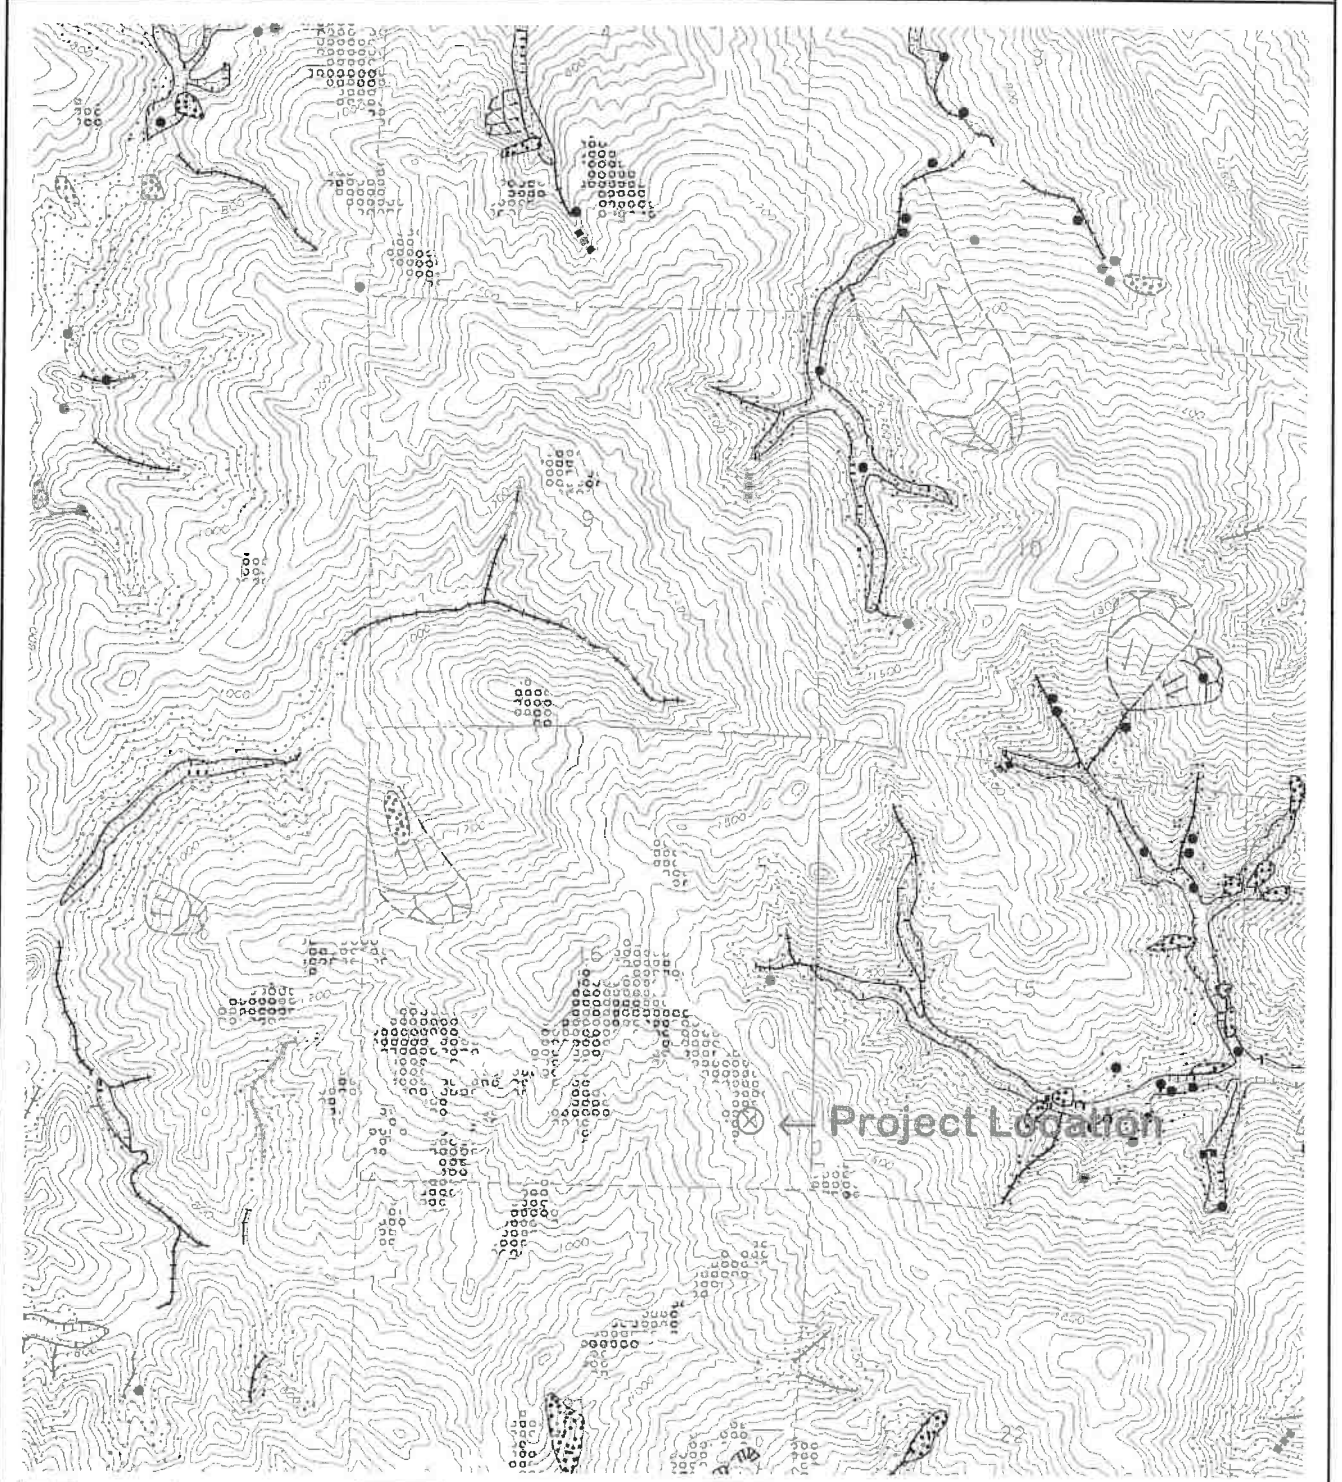
Lindberg Geologic Consulting	Engineering-Geologic R-2 Soils Exploration Report	Figure 5
Post Office Box 306	161 Oak Rock Road, Garberville, Humboldt County, California	February 20, 2018
Cutten, CA 95534	APN 222-071-030, Mr. Justin Baldwin, Client	Project 0267.00
(707) 442-6000	Geomorphic Features Related to Landsliding	1 inch \cong 2,255 feet

Amphitheater Slope	Translational/Rotational Slide (dashed line indicates dormant)	Inner Gorge	• Active Slide (too small to delineate @ 1:24000)
Disrupted Ground	Earthflow (dashed line indicates dormant)		••••• Torrent Tracks (active)
Debris Slide (dashed line indicates dormant)			••••• Torrent Tracks (dormant)
			— Inner Gorge (too small to delineate @ 1:24000)

Modified from: Spittler, T. E., 1983. N \cong
