COUNTY OF HUMBOLDT, CALIFORNIA

SOCIAL SERVICES

ADA ACCESS COMPLIANCE ASSESSMENT

600 W CLARK STREET, EUREKA CA
(COUNTY LEASED FACILITY)

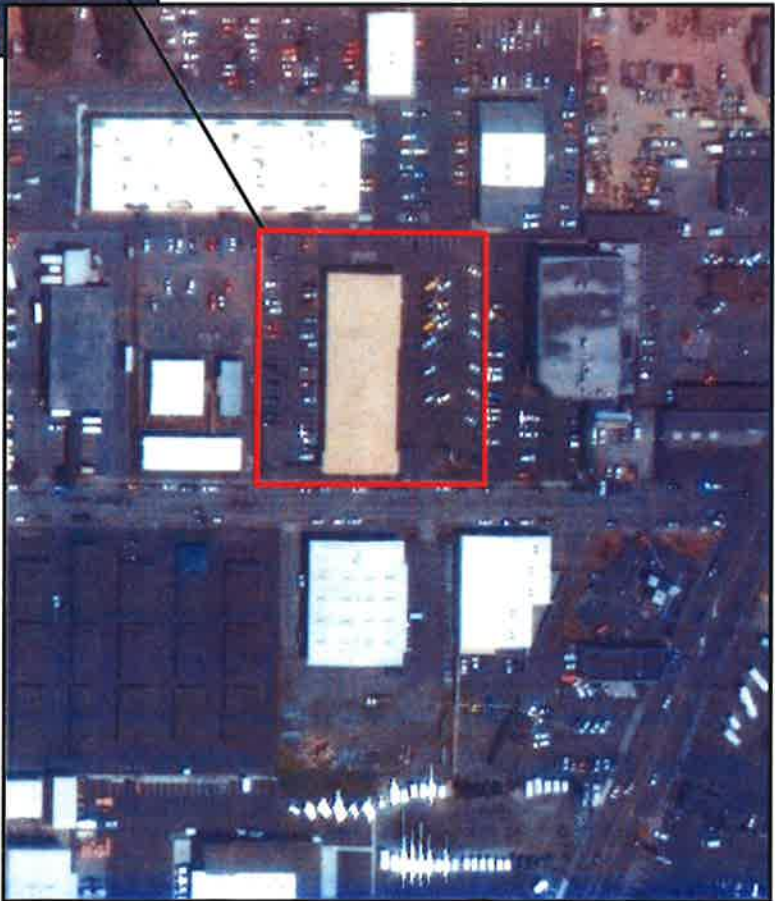
Exhibit B – Floor Plan

Humboldt County
 Department of Health &
 Human Services
 600 W. Clark Street
 Eureka, CA 95501
 Building S000600
