Water Resource Protection Plan

WDID# - 1B16891CHUM

APN 523-021-004

Timberland Resource Consultants

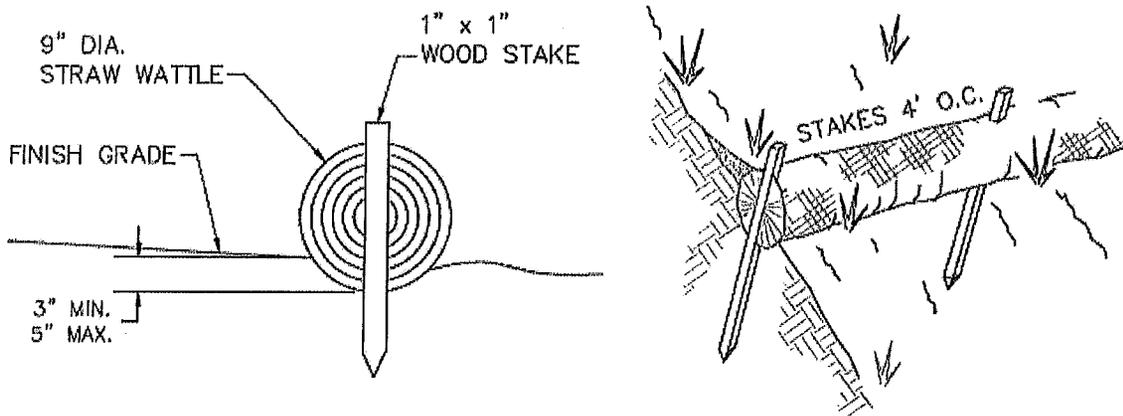
- Straw Wattles (if used) shall be installed with 18 or 24 inch wood stakes at four feet on center. The ends of adjacent straw wattles shall be abutted to each other snugly or overlapped by six inches. Wattles shall be installed so that the wattle is in firm contact with the ground surface.

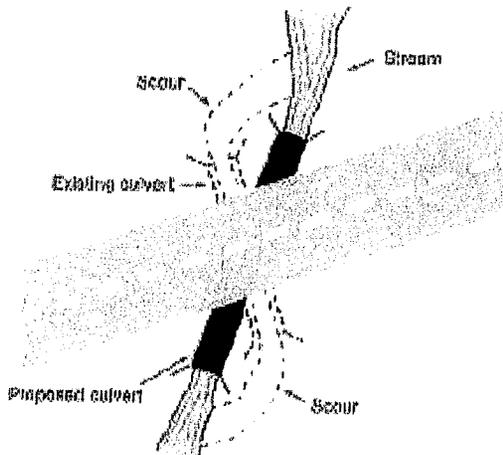
FIGURE 97. Culvert alignment should be in relation to the stream and not the road. It is important that the stream enters and leaves the culvert in a relatively straight horizontal alignment so streamflow does not have to turn to enter the inlet or discharge into a bank as it exits. This figure shows a redesigned culvert installation that replaces the bending alignment that previously existed. Channel turns at the inlet increase plugging potential because wood going through the turn will not align with the inlet. Similarly, channel turns at the inlet and outlet are often accompanied by scour against the channel banks (Wisconsin Transportation Intermedia-
tion Center, 2004).

- Align culverts with the natural stream channel orientation to ensure proper function, prevent bank erosion, and minimize debris plugging. See Figure 97 below.

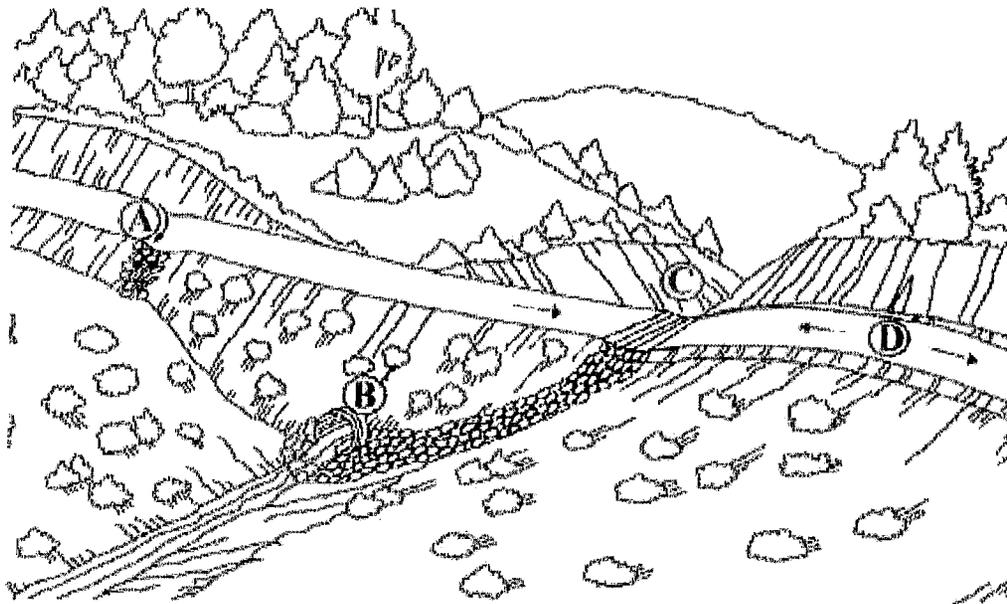
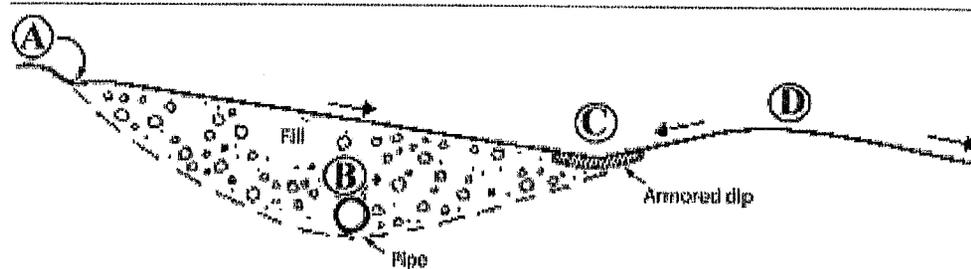
FIGURE 84. Critical dips or dipped crossing fills should be centered near a stream crossing's down-road hinge line, not over the centerline of the crossing where overtopping could cause washout or severe erosion of the fill. If the stream crossing culvert (B) plugs, water will pond behind the fill until reaching the critical dip or low point in the crossing (C) and flowing back down into the natural stream channel. The down-road ditch must be plugged to prevent streamflow from diverting down the ditch line. For extra protection in this sketch, riprap armor has been placed at the critical dip outfall and extending downslope to the stream channel. This is only required or suggested on stream crossings where the culvert is highly likely to plug and the crossing fill overtopped. The dip at the hinge line is usually sufficient to limit erosional damage during an overtopping event. Road surface and ditch runoff is disconnected from the stream crossing by installing a rolling dip and ditch relief culvert just up-road from the crossing (A) (Keller and Sherar, 2003).

- Critical dips shall be installed on culvert crossings to eliminate diversion potential. Refer to Figure 84 below.
- Road approaches to crossings shall be treated out to the first drainage structure (i.e. waterbar, rolling dip, or hydrologic divide) to prevent transport of sediment.

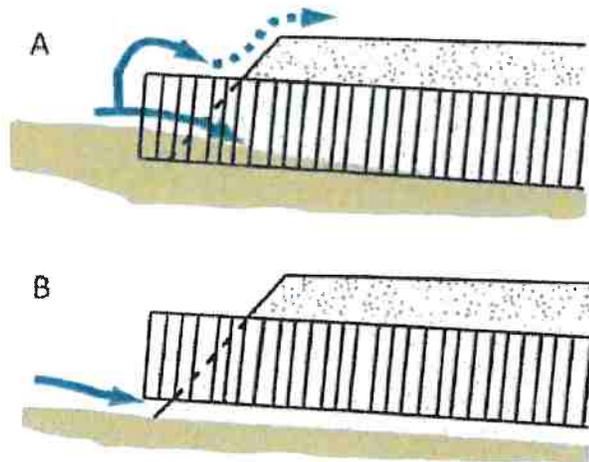
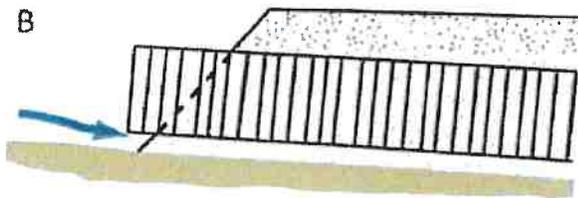
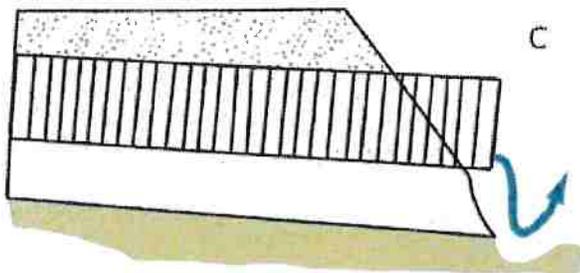
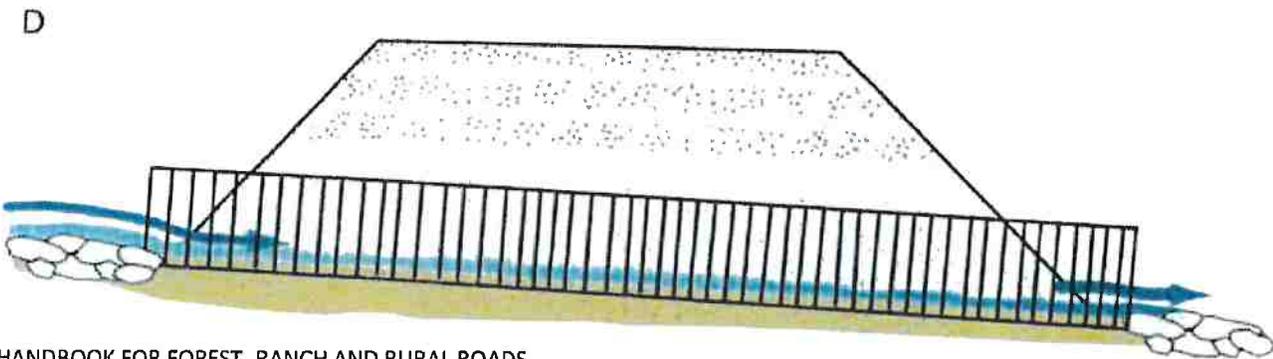
FIGURE 155. Proper culvert installation involves correct culvert orientation, setting the pipe slightly below the bed of the original stream, and backfilling and compacting the fill as it is placed over the culvert. Installing the inlet too low in the stream (A) can lead to culvert plugging, yet if set too high (B) flow can undercut the inlet. If the culvert is placed too high in the fill (C), flow at the outfall will erode the fill. Placed correctly (D), the culvert is set slightly below the original stream grade and protected with armor at the inlet and outlet. Culverts installed in fish-bearing stream channels must be inset into the streambed sufficiently (>25% embedded) to have a natural gravel bottom throughout the culvert (Modified from: MDSL, 1991).

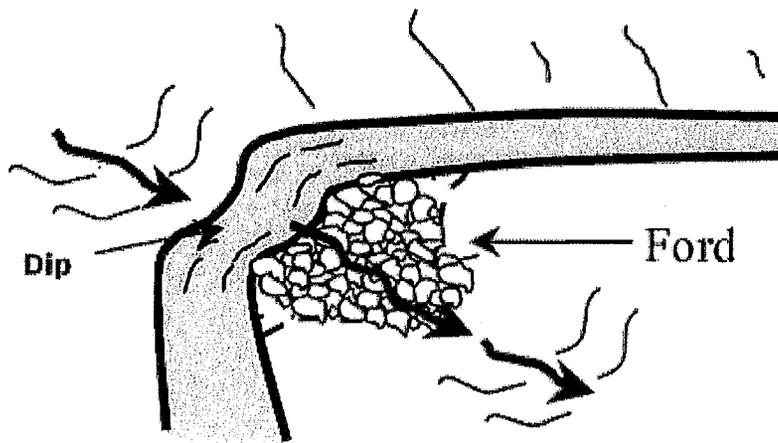
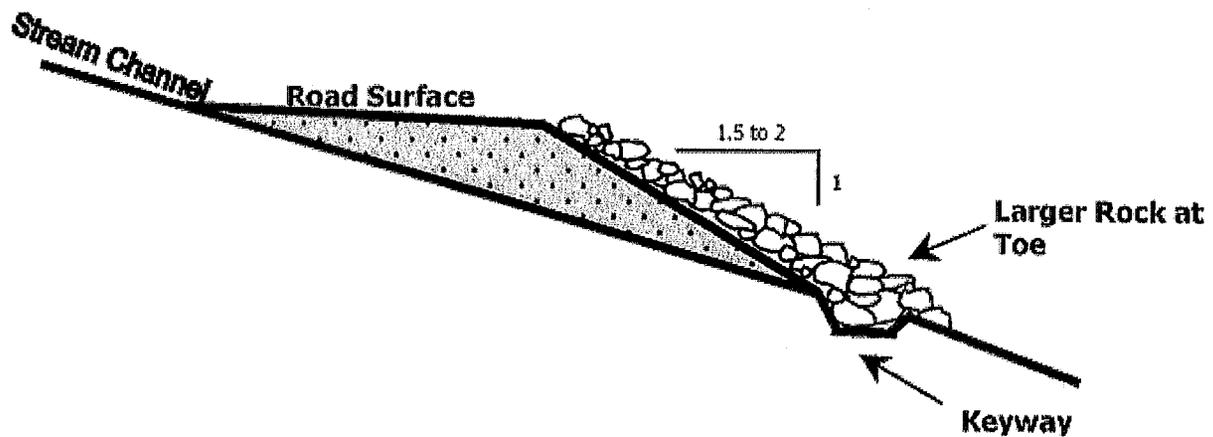
FORD: A large dip is graded into the road at the axis of the stream channel. The outside fill face is dished out to form a spillway with large rock. On large watercourses, rock is keyed several feet into firm native soils. The road surface is rocked with 6" of minus rock.

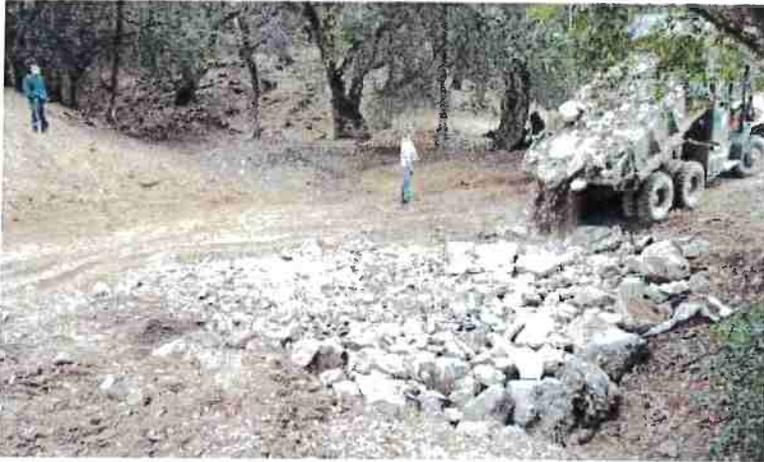
FIGURE 121D. Well graded rock armor is then backfilled into the structure and spread across the breadth of the U-shaped stream crossing, and about one-third the way up the roadbed, so that streamflow will only flow over or come in contact with resistant armor material. The armor must be spread and compacted across the design width of the expected flood flow channel width so peak flows will not flank the armored structure.

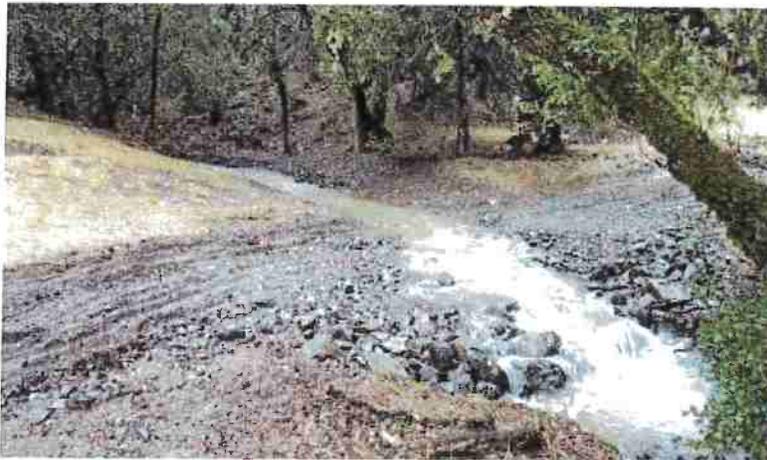
FIGURE 121E. Two weeks after this armored fill was constructed, a storm flow event occurred and the structure maintained its function and integrity. The road approaches had not yet been compacted or surfaced with road rock.

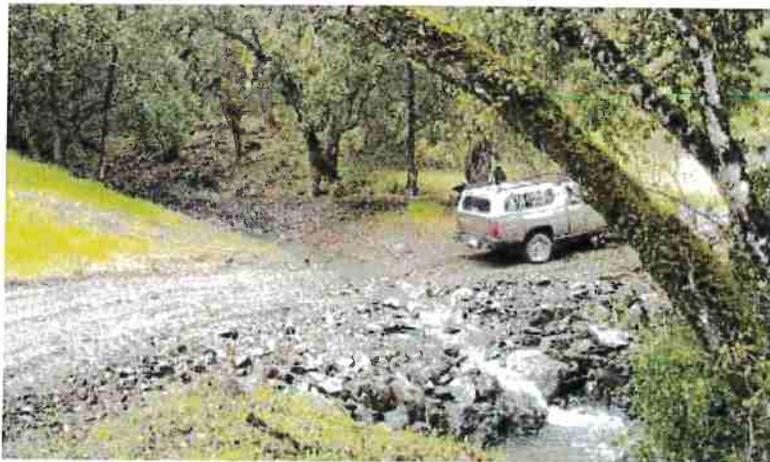
FIGURE 121F. The same armored fill as it appeared after the first winter flood flows. No maintenance was required to reopen the road. It is also clear that no stream diversion is possible at this stream crossing site, and the volume of fill within the crossing has been reduced to the minimum amount needed to maintain a relatively smooth driving surface on this low volume road.

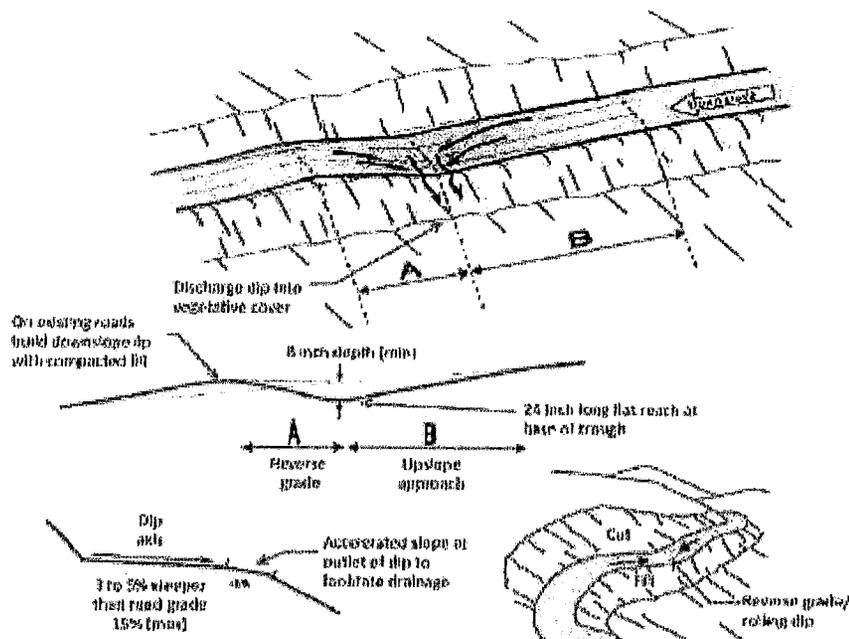
FIGURE 34. A classic Type I rolling dip, where the excavated up-road approach (B) to the rolling dip is several percent steeper than the approaching road and extends for 60 to 80 feet to the dip axis. The lower side of the structure reverses grade (A) over approximately 15 feet or more, and then falls down to rejoin the original road grade. The dip must be deep enough that it is not obliterated by normal grading, but not so deep that it is difficult to negotiate or a hazard to normal traffic. The outward cross-slope of the dip axis should be 3% to 5% greater than the up-road grade (B) so it will drain properly. The dip axis should be out-sloped sufficiently to be self-cleaning, without triggering excessive downcutting or sediment deposition in the dip axis (Modified from: Best, 2013).

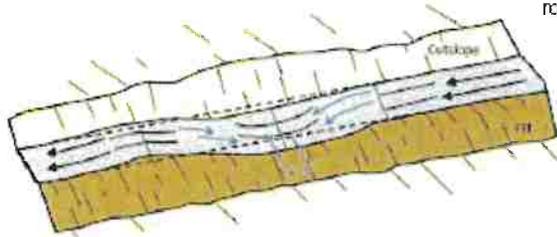
Type 1 Rolling Dip (Standard)

Type 1 rolling dips are used where road grades are less than about 12-14% and road runoff is not confined by a large through cut or berm. The axis of the dip should be perpendicular to the road alignment and sloped at 3-4% across the road tread. Steep roads will have longer and more abrupt dip dimensions to develop reverse grade through the dip axis. The road tread and/or the dip outlet can be rocked to protect against erosion, if needed.

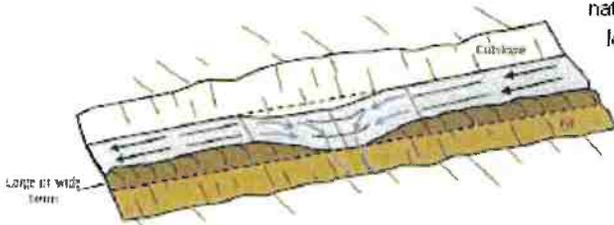
Type 2 Rolling Dip (Through-cut or thick berm road reaches)

Type 2 rolling dips are constructed on roads up to 12-14% grade where there is a through cut up to 3 feet tall, or a wide or tall berm that otherwise blocks road drainage. The berm or native through cut material should be removed for the length of the dip, or at least through the axis of the dip, to the extent needed to provide for uninterrupted drainage onto the adjacent slope. The berm and slope material can be excavated and endhauled, or the material can be sidecast onto native slopes up to 45%, provided it will not enter a stream.

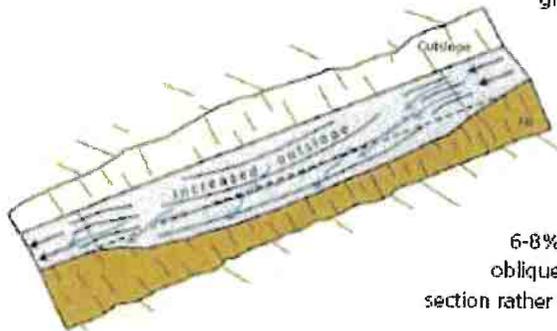
Type 3 Rolling Dip (Steep road grade)

Type 3 rolling dips are utilized where road grades are steeper than about 12% and it is not feasible to develop a reverse grade that will also allow passage of the design vehicle (steep road grades require more abrupt grade reversals that some vehicles may not be able to traverse without bottoming out).

Instead of relying on the dip's grade reversal to turn runoff off the roadbed, the road is built with an exaggerated outslope of 6-8% across the dip axis. Road runoff is deflected obliquely across the dip axis and is shed off the outsloped section rather than continuing down the steep road grade.

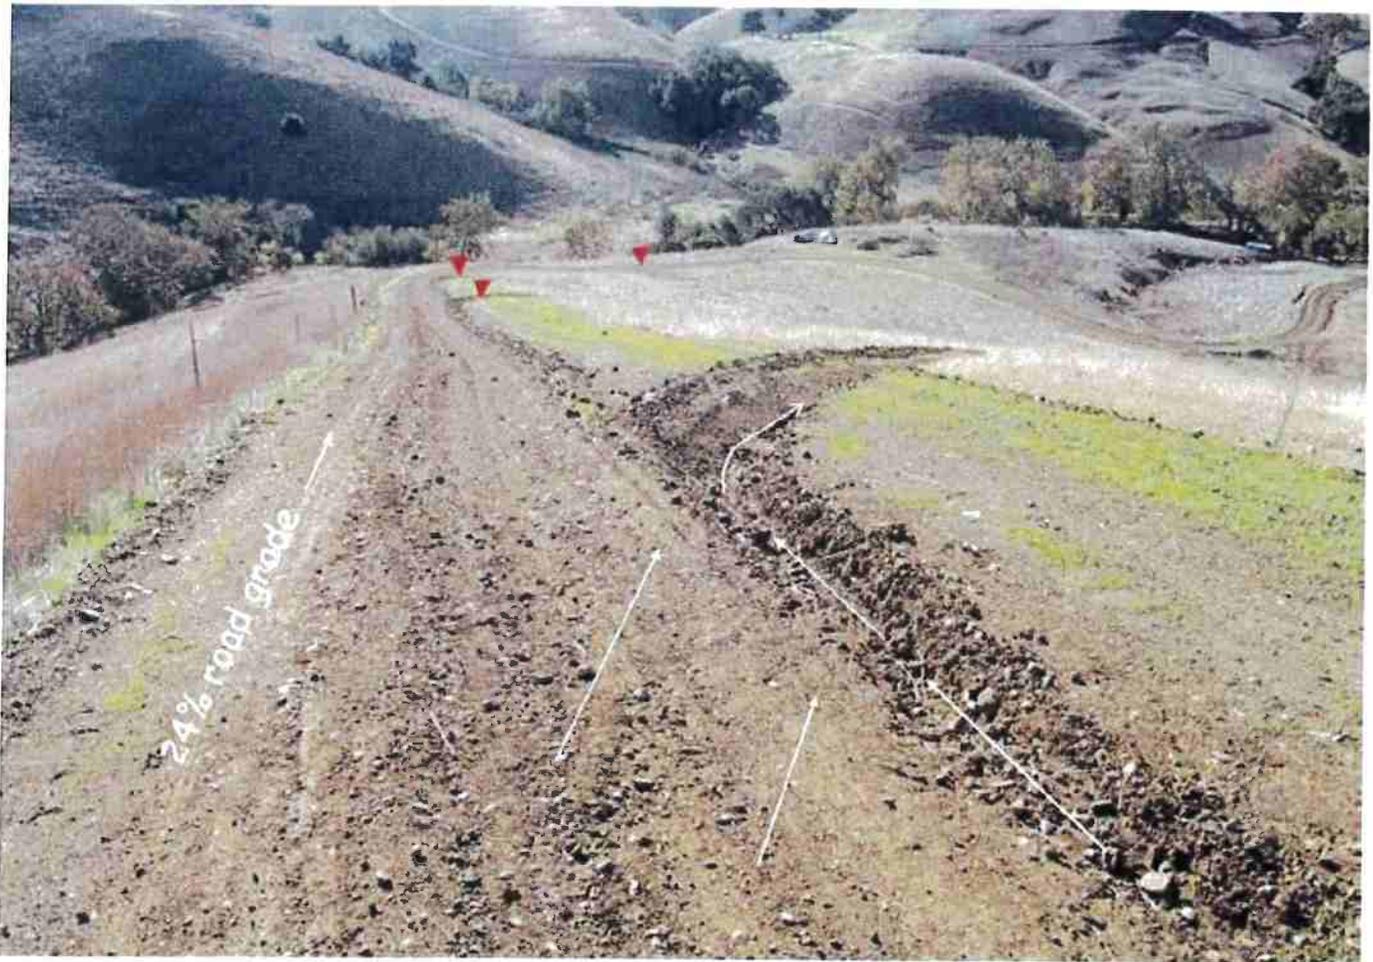
FIGURE 55. Steep roads that go straight up or down a hillside are very difficult to drain. This steep, fall line road developed a through cut cross section that was drained using lead out ditches to direct runoff off the road and onto the adjacent, vegetated hillside. The road was “outsloped” to drain runoff to the right side, and the lead out ditch was built slightly steeper than the road grade, to be self-cleaning. Four lead out ditches have been constructed at 100-foot intervals to the bottom of the hillside.

- Steep road drainage structures are used on permanent roads where water bars would obstruct access and where roads are too steep (<14%).
- Structures consist of an outsloped section of road leading to a “push-out” ditch that carries water away from the road. The outslope of the road may be either continuous or intermittent at the location of an individual push-out.
- To avoid push-outs requiring regular maintenance, a push-out ditch should have a grade that is greater than or equal to the grade of road draining to it to prevent sediment from settling out and filling in the push-out ditch.

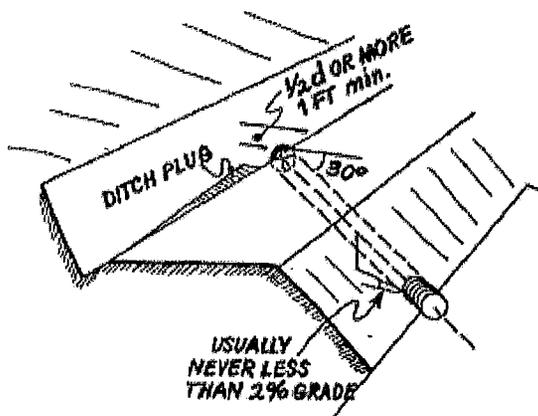
FIGURE 48. The elements of a properly installed ditch relief culvert. The culvert is angled at about 30 degrees to the road alignment to help capture flow and prevent culvert plugging or erosion of the inlet area. It is set at the base of the fill (ideally) or with a grade slightly steeper than the grade of the contributing ditch (but never with a grade less than 2 percent) (USDA-SCS, 1983). At a minimum, the grade of the ditch relief culvert should be sufficient to prevent sediment accumulation at the inlet or deposition within the culvert itself (it should be self-cleaning) (USDA-SCS, 1983).

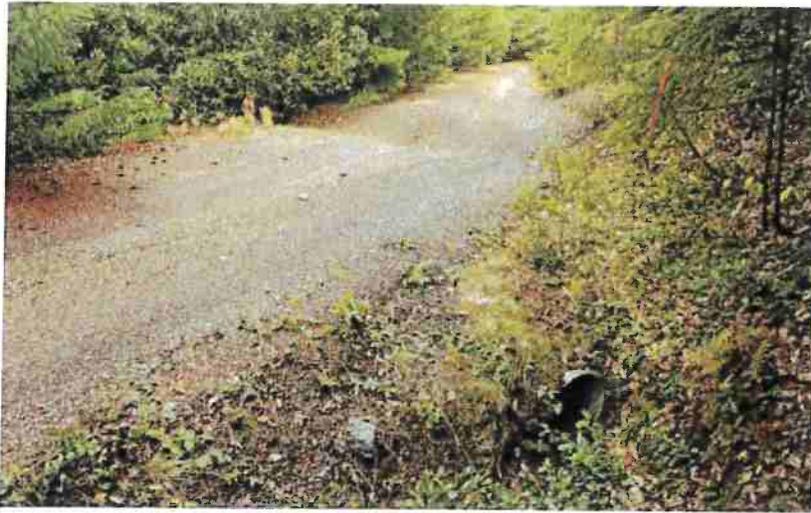
FIGURE 39.

Waterbars are often used to drain surface runoff from seasonal, unsurfaced roads. Because they are easily broken down by vehicles, waterbars are only used on unsurfaced roads where there is little or no wet weather traffic. In this photo, a waterbar and ditch relief culvert are used to drain all road surface and ditch runoff from the insloped road prism.

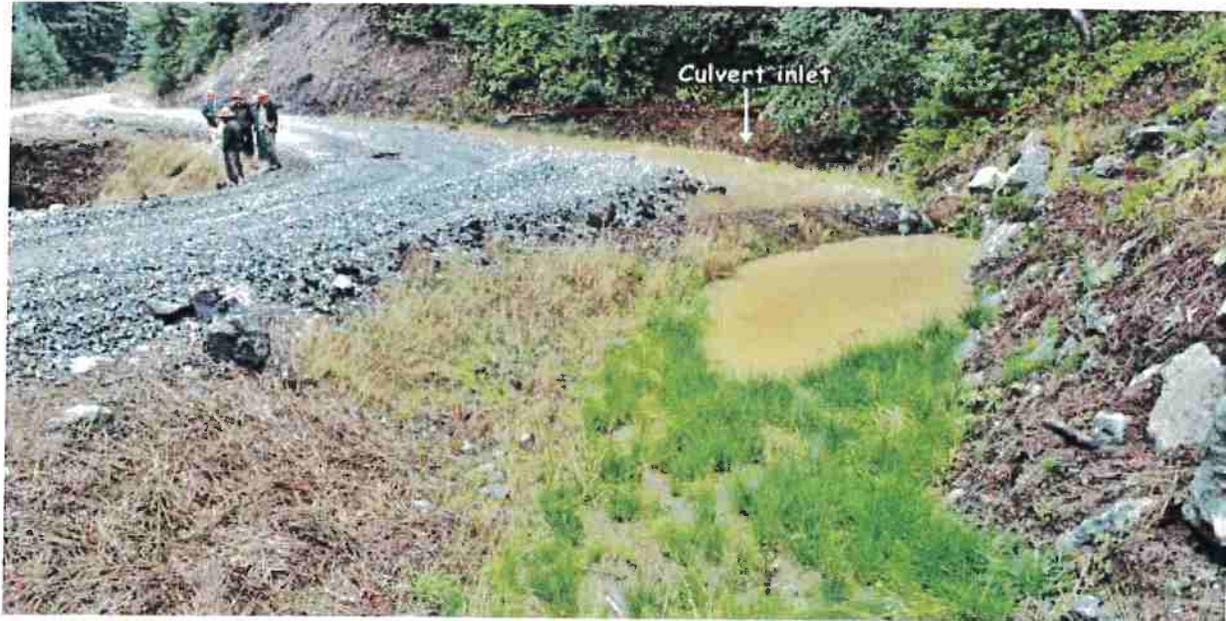
FIGURE 238. Traffic and surface runoff from graveled roads often produces surface erosion, turbid runoff and fine sediment transport that can be delivered to streams. Where ditches can't be eliminated, sediment traps and roadside settling basins can be installed to capture and remove most of the eroded sediment. This settling basin has been constructed along the inside ditch just before a stream crossing culvert inlet (see arrow). Eroded sediment from the road and ditch are deposited in the basin before flow is released to the stream. Fine sediments have filled about 1/3 of this basin and vegetation is now growing. Sediment basins require periodic maintenance to maintain their storage capacity.

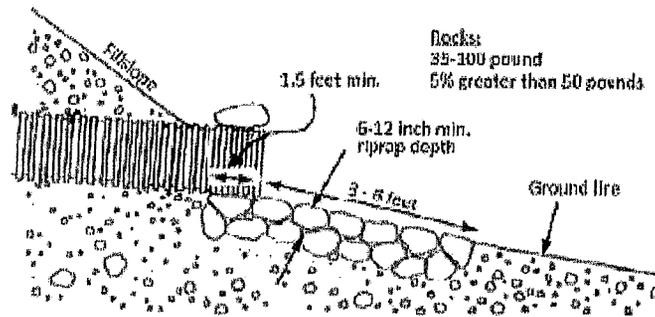
FIGURE 107A. Riprap armor at culvert outlet (Modified from: Keller et al., 2011).

- Inlets may require construction of an inlet basin.
- Slopes at the outlet should be shaped to a 2:1 or natural slope prior to placing rock armor.
- Rock used at culvert inlets and outlets should be a matrix of various sized rocks and rip-rap that range from a 3" dia. to a 2' dia.

- The largest rocks should be places at the base of the culvert or fill. Incrementally smaller rocks shall be placed over the larger rocks at the armoring extend up the slope. Voids and spaces shall be back filled with smaller gravels and rocks.

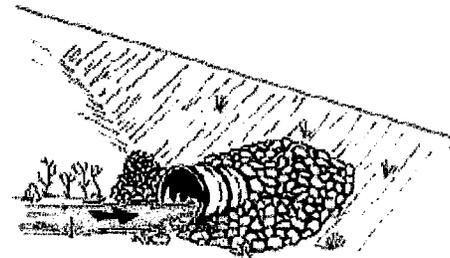
FIGURE 107B. Riprap armor at culvert inlet (Keller and Sherar, 2003).
