# **ENGINEERING GEOLOGIC SOILS REPORT**

**GEOLOGIC HAZARDS AND DEVELOPMENT CLASS R2**

Aurel Coza  
APN: 110-251-037 & 110-251-038  
Block 199, Lots 31 & 32  
Shelter Cove, CA  
Humboldt County

Job# 23-6059

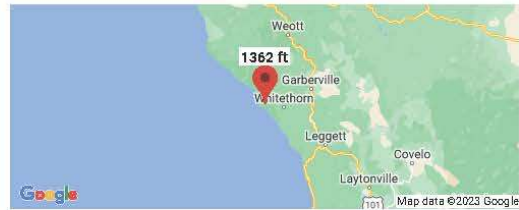
## Seismic Design Parameters

**Coordinates:** 40.028, -124.0457  
**Elevation:** 1362 ft  
**Timestamp:** 2023-11-20T23:03:12.082Z  
**Hazard Type:** Seismic  
**Reference Document:** ASCE7-10  
**Risk Category:** II  
**Site Class:** D
