Water Resource Protection Plan

WDID# - 1B171705CHUM

Timberland Resource Consultants

WRPP - Mitigation Report

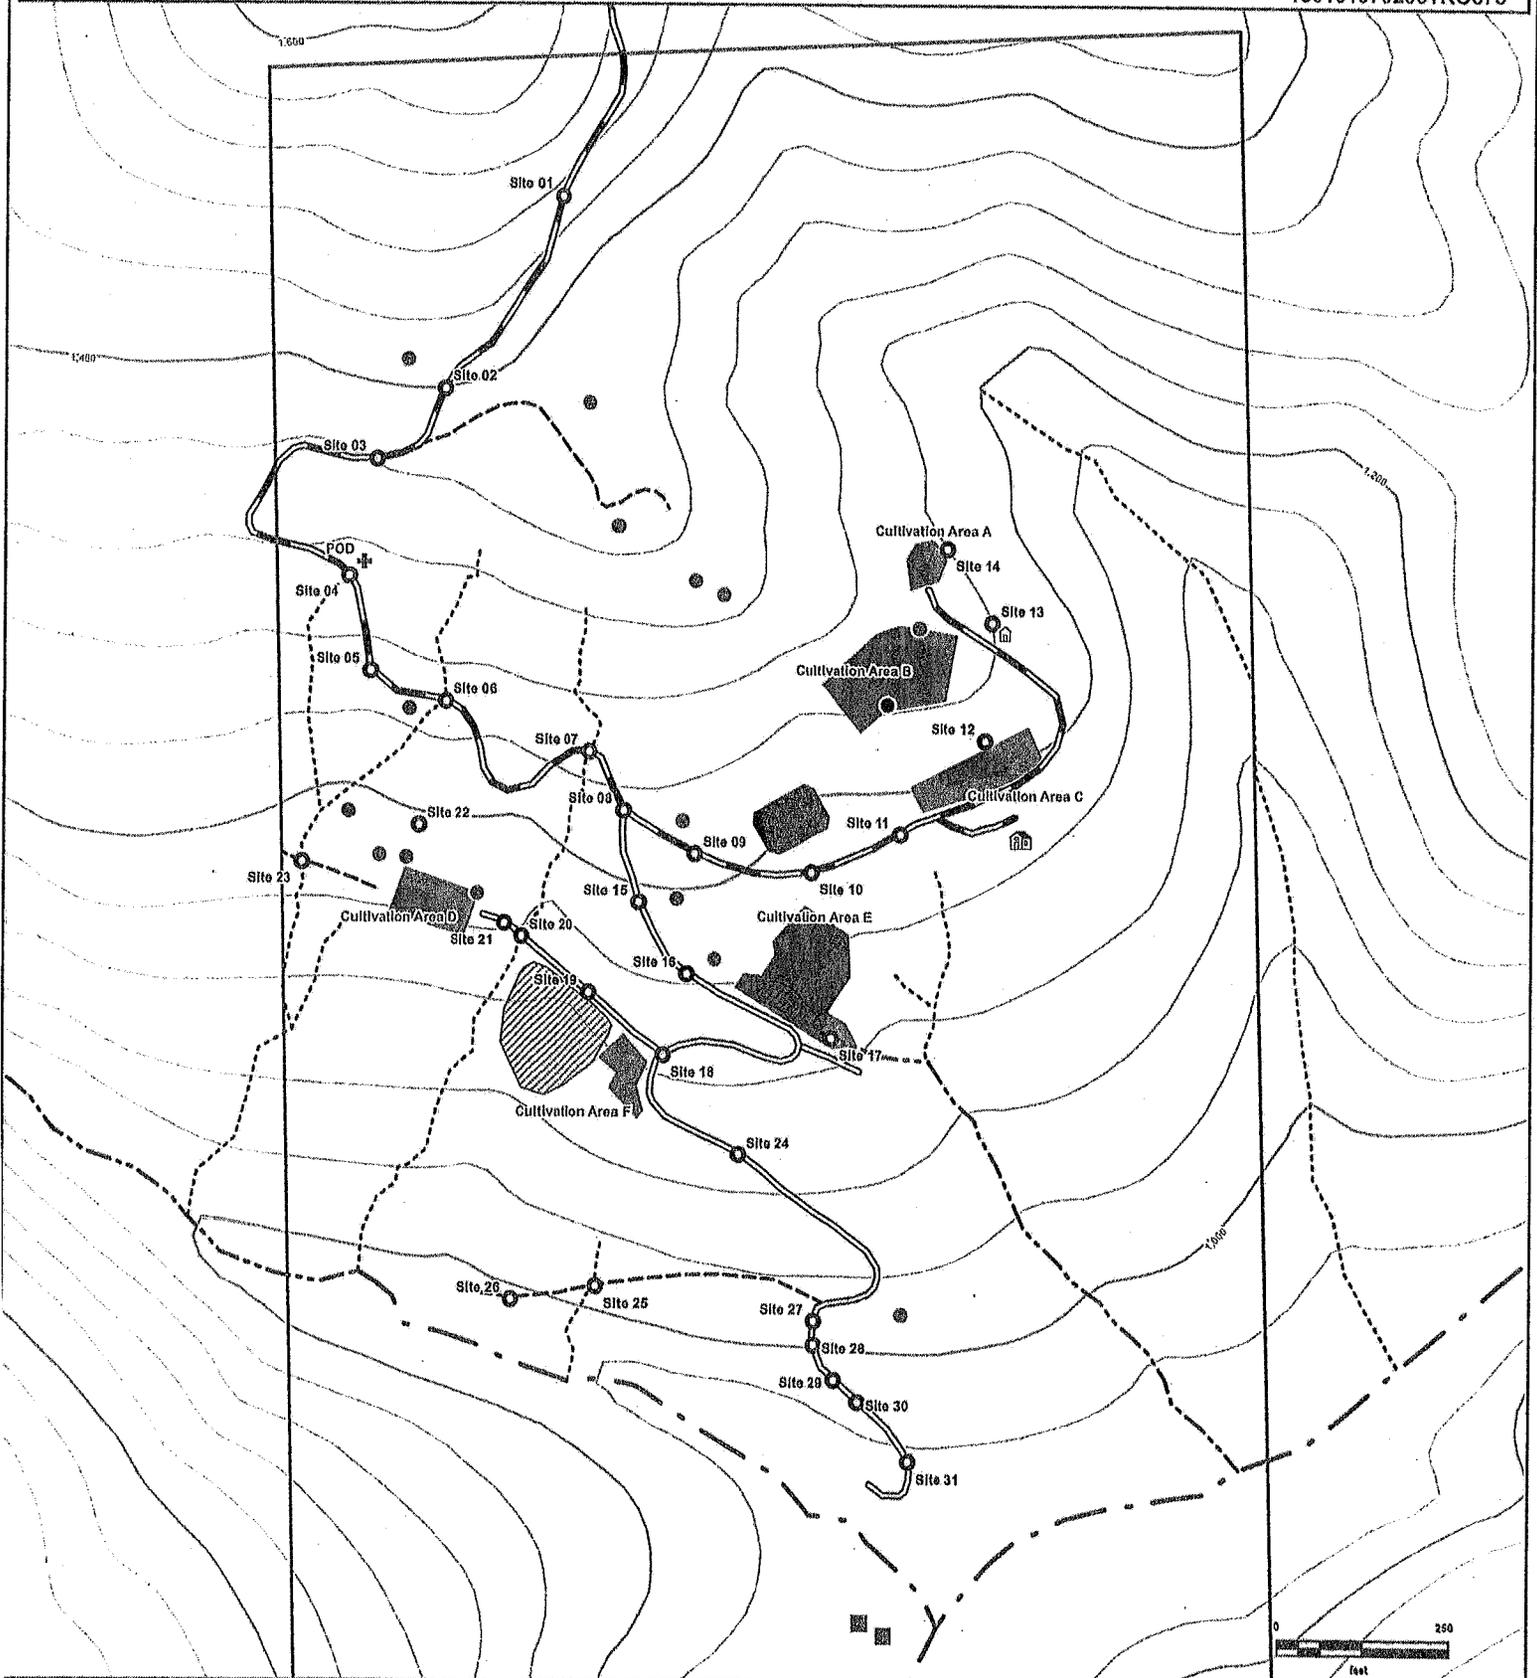
Site Map [WDID# - 1B171705CHUM]

Monitoring of the site includes visual inspection and photographic documentation of each feature of interest listed on the site map, with new photographic documentation recorded with any notable changes to the feature of interest. At a minimum, all site features must be monitored annually, to provide the basis for completion of the annual re-certification process. Additionally, sites shall be monitored at the following times to ensure timely identification of changed site conditions and to determine whether implementation of additional management measures are necessary to prevent, minimize, and mitigate discharges of waste to surface water: 1) just prior to October 15 to evaluate site preparedness for storm events and storm water runoff, 2) following the accumulation of 3" total precipitation or by November 15, whichever is sooner, and 3) following any rainfall event with an intensity of 3" precipitation in 24 hours. Precipitation data can be obtained from the National Weather Service Forecast Office (e.g. by entering the zip code of the parcel location at <http://www.srh.noaa.gov/forecast>). Sites requiring monitoring are indicated as such within the WRPP Mitigation report in the follow pages.

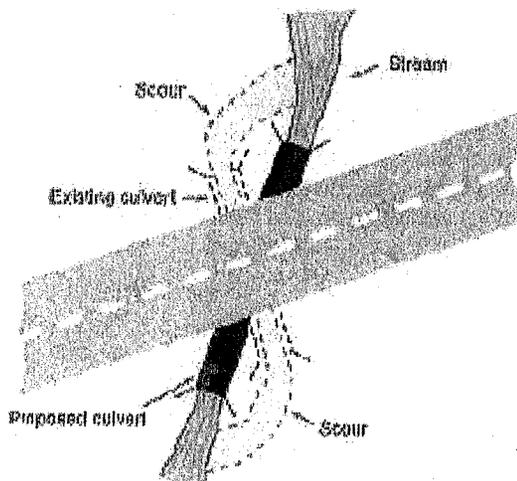
FIGURE 97. Culvert alignment should be in relation to the stream and not the road. It is important that the stream enters and leaves the culvert in a relatively straight horizontal alignment so streamflow does not have to turn to enter the inlet or discharge into a bank as it exits. This figure shows a redesigned culvert installation that replaces the bending alignment that previously existed. Channel turns at the inlet increase plugging potential because wood going through the turn will not align with the inlet. Similarly, channel turns at the inlet and outlet are often accompanied by scour against the channel banks (Wisconsin Transportation Information Center, 2004).

- Align culverts with the natural stream channel orientation to ensure proper function, prevent bank erosion and minimize debris plugging. See Figure 97 below.

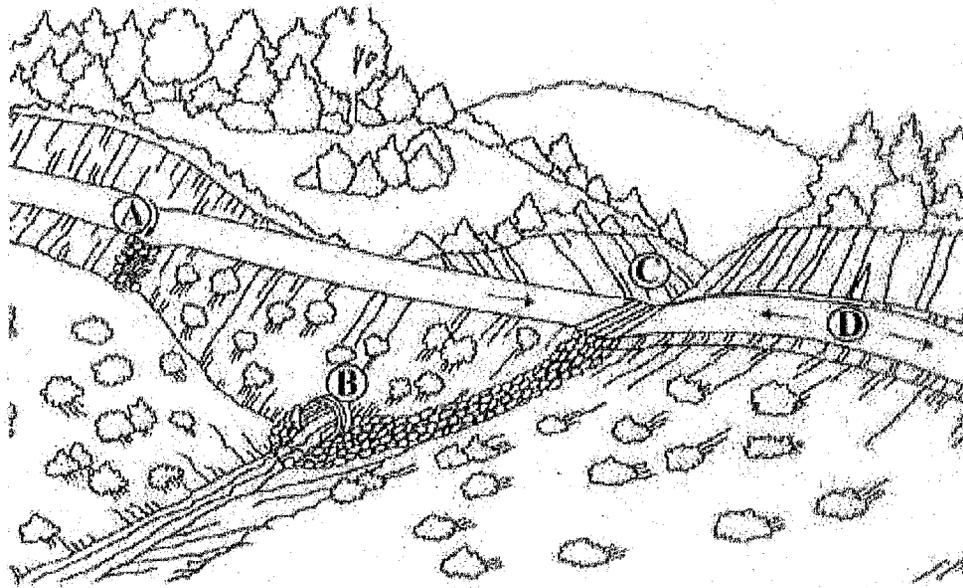
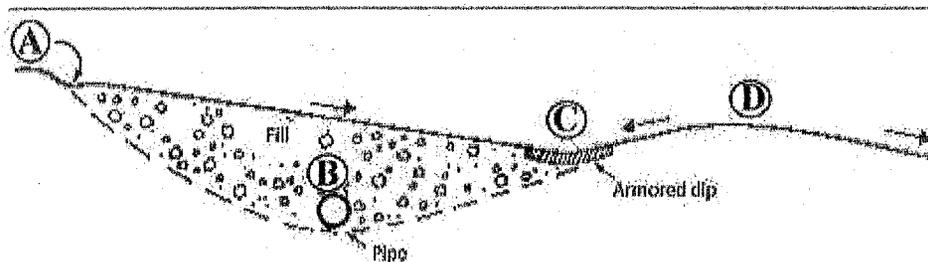
FIGURE 84. Critical dips or dipped crossing fills should be centered near a stream crossing's down-road hinge line, not over the centerline of the crossing where overtopping could cause washout or severe erosion of the fill. If the stream crossing culvert (B) plugs, water will pond behind the fill until reaching the critical dip or low point in the crossing (C) and flowing back down into the natural stream channel. The down-road ditch must be plugged to prevent streamflow from diverting down the ditch line. For extra protection in this sketch, riprap armor has been placed at the critical dip outfall and extending downslope to the stream channel. This is only required or suggested on stream crossings where the culvert is highly likely to plug and the crossing fill overtopped. The dip at the hinge line is usually sufficient to limit erosional damage during an overtopping event. Road surface and ditch runoff is disconnected from the stream crossing by installing a rolling dip and ditch relief culvert just up-road from the crossing (A) (Keller and Sherar, 2003).

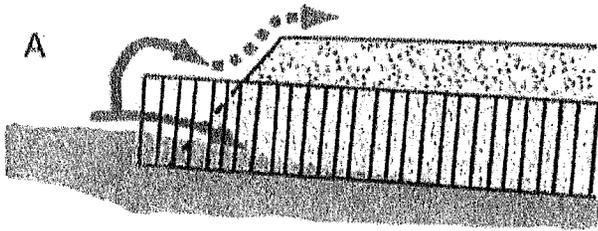
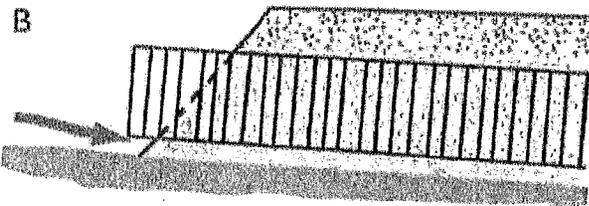
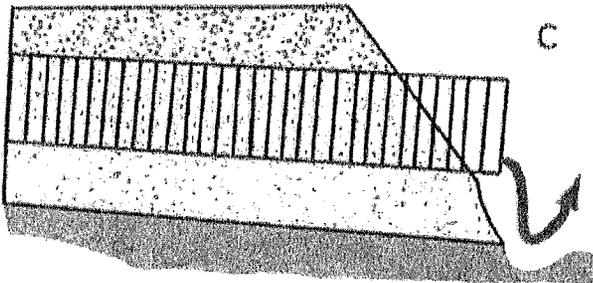
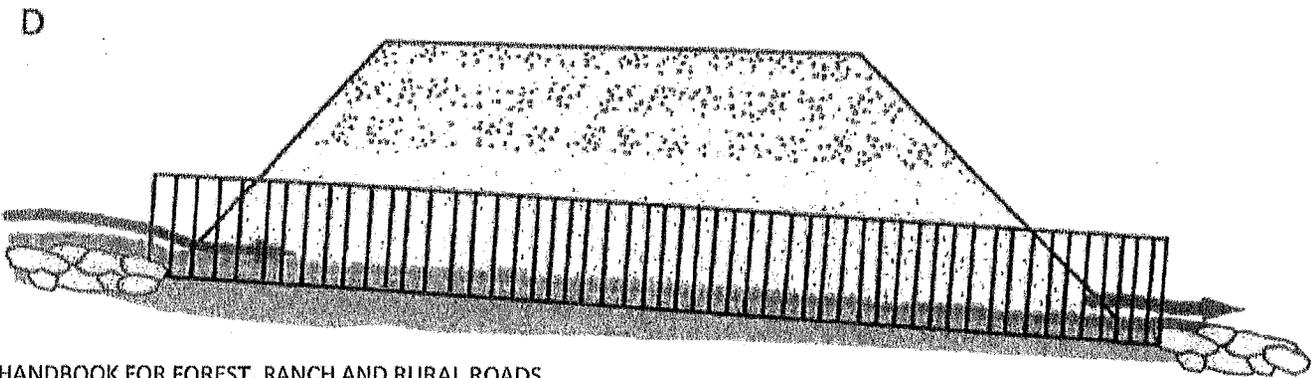
FIGURE 155. Proper culvert installation involves correct culvert orientation, setting the pipe slightly below the bed of the original stream, and backfilling and compacting the fill as it is placed over the culvert. Installing the inlet too low in the stream (A) can lead to culvert plugging, yet if set too high (B) flow can undercut the inlet. If the culvert is placed too high in the fill (C), flow at the outfall will erode the fill. Placed correctly (D), the culvert is set slightly below the original stream grade and protected with armor at the inlet and outlet. Culverts installed in fish-bearing stream channels must be inset into the streambed sufficiently (>25% embedded) to have a natural gravel bottom throughout the culvert (Modified from: MDSL, 1991).

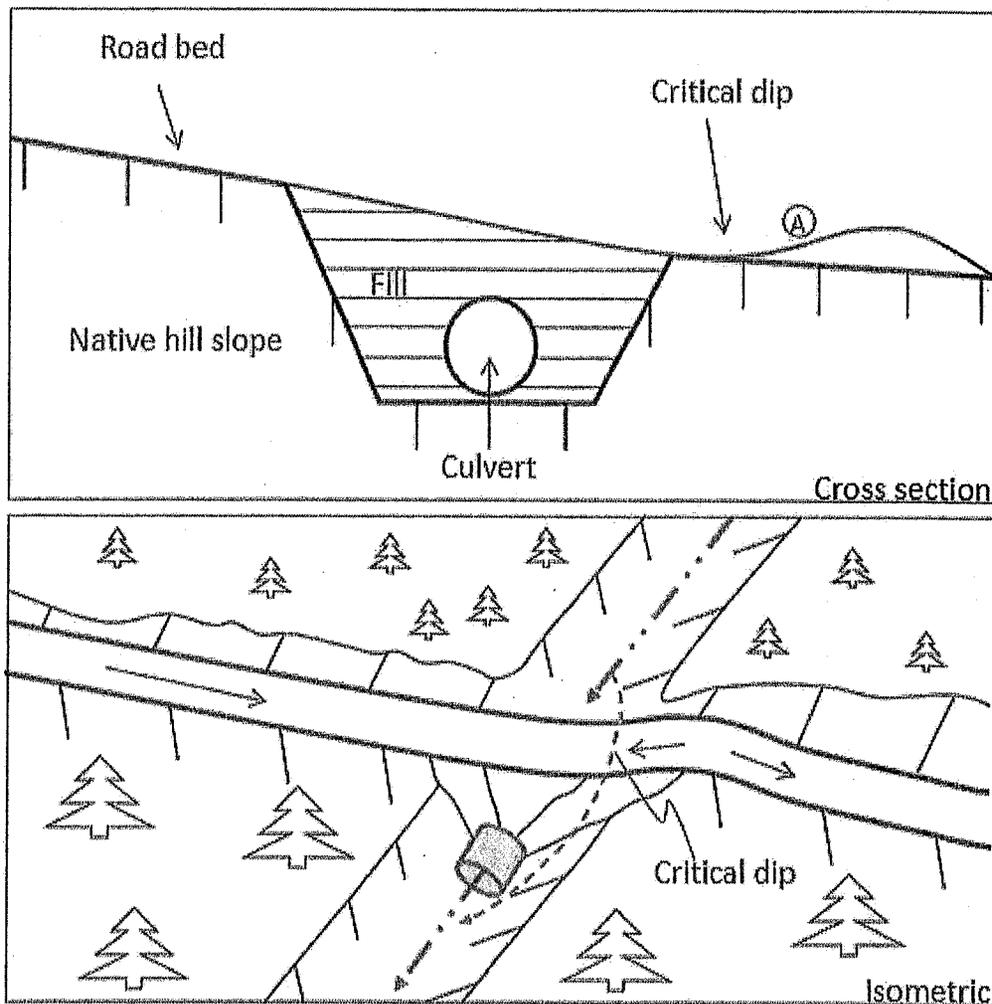
Typical Critical Dip Design for Stream Crossings with Diversion Potential

Critical Dip Construction:

1. Critical dip will be constructed on the lower side of crossing.
2. Critical dip will extend from the cutbank to the outside edge of the road surface. Be sure to fill inboard ditch, if present.
3. Critical dip will have a reverse grade (A) from cutbank to outside edge of road to ensure flow will not divert outside of crossing.
4. The rise in the reverse grade will be carried for about 10 to 20 feet and then return to original slope.
5. The transition from axis of bottom, through rising grade, to falling grade, will be in the road distance of at least 15 to 30 feet.
6. Critical dips are usually built perpendicular to the road surface to ensure that flow is directed back into the stream channel.

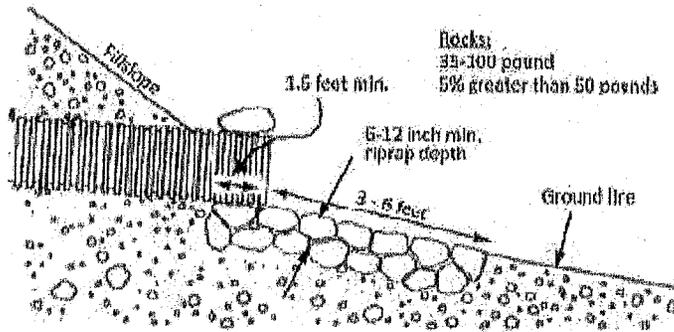
FIGURE 107A. Riprap armor at culvert outlet (Modified from: Keller et al., 2011).

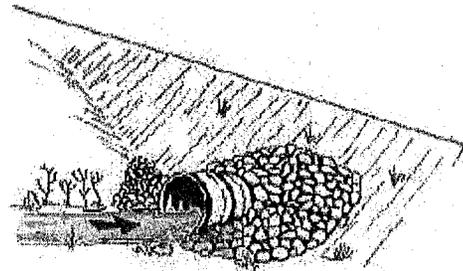
FIGURE 107B. Riprap armor at culvert inlet (Keller and Shera, 2003).

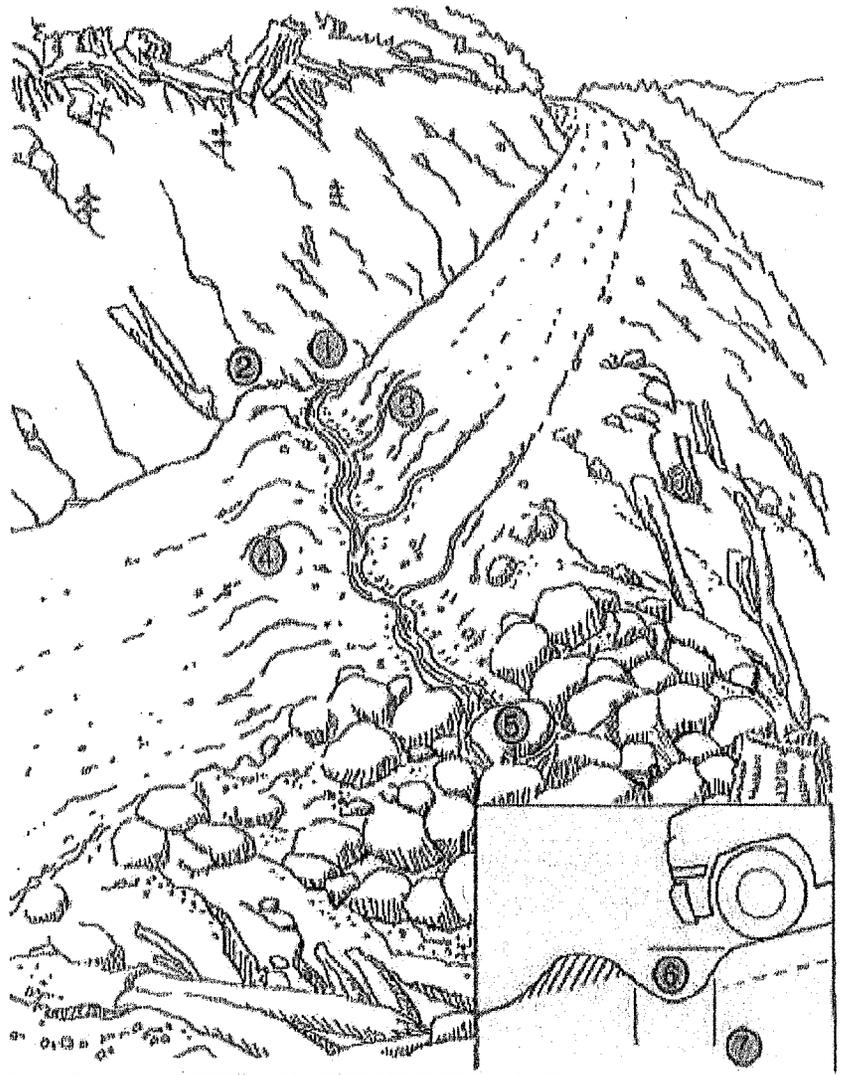
FIGURE 40. Waterbars are constructed on unsurfaced forest and ranch roads that will have little or no traffic during the wet season. The waterbar should be extended to the cutbank to intercept all ditch flow (1) and extend beyond the shoulder of the road. A berm (2) must block and prevent ditch flow from continuing down the road during flood flows. The excavated waterbar (3) should be constructed to be self-cleaning, typically with a 30° skew to the road alignment with the excavated material bermed on the downhill grade of the road (4). Water should always be discharged onto the downhill side on a stable slope protected by vegetation. Rock (shown in the figure) should not be necessary if waterbars are spaced close enough to prevent serious erosion. (5) The cross ditch depth (6) and width (7) must allow vehicle cross-over without destroying the function of the drain. Several alternate types of waterbars are possible, including one that drains only the road surface (not the ditch), and one that drains the road surface into the inside ditch (BCMF, 1991).

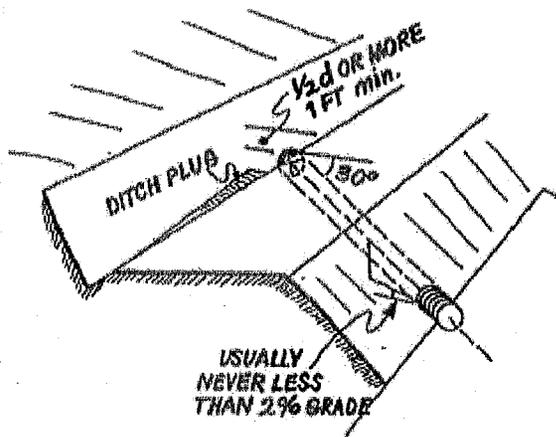
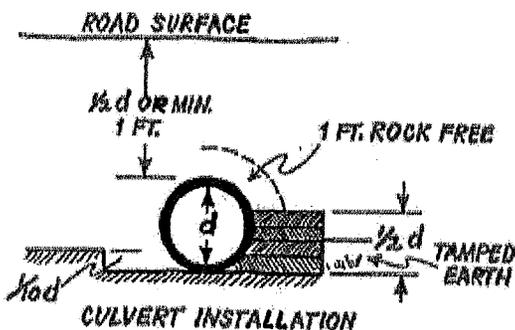
FIGURE 48. The elements of a properly installed ditch relief culvert. The culvert is angled at about 30 degrees to the road alignment to help capture flow and prevent culvert plugging or erosion of the inlet area. It is set at the base of the fill (ideally) or with a grade slightly steeper than the grade of the contributing ditch (but never with a grade less than 2 percent) (USDA-SCS, 1983). At a minimum, the grade of the ditch relief culvert should be sufficient to prevent sediment accumulation at the inlet or deposition within the culvert itself (it should be self-cleaning) (USDA-SCS, 1983).

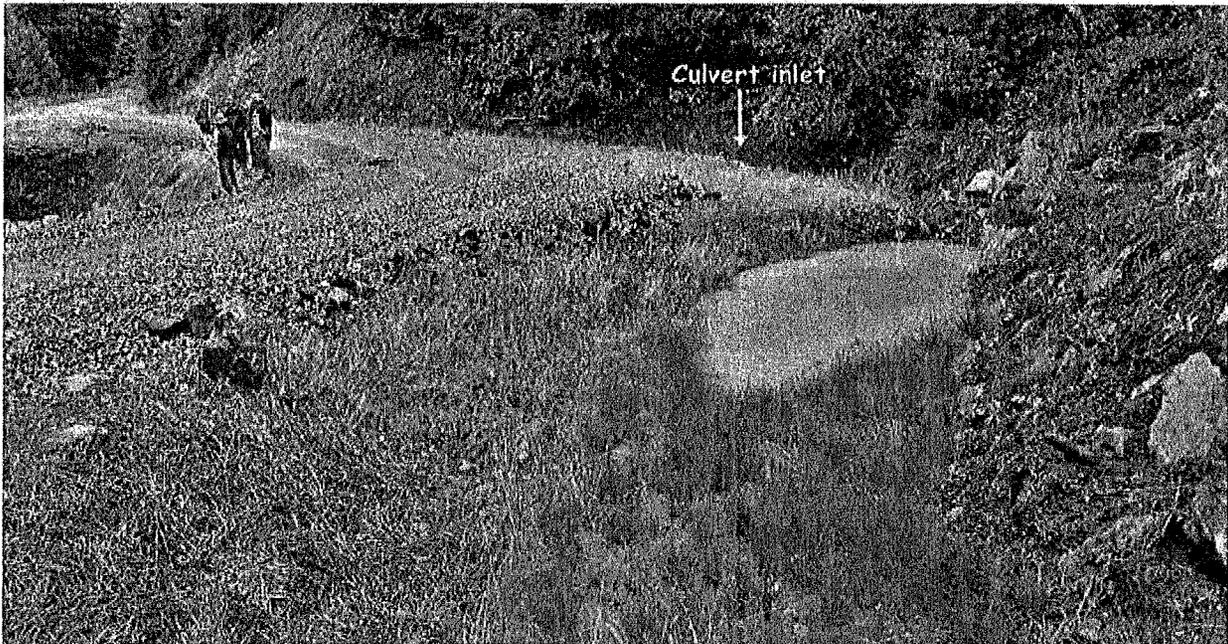
FIGURE 238. *Traffic and surface runoff from graveled roads often produces surface erosion, turbid runoff and fine sediment transport that can be delivered to streams. Where ditches can't be eliminated, sediment traps and roadside settling basins can be installed to capture and remove most of the eroded sediment. This settling basin has been constructed along the inside ditch just before a stream crossing culvert inlet (see arrow). Eroded sediment from the road and ditch are deposited in the basin before flow is released to the stream. Fine sediments have filled about 1/3 of this basin and vegetation is now growing. Sediment basins require periodic maintenance to maintain their storage capacity.*

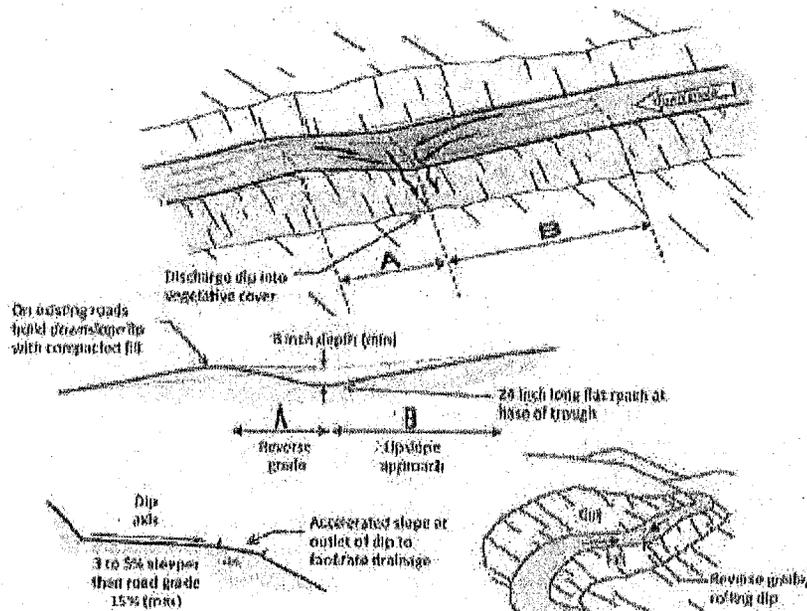
FIGURE 34. A class: Type I rolling dip, where the excavated up-road approach (B) to the rolling dip is several percent steeper than the approaching road and extends for 80 to 80 feet to the dip axis. The lower side of the structure reverses grade (A) over approximately 15 feet or more, and then falls down to rejoin the original road grade. The dip must be deep enough that it is not obliterated by normal grading, but not so deep that it is difficult to negotiate or a hazard to normal traffic. The outward cross-slope of the dip axis should be 3% to 5% greater than the up-road grade (B) so it will drain properly. The dip axis should be out-sloped sufficiently to be self-cleaning, without triggering excessive downcutting or sediment deposition in the dip axis (Modified from: Best, 2013).

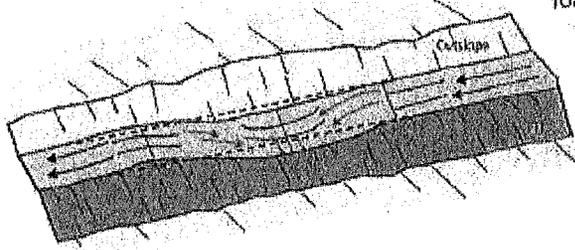
Type 1 Rolling Dip (Standard)

Type 1 rolling dips are used where road grades are less than about 12-14% and road runoff is not confined by a large through cut or berm. The axis of the dip should be perpendicular to the road alignment and sloped at 3-4% across the road tread. Steep roads will have longer and more abrupt dip dimensions to develop reverse grade through the dip axis. The road tread and/or the dip outlet can be rocked to protect against erosion, if needed.

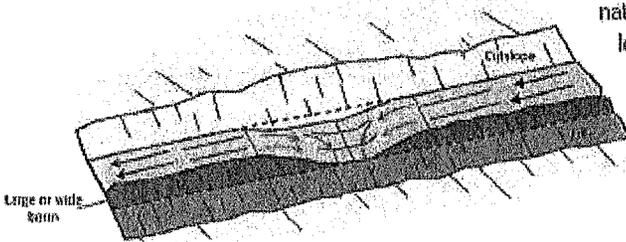
Type 2 Rolling Dip (Through-cut or thick berm road reaches)

Type 2 rolling dips are constructed on roads up to 12-14% grade where there is a through cut up to 3 feet tall, or a wide or tall berm that otherwise blocks road drainage. The berm or native through cut material should be removed for the length of the dip, or at least through the axis of the dip, to the extent needed to provide for uninterrupted drainage onto the adjacent slope. The berm and slope material can be excavated and endhailed, or the material can be sidecast onto native slopes up to 45%, provided it will not enter a stream.

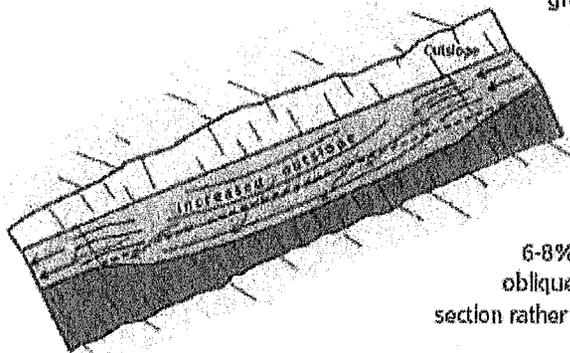
Type 3 Rolling Dip (Steep road grade)

Type 3 rolling dips are utilized where road grades are steeper than about 12% and it is not feasible to develop a reverse grade that will also allow passage of the design vehicle (steep road grades require more abrupt grade reversals that some vehicles may not be able to traverse without bottoming out).

Instead of relying on the dip's grade reversal to turn runoff off the roadbed, the road is built with an exaggerated outslope of 6-8% across the dip axis. Road runoff is deflected obliquely across the dip axis and is shed off the outsloped section rather than continuing down the steep road grade.

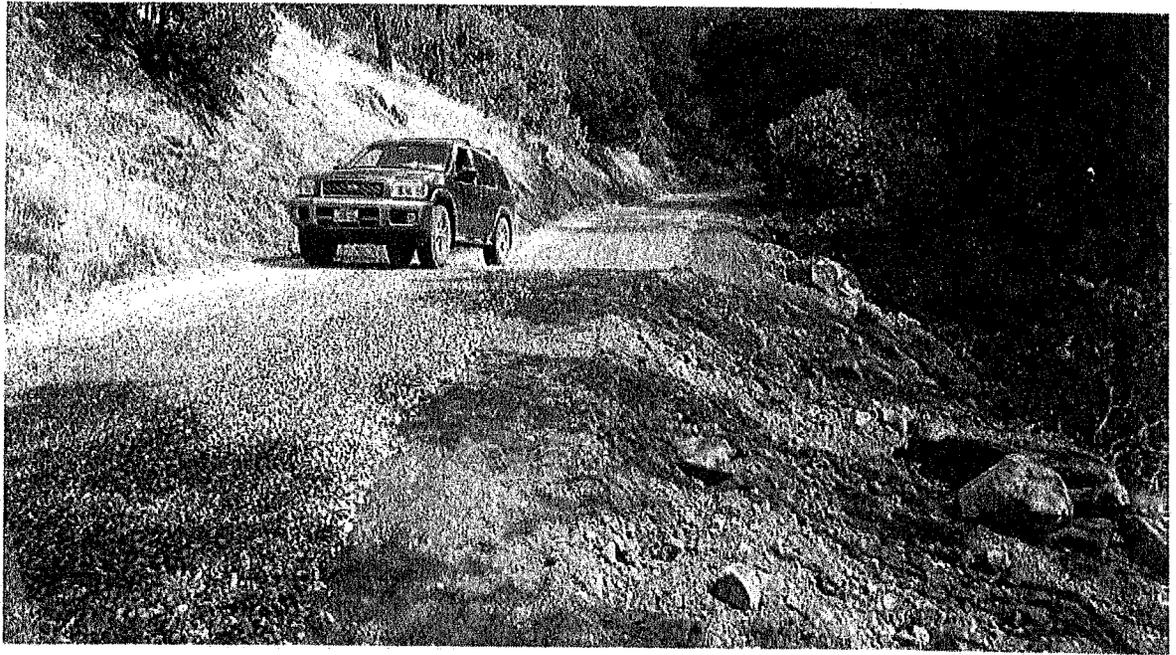
FIGURE 33A.

Rolling dip constructed on a rock surfaced rural road. The rolling dip represents a change-in-grade along the road alignment and acts to discharge water that has collected on, or is flowing down, the road surface. This road was recently converted from a high maintenance, insloped, ditched road to a low maintenance, outsloped road with rolling dips.

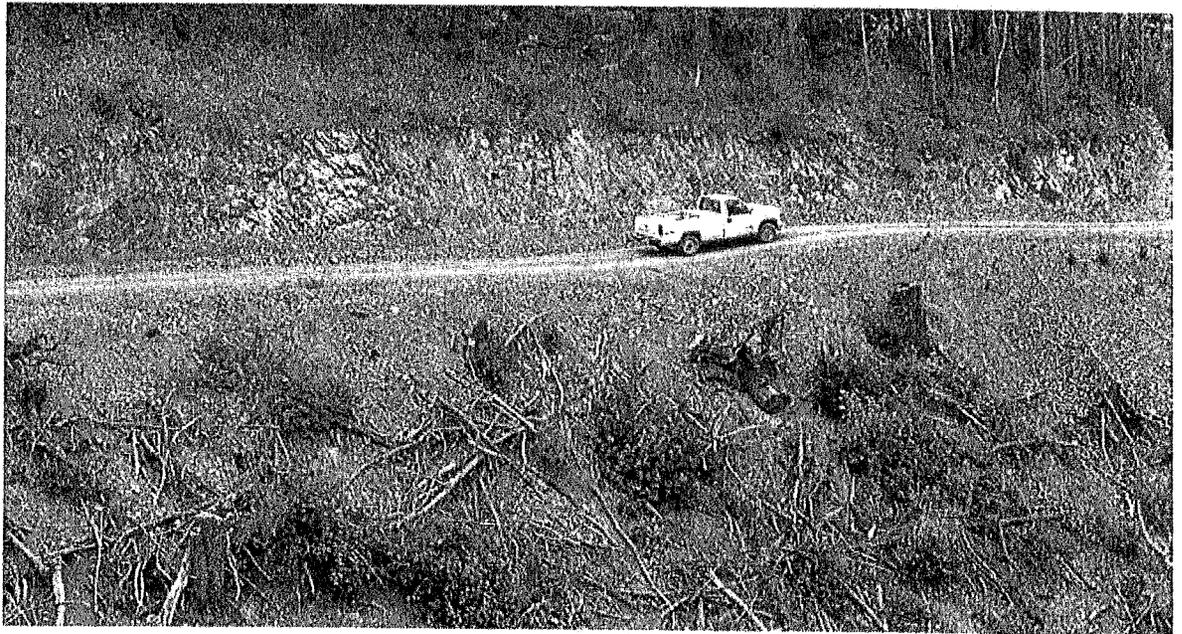
FIGURE 33B.

This side view of an outsloped road shows that the rolling dip does not have to be deep or abrupt to reverse road grade and effectively drain the road surface. This outsloped forest road has rolling dips that allow all traffic types to travel the route without changing speed.

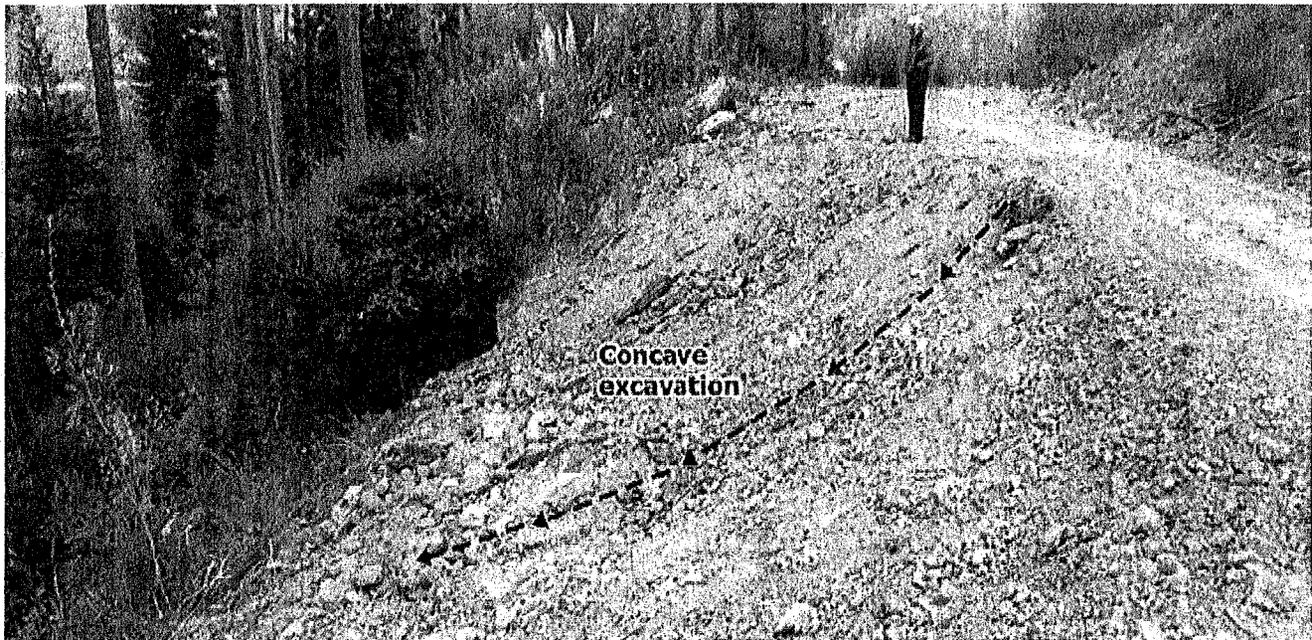
FIGURE 230. *The most cost-effective treatment for unstable fills along the outside of a forest, ranch or rural road is simply the direct excavation of the unstable material. If road width is too narrow, additional width can often be derived from cutting into the bank. The excavation should encompass the unstable fill materials, beginning at the inside crack or scarp, and extending out and down the fill slope as far as possible. For proper surface drainage, and to retrieve most of the unstable fill, the excavation should have a concave profile when completed. Typically, the bulk of the fill is within 20 to 25 feet of the outside edge of the road and is easily reached by a mid-sized excavator. Any remaining fill is likely to be small enough that it will not fail or travel far enough to reach the stream.*

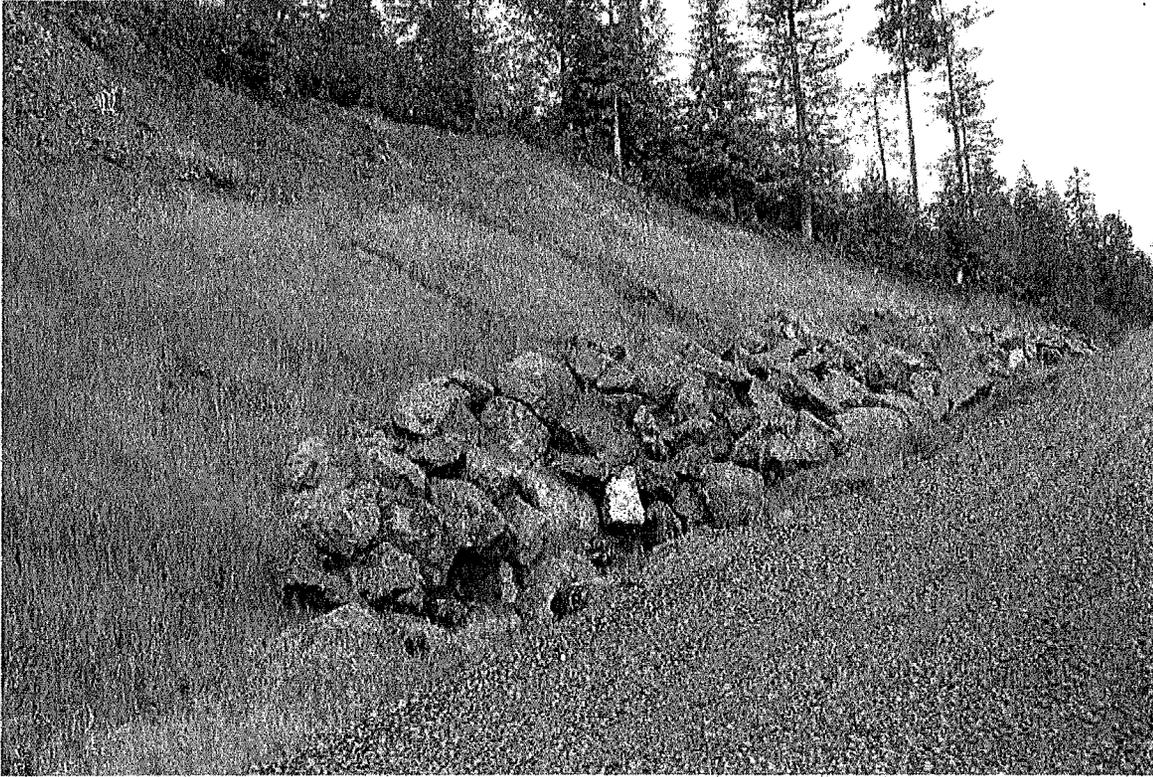
FIGURE 52. *This wet and potentially unstable cut slope on a newly constructed road was stabilized using a buttress of large rock armor. To assure their effectiveness, rock buttresses and other retaining structures should be designed by a qualified engineer or engineering geologist.*
