WETLAND DELINEATION REPORT

3611 LITTLE LARABEE CREEK RD BRIDGEVILLE, CA 95526 Parcel Number: 208-113-008-000

Prepared for Humboldt County Planning Department

Jon Backus West Coast Wild Ecological Restoration LLC 5370 Volkerts Rd Sebastopol, CA 95472 JULY 2024

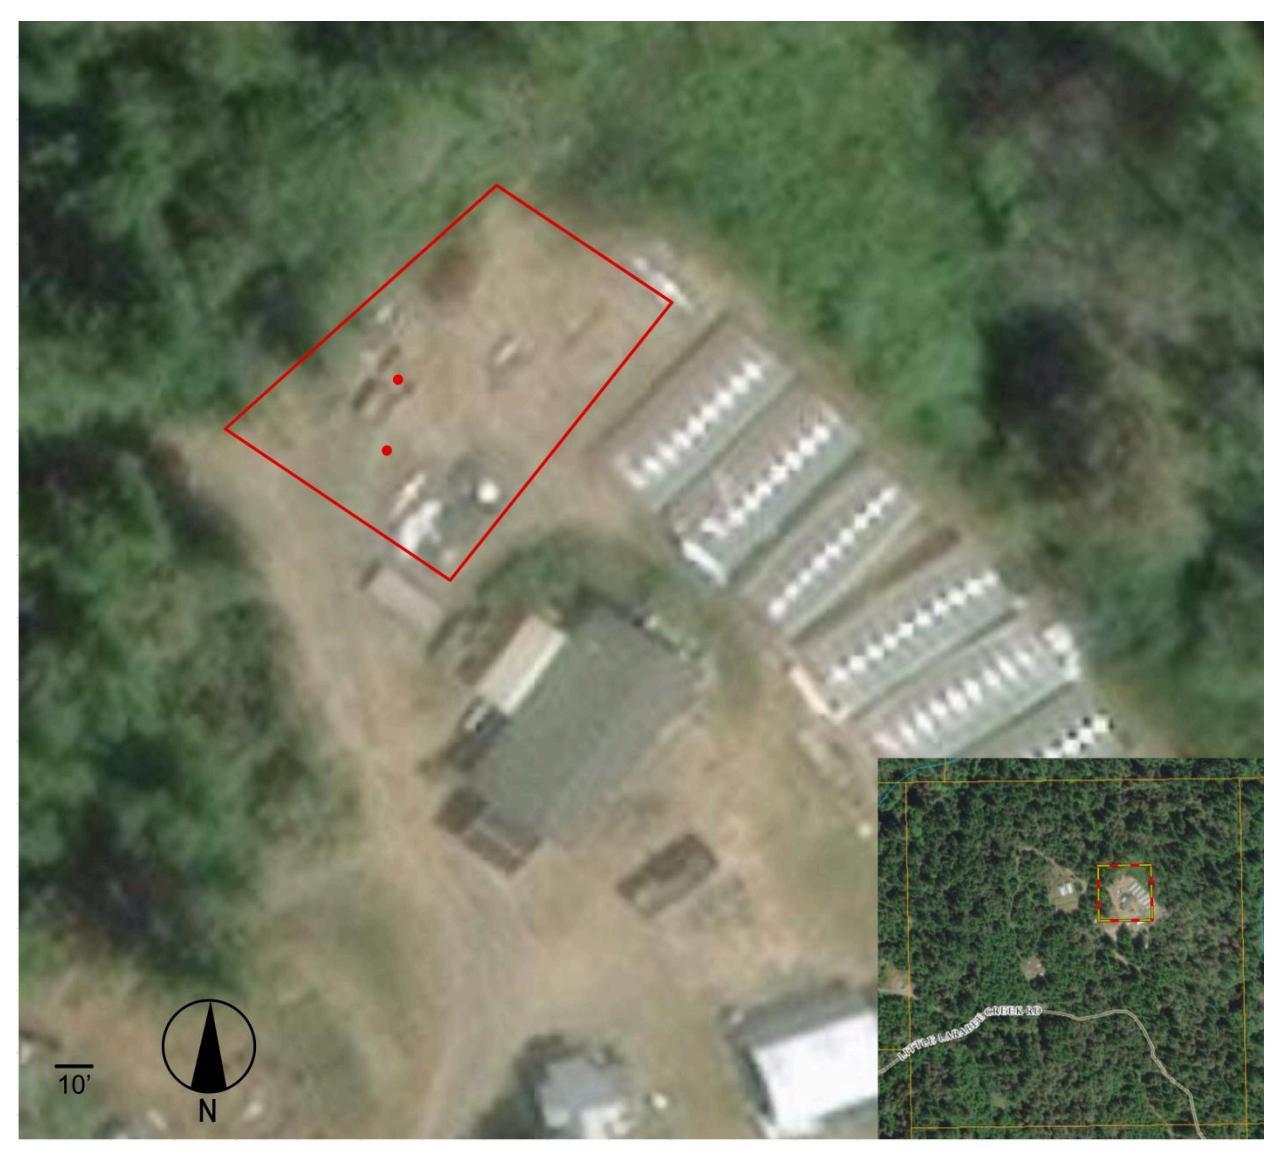
Figure 2: Project area location and sampling points. Sampling locations were selected based on presence of wetland indicator species. Base map from Humboldt County Web GIS. Accessed July 10, 2024.

Soil samples were taken from two locations within the project area adjacent to wetland indicator species (Figure 2). Soil samples from both pits showed very little O horizon (<1 inch of organic matter) followed by consistent clay loam. Neither sample pit yielded evidence of hydric soils. The soil color (10YR 6/3) was fairly consistent within the top 18 inches at both sites and showed no signs of gleying. The soils match the characteristics described by the soil websurvey (UC Davis, 2019) and indicate standing water does not persist long enough to create anaerobic conditions in the soil.

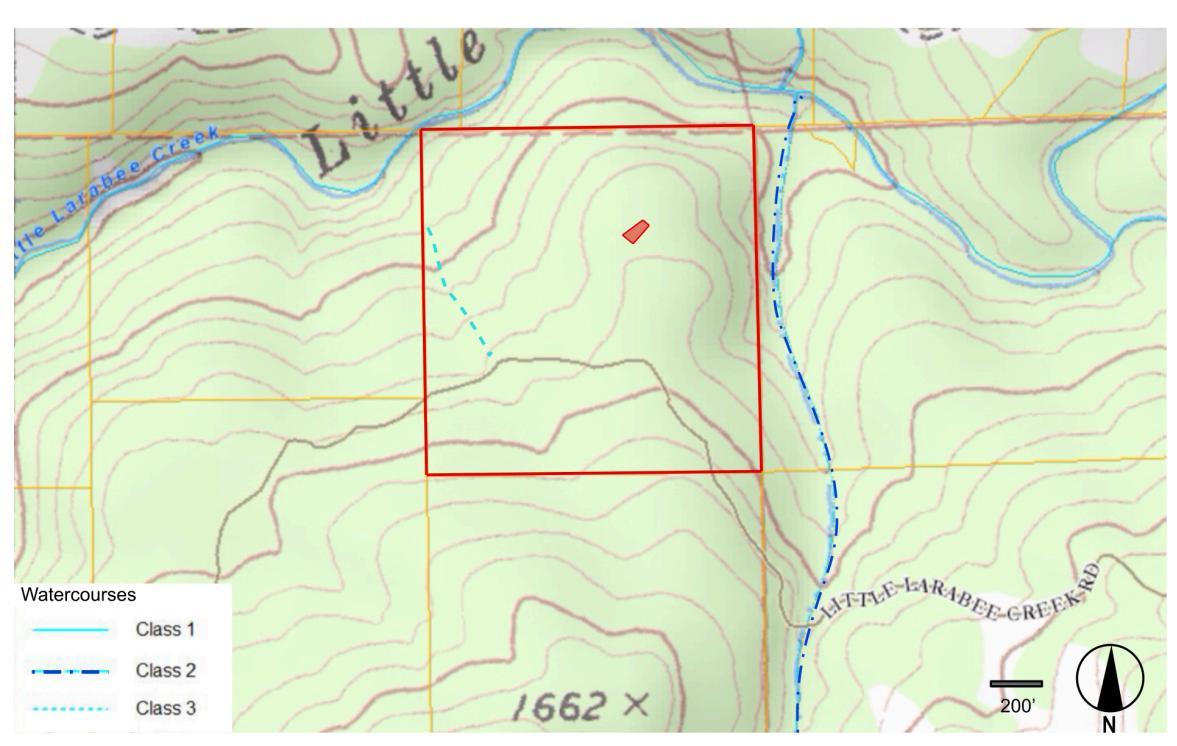
Figure 3: Topographic parcel map with approximate locations of hydrologic features including Little Larabee creek (Class I watercourse) north of the property line, a Class II waterway east of the parcel boundary and a Class III waterway located on the south western portion of the parcel. The project area for the delineation is marked by the red polygon in the north eastern portion of the parcel. Base map from Humboldt County Web GIS accessed July 10, 2024.

The parcel is located in the North Coast Mountain Range with slopes of 15-50% (Figure 3). Little Larabee Creek, a Class I watercourse, runs west along the northern property line. An unnamed Class III watercourse runs towards the northwest property corner. An unnamed Class II watercourse runs north in the adjacent parcel to the east. The property has been graded and terraced for development. Through this development water runs downhill and down the access road and collects on created terraces.

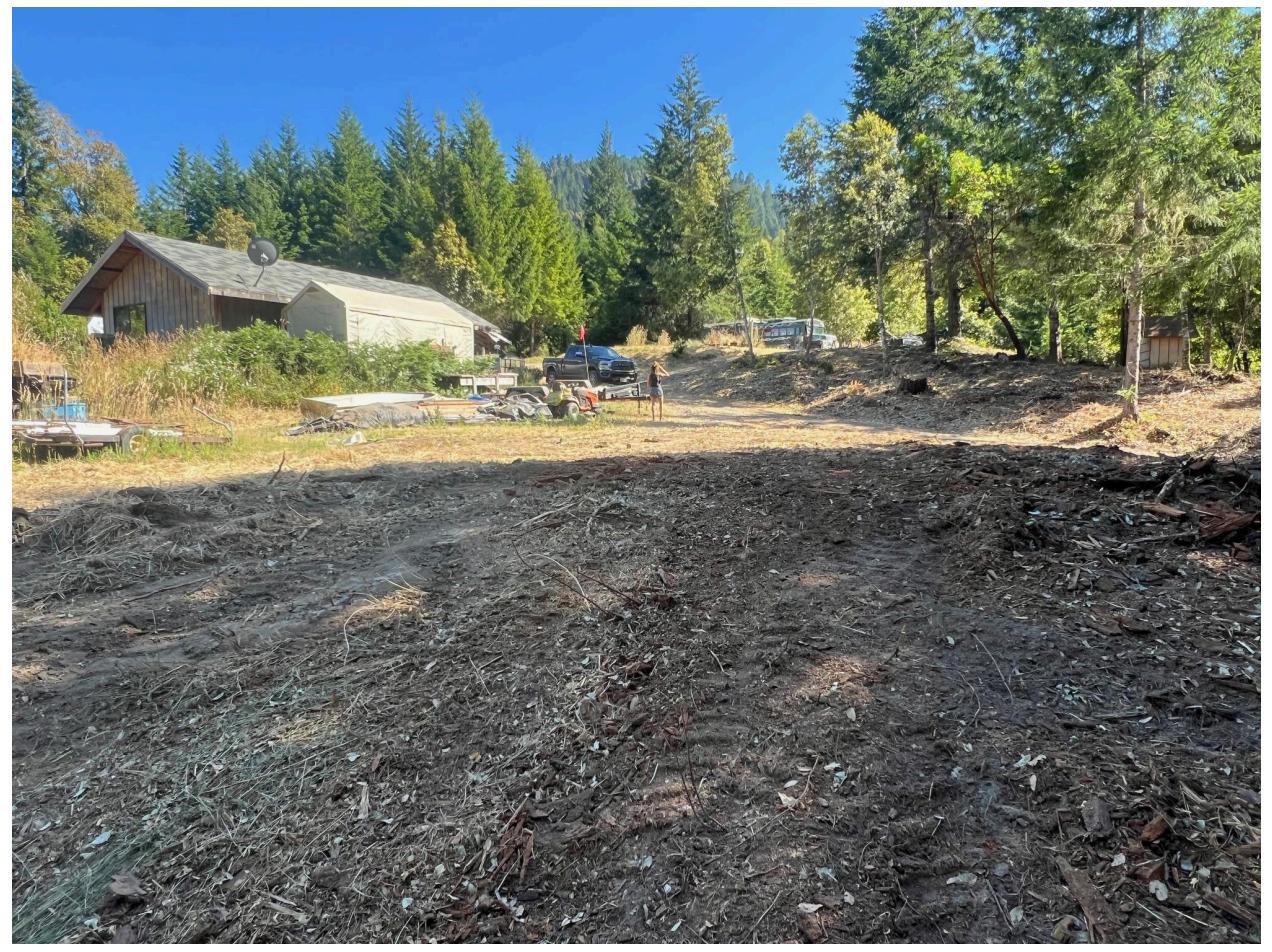
Project site facing south west. Fire abatement measures disturbed project site vegetation including removal of trees on the western portion of the project site and disturbance to the herbaceous layer of vegetation from operating heavy machinery in the area.

property also recently underwent fire abatement measures, which included clearing trees and shrubs on the western side of the project area adjacent to existing forest. Clearing with heavy machinery caused disturbance to the soil surface and vegetation within the project area. Site photos included in Appendix B.

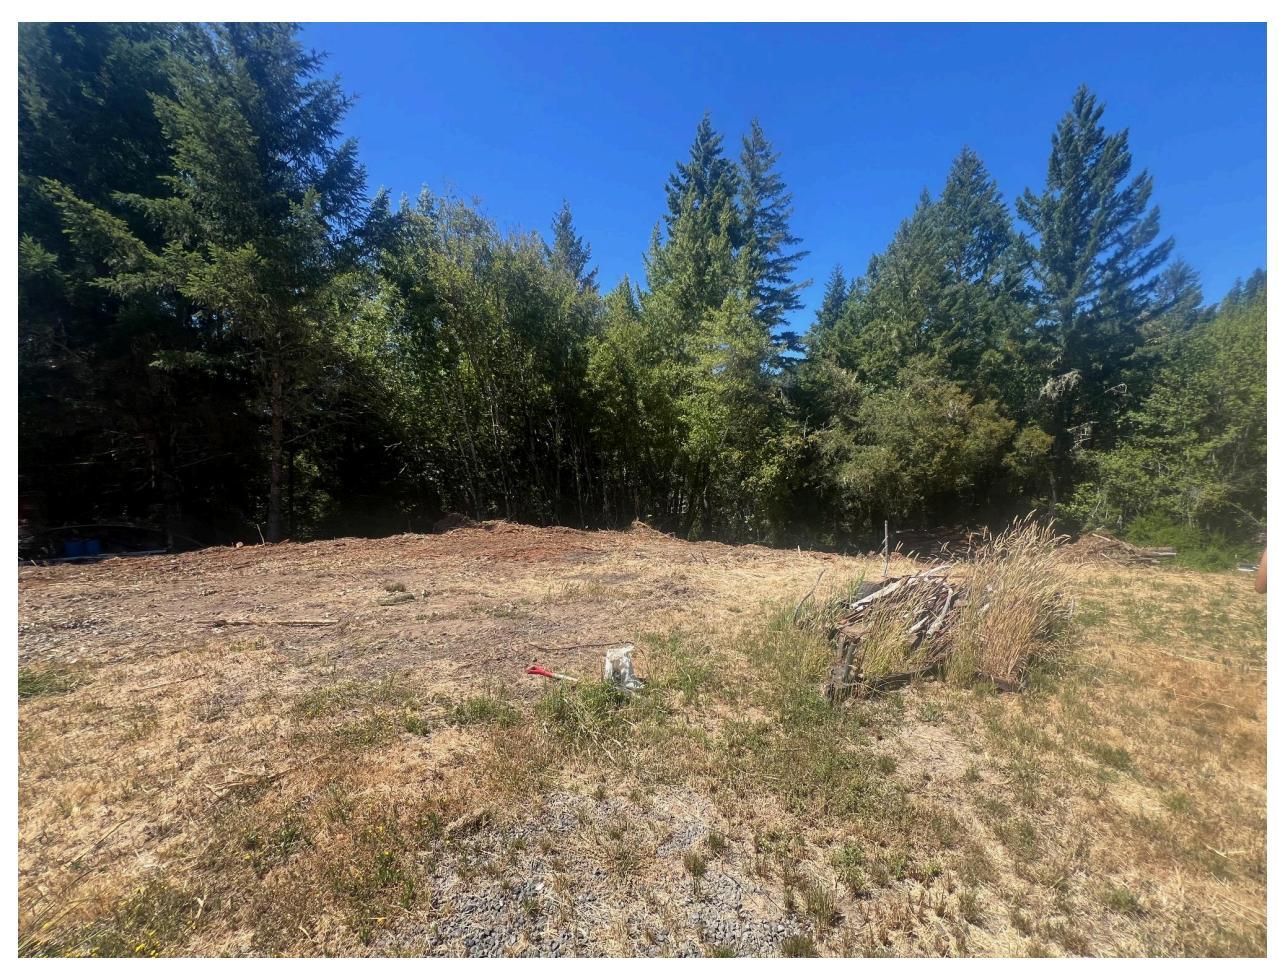
Project site facing North west. No standing water observed on the project site.

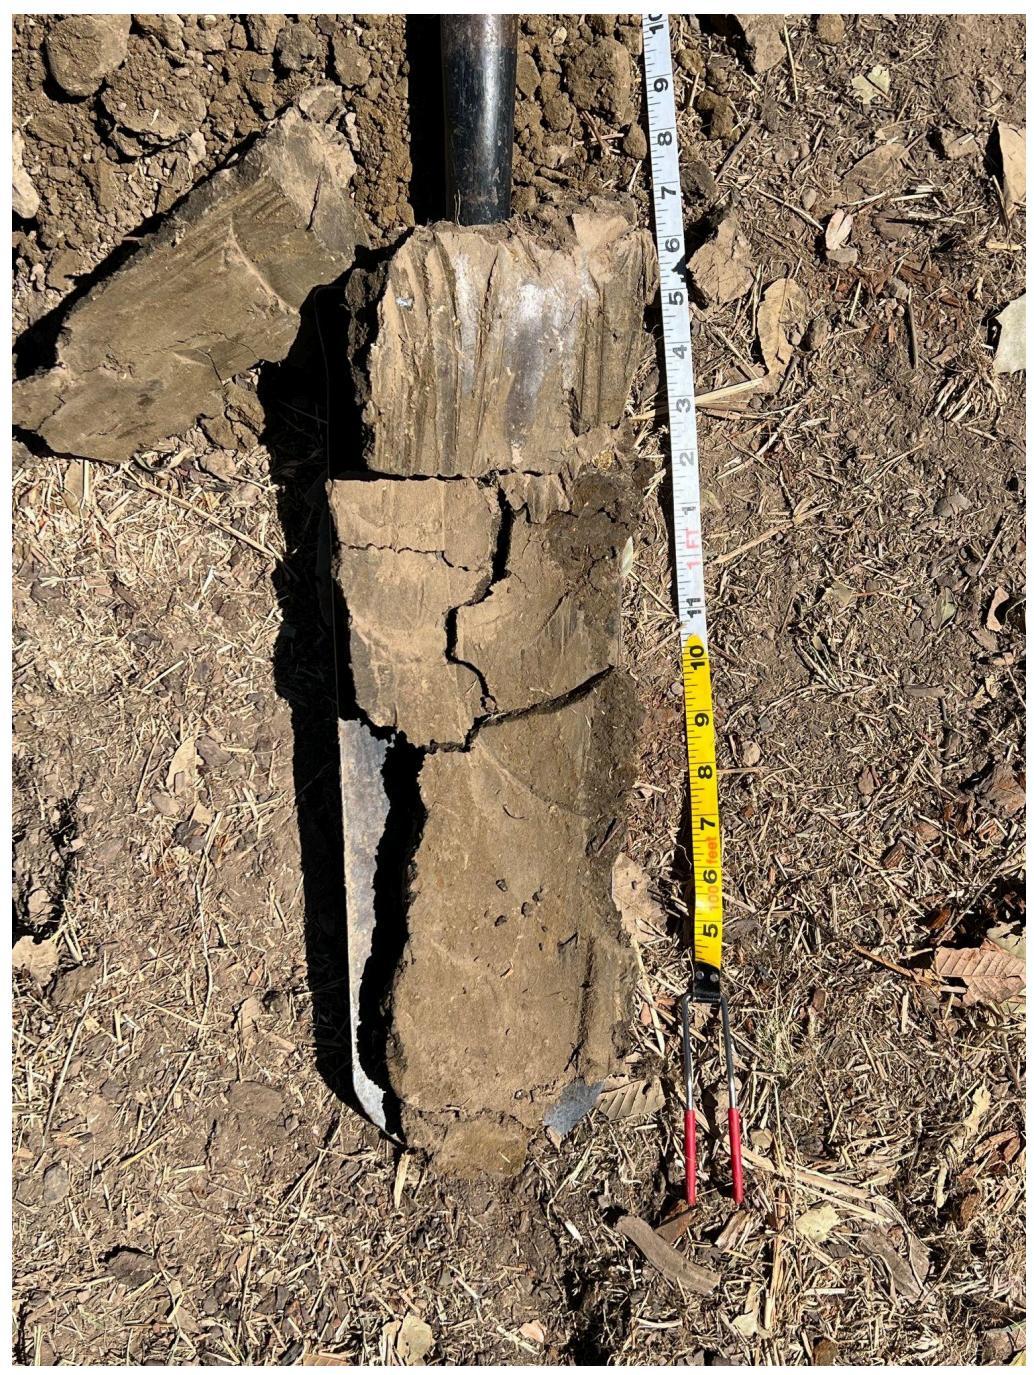
Soil profile for sample plot 1. The soil color (10YR 6/3) was consistent within the top 18 inches and showed no signs of gleying. The characteristics of the soil indicate standing water does not persist long enough to create anaerobic conditions in the soil.

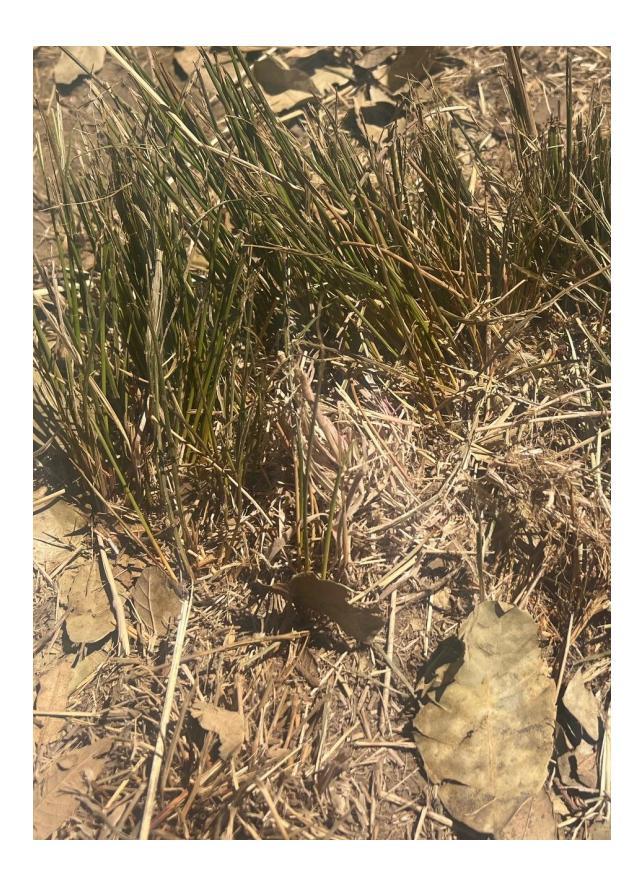
Above left: *Juncus patens* at project site. *Juncus patens* is a facultative wetland plant, usually found in wetlands but it can also be found in non-wetlands.

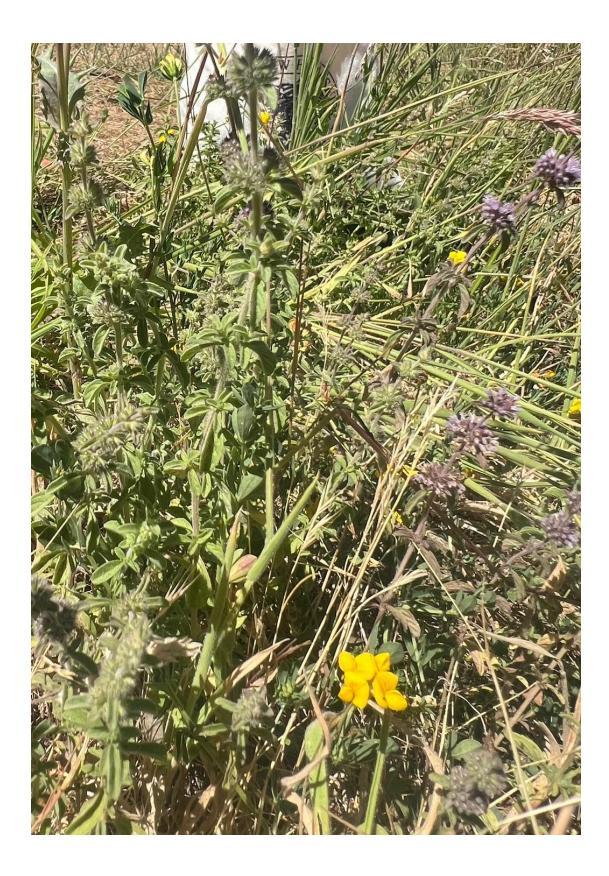
Above right: *Mentha pulegium* at project site. *Mentha pulegium* is a non-native obligate wetland plant, almost always growing in wetland habitat, though it can tolerate seasonal drought.
