HUMBOLDT COUNTY DEPARTMENT OF PUBLIC WORKS  
ROAD EVALUATION REPORT

Road Name: Salmon Creek Road (Segment 1) (complete a separate form for each road)

## TECHNICAL MEMORANDUM

DATE: 13 October 2017  
TO: Humboldt County Department of Public Works  
FROM: Joel Monschke, Stillwater Sciences  
SUBJECT: Road Evaluation for APN 221-081-004 (Blido Property):  
**Segment 1** - 1.7 miles of Humboldt County maintained Salmon Creek Road from  
Maple Hills Road junction to Thomas Road turnout

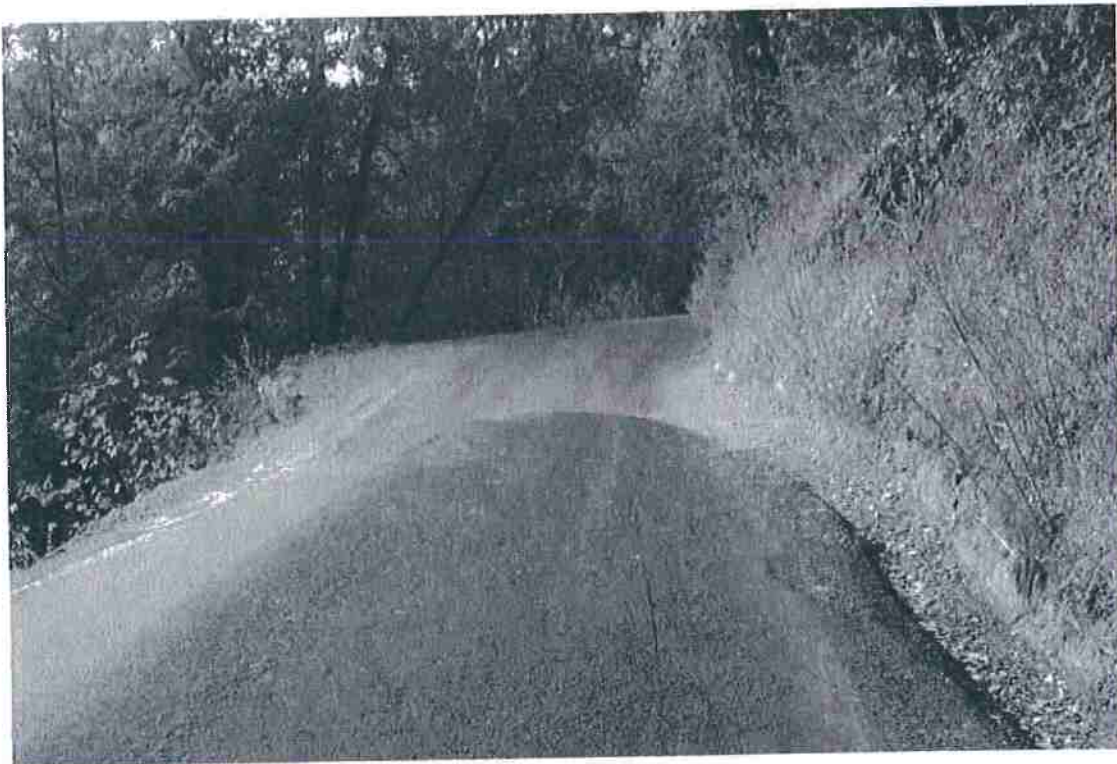
- Mile 0.8: relatively narrow section, 16-ft road width, no shoulder, deep ditch.
- Mile 0.9: Relatively narrow section, 15-ft road width with 1-ft shoulders.

Photo 4. Mile 0.9: relatively narrow section, 15' width, 1' shoulders.

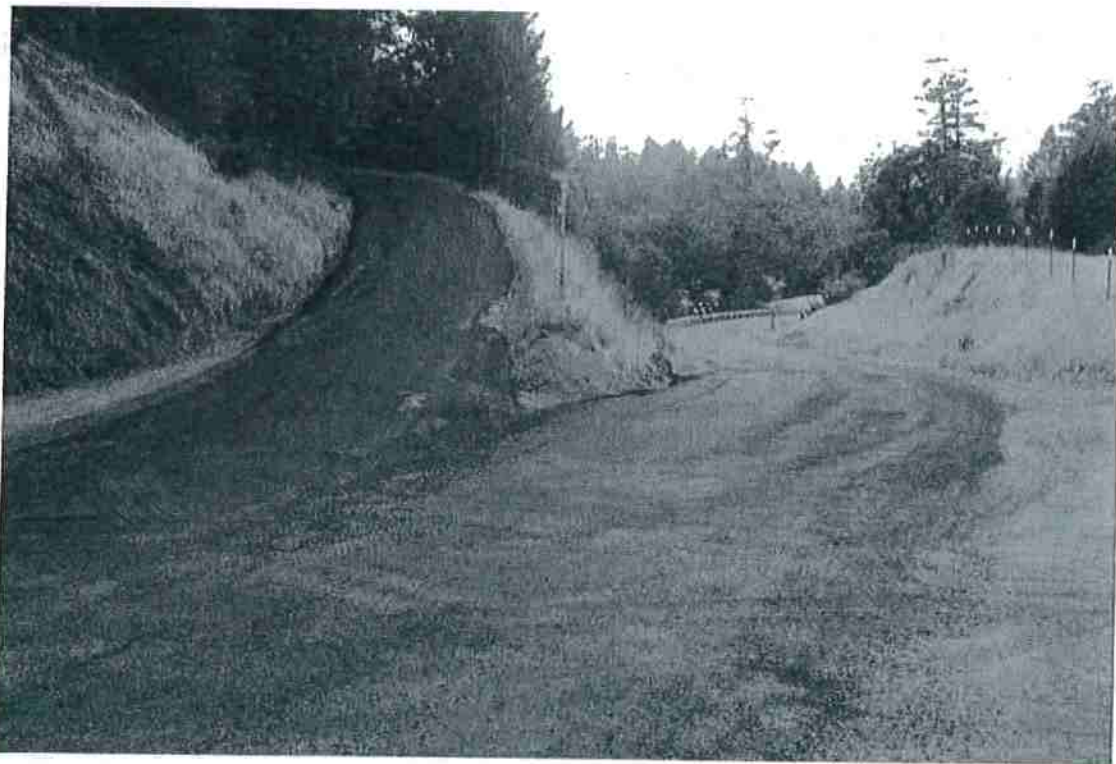
Photo 14. Mile 1.7: Thomas/ Salmon Creek Road split, 32' width, 2' shoulders (end of Segment 1).

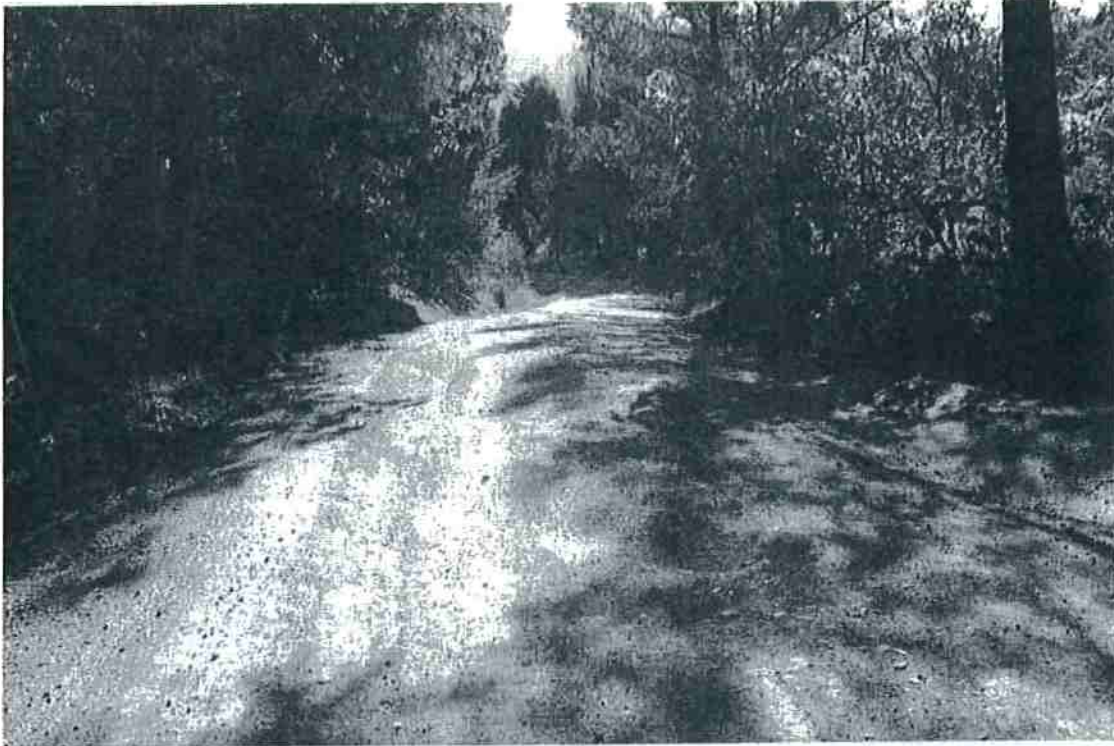
**Photo 1.** Mile 0.1: 18-ft road width with 1-ft shoulder (begin of segment).

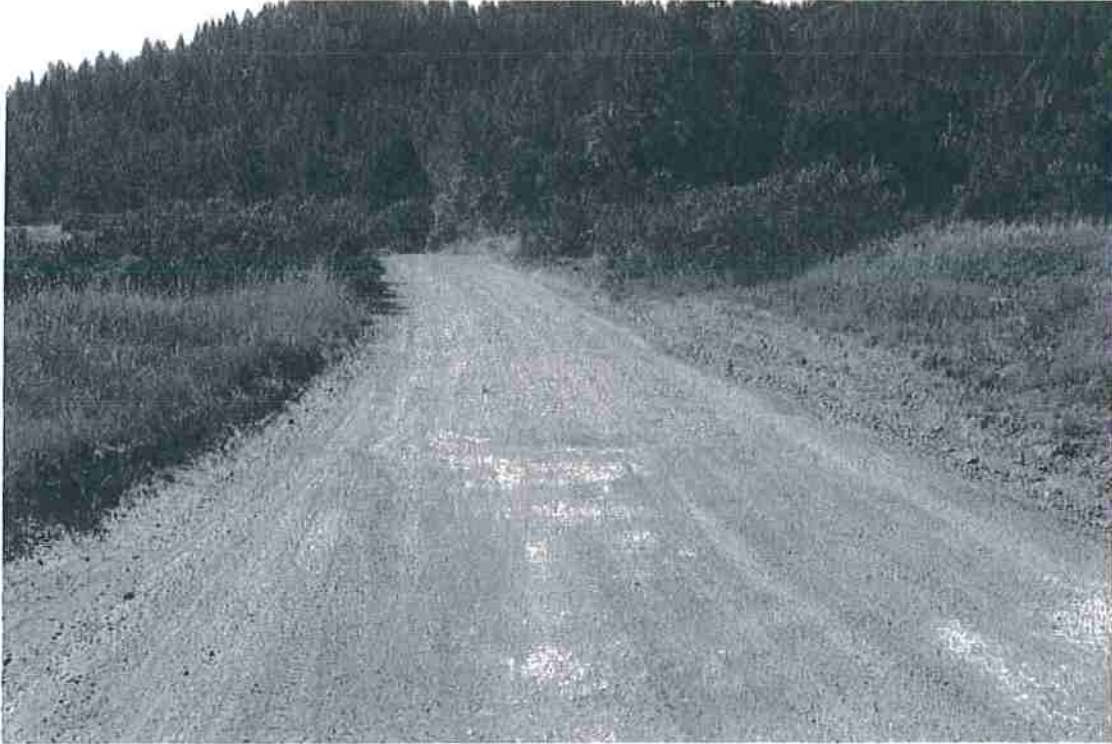
**Photo 19.** Mile 1.6: 18-ft road width with 1-ft shoulder. End of Segment 3 at Salmon Creek School.

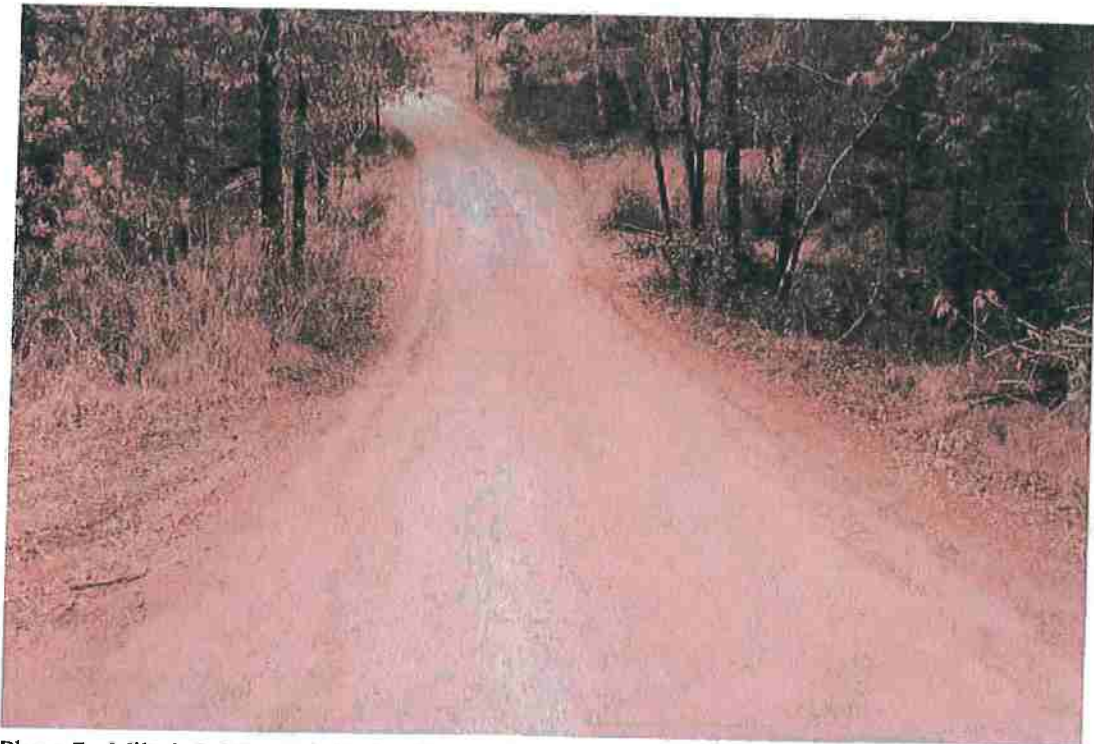
Photo 7 - Mile 0.6: 16' width 1' shoulders, culvert crossing, good visibility

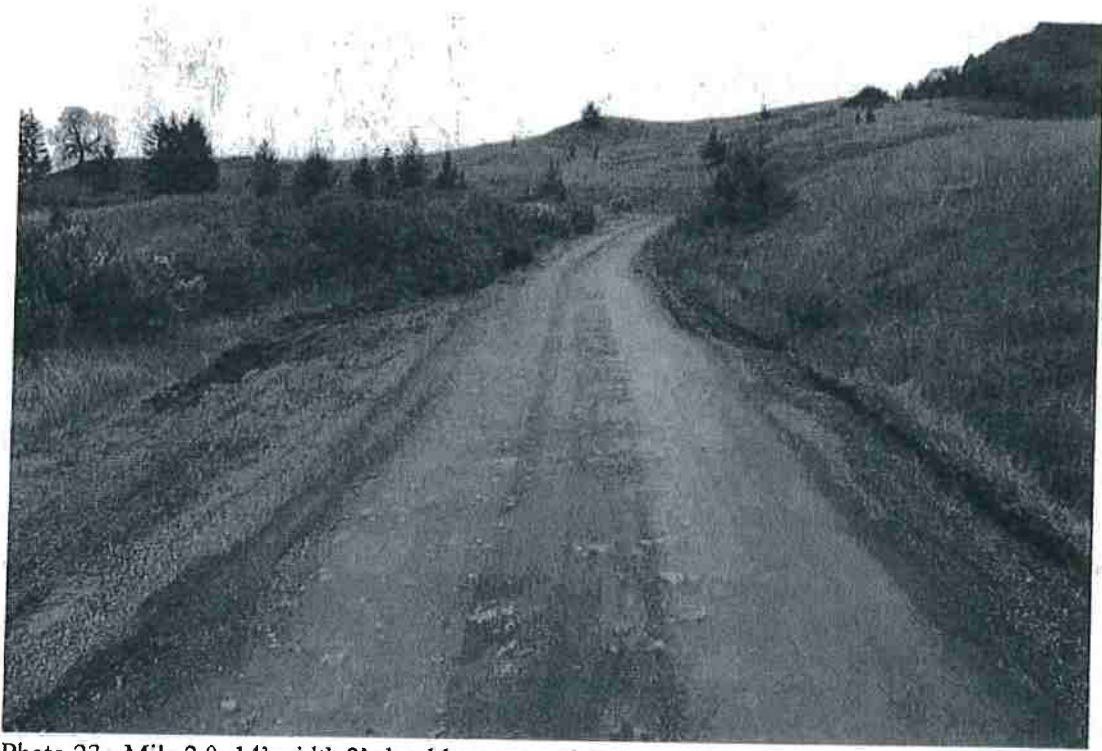
Photo 23 - Mile 2.0: 14' width 2' shoulders, great visibility, with turnouts

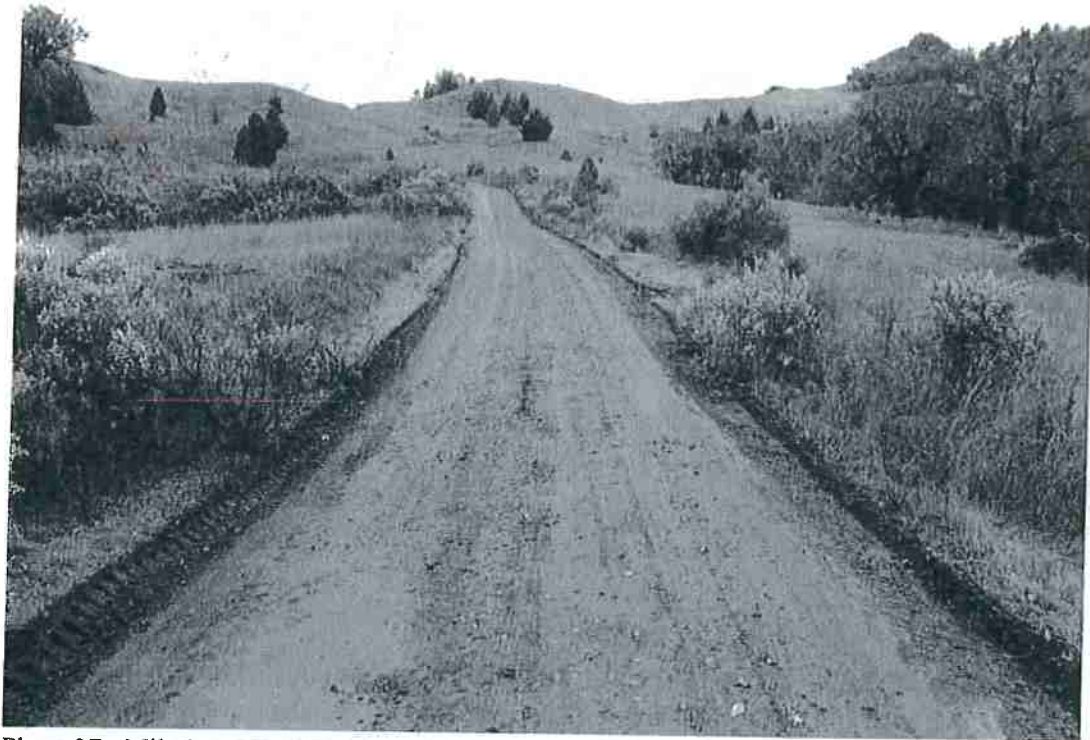
Photo 27 - Mile 2.4: 15' width 2' shoulders, great visibility, with turnouts

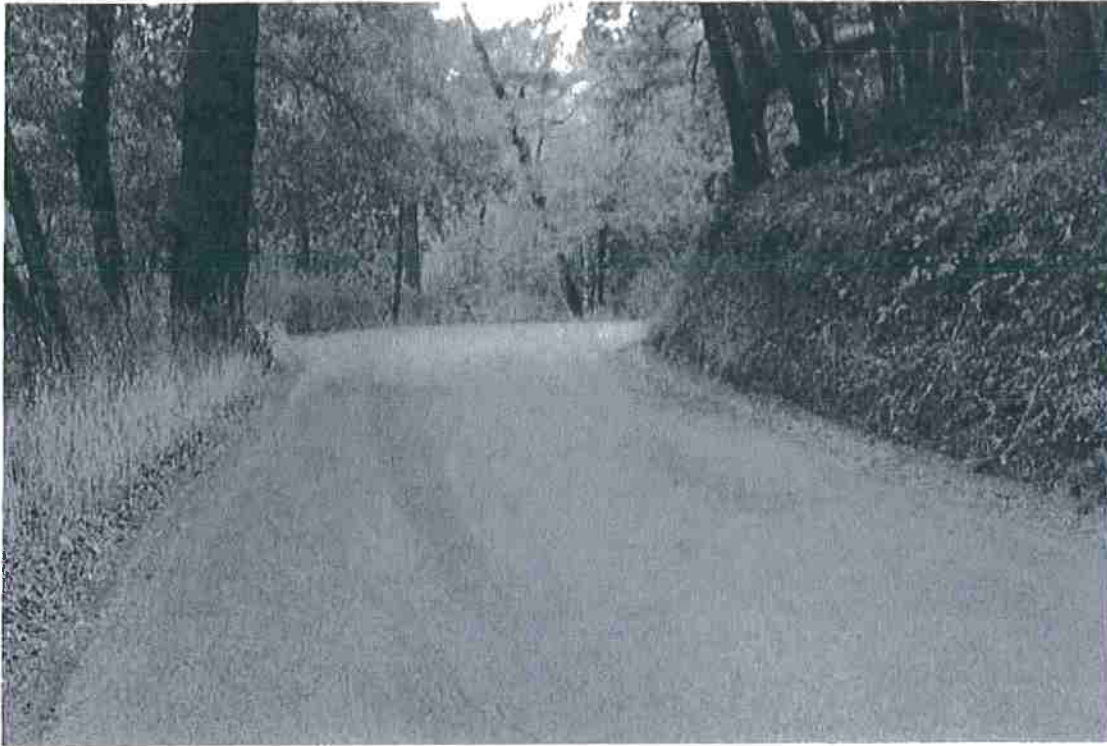
- Mile 1.0: 15-ft-wide pinch point with 1-ft shoulder caused by tree at blind corner.
- Mile 1.1: 20-ft road width with 1-ft shoulder.
- Mile 1.2: 20-ft road width with 1-ft shoulder.

**Photo 11.** Mile 1.0: Pinch point at tree on blind corner; 15-ft road width with 1-ft shoulder. Recommend widening.

- Mile 0.1: Cut vegetation to improve visibility, upgrade pavement to allow for minimal 18' wide driving surface width where feasible
- Mile 1.0: We recommend widening the roadway including removal of a Douglas Fir tree to improve the road width and visibility at the blind corner.
- Mile 1.9 to mile 2.2: There are some pinch points along this segment, but the segment traverses steep terrain so widening would be difficult and have potentially significant environmental impacts. Recommend signage reminding drivers to slow down and stay on their side of the road.
- Mile 2.4: We recommend widening the corner on the inside to improve width and visibility at the blind corner. Also nearby at mile 2.35, need to repair slumping outboard edge of road.

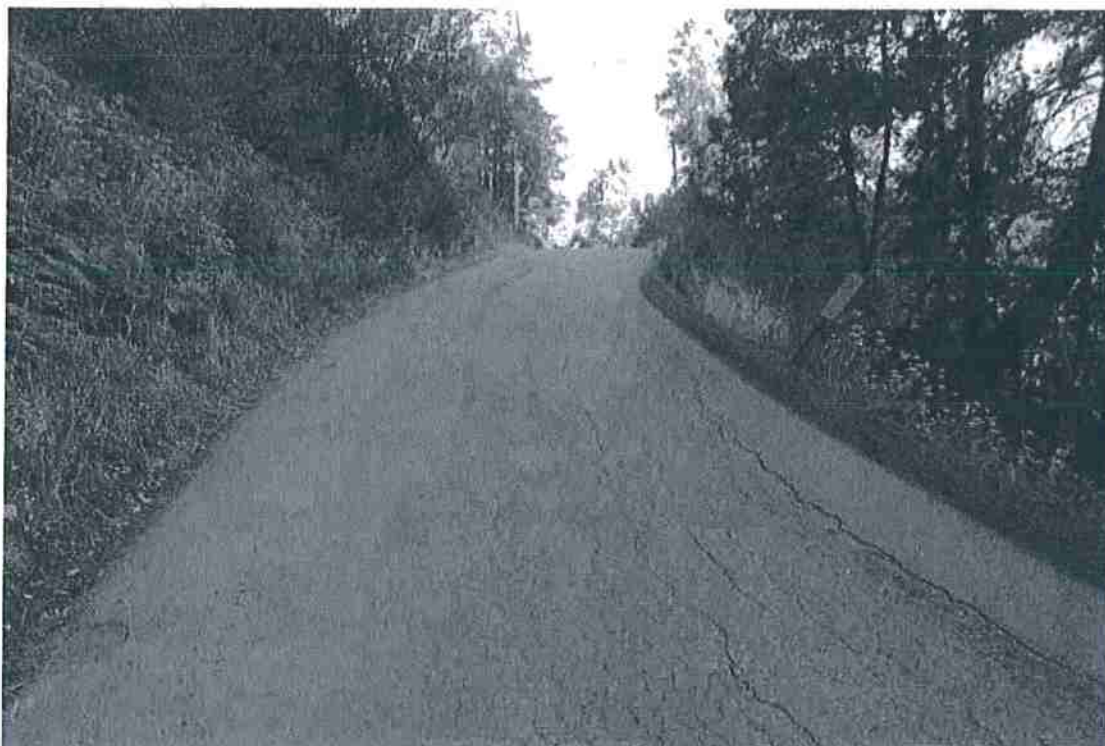
Photo 27. Mile 2.37: ~15-ft road width pinch point past partial road failure.

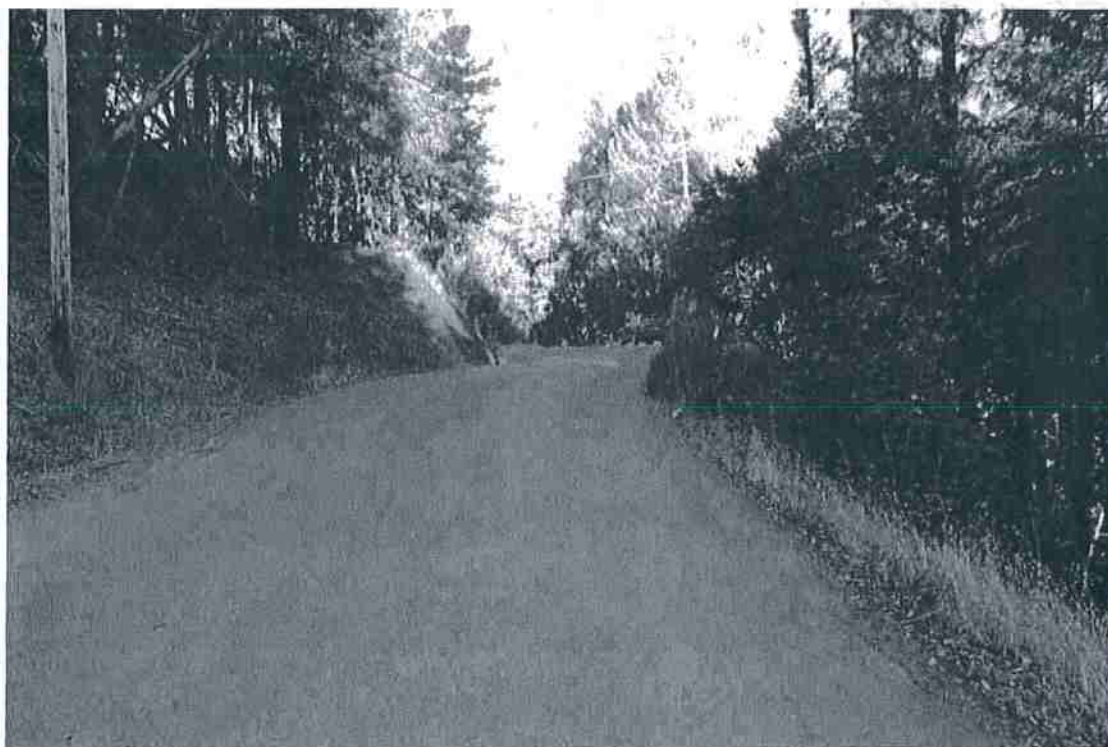
- Mile 2.3: 20-ft road width with 2-ft shoulder.
- Mile 2.35: ~15-ft-wide pinch point at partial road failure
- Mile 2.4: 16-ft road width with 1-ft shoulder. Dangerous blind corner.

Photo 28. Mile 2.4: 16-ft road width with 1-ft shoulders at blind corner. Potential spot to widen corner on the inside to improve width and visibility.

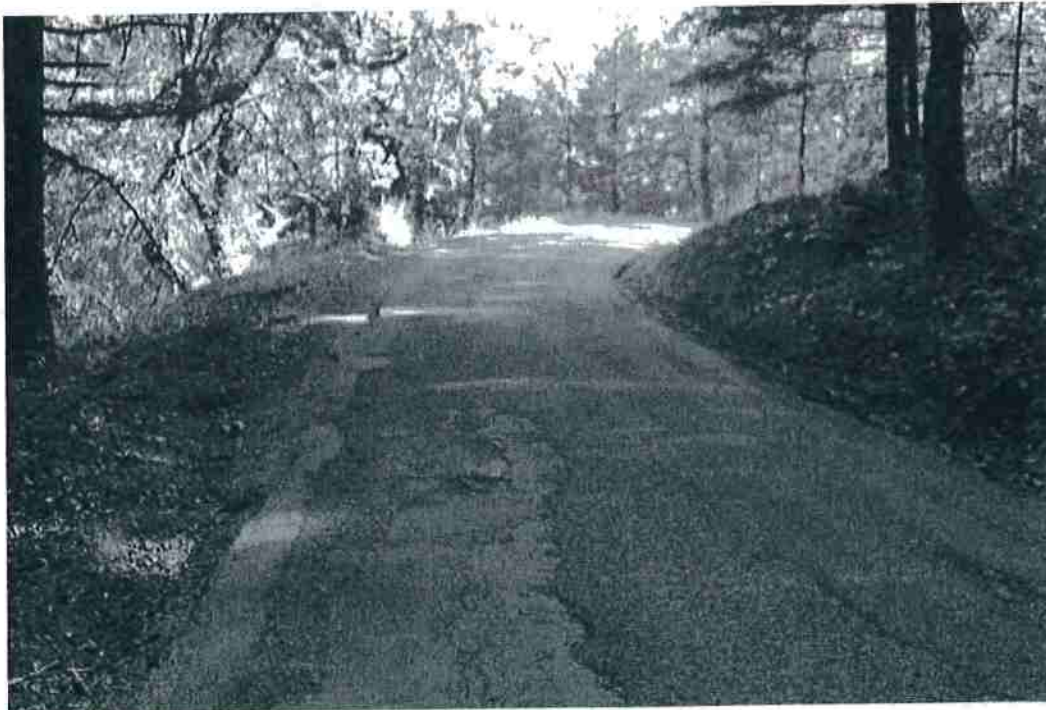
- Mile 3.7: 12-ft road width with 10ft shoulder. Partially blind corner with deep ditch.
- Mile 3.8: 18-ft road width with 1-ft shoulder.
- Mile 3.9: 15-ft road width with 2-ft shoulder, broken pavement edges make segment more treacherous.

**Photo 46.** Mile 3.9: 15-ft road width with 2-ft shoulders. Broken pavement edges make segment more treacherous.

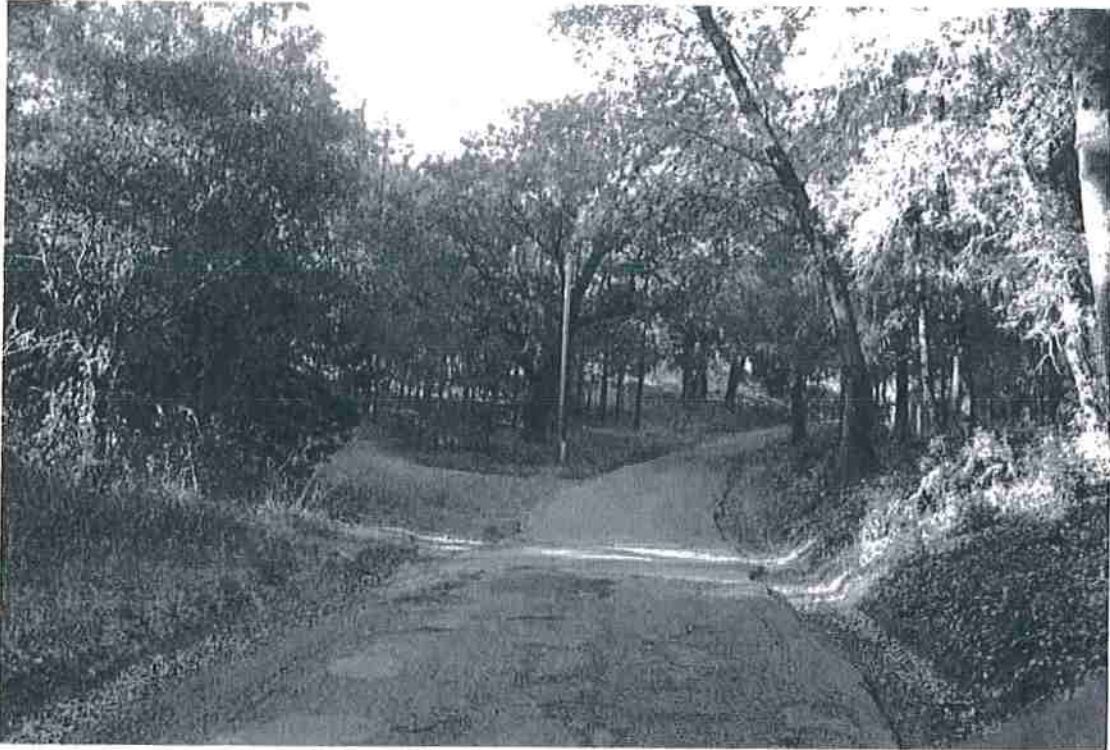
- Mile 4.0: 15-ft road width with 2-ft shoulder, broken pavement edges make segment more treacherous.
- Mile 4.1: 20-ft road width with 2-ft shoulders at intersection with Upper Thomas Road. End of County-maintained road (and end of segment 2).

**Photo 47.** Mile 4.0: 15-ft road width with 2-ft shoulders. Broken pavement edges make segment more treacherous.
