JOURNEY AQUARIAN – HUMBOLDT KINGZ, LLC
RESTORATION PLAN
APN: 216-136-004 / 216-135-008

COMMERCIAL CANNABIS CULTIVATION FACILITIES

**Restoration Plan
Journey Aquarian of Humboldt Kingz, LLC
APN # 216-135-008 / 216-136-004
Apps # 12125
CUP16-539**

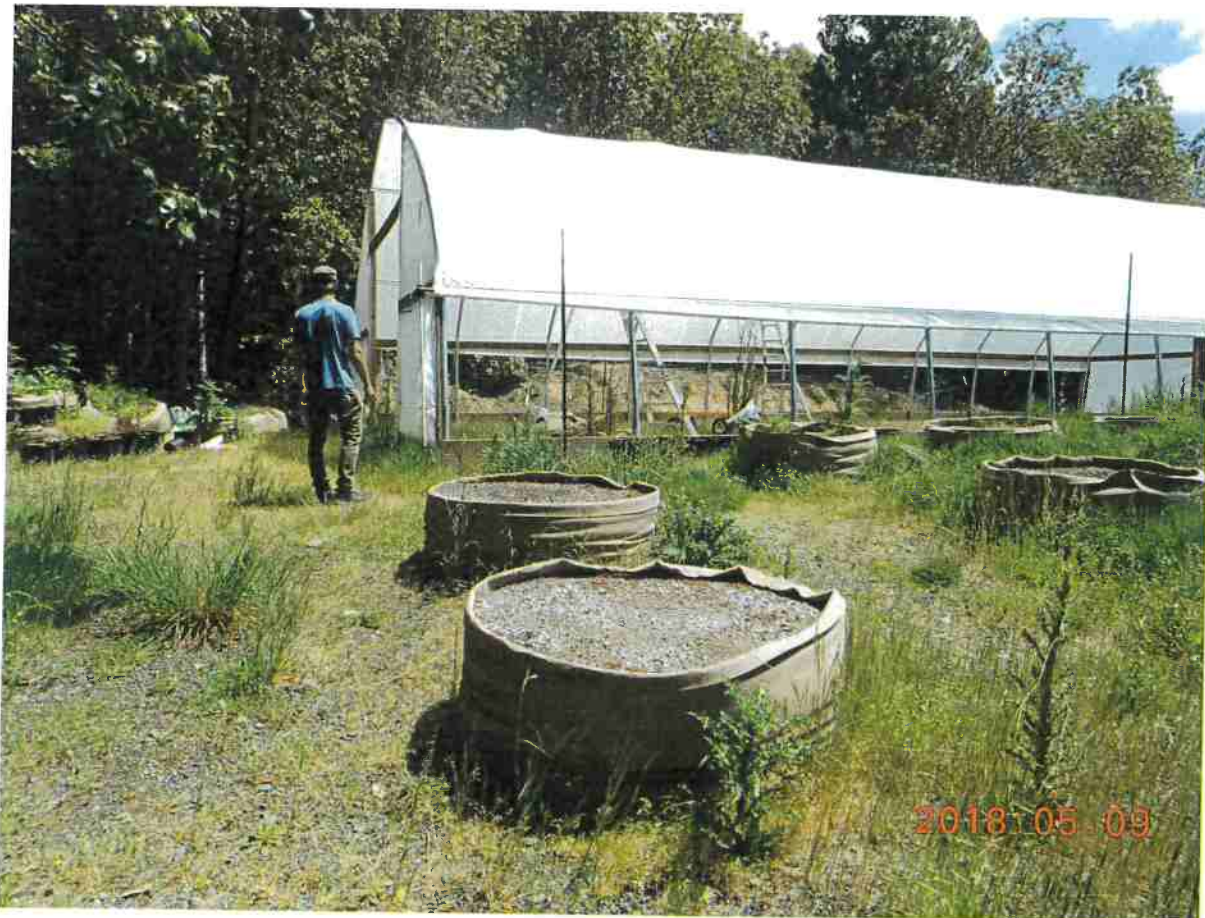
- Area A historically had approximately 7,000 sq. ft. of outdoor cultivation and light-deprivation cultivation in a 30' x 50' greenhouse. This greenhouse may be relocated to Area H or I due to proximity to the property boundary (boundary survey pending).

Cultivation Area A – Greenhouse proposed to be relocated

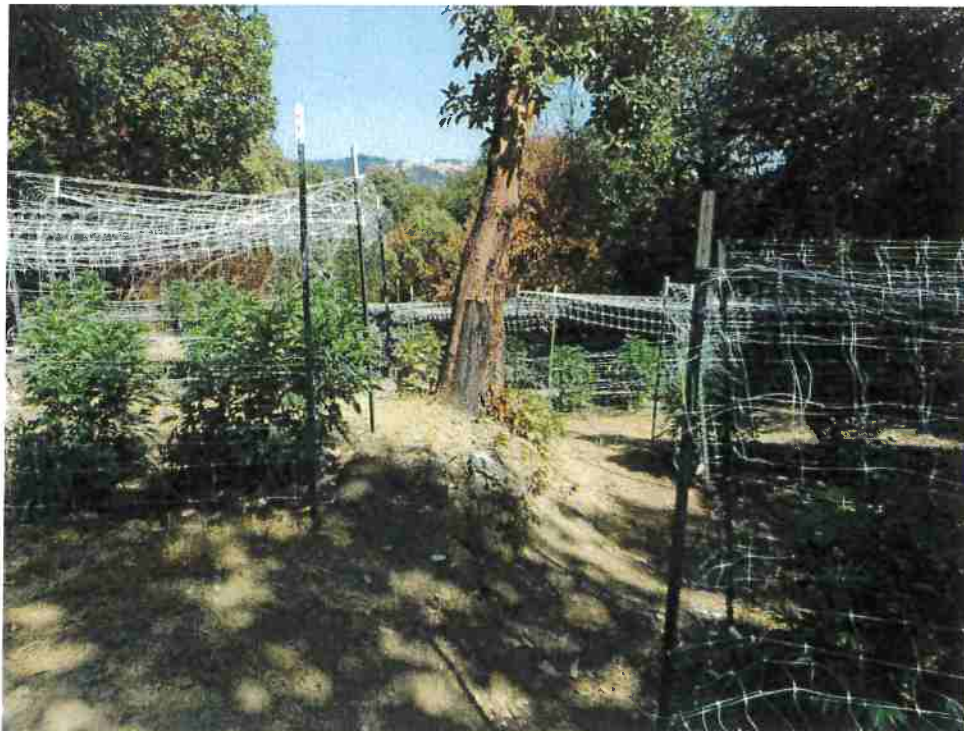
Cultivation Area B – to remain as-is

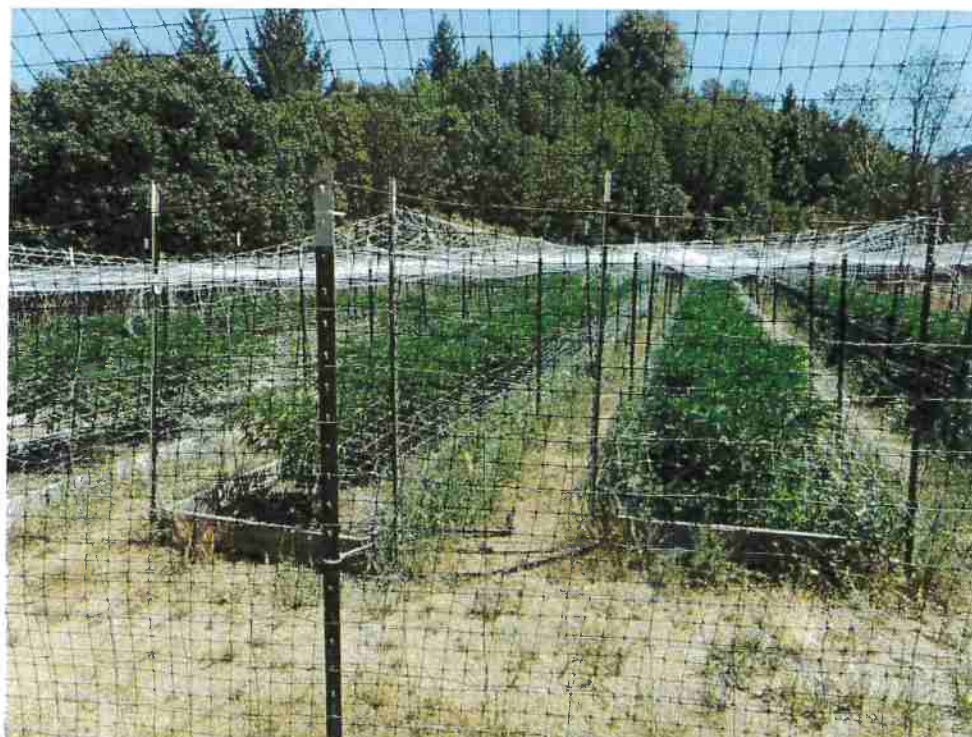
- Area B historically had approximately 4,000 sq. ft. of outdoor cultivation and can remain as-is.
- Area C historically had approximately 6,000 sq. ft. of outdoor cultivation and needs to be reduced to 2,700 sq. ft. to comply with a 50' riparian buffer off a Class III watercourse near the north side of the cultivation area.

Cultivation Area C – to be reduced out of riparian setback

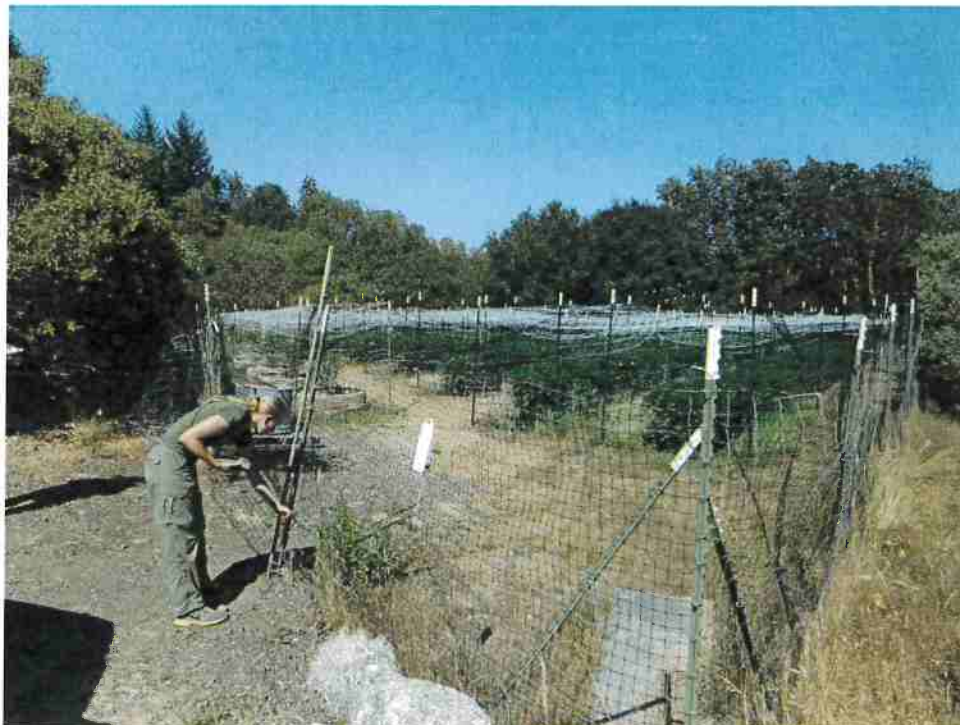
Cultivation Area D – to remain as-is

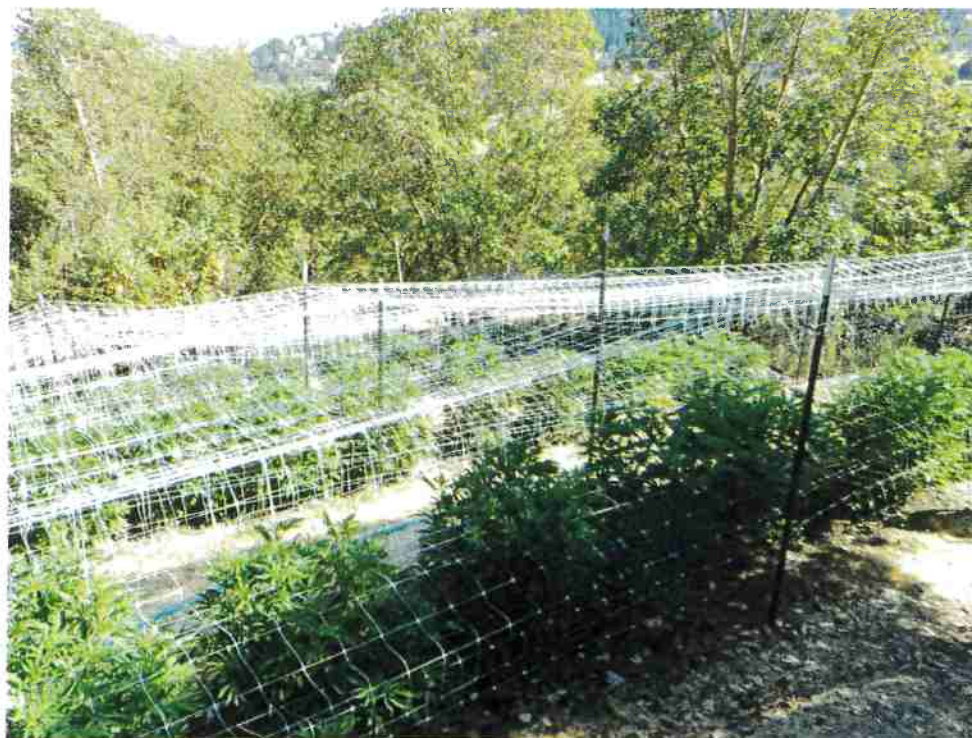
- Area D historically had approximately 6,000 sq. ft. of outdoor cultivation and can remain as-is.
- Area E historically had approximately 2,800 sq. ft. of outdoor cultivation but is located entirely within a riparian setback from a Class III watercourse. All cultivation-related equipment will be completely removed from this area and the area will be restored with natural vegetation.

Cultivation Area E – to be removed out of riparian buffers and restored

The ~3,000 sq. ft. of disturbed area in Area E will be revegetated with shrubs and trees to match the surrounding vegetation composition. The dominant overstory is characterized as madrone and the dominant understory is identified as manzanita. The following tree and shrub species were identified: Tanoak (*Notholithocarpus densiflorus*), White oak (*Quercus alba*), Pacific madrone (*Arbutus menziesii*), Blueblossom (*Ceanothus thyrsiflorus*), and Hoary Manzanita (*Arctostaphylos canescens*). species in the manzanita family (*Arctostaphylos*). Approximately ten (10) of the above trees will be planted in the area. A site visit revealed that native grasses were already naturally re-seeding the area to help stabilize the soil.

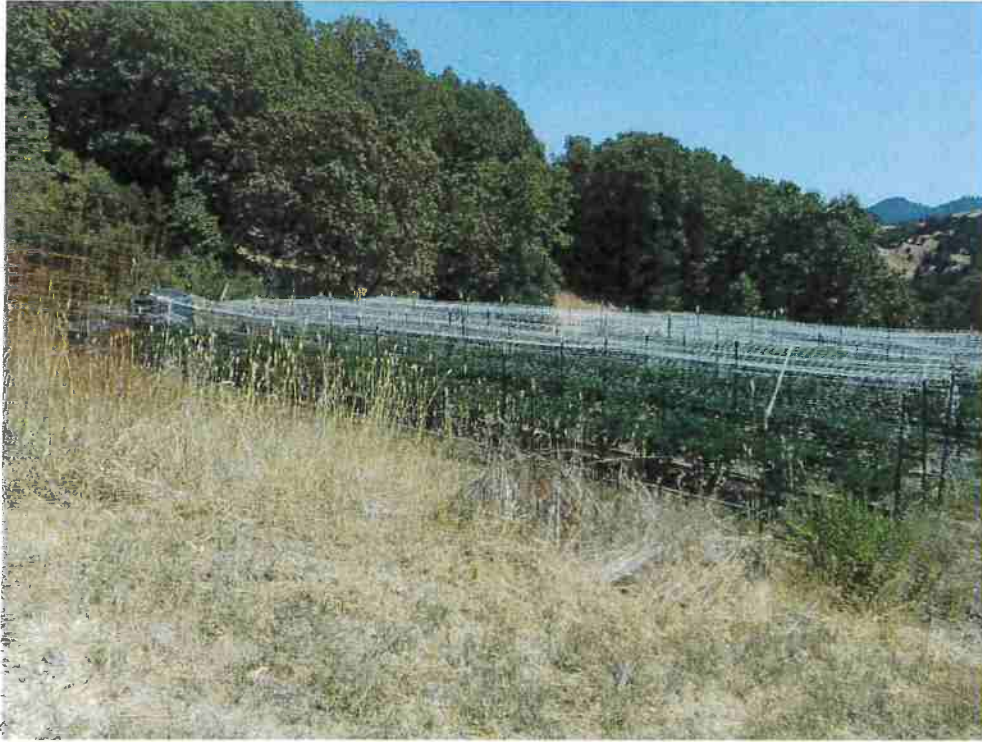
- Area F historically had approximately 7,500 sq. ft. of cultivation. This area is located entirely within 100' from a Class II watercourse and 50' from a Class III drainage. All cultivation-related equipment will be completely removed from this area and the area will be restored with natural vegetation.

Cultivation Area F – to be removed out of riparian setbacks and restored entirely

The ~8,000 sq. ft. of disturbed area in Area F will be revegetated with shrubs and trees to match the surrounding vegetation composition. As Area F is being relocated due to a Class II riparian buffer, the dominant overstory is characterized riparian hardwood trees and the dominant understory is manzanita and riparian shrubs. The following tree and shrub species were identified in the area: California bay (*Umbellularia californica*), Bigleaf Maple (*Acer macrophyllum*), Douglas Fir (*Pseudotsuga menziesii*), Pacific madrone (*Arbutus menziesii*), Tanoak (*Notholithocarpus densiflorus*), and Hoary Manzanita (*Arctostaphylos canescens*). Approximately 20 – 30 of the above trees will be planted in the area. To stabilize the exposed soil while the trees are growing, the area will be seeded with native California grass species (approximately 15 lbs. of "Habitat Mix" from Pacific Coast Seed, Inc. or similar seed medley, which contains Native California Brome (*Bromus carinatus*), Blue Wildrye (*Elymus glaucus*), California Barley (*Hordeum californicum*), Idaho Fescue (*Festuca idahoensis*), Purple Needlegrass (*Nassella pulchra*), and Pine Bluegrass (*Poa secunda*)).

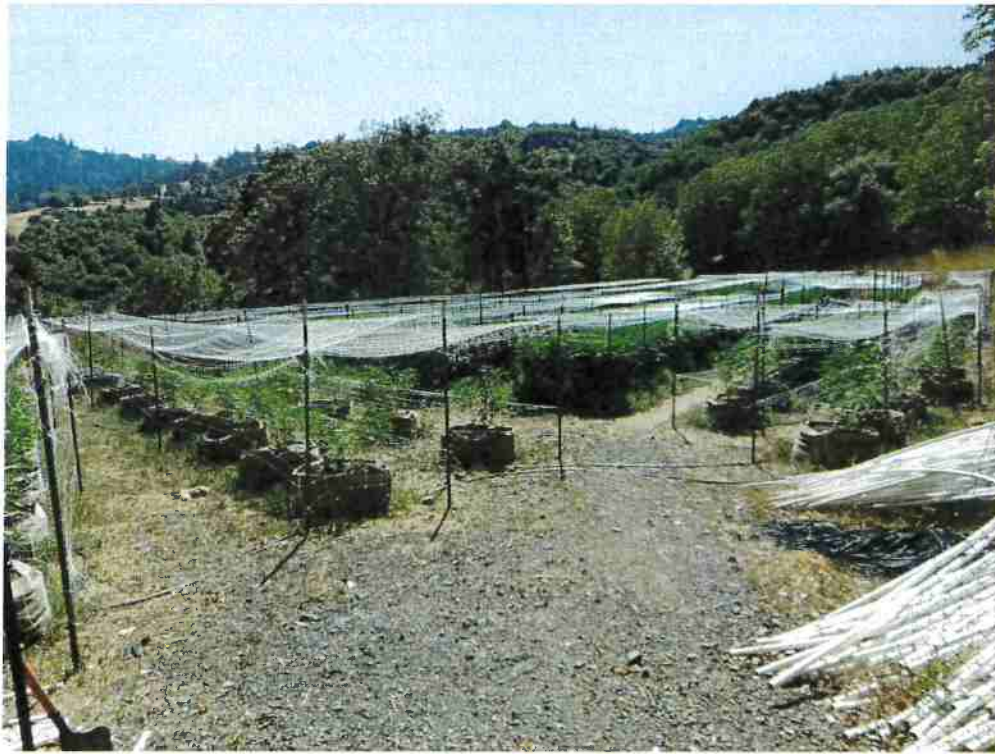
- Area G historically had approximately 11,660 sq. ft. of cultivation and will be reduced to approximately 8,650 sq. ft. of cultivation (~6,400 sq. ft. in light-deprivation greenhouses) due to proximity to a Class III drainage.

Cultivation Area G – to be altered out of 50' riparian setback

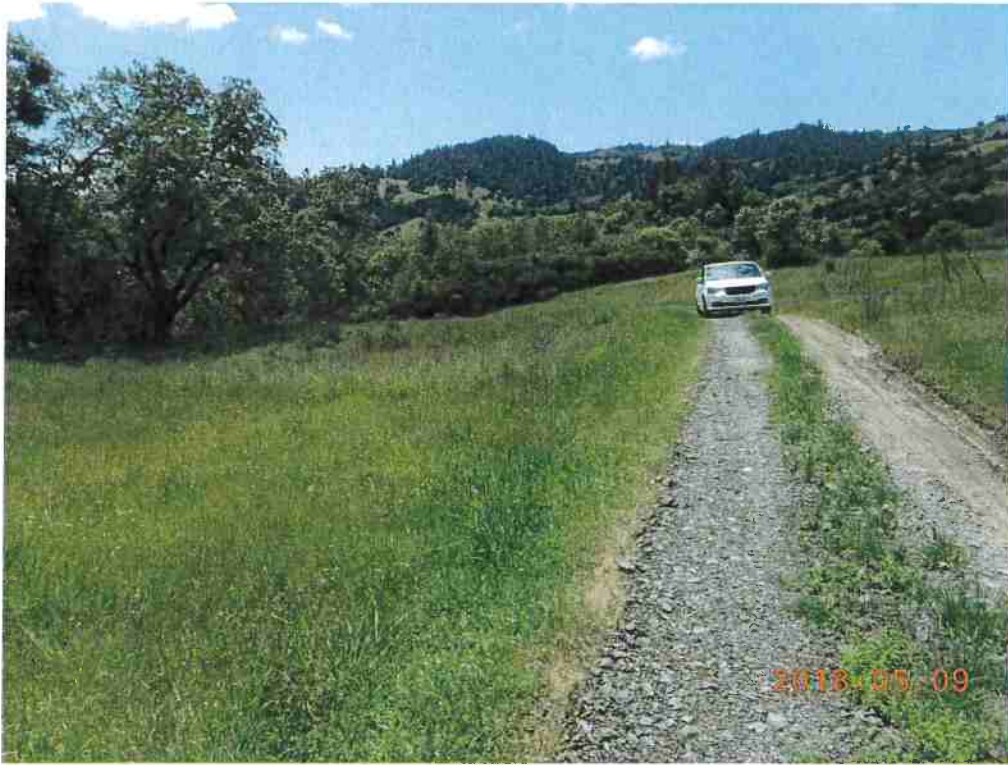
(Proposed) Cultivation Area H

Cultivation area H is located 200' from the nearest watercourse (Class II drainage) and Cultivation Area I is located over 100' from the nearest watercourse (Class II drainage). As stated in the Cannabis Cultivation Policy, disturbed areas located within riparian buffers are more likely to "discharge waste constituents to surface water"², which has the potential to impact water quality and/or aquatic life. Relocating cultivation out of riparian areas will help protect and restore the quality of the riparian area, which is beneficial for fish and wildlife habitat and well-being, human health, municipal, domestic, and agricultural water supply, and recreational purposes.

Cultivation Area H is located on an existing flat road in the east of the parcel with slopes less than 8% and Cultivation Area I is located on an historic logging terrace in the northwest of the parcel on slopes of less than 10%. Due to these shallow slopes, both areas will require minimal grading to relocate approximately 12,000 sq. ft. of cultivation. Neither area requires significant vegetation removal. Both areas are easily accessible from a wide, flat, graveled road in good condition that meets the equivalent of Category Four Road standards. Using this road to access the area and ceasing use of the steep road segments leading to existing cultivation areas will help reduce sediment transport from roadways to nearby watercourses.
