# STRUCTURE TYPE SELECTION REPORT

Hammond Trail Bridge over the Mad River

County of Humboldt Department of Public Works

November 2024

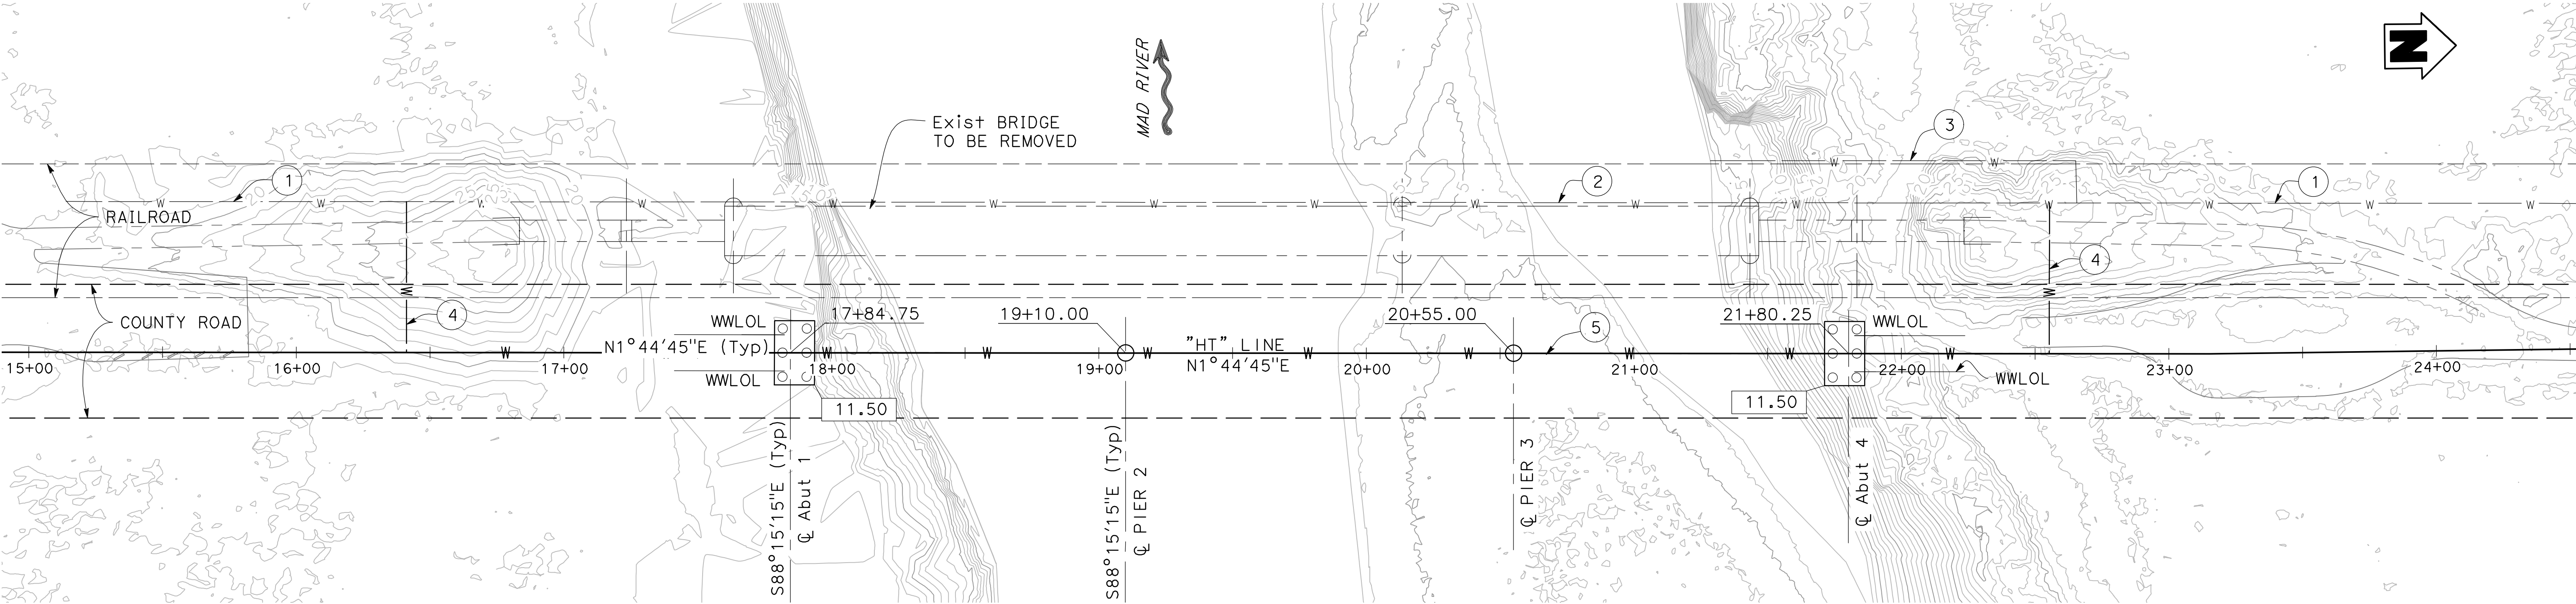
| | PHOTOGRAMMETRY AS OF: X | ALIGNMENT TIES:X | | DETAILS | BY X | CHECKED X | X | FOUNDATION PLAN - ALTERNATIVE 1 & 2 | | | | | | | | | | | | | | | |

The location of the utility line and schematic rerouting to the new bridge is shown on the Foundation Plan provided in Attachment A.

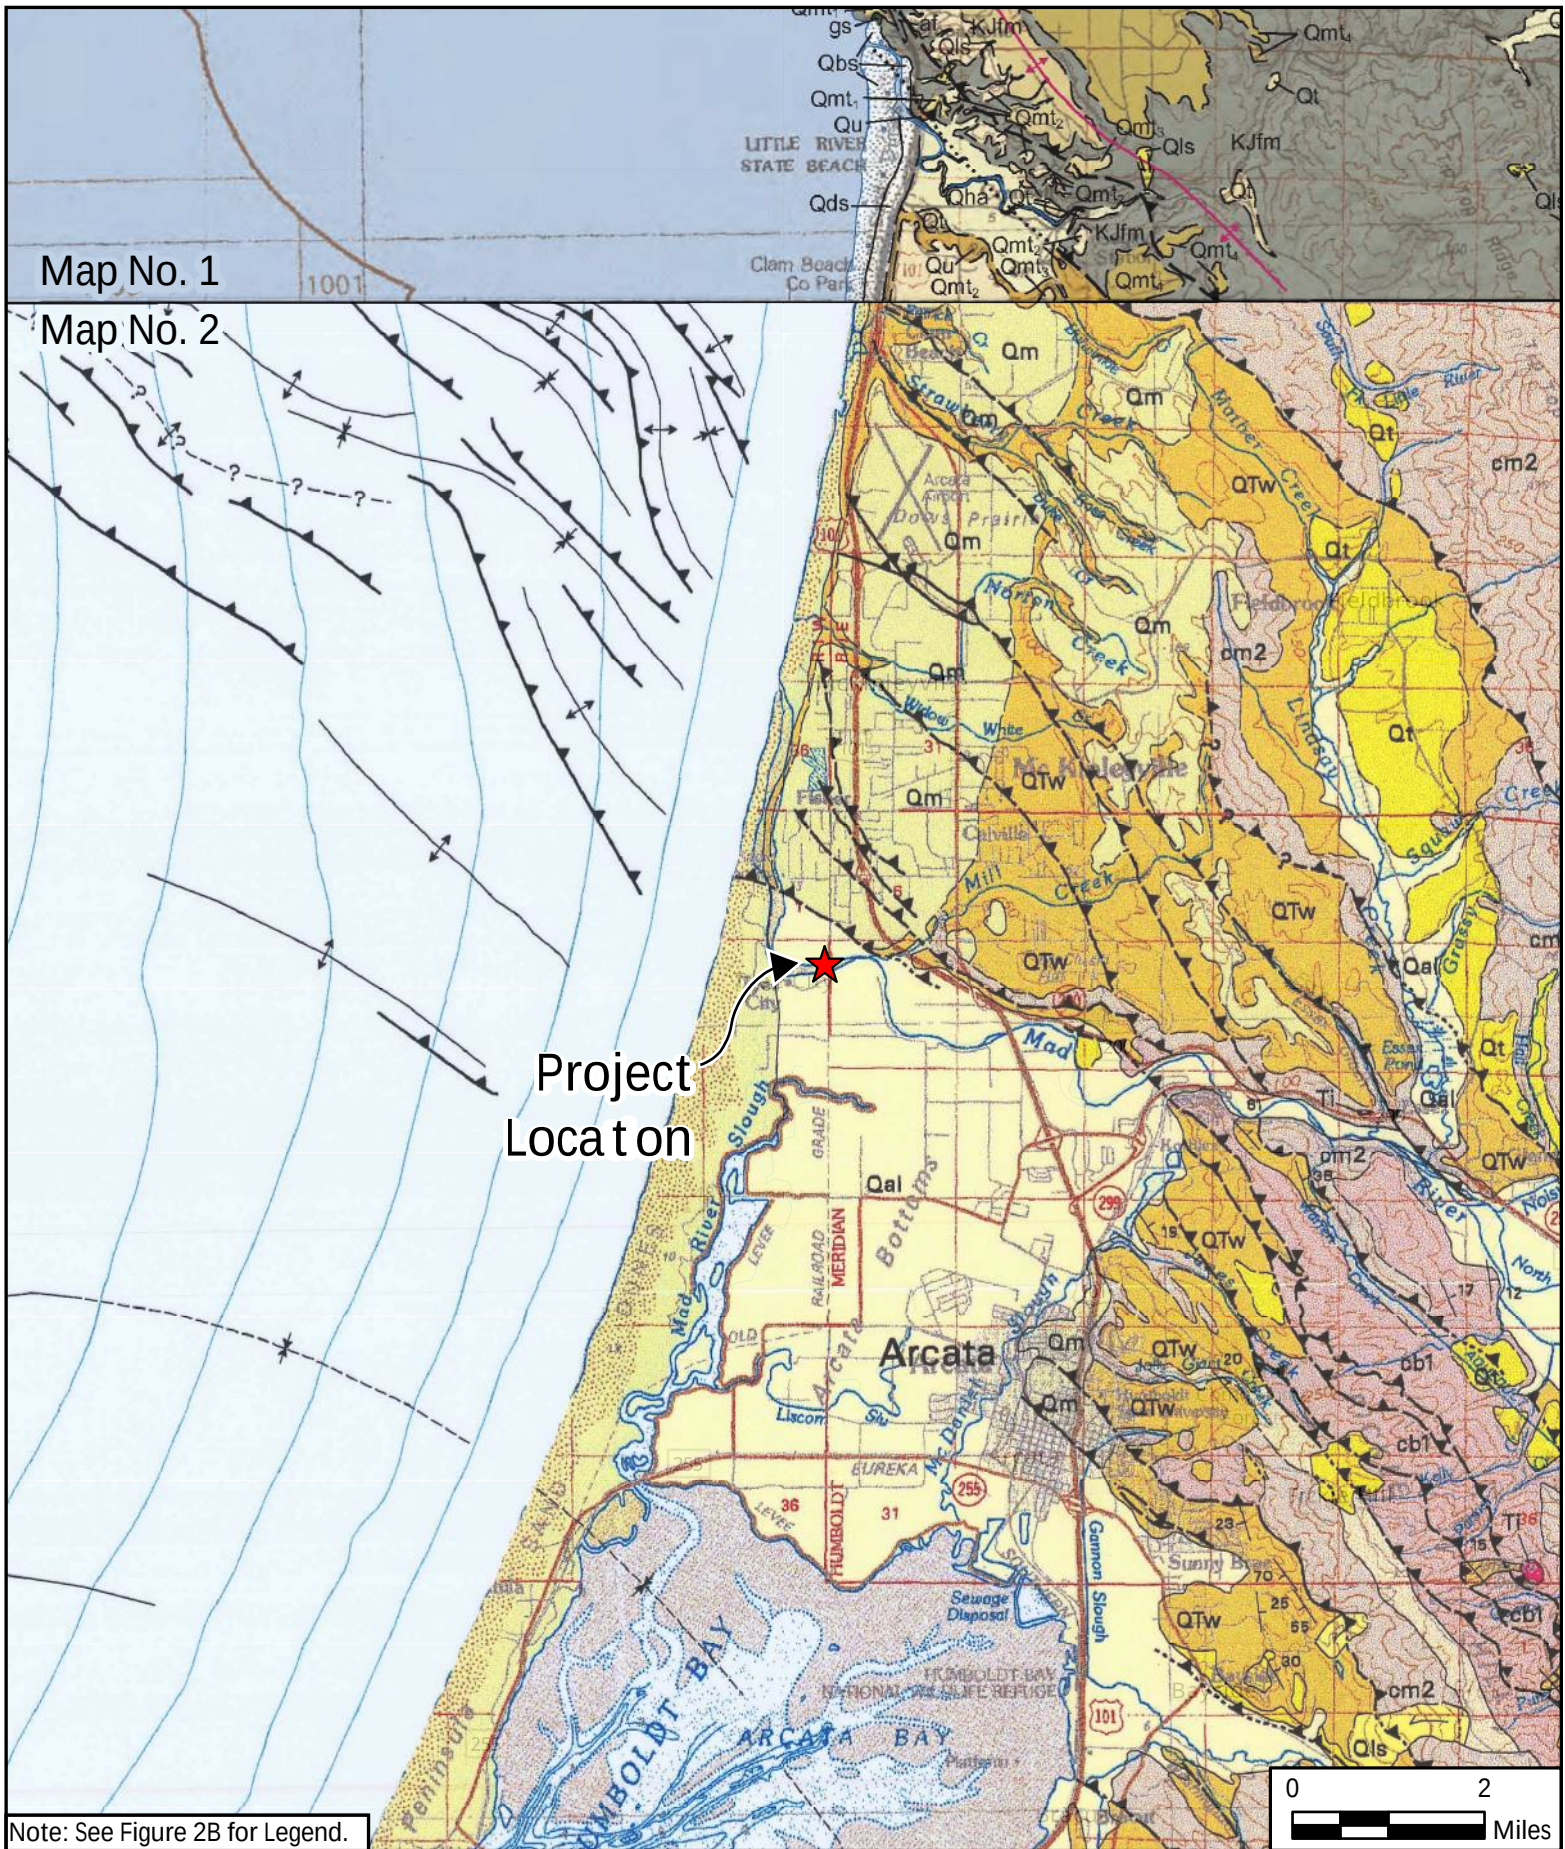
Figure 2A  
Geologic Map

Published geologic mapping<sup>4</sup> (Appendix A – Figure 2) shows the site immediately underlain by Holocene- to late Pleistocene-age Alluvial Deposits (Qal). This unit is typically comprised of clay, silt, sand, gravel, and boulders deposited in stream beds, terraces, and flood plains. SHN interpreted that this formation extended to depths of about 60 to 75 feet below the surface. The older sediments (sand and gravel) below this formation to the full depth explored were interpreted by SHN as middle Pleistocene to middle Pliocene-age Falor Formation, which is included within the Marine and Nonmarine Overlap Deposits (QTW) shown on Figure 2 to the east of the project site.

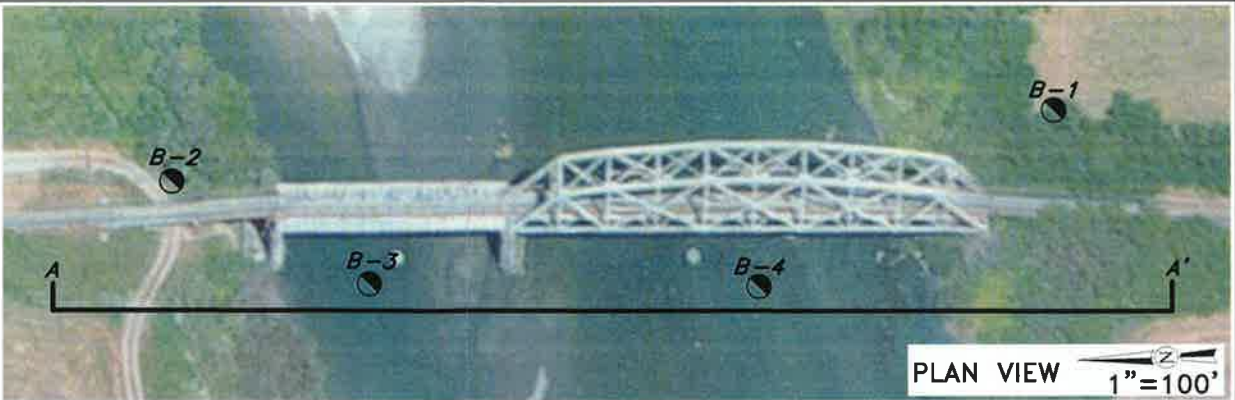
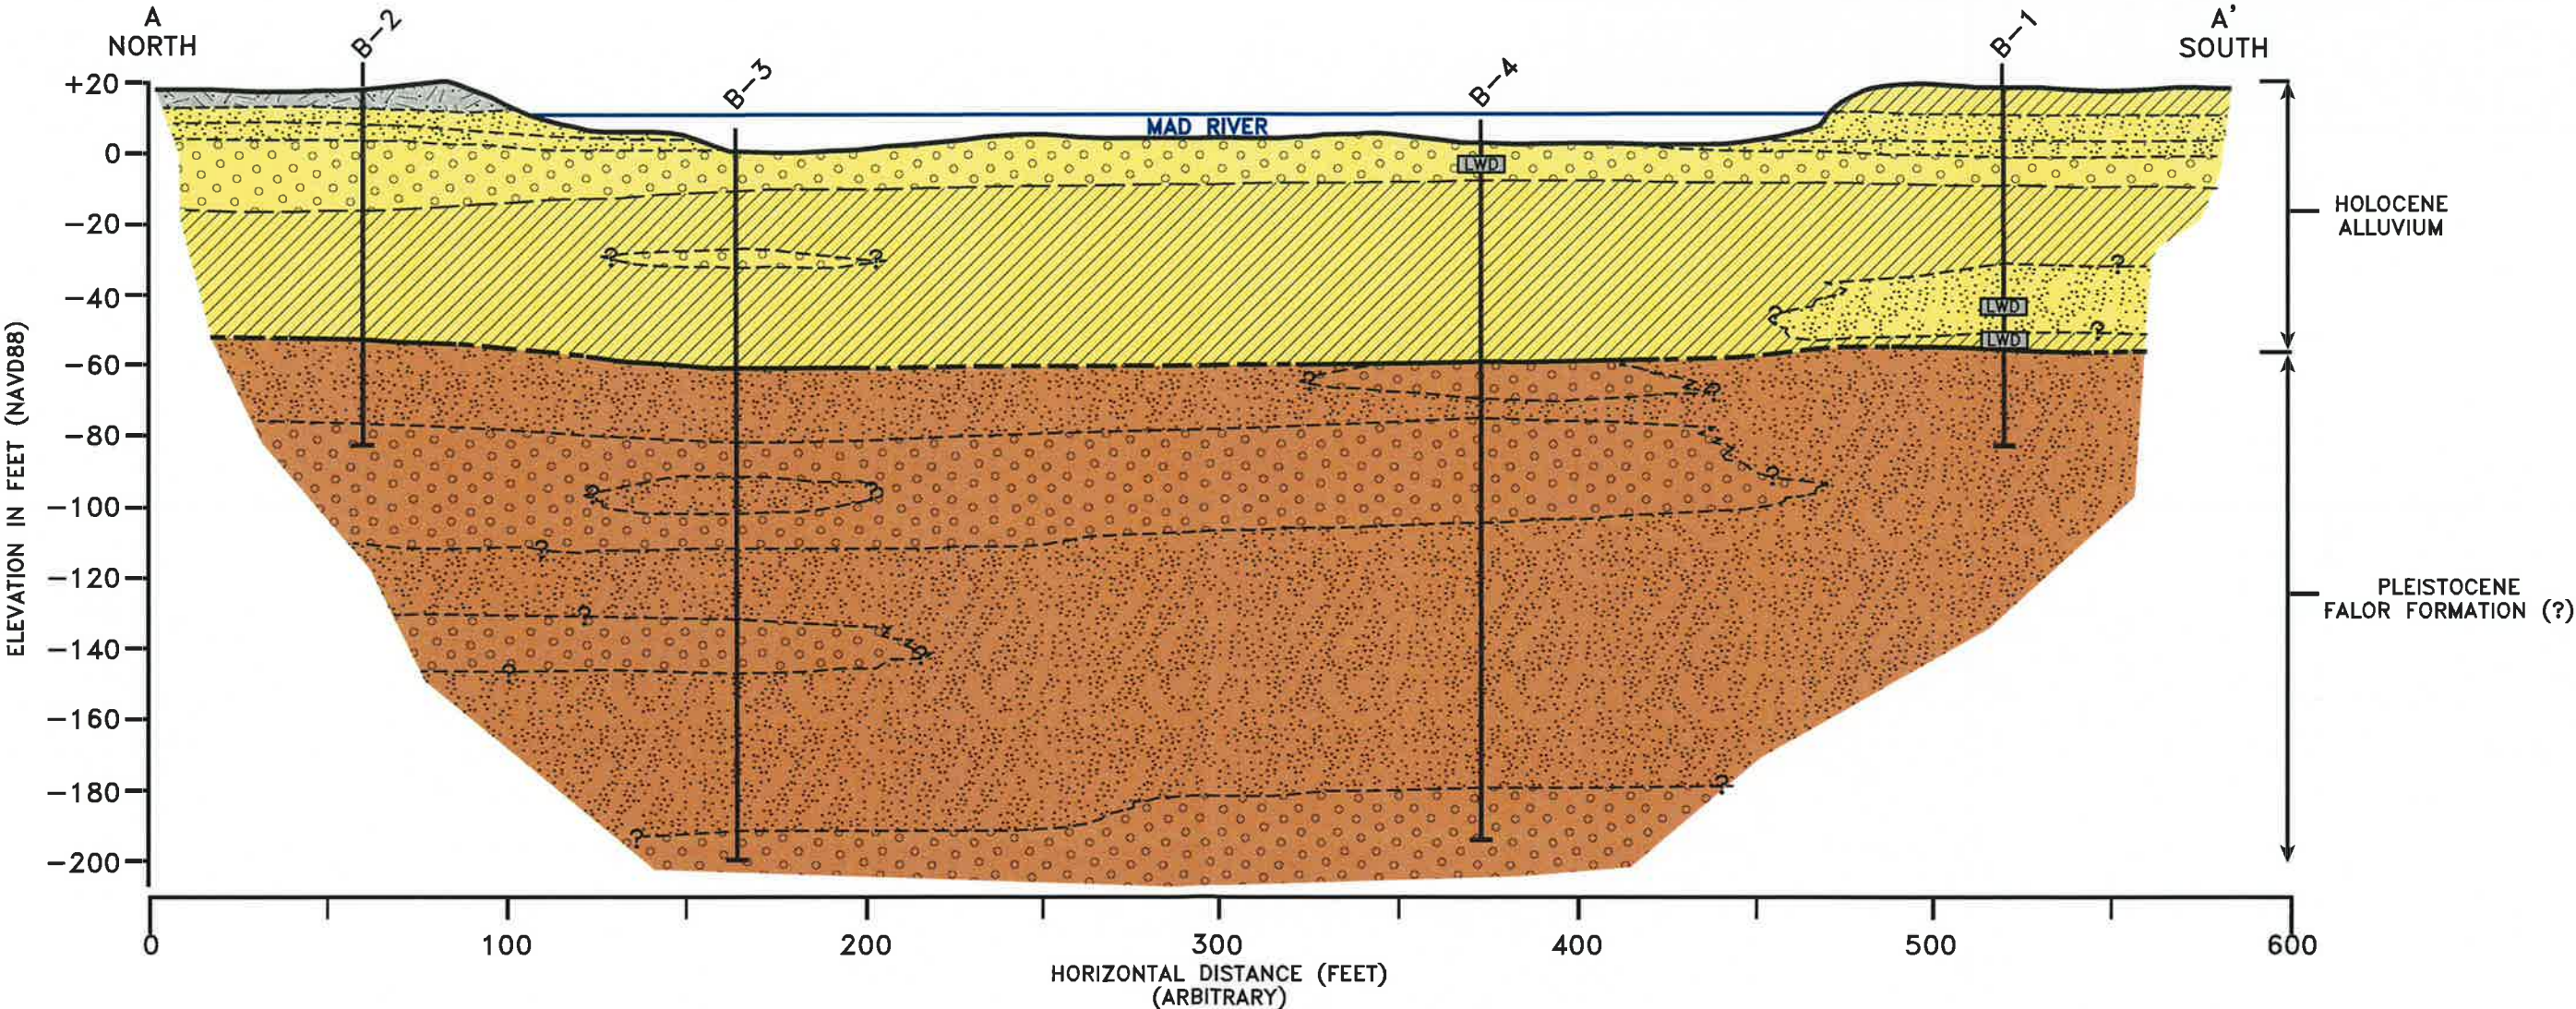
INTERPRETED GEOLOGIC CROSS SECTION  
HAMMOND TRAIL PEDESTRIAN BRIDGE

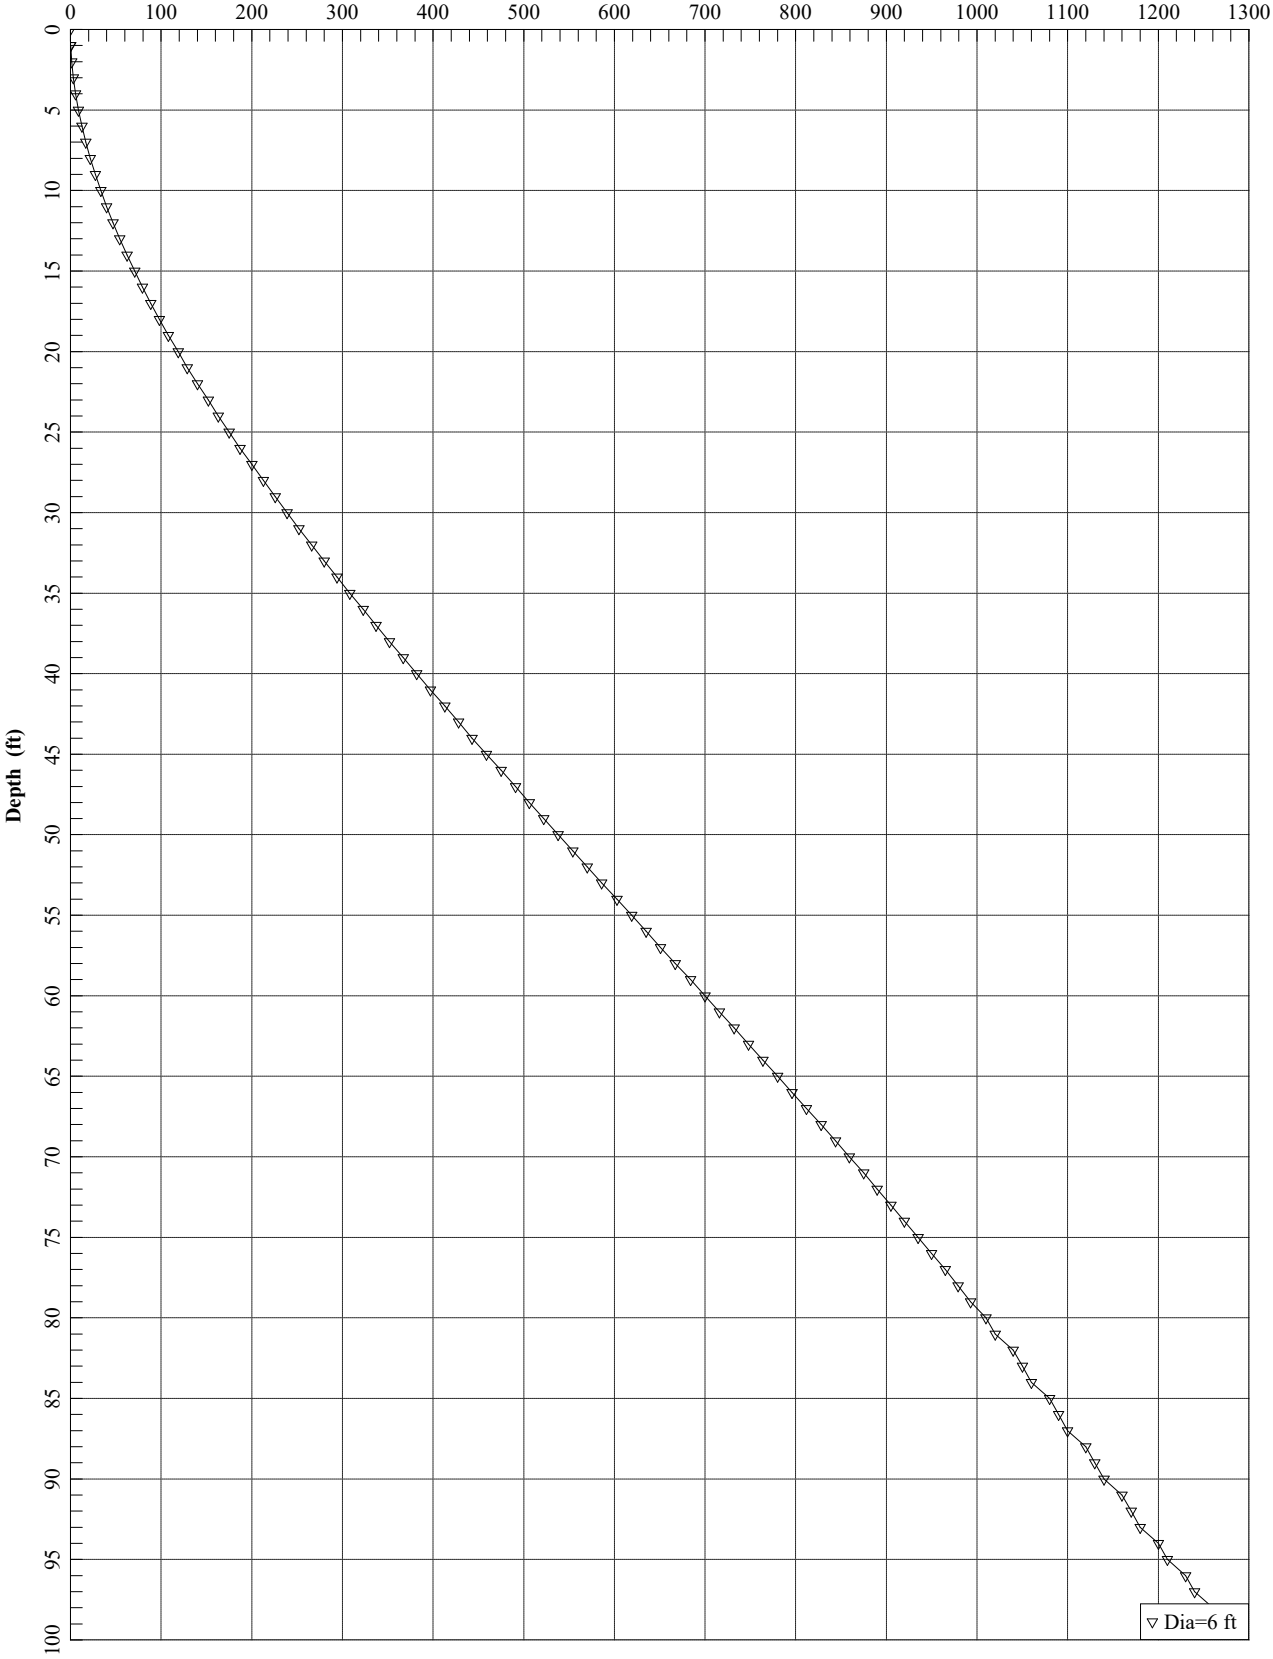
3-948.9 - Hammond Trail Pedestrian Bridge - North Channel - Strength (Compression)  
Ultimate Skin Friction (tons)

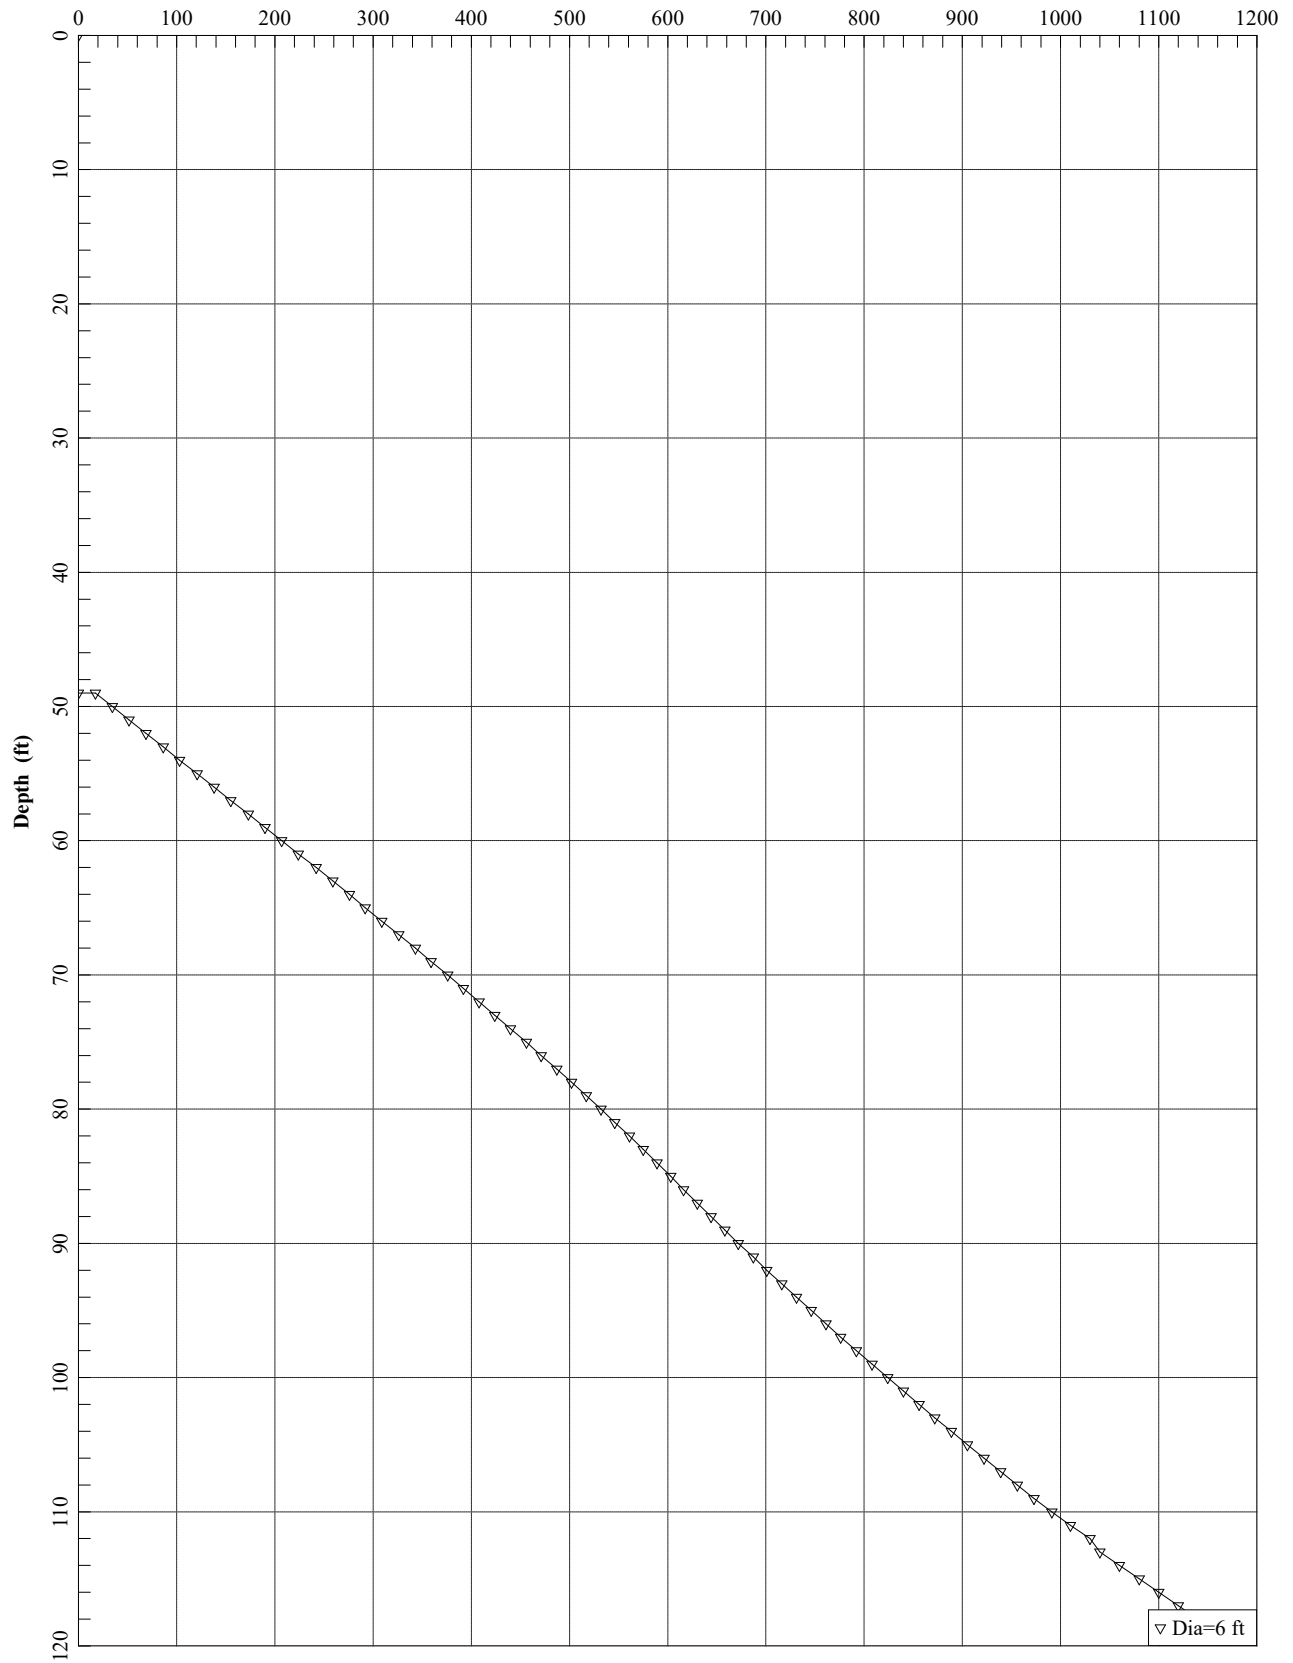
**3-948.9 - Hammond Trail Pedestrian Bridge - North Channel - Extreme w/o DD (Compression)**  
**Ultimate Skin Friction (tons)**

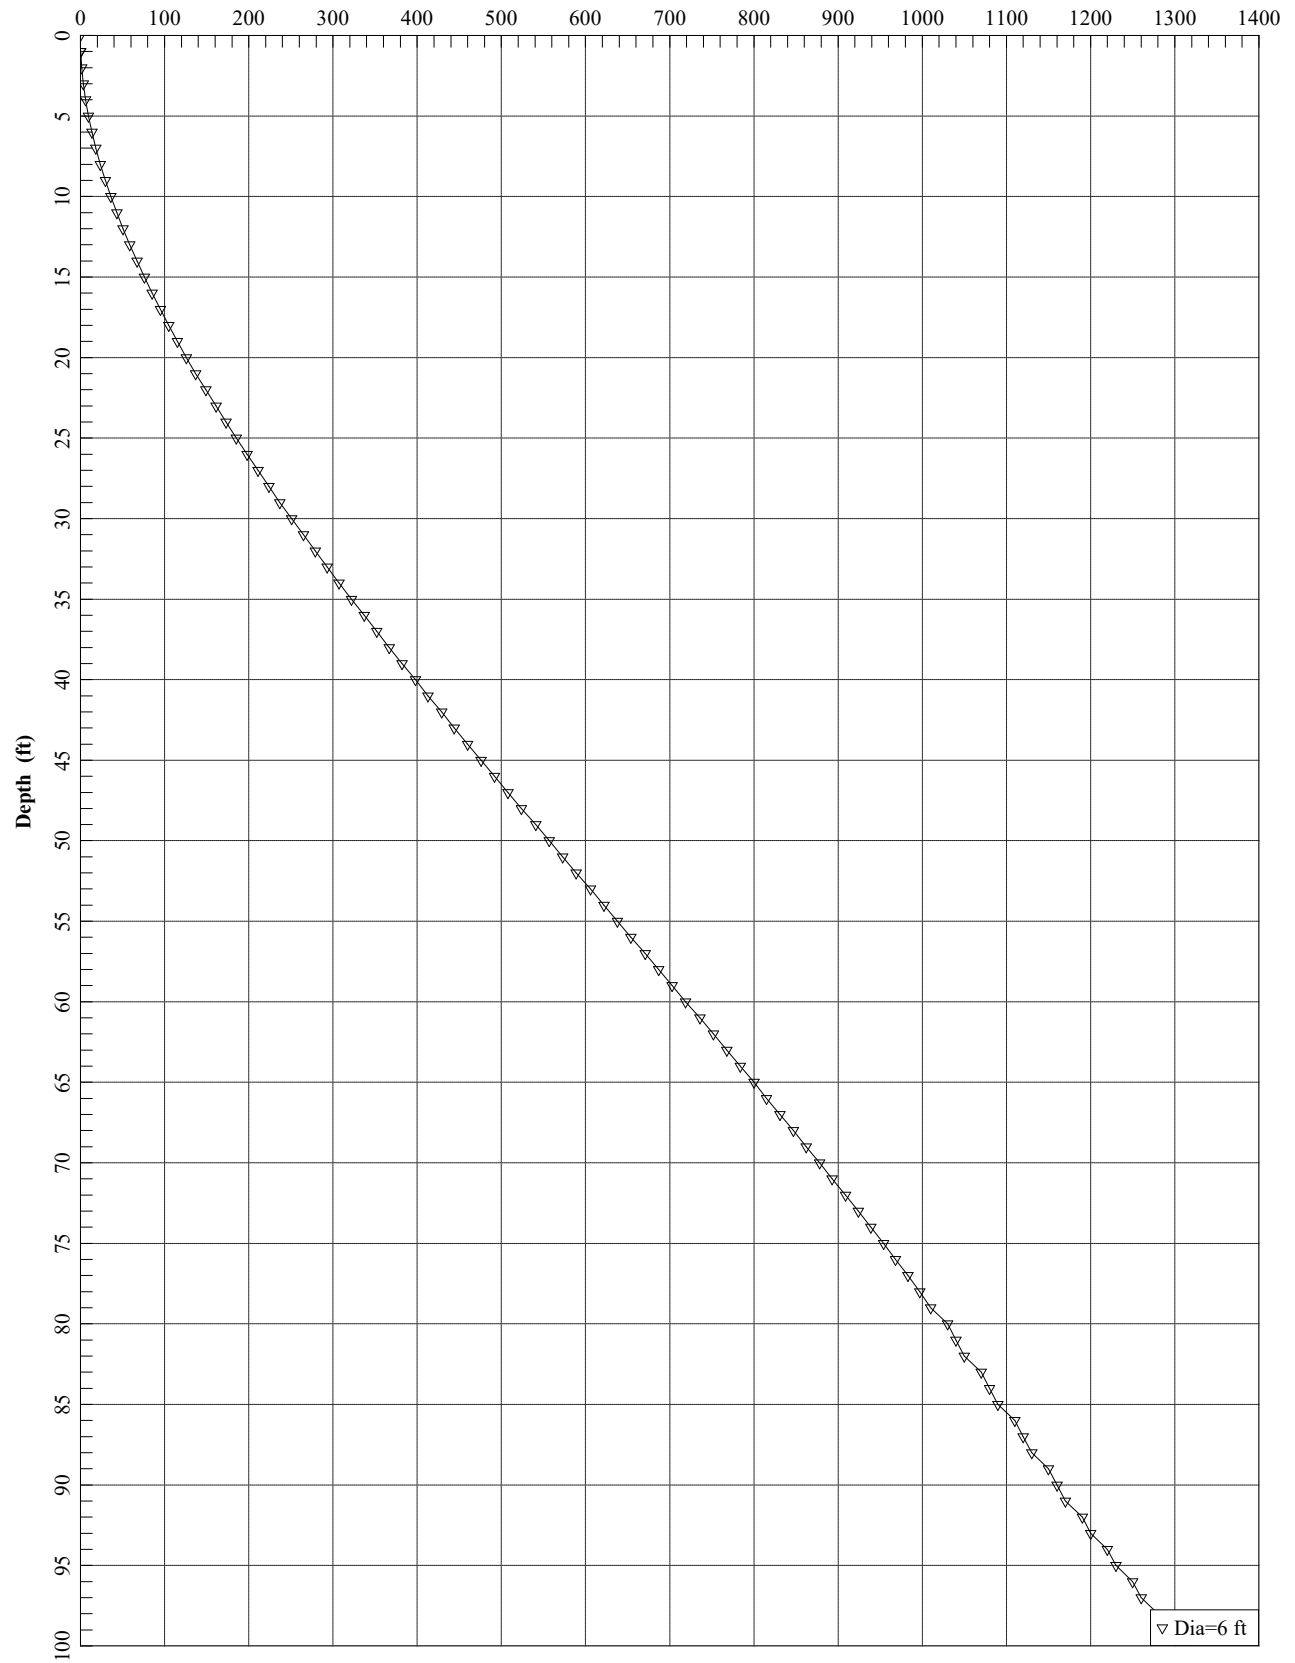
3-948.9 - Hammond Trail Pedestrian Bridge - North Channel - DDMax (Compression)  
Ultimate Skin Friction (tons)

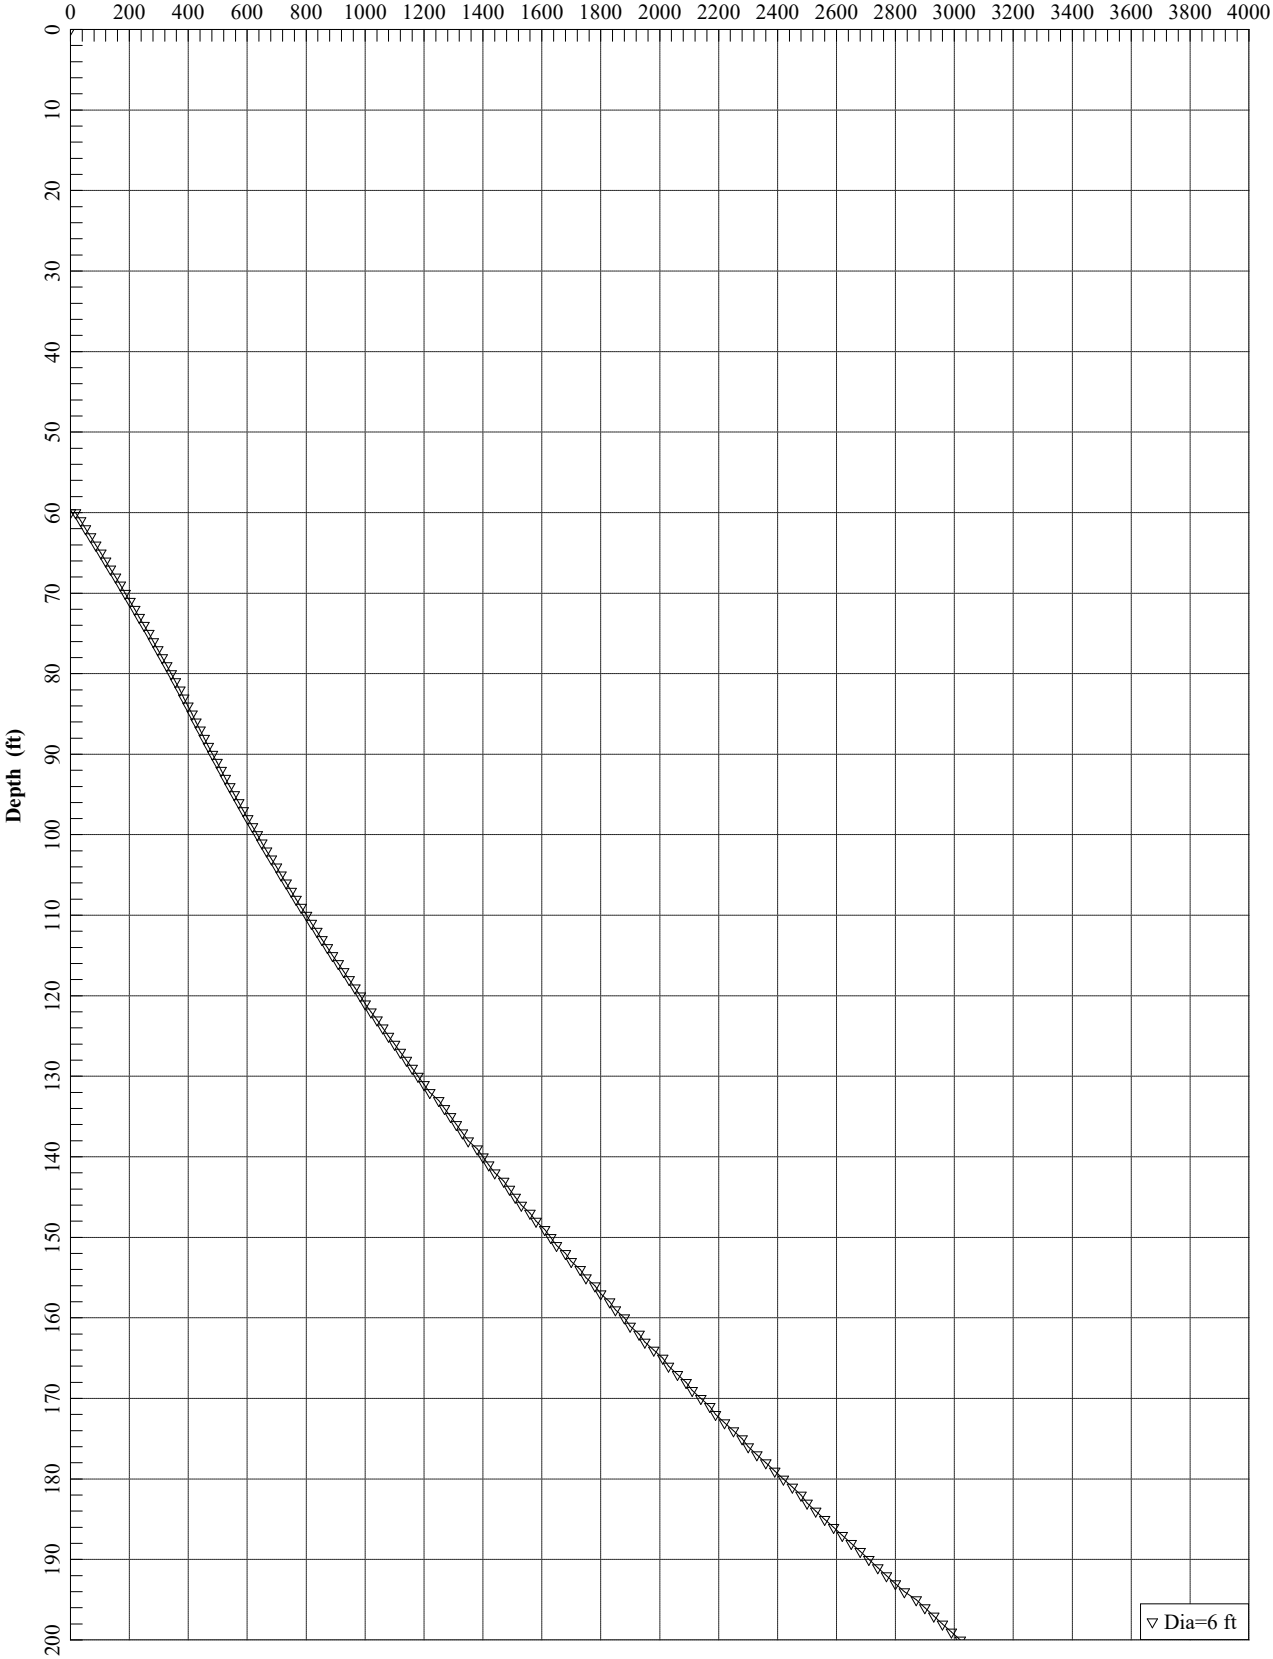
3-948.9 - Hammond Trail Pedestrian Bridge - North Channel - Extreme w/ DD (Compression)  
Ultimate Skin Friction (tons)

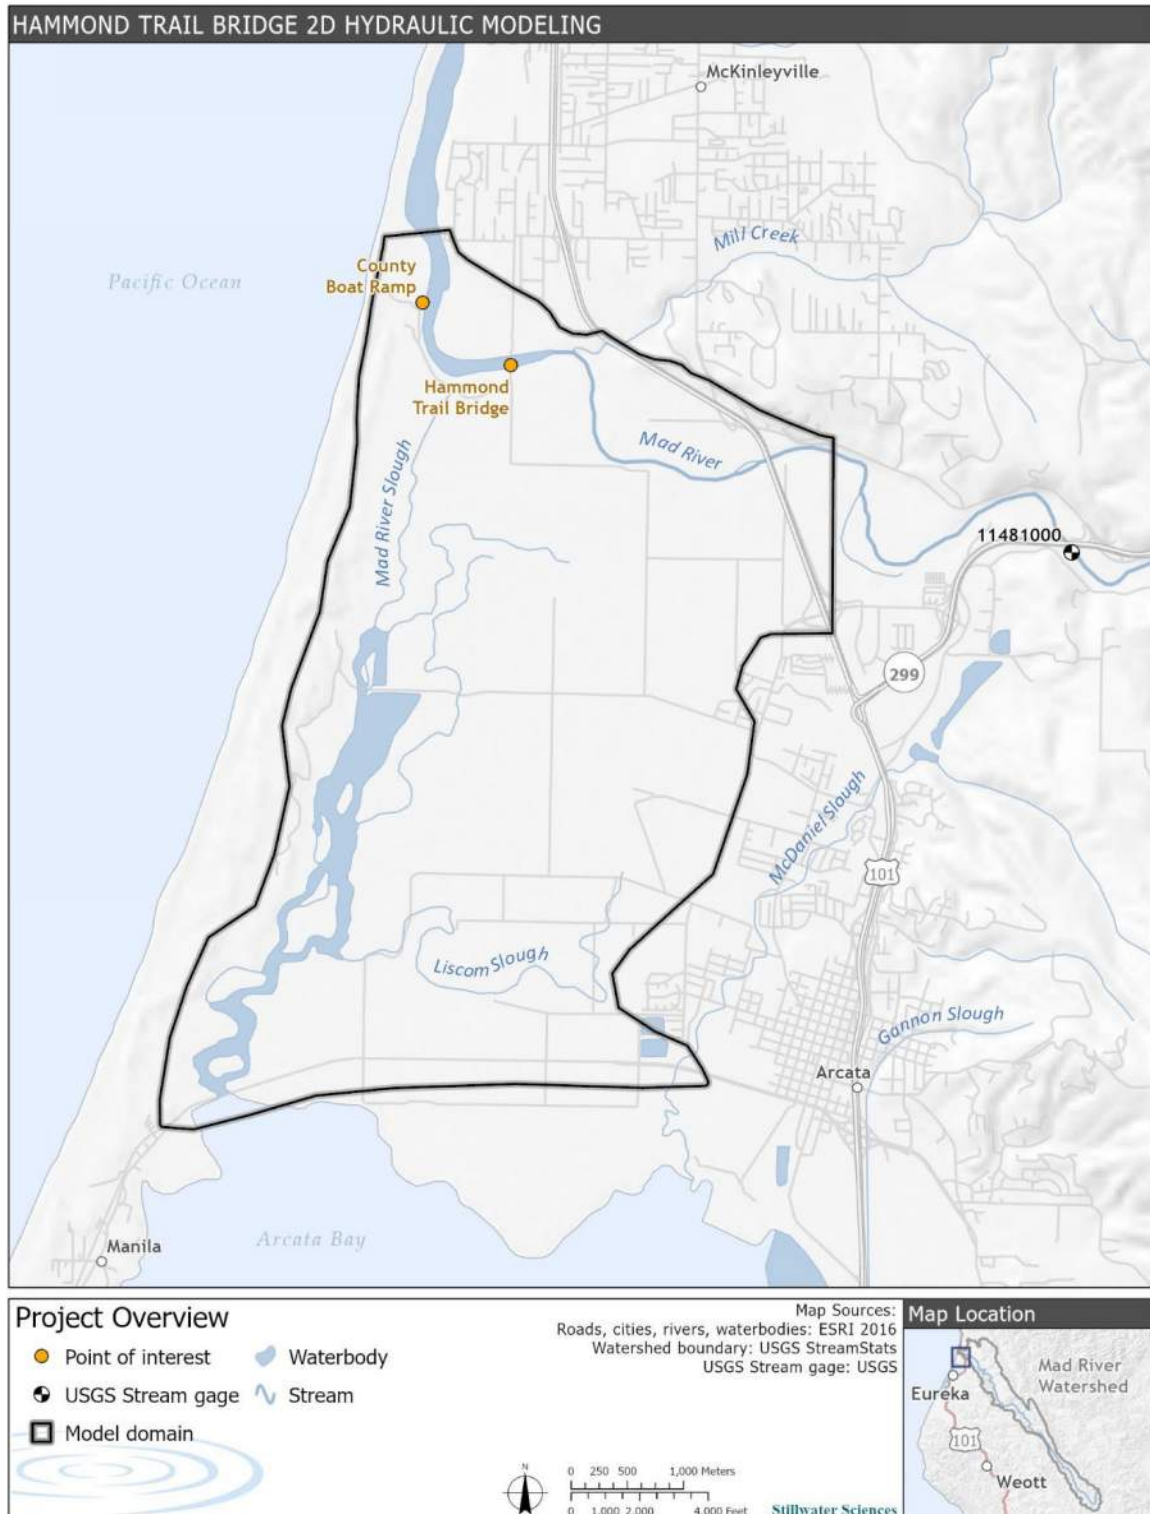
| CONTRACT ITEMS | | UNIT | QUANTITY | PRICE | AMOUNT |
|---|---|---|---|---|---|
| FOR BUDGET PURPOSES - USE | | | | | \$ 9,460,000 |

**Figure 1.** Study area map showing the extent of hydraulic modeling and locations of the Hammond Trail Bridge, USGS gaging station, and public boat launch.

The Mad River drains approximately 500 square miles of the northern California Coast Range in Trinity and Humboldt counties. The river follows a predominately northwesterly course from its headwaters at an elevation of 5,300 feet to sea level where it drains into the Pacific Ocean near the community of McKinleyville, California. The Hammond Trail Bridge is located approximately 3.75 miles upstream of the present-day Mad River mouth and connects the northern and southern sections of the Hammond Trail. Originally constructed as a railroad bridge for timber operations in 1941, the 540-foot-long structure has served as a public pedestrian and bicycle crossing since 1983 (CH2MHILL, 1998).
