# STRUCTURE TYPE SELECTION REPORT

Hammond Trail Bridge over the Mad River

County of Humboldt Department of Public Works

November 2024

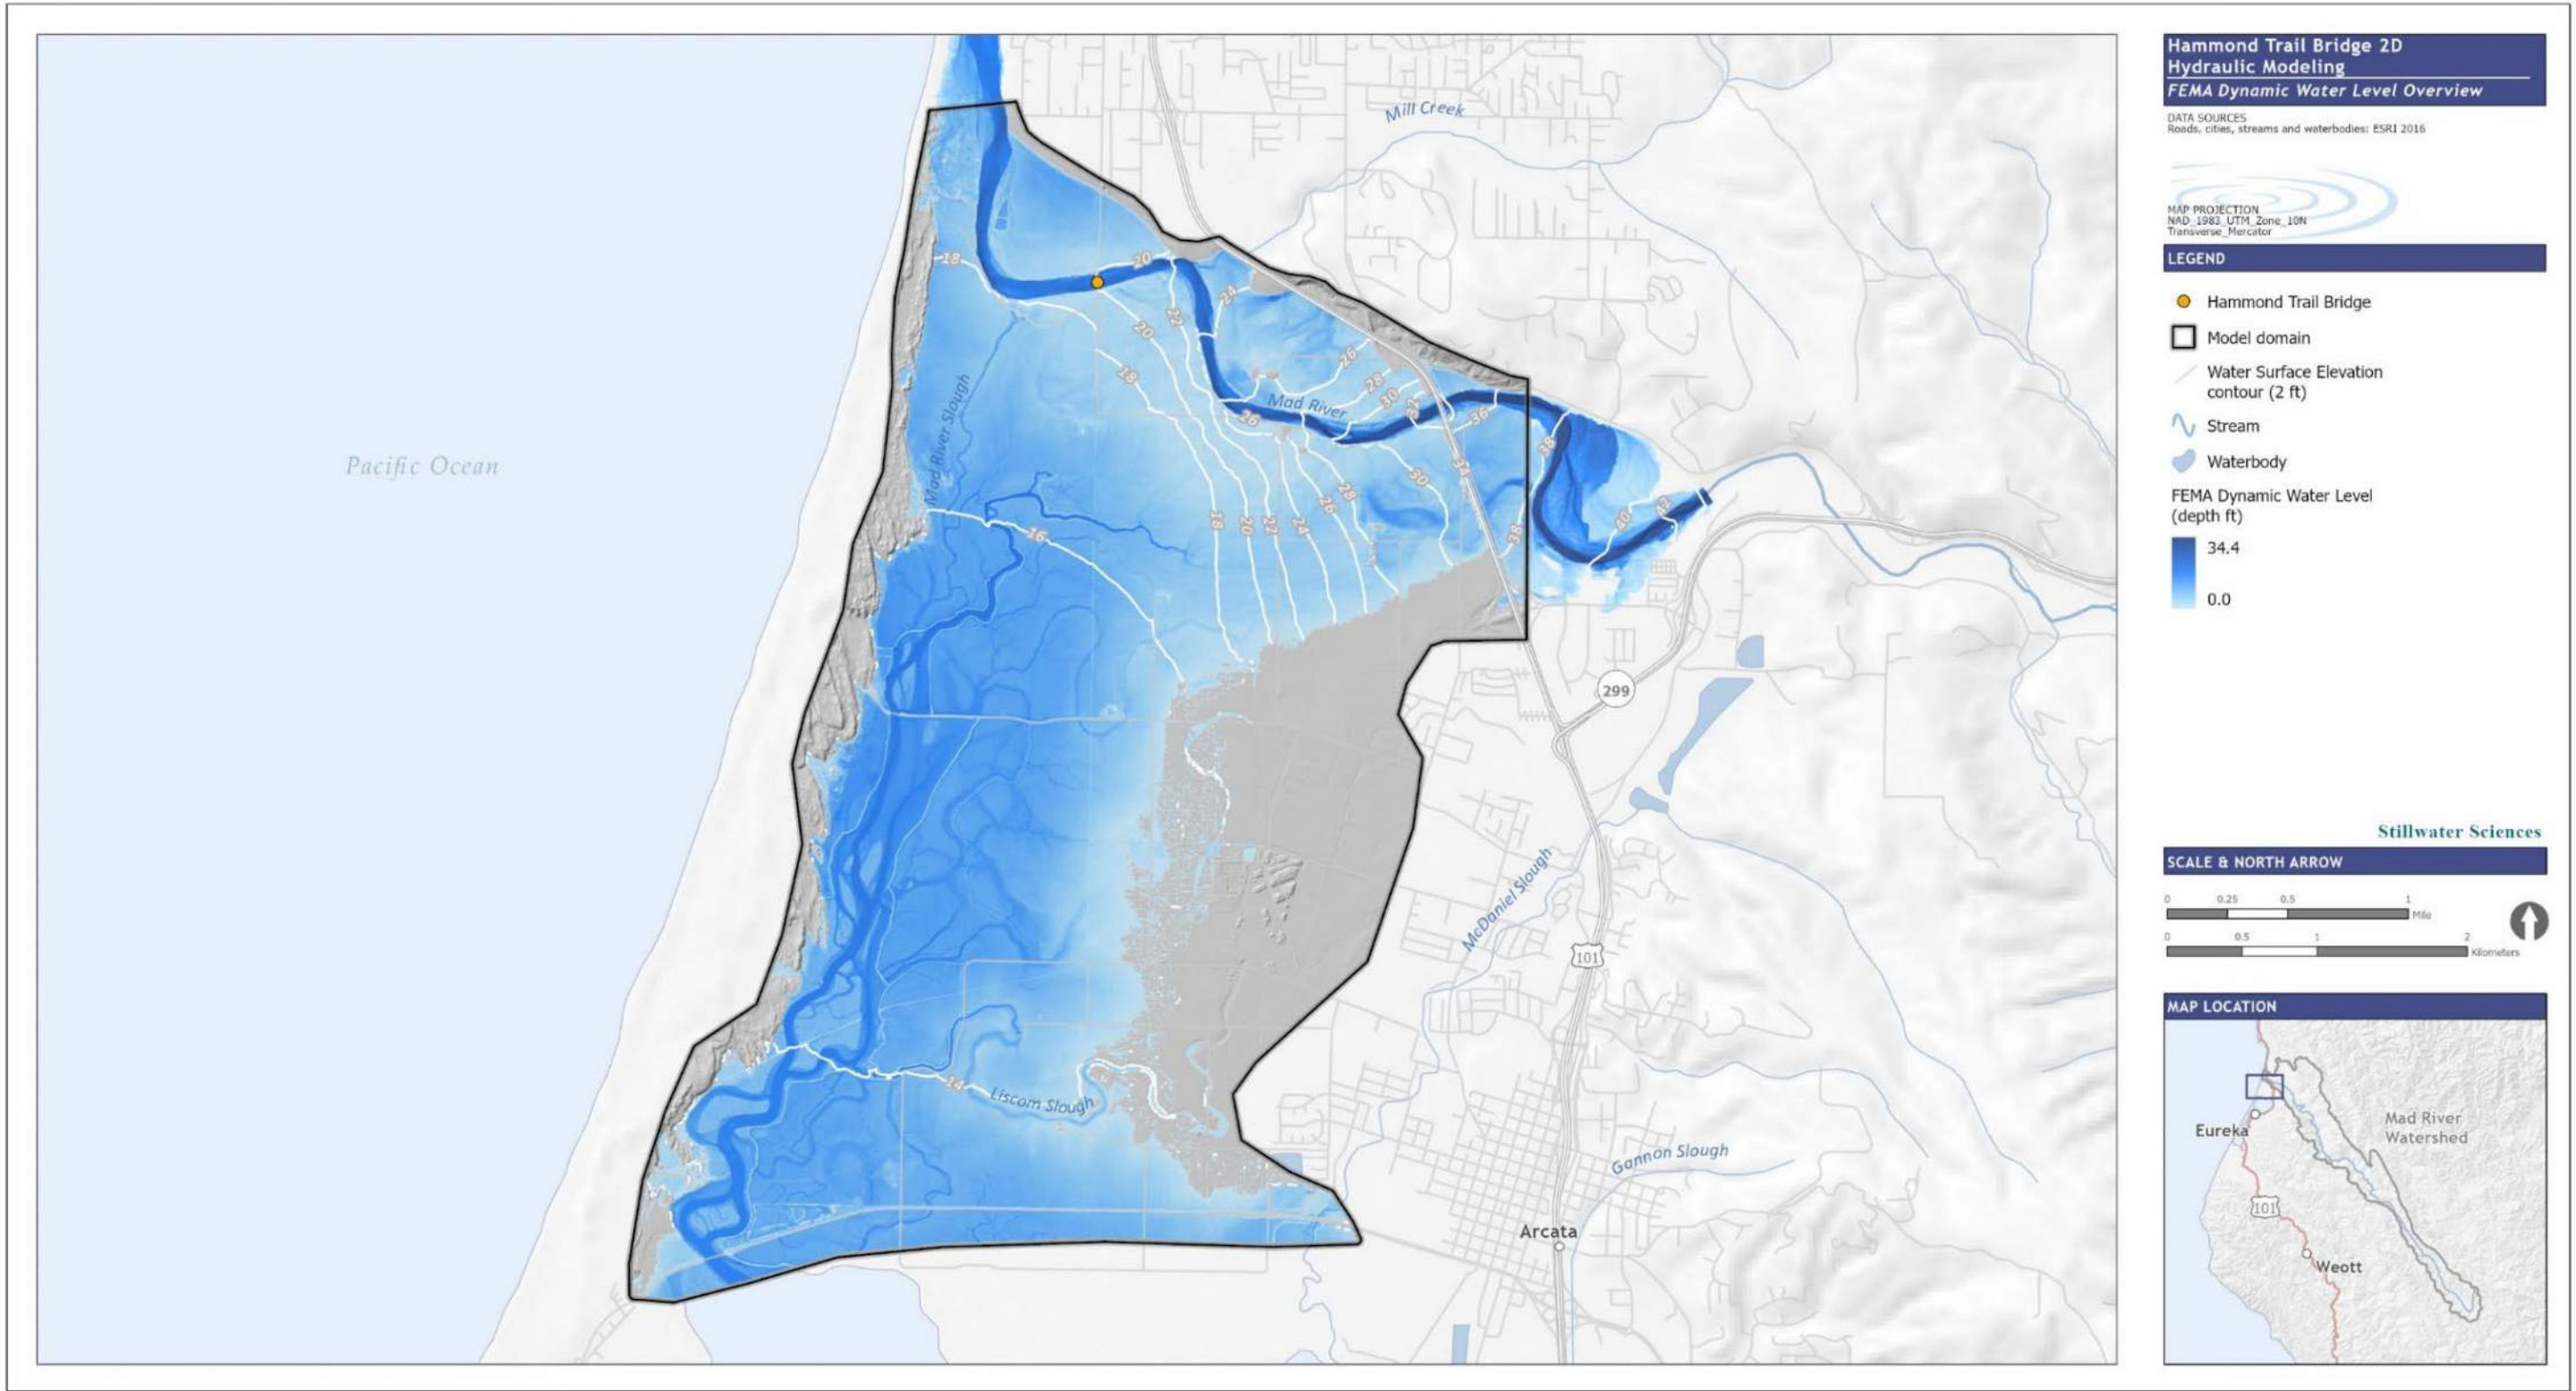
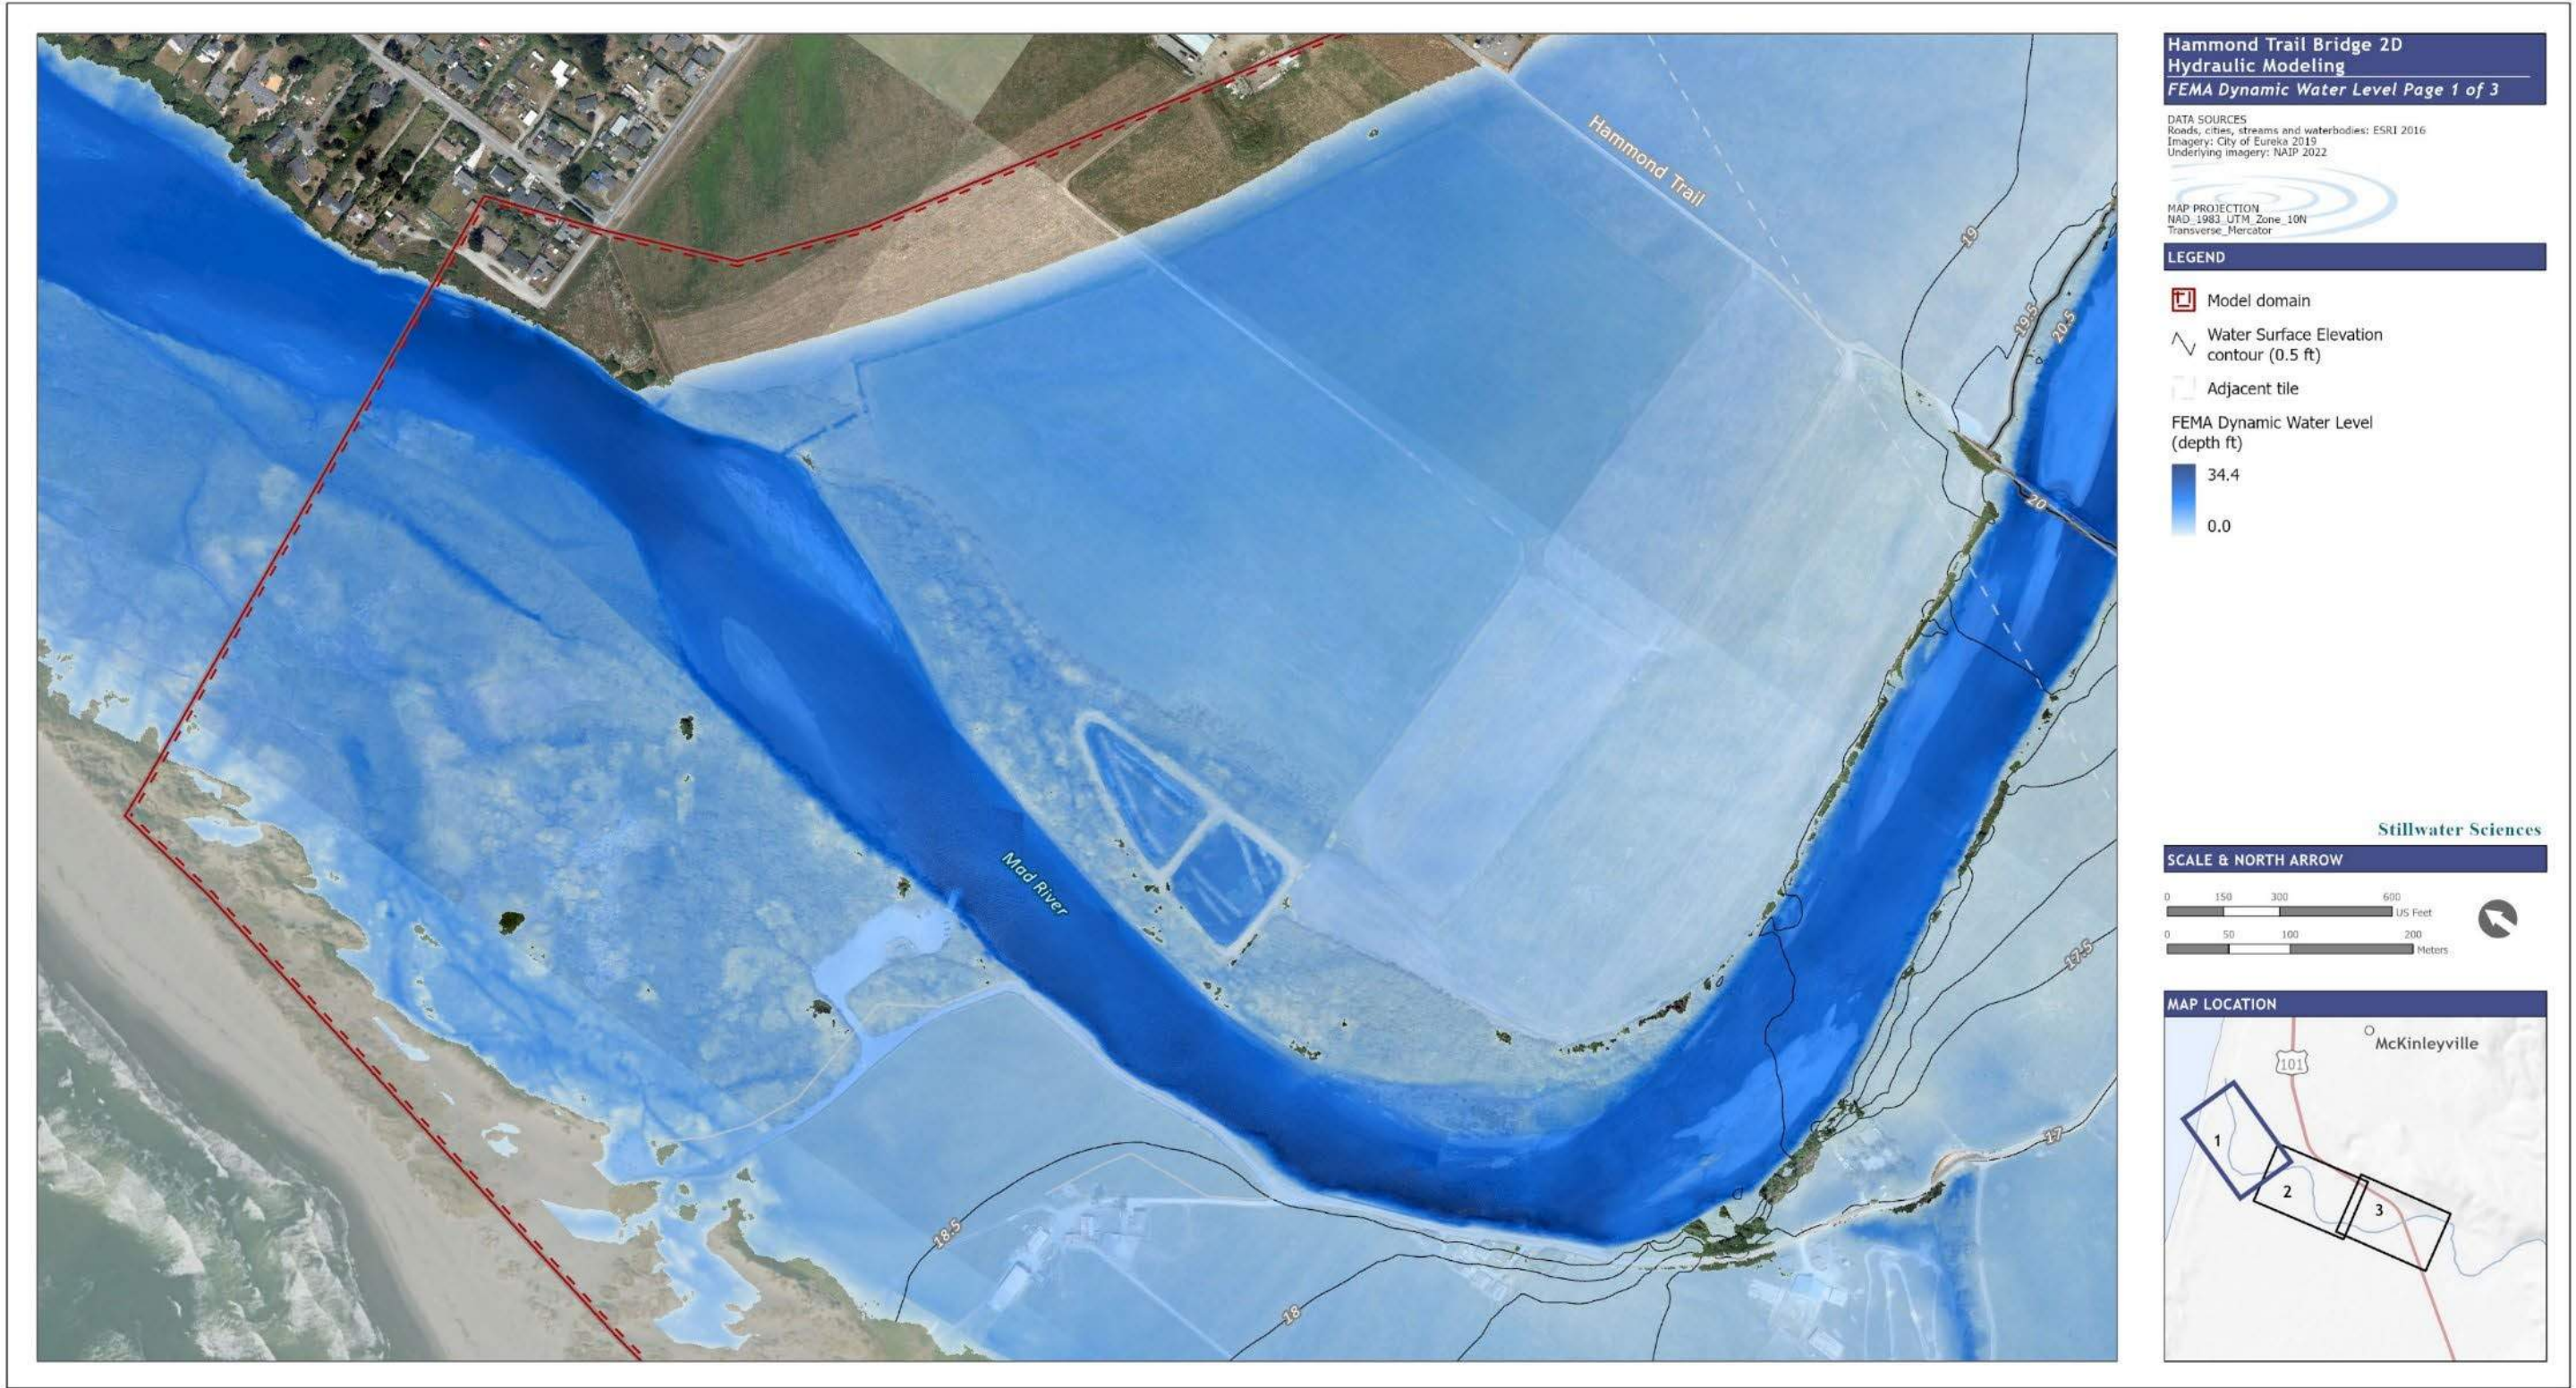
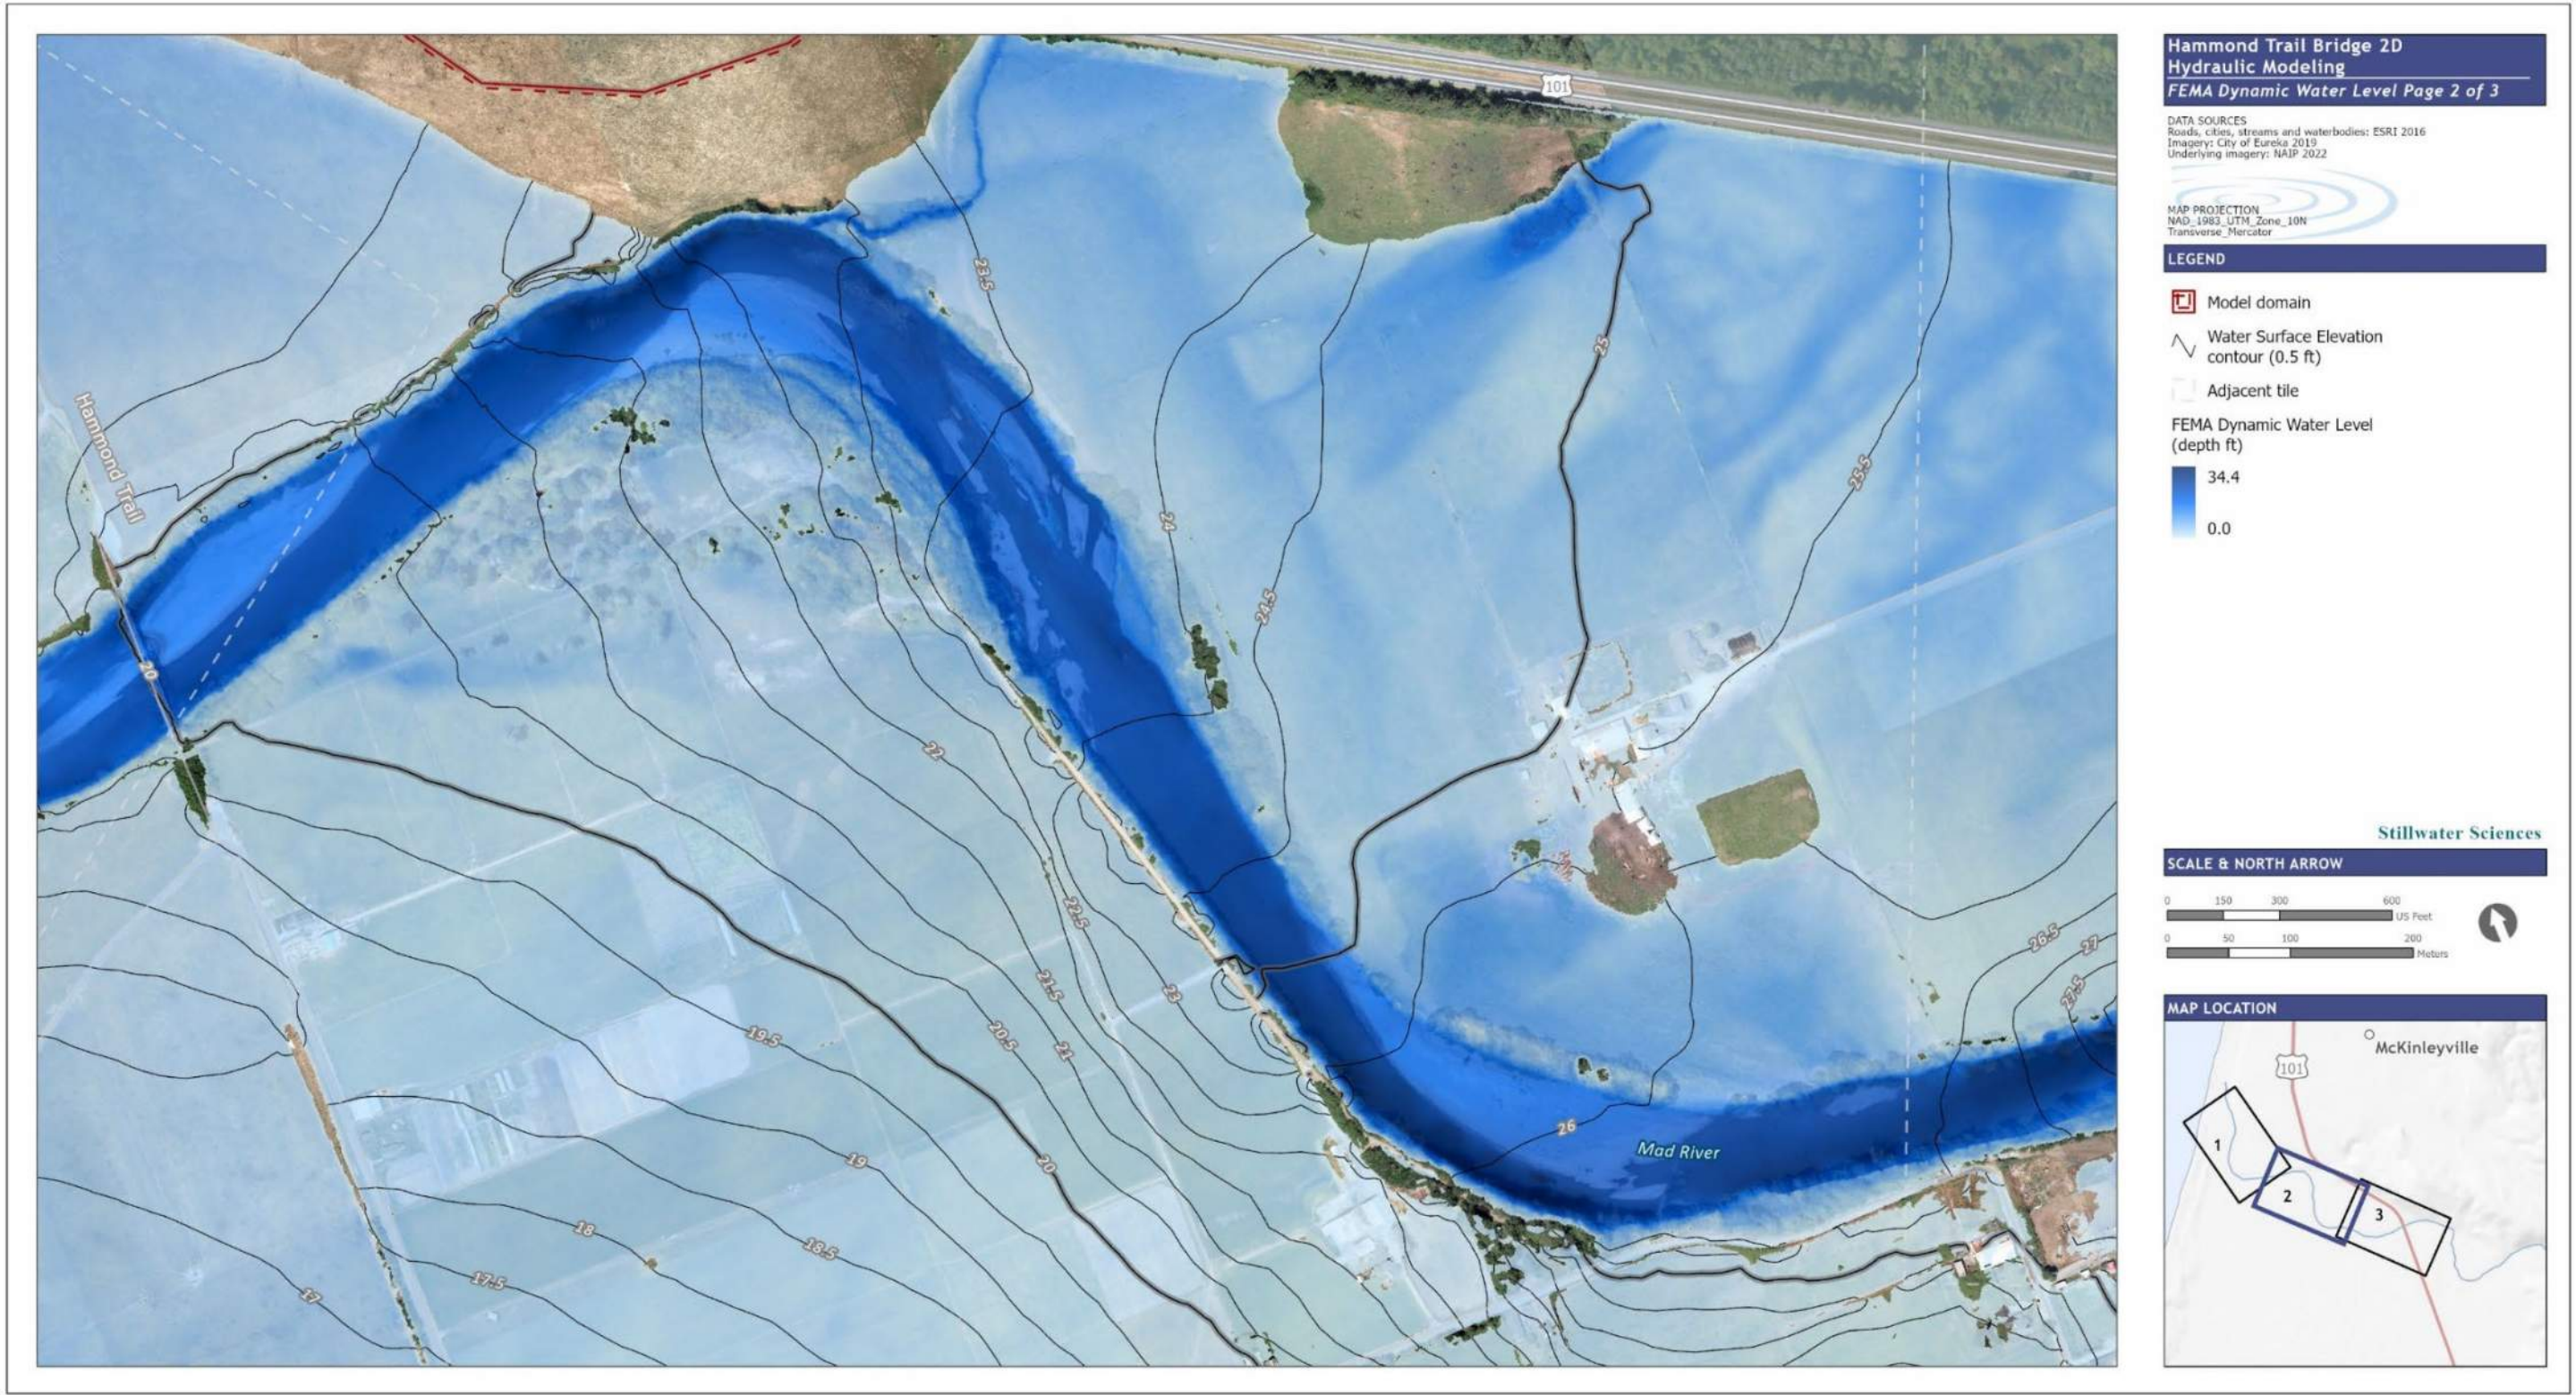
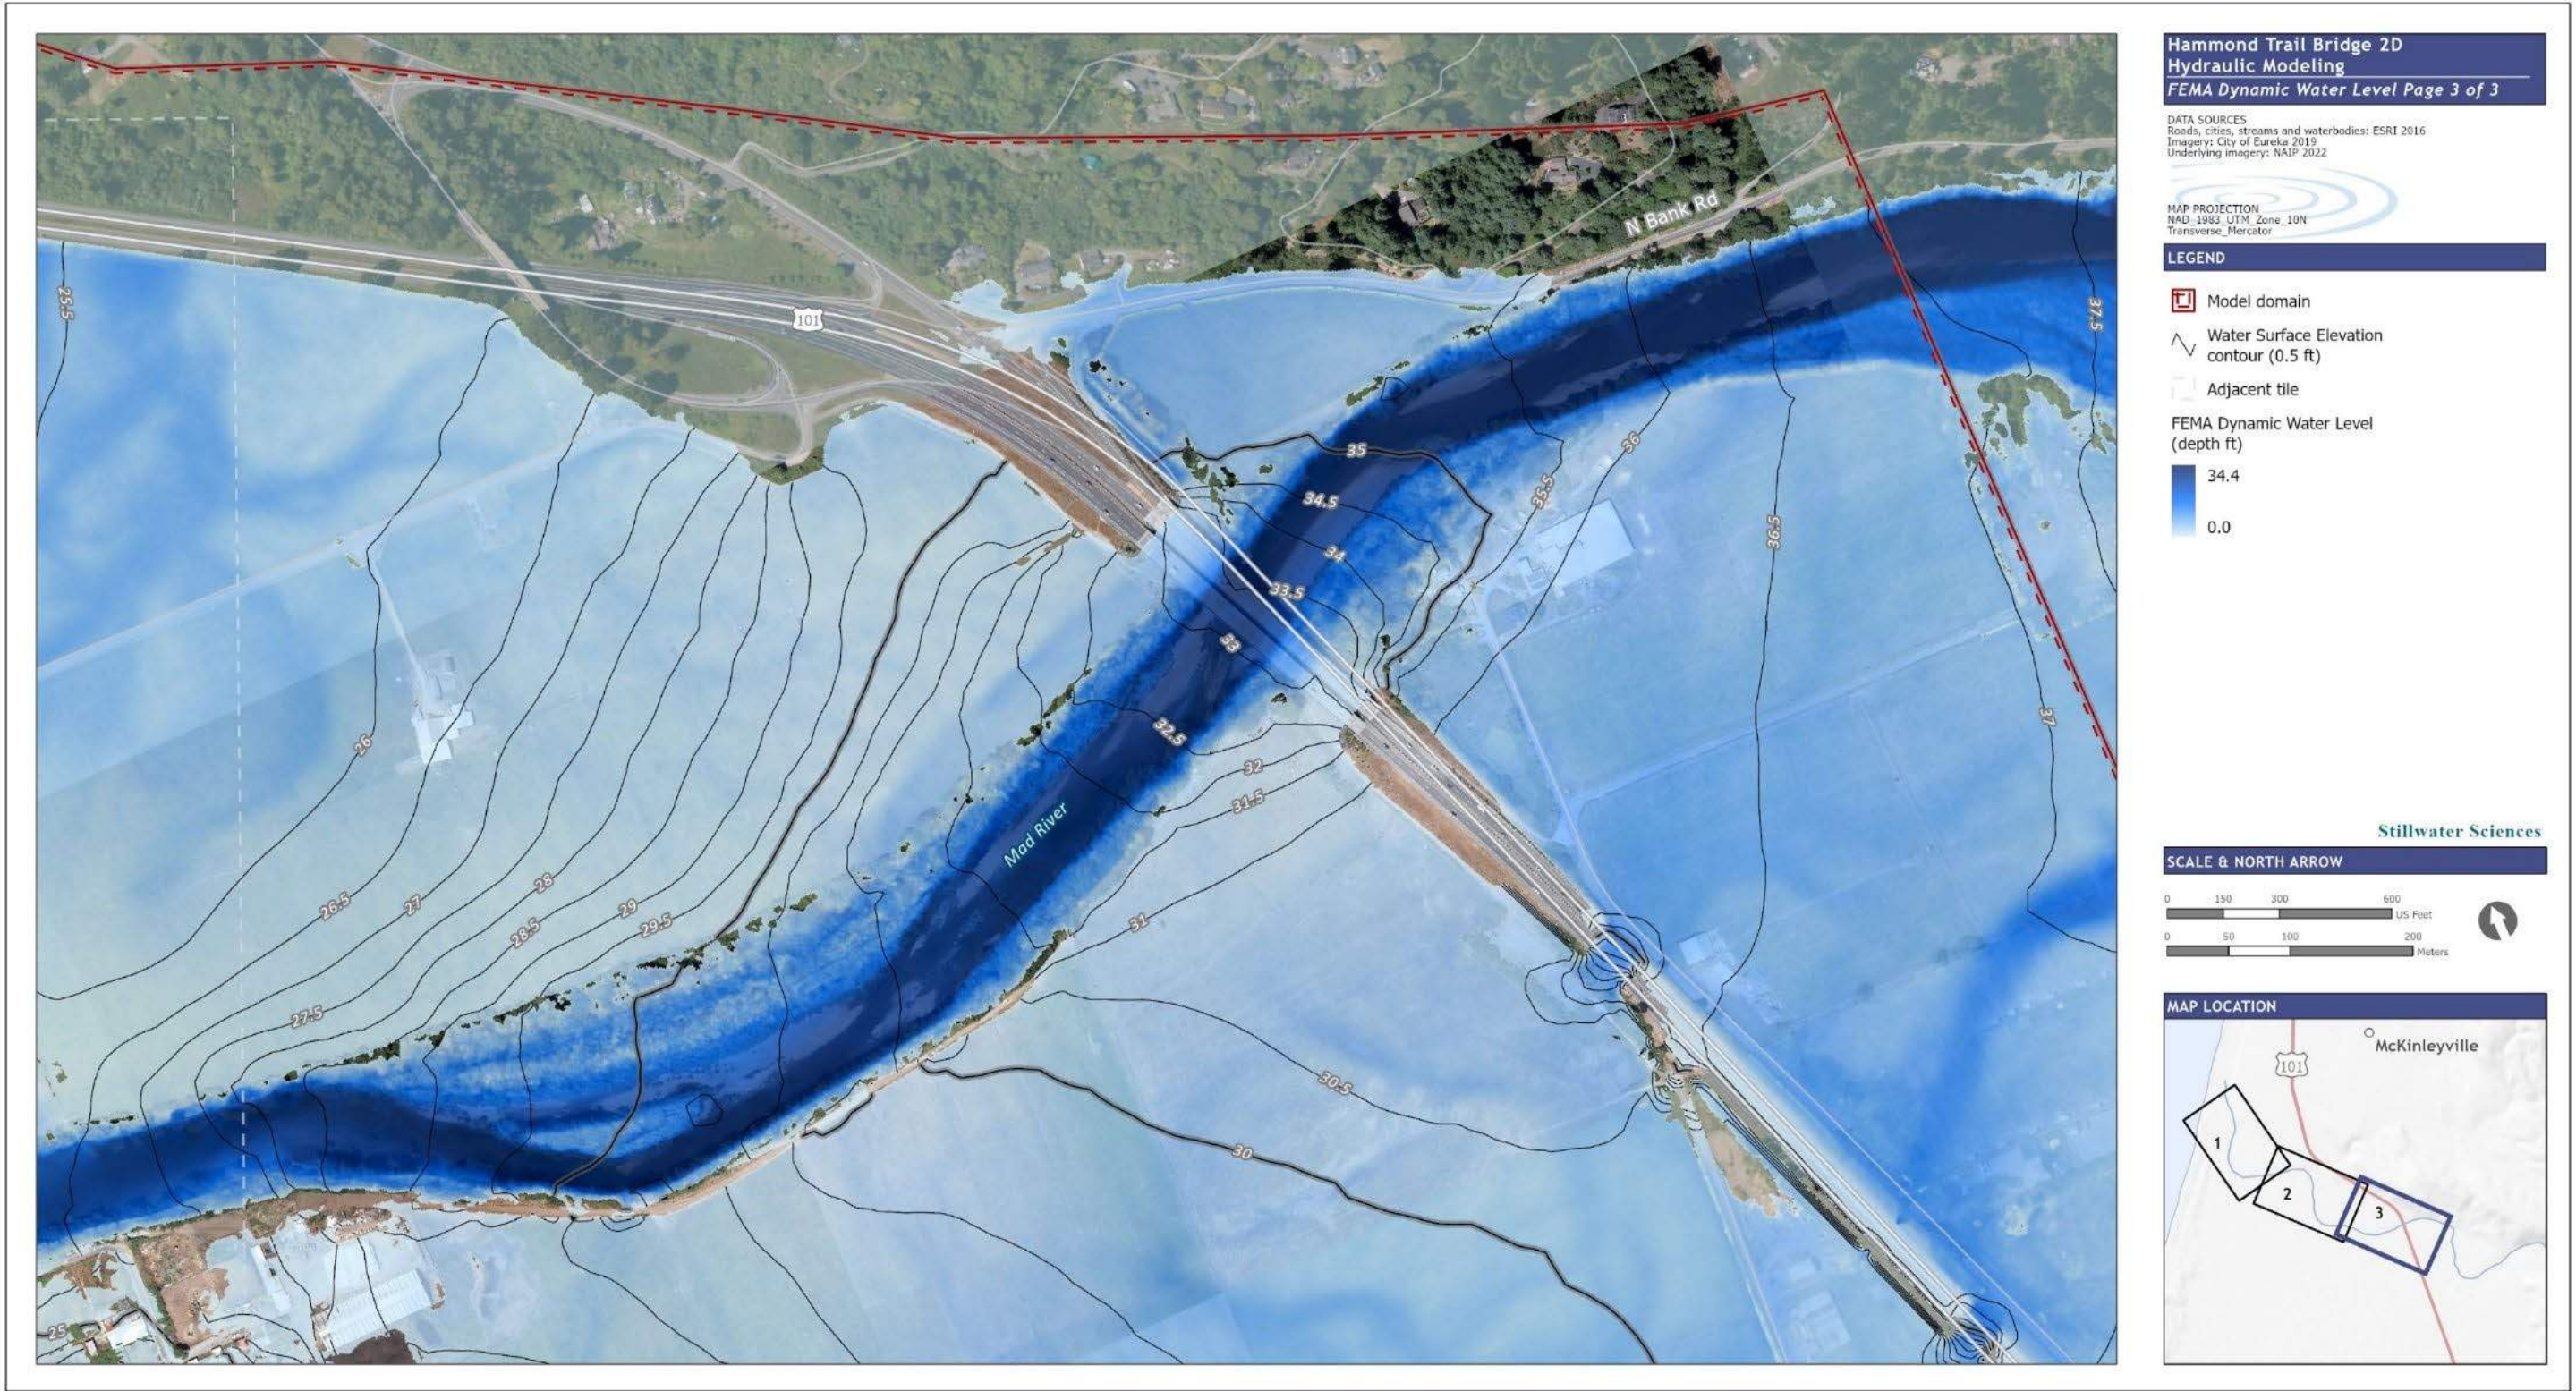
### **Floodplain Maps Showing Average Expected Inundation and Water Surface Elevations During 100-year Storm Event for the FEMA Dynamic Water Level Scenario**

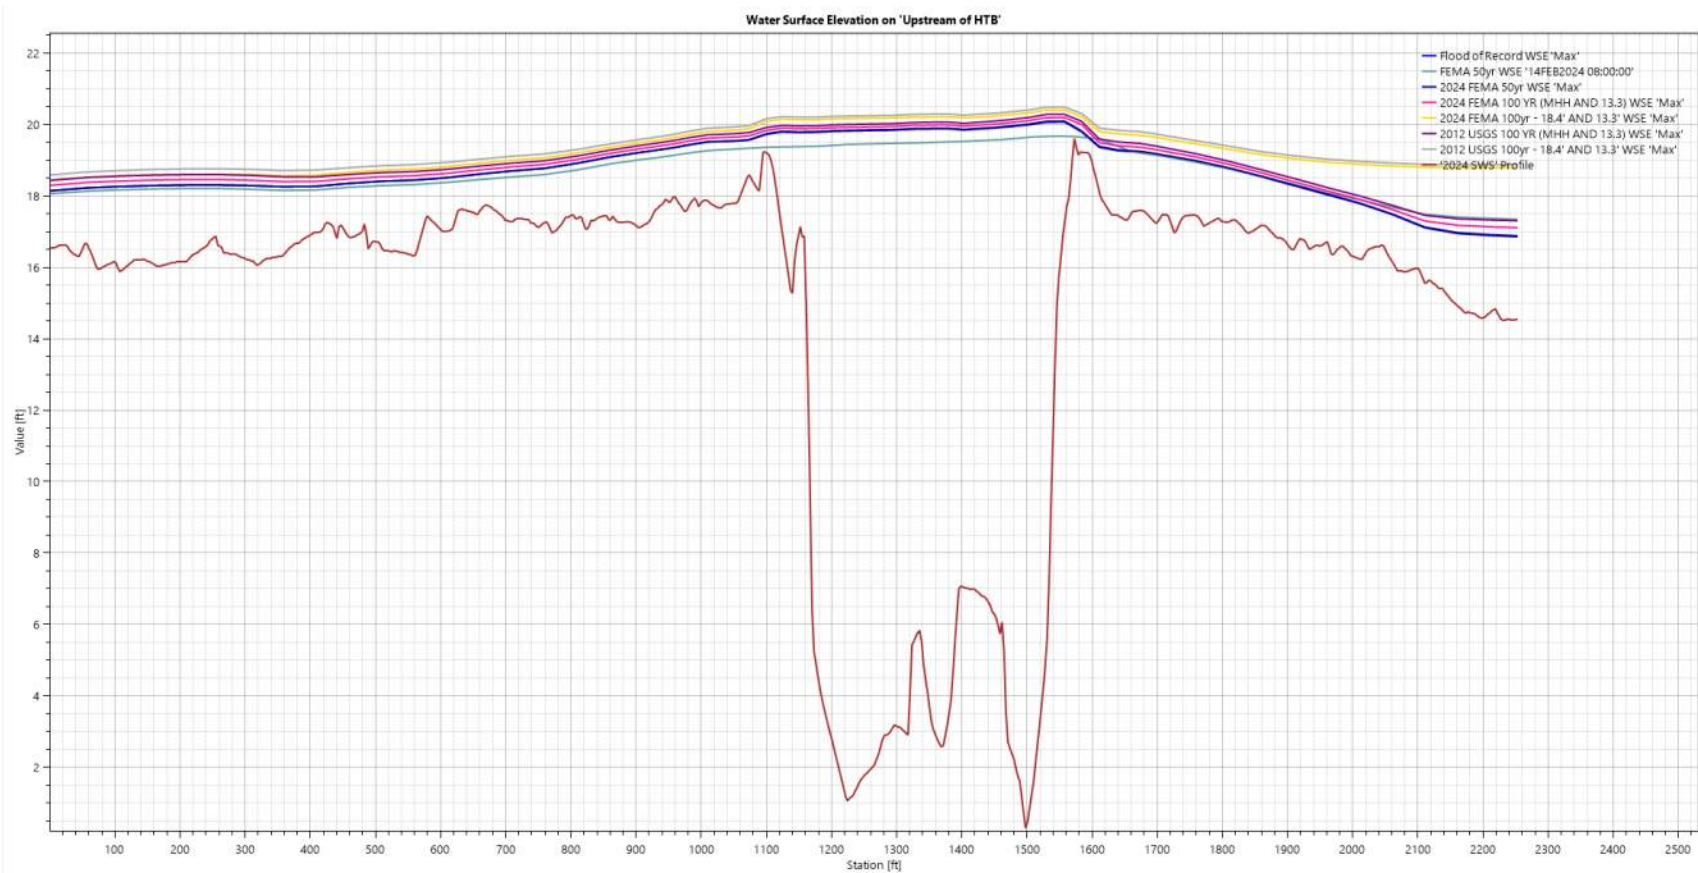
Figure 1. Cross-Section upstream of Hammond Trail Bridge. 2024 SWS is the combined terrain discussed in Section 2.1 Digital Terrain Model Development.

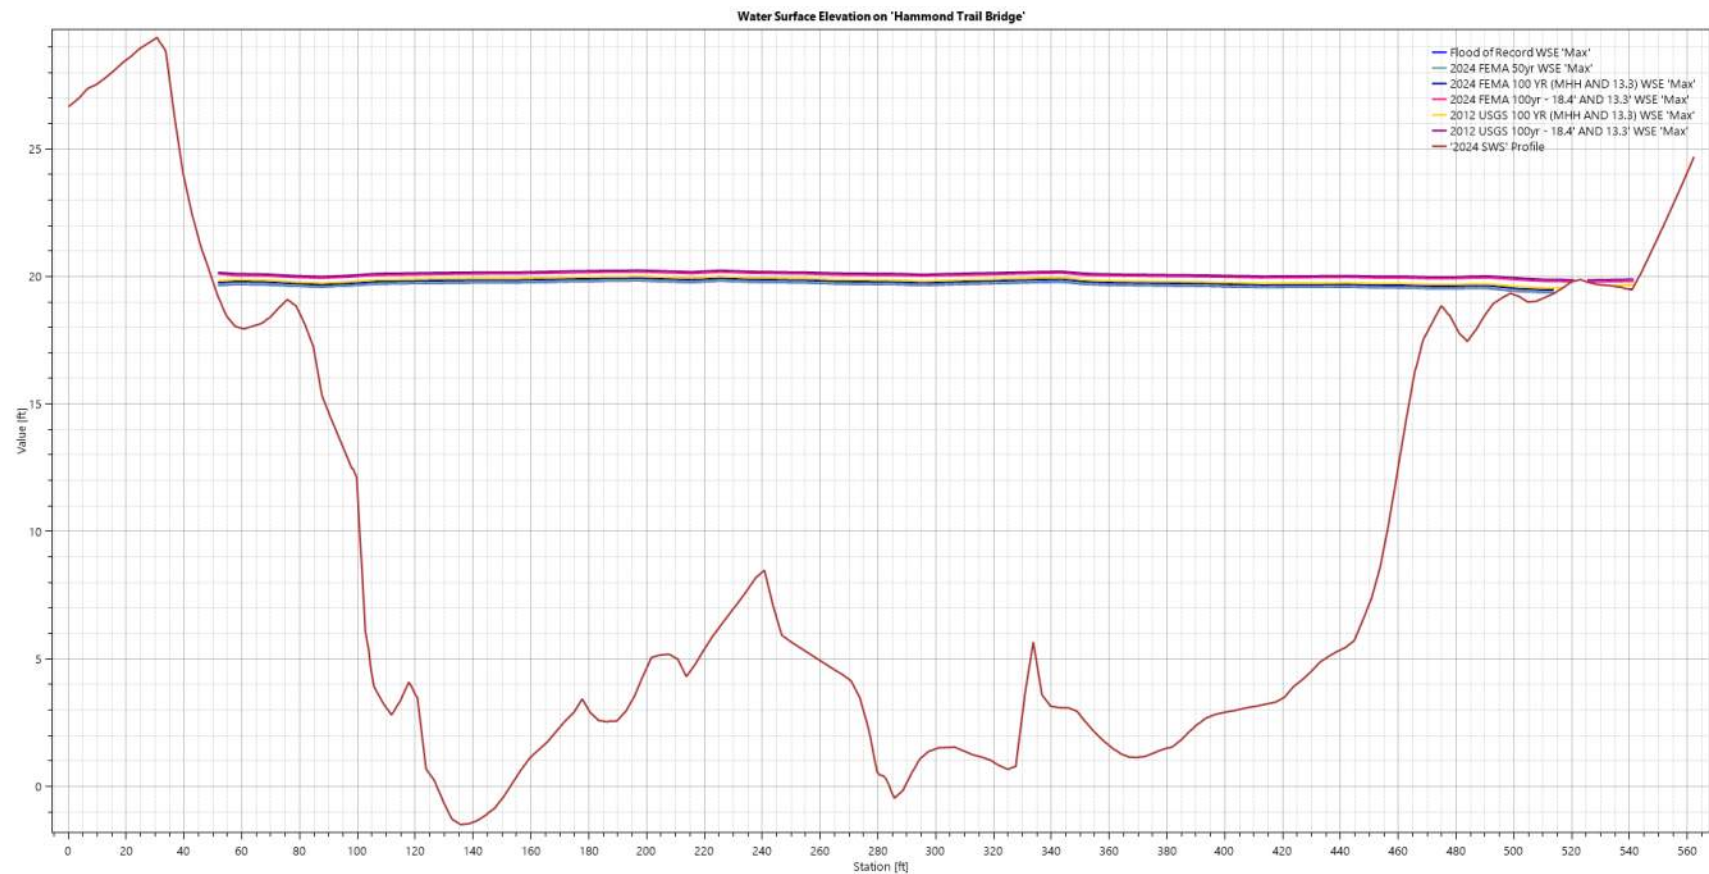
Figure 2. Cross-Section at Hammond Trail Bridge between the approach embankments. 2024 SWS is the combined terrain discussed in Section 2.1 Digital Terrain Model Development.

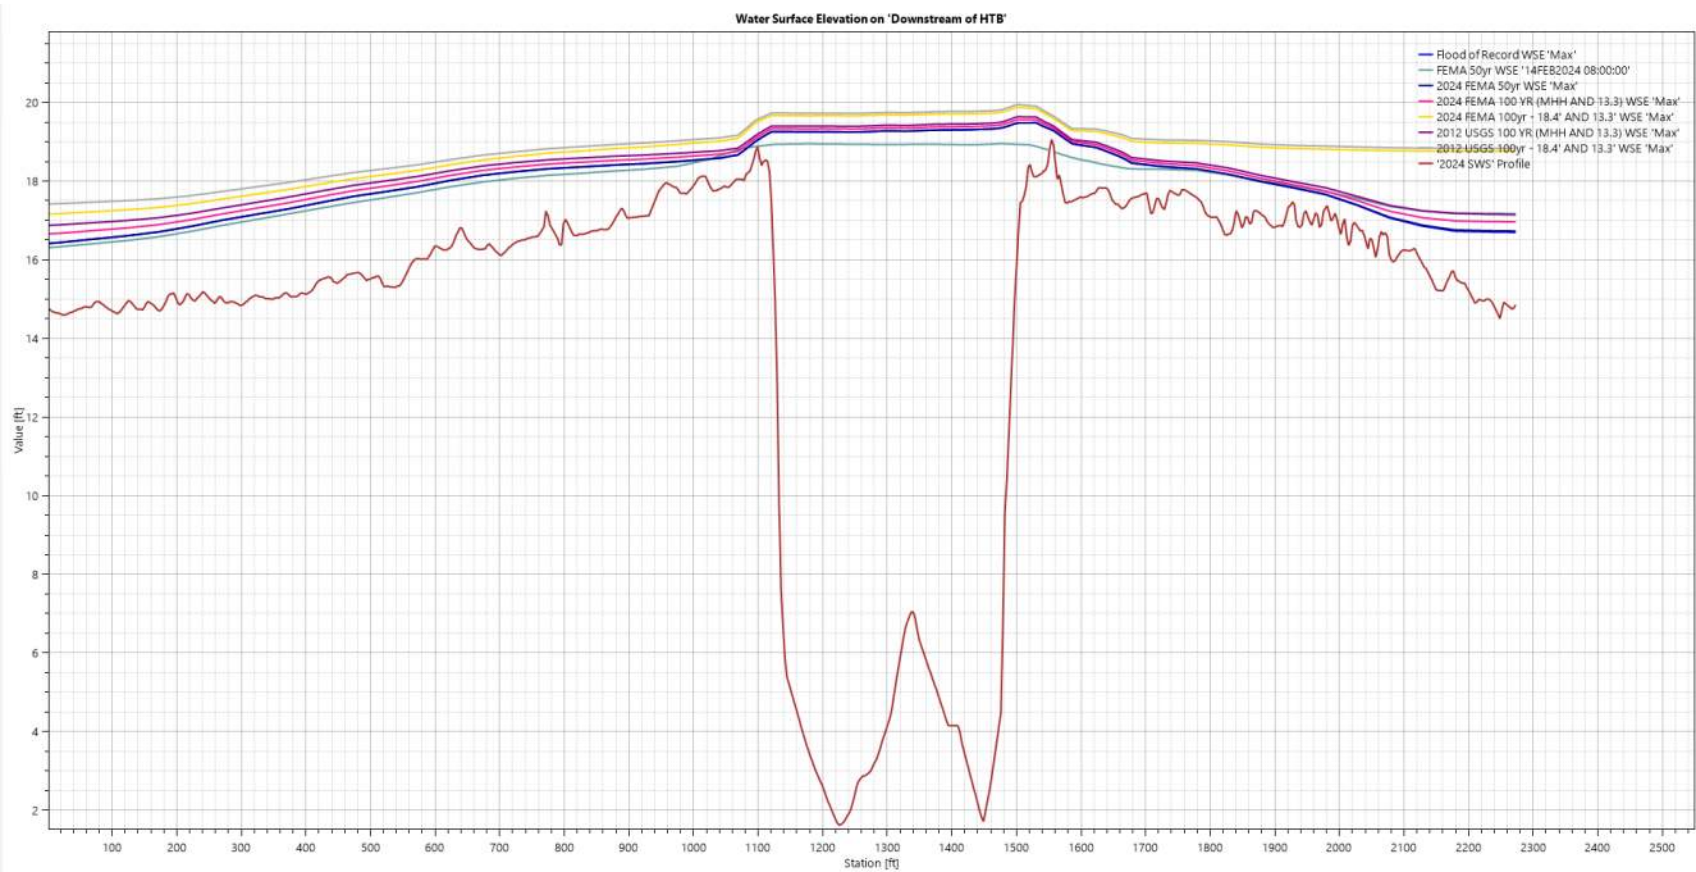
Figure 3. Cross-Section downstream of Hammond Trail Bridge. 2024 SWS is the combined terrain discussed in Section 2.1 Digital Terrain Model Development.
