### HUMBOLDT COUNTY DEPARTMENT OF PUBLIC WORKS ROAD EVALUATION REPORT

Applicant Name: Lost Creek Farms APN: 211-184-006

# TECHNICAL MEMORANDUM

Subject: Road Evaluation for APN: 211-184-006

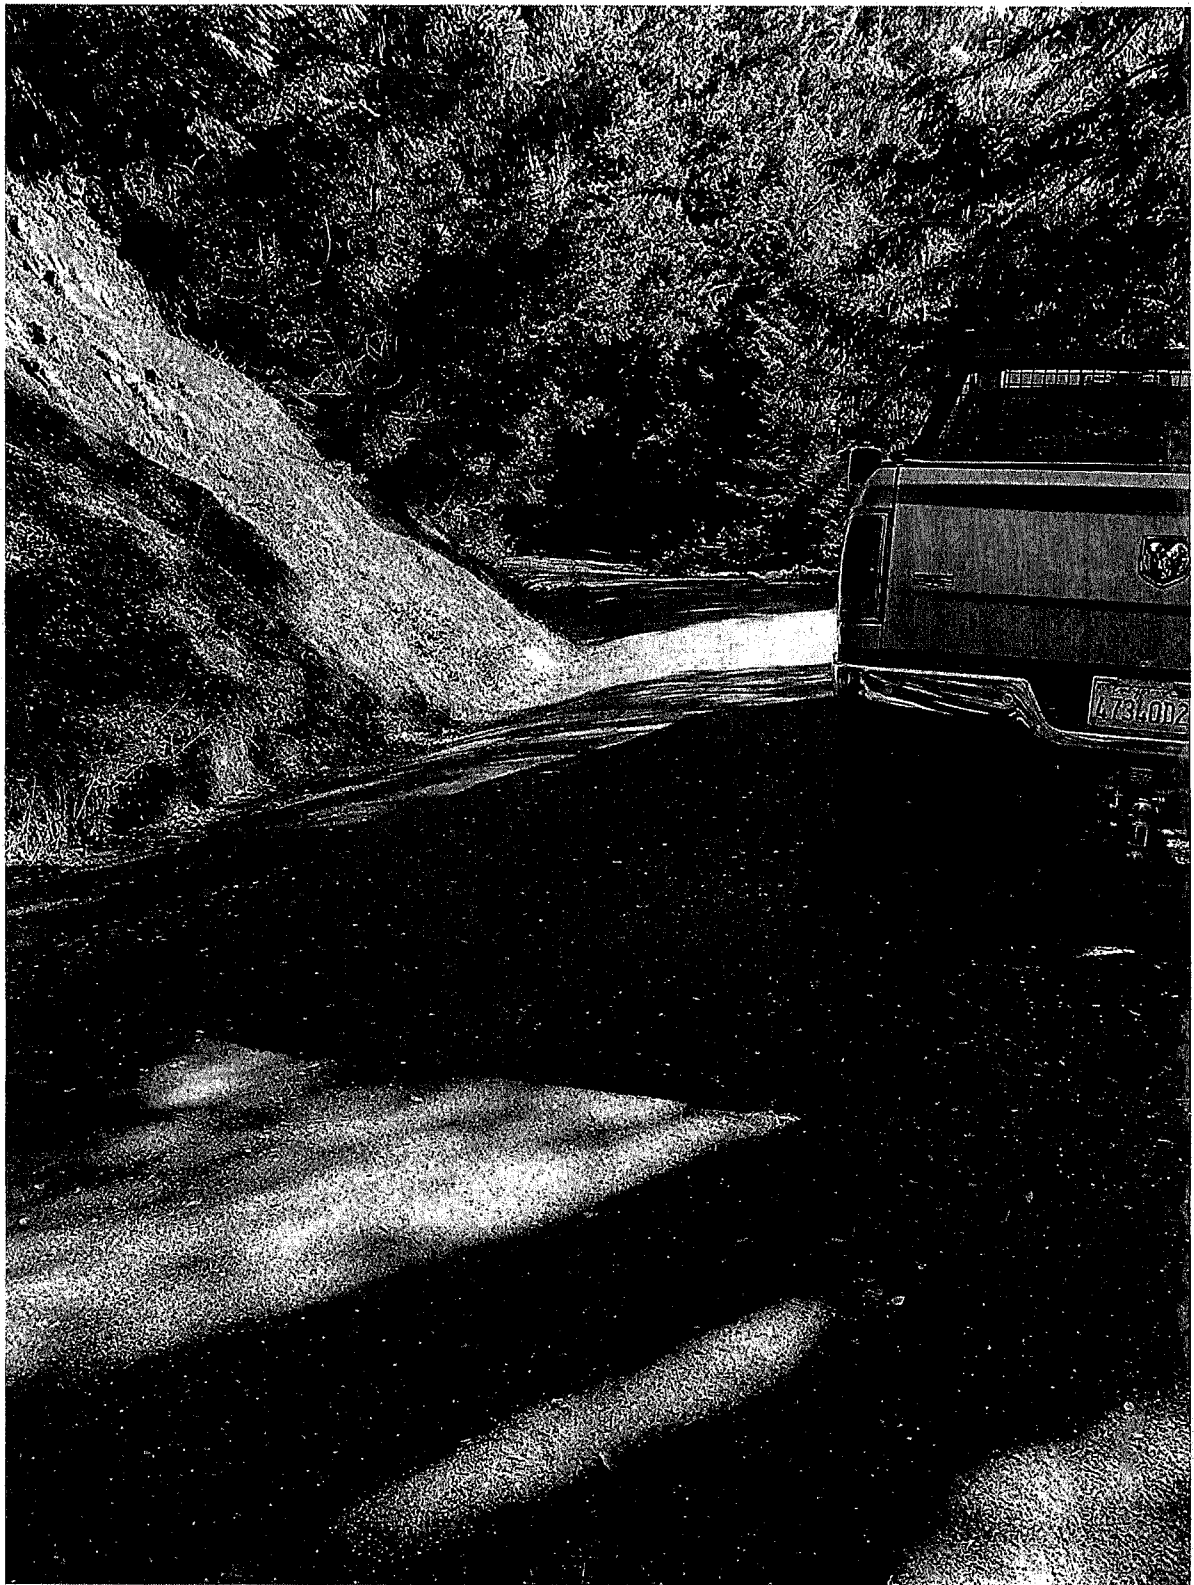
Appendix A  
Photos

Overall, the 1.7 mile segment of Private Drive is in relatively good condition. The road has been blocked off due to a slide and is unusable until the county repairs the road. There is no evidence of skid marks along the segment. The road is fairly narrow, but it only serves \_\_\_\_\_ property(s) so the width is adequate.

Brush Trimming to improve visibility, County repair for road-slide needed
