North Coast Regional Water Quality Control Board

Subject: Notice of Violation and Transmittal of Inspection Report for March 23, 2021 Inspection of Humboldt County Assessor's Parcel 271-217-002

FACILITIES INSPECTION REPORT

Maps and Photolog for Inspection of Humboldt APN 217-271-002 (Prop B) on March 23, 2021. WDID 1_12CC419772, CIWQS Inspection ID 43510635.

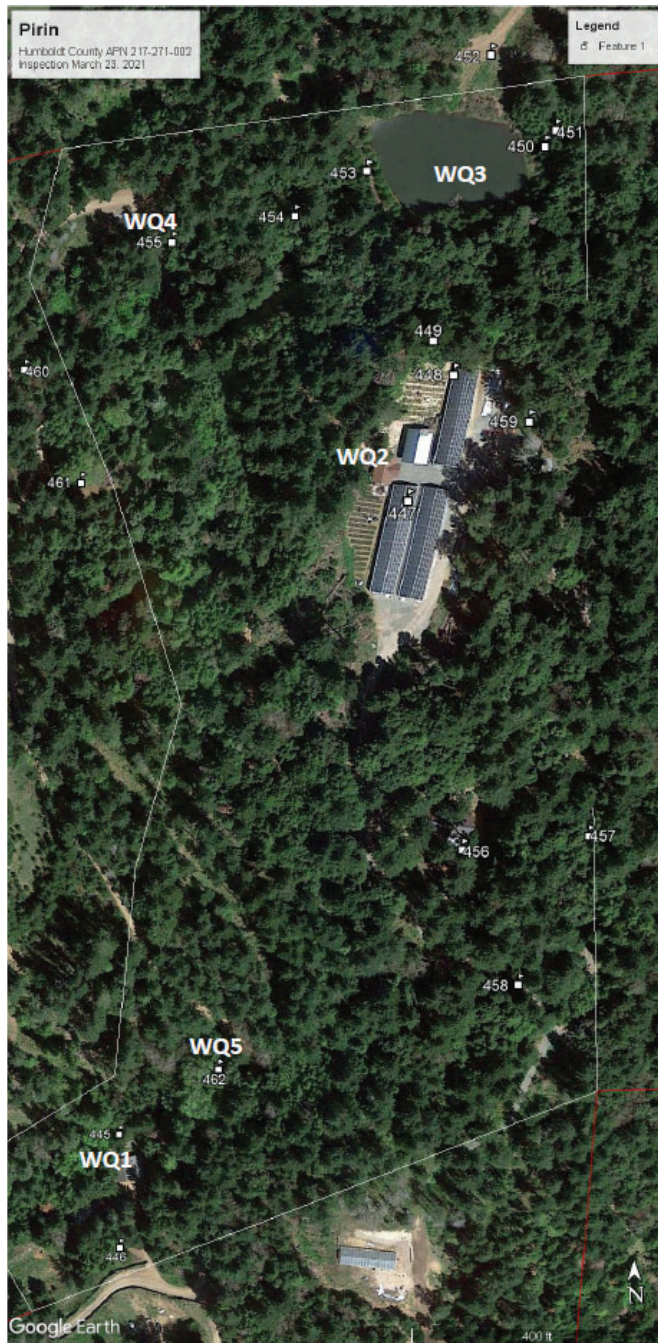
Figure 1. Inspection map including, Google Earth 2019 aerial imagery, GPS locations of field identified features, and water quality locations of concern WQ1-WQ5.

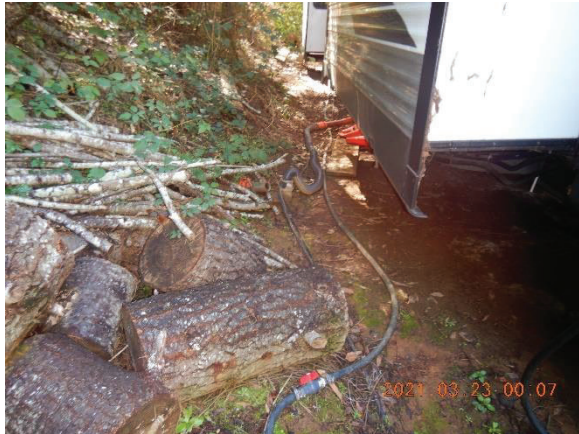
Figure 3. Trailer with waste line presumably to onsite septic system.

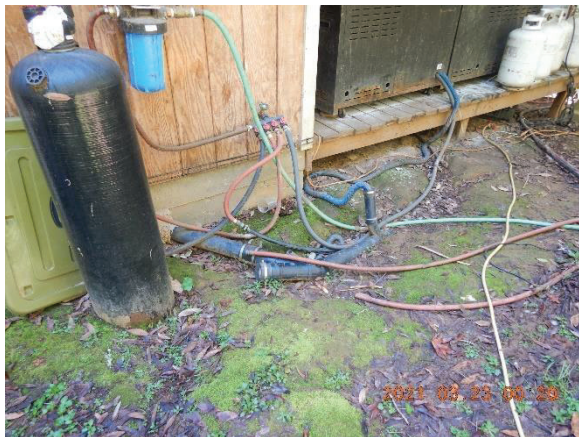
WQ1 - Residential Area adjacent to and uses encroaching on riparian setback of Class II watercourse; appears to be on septic. Behind structures is old road, that does not appear to be in use, with an undersized stream crossing. The culvert was not included in LSAA and appears appropriate for decommissioning. Water pump with lines through culvert. Generator with small spill, assessed by HazMat

Figure 4. Primary residential facility with waste lines, located within approximately 50 feet of Class II watercourse.

1. Submit SMP, including all stream crossings, pond at WQ3, and uses at WQ1 in riparian
2. Prior to additional instream work, obtain water quality certification.
3. Improve road drainage and hydrologic disconnections to prevent sediment discharge
4. Consult Water Rights on pond at WQ3 and associated water diversion and use for conformance with Cannabis Policy.
5. Implement measures to ensure that there is no threat of waste discharge from WQ2 to pond & surface waters

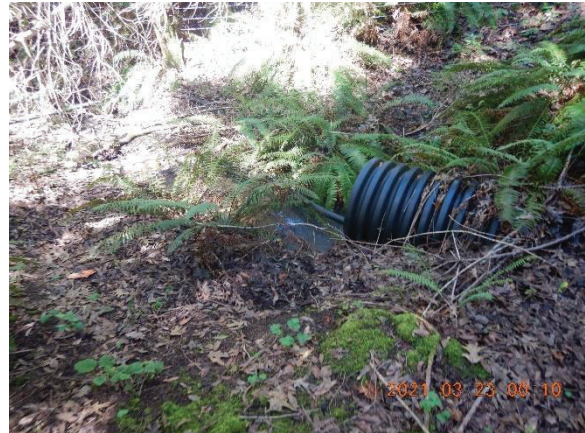
Figure 5. GPS point 445, inlet of 24" which is misaligned located on a Class II watercourse, on a road behind residence, road does not appear to be in use. The culvert was not disclosed in LSA.

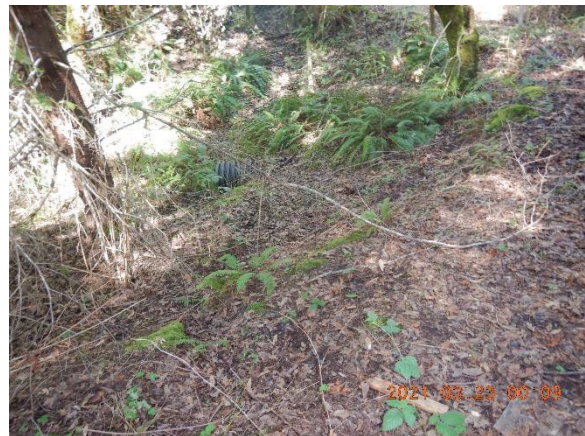
Figure 6. Outlet of culvert at GPS Point 445.

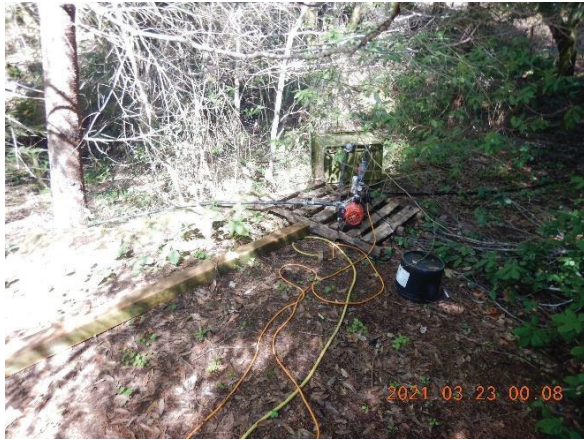
Figure 7. Water pump connected to waterlines running through culvert at GPS point 445.

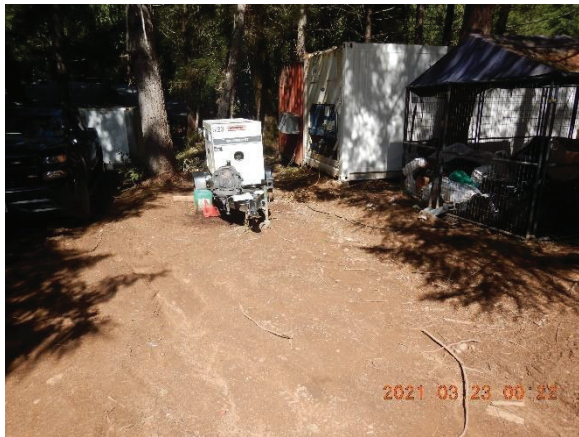
Figure 8. GPS point 446, Generator with evidence of small spill, assessed by Humboldt County HazMat.

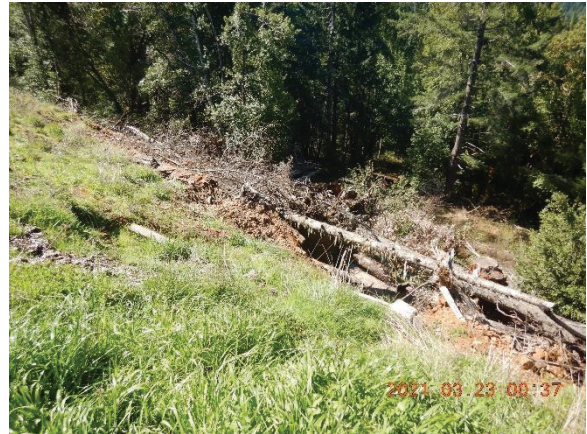
Figure 9. Upper graded flat, near GPS Point 447, slash at toe of fill slope.

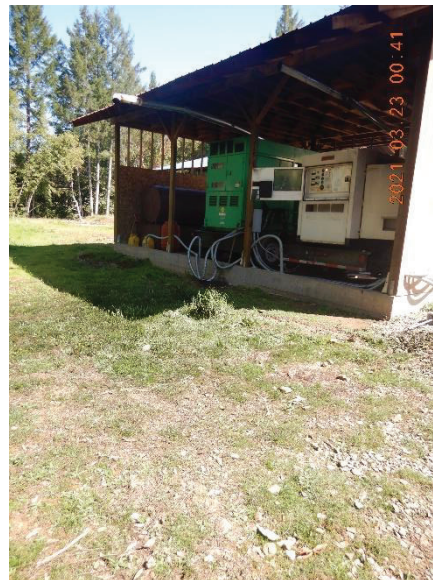
Figure 10. Generator at GPS location 447.

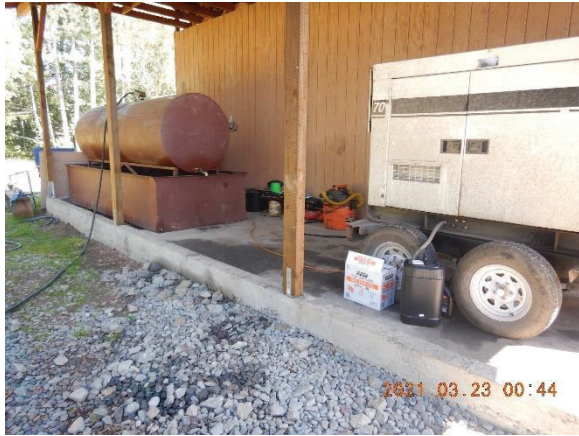
Figure 11. GPS location 447. A large generator powers the three large greenhouses. Indications of numerous small spills, as assessed by HumCo HazMat.

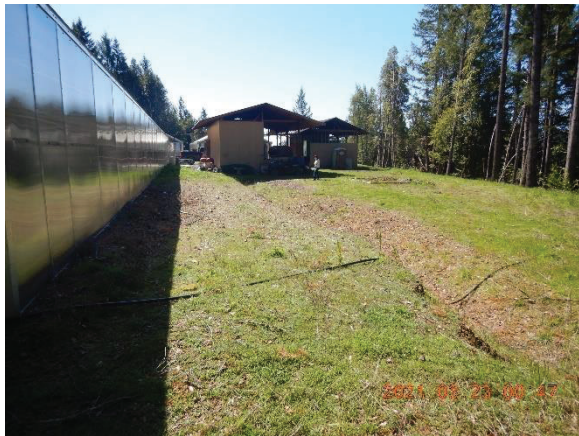
WQ2 - Upper graded flat with runoff from approximately 1 acre, including greenhouse roof catchment and ground surface near generator and fuel storage, is directed to a drain-pipe which discharges to steep hillside, approx. 160 feet above pond.

Figure 12. GPS location 448. Gutters catch approx. 12,000 sq ft of greenhouse roof runoff and route it to a trench, located on back side of fuel storage and generator area shown in previous figure. Runoff from the generator area could transport to the trench.

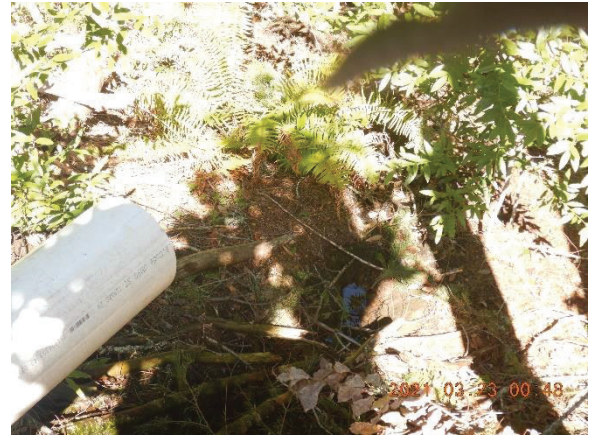
Figure 13. GPS location 449. Trench in previous figure outlets to a pipe that discharges over slope above pond; trench and pipe have potential to carry pollutants to the pond, which provides aquatic habitat and discharges to surface waters.

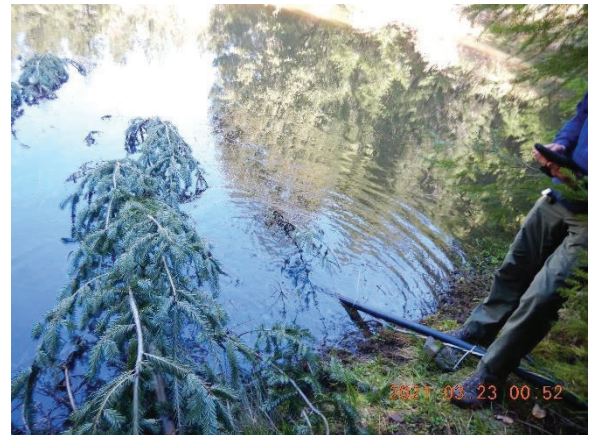
Figure 14. Water diversion from pond.

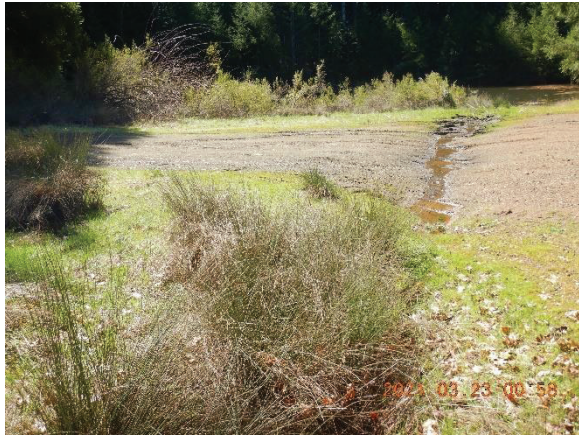
Figure 15. Class IV watercourse along road ditch where it drains to pond, with some wetland vegetation and flowing water.

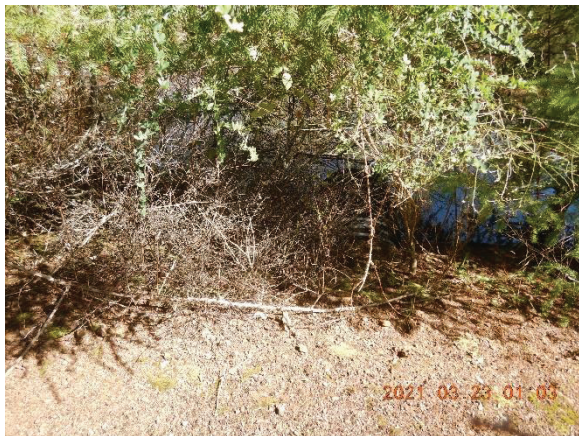
Figure 16. GPS location 454. Top of berm where the outlets to watercourse via two parallel pipes, with 45s and downspouts over the rocked fill face.

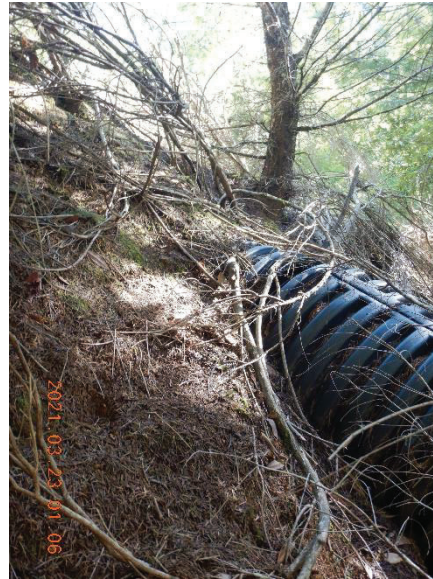
WQ3 - An approx. 0.66 acre pond constructed with discharges via two corrugated plastic outlet pipes over fillslope to watercourse; one pipe collar has separated at the top of the berm. Draining into pond, I observed a class IV road ditch with surface flow and small swales with minor scour. Point of diversion up to tank at WQ2.

Figure 17. GPS point 454. One of the pond outlet pipes is separated at the 45, near the top of the berm

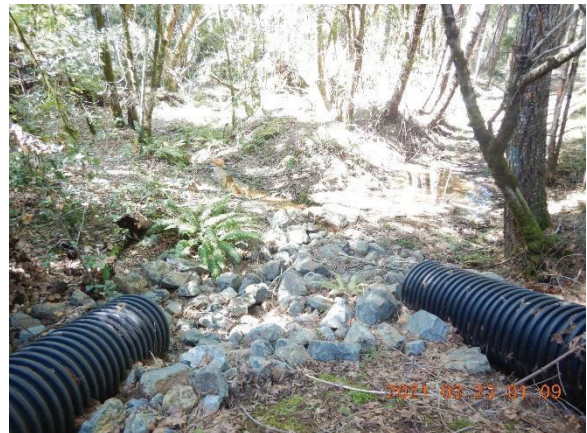
Figure 18. At base of pond berm, outlet pipes drain to watercourse. The LSA included the rock placement.

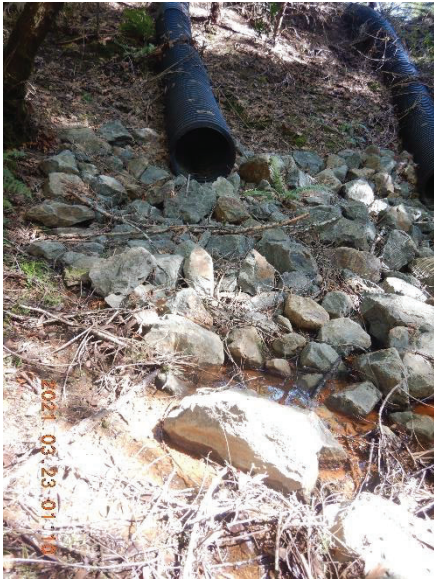
Figure 19. The separated pipe was not flowing water but I observed water between the rip rap at the outlet, indicating seepage at pipe separation or berm seepage.

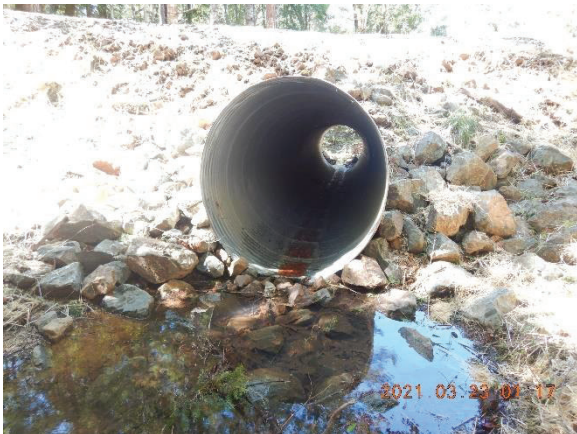
WQ4 - Crossing 3 inlet was high and not set to grade.

Figure 20. GPS location 455, LSA Crossing 3. Downstream of pond, the stream crossing Culvert was upgraded in ~2018, while enrolled in cannabis general order, without first obtaining authorization for instream work from the Regional Water Board. The inlet is a bit

high and there appears to be seepage underneath.

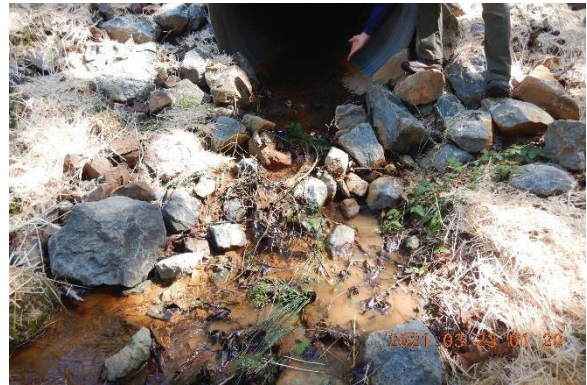
Figure 21. GPS location 455. Outlet of Crossing 3 with evidence of sediment deposits in downstream channel. According to CDFW, the erosion control measures weren't installed at the time of there inspection in December 2020.

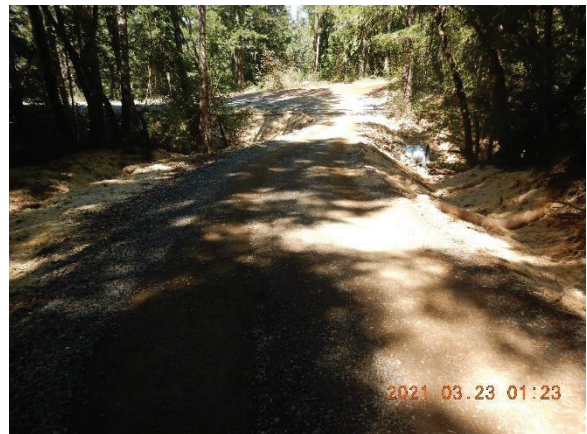
Figure 22. GPS location 455. Looking downslope along road approach to Crossing 3.

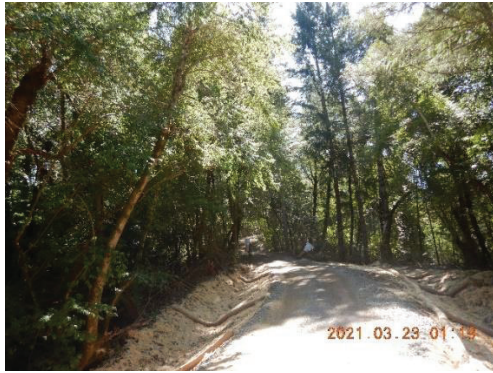
A December 2020 CDFW inspection identified road-related discharges associated with failure to install hydrologic disconnections and erosion control measures. Since then, rock armoring and straw had been added. I observed that the roads remain hydrologically connected at most stream crossings due to lack of treatments to road approaches and inboard ditches.

Figure 23. GPS location 455. The road approach to Crossing 3 lacks hydrologic disconnects.

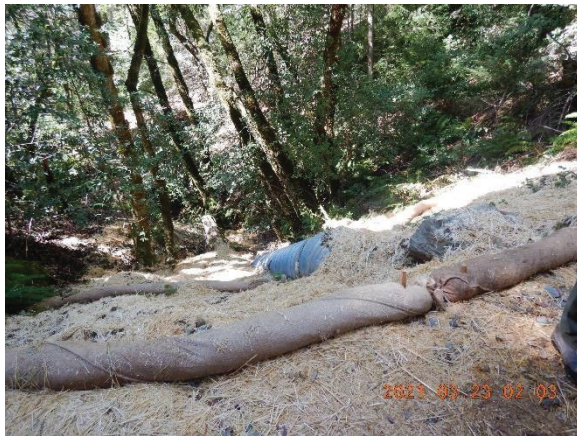
WQ5 - Crossing 1 had sediment discharges following upgrade due to inadequate alignment and grade, armoring, and erosion control measures.

Figure 24. GPS location 462. Crossing 1. Downspout was included in the LSAA but was added during installation of the 36" culvert.

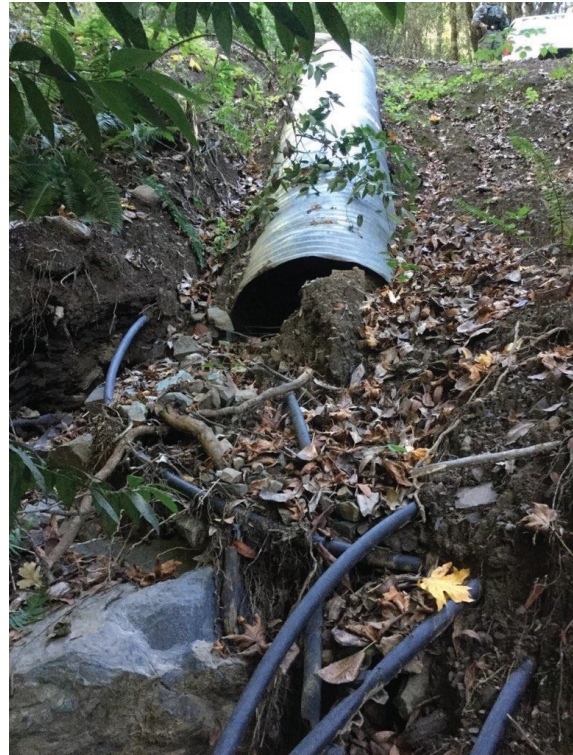
Figure 25. Photo of Crossing 1, by Ryan Bourque of CDFW taken on December 7, 2020 inspection. Photo shows lack of erosion control and erosion and sediment transport to the watercourse at the outlet of the downspout.

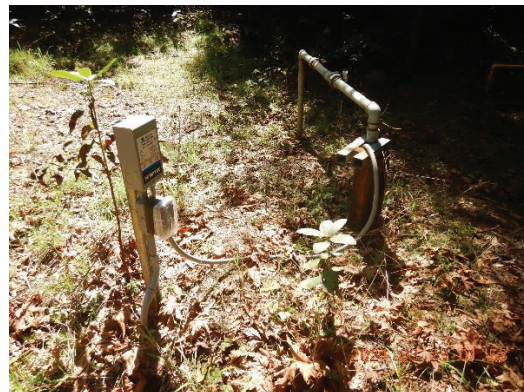
Figure 26. GPS location 461. Well without proper cap.
