HUMBOLDT COUNTY DEPARTMENT OF PUBLIC WORKS
ROAD EVALUATION REPORT

Road Name: Salmon Creek Road (Segment 1) (complete a separate form for each road)

Road Name: Salmon Creek Road (Segment 1) Date Inspected: 10/3/17 APN: 221-081-004
 From Road: Maple Hills Road (Post Mile N/A) Planning & Building
 To Road: Thomas Road (Post Mile N/A) Department Case/File No.:

DATE: 13 October 2017
TO: Humboldt County Department of Public Works
FROM: Joel Monschke, Stillwater Sciences
SUBJECT: Road Evaluation for APN 221-081-004 (Blido Property):
Segment 1 - 1.7 miles of Humboldt County maintained Salmon Creek Road from
Maple Hills Road junction to Thomas Road turnout

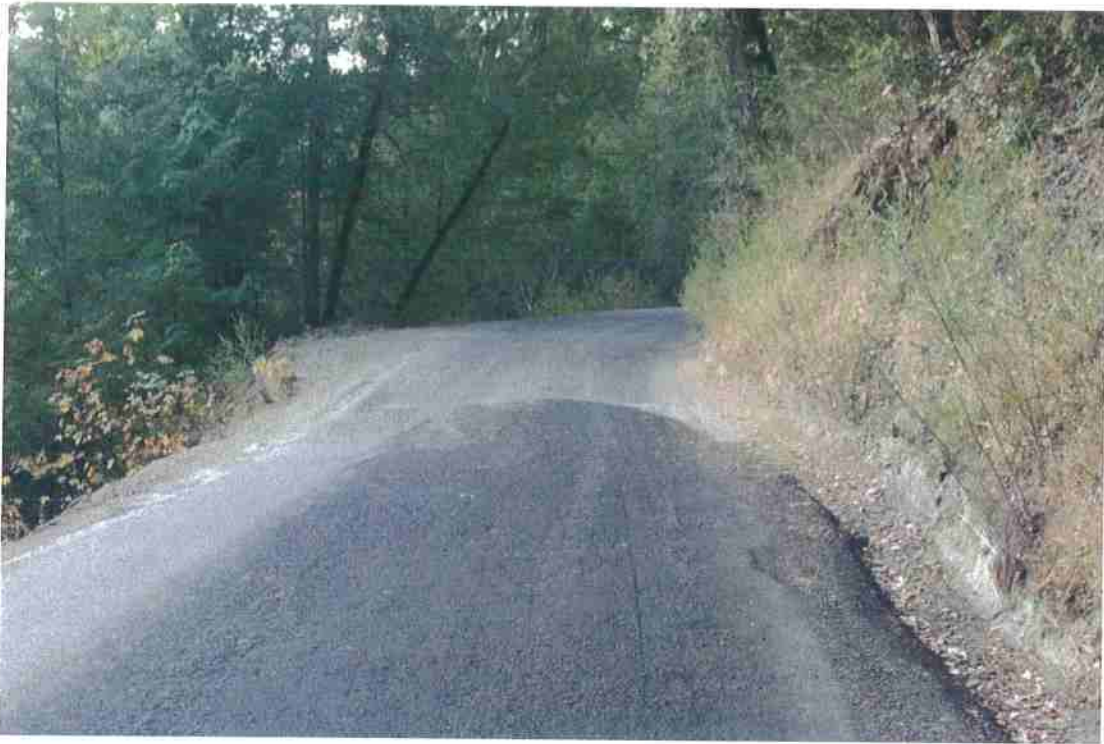
Photo 4. Mile 0.9: relatively narrow section, 15' width, 1' shoulders.

- Mile 0.3: We recommend removing trees and dirt that has slumped off cut slope. Widening roadway to 20 feet with shoulders, need to consider environmental impact (high priority).
- Mile 0.8 to 1: This is a trickier road segment to widen due to a deep landslide in the vicinity. However, minor improvements to the roadway could improve safety and width including paving work to stabilize the inboard ditch and outboard edge of the roadway at select locations and fix pavement edges that are broken and treacherous at numerous locations.

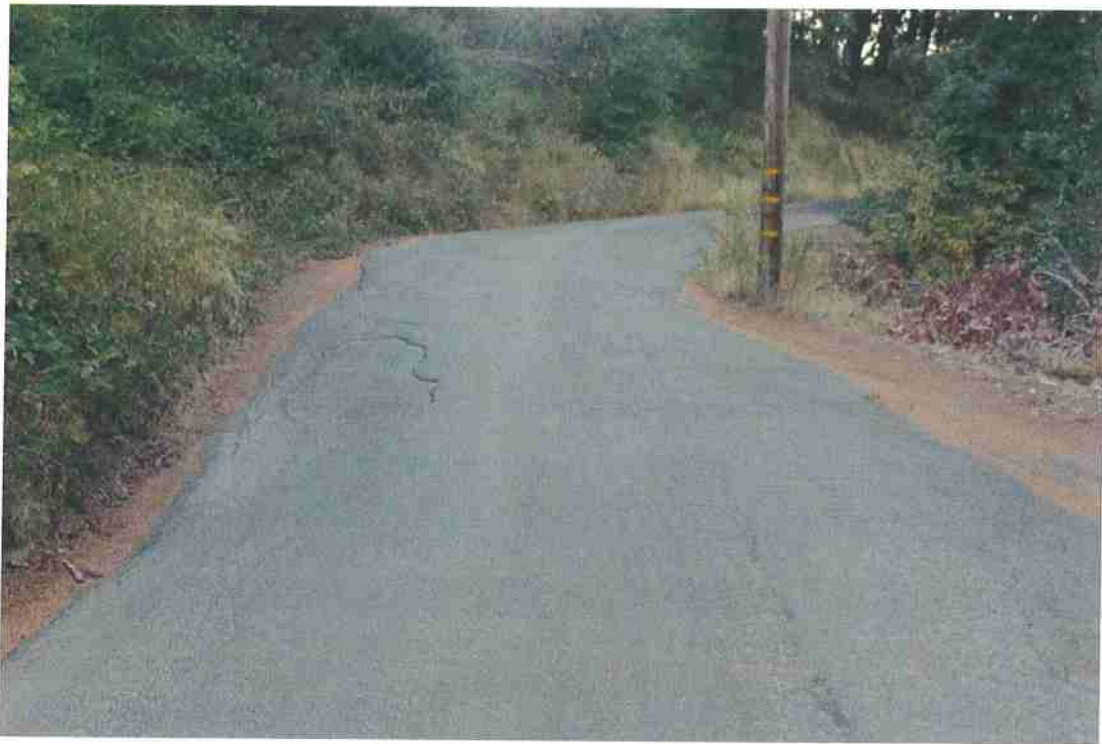
Photo 5. Mile 1.0: 18' width, 1' shoulder.

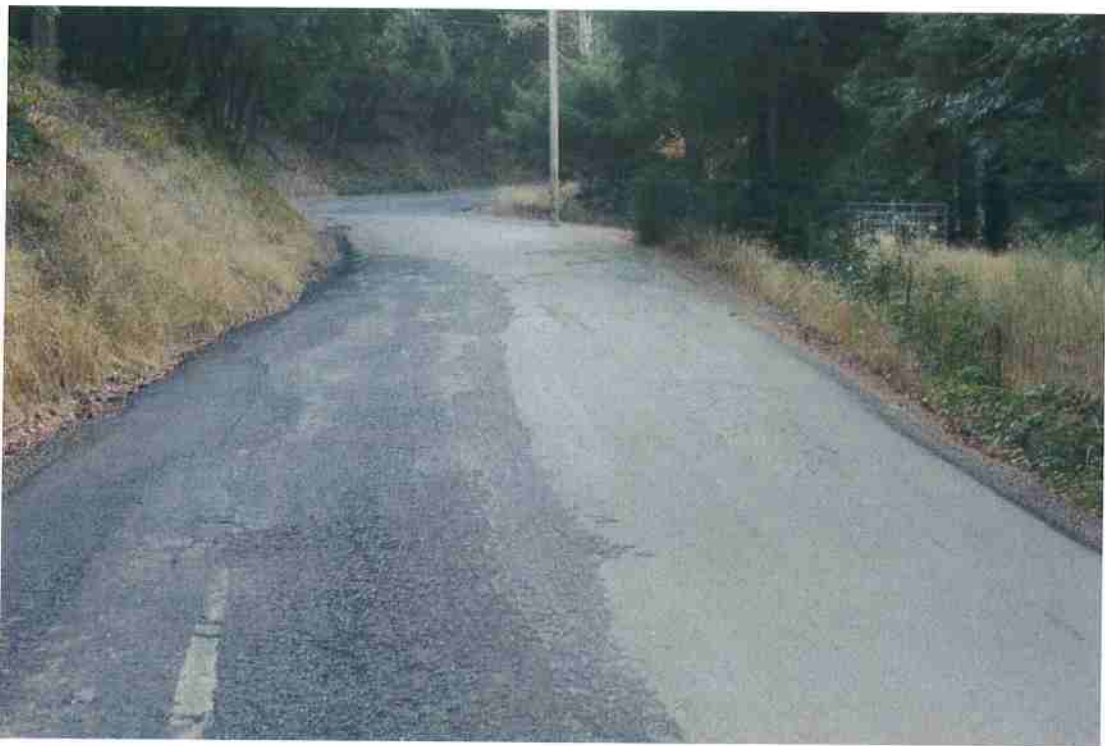
Photo 6. Mile 1.1: 20' width, 1' shoulders.

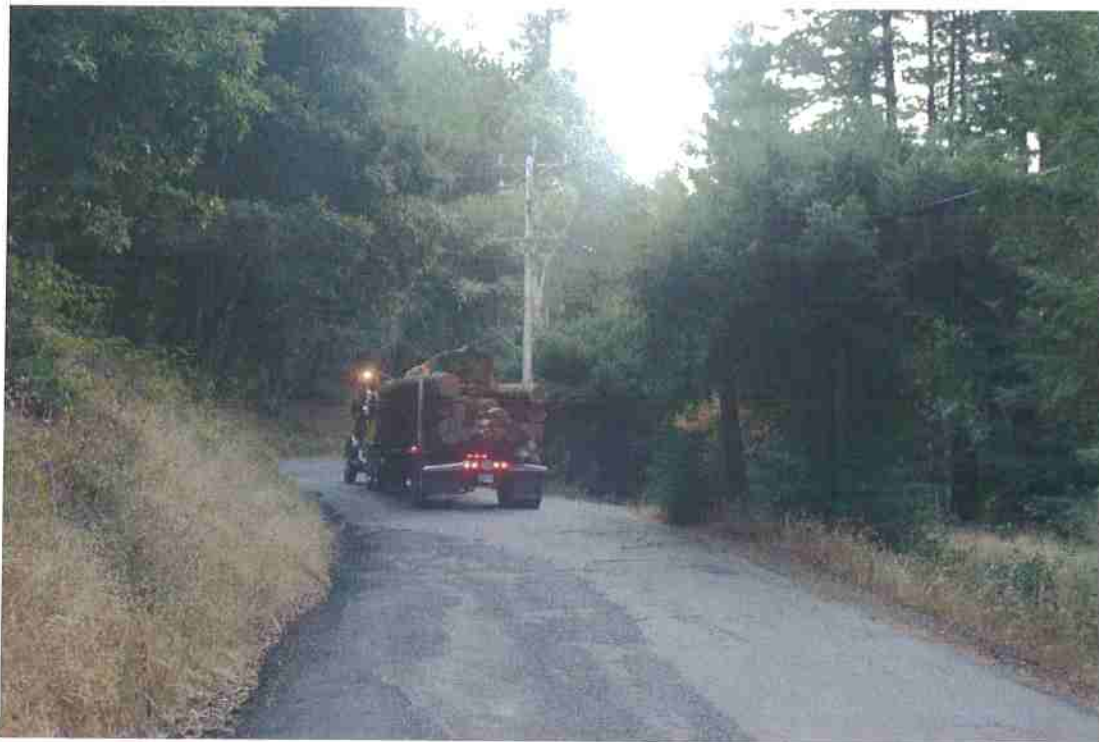
Photo 7. Mile 1.1: Logging truck on road.

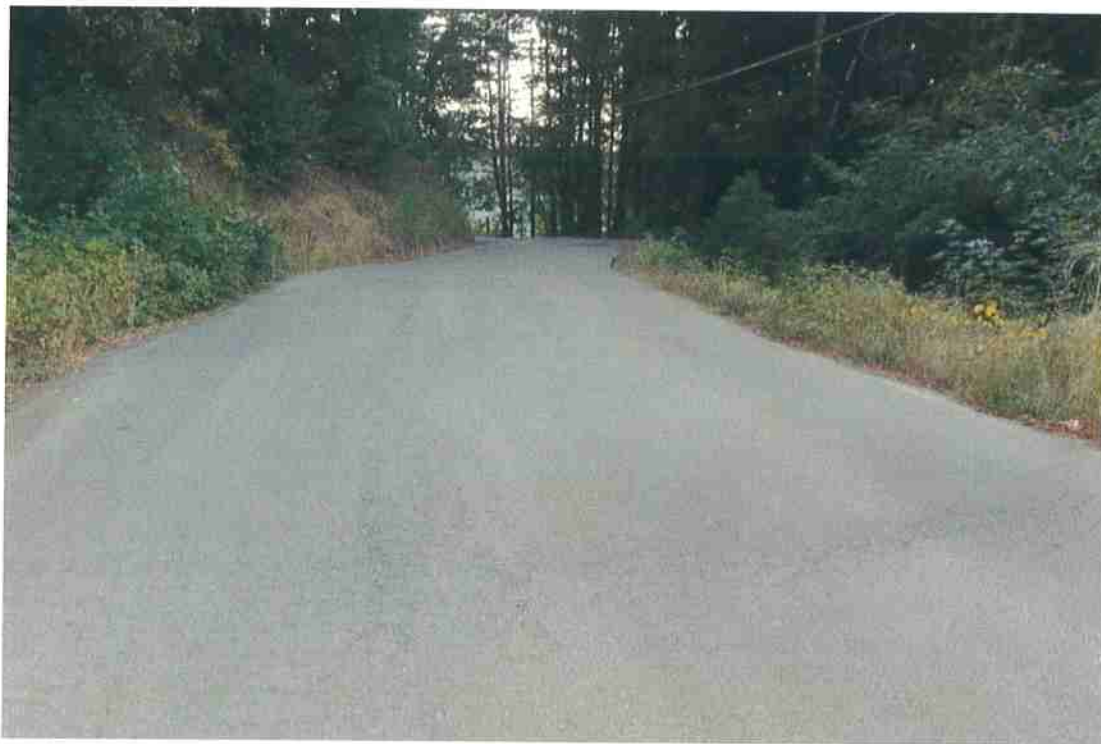
Photo 8. Mile 1.2: 24' width, 1' shoulders.

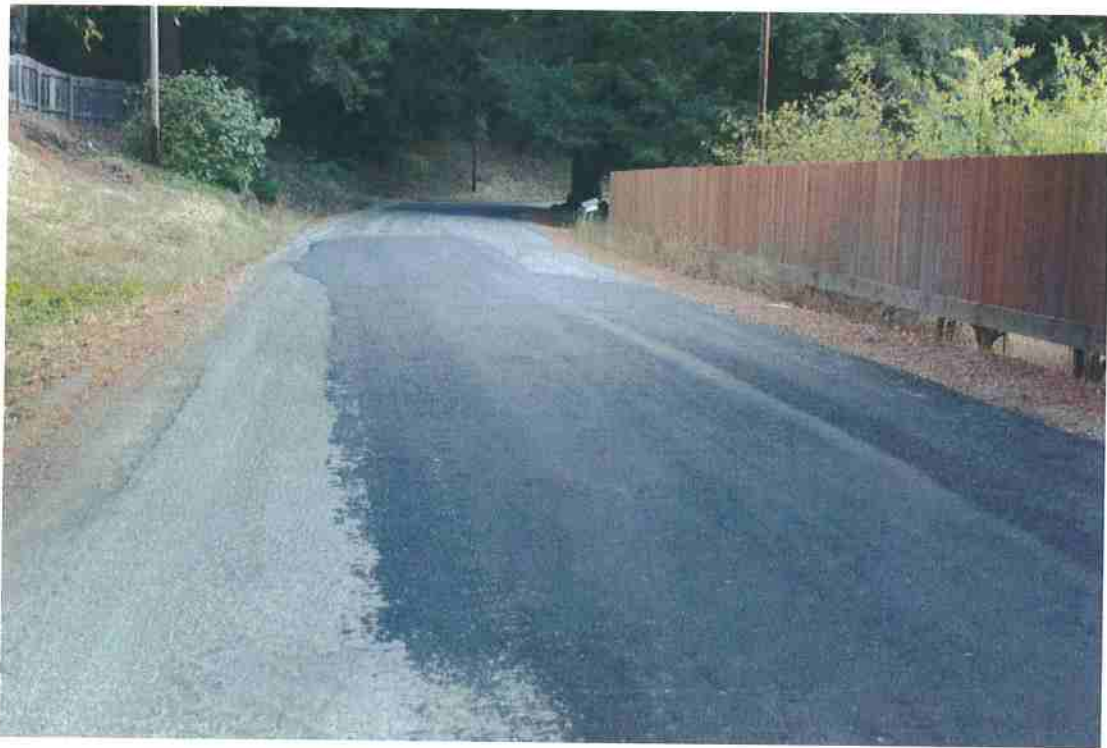
Photo 10. Mile 1.4: 22' width, 2' shoulders.

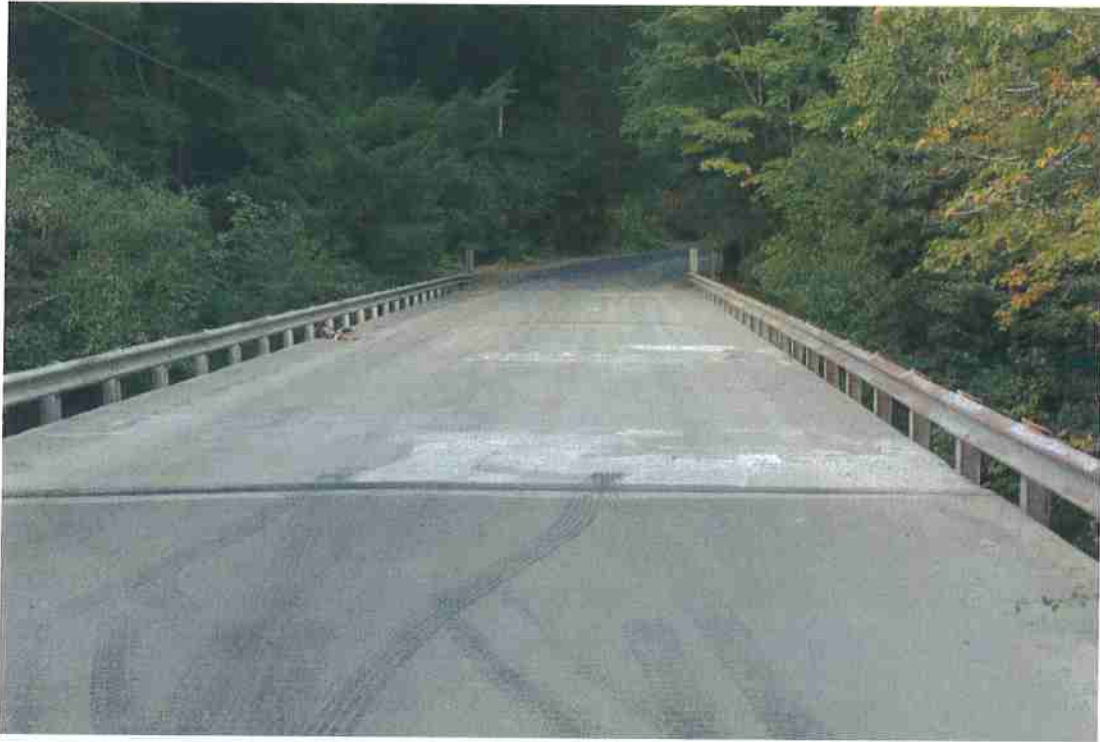
Photo 11. Mile 1.45: 28' width bridge, no shoulders.

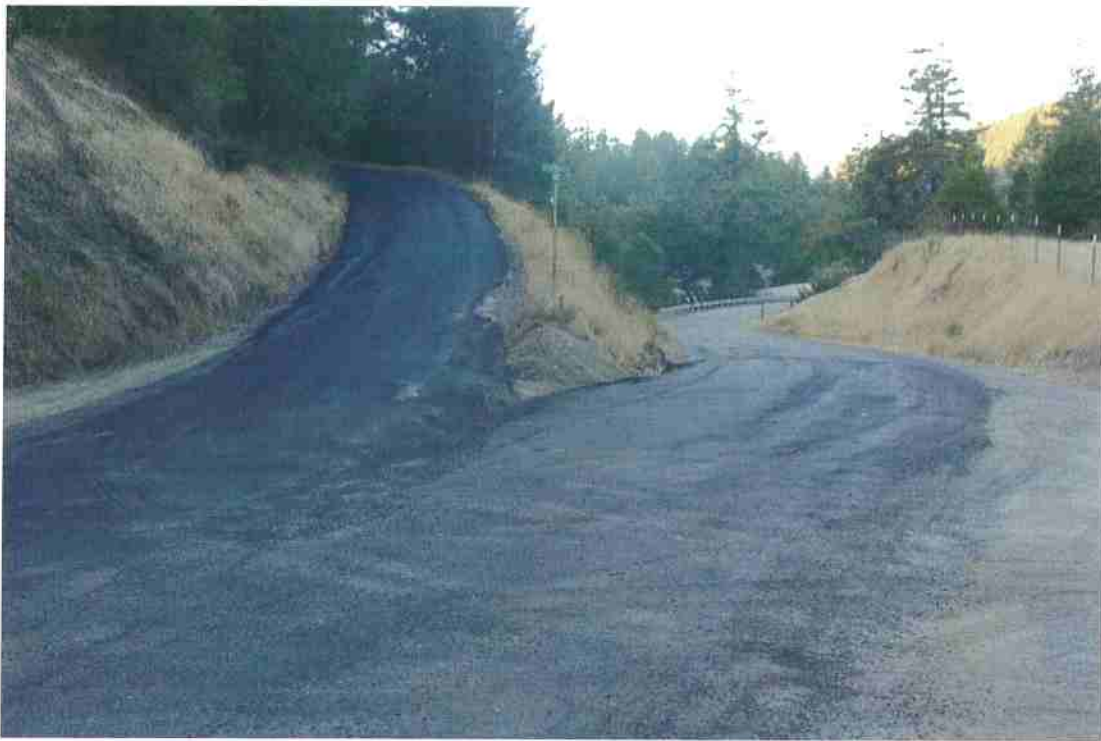
Photo 14. Mile 1.7: Thomas/ Salmon Creek Road split, 32' width, 2' shoulders (end of Segment 1).

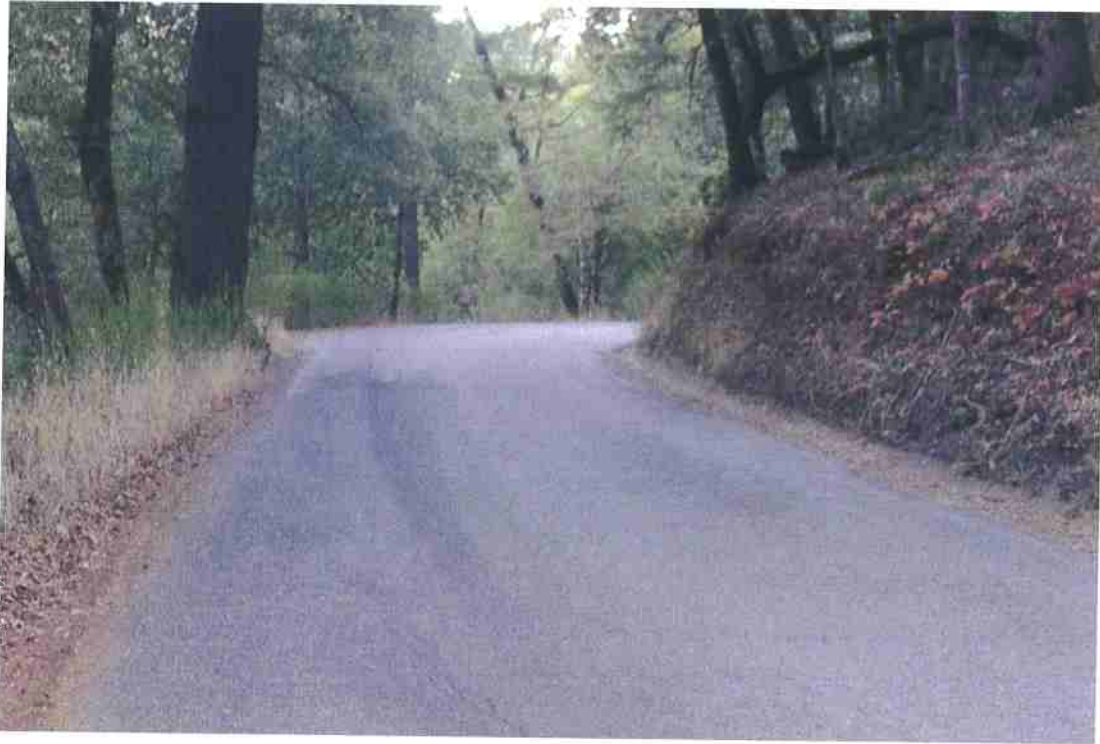
- Mile 1.0: 15-ft-wide pinch point with 1-ft shoulder caused by tree at blind corner.
- Mile 1.1: 20-ft road width with 1-ft shoulder.
- Mile 1.2: 20-ft road width with 1-ft shoulder.

Photo 11. Mile 1.0: Pinch point at tree on blind corner; 15-ft road width with 1-ft shoulder. Recommend widening.

- Mile 0.1: Cut vegetation to improve visibility, upgrade pavement to allow for minimal 18' wide driving surface width where feasible
- Mile 1.0: We recommend widening the roadway including removal of a Douglas Fir tree to improve the road width and visibility at the blind corner.
- Mile 1.9 to mile 2.2: There are some pinch points along this segment, but the segment traverses steep terrain so widening would be difficult and have potentially significant environmental impacts. Recommend signage reminding drivers to slow down and stay on their side of the road.
- Mile 2.4: We recommend widening the corner on the inside to improve width and visibility at the blind corner. Also nearby at mile 2.35, need to repair slumping outboard edge of road.

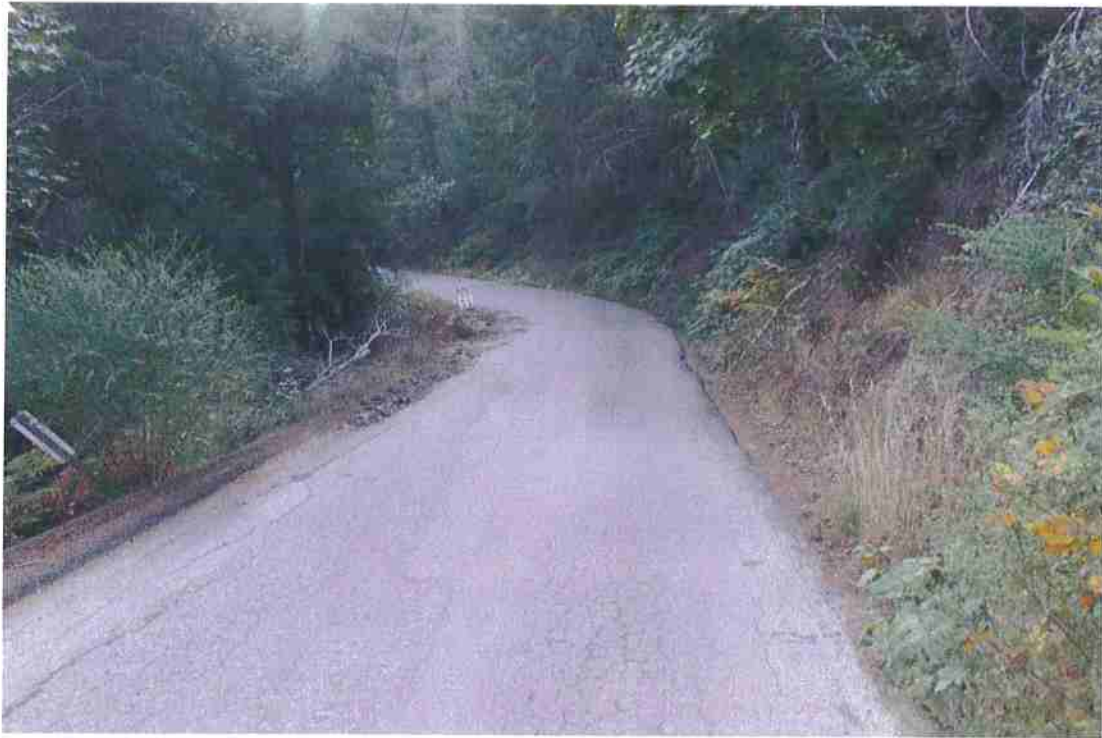
- Mile 2.3: 20-ft road width with 2-ft shoulder.
- Mile 2.35: ~15-ft-wide pinch point at partial road failure
- Mile 2.4: 16-ft road width with 1-ft shoulder. Dangerous blind corner.

Photo 26. Mile 2.35: ~15-ft road width pinch point at partial road failure.

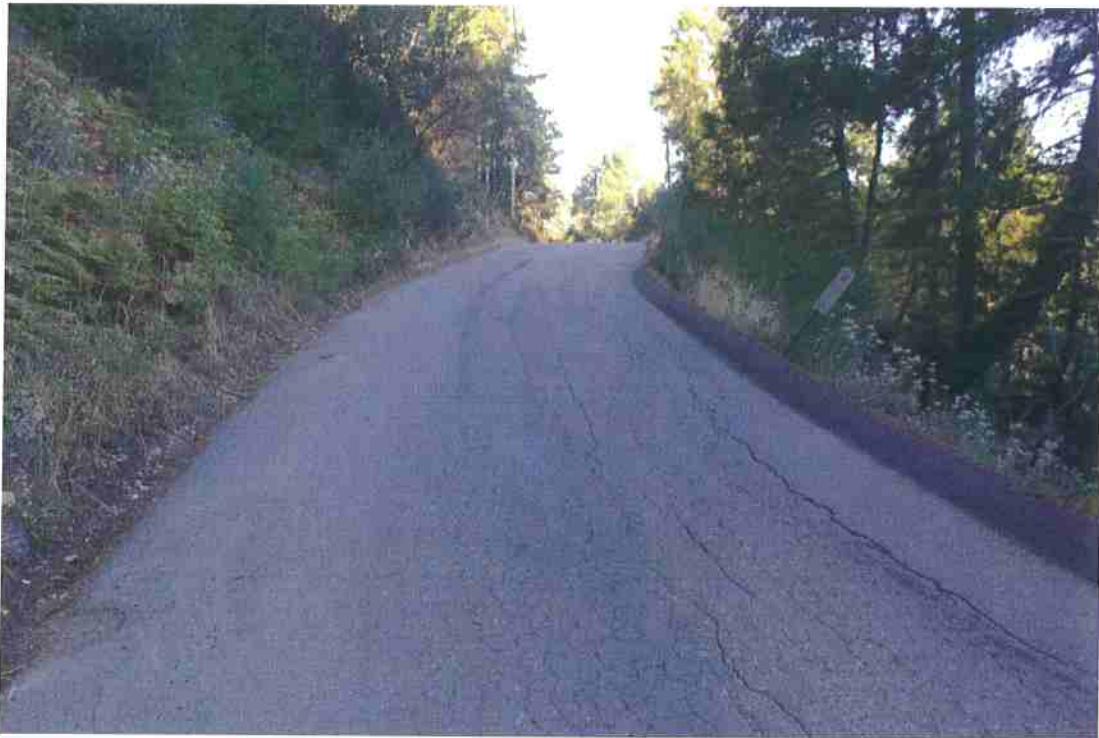
Photo 27. Mile 2.37: ~15-ft road width pinch point past partial road failure.

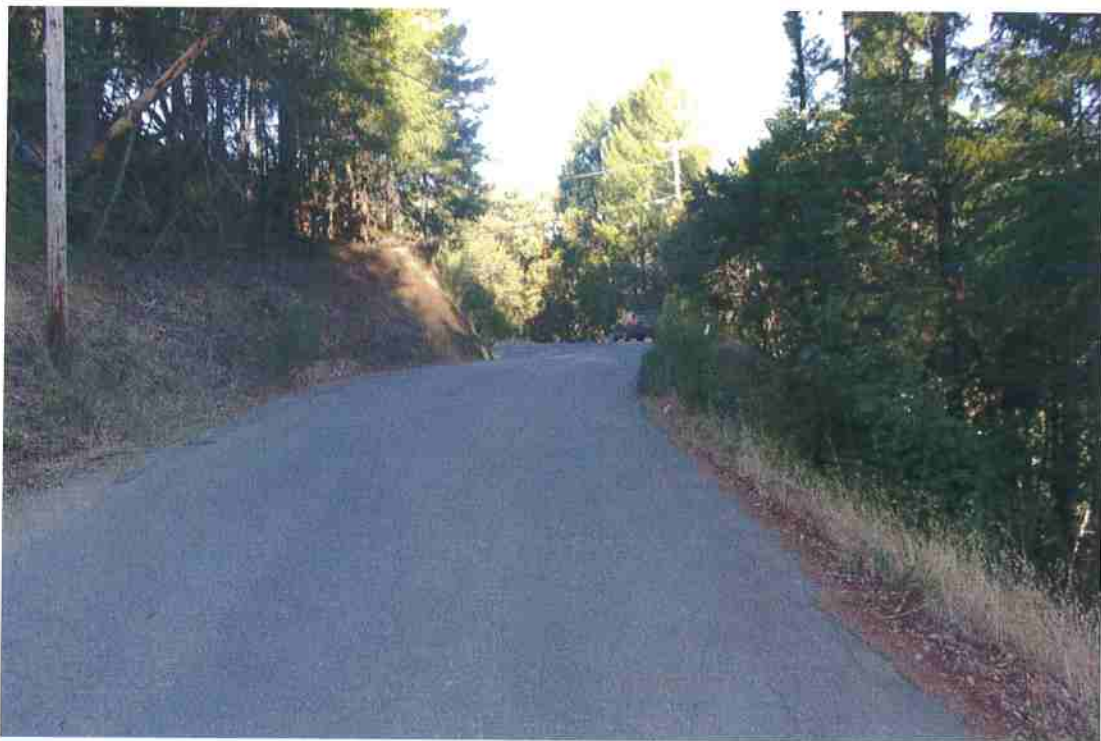
Photo 28. Mile 2.4: 16-ft road width with 1-ft shoulders at blind corner. Potential spot to widen corner on the inside to improve width and visibility.

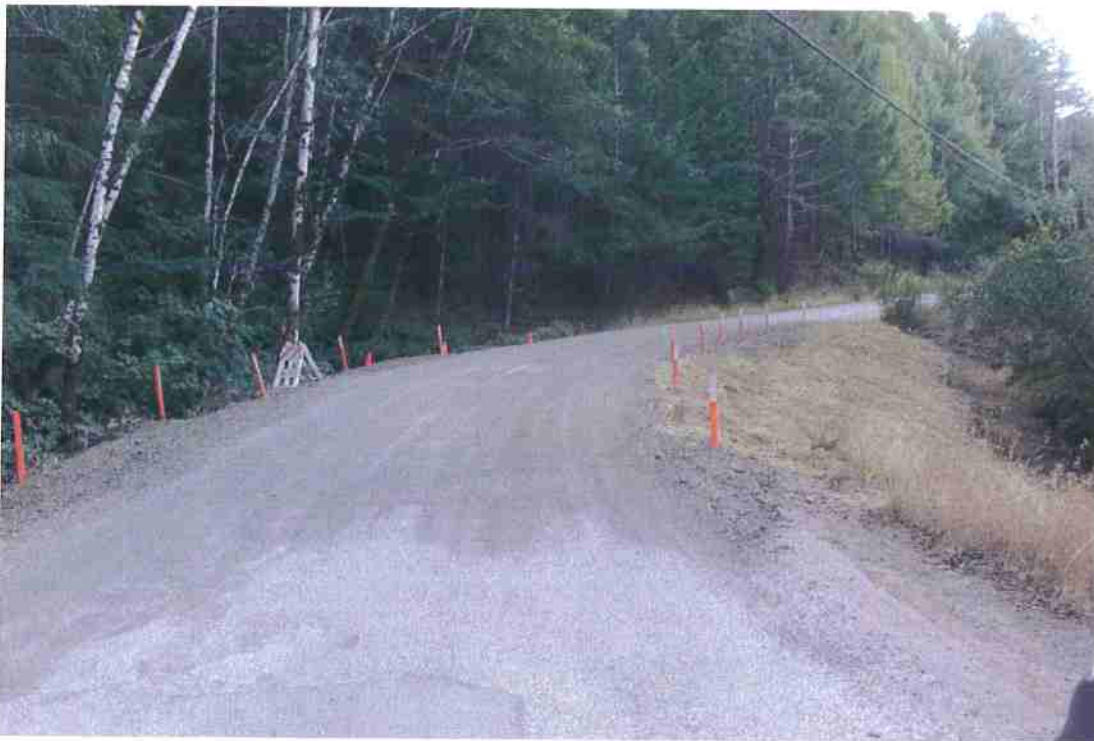
- Mile 2.6: The culvert at this location was recently repaired. The short segment over the culvert is gravel and 18-ft wide with 2-ft shoulder.
- Mile 2.7: 20-ft road width and 2-ft shoulder.

Photo 30. Mile 12.6: Recent culver repair, short gravel segment. 18-ft road width with 2-ft shoulders.

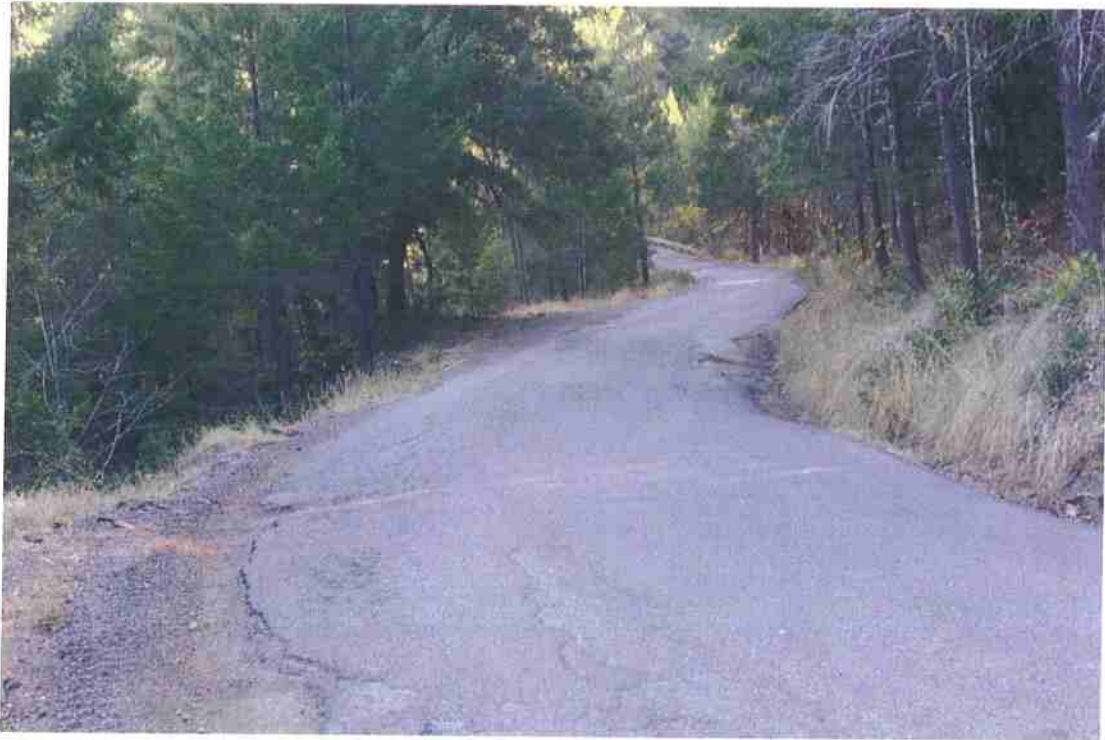
Photo 39. Mile 3.4: 16-ft road width with 1-ft shoulder. Pinch point at downgradient extent of blind corner. Potential spot to widen corner on inside to improve width and visibility.

- Mile 3.3: We recommend removing vegetation on western extent of bridge to improve visibility.
- Mile 3.4: We recommend widening corner on inside to improve width and visibility at blind corner.

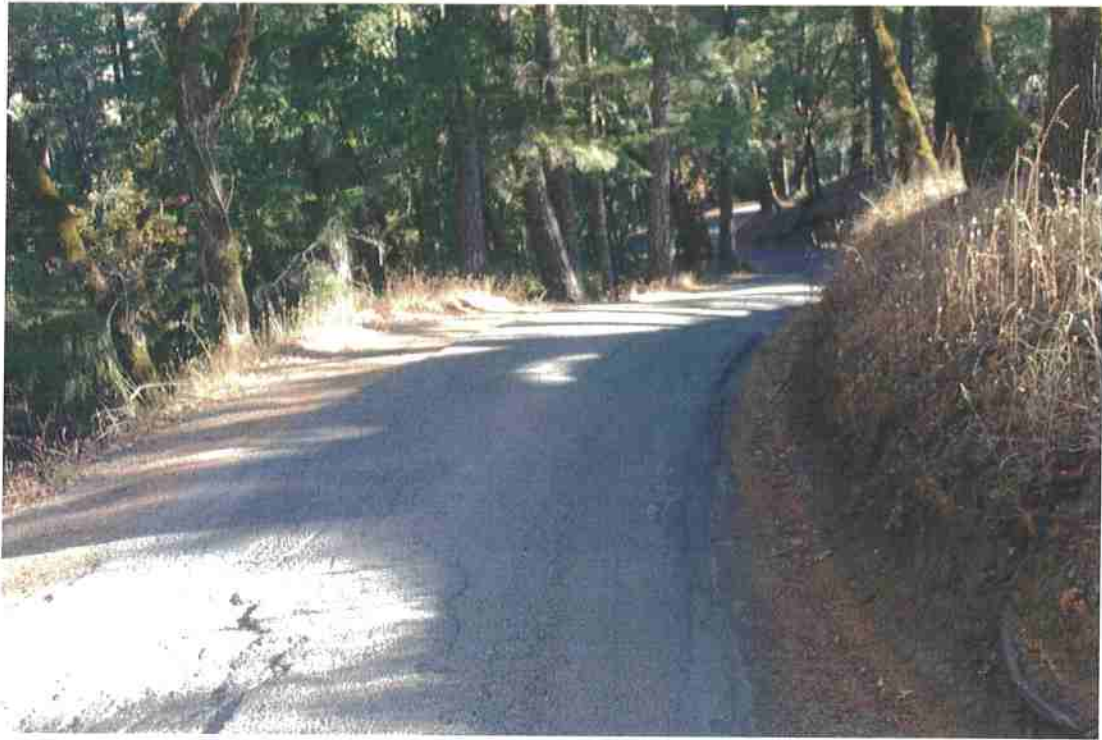
Photo 41. Mile 3.6: 12-ft road width with 2-ft shoulders. Pinch point but decent visibility with turnouts.

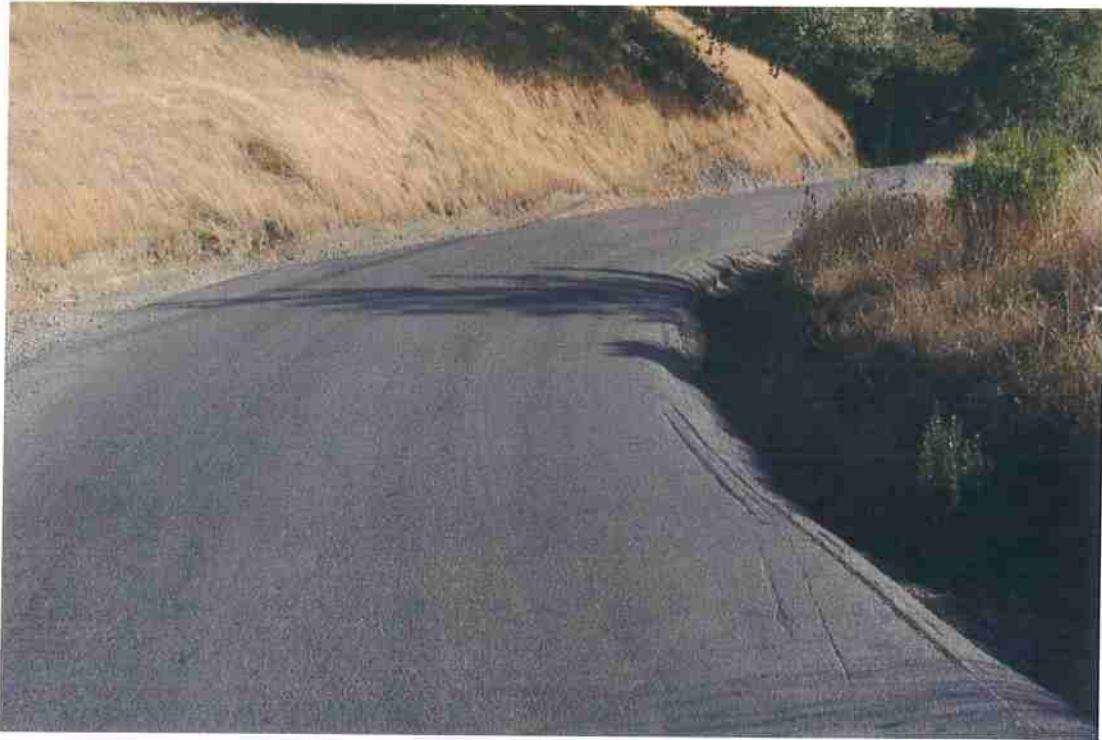
- Mile 3.7: 12-ft road width with 10ft shoulder. Partially blind corner with deep ditch.
- Mile 3.8: 18-ft road width with 1-ft shoulder.
- Mile 3.9: 15-ft road width with 2-ft shoulder, broken pavement edges make segment more treacherous.

Photo 43. Mile 3.7: 12-ft road width with 1-ft shoulder. Partially blind corner with deep ditch. Potential spot to widen corner on inside to improve width and visibility.

- Mile 3.65 to mile 3.7: Potential locations to widen several corners on inside to improve road width and visibility at blind curves.
- Mile 3.7: Potential location to widen corner on inside to improve road width and visibility at partially blind curve.

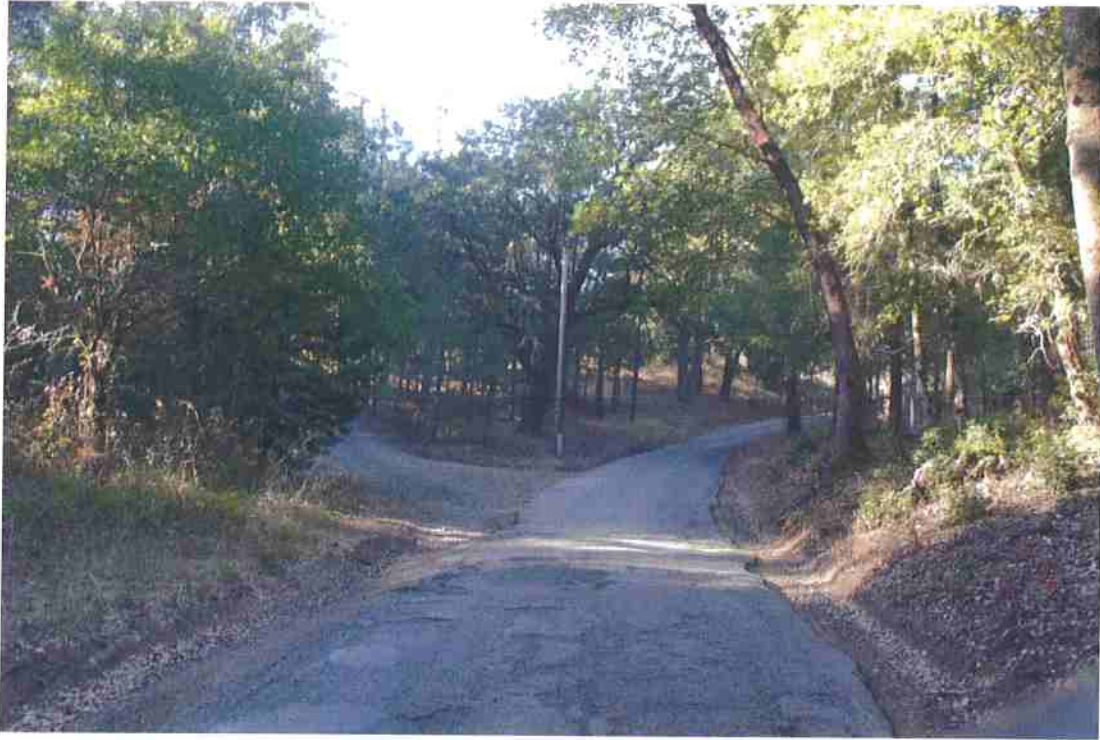
- Mile 4.0: 15-ft road width with 2-ft shoulder, broken pavement edges make segment more treacherous.
- Mile 4.1: 20-ft road width with 2-ft shoulders at intersection with Upper Thomas Road. End of County-maintained road (and end of segment 2).

Photo 47. Mile 4.0: 15-ft road width with 2-ft shoulders. Broken pavement edges make segment more treacherous.

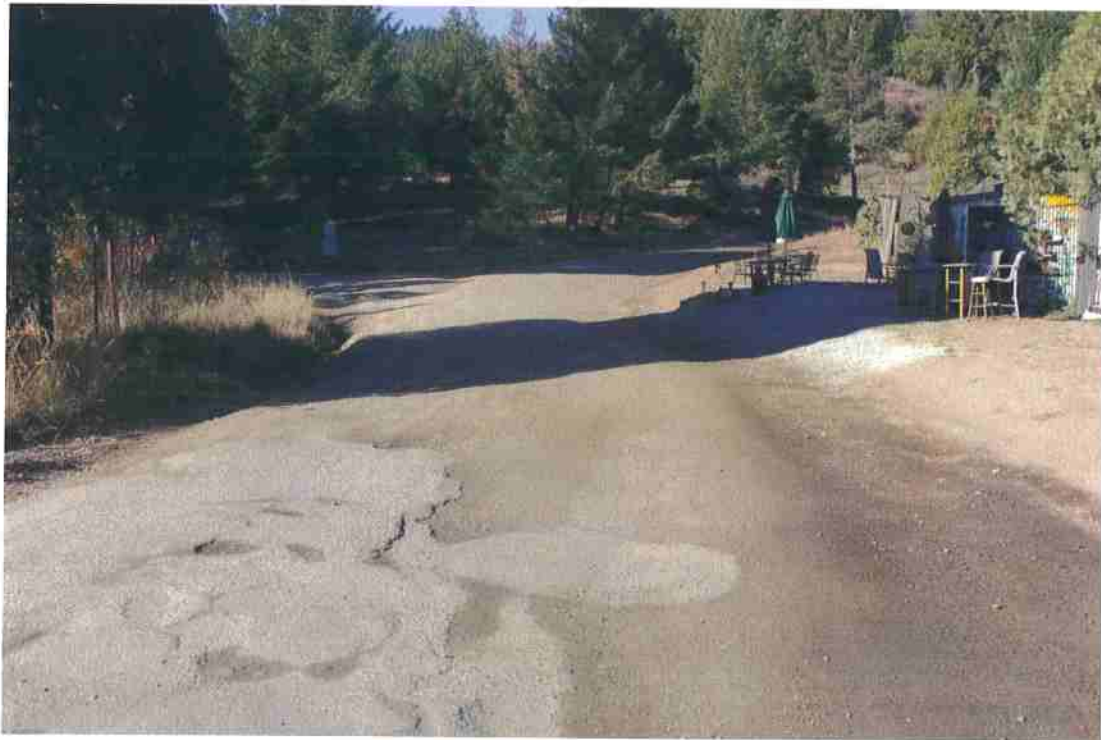
Photo 48. Mile 4.1: 20-ft road width with 2-ft shoulders. Intersection with Upper Thomas Road and end of County-maintained road. End of Segment 2.

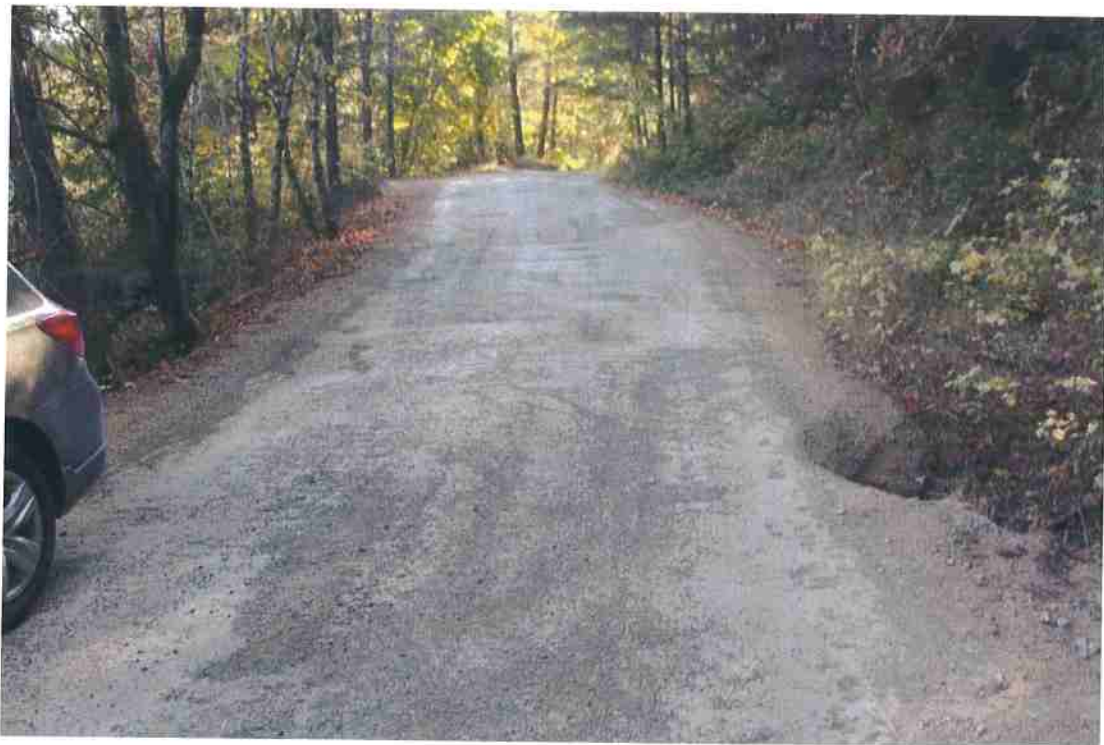
Photo 2. Mile 0.2: 16-ft road width with no shoulder at culvert crossing. The road could be widened at the culvert but there is decent visibility at the site so widening is not necessary.

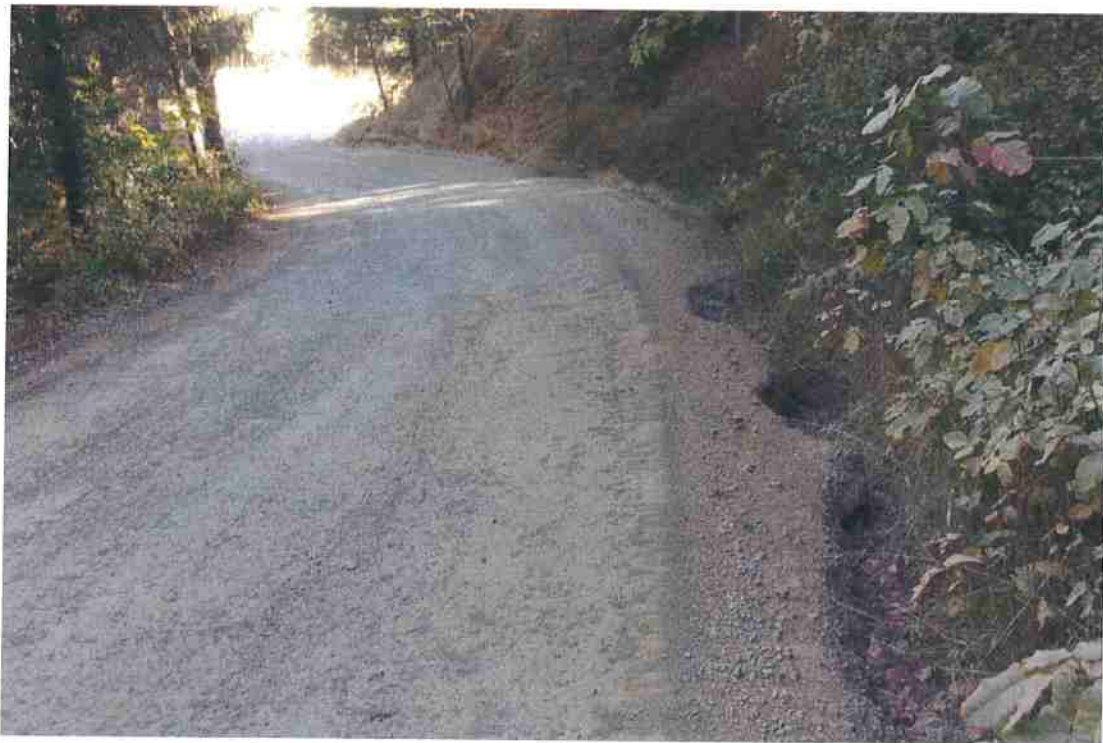
Photo 4. Mile 0.35: Inboard ditch eroding into road.

- Mile 0.35: replace culvert to widen road at pinch point. Armor inboard ditch to eliminate erosion of the road. Note that this is a moderate priority as compared to the recommendations in Segment 2 (County-maintained Thomas Road).

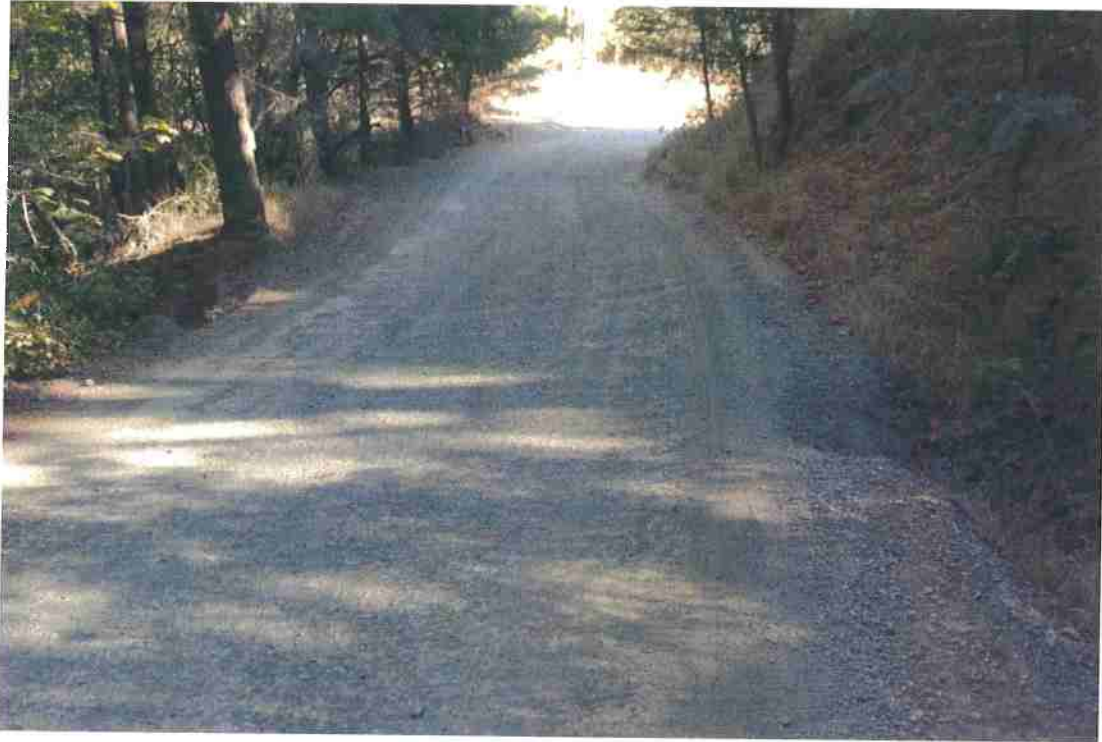
Photo 5. Mile 0.35: Pinch point at culvert; 16-ft road width with no shoulder and partial blind corner.

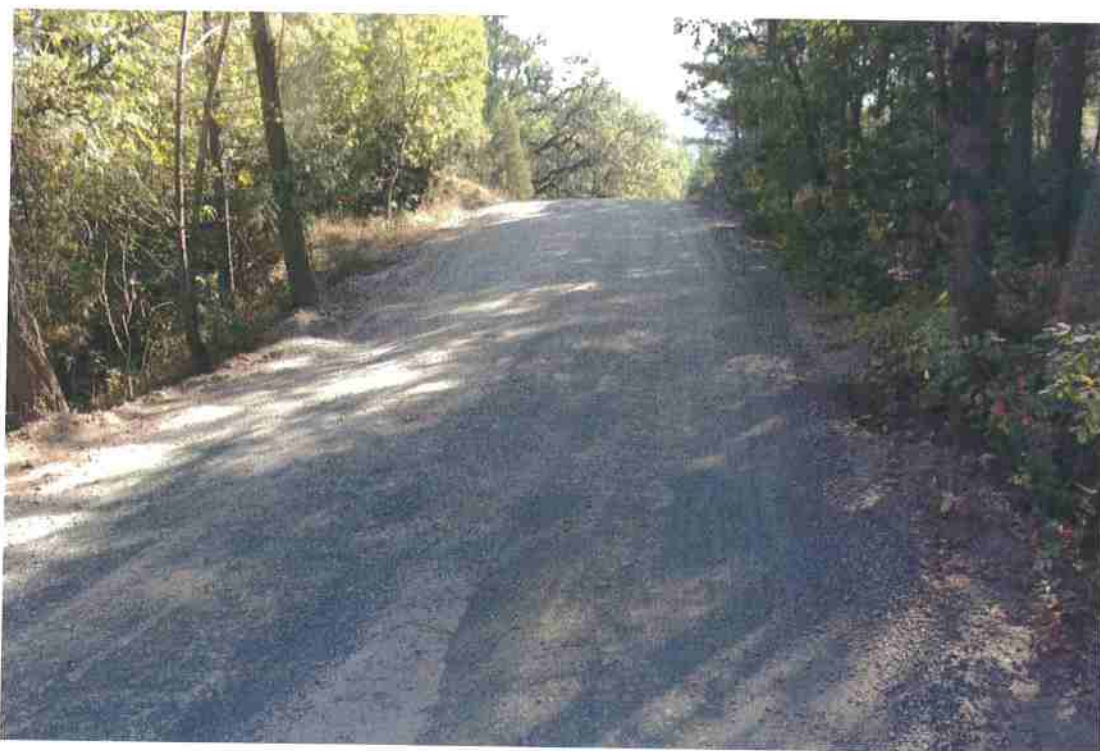
Photo 8. Mile 0.55: Pinch point at culvert; 16-ft road width with no shoulder. The road could be widened at the culvert location but there is decent visibility.

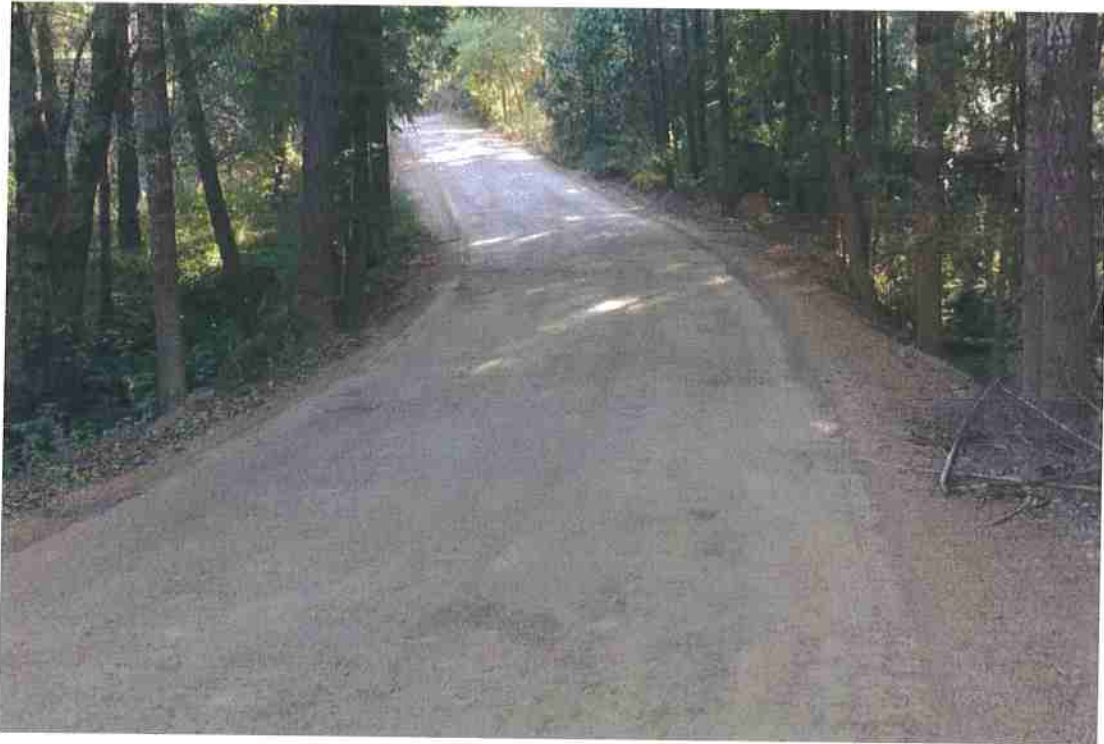
Photo 15. Mile 1.2: 18-ft road width with no shoulder at culvert crossing with decent visibility.
