## Water Resource Protection Plan (WRPP)

**APN 522-025-003, 522-024-002 and 522-024-005**

**New 3 Creeks Road  
Willow Creek, California**

**May, 2017**

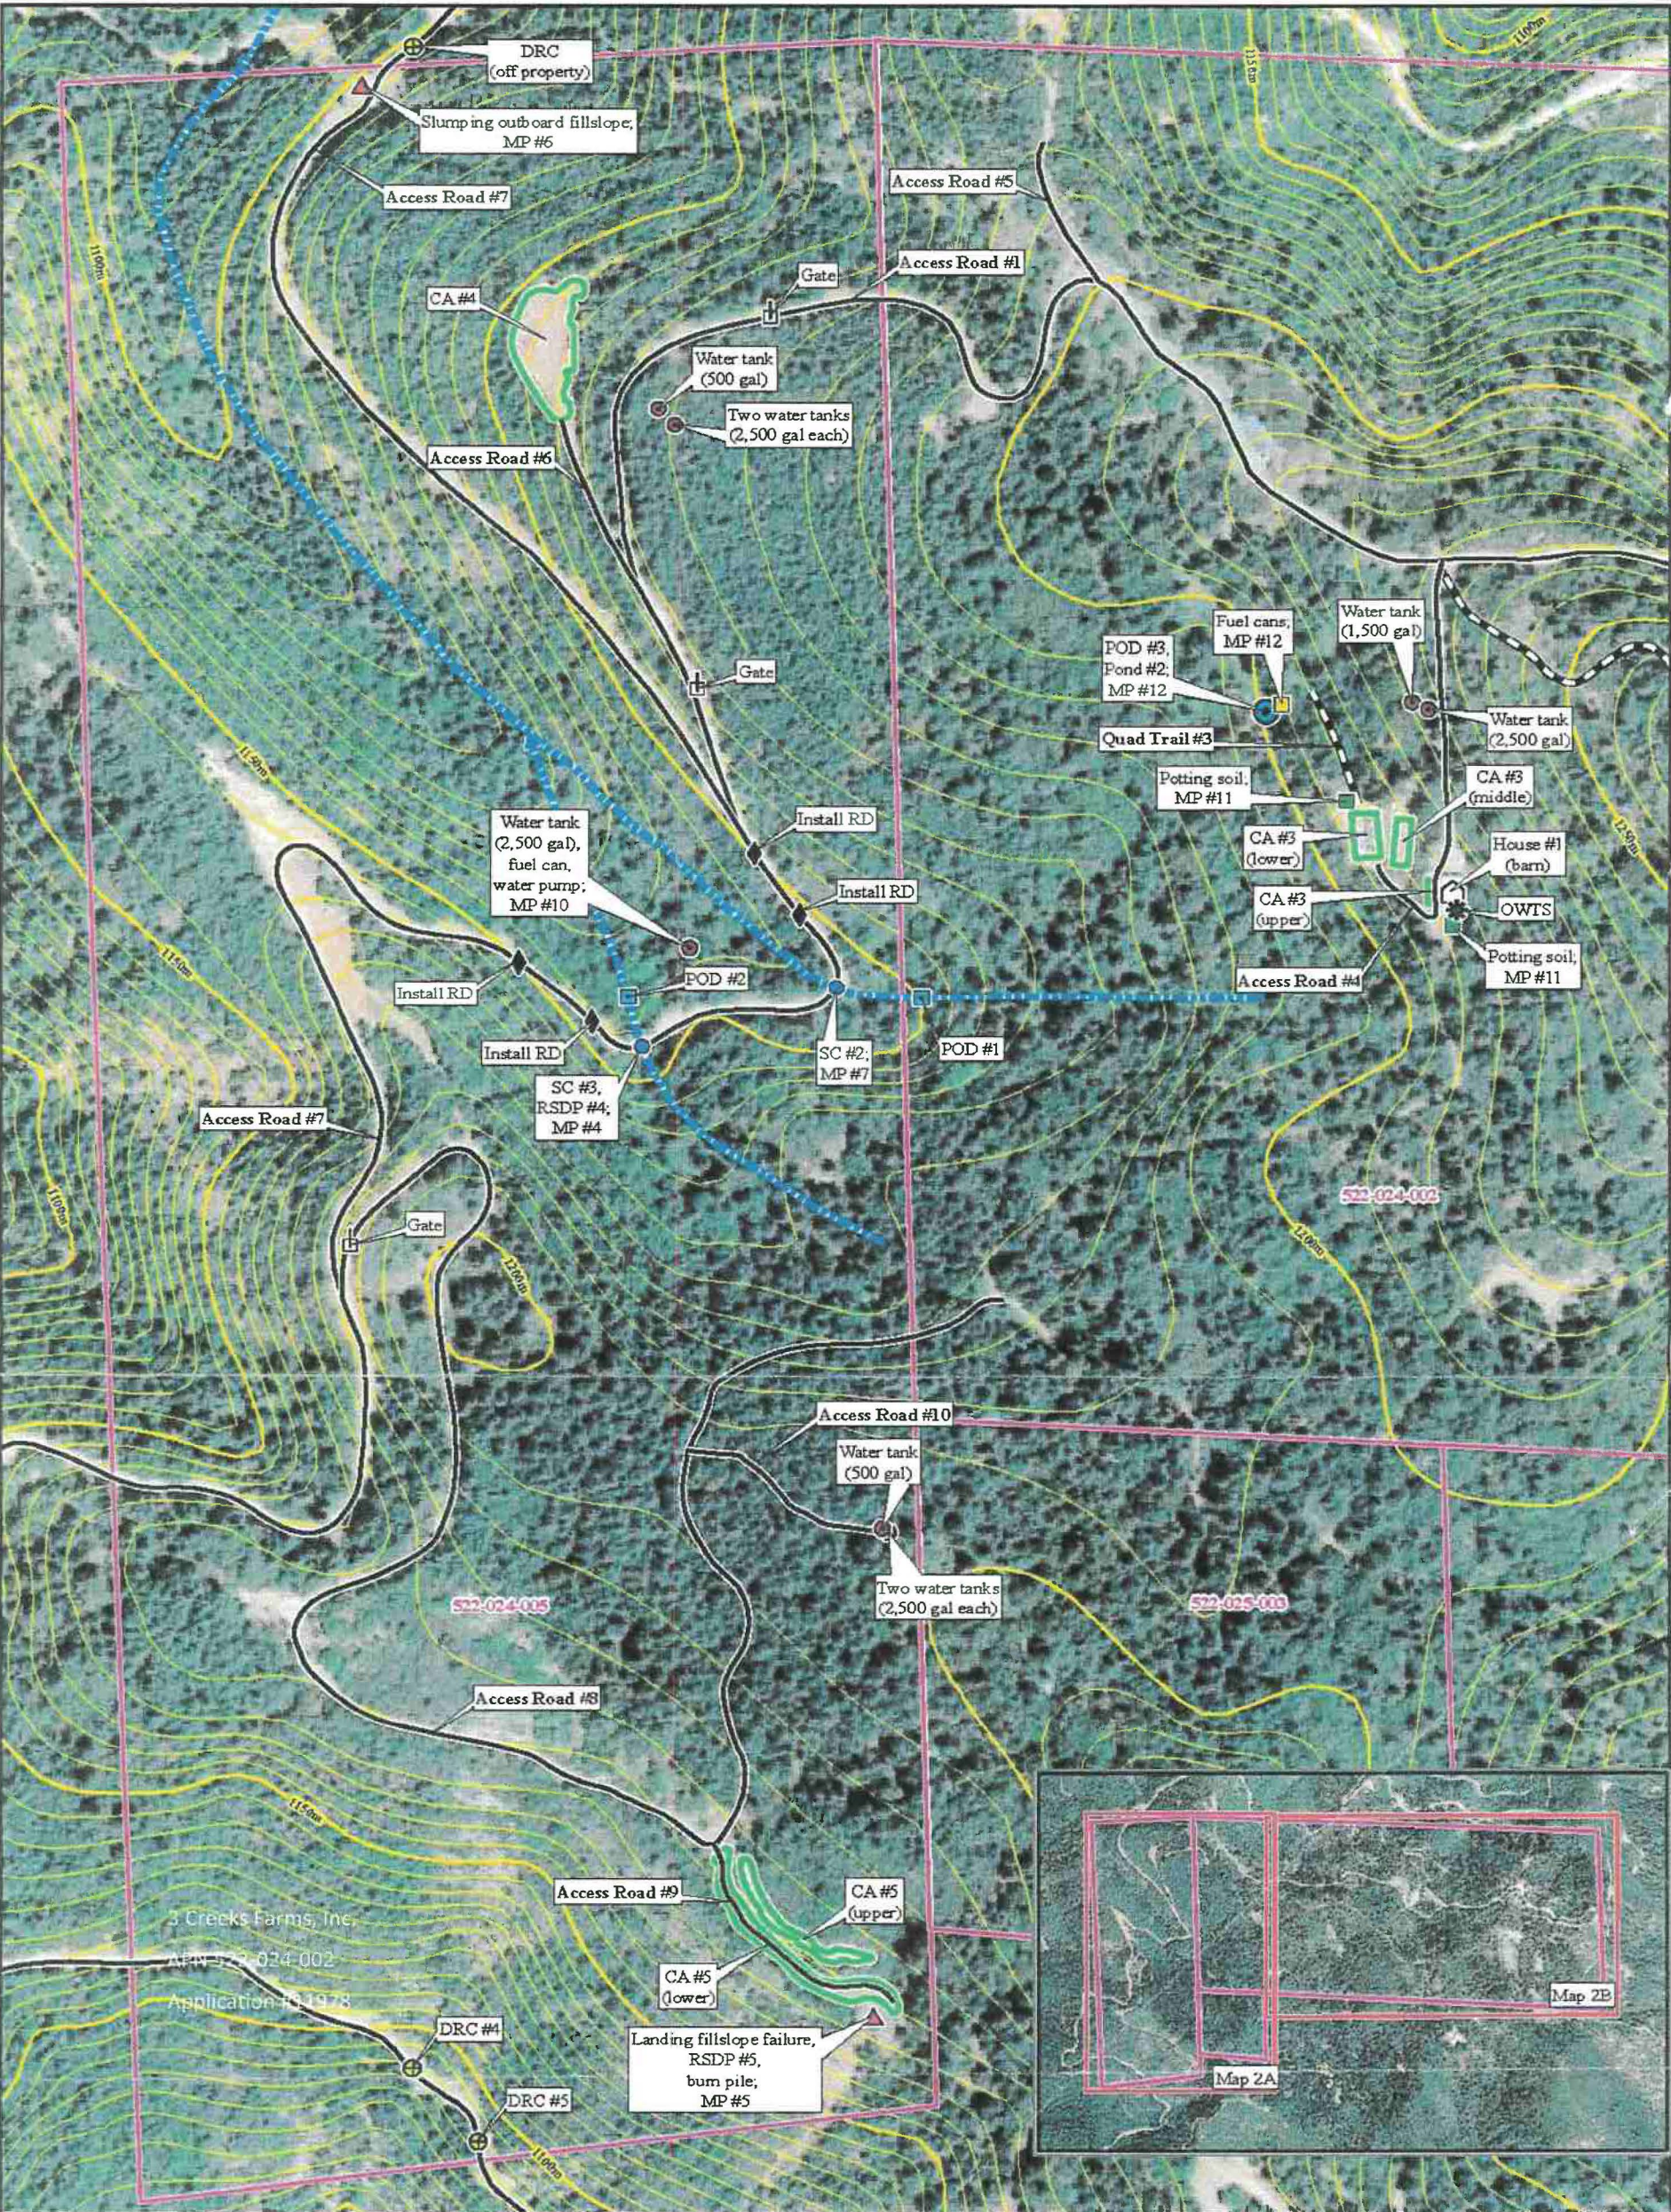
Figure 2A. Site map for WDID #1B16635CHUM, APN 522-024-002, 522-024-005, and 522-025-003, Willow Creek, Humboldt County, California.

**Standard Condition #5 - General comments and recommendations:** Currently, the source of water for both irrigation and domestic use are two points of diversion located on two separate Class II streams and Pond #2 (Figure 2A). There is 26,550 gallons of water storage capacity in hard plastic tanks and 25,183 gallons in Pond #2. Pond #2 will need to be inspected by a certified engineer and CDFW. At this time it appears that the water storage capacity contained within this Project Site does not fully satisfy the demand that would be expected from the cultivation area (~42,684 ft<sup>2</sup>) during the dry season (May 15<sup>th</sup> through October 31<sup>st</sup>). A Water Budget will be developed and refined by water monitoring to determine if water storage is adequate or whether dry season surface water diversions are required for the operation. A groundwater well is proposed for the Project Site and scheduled to be installed in 2017. Additional storage will need to be added so the diverter can completely forbear (not divert) during the dry season. In this way, as per the Order, it can then be assumed that water use will not impact downstream water quality or beneficial uses.

**Corrective or remedial actions needed:** See Figure 2 for proposed road drainage feature locations. Rolling dips should be spaced approximately 150-200 feet apart and connected to the cutbank or inboard ditch unless otherwise noted. Install eight rolling dips on Access Road #1 from 100 feet right of DRC #1 to 250 feet left of DRC #2. Install four rolling dips up the left road approach from Stream Crossing #1 (SC #1). Install two rolling dips to the right of SC #2. Install two rolling dips to the left of SC #3. Install additional rolling dips with adequate spacing intervals at any other location on the road system where concentrated road runoff and resultant rutting, rill erosion or gully erosion is observed. Typical drawings included in Appendix H will provide guidance for proper rolling dip construction.
