ENGINEERING GEOLOGIC R-2 SOILS EXPLORATION

Report of Findings Old Three Creeks Road Indian Field Ridge

Assessor's Parcel Number: 522-021-010

Prepared for: Stay Humboldt LLC, Mr. Kevin Dobosh

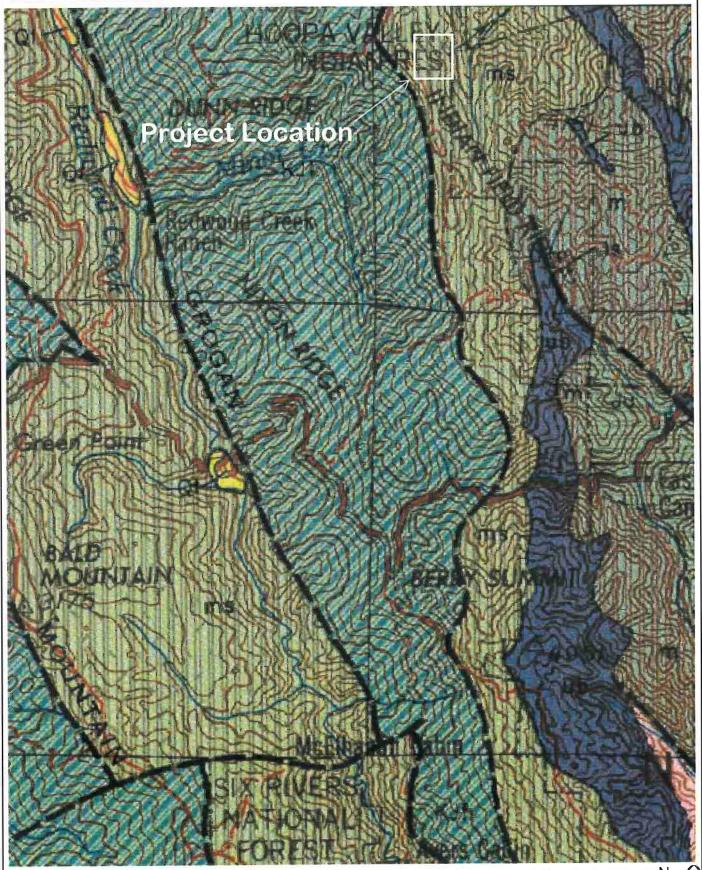
Lindberg Geologic Consulting	Engineering Geologic R-2 Soils Report	Figure 4
Post Office Box 306	Indian Field Ridge, Old Three Creeks Road, Humboldt County	January 29, 2020
Cutten, CA 95534	APN 522-021-010, Stay Humboldt LLC, Mr. Kevin Dobosh, Client	Project 0349.00
(707) 442-6000	Project Geologic Map (locations approximate)	1" ≅ 1.3 miles

This parcel is located near the coast within California's northern Coast Ranges Geomorphic Provence, a seismically active region in which large earthquakes are expected to occur during the economic life span (70 years) of any developments on the subject property. As mapped by the California Division of Mines and Geology in 1962, this parcel is underlain by undivided Pre-Cretaceous metasedimentary rocks (ms). Based on our subsurface explorations at this site, native soils are interpreted to be relatively-uniform across the existing and proposed developments. The soil profile consists of more than 5 feet of medium dense to dense, angular gravel with silty fine sand and clay (GW). Free groundwater was not encountered on-site on December 20, 2019.
