From: David Nicoletti PE QSD\QSP
DTN Engineering & Consulting
2731 K Street Unit A
Eureka, CA 95501
Email: dnicoletti@dtngineering.com

Subject: Roadway Evaluation for Cobb Road from Rattlesnake Bridge to APN 208-341-016

Introduction

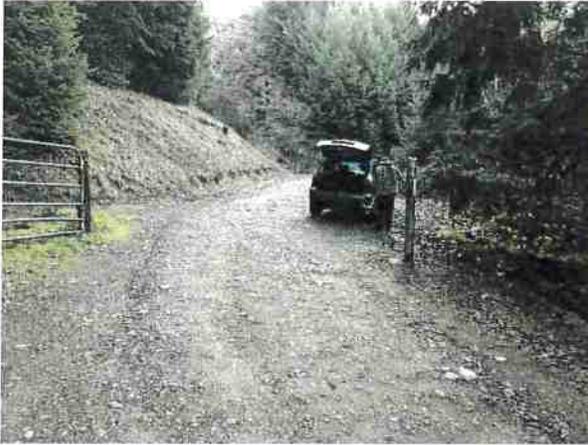
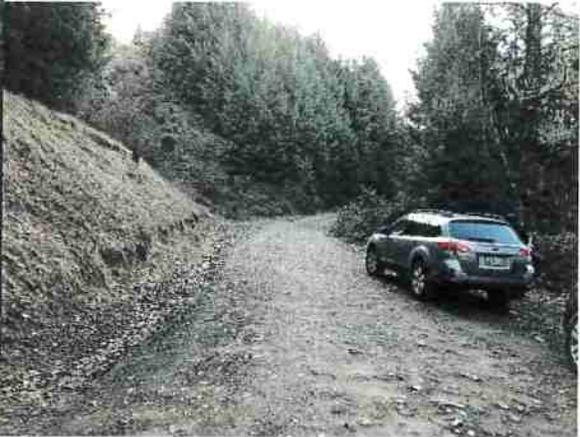
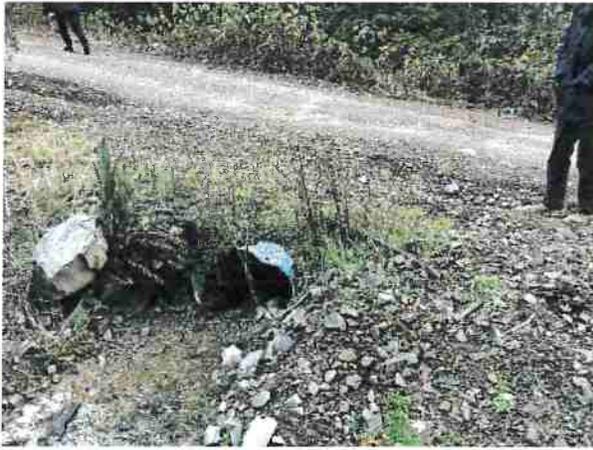
Pictures 1-3

The road evaluation begins at the gated entrance to Cobb Rd and the intersection of Rattlesnake Bridge (Pictures 1-2). At this location Cobb Rd. is within the SMA and an unidentified culvert conveys water under Cobb Rd. The roadway at this location is 16 feet wide and the grade abruptly increases to approximately 8% past the gate. As Cobb Rd proceeds to the southeasterly direction the first culvert is encountered (Picture 3). The culvert is an 18 inch CMP culvert in poor condition that is supplied by a drainage way. This culvert has previously been blocked due to sediment traveling downslope from the unstabilized PG&E easement.

Picture #1 Gate @ Cobb Rd & Rattlesnake Bridge looking E.

Picture #2 Cobb Rd & Rattlesnake Bridge looking E. @ curve.

Picture #3 Cobb Rd at Curve in Picture #2 looking @ 12" CMP

At this specific location it is recommended to replace the existing culvert with a new minimum 18 inch culvert and construct an approved turnout in accordance with the Humboldt County Ordinance for California Fire Safe Regulation. In order to prevent this culvert from clogging in the future, stabilize the PG&E easement, create a little ponded rock area at the inlet of the culvert for sediment to settle out, and possibly increase the culvert diameter to 24 inches. Reestablishment of the existing roadside ditches are also recommended.

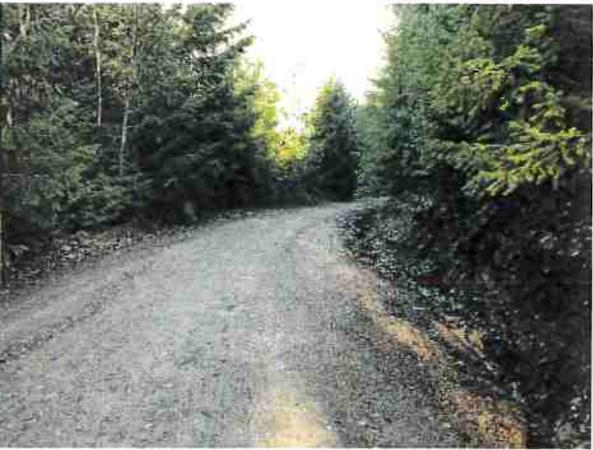
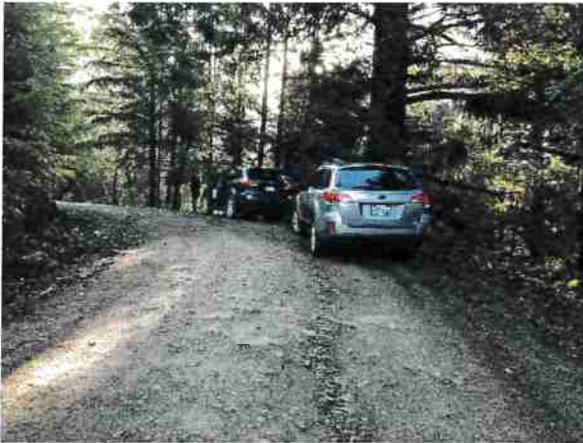
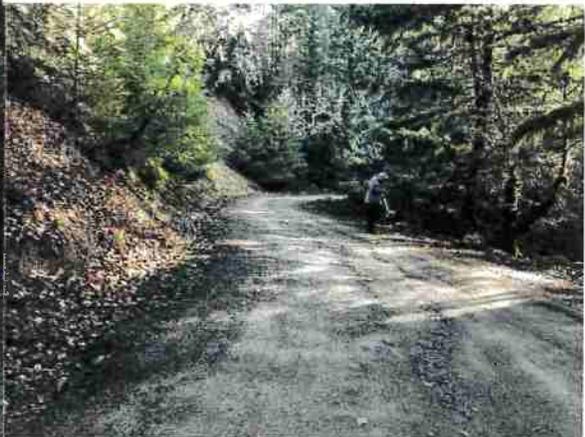
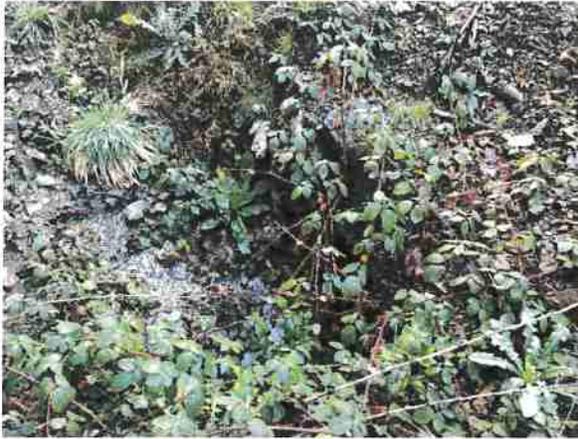
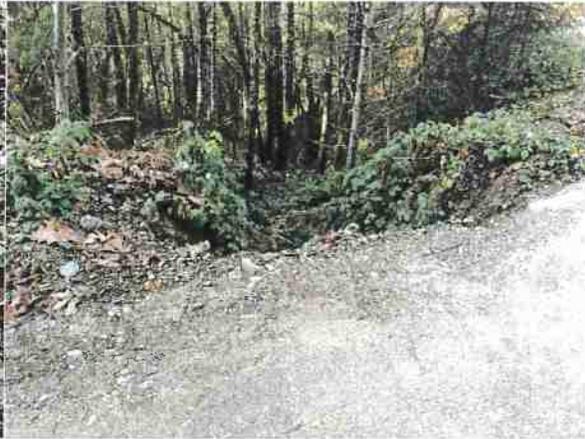
Pictures 4-8

Proceeding southeasterly up grade at approximately 8%, the first curve in the roadway is encountered (Pictures 4 & 5). As shown (Picture 5), there is sufficient space for two vehicles to pass, but as with the case of all pull outs at curves evaluated on Cobb Rd, they aren't in accordance with the Humboldt County Ordinance for California Fire Safe Regulation for turnouts (Exhibit D). The width

of the roadway at the turnout is approximately 16 feet and at both end of the curve the width narrows to 11.5 feet. The pictures depict erosion occurring at the edge of the inside of the curve eroding the toe of the slope. In addition, Google Earth shows a drainage developing due to the clearing in the PG& E easement above the road, this is also contributing to the erosion on the upslope side of the curve.

Proceeding southeasterly, the next curve is encountered (Picture 6) and as shown in the picture there are no turnouts, preventing the safe passage of two vehicles. At this location a 12 inch culvert exists, but at one point it was blocked and water cascaded over the road and over the downslope side of the hill (Picture 8). On the Google Earth image, the water overtopping the road is shown as well. Also, on the Google Earth image a drainageway is developing to the north, due to the clearing in the PG&E easement above the road.

Picture #4 Cobb Rd @ curve looking NW

Picture #5 Cobb Rd @ curve in Picture #4 looking SE

Picture #6 Cobb Rd looking E. @ curve

Picture #7 Cobb Rd @ 12" CMP inlet at curve

Picture #8 road washout due to culvert being clogged.

At this specific location it is recommended to replace the existing culvert with a new minimum 18 inch culvert. In order to prevent this culvert from clogging in the future, stabilize the PG&E easement, create a little ponded rocked area at the inlet of the culvert for sediment to settle out, and possibly increase the culvert diameter to 24 inches. Also, construct turnouts in accordance with the Humboldt County Ordinance for California Fire Safe Regulation at the curve. Reestablishment of the existing roadside ditches are also recommended.

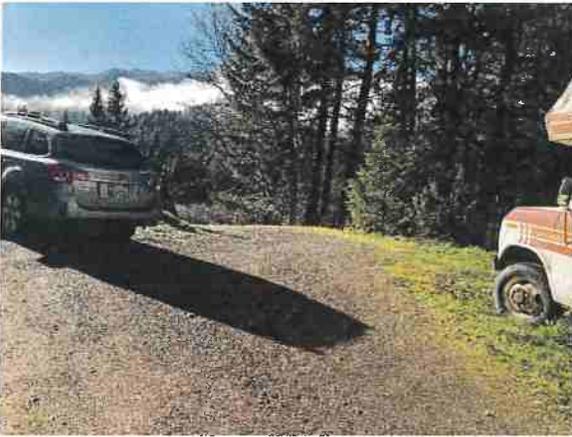
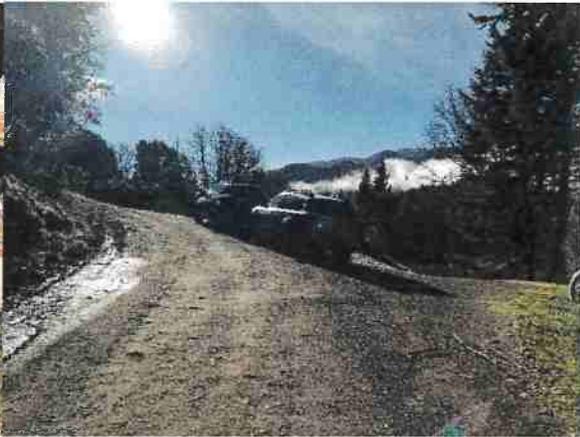
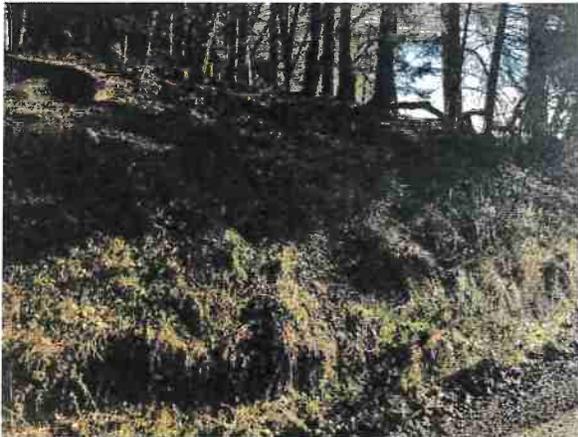
Pictures 9-11

Continuing southeasterly, the first driveway is encountered (Picture 9), and just passed that driveway (Picture 10), a curve is encountered with a slope of approximately 7% upslope from the driveway. The driveway as shown (Picture 9), is steep as it intersects Cobb Rd without appropriate SSD in accordance with Humboldt County Standards for Commercial Rural Driveway (Exhibit D). Looking northeasterly (Picture 11), the upslope side of the road embankment is sloughing and as described below in sections Pictures 12-14 & 57-59, the unstabilized graded flats above the roadway on APN #208-341-011, are creating erosion and runoff coming down the hillside. The erosion is also impacting and on the inside edge of the roadway curve the runoff is eroding the toe of the slope as shown (Picture 11), causing sloughing of the hillside. The grade upslope is approximately 7%. At the drive the width of the roadway and flat area is approximately 18 feet narrowing down to 14 feet (Picture 10). At either end of the curve the roadway narrows down to 11.5 feet.

Picture #9 Cobb Rd @ unsafe driveway

Picture #10 Cobb Rd looking SE towards curve & drive in #9

Picture #11 Cobb Rd looking NE @ sloughing of embankment

At this specific location it is recommended to improve the existing driveway for compliance with Humboldt County Standards for Commercial Rural Driveway. It is

also recommended to stabilize the sloughing of the north road embankment with engineered fill and appropriate slope armoring.

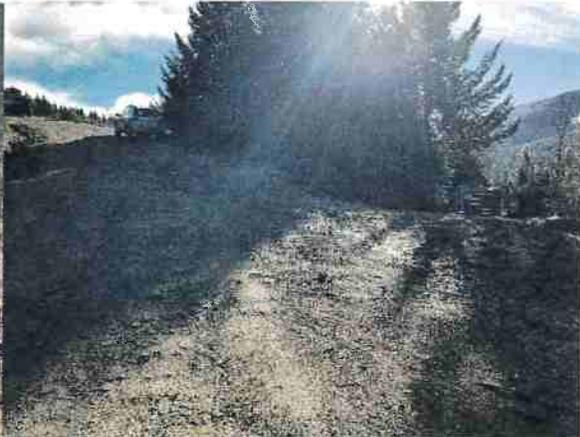
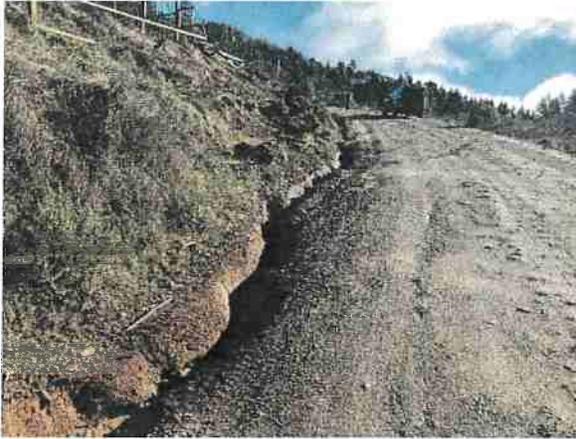
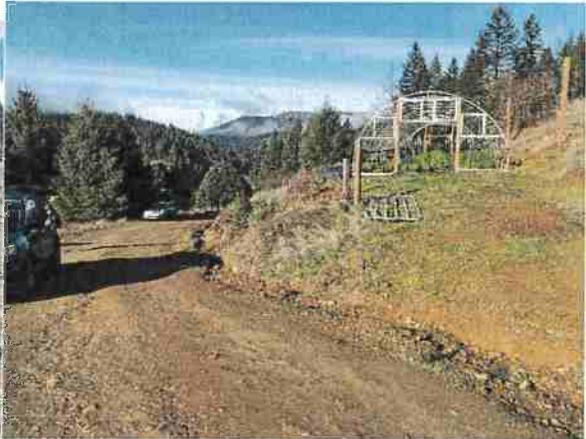
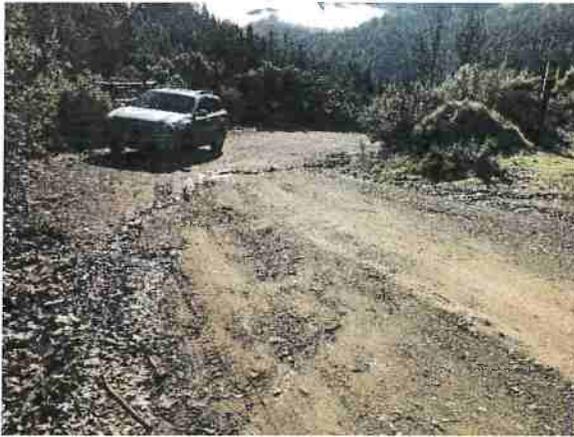
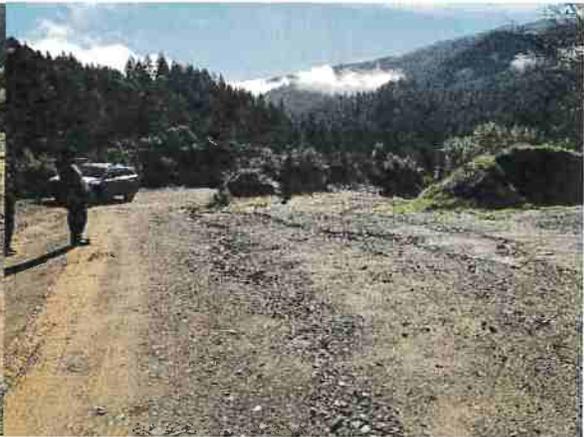
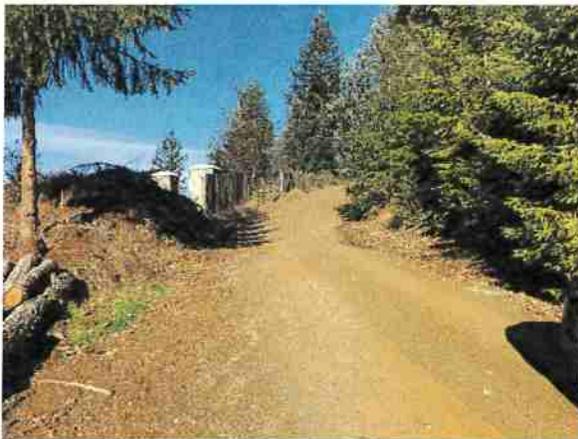
Pictures 12-17

Continuing southeasterly, coming upon the horseshoe curve at APN #208-341-011 (Picture 12), which depicts the second driveway encountered. This driveway as shown also does not meet Humboldt County Standards for Commercial Rural Driveway for SSD at driveways intersecting roadways. The roadway width around the horseshoe curve expands from 12 feet at the beginning of the curve travelling southeasterly. Significant drainage is entering the roadway from the graded flat on APN #208-341-011 and is eroding the inside toe of the slope creating erosion issues, sloughing of the hillside as described in section Pictures 9-11, and the blocked culvert described in section Pictures 57-59. The roadway around the curve expands to approximately 18 feet wide with a driveway that appears to be in conformance with Humboldt County Standards for Commercial Rural Driveway is encountered with a sufficient turnout space exists allowing two vehicles to pass at the same time. After the driveway the roadway narrows in width back to approximately 12 feet with a grade of 6% approaching the next curve (Picture 22). Looking northwesterly (Picture 17) the next curve is encountered and a pull out does exist for a car to pull out, but it is placed on the opposite side of travel as the curve is approached.

Picture #12 Cobb Rd looking SE @ curve & driveway

Picture #13 Cobb Rd looking NE @ erosion due to drainage

Picture #14 Cobb Rd looking SW towards curve.

Picture #15 Cobb Rd looking SE towards curve in 14 w/ erosion

Picture #16 Cobb Rd looking SE towards curve in 14 @ drive

Picture #17 Cobb Rd looking NW towards curve

At the specific location shown (Picture 17) it is recommended to construct a turnout on the north side of the roadway in compliance with Humboldt County Ordinance for California Fire Safe Regulation. A large part of the erosion and drainage issues identified in sections Pictures 9-11, Pictures 57-59, and Pictures 12-17, have been created by APN #208-341-011 due to clearing and grading for flats without proper slope stabilization. Reestablishment of the existing roadside ditches are also recommended.

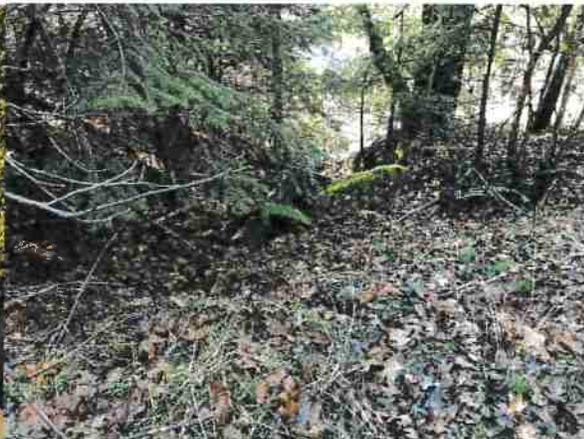
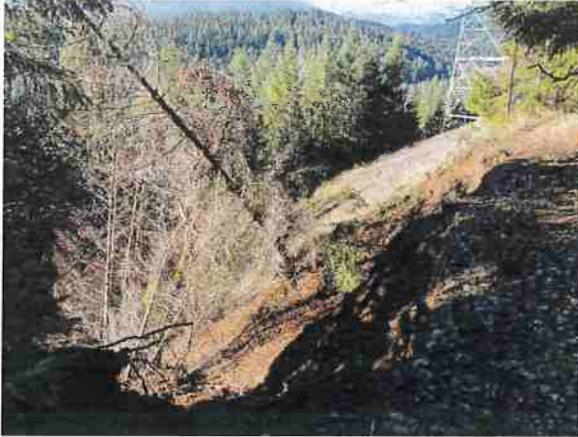
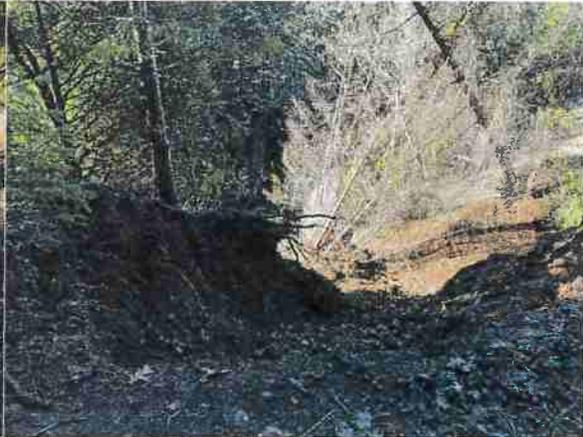
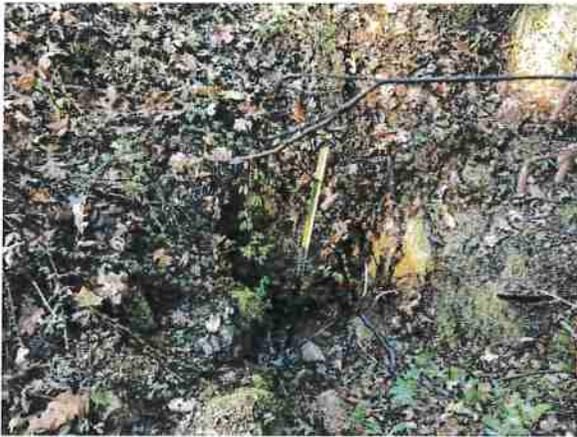
Pictures 18-21

This section evaluates part of the PG&E easement clearing along with a water tank placed on the edge of a slope, along with drainage and erosion issues. The tank is shown looking downslope, Picture 25 in section Picture 22-25 below. Erosion is occurring (Pictures 19 & 20) due to un-stabilized slopes that have been created by the clearing of the PG&E easement. A 12 inch culvert that appears partially blocked (Pictures 18 & 21) on the intake side exists. There is a steel delineator marking the inlet of the 12 inch culvert (Picture 21).

Picture #18 Cobb Rd @ 18" culvert outlet looking W @ esmt.

Picture #19 On PG&E esmt looking SW

Picture #20 On PG&E esmt looking SW @ erosion.

Picture #21 On PG&E esmt looking NE @ outlet from Cobb Rd

At this location it is recommended to coordinate with PG&E regarding to legal responsibility for maintaining environmental control over the easement. Also, it is recommended to replace the existing culvert with a new minimum 18inch culvert.

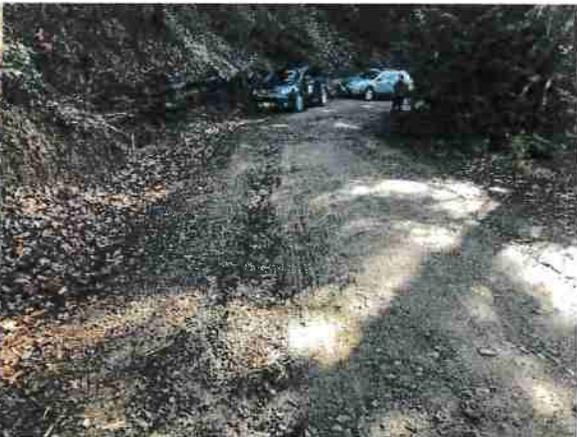
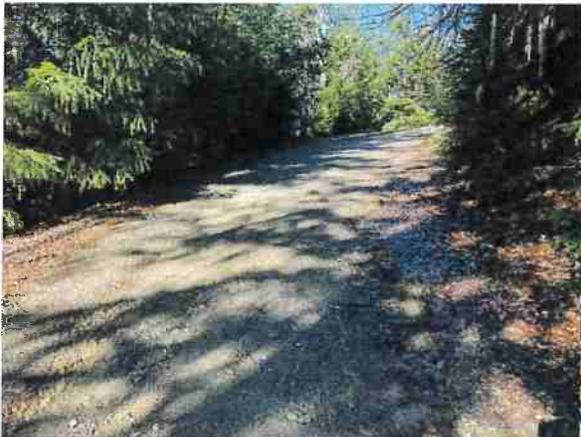
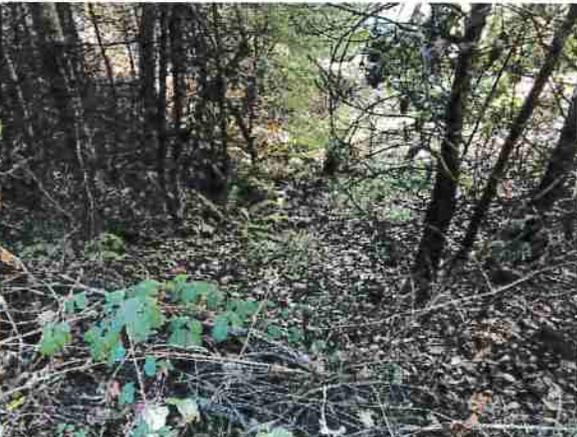
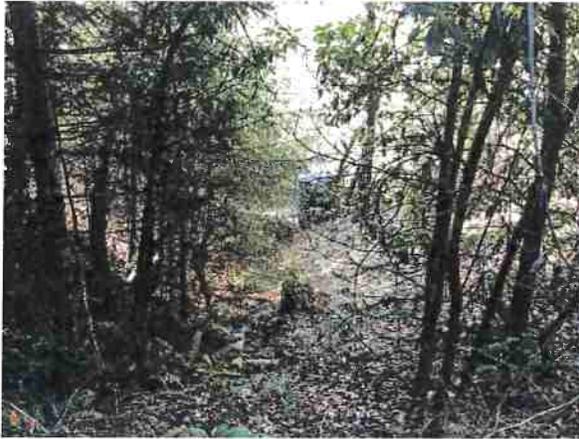
Picture 22-25

Continuing northwesterly, the next curve and culvert location is encountered (Pictures 22-25). As depicted (Picture 22) there is a narrow turnout allowing two vehicles to pass around the curve. Additionally, there is erosion and drainage occurring downhill due to the 12 inch culvert being blocked in the past as well as the ditch on either side of the road being congested with debris. The roadway before and after the curve is approximately 12 feet with clogged ditches on either side of the traveled way. The slope of the road is approximately 8%.

Picture #22 Cobb Rd SE towards curve

Picture #23 Cobb Rd looking NW @ curve

Picture #24 Cobb Rd looking @ culvert @ PG&E esmt (tank)

Picture #25 Cobb Rd outlet of 12" culvert looking @ tank

At this specific location it is recommended to replace the existing culvert with a new minimum 18inch culvert and construct a turnout at the curve in accordance with the Humboldt County Ordinance for California Fire Safe Regulation. Reestablishment of the existing roadside ditches are also recommended.

A tank was identified above on the edge of a slope (Picture 25). It is recommended to evaluate the existing slopes, the load that the tank is placing on those slopes and take remediation measures as necessary including the possibility of relocating the tank.

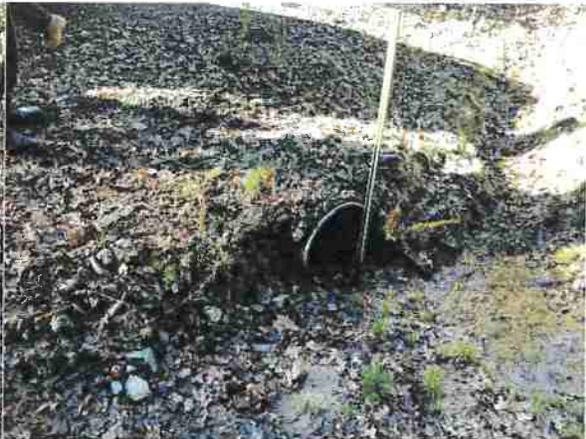
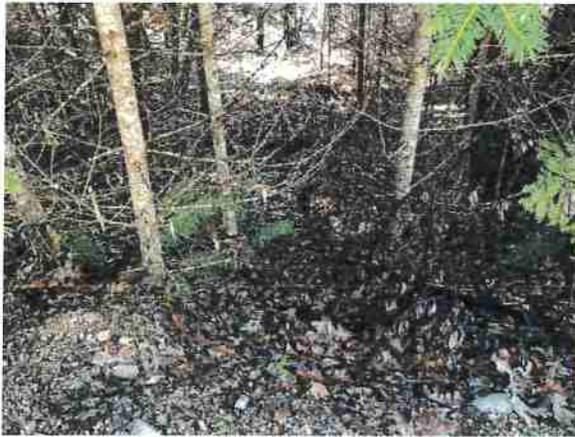
Picture 26&27

Continuing around the next horseshoe curve, a 12 inch culvert is encountered (Pictures 26 & 27). This culvert is discharging at a steep slope down hill (Picture 27) and without armoring the drainage is causing erosion. The roadway here is approximately 12 feet wide and the grade approaches 5% approaching the next curve.

Picture #26 Cobb Rd inlet of 12" culvert in Picture 27.

Picture #27 Cobb Rd outlet & erosion from culvert @ Picture 26

At this specific location it is recommended to replace the existing culvert with a new minimum 18inch culvert.

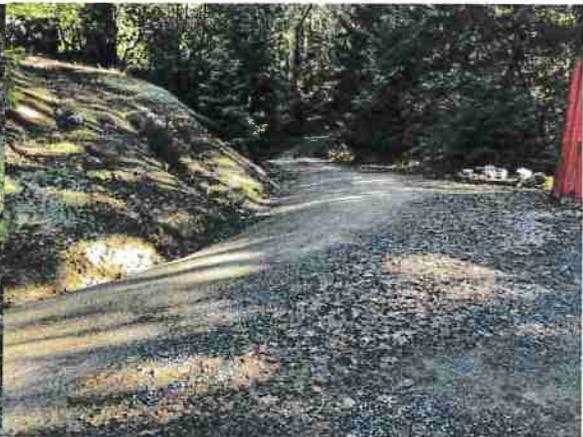
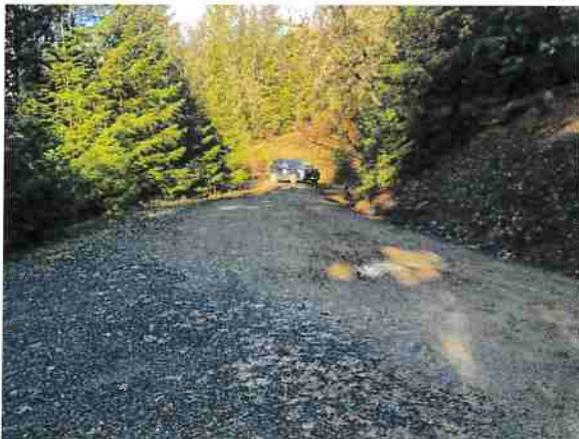
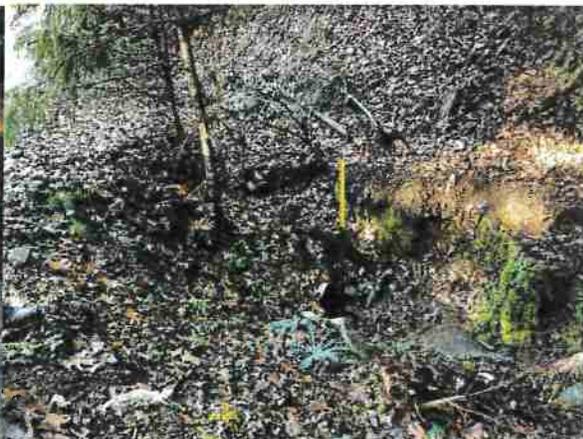
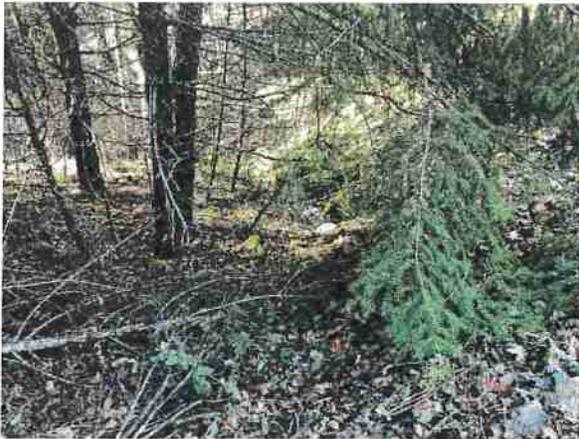
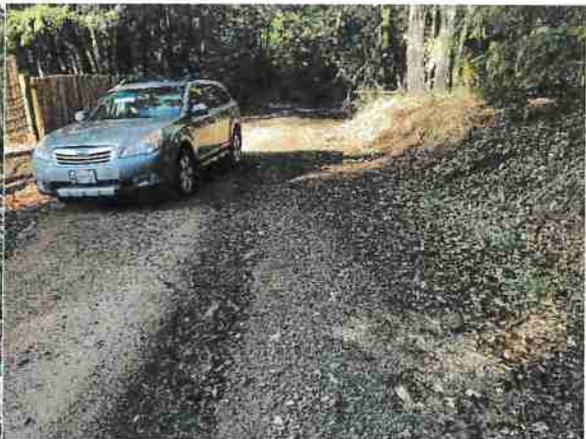
Picture 28-32

Continuing northeasterly around the next curve, another driveway is encountered at the midpoint of the curve, and the driveway appears to meet Humboldt County Standards for Commercial Rural Driveway. The roadway at this location is 18 feet wide sloping gently, allowing two vehicles to pass.. The width of the roadway before and after the curve are 12 feet with a 5% grade approaching (Picture 28) and a 3% slope departing the curve (Picture 29). A 12 inch culvert exists (Pictures 30 & 31).

Picture #28 Cobb Rd looking E towards curve

Picture #29 Cobb Rd looking NW towards curve

Picture #30 Cobb Rd 12" culvert inlet

Picture #31 Cobb Rd 12" culvert outlet

Picture #32 Cobb Rd looking W towards curve.

At this specific location it is recommended to replace the existing culvert with a new minimum 18inch culvert and construct a turnout at the curve in accordance with the Humboldt County Ordinance for California Fire Safe Regulation. Reestablishment of the existing roadside ditches are also recommended.

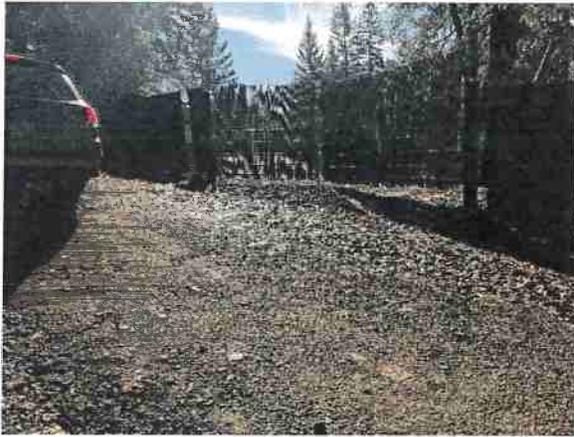
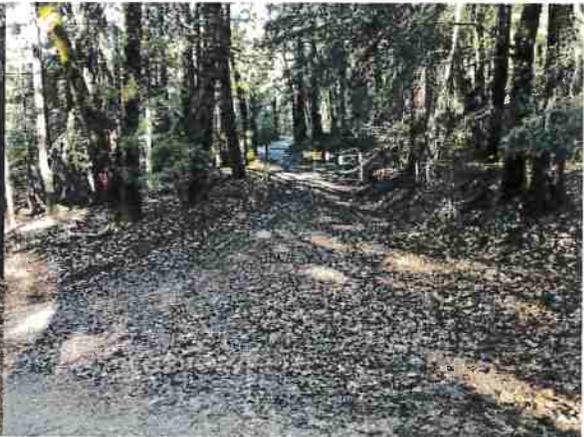
Picture 33 & 34

At this location a gated drive (Picture 33), exists on the southside of the roadway and the northside of the roadway (Picture 34), exists a drive that is steep and carrying drainage and erosion onto Cobb Rd. The roadway width at this location is 12 feet at a 3% grade and erosion is occurring along the north side of the road, eroding the toe of the slope creating a potential sloughing situation on the hillside.

Picture #33 Cobb Rd looking @ driveway

Picture #34 Cobb Rd looking N. @ driveway w/ erosion

At this location a specific recommendation to stabilize the driveway at this location and construct a grated 18inch CMP pipe parallel to Cobb Rd to capture drainage from the driveway and convey it downhill minimizing erosion. Reestablishment of the existing roadside ditches are also recommended.

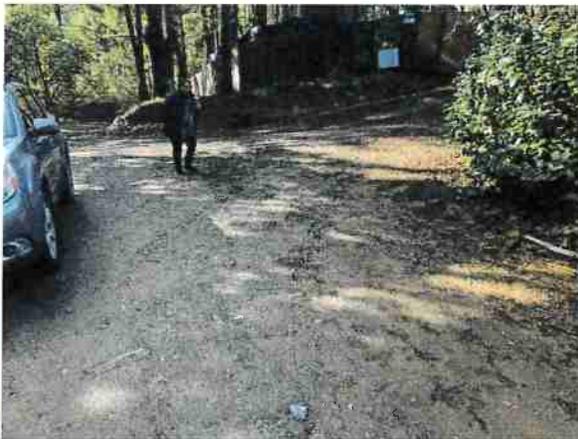
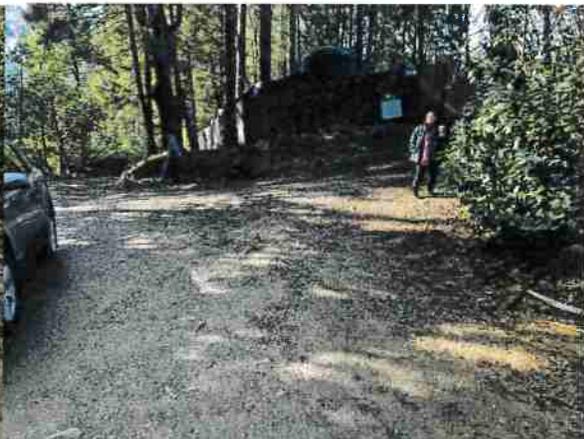
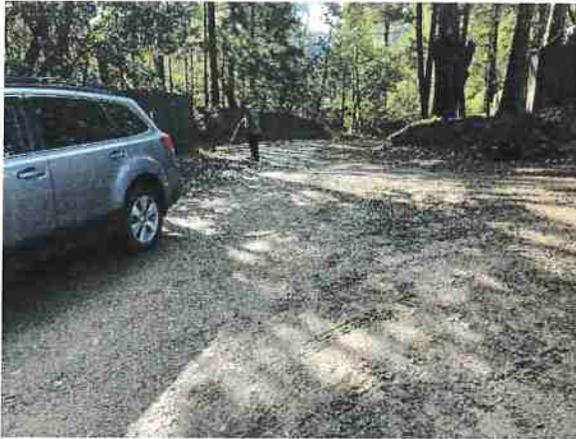
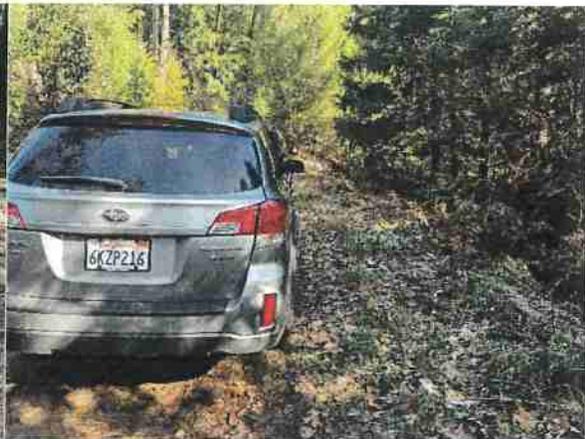
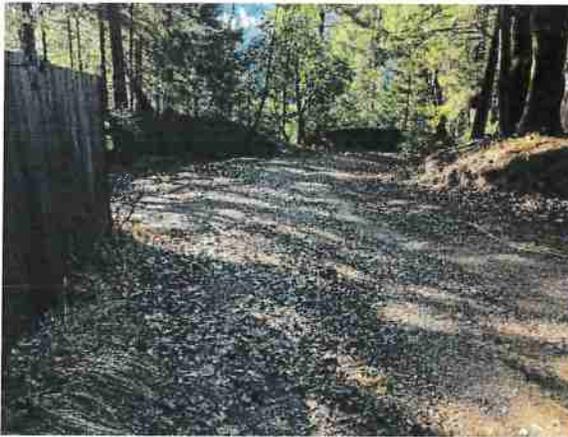
Picture 35-39

Continuing southeasterly around the next curve (Picture 38 & 39), the curve does have a pull out allowing two vehicles to pass. At this location the roadway widens to from 12 feet at 4% grade to 18 feet at the next driveway, which appears to be in conformance with Humboldt County Standards for Commercial Rural Driveway. Drainage appears to be coming off of the driveway serving APN #208-341-005,

flowing southwesterly along the toe of the slope eroding away the toe and creating a sloughing situation (Picture 39).

Picture #35 Cobb Rd looking SW towards curve

Picture #36 Cobb Rd looking SW at driveway

Picture #37 RVF Cobb Rd looking SE towards curve

Picture #38 RVF Access Rd looking NW towards curve pullout.

Picture #39 Cobb Rd looking SE towards curve

At this specific location it is recommended to construct a turnout at the curve in accordance with the Humboldt County Ordinance for California Fire Safe Regulation and to reestablish the roadside ditches are also recommended.

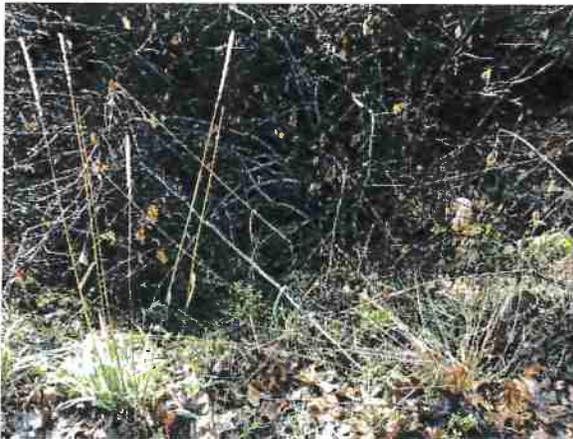
Picture 40 & 41

At this location a 12 inch CMP culvert exists. The roadway is 12 feet wide and the grade is gradual at approximately 3%.

Picture #41 Cobb Rd looking @ outlet of 12" culvert in Picture 40

At this specific location it is recommended to replace the existing culvert with a new minimum 18 inch culvert. Reestablishment of the existing roadside ditches are also recommended.

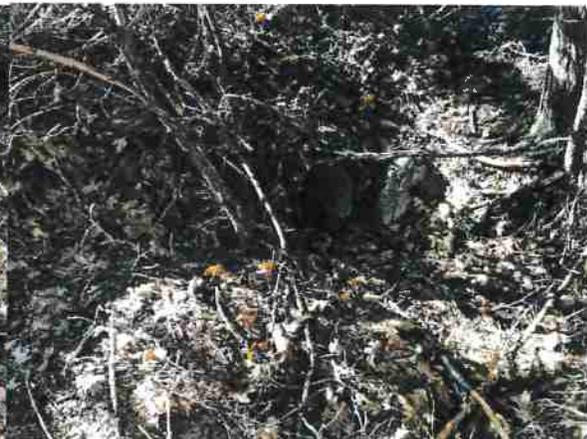
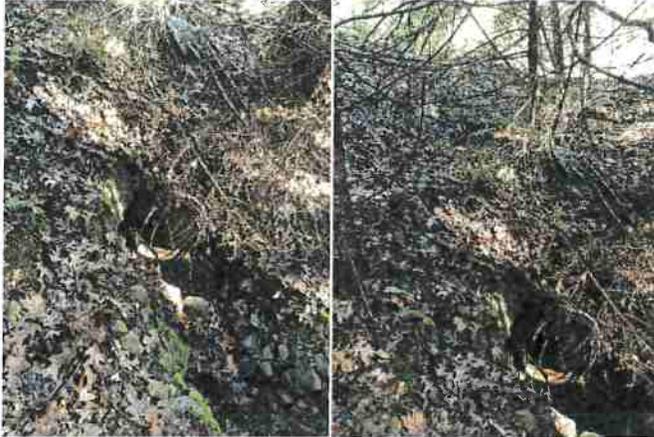
Picture 42-44

At this location a 12 inch CMP culvert exists. The roadway is 12 feet wide and the grade is gradual at approximately 3%

Picture #42 Cobb Rd looking @ inlet of 12" culvert

Picture #43 Cobb Rd inlet of 12" culvert Picture #44 Cobb Rd outlet from culverts in Pictures 42 & 43.

At this specific location it is recommended to replace the existing culvert with a new minimum 18 inch culvert. Reestablishment of the existing roadside ditches are also recommended.

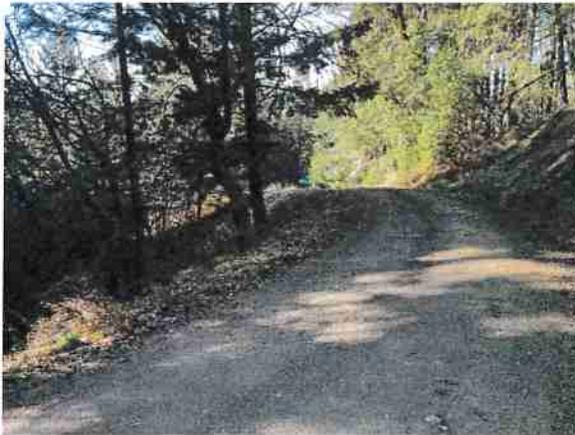
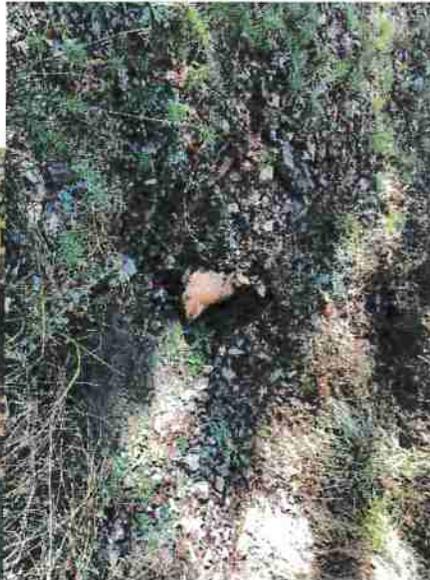
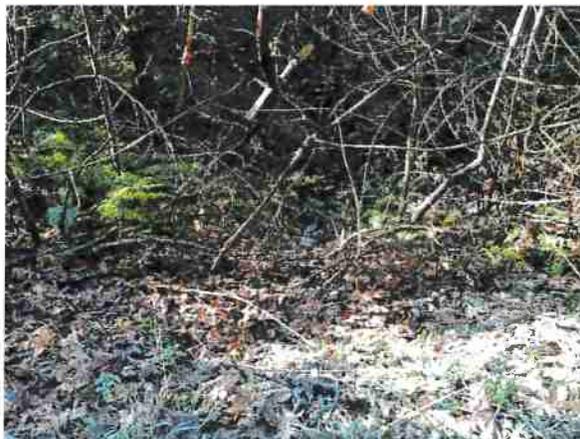
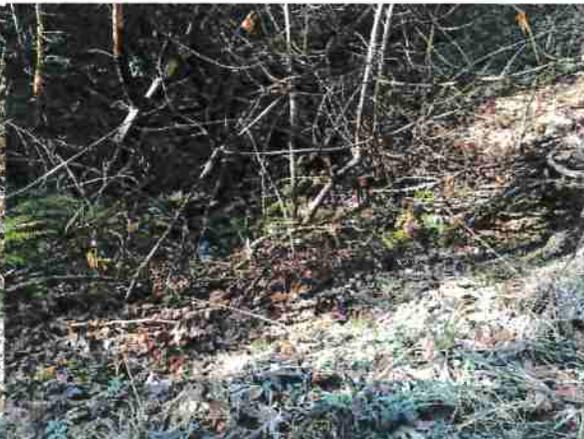
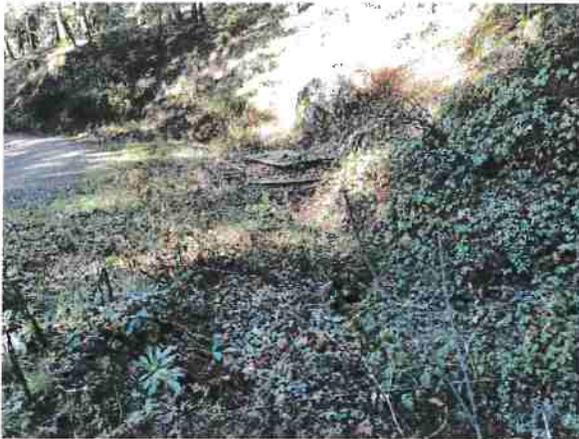
Picture 45-49

Continuing northeasterly the next curve is encountered. The roadway approaching the curve is 12 feet in width and at the curve the roadway widens to 16 feet (Pictures 45 & 49). At the middle of the curve on the northside of the road where the roadway widens, two 12 inch CMP culverts exists (Pictures 46 & 49) with a constructed dam between them (Picture 49). The inlets are damaged, and the outlets are unarmored creating erosion downstream (Pictures 47 & 48).

Picture #45 Cobb Rd looking NE @ curve

Picture #46 Cobb Rd looking at 12" crushed CMP inlet

Picture #47 Cobb Rd outlet of 12" culvert in Picture 46

Picture #48 Cobb Rd outlet of 12" culvert in Picture 46

Picture #49 Cobb Rd @ double 12" culvert w/ dam in middle

At this specific location it is recommended to replace the existing culvert with a new minimum 18 inch culvert and construct a turnout at the curve in accordance with the Humboldt County Ordinance for California Fire Safe Regulation. Reestablishment of the existing roadside ditches are also recommended.

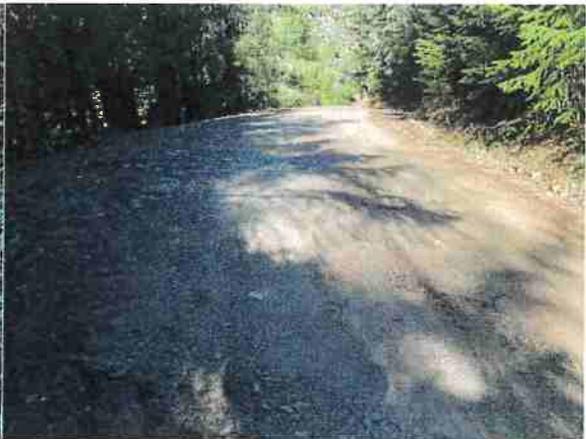
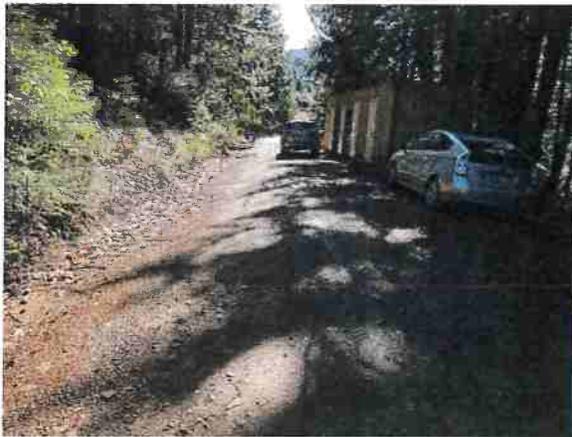
Pictures 50 & 51

Continuing southeasterly the roadway is 12 feet wide with 1-2 foot drainage ditches on either side of the road that are clogged with debris. The gradient is approximately is gradual at 2-3%. There is a largen container stored on the south side of the roadway (Picture 51) creating a traffic hazard.

Picture #50 Cobb Rd looking SW towards curve.

Picture #51 Cobb Rd looking NE at storage container in road

It is recommended to immediately remove the container. Reestablishment of the existing roadside ditches are also recommended.

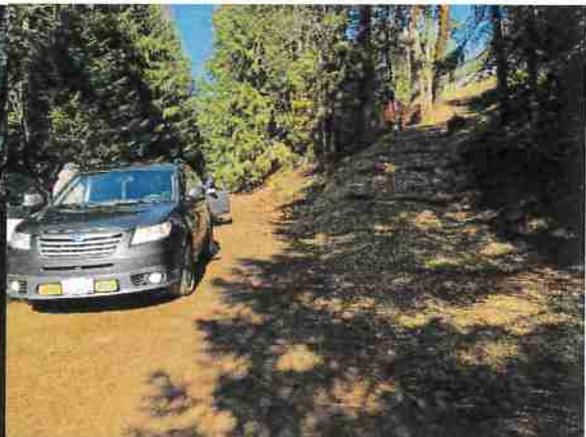
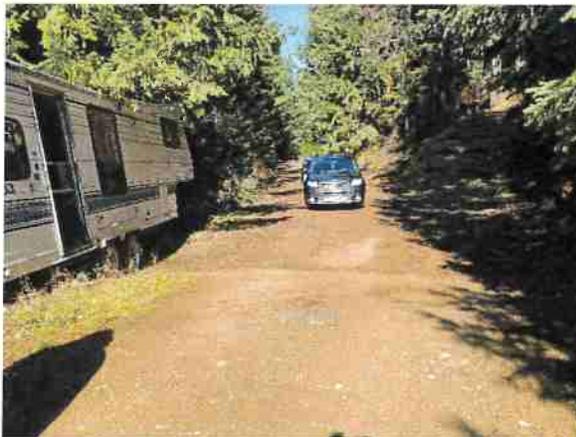
Pictures 52 & 53

Continuing southeasterly the roadway is 12 feet wide with 1-2 foot drainage ditches on either side of the road. The gradient is also gradual at 2-3%. On the northside of the roadway exists a stabilized slope that looks as if it were a driveway at one time. The stabilization with both mulch and fiber rolls is appropriate and should be used as an example for stabilizing the slopes that are mentioned in the Summary and Recommendations section of this report below. There is a container stored on the south side of the roadway creating a traffic hazard (Picture 53).

Picture #52 Cobb Rd looking NW towards properly stabilized slope

Picture #53 Cobb Rd looking NW @ abandoned RV in road

It is recommended to immediately remove the container. Reestablishment of the existing roadside ditches are also recommended.

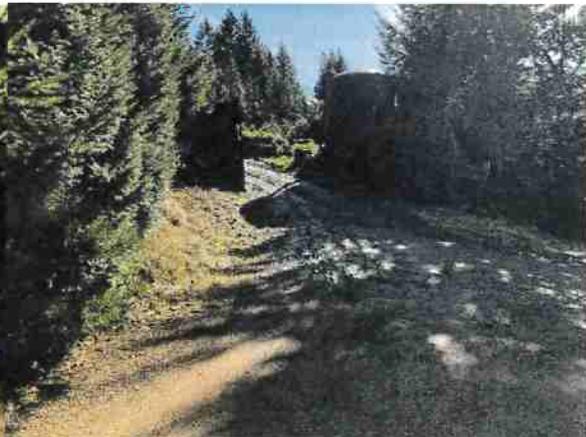
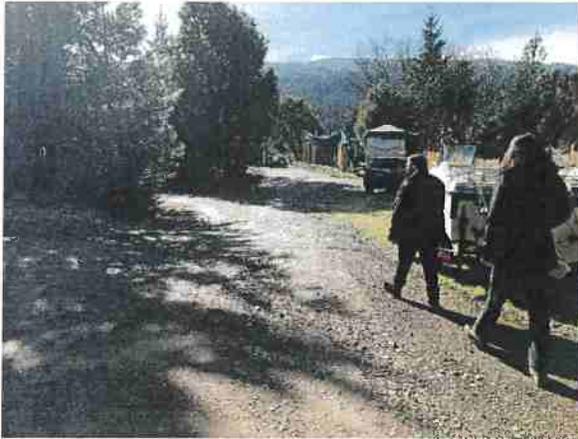
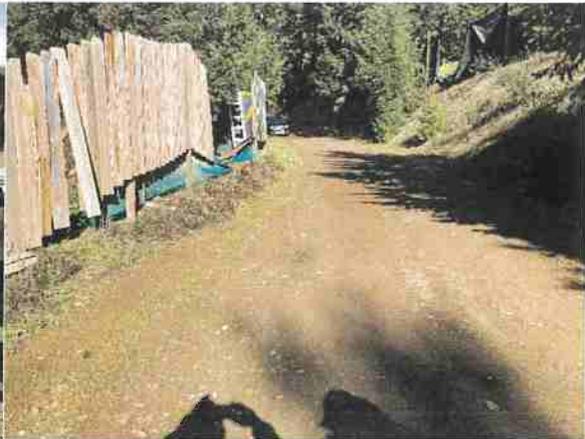
Pictures 54 – 56

Continuing southeasterly the roadway is 12 feet wide with 1-2 foot drainage ditches on either side of the road. The gradient is approximately is gradual at 2-3%. At this location the road evaluation is terminated and there are two driveways at this location as Cobb Rd continues in a southerly location serving four additional parcels.

Picture #54 Cobb Rd looking E @ driveway

Picture #55 Cobb Rd looking SE @ road end

Picture #56 Cobb Rd at road end looking NW.

It is recommended to construct a turnaround in accordance with the Humboldt County Ordinance for California Fire Safe Regulation. Reestablishment of the existing roadside ditches are also recommended.

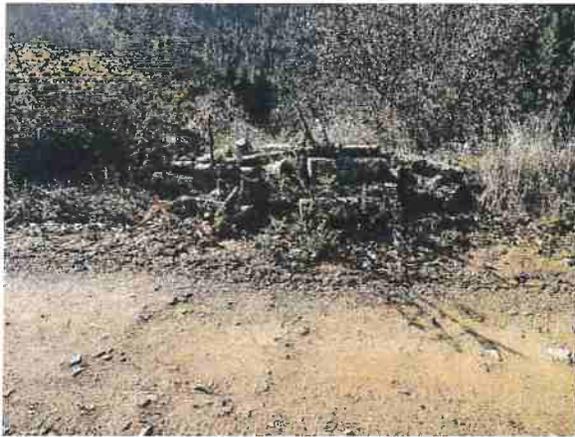
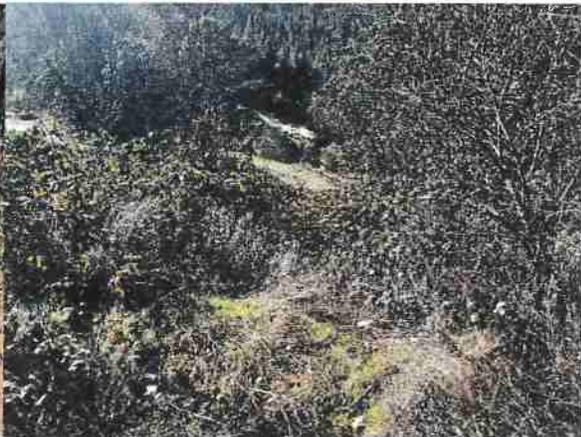
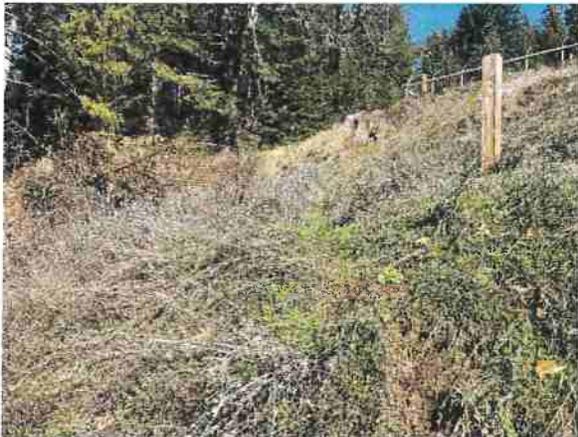
Pictures 57-59

Continuing southeasterly a previously blocked and undersized 12 inch CMP culvert exists (Pictures 57-59). Because of the erosion coming off the hillside from the graded flat above, the carried sediment is clogging the culvert forcing water over the road. One of the residents living below that part of the road has constructed a dam to prevent water from overtopping the road onto their property (Picture 57). The roadway at this location is approximately 12 feet wide with 1 foot shoulders and the roadway has minimal slope at this location.

Picture #57 Cobb Rd @ outlet of culvert where water tops road

Picture #58 Cobb Rd outlet of culvert in Picture 57

Picture #59 Looking uNW @ erosion @ outlet of culvert in Picture 58

At this specific location it is recommended to replace the existing culvert with a new minimum 18 inch culvert. The drainage issues with APN #208-341-011 are impacting Cobb Rd and the parcels downslope. With that APN securing a permit through the Humboldt County Commercial Medical Marijuana Ordinance, the conditions of that permit should address the erosion and drainage issues created by clearing and grading the flats without proper permits and engineering. It is recommended that a site evaluation to be performed as soon as possible to begin remediation of the issues impacting the roadway. Reestablishment of the existing roadside ditches are also recommended.

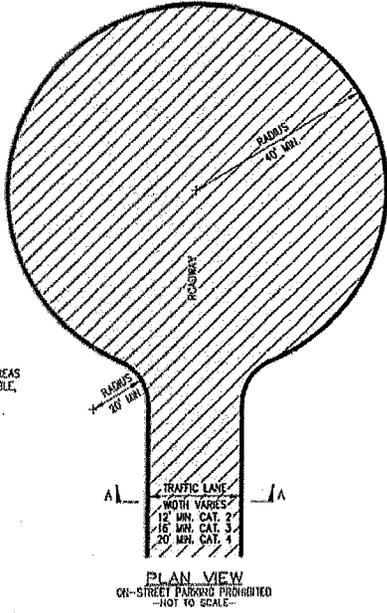
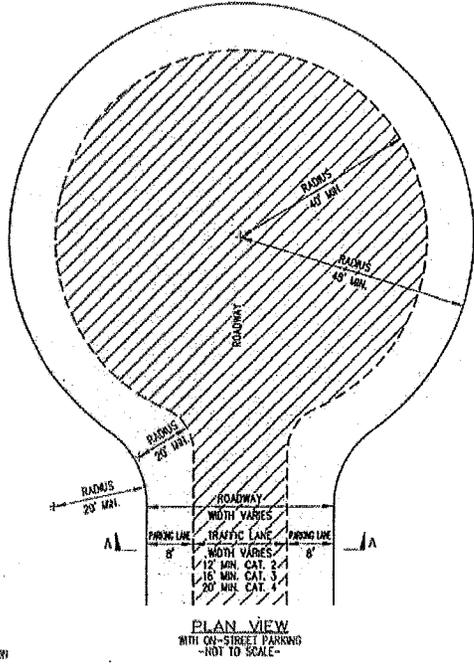
FIGURE 3112-7A
 Cul-de Sac

Type 1
 On-Street Parking Prohibited

Type 2
 On-Street Parking Allowed

Turnarounds are required on driveways and dead-end roads as specified in these regulations. The minimum turning radius for a turnaround shall be 40 feet from the center line of the road, not including the parking lane. If a hammerhead "T" is used, the top of the "T" shall be a minimum of 60 feet in length. If a slip "T" design is used, the projection shall have a minimum depth of forty (40) feet. Turnaround designs shall conform to the diagrams below in Figures 3112-7A, 3112-7B and 3112-7C, as applicable. (Ord. 1952, § 1, 12/17/1991; amended by Ord. 2540, Section 1, 11/17/2015)

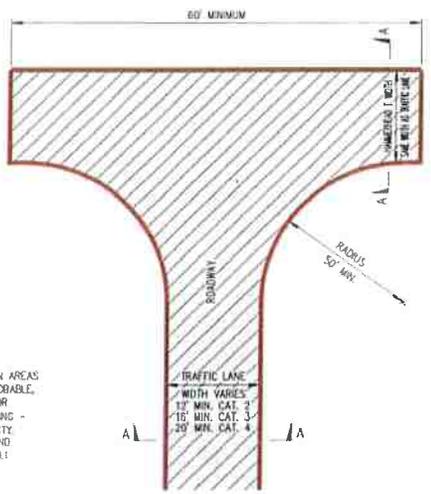
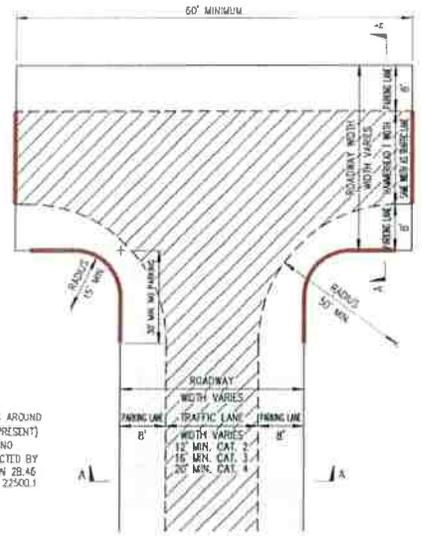
FIGURE 3112-7B
Hammerhead "T"

PLAN VIEW
ON ROADWAY PARKING PROHIBITED
-NOT TO SCALE-

PLAN VIEW
ON ROADWAY PARKING ALLOWED
-NOT TO SCALE-

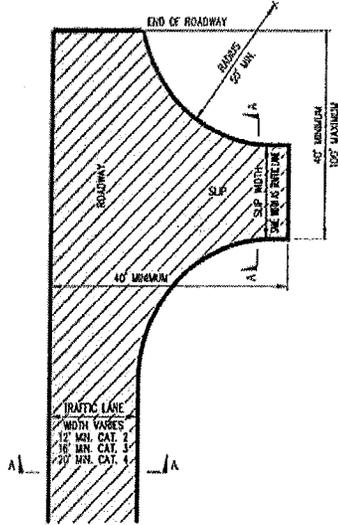
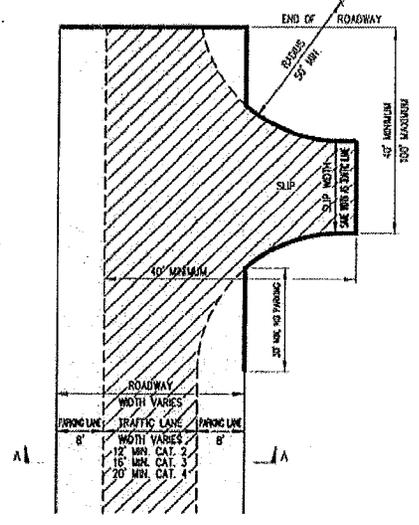
FIGURE 3112-7C
 Slip "T"

PLAN VIEW
 ON ROADWAY PARKING PROHIBITED
 -NOT TO SCALE-

PLAN VIEW
 ON ROADWAY PARKING ALLOWED
 -NOT TO SCALE-

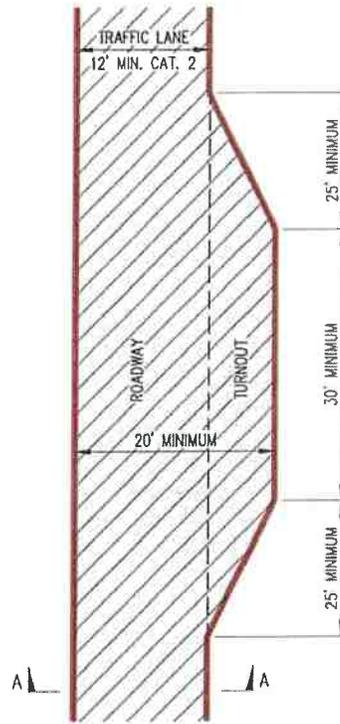
FIGURE 3112-8
Roadway Turnout

PLAN VIEW
ON ROADWAY PARKING PROHIBITED
-NOT TO SCALE-
