# TECHNICAL MEMORANDUM

## Shelter Cove Resort Improvement District #1, Recycled Water Project Summary of Walking Survey for Sensitive Species Presence and Habitat Potential

Date: November 20, 2015

Project No.: 8022.08

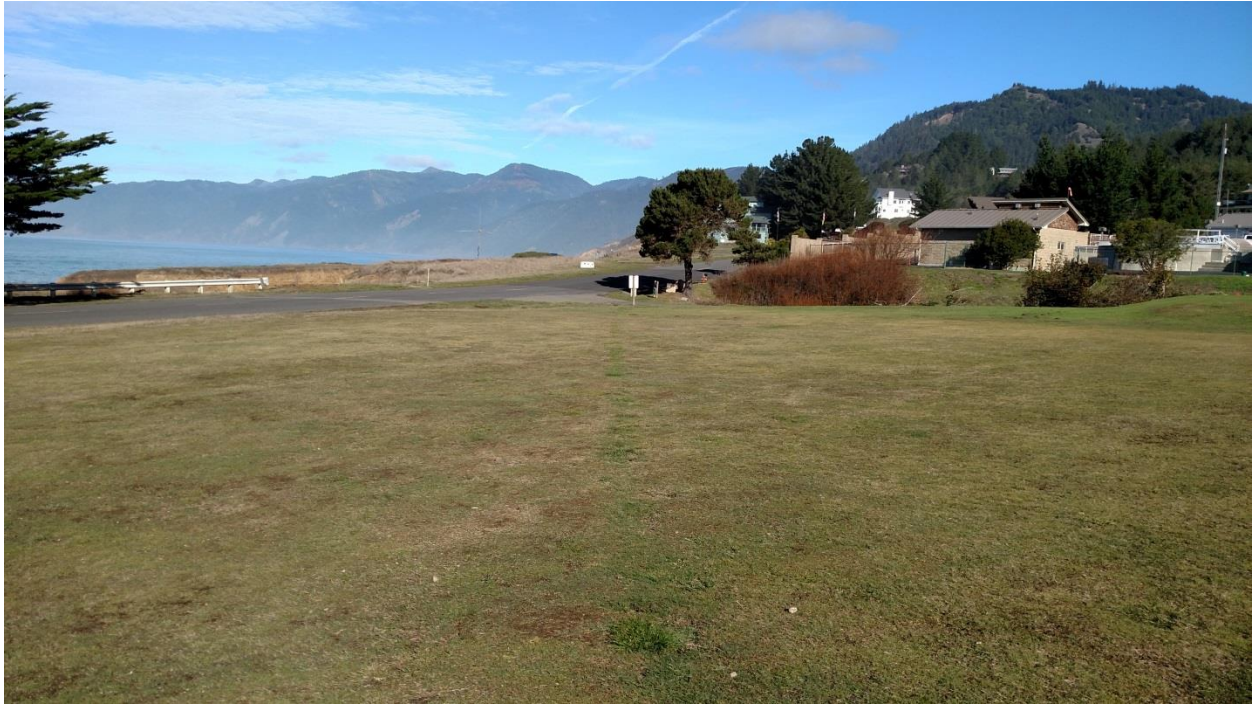
**Figure 1: Existing Pipeline Route Delineated by Vegetation**

The walking survey generally followed the course of the existing pipeline, delineated by an obvious change in vegetation along the pipeline route as well as regularly spaced Christy boxes on the west side of the runway (Figure 1). These boxes are located along the length of the pipeline between the north end of the runway and the irrigation pond on the southwest edge of the runway. Generally speaking, the golf course and runway are highly modified habitats that have been graded and compacted, and are well maintained with regular mowing. The grass on the golf course and runway apron is very short. Native shrubs are present but restricted by frequent mowing, with no large shrubs or bushy vegetation present until the property edges. Given the highly modified nature of the site, the potential for endangered and rare plants is considered low.

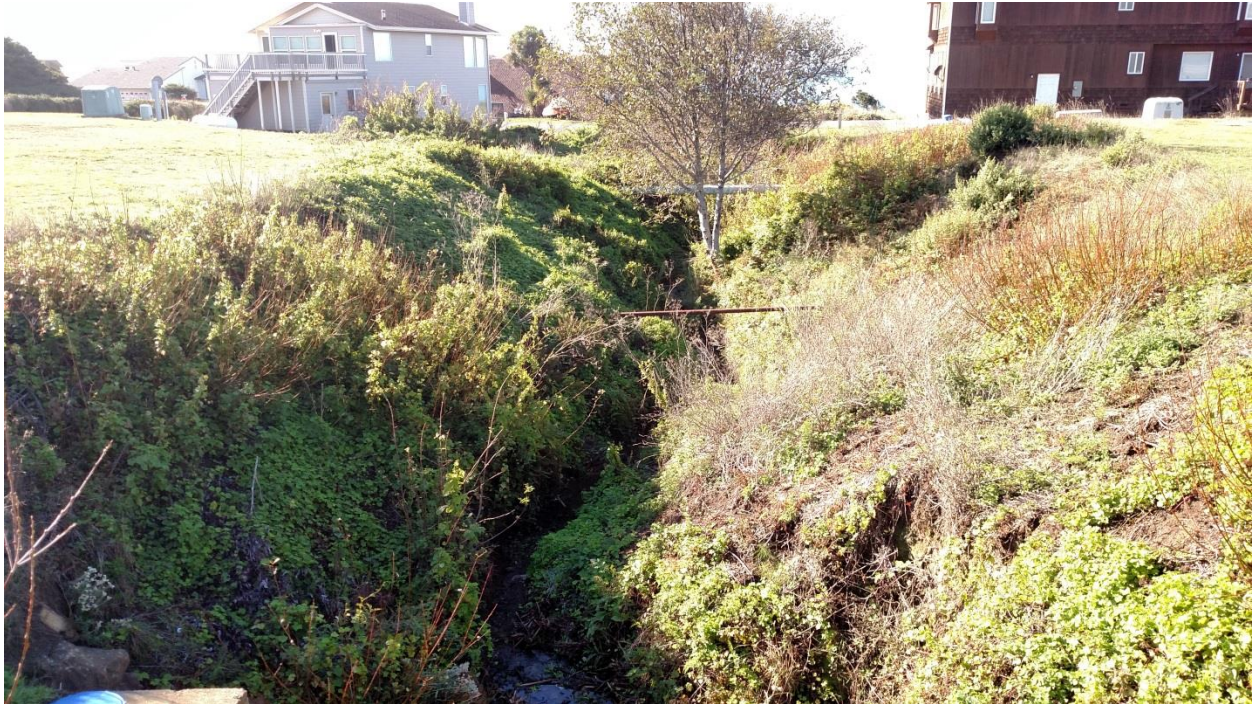
**Figure 2: Representative Riparian Habitats at Existing Culvert Outfalls**

Habitats identified along the route were limited to the culvert outfalls that drain both the creeks from east of the runway, and the existing irrigation pond that is filled with tertiary treated recycled water. These outfalls and the associated habitats were located approximately 50 feet from the edge of the runway. These were characterized by riparian vegetation associated with the culvert outfall, none of which extended beyond the edges of the small gullies created by the outfalls (Figure 2).

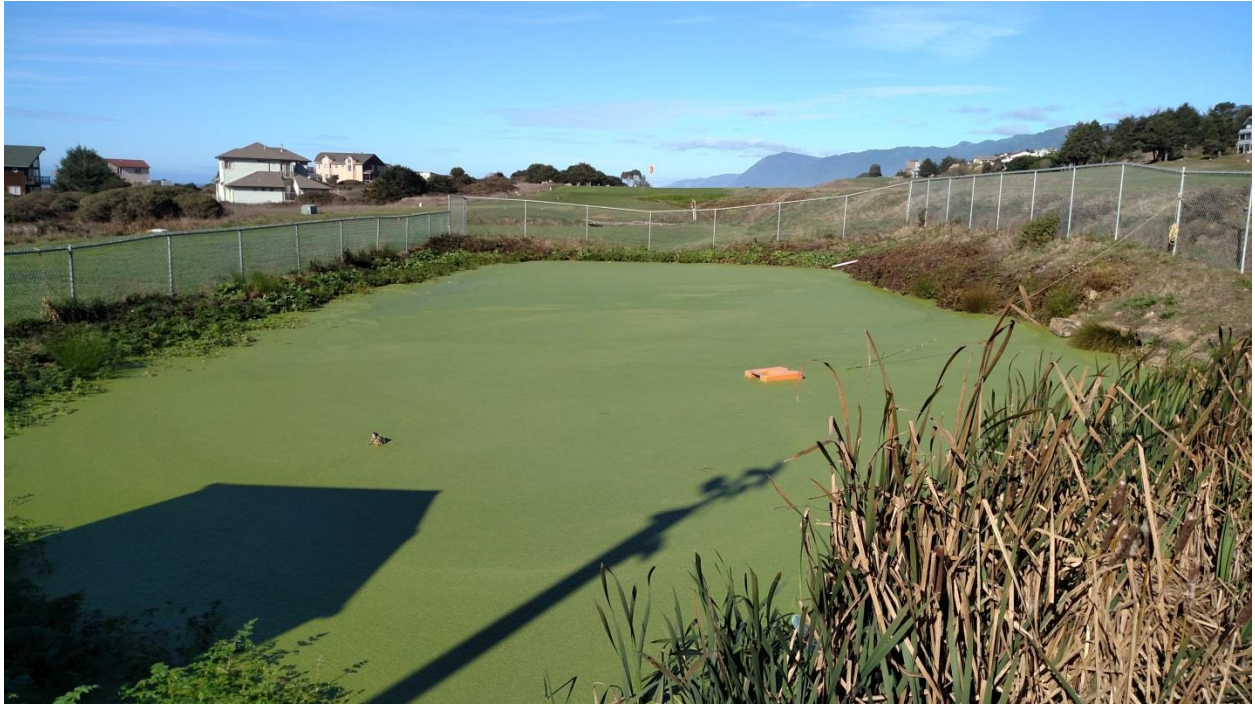
**Figure 3: Existing Irrigation Pond**

No wetland areas were encountered on the northeast corner of the runway at the proposed location for the storage tank sites. Areas exhibiting wetland characteristics were limited to the west side of the runway at the culvert outfalls and the existing irrigation pond (Figure 3), as well as the east side of the runway where the two creeks enter the culverts. These culvert inlets on the east side of the runway are located south of the proposed tank locations, and would not be impacted by the excavations required to bury the proposed storage tanks.
