Water Resource Protection Plan

WDID – 1B16435CHUM

WRPP - Mitigation Report

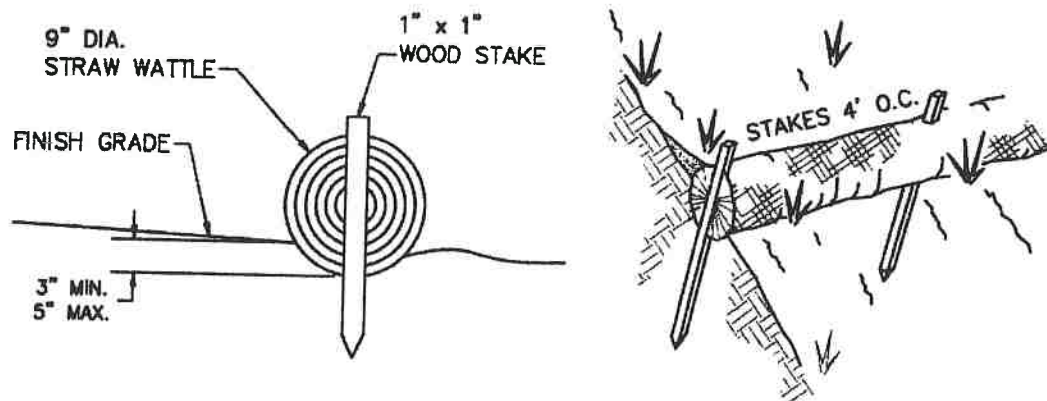
- Straw Wattles (if used) shall be installed with 18 or 24 inch wood stakes at four feet on center. The ends of adjacent straw wattles shall be abutted to each other snugly or overlapped by six inches. Wattles shall be installed so that the wattle is in firm contact with the ground surface.

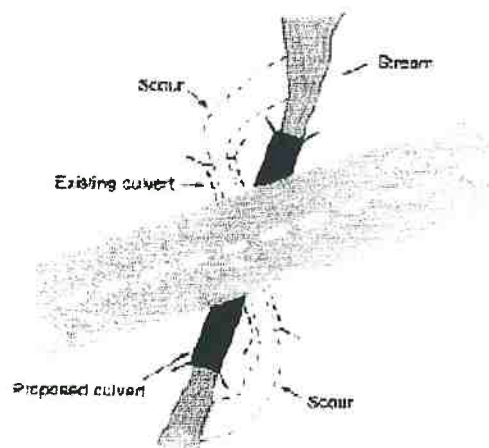
FIGURE 97. Culvert alignment should be in relation to the stream and not the road. It is important that the stream enters and leaves the culvert in a relatively straight horizontal alignment so streamflow does not have to turn to enter the inlet or discharge into a bank as it exits. This figure shows a redesigned culvert installation that replaces the bending alignment that previously existed. Channel turns at the inlet increase plugging potential because wood going through the turn will not align with the inlet. Similarly, channel turns at the inlet and outlet are often accompanied by scour against the channel banks (Wisconsin Transportation Information Center, 2004).

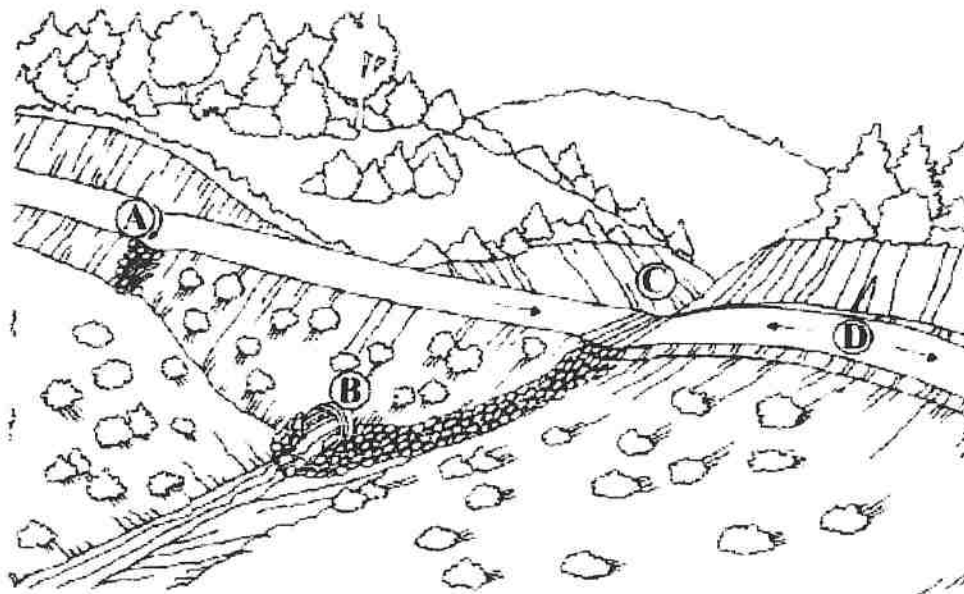
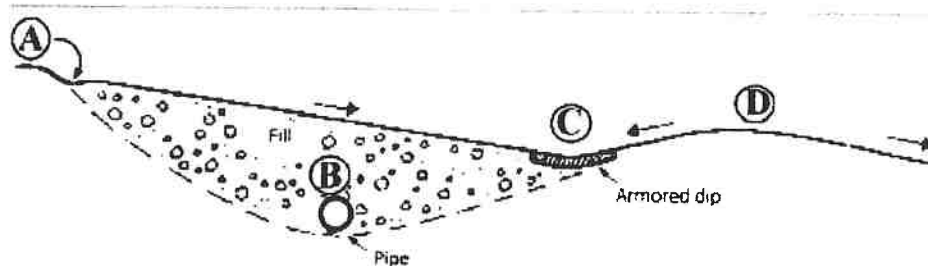
FIGURE 84. Critical dips or dipped crossing fills should be centered near a stream crossing's down-road hingeline, not over the centerline of the crossing where overtopping could cause washout or severe erosion of the fill. If the stream crossing culvert (B) plugs, water will pond behind the fill until reaching the critical dip or low point in the crossing (C) and flowing back down into the natural stream channel. The down-road ditch must be plugged to prevent streamflow from diverting down the ditch line. For extra protection in this sketch, riprap armor has been placed at the critical dip outfall and extending downslope to the stream channel. This is only required or suggested on stream crossings where the culvert is highly likely to plug and the crossing fill overtopped. The dip at the hinge line is usually sufficient to limit erosional damage during an overtopping event. Road surface and ditch runoff is disconnected from the stream crossing by installing a rolling dip and ditch relief culvert just up-road from the crossing (A) (Keller and Sherar, 2003).

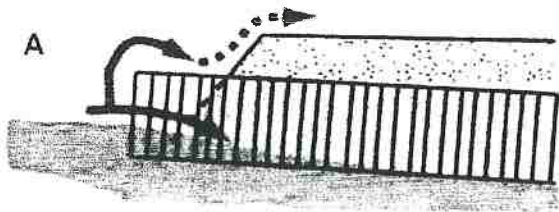
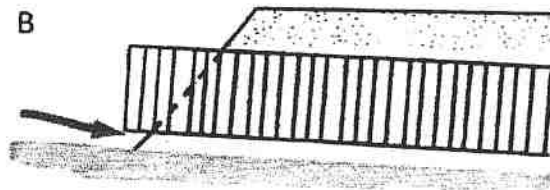
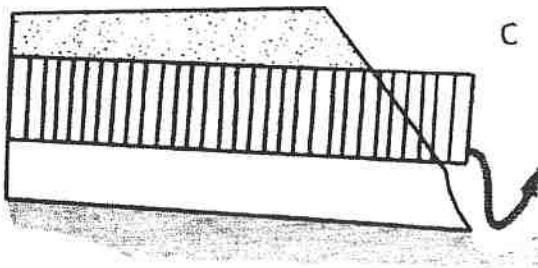
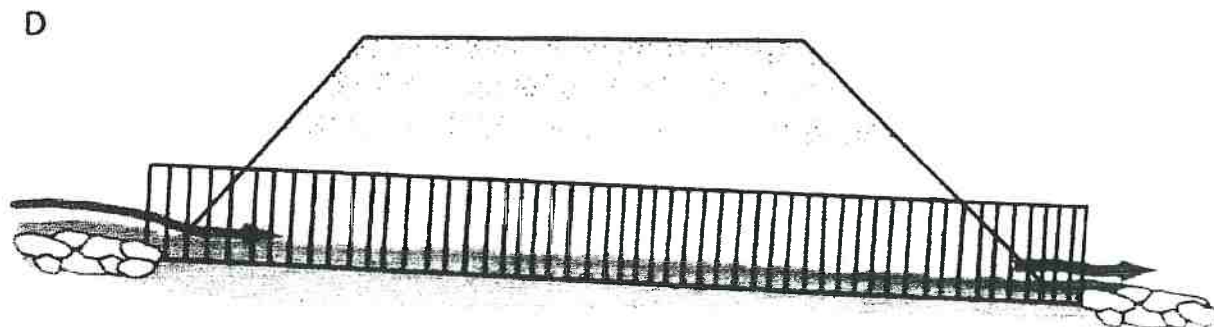
FIGURE 155. Proper culvert installation involves correct culvert orientation, setting the pipe slightly below the bed of the original stream and backfilling and compacting the fill as it is placed over the culvert. Installing the inlet too low in the stream (A) can lead to culvert plugging, yet if set too high (B) flow can undercut the inlet. If the culvert is placed too high in the fill (C) flow at the outfall will erode the fill. Placed correctly (D), the culvert is set slightly below the original stream grade and protected with armor at the inlet and outlet. Culverts installed in fish-bearing stream channels must be inset into the streambed sufficiently (~25% embedment) to have a natural gravel bottom throughout the culvert (Modified from MDSL, 1991).

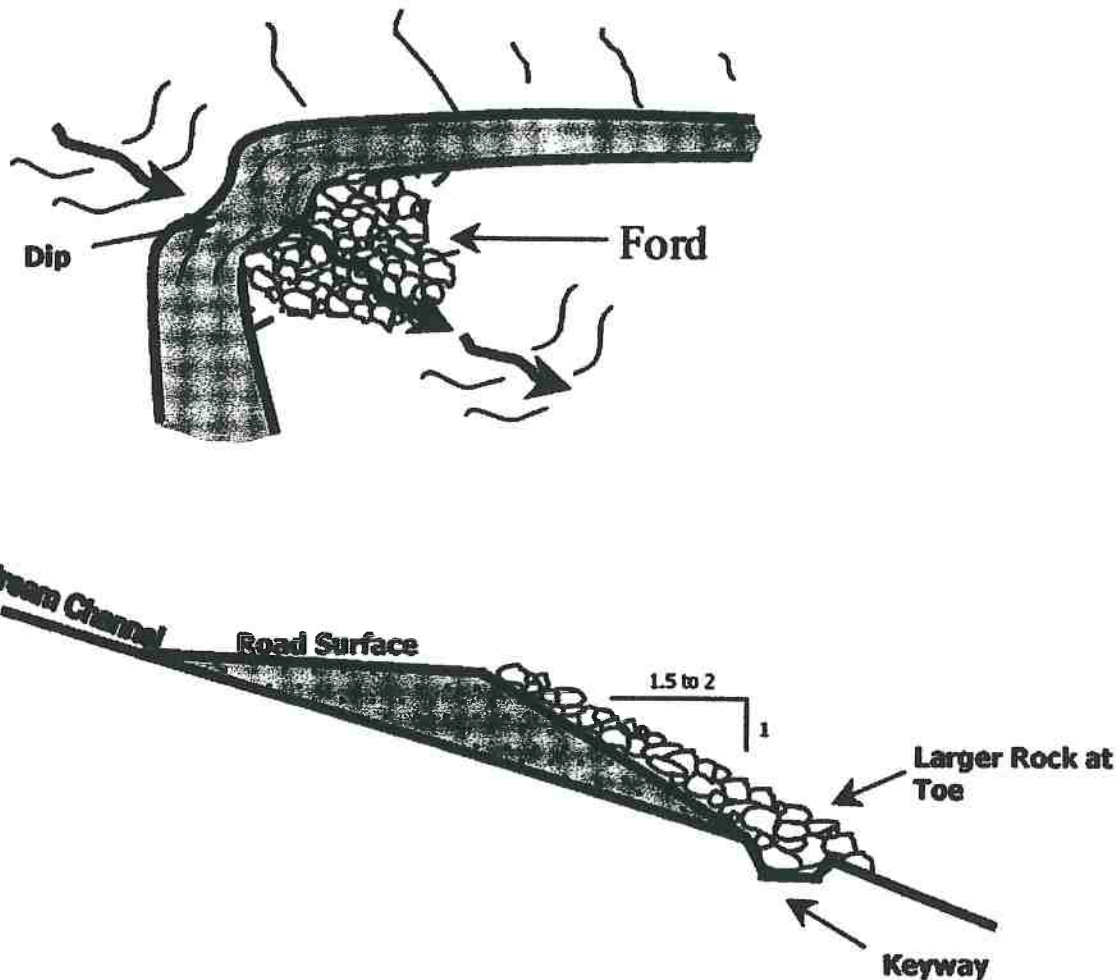
FORD: A large dip is graded into the road at the axis of the stream channel. The outside fill face is dished out to form a spillway with large rock. On large watercourses, rock is keyed several feet into firm native soils. The road surface is rocked with 6" of minus rock.

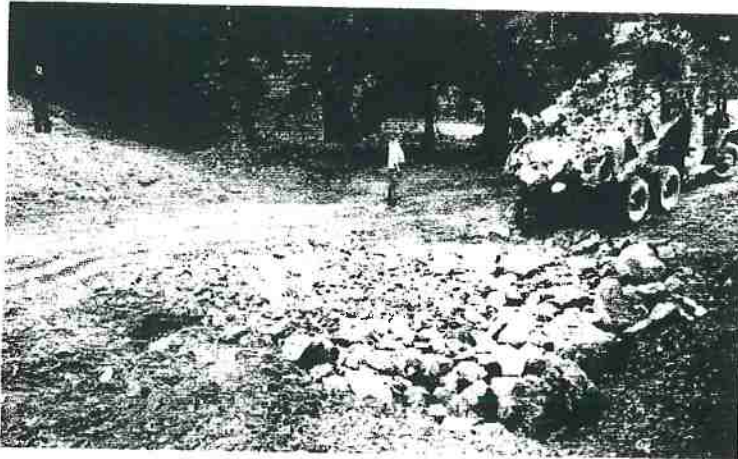
FIGURE 121D. Well graded rock armor is then backfilled into the structure and spread across the breadth of the U-shaped stream crossing, and about one-third the way up the roadbed, so that streamflow will only flow over or come in contact with resistant armor material. The armor must be spread and compacted across the design width of the expected flood flow channel width so peak flows will not flank the armored structure.

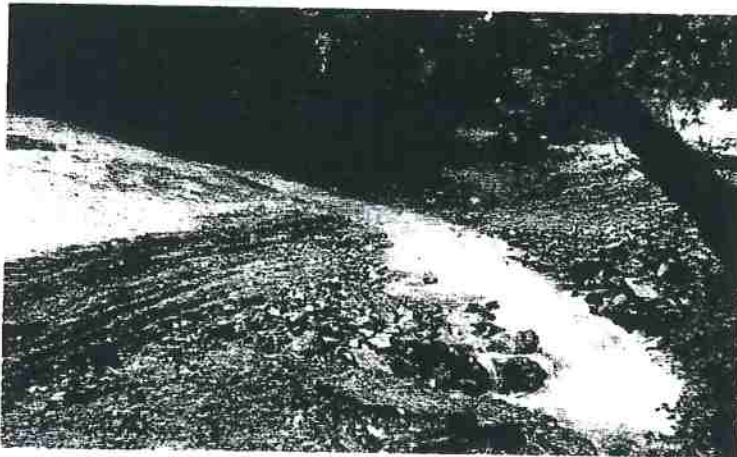
FIGURE 121E. Two weeks after this armored fill was constructed, a storm flow event occurred and the structure maintained its function and integrity. The road approaches had not yet been compacted or surfaced with road rock.

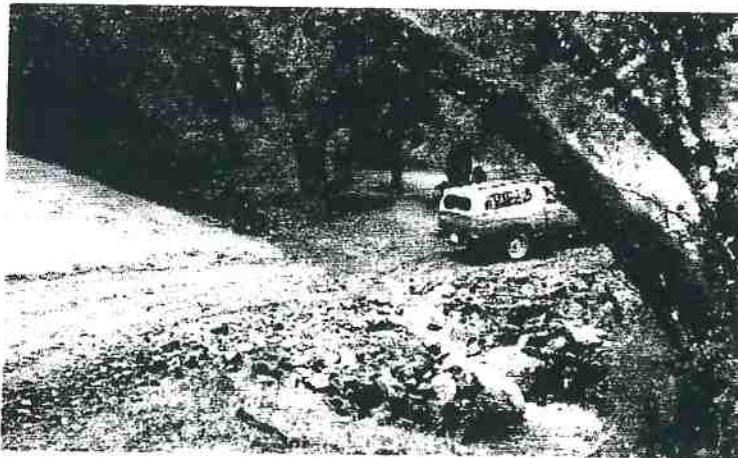
FIGURE 121F. The same armored fill as it appeared after the first winter flood flows. No maintenance was required to reopen the road. It is also clear that no stream diversion is possible at this stream crossing site, and the volume of fill within the crossing has been reduced to the minimum amount needed to maintain a relatively smooth driving surface on this low volume road.

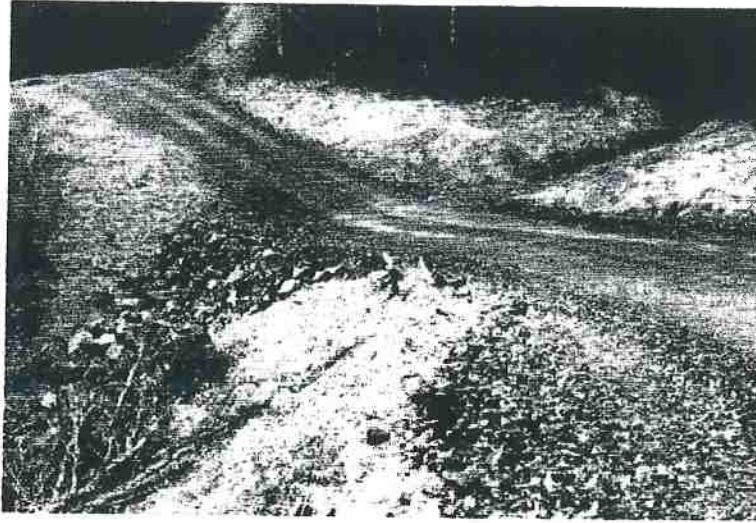
FIGURE 120. This armored fill crossing of a steep, ephemeral stream was constructed to provide a low maintenance crossing. The crossing has been deeply dipped to reduce the volume of road fill and to eliminate the potential for stream diversion. The fill slope has been heavily armored through the axis of the crossing to contain flood flows and prevent down-cutting. Armored fills cannot be used on fish bearing streams.

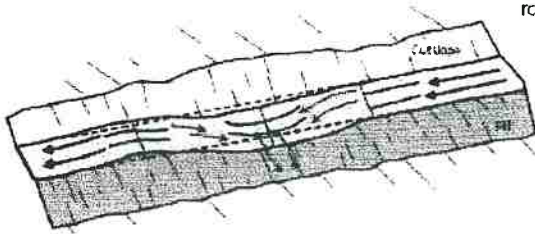
Type 1 Rolling Dip (Standard)

Type 1 rolling dips are used where road grades are less than about 12-14% and road runoff is not confined by a large through cut or berm. The axis of the dip should be perpendicular to the road alignment and sloped at 3-4% across the road tread. Steep roads will have longer and more abrupt dip dimensions to develop reverse grade through the dip axis. The road tread and/or the dip outlet can be rocked to protect against erosion, if needed.

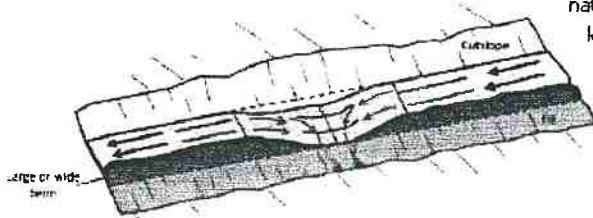
Type 2 Rolling Dip (Through-cut or thick berm road reaches)

Type 2 rolling dips are constructed on roads up to 12-14% grade where there is a through cut up to 3 feet tall, or a wide or tall berm that otherwise blocks road drainage. The berm or native through cut material should be removed for the length of the dip, or at least through the axis of the dip, to the extent needed to provide for uninterrupted drainage onto the adjacent slope. The berm and slope material can be excavated and endhailed, or the material can be sidecast onto native slopes up to 45%, provided it will not enter a stream.

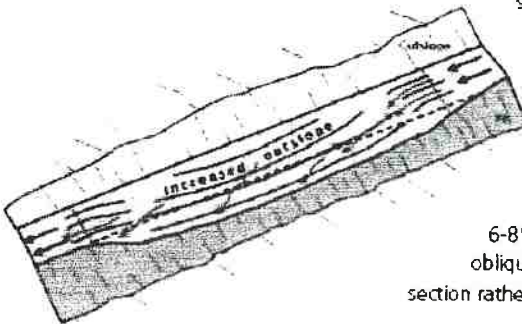
Type 3 Rolling Dip (Steep road grade)

Type 3 rolling dips are utilized where road grades are steeper than about 12% and it is not feasible to develop a reverse grade that will also allow passage of the design vehicle (steep road grades require more abrupt grade reversals that some vehicles may not be able to traverse without bottoming out).

Instead of relying on the dip's grade reversal to turn runoff off the roadbed, the road is built with an exaggerated outslope of 6-8% across the dip axis. Road runoff is deflected obliquely across the dip axis and is shed off the outsloped section rather than continuing down the steep road grade.

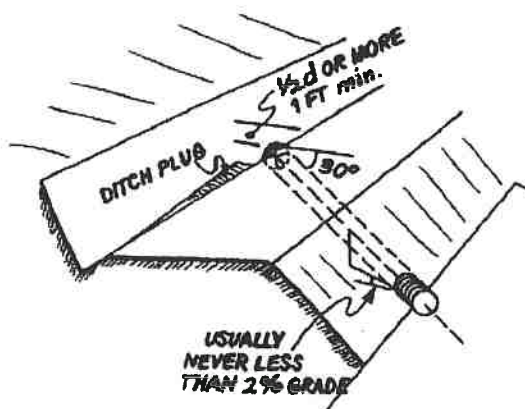
FIGURE 48. The elements of a properly installed ditch relief culvert. The culvert is angled at about 30 degrees to the road alignment to help capture flow and prevent culvert plugging or erosion of the inlet area. It is set at the base of the fill (ideally) or with a grade slightly steeper than the grade of the contributing ditch (but never with a grade less than 2 percent) (USDA-SCS, 1983). At a minimum, the grade of the ditch relief culvert should be sufficient to prevent sediment accumulation at the inlet or deposition within the culvert itself (it should be self-cleaning) (USDA-SCS, 1983).

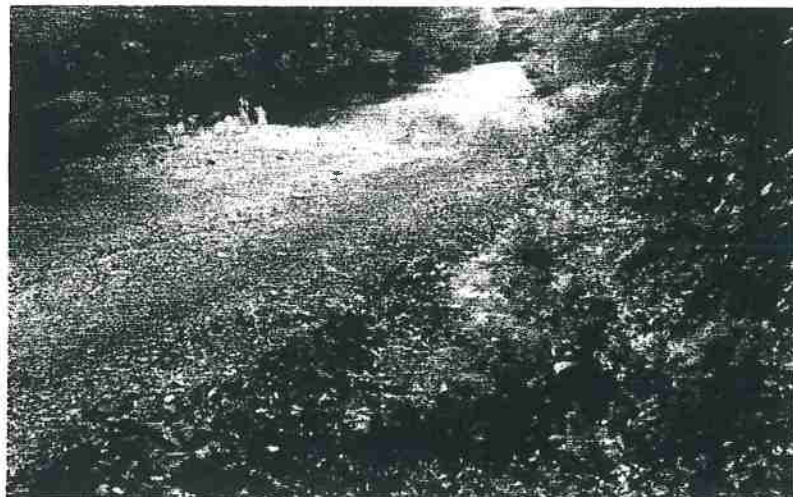
FIGURE 39.

Waterbars are often used to drain surface runoff from seasonal, unsurfaced roads. Because they are easily broken down by vehicles, waterbars are only used on unsurfaced roads where there is little or no wet weather traffic. In this photo, a waterbar and ditch relief culvert are used to drain all road surface and ditch runoff from the insloped road prism.

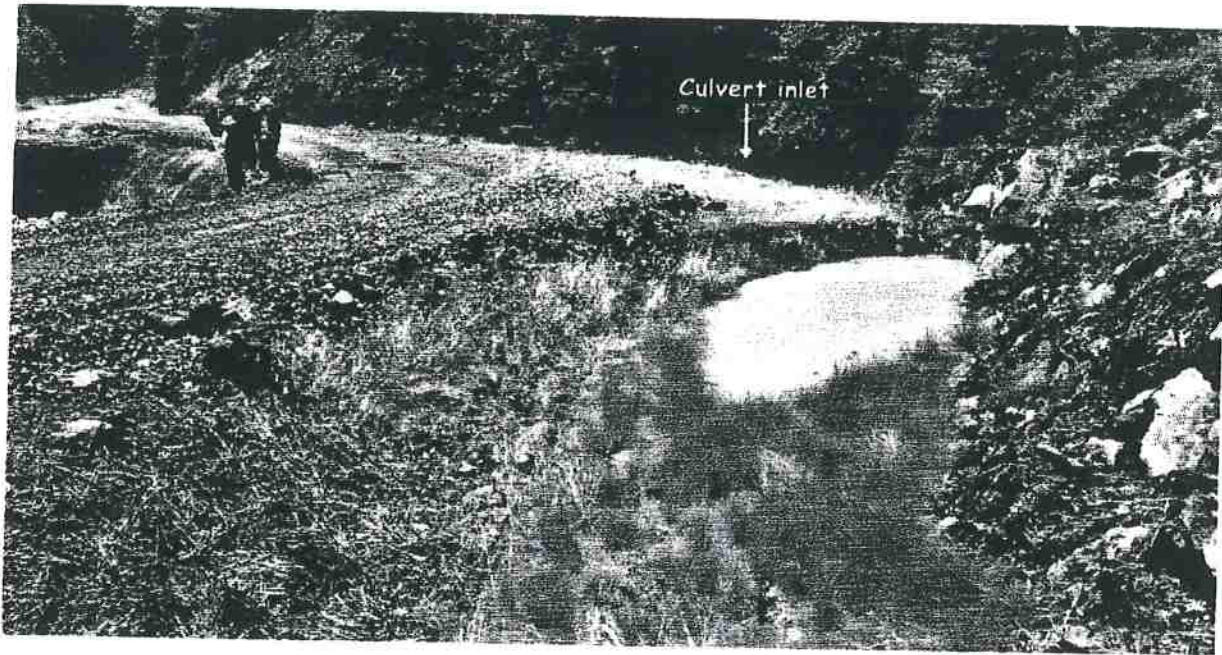
FIGURE 238. Traffic and surface runoff from graveled roads often produces surface erosion, turbid runoff and fine sediment transport that can be delivered to streams. Where ditches can't be eliminated, sediment traps and roadside settling basins can be installed to capture and remove most of the eroded sediment. This settling basin has been constructed along the inside ditch just before a stream crossing culvert inlet (see arrow). Eroded sediment from the road and ditch are deposited in the basin before flow is released to the stream. Fine sediments have filled about 1/3 of this basin and vegetation is now growing. Sediment basins require periodic maintenance to maintain their storage capacity.

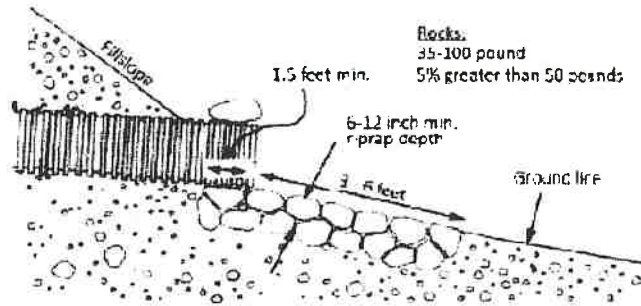
FIGURE 107A. Riprap armor at culvert outlet (Modified from: Keller et al., 2011).

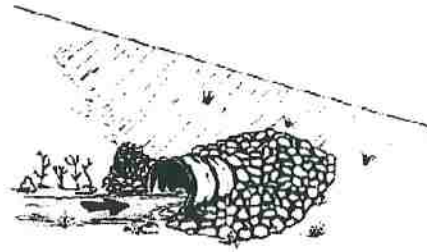
FIGURE 107B. Riprap armor at culvert inlet (Keller and Scharf, 2003).
